# Ministerial Statement Compliance Assessment Report

**Bunbury Outer Ring Road - South  
Ministerial Statement 1191**

**2025 - 2026 Reporting Period**

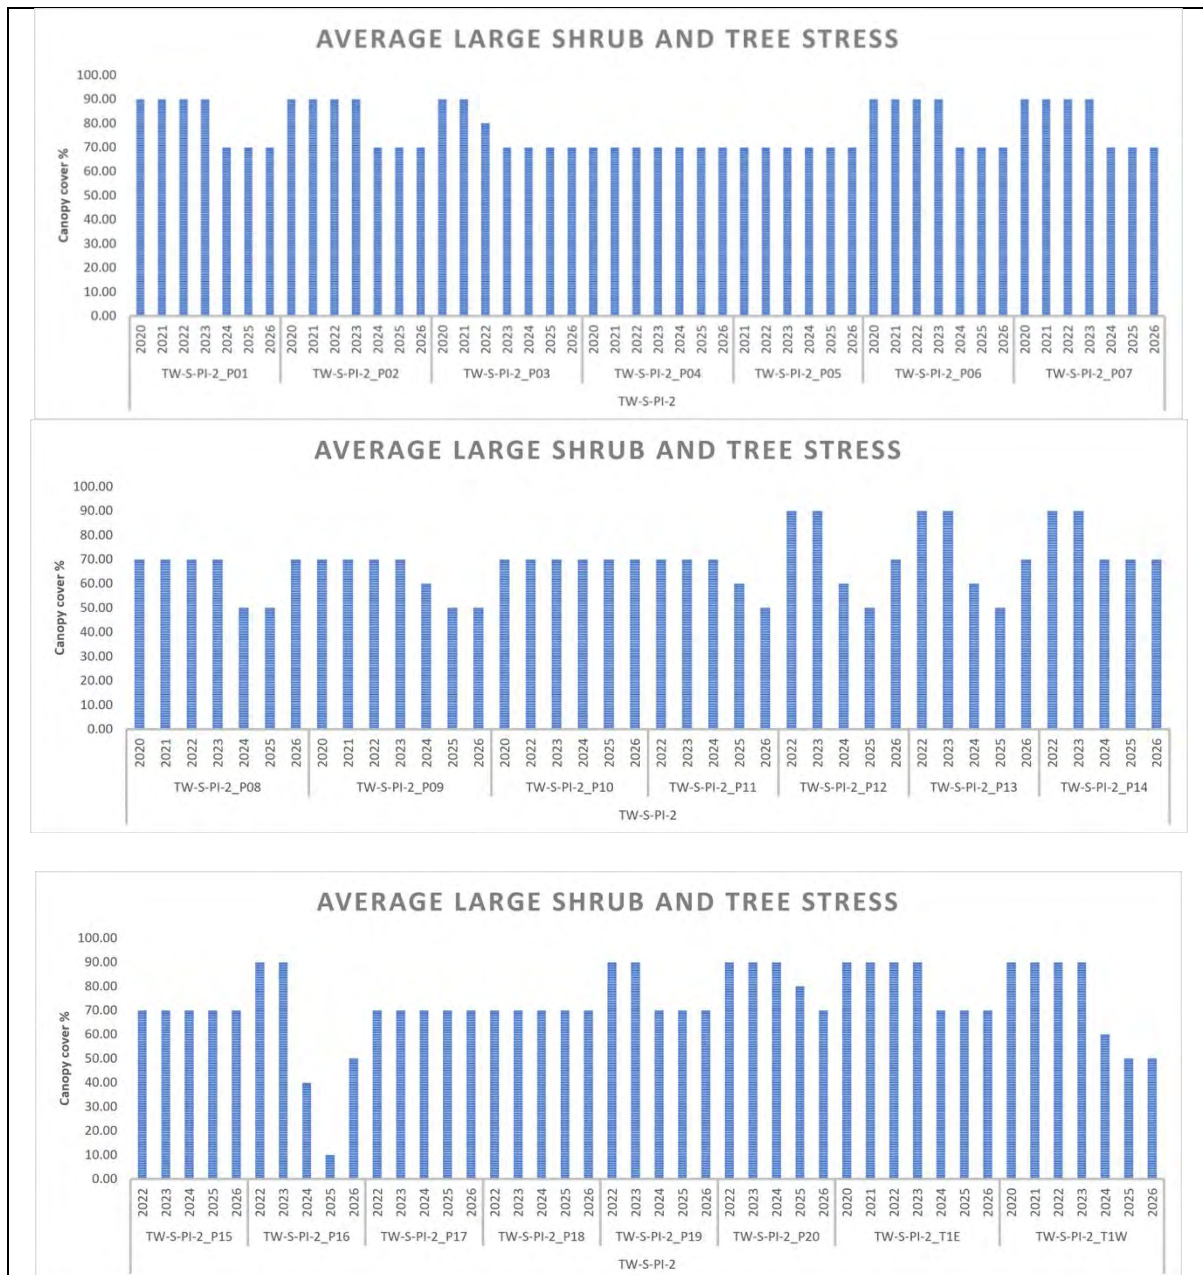
Like BW-S-PI-8, TW-S-PI-2 (**Figure 34**) experienced severe drought impacts to parts of its vegetation following the record breaking 23/24 drought and like BW-S-PI-8, there was concern that the impacts of the drought reported in the two previous monitoring rounds, Ecoedge (2024) and Ecoedge (2025), would continue and result in worsening impacts at the site. However, the above-average rainfall that followed the 2024 drought and the average rainfall in 2025 appear to have had only a limited impact, with only one site, TW-S-PI-2\_P11, showing increased stress in the autumn 2026 monitoring round. By contrast, three sites, TW-S-PI-2\_P12, P13 and P16, recorded a decrease in stress. **Plate 17** shows evidence of recovering Peppermint trees (*Agonis flexuosa*) near TW-S-PI-2\_P16.

Figure 34. Change in average large shrub and tree stress for Tuart woodland potential impact TW-S-PI-2.

There are no project attributable indirect impacts and therefore no reportable declines associated with the potential impact site TW-S-PI-2. There were no significant increases in stress for this monitoring round, and all previous increases in stress at the site are attributable to the record drought (BOM 2024a and BOM 2024b), as discussed above.

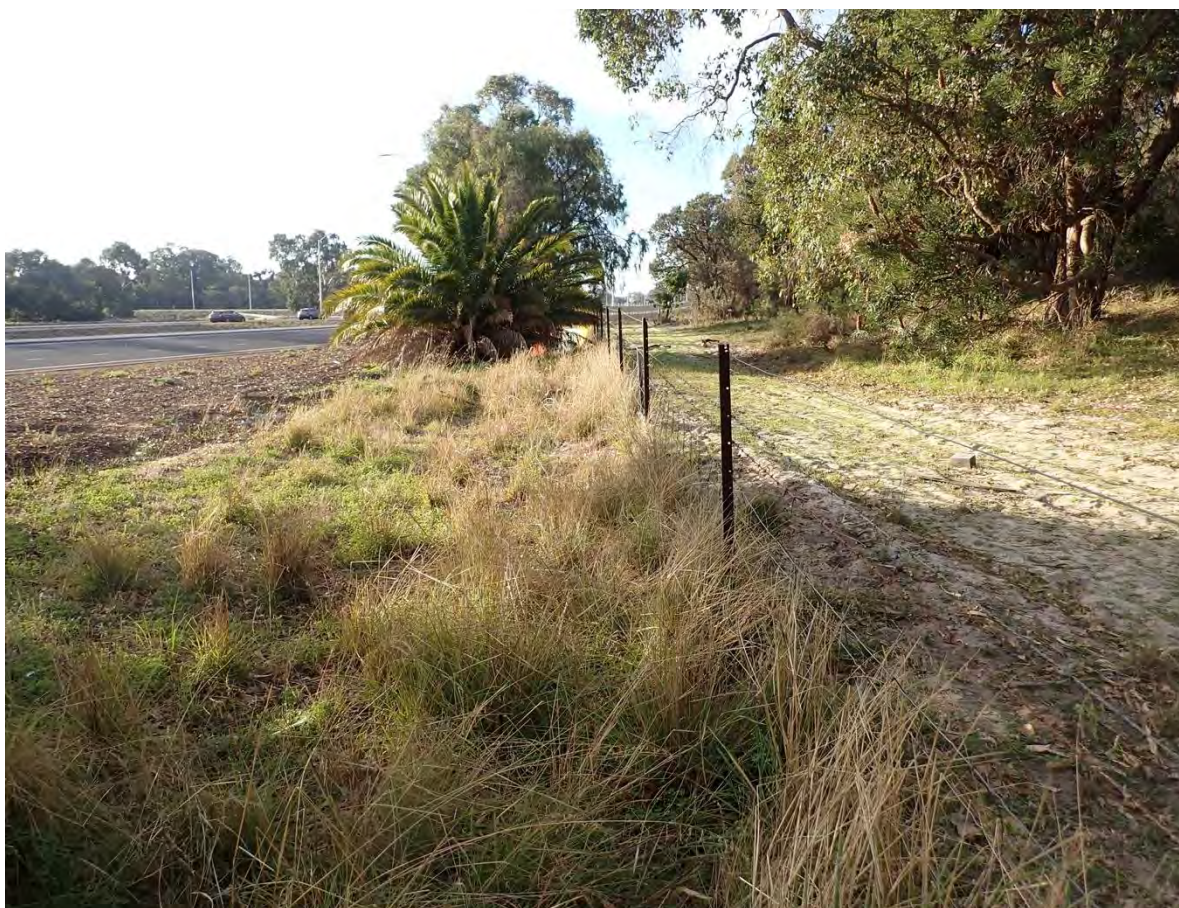
An increase in stress at TW-S-PI-3\_P01 with trees reducing their canopy cover from >81 % to 61-80% was observed for the first time in Spring 2025. Similar to TW-S-PI-3\_P03 the increase was not attributed to the BORR, as there was no logical cause for this to be case. **Plate 18** shows the area adjacent to TW-S-PI-3\_P01, including revegetation activities.

Plate 18. Revegetation activities adjacent to TW-S-PI-3\_P01 which is located on the east side of the fence.

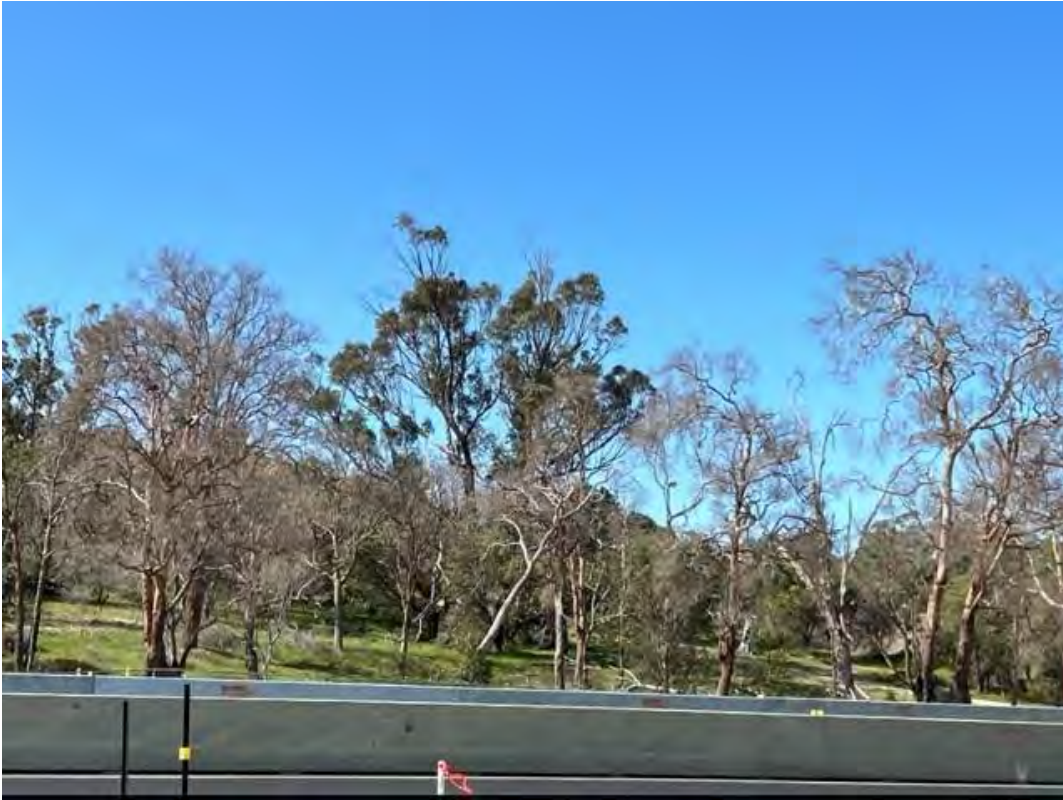
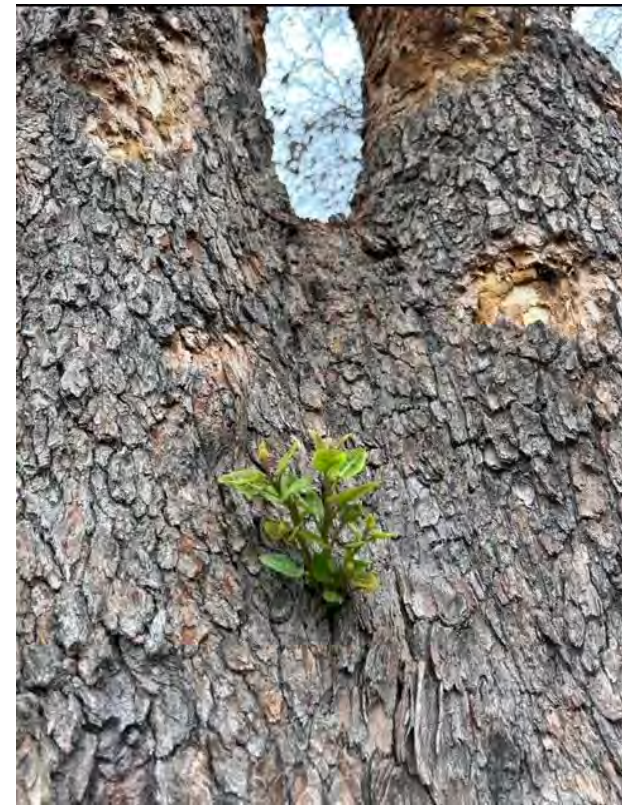
There was concern that there may be further deterioration at the impacted sites in subsequent monitoring rounds, however this has not been the case and no additional vegetation drying or decline was observed at any of the sites. The Banksia and Tuart woodland vegetation has demonstrated signs of ongoing recovery, with epicormic regrowth remaining viable and relatively healthy across previously affected individuals (**Plate 19** and **Plate 20**). A summary of the impacts at these sites is provided in **Table 17**.

Plate 19. Ongoing drying effects from autumn 2024, with trees showing signs of recovery with epicormic growth.

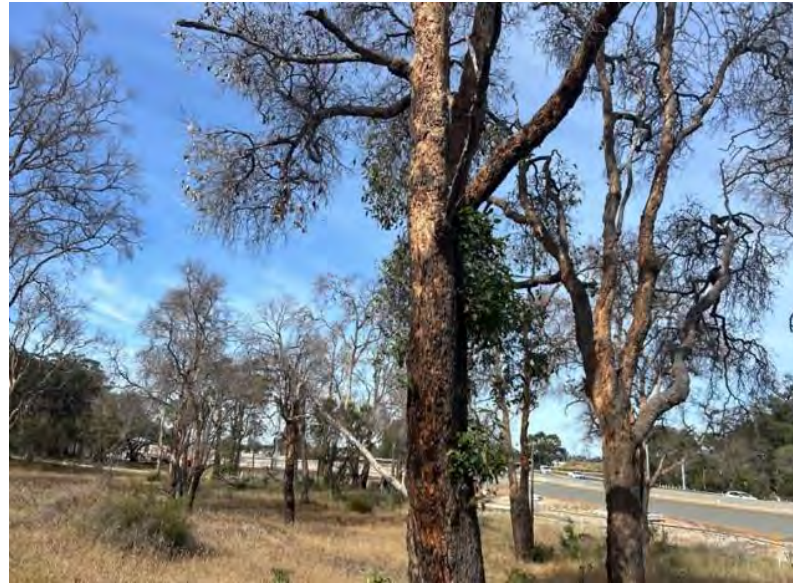
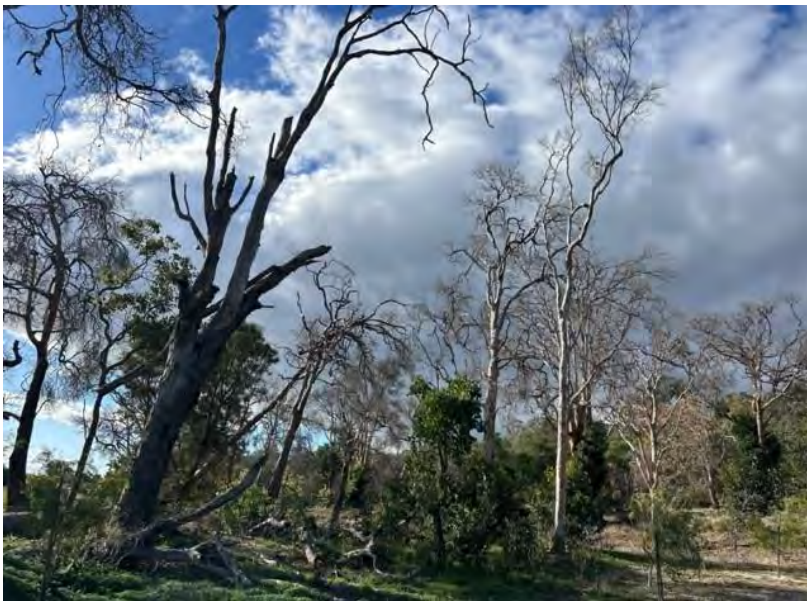
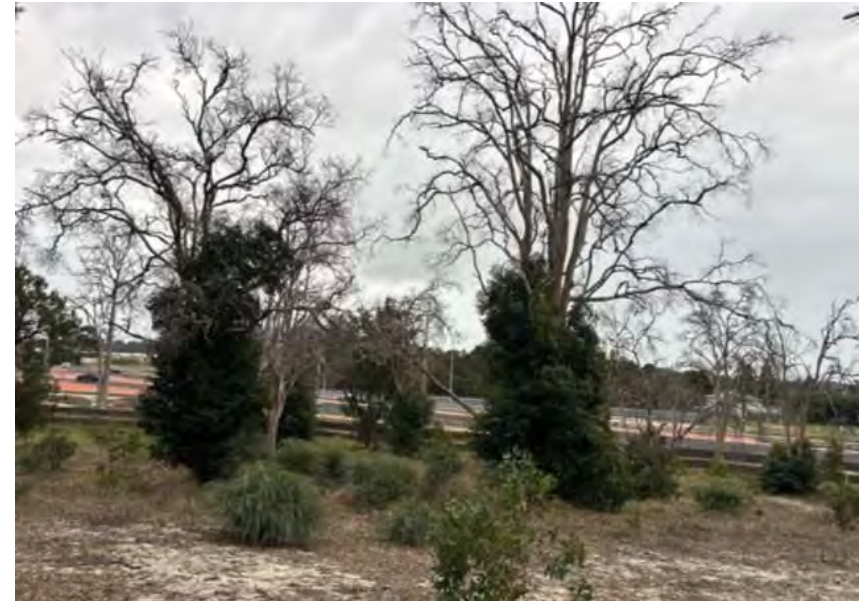
Epicormic growth in spring 2024.

Plate 20. Epicormic growth and recovery in autumn 2025

and

autumn 2026.

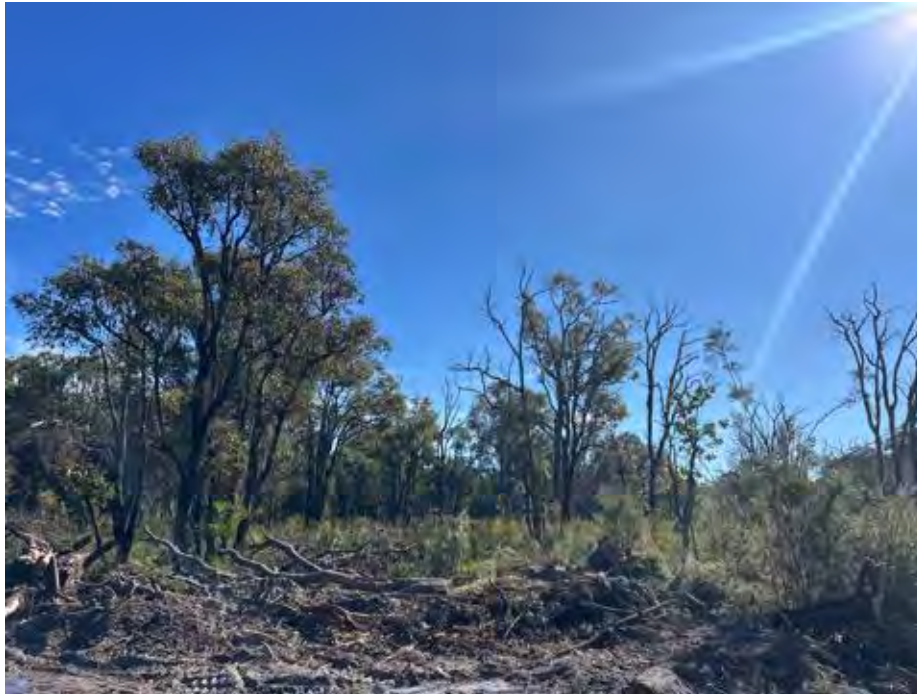
| comment_2026a | Large fire break on private property |

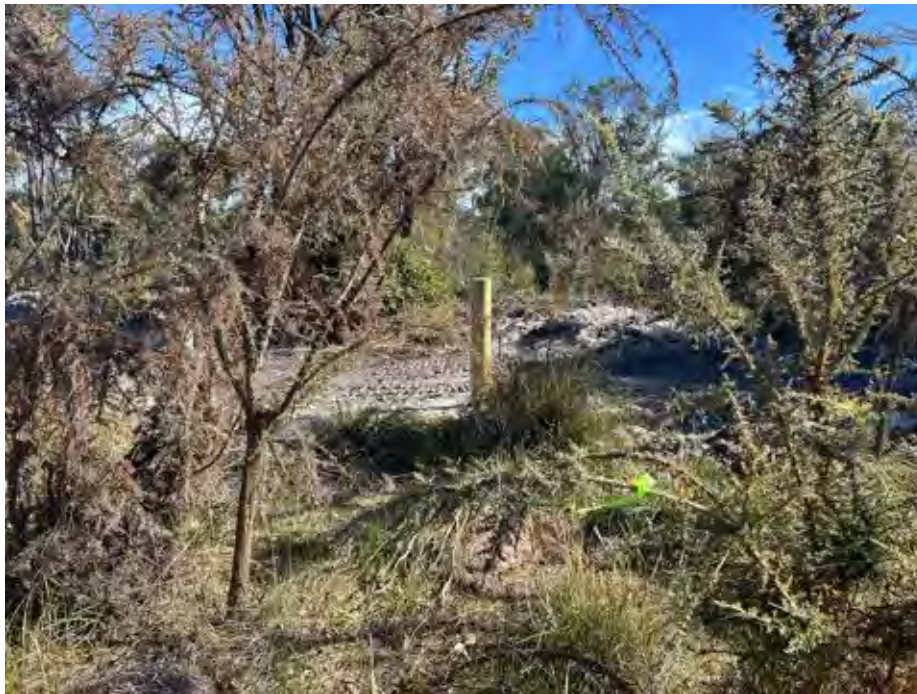
| comment_2026a | MP move out to edge of road |

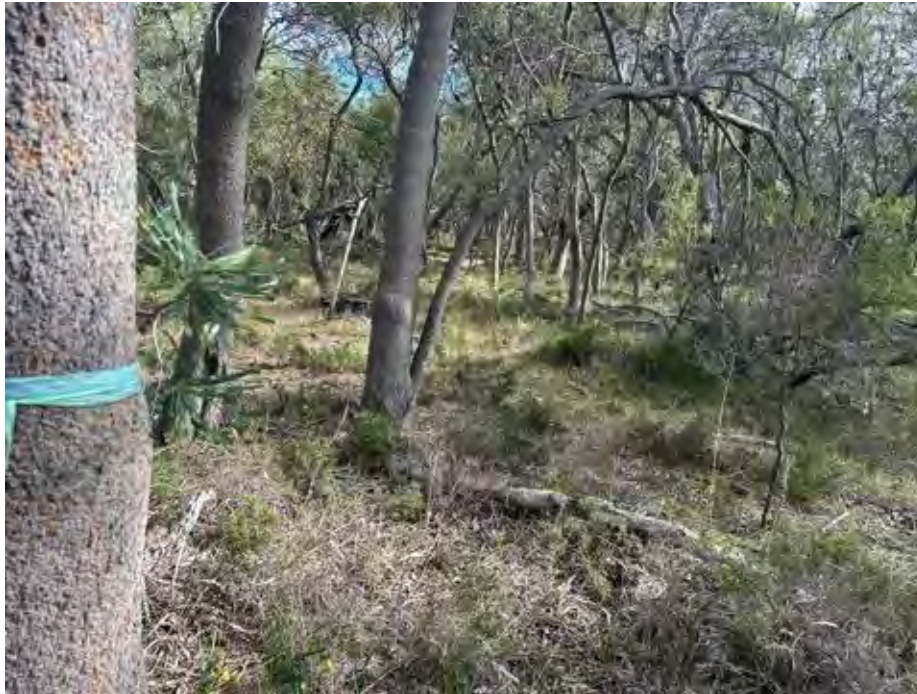
| comment_2026a | Point moved off private property |

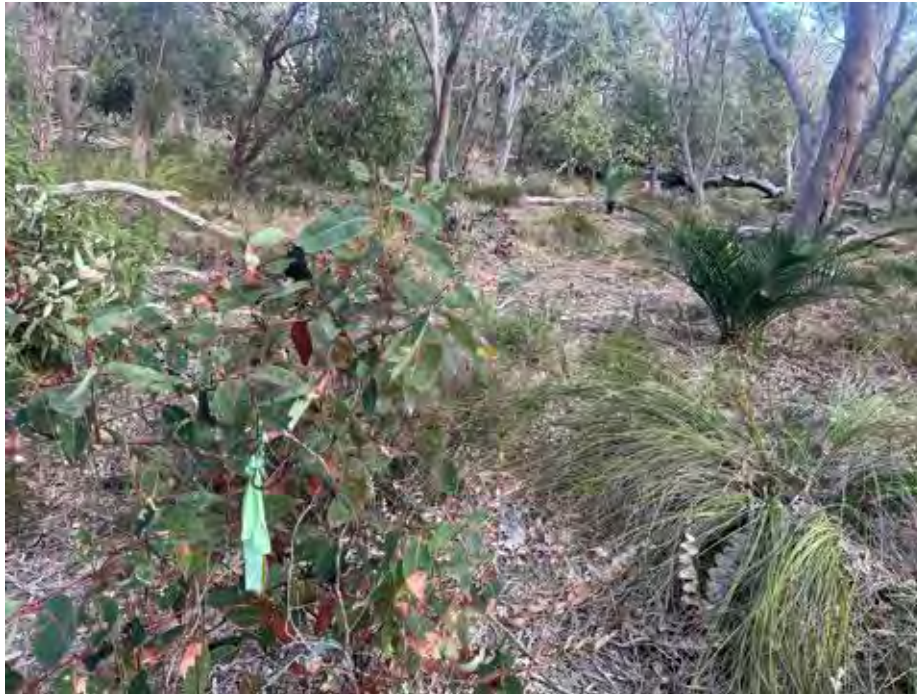
| comment_2026a | Stable |

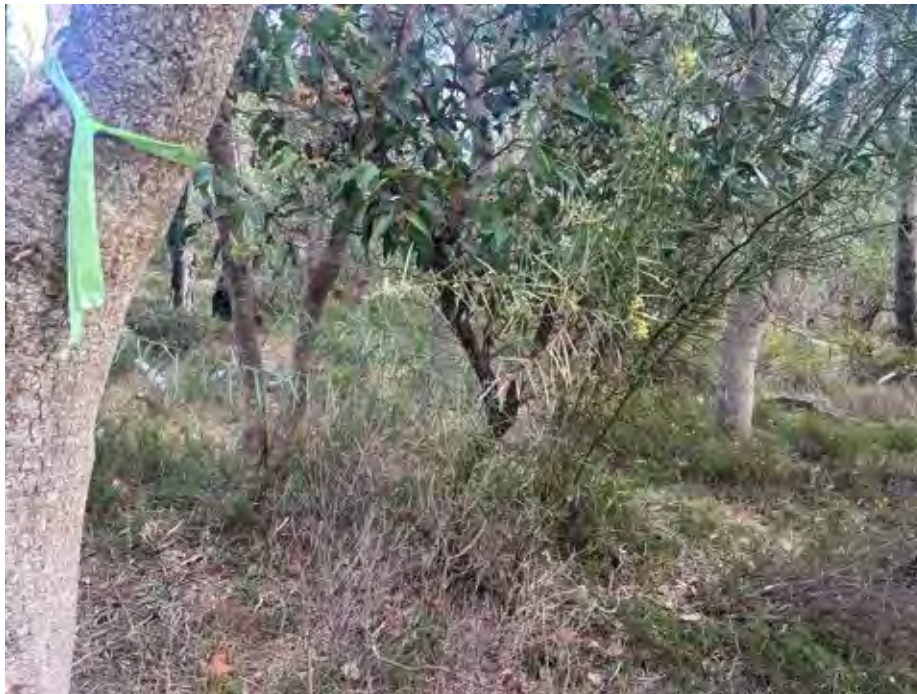
| comment_2026a | Stable |

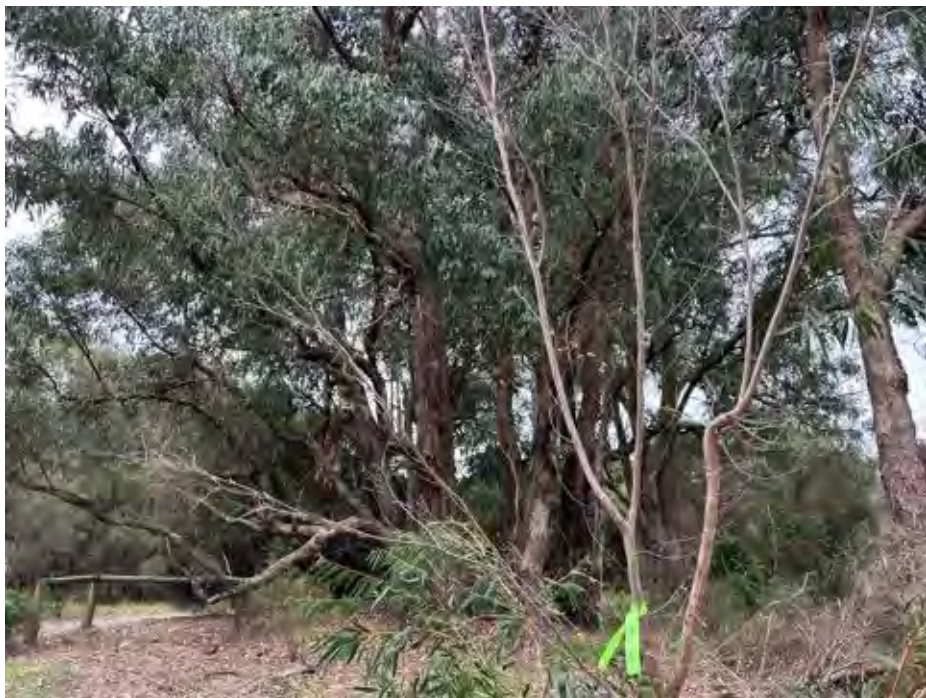
a4f3d0fd-dd05-4441-b9ce-176d57ea156e

| comment_2026a | Weedy |

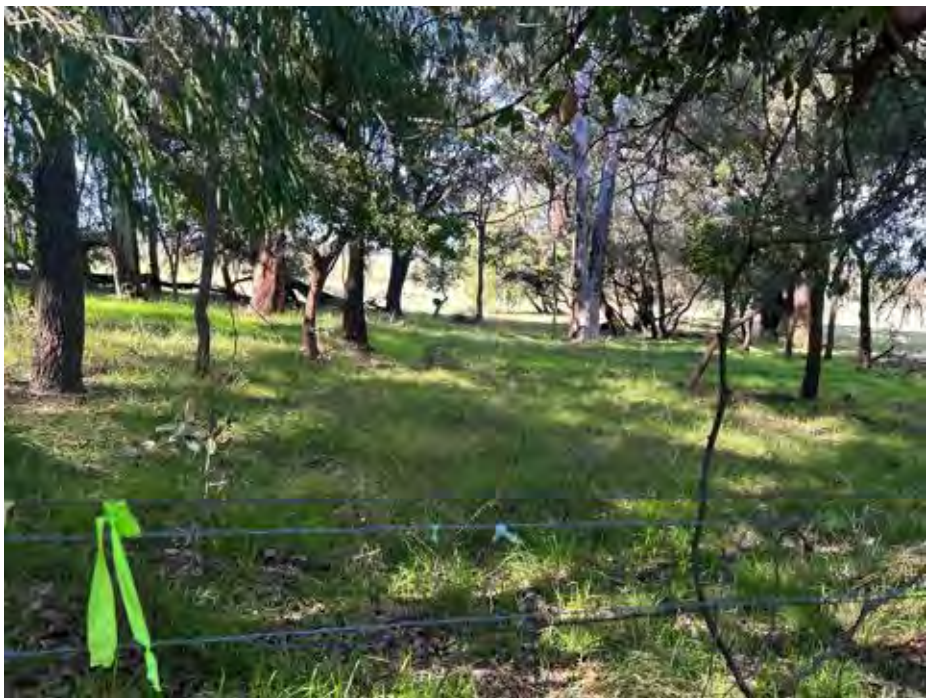
1d5379a5-f248-432f-91ff-009c6d69d87b

| comment_2026a | New fence |

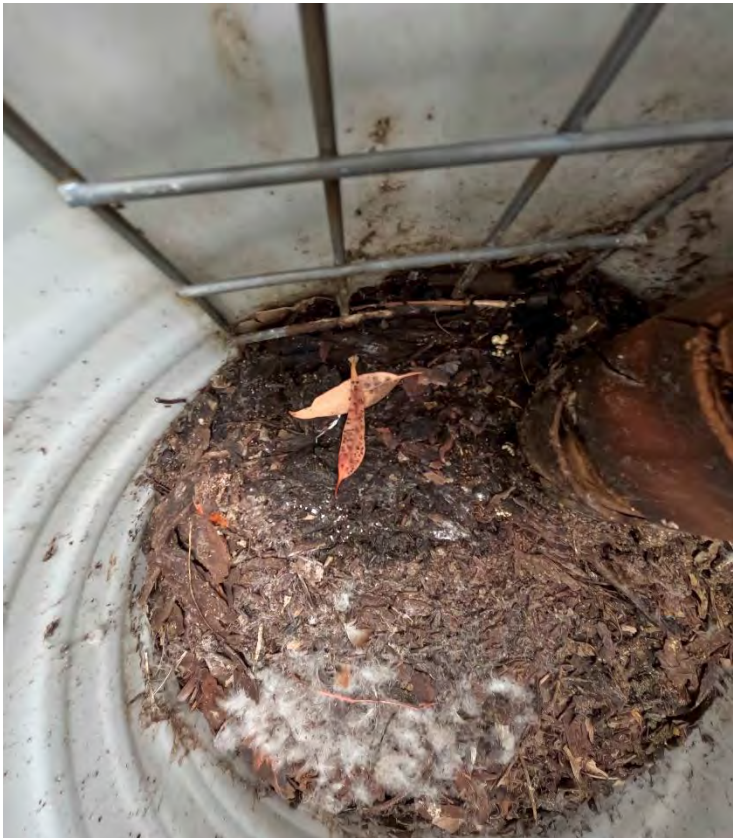
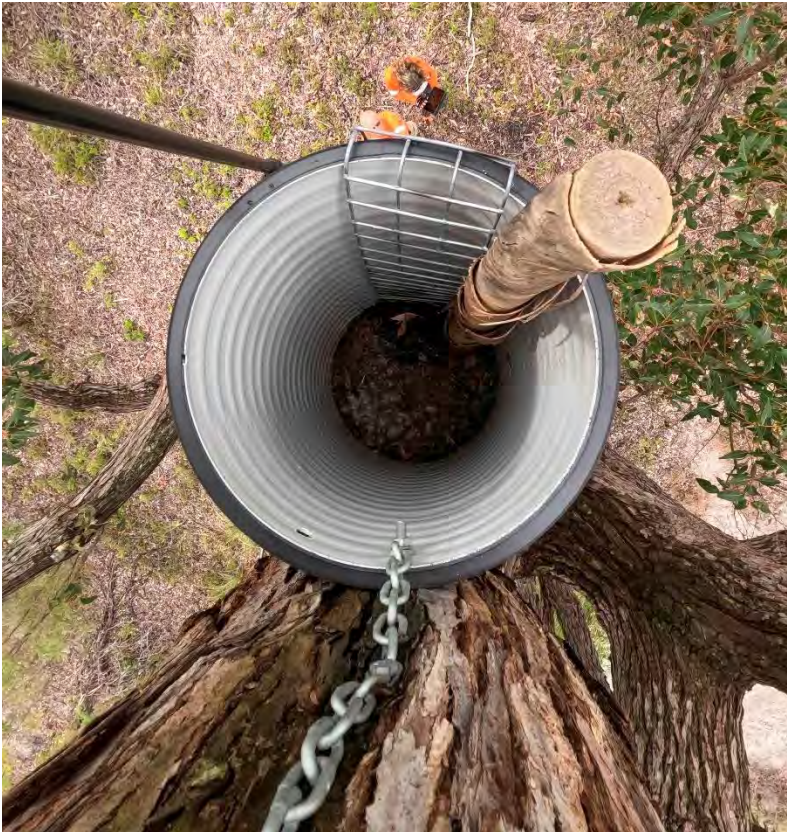
Artificial Hollow D01

| Hollow No | Comments | Chipping score 0-10 | Wood Chips | Tree condition | Fixings and Hollow condition | Recommended repairs |
|---|---|---|---|---|---|---|
| D01 | No signs of nesting or inspection by Black Cockatoos. Duck at base of hollows | 0 | Nil | Good | Good | Nil |

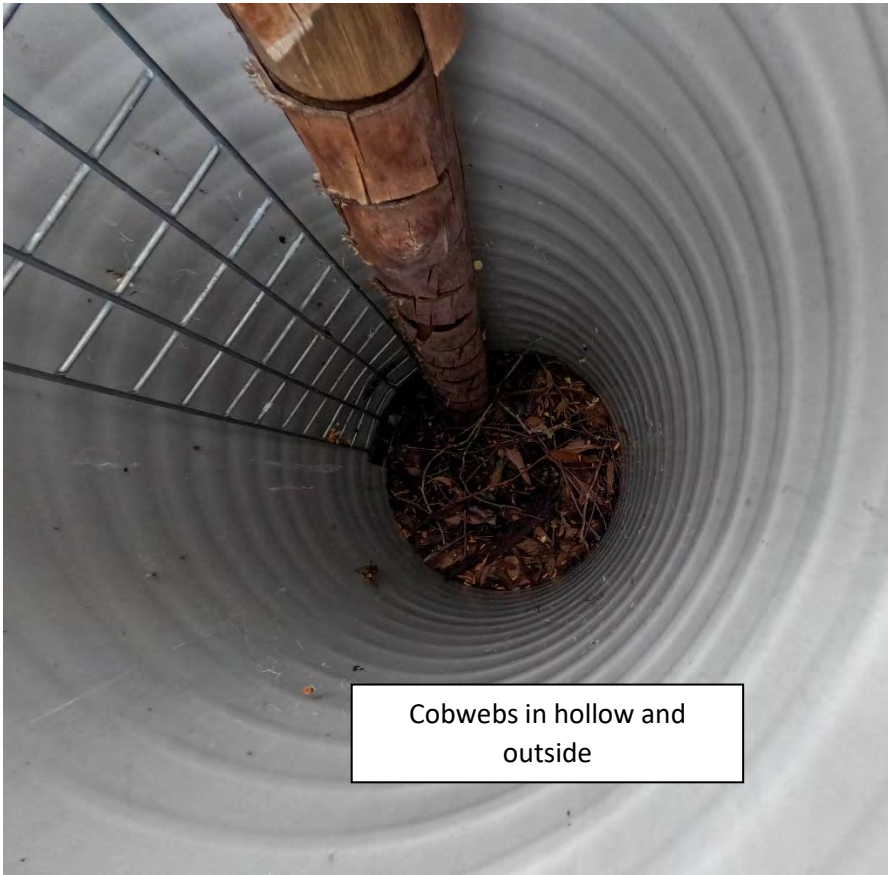
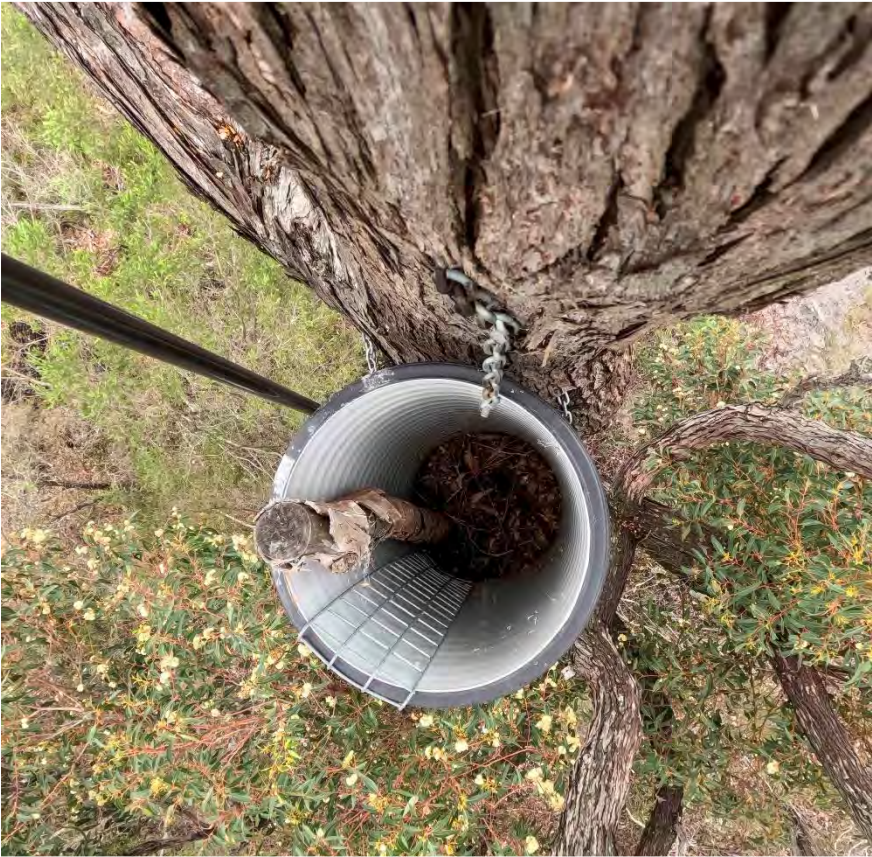
# Artificial Hollow D02

| Hollow No | Comments | Chipping score 0-10 | Wood Chips | Tree condition | Fixings and Hollow condition | Recommended repairs |
|---|---|---|---|---|---|---|
| D02 | No signs of nesting or inspection by Black Cockatoos. Cobwebs | 0 | Nil | Good | Good | Nil |

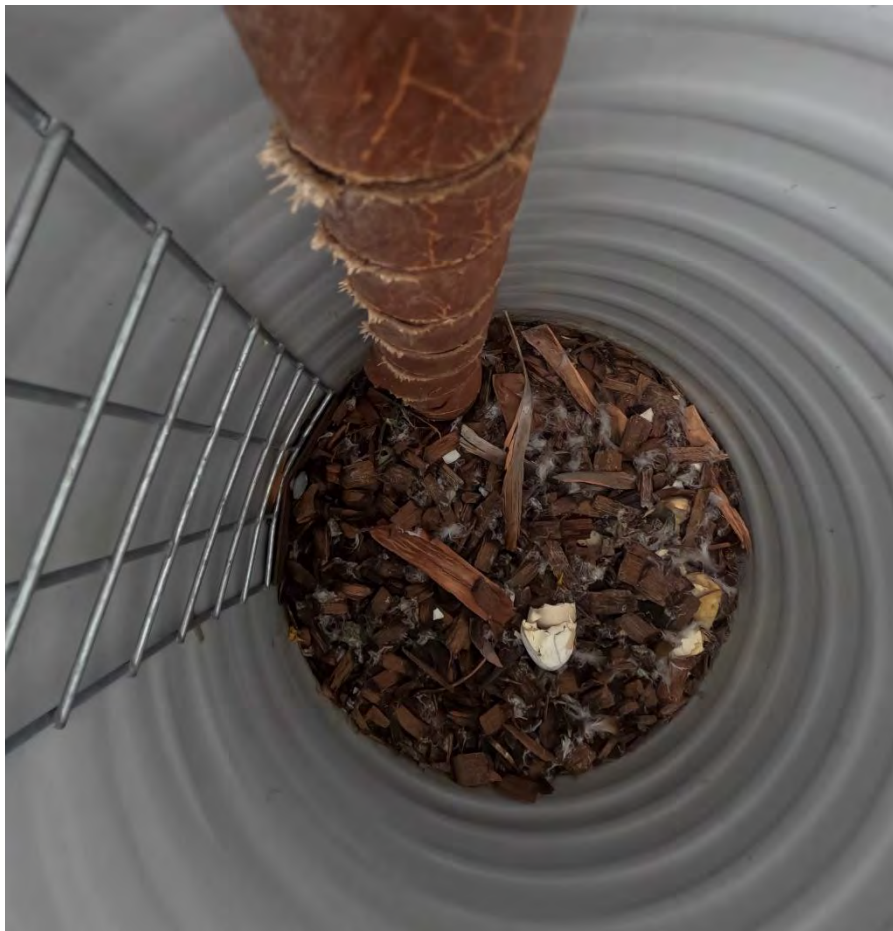
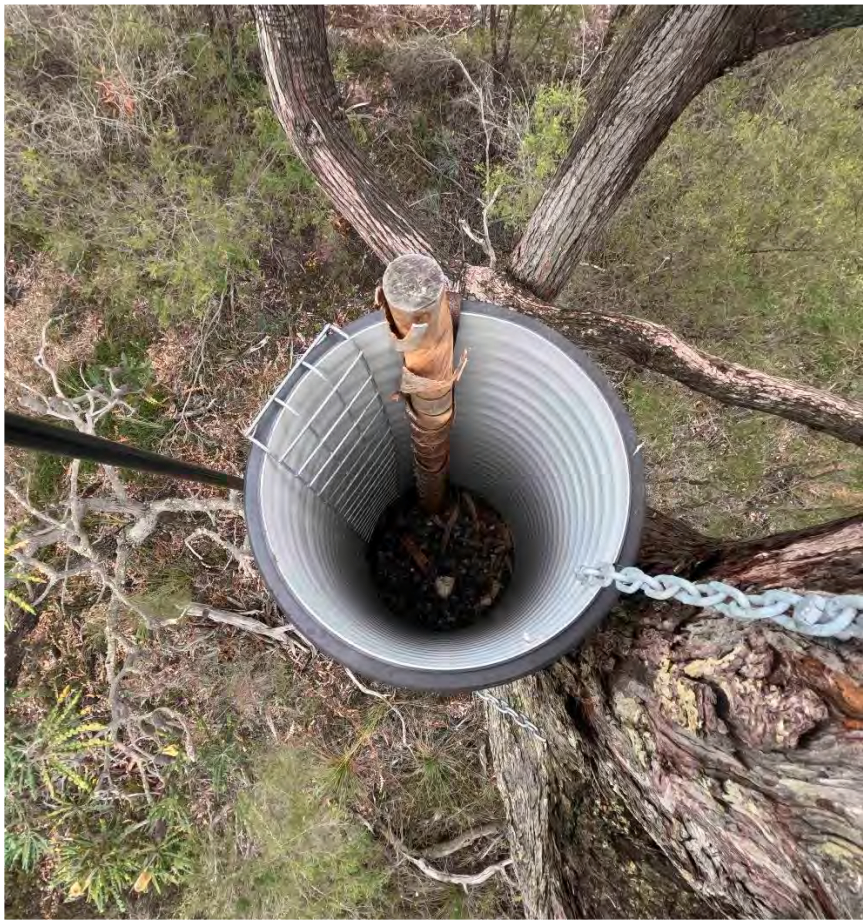
# Artificial Hollow D03

| Hollow No | Comments | Chipping score 0-10 | Wood Chips | Tree condition | Fixings and Hollow condition | Recommended repairs |
|---|---|---|---|---|---|---|
| D03 | No signs of nesting or inspection by Black Cockatoos. Cobwebs at entry, duck down and one broken duck egg | 0 | Nil | Good | Good | Nil |

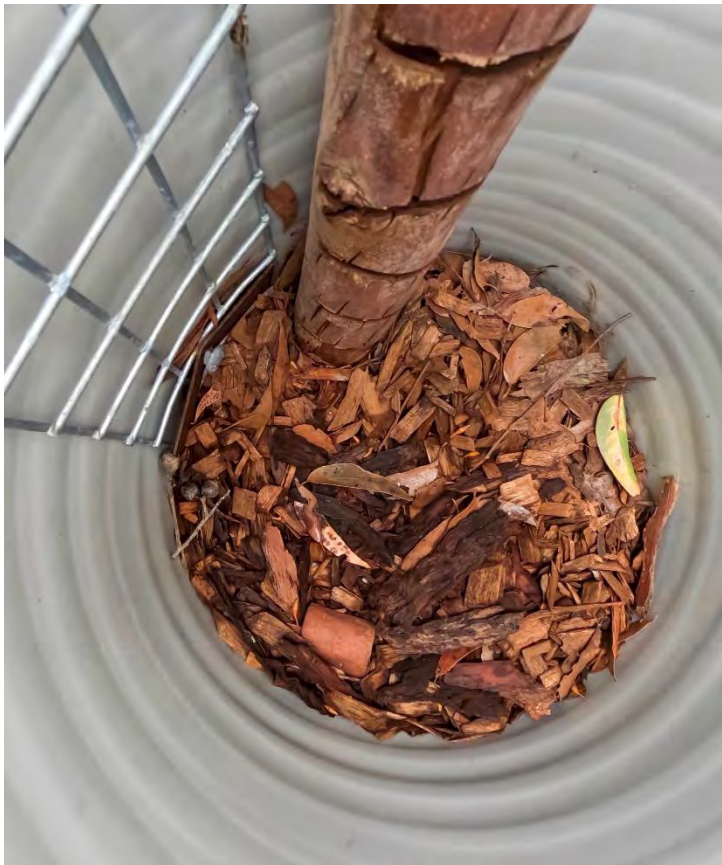
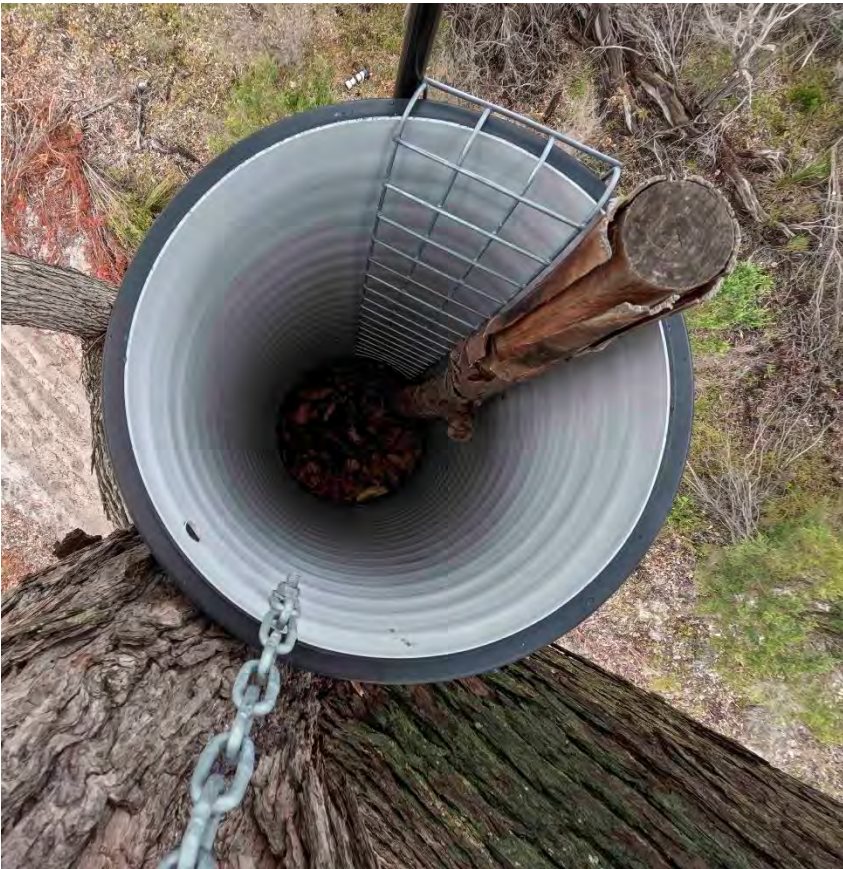
# Artificial Hollow D04

| Hollow No | Comments | Chipping score 0-10 | Wood Chips | Tree condition | Fixings and Hollow condition | Recommended repairs |
|---|---|---|---|---|---|---|
| D04 | No signs of nesting or inspection by Black Cockatoos | 0 | Nil | Good | Good | Nil |

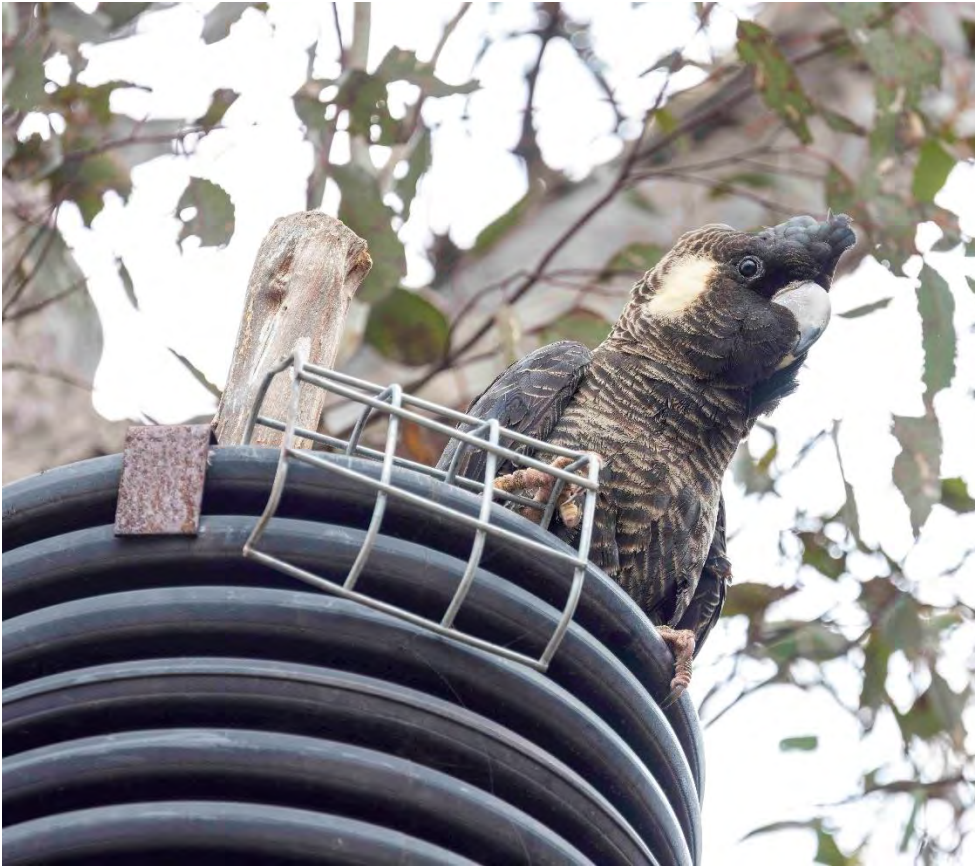
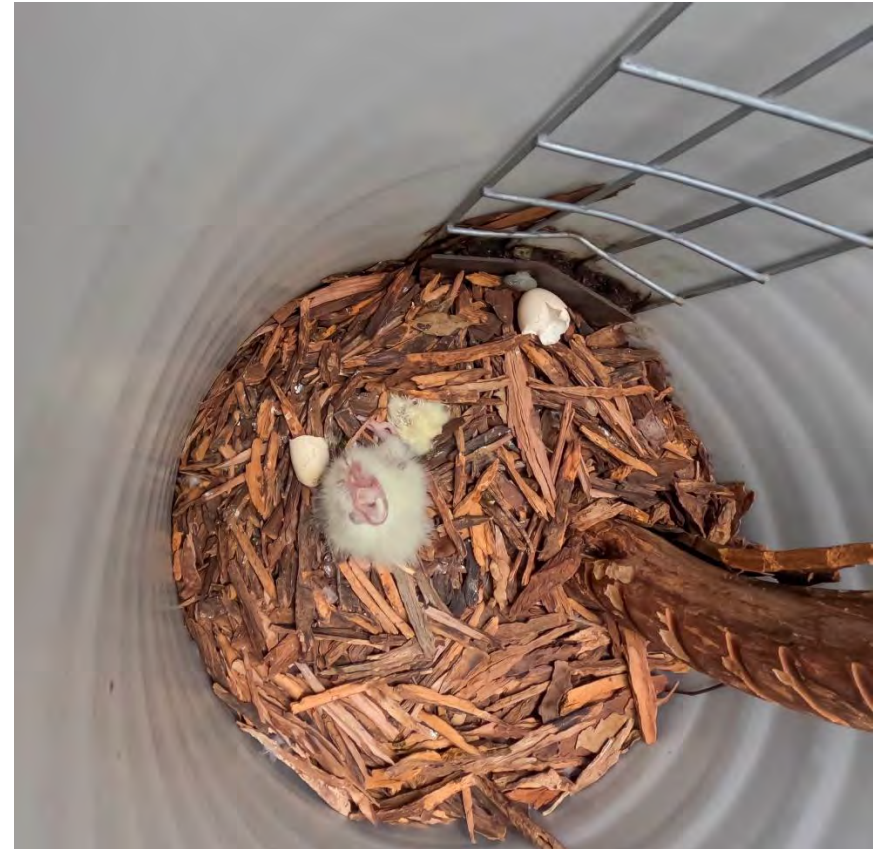
## Artificial Hollow BY01

| Hollow No | Comments | Chipping score 0-10 | Wood Chips | Tree condition | Fixings and Hollow condition | Recommended repairs |
|---|---|---|---|---|---|---|
| BY01 | Female CC Flushed 1 x 8-10day old CC nestling, second CC nestling dead (48hrs) | 3 | Nil | Good | Good | Nil |

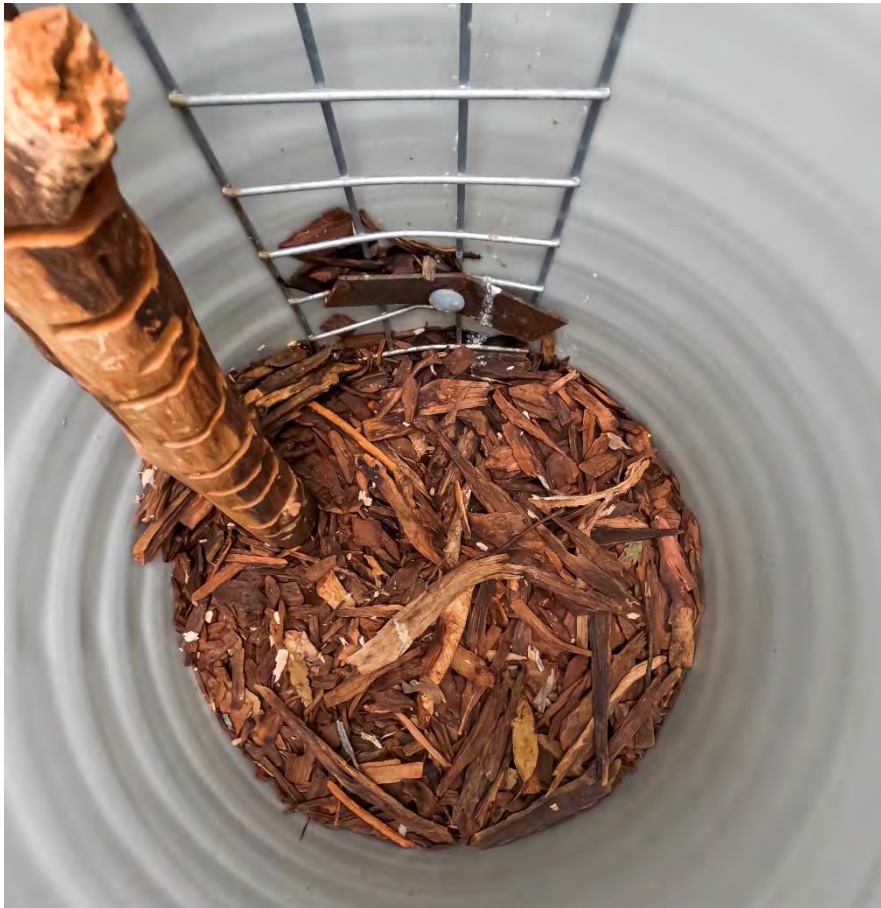
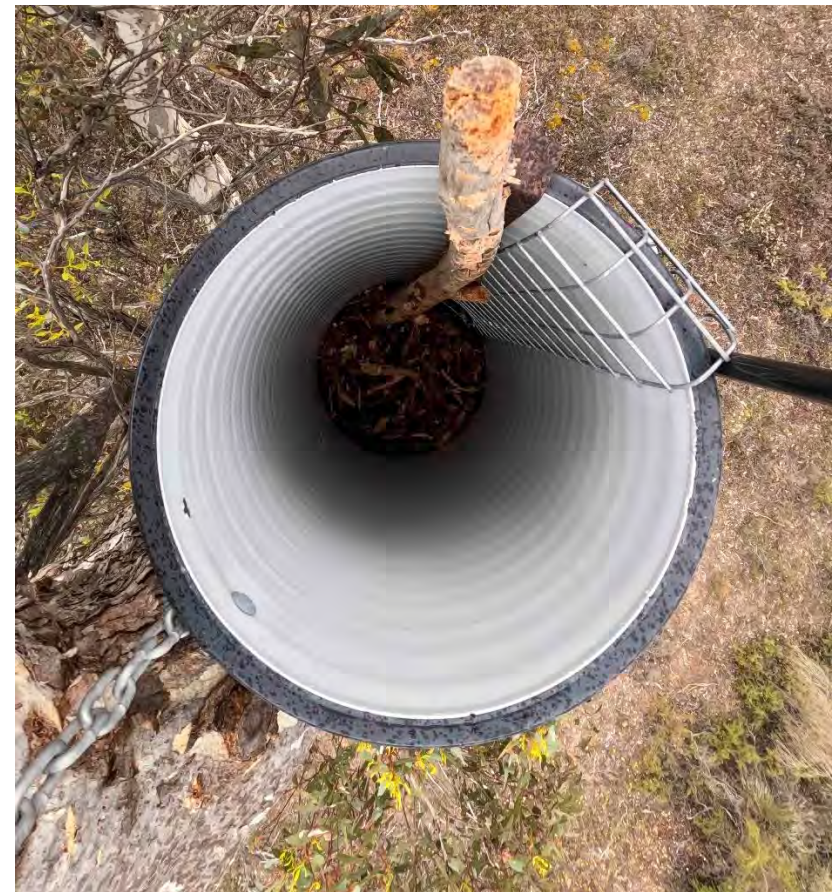
## Artificial Hollow BY02

| Hollow No | Comments | Chipping score 0-10 | Wood Chips | Tree condition | Fixings and Hollow condition | Recommended repairs |
|---|---|---|---|---|---|---|
| BY02 | Chewing on post no signs of Breeding | 3 | Nil | Good | Good | Nil |

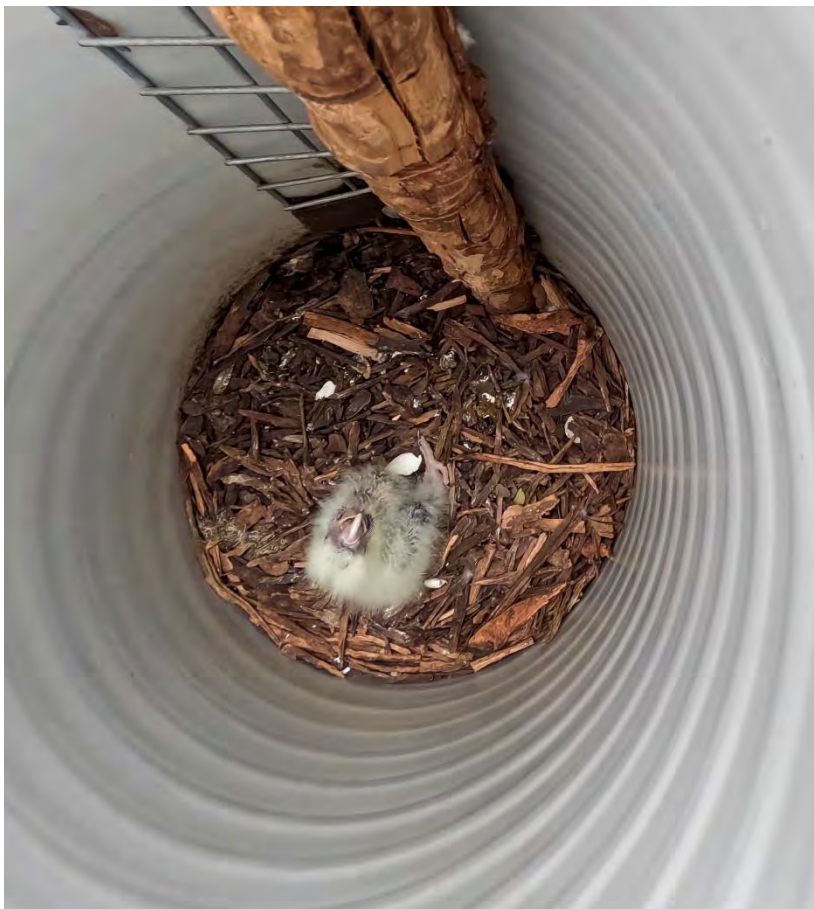
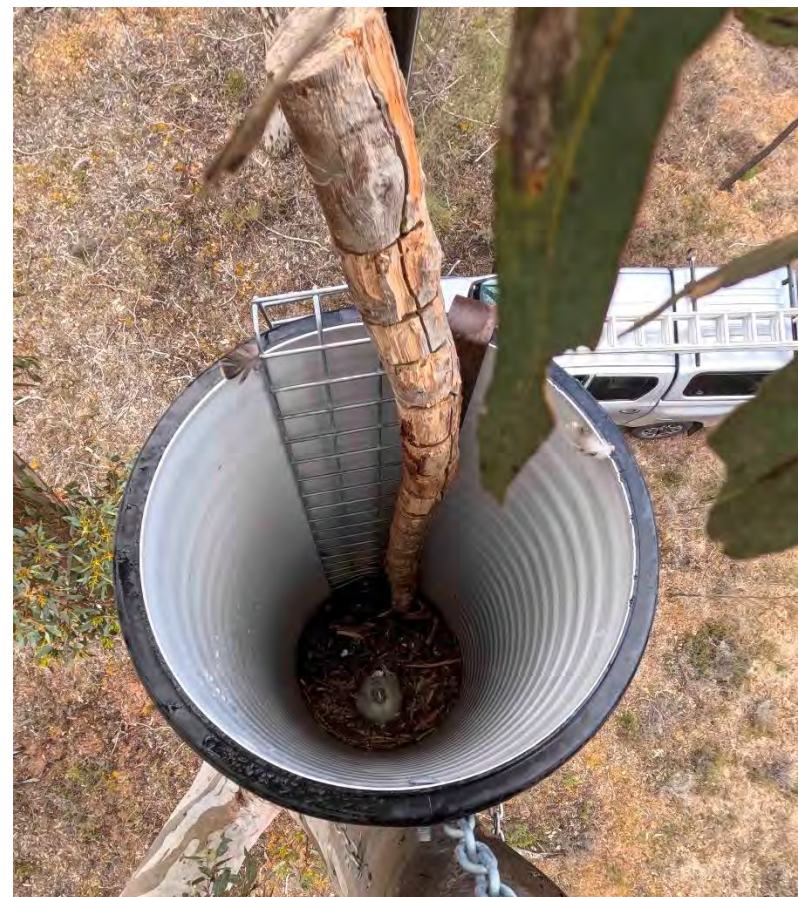
## Artificial Hollow BY03

| Hollow No | Comments | Chipping score 0-10 | Wood Chips | Tree condition | Fixings and Hollow condition | Recommended repairs |
|---|---|---|---|---|---|---|
| BY03 | Female CC flushed, One 13 to 15-day old CC nestling Chewing on post. | 3 | Nil | Good | Good | Nil |
