# Ministerial Statement Compliance Assessment Report

**Bunbury Outer Ring Road - South  
Ministerial Statement 1191**

**2025 - 2026 Reporting Period**

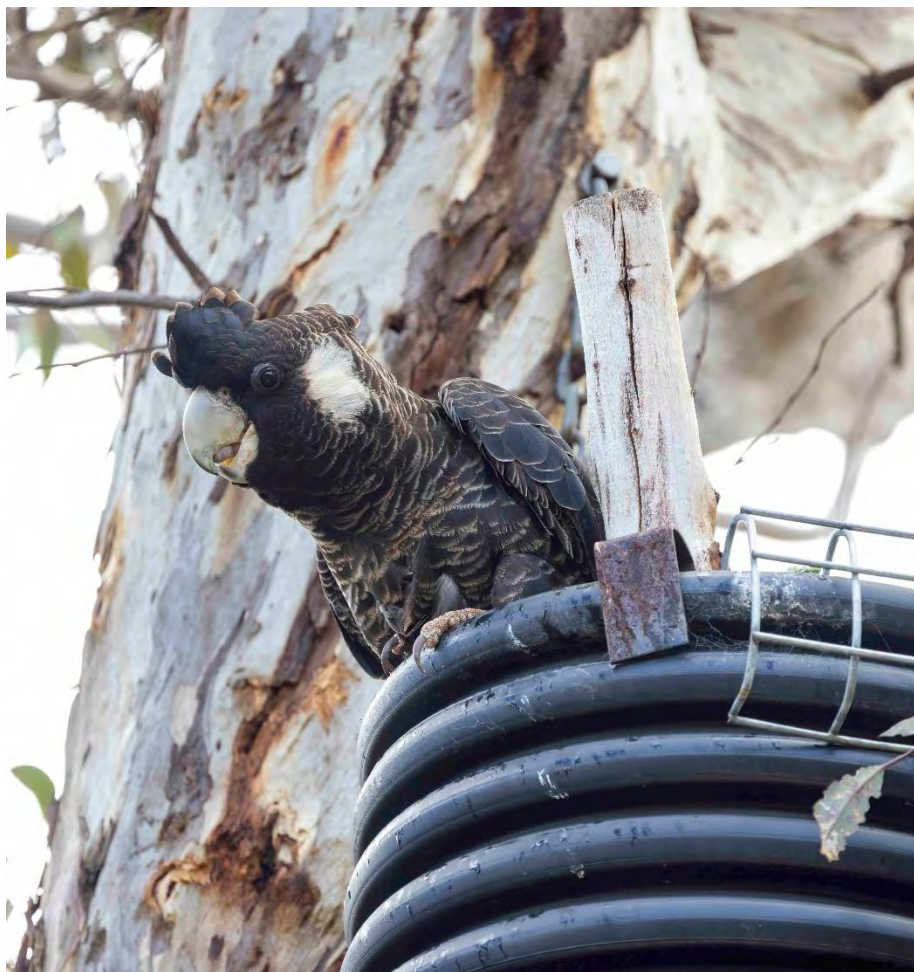
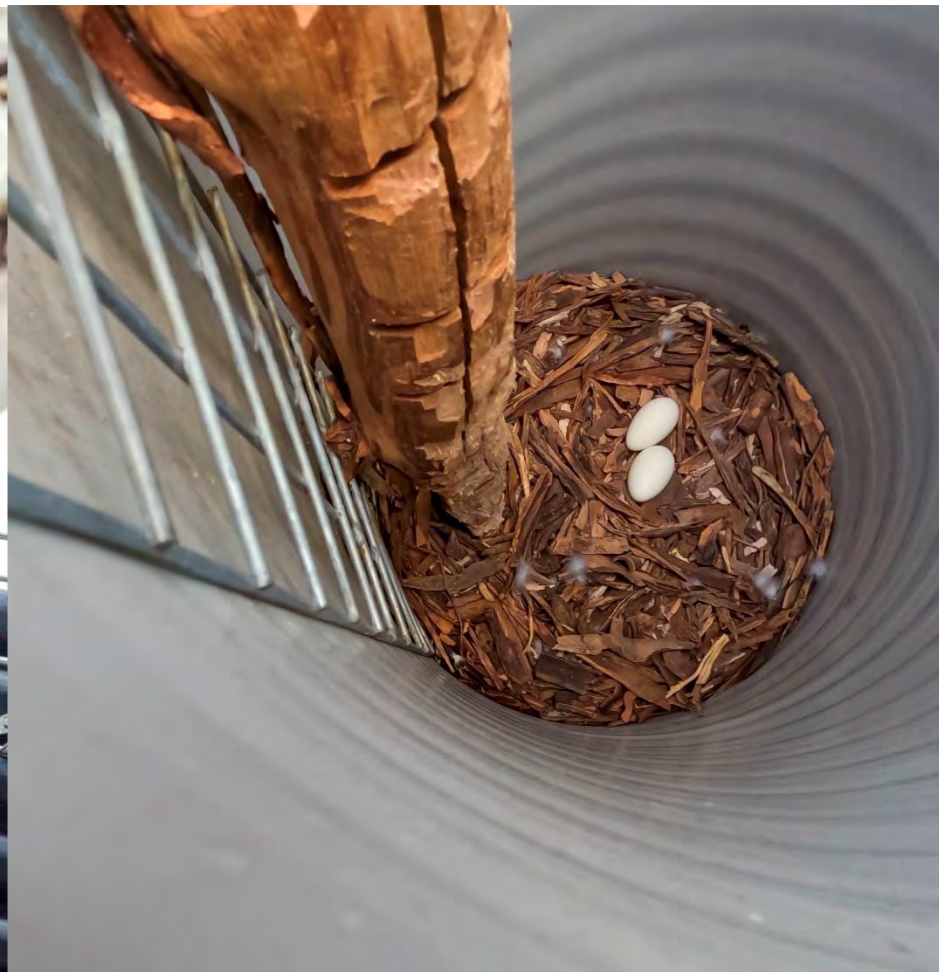
## Artificial Hollow BY04

| Hollow No | Comments | Chipping score 0-10 | Wood Chips | Tree condition | Fixings and Hollow condition | Recommended repairs |
|---|---|---|---|---|---|---|
| BY04 | Female CC flushed, 2 x CC eggs, chewing on post | 3 | Nil | Good | Good | Nil |

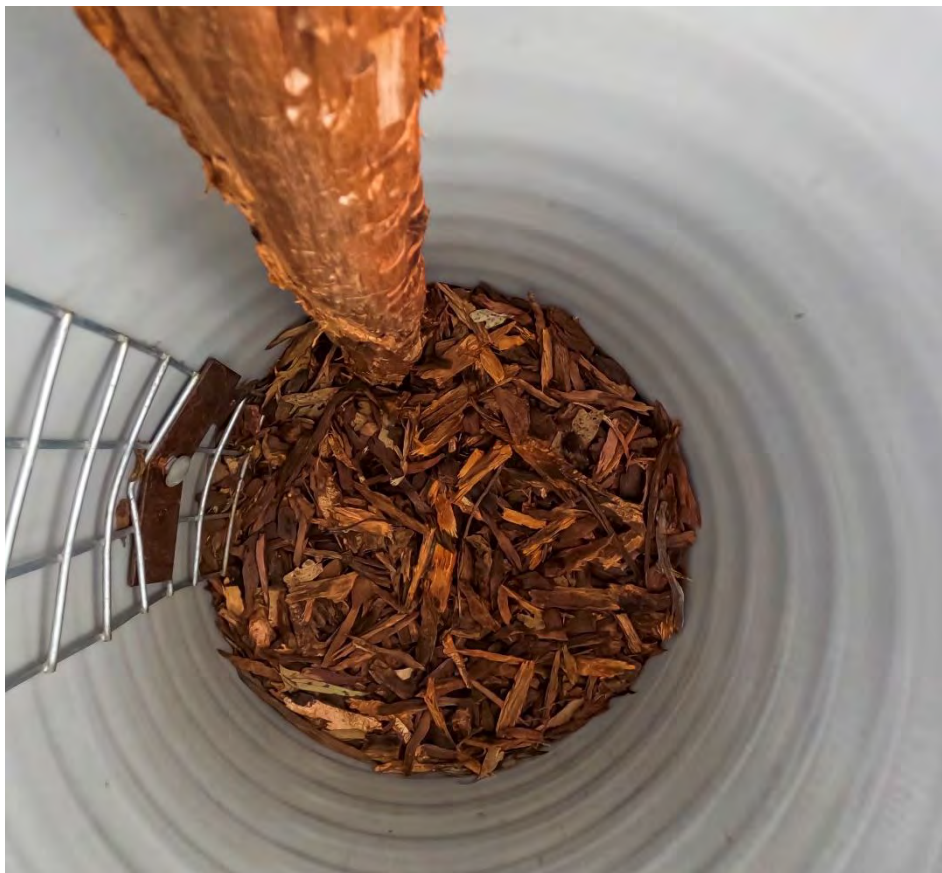
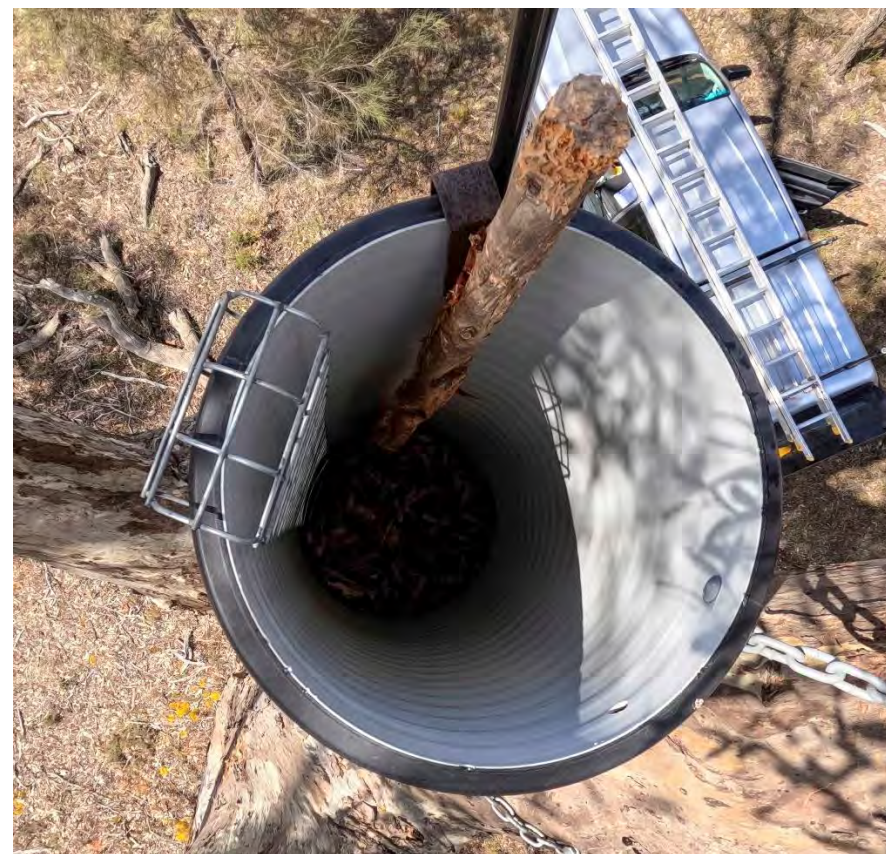
## Artificial Hollow BY05

| Hollow No | Comments | Chipping score 0-10 | Wood Chips | Tree condition | Fixings and Hollow condition | Recommended repairs |
|---|---|---|---|---|---|---|
| BY05 | Chewing on post no signs of Breeding. Faeces in bottom of hollow | 3 | Nil | Good | Good | Nil |

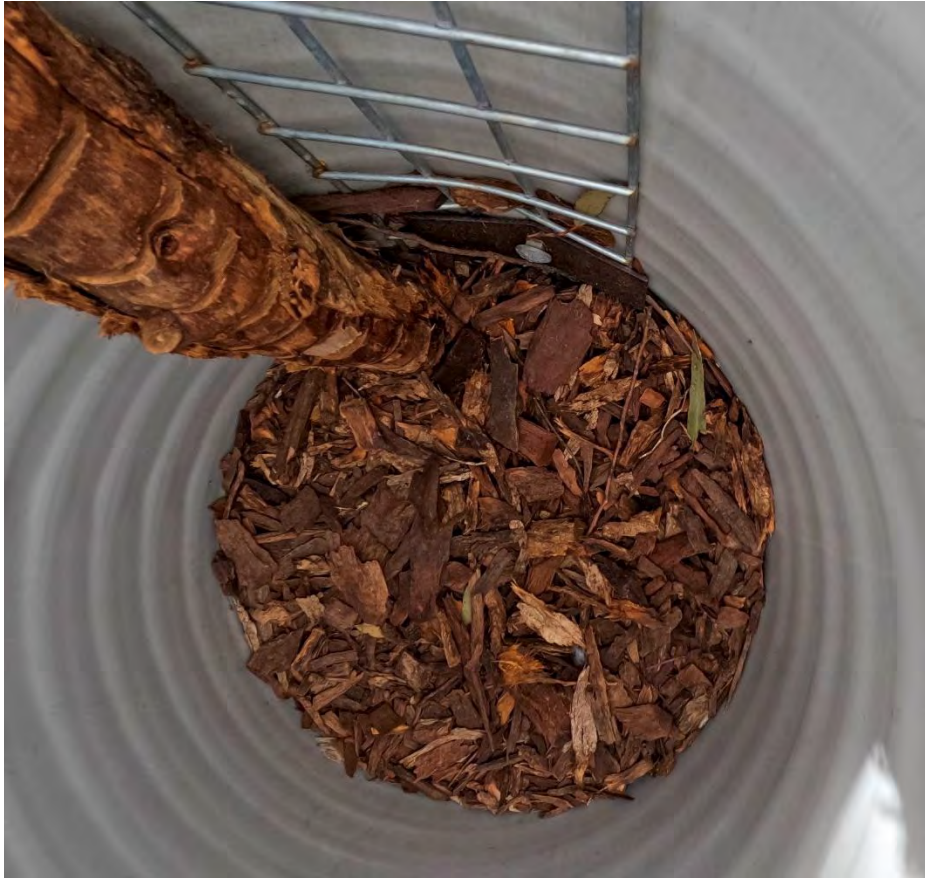
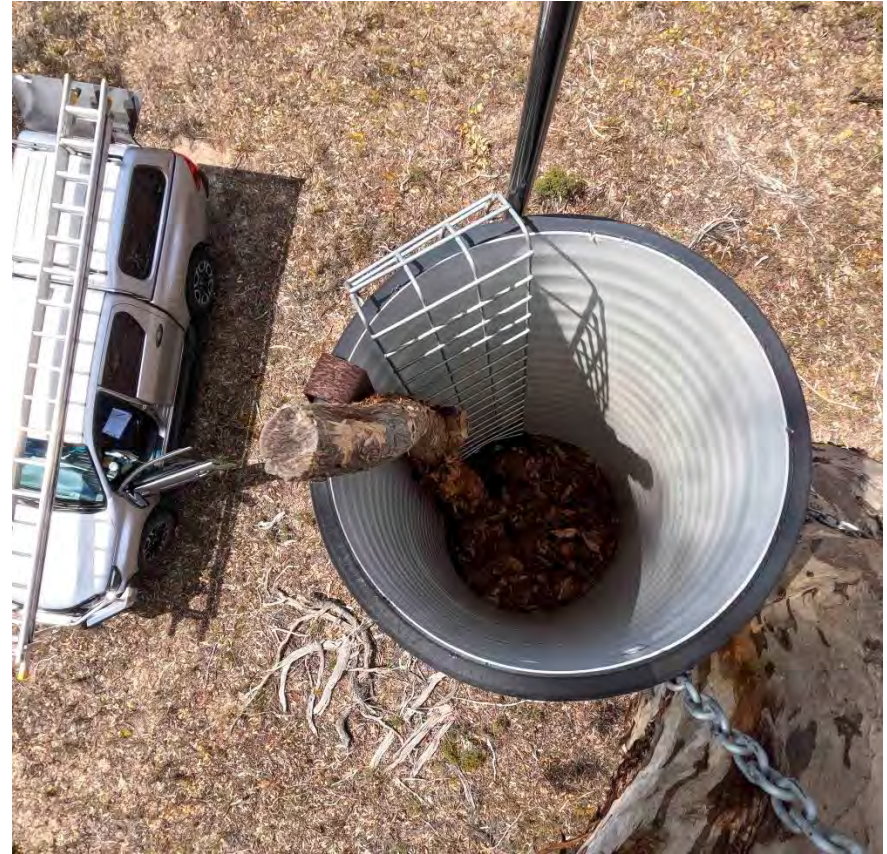
## Artificial Hollow BY06

| Hollow No | Comments | Chipping score 0-10 | Wood Chips | Tree condition | Fixings and Hollow condition | Recommended repairs |
|---|---|---|---|---|---|---|
| BY06 | Minor chewing on post, no signs of Breeding | 2 | Nil | Good | Good | Nil |

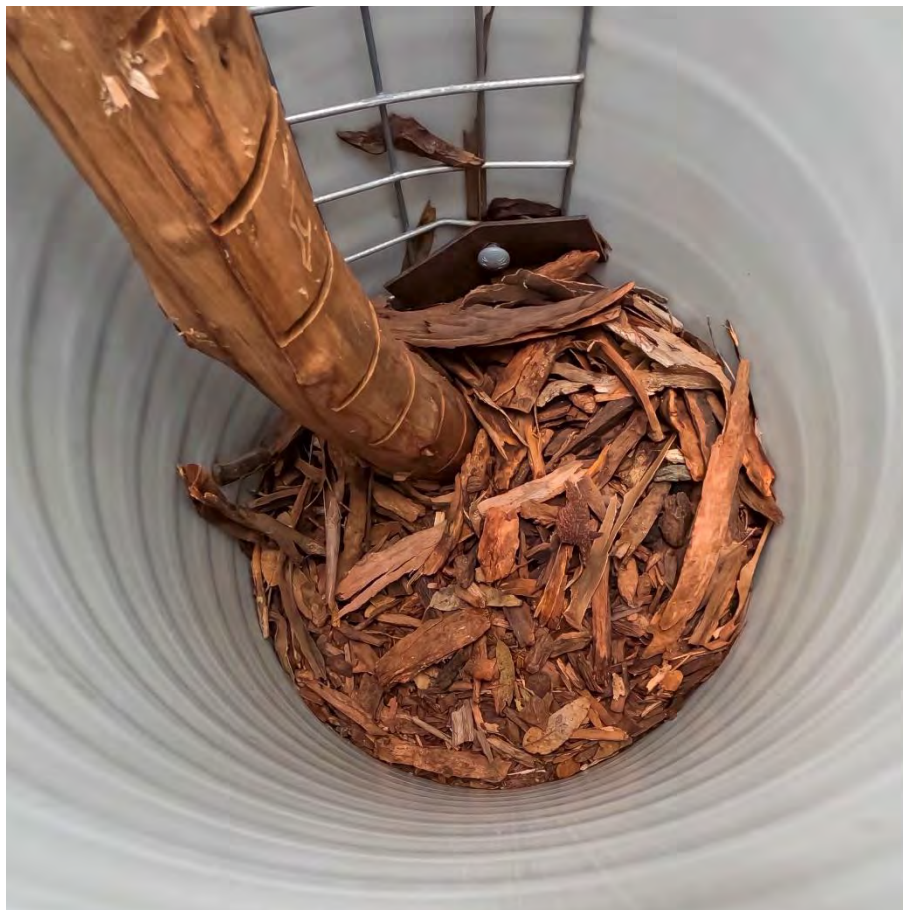
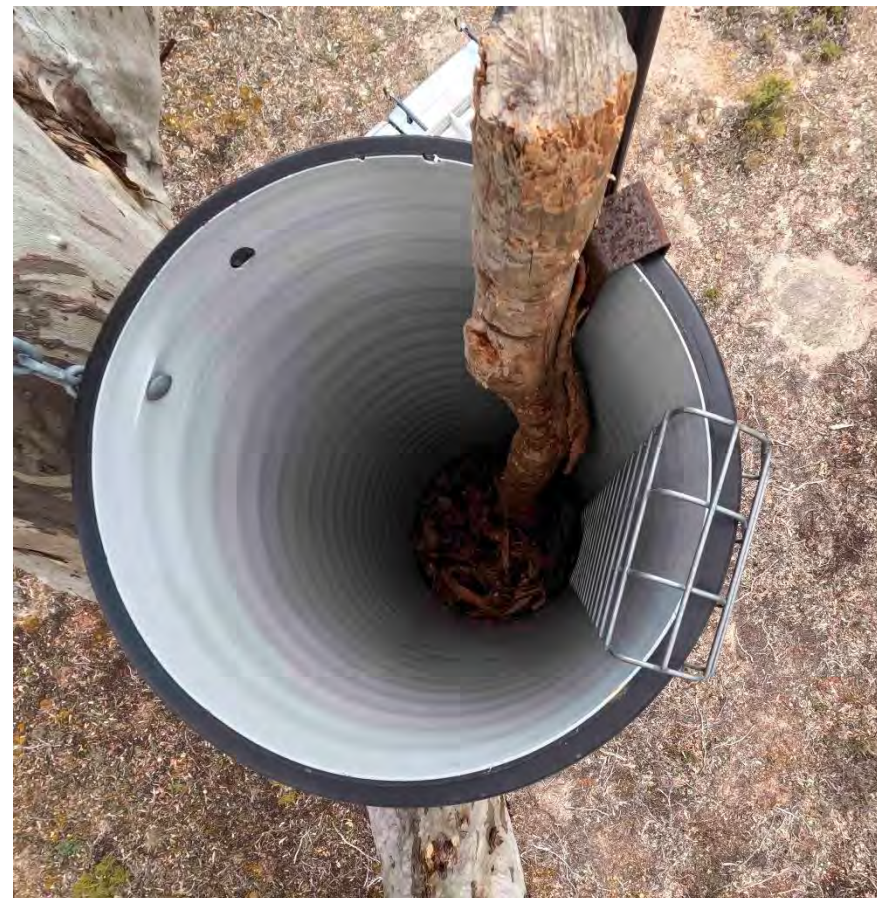
## Artificial Hollow BY07

| Hollow No | Comments | Chipping score 0-10 | Wood Chips | Tree condition | Fixings and Hollow condition | Recommended repairs |
|---|---|---|---|---|---|---|
| BY07 | Chewing on post no signs of Breeding | 2 | Nil | Good | Good | Nil |

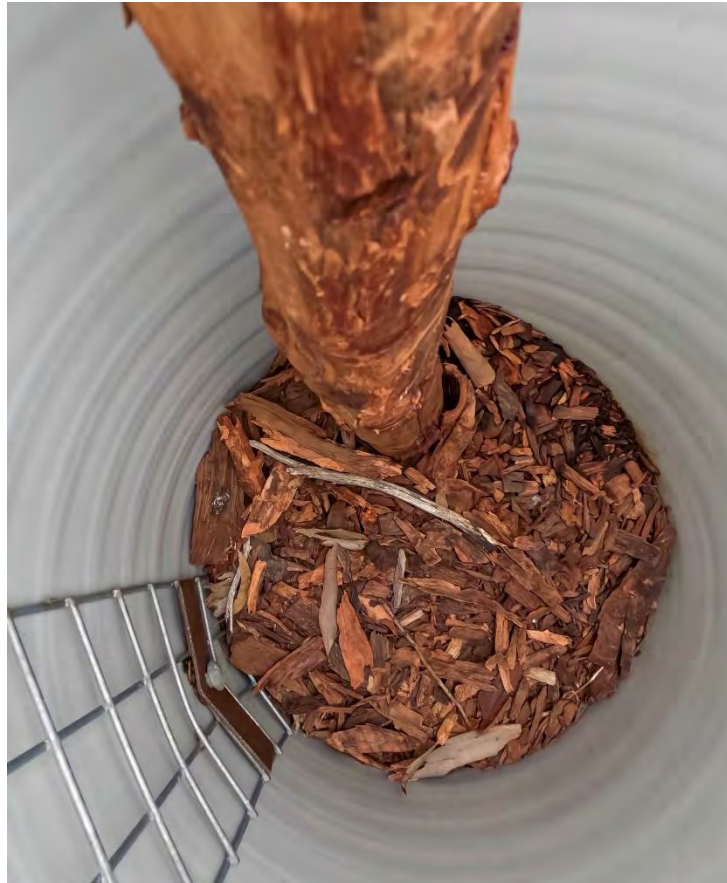
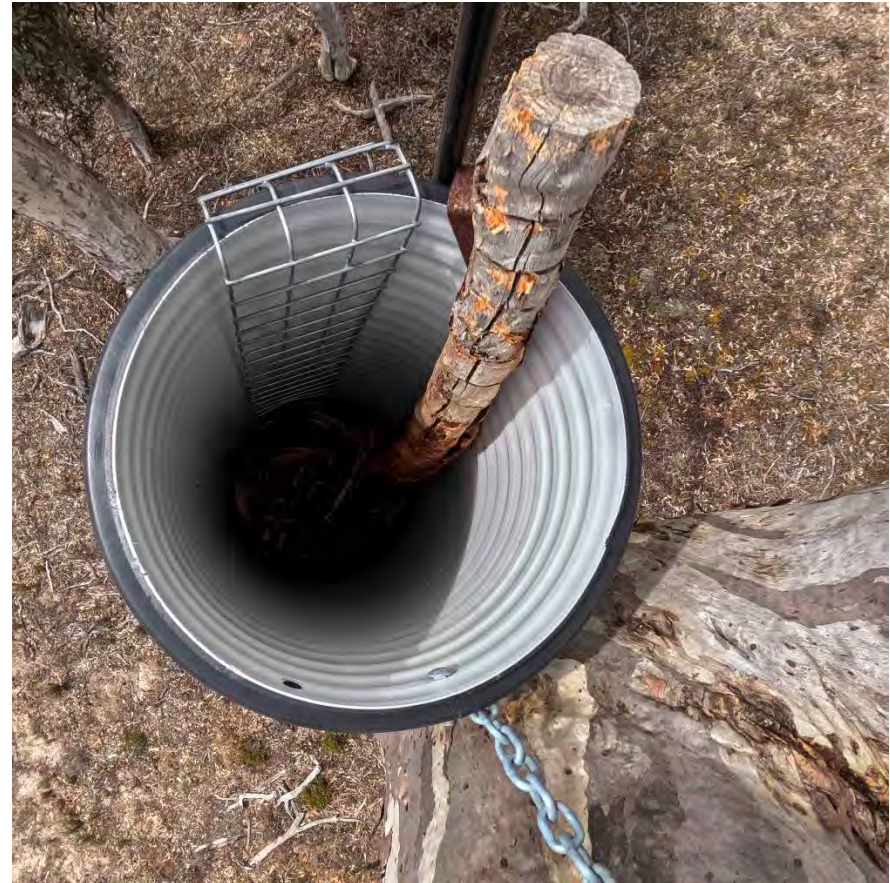
## Artificial Hollow BY08

| Hollow No | Comments | Chipping score 0-10 | Wood Chips | Tree condition | Fixings and Hollow condition | Recommended repairs |
|---|---|---|---|---|---|---|
| BY08 | Chewing on post no signs of Breeding | 2 | Nil | Good | Good | Nil |

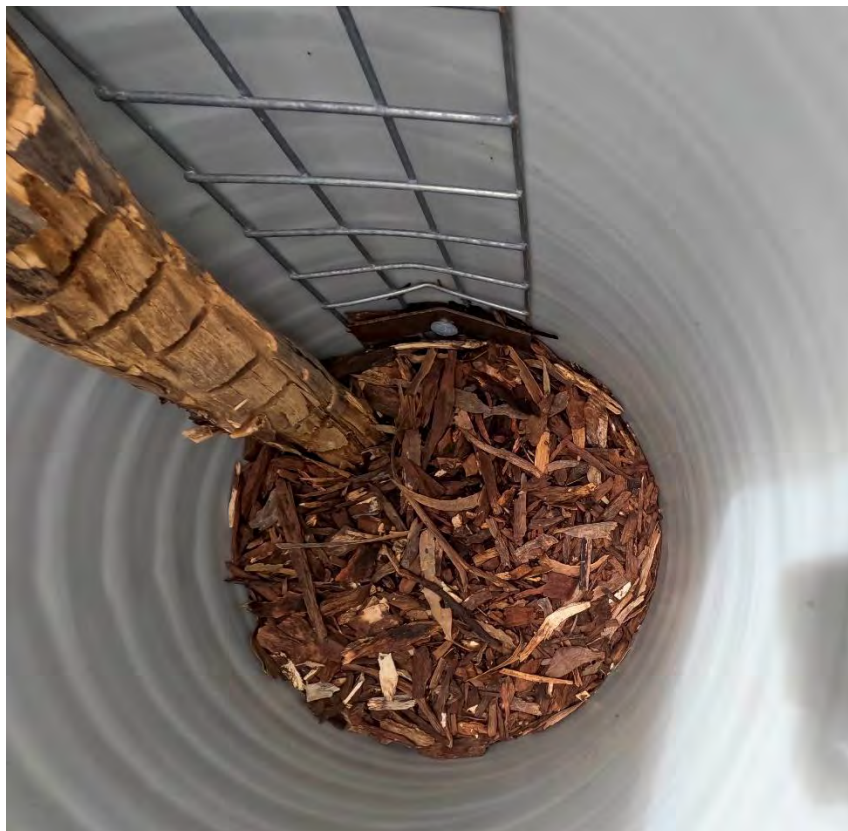
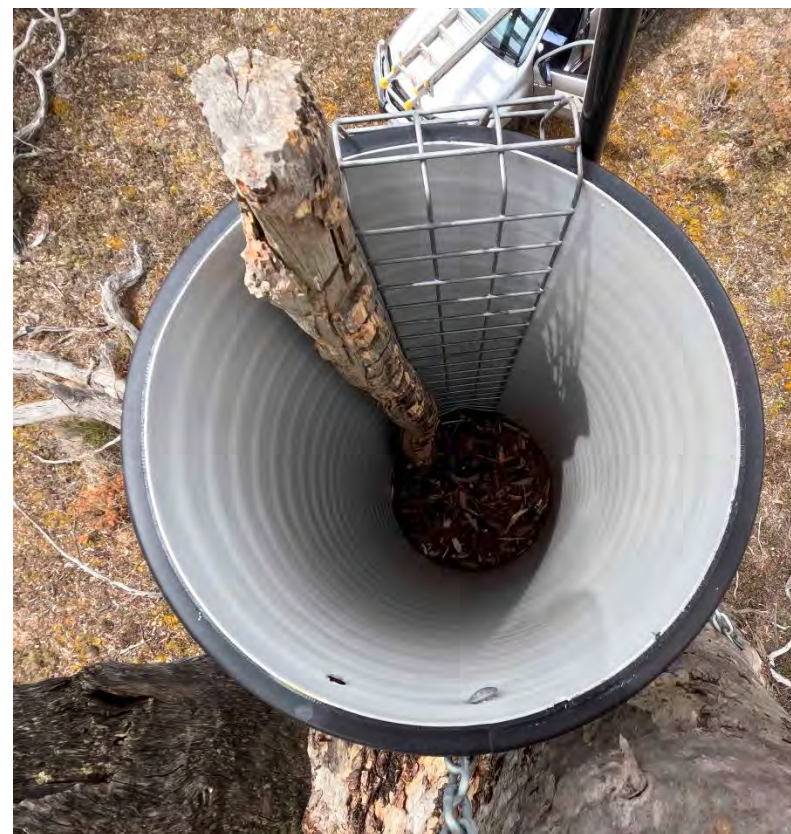
## Artificial Hollow BY09

| Hollow No | Comments | Chipping score 0-10 | Wood Chips | Tree condition | Fixings and Hollow condition | Recommended repairs |
|---|---|---|---|---|---|---|
| BY09 | Chewing on post no signs of Breeding | 3 | Nil | Good | Good | Nil |

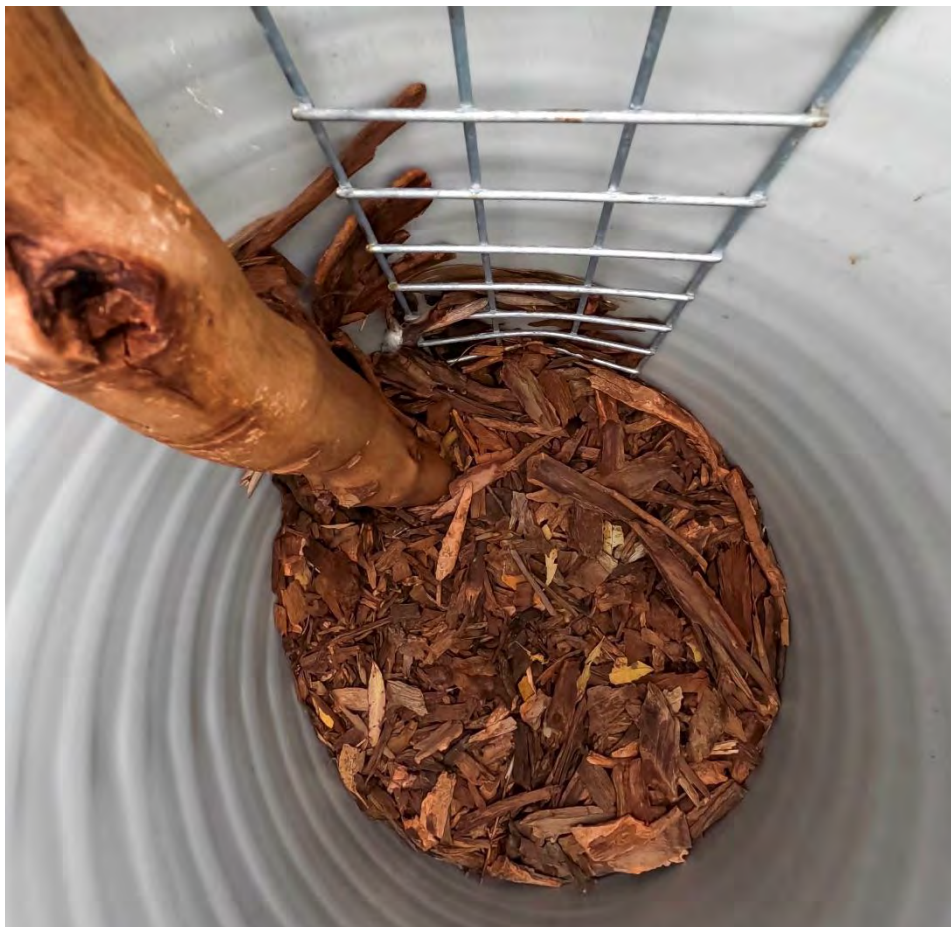
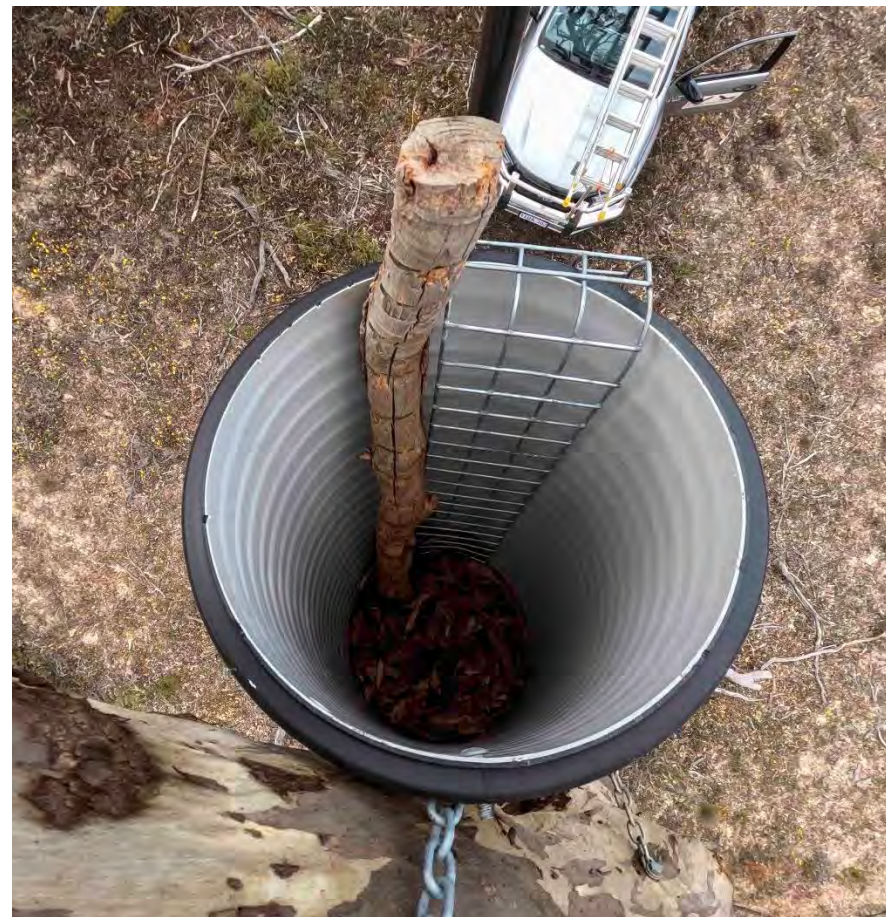
## Artificial Hollow BY10

| Hollow No | Comments | Chipping score 0-10 | Wood Chips | Tree condition | Fixings and Hollow condition | Recommended repairs |
|---|---|---|---|---|---|---|
| BY10 | Chewing on post no signs of Breeding | 2 | Nil | Good | Good | Nil |

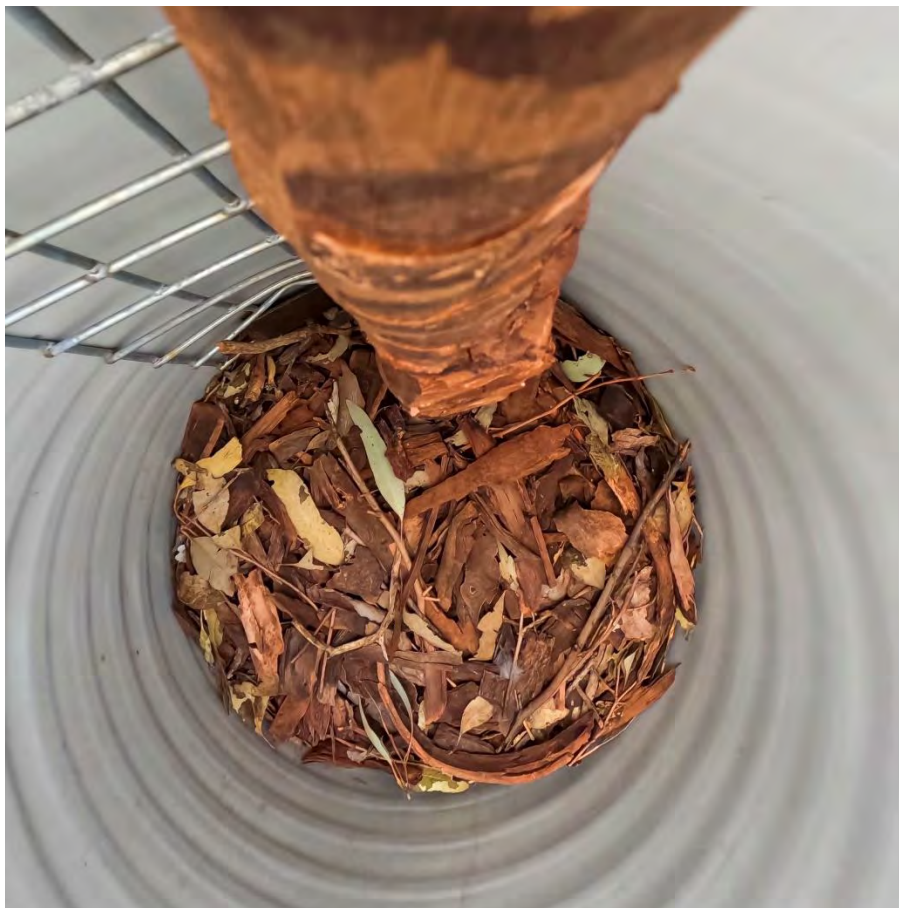
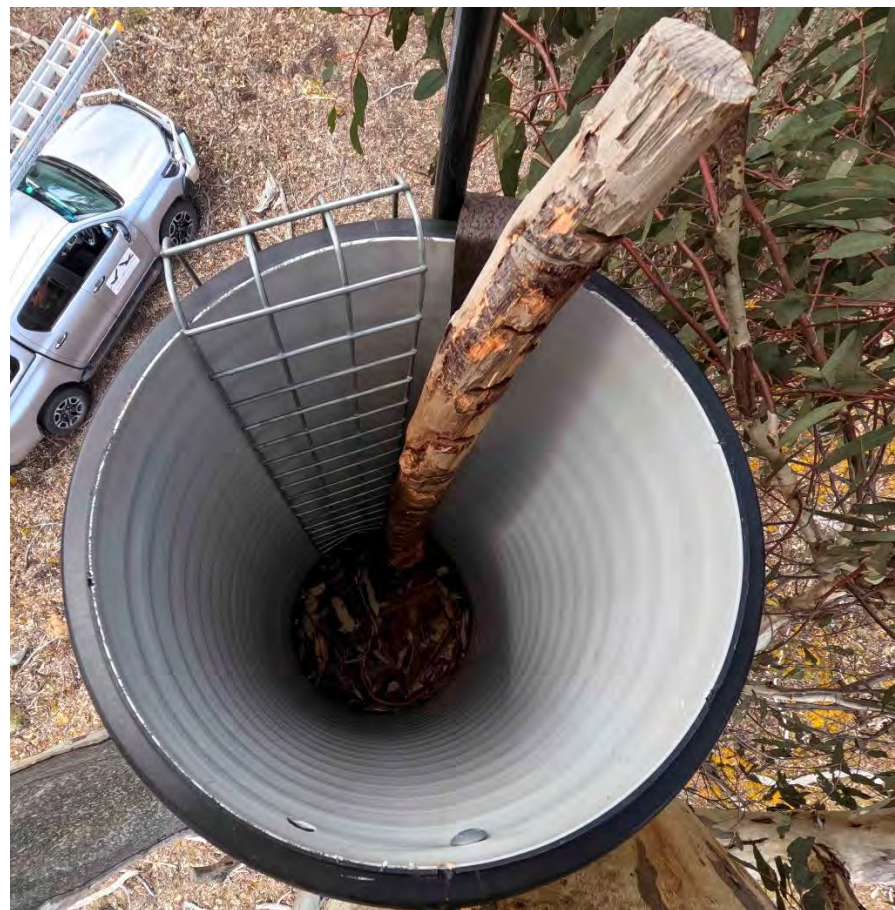
## Artificial Hollow BY11

| Hollow No | Comments | Chipping score 0-10 | Wood Chips | Tree condition | Fixings and Hollow condition | Recommended repairs |
|---|---|---|---|---|---|---|
| BY11 | Chewing on post no signs of Breeding | 2 | Nil | Good | Good | Nil |

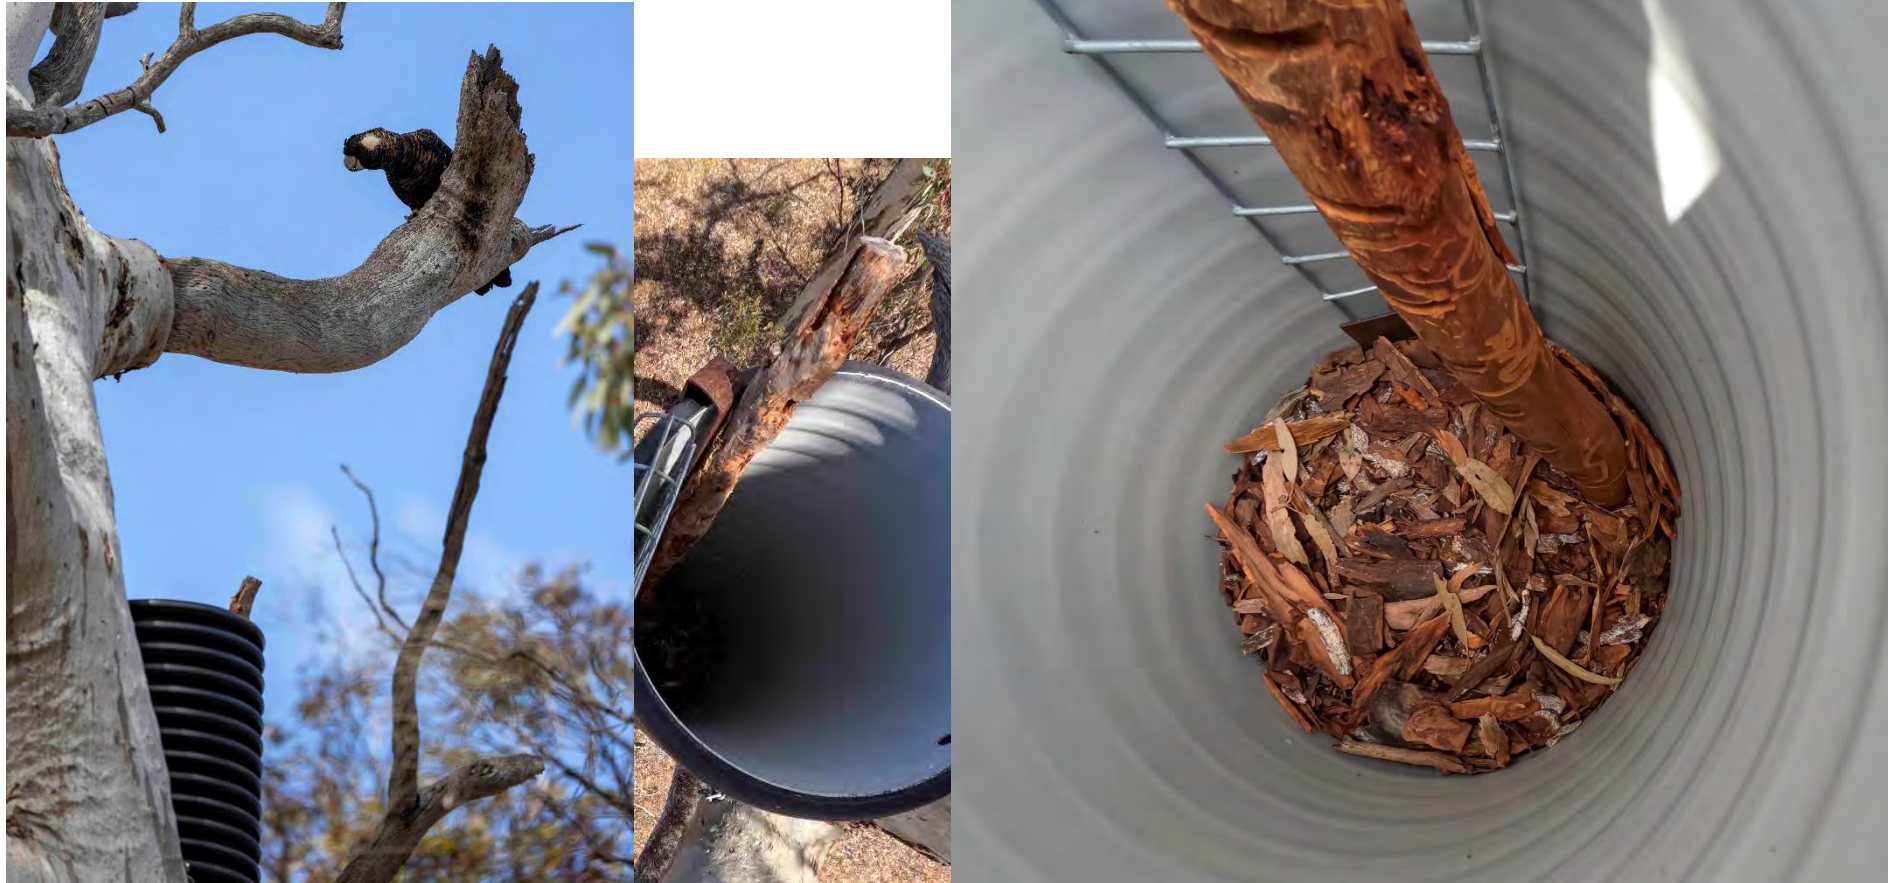
## Artificial Hollow BY12

| Hollow No | Comments | Chipping score 0-10 | Wood Chips | Tree condition | Fixings and Hollow condition | Recommended repairs |
|---|---|---|---|---|---|---|
| BY12 | Female CC prospecting at hollow with Male, chewing on post no sign of Breeding | 2 | Nil | Good | Good | Nil |

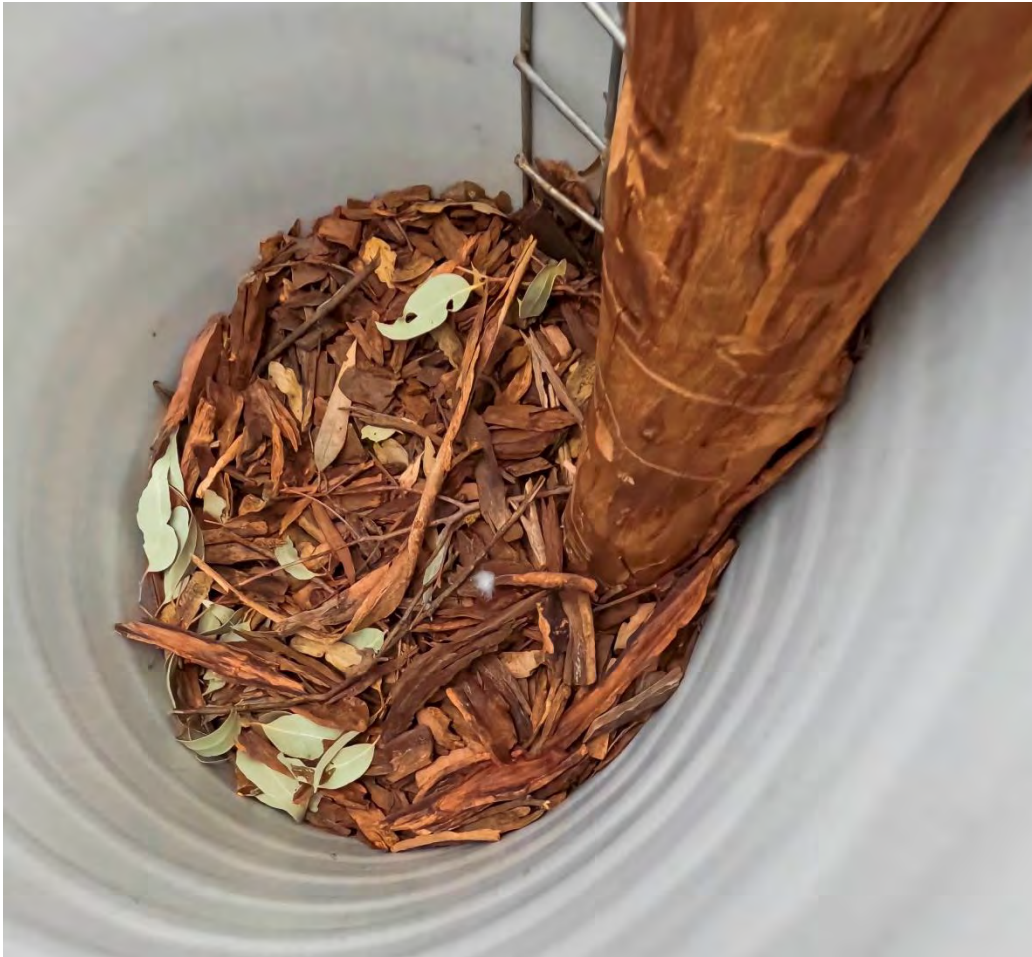
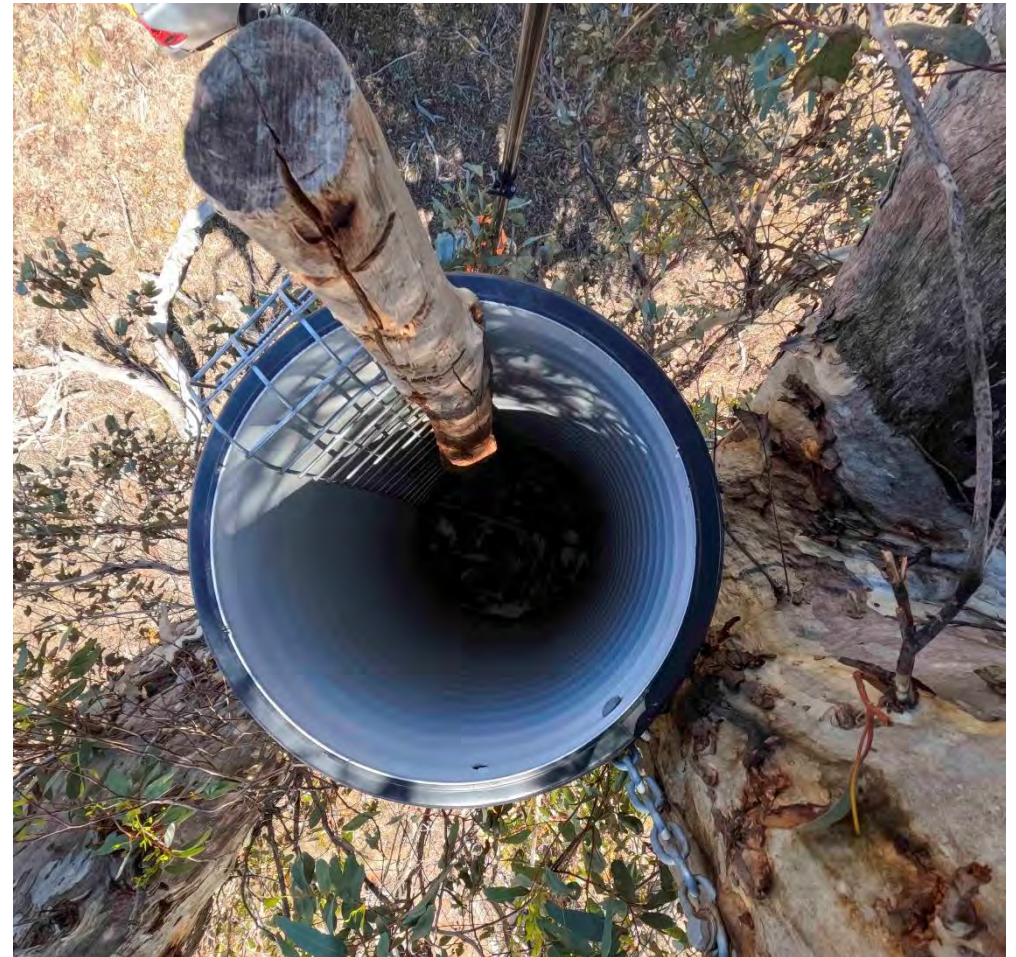
## Artificial Hollow BY13

| Hollow No | Comments | Chipping score 0-10 | Wood Chips | Tree condition | Fixings and Hollow condition | Recommended repairs |
|---|---|---|---|---|---|---|
| BY13 | Chewing on post no signs of Breeding | 2 | Nil | Good | Good | Nil |

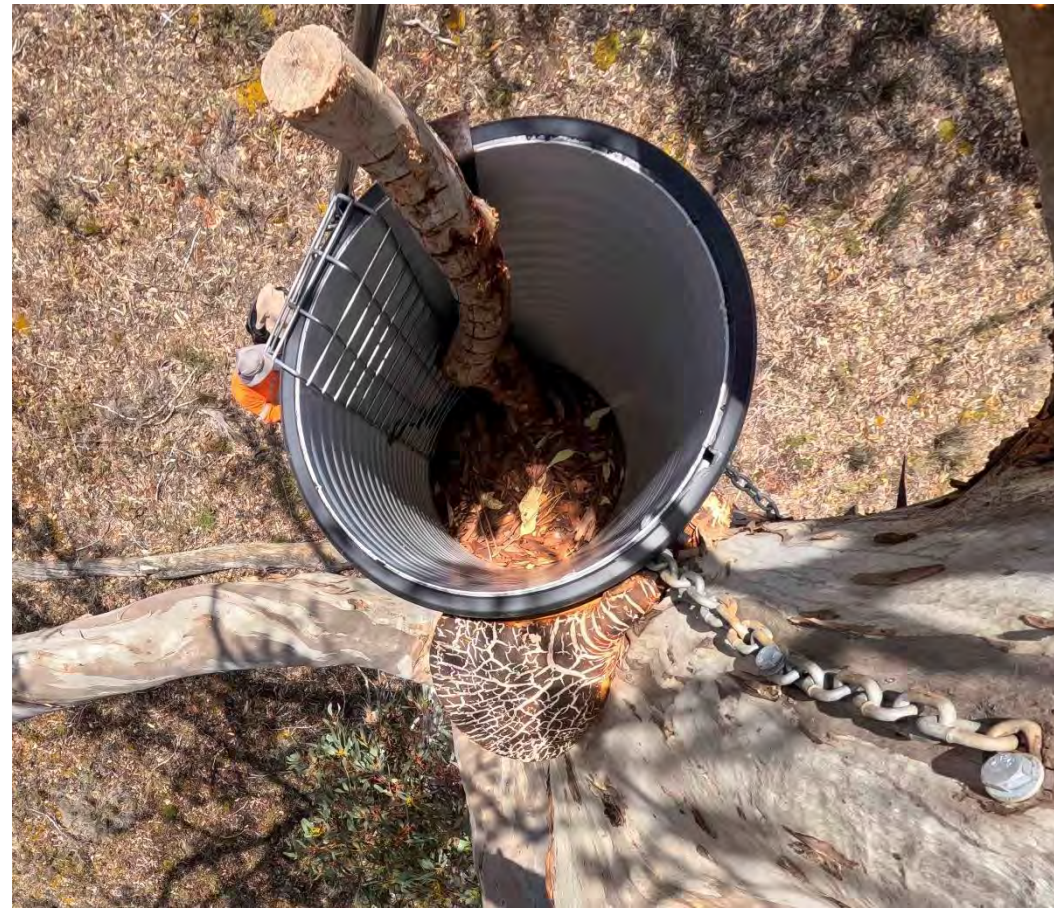
## Artificial Hollow BY14

| Hollow No | Comments | Chipping score 0-10 | Wood Chips | Tree condition | Fixings and Hollow condition | Recommended repairs |
|---|---|---|---|---|---|---|
| BY14 | Chewing on post no signs of Breeding | 2 | Nil | Good | Good | Nil |

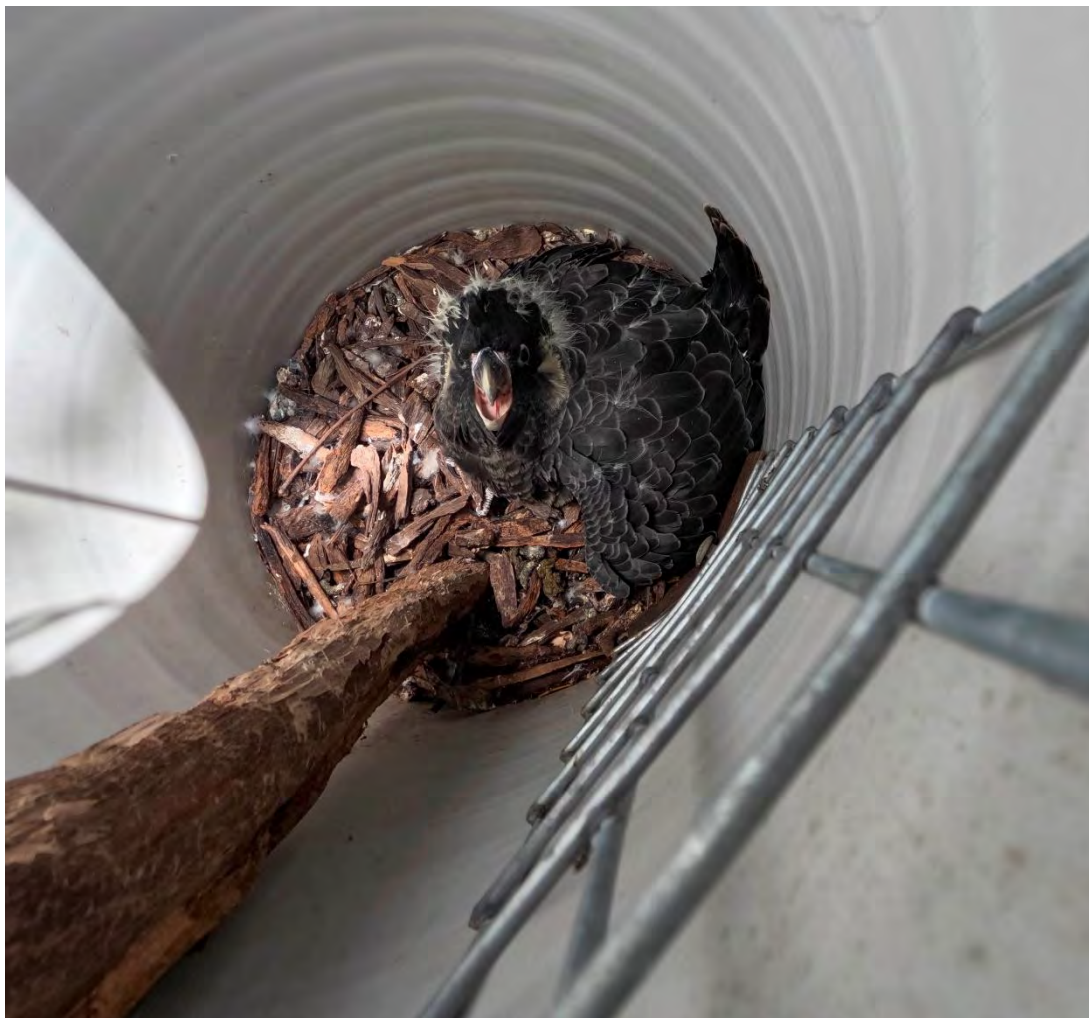
## Artificial Hollow BY15

| Hollow No | Comments | Chipping score 0-10 | Wood Chips | Tree condition | Fixings and Hollow condition | Recommended repairs |
|---|---|---|---|---|---|---|
| BY15 | One Male 50-day old CC nestling.<br>Leg banded | 5 | Nil | Good | Good | Nil |

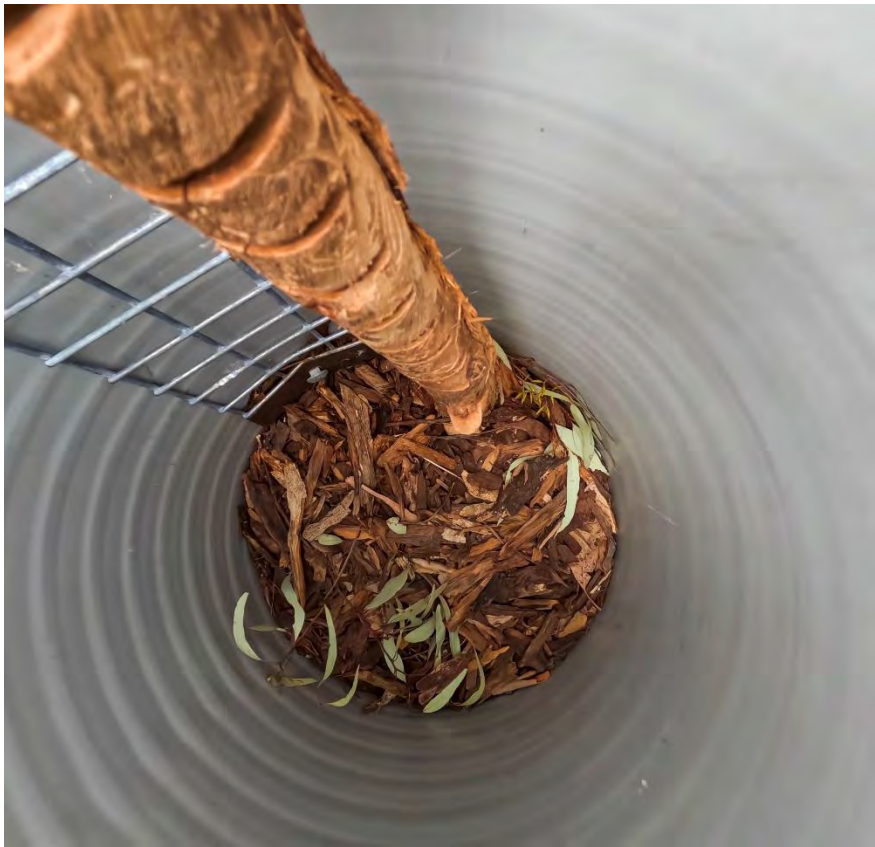
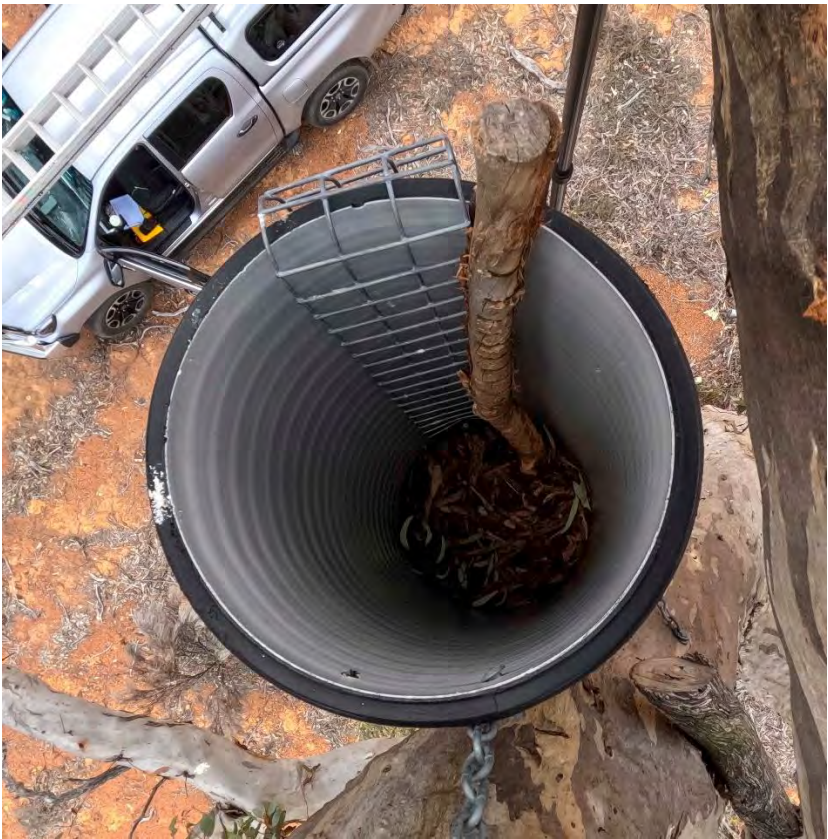
Artificial Hollow BY16

| Hollow No | Comments | Chipping score 0-10 | Wood Chips | Tree condition | Fixings and Hollow condition | Recommended repairs |
|---|---|---|---|---|---|---|
| BY16 | Chewing on post no signs of Breeding | 2 | Nil | Good | Good | Nil |

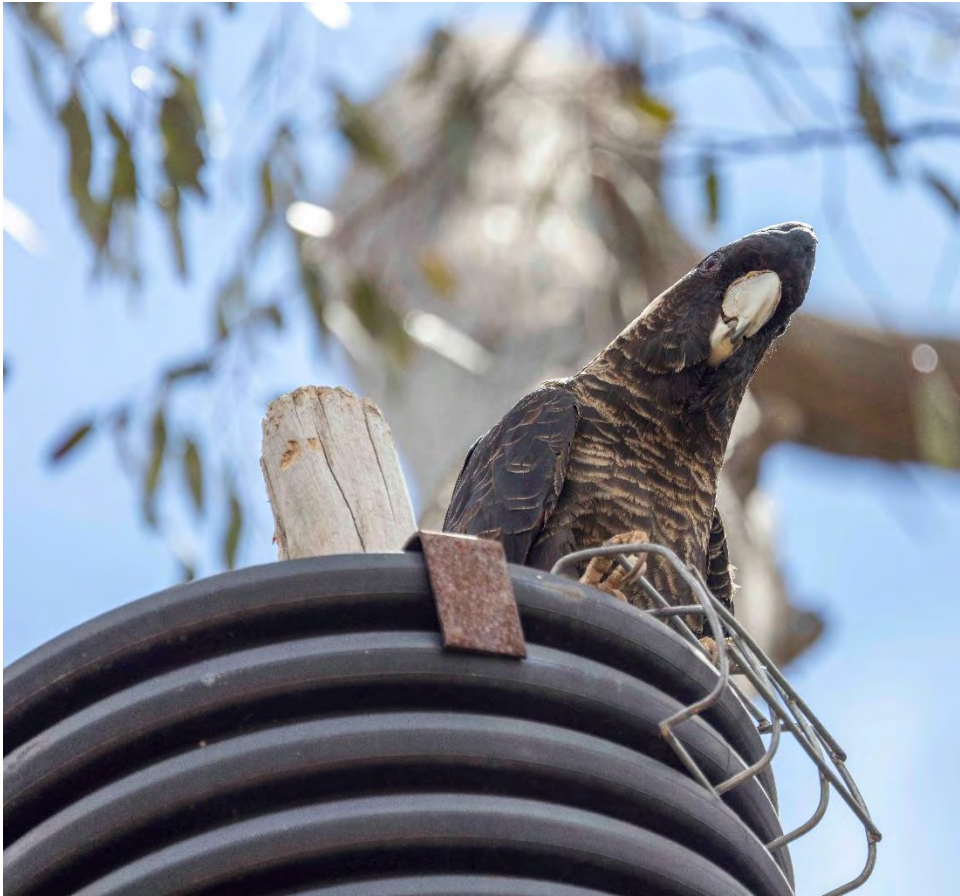
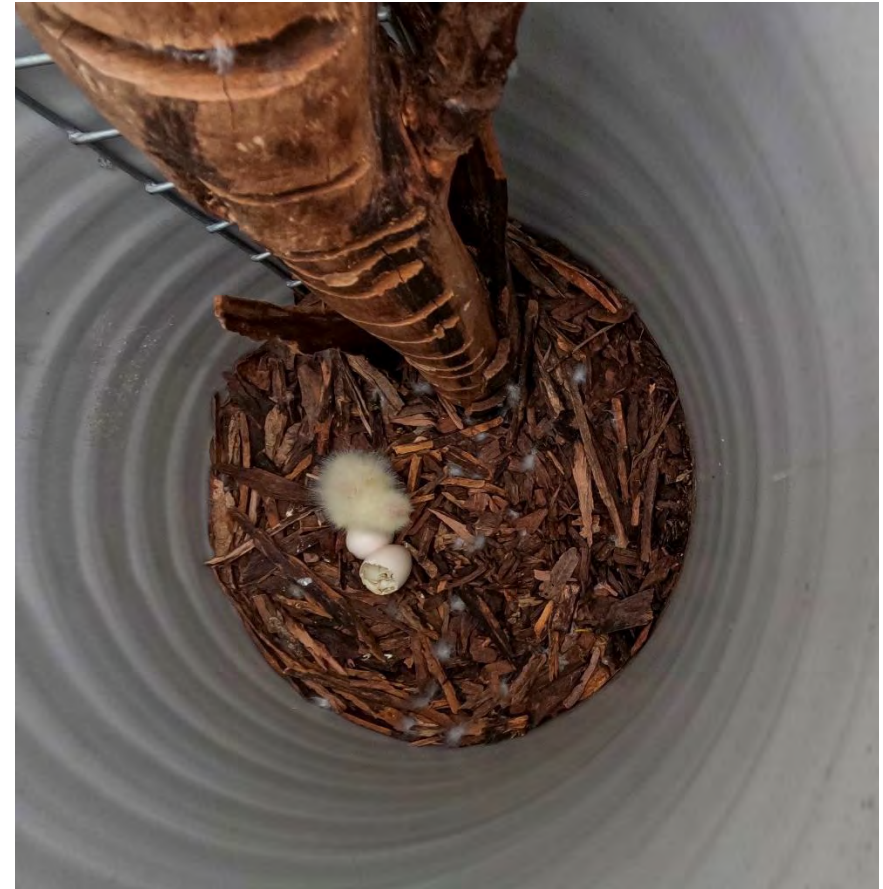
## Artificial Hollow BY17

| Hollow No | Comments | Chipping score 0-10 | Wood Chips | Tree condition | Fixings and Hollow condition | Recommended repairs |
|---|---|---|---|---|---|---|
| BY17 | Female CC flushed, One 4-5-day old CC nestling, and still incubating second egg, Chewing on post. | 2 | Nil | Good | Good | Nil |
