# Ministerial Statement Compliance Assessment Report

**Bunbury Outer Ring Road - South  
Ministerial Statement 1191**

**2025 - 2026 Reporting Period**

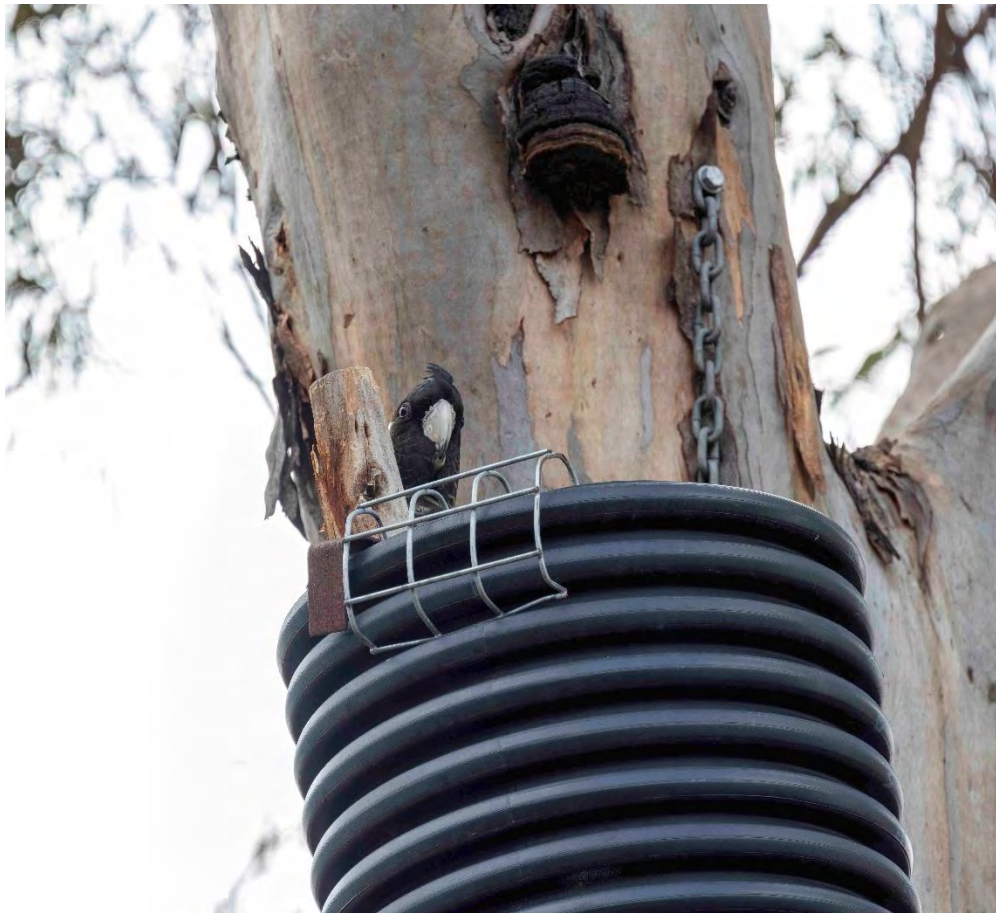
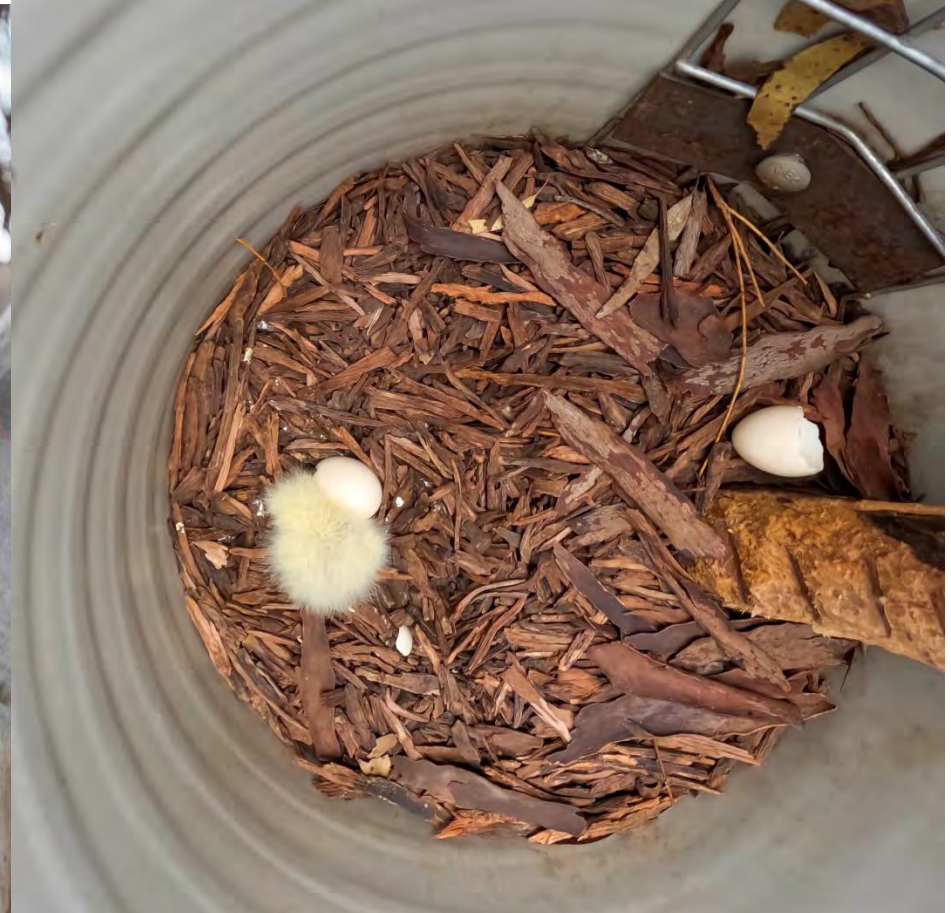
## Artificial Hollow BY18

| Hollow No | Comments | Chipping score 0-10 | Wood Chips | Tree condition | Fixings and Hollow condition | Recommended repairs |
|---|---|---|---|---|---|---|
| BY18 | Female CC flushed, One 4-5-day old CC nestling, and still incubating second egg, Chewing on post. | 5 | Nil | Good | Good | Nil |

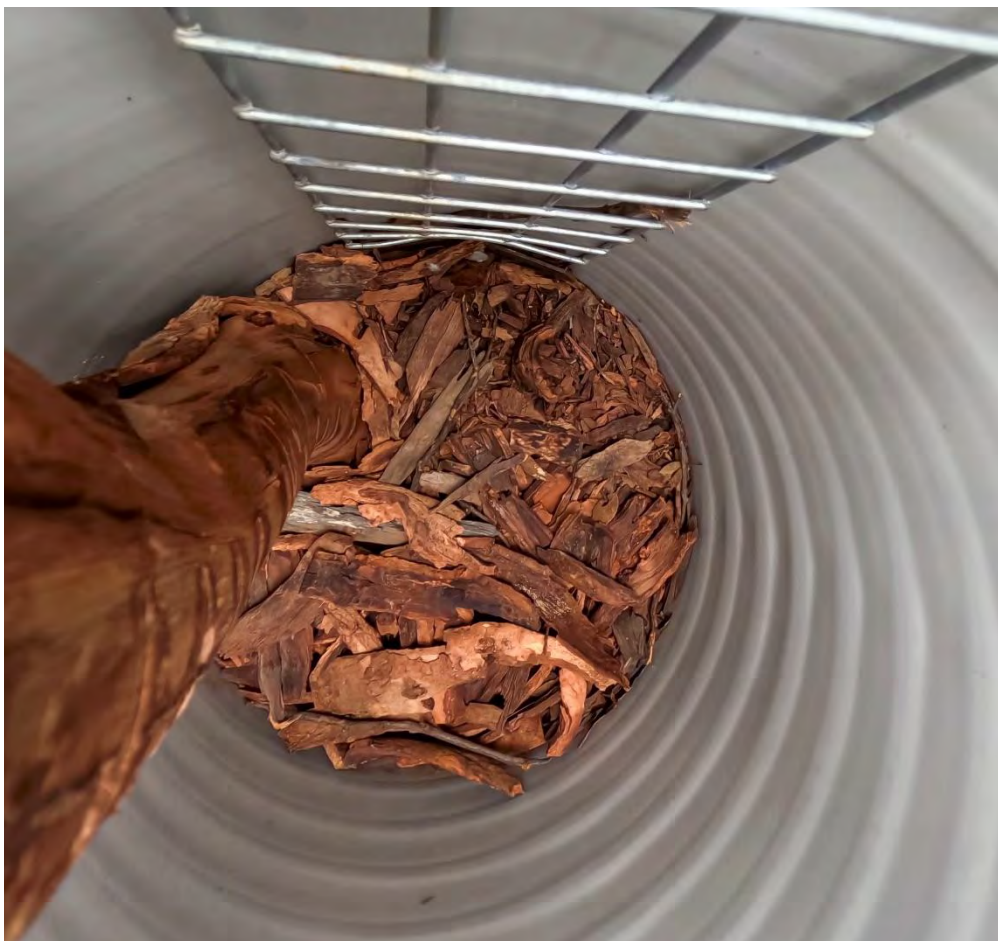
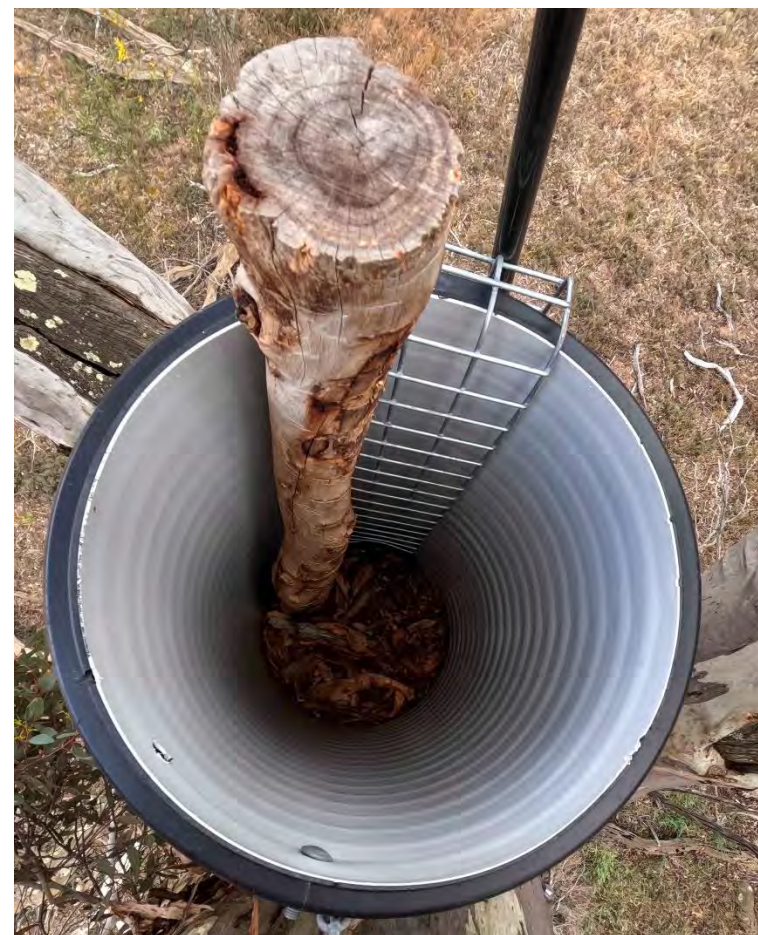
## Artificial Hollow BY19

| Hollow No | Comments | Chipping score 0-10 | Wood Chips | Tree condition | Fixings and Hollow condition | Recommended repairs |
|---|---|---|---|---|---|---|
| BY19 | Chewing on post no signs of Breeding | 1 | Nil | Good | Good | Nil |

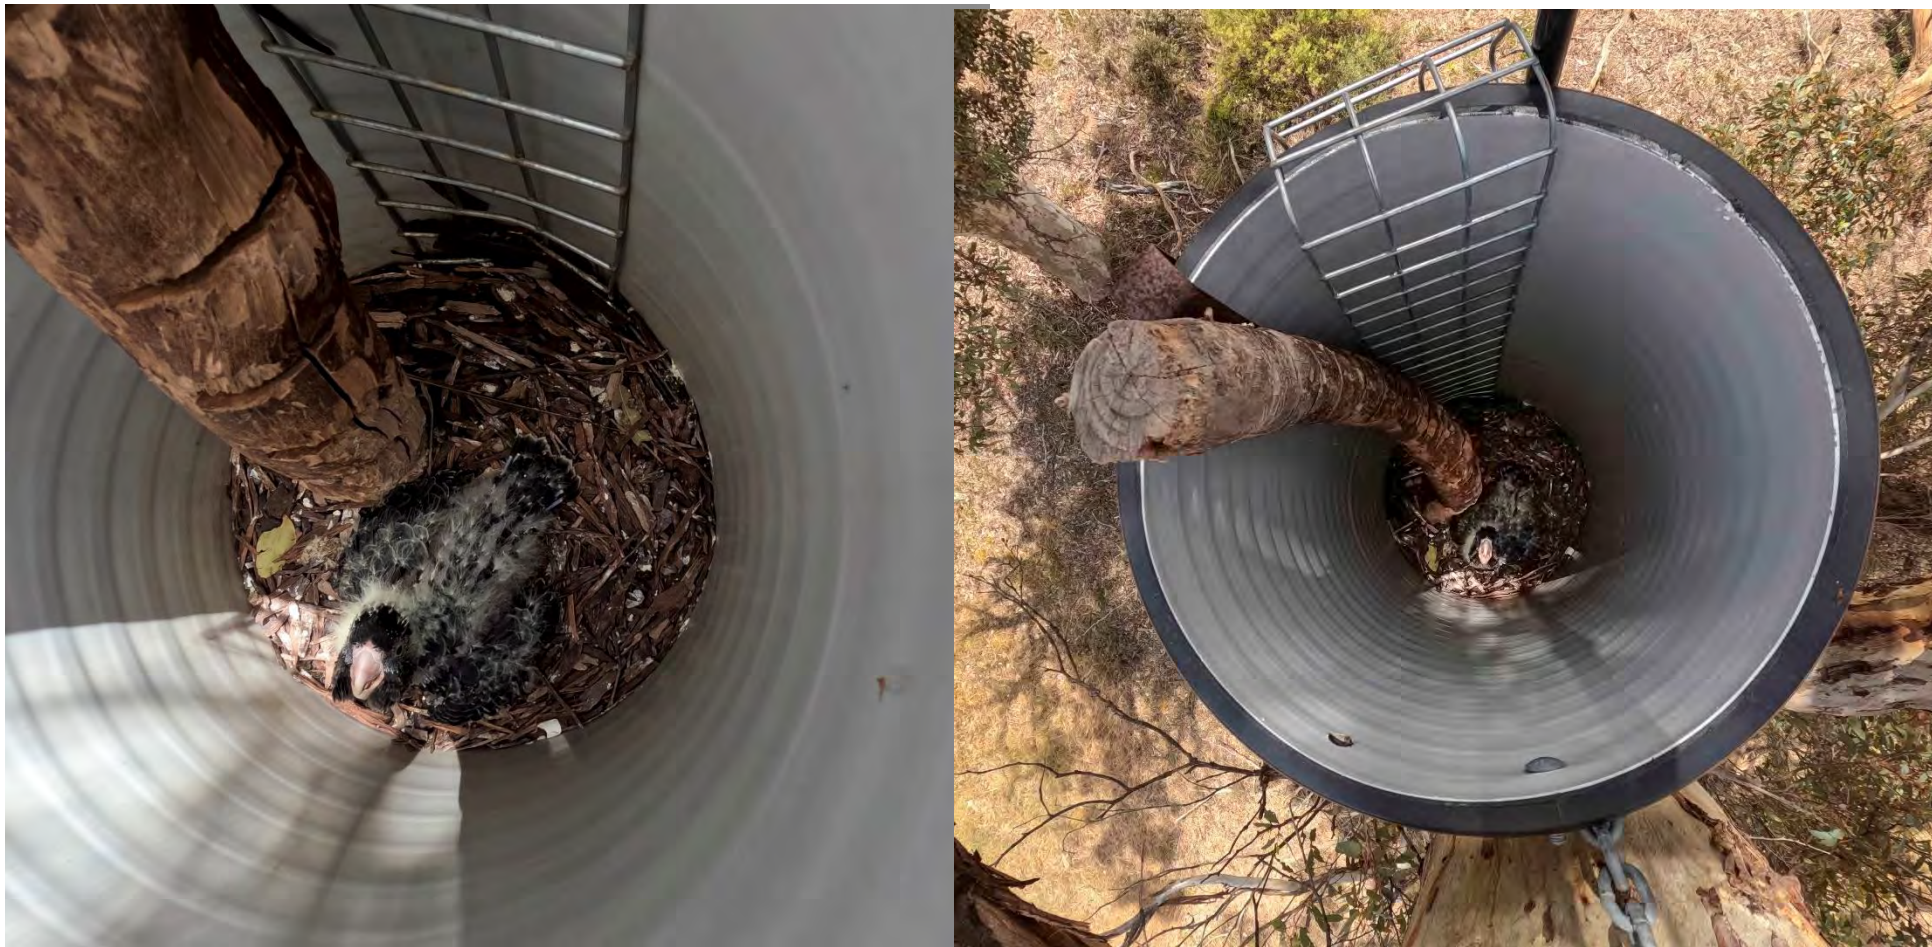
## Artificial Hollow BY20

| Hollow No | Comments | Chipping score 0-10 | Wood Chips | Tree condition | Fixings and Hollow condition | Recommended repairs |
|---|---|---|---|---|---|---|
| BY20 | One Female CC nestling 35 days old. Second nestling dead (48 hours) Chewing on post | 4 | Nil | Good | Good | Nil |

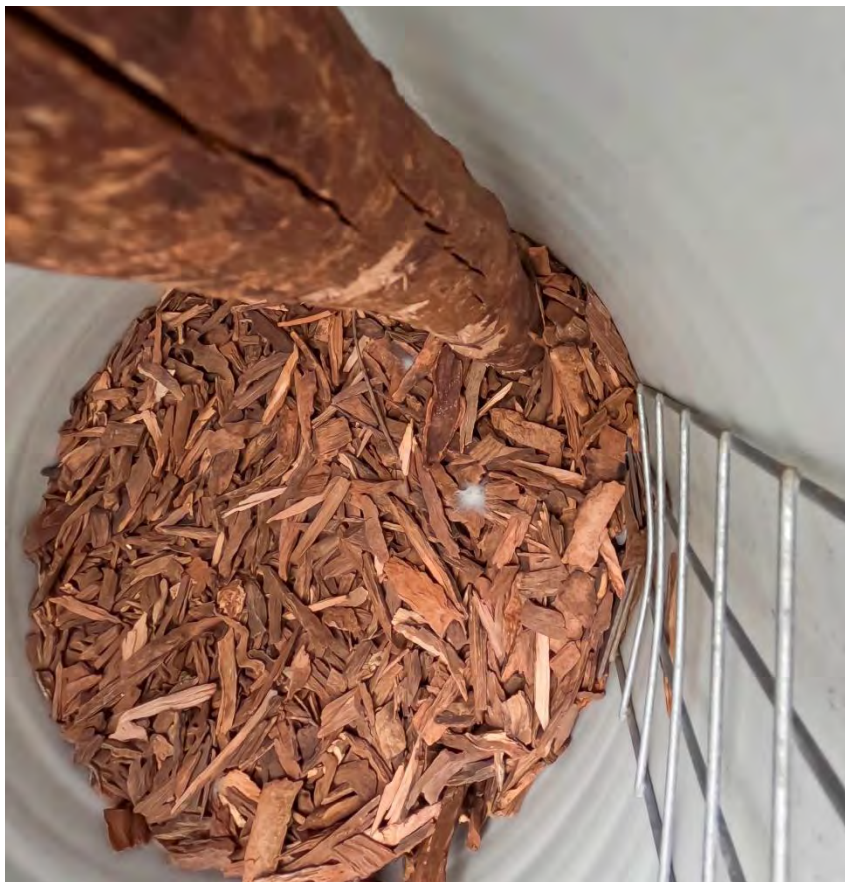
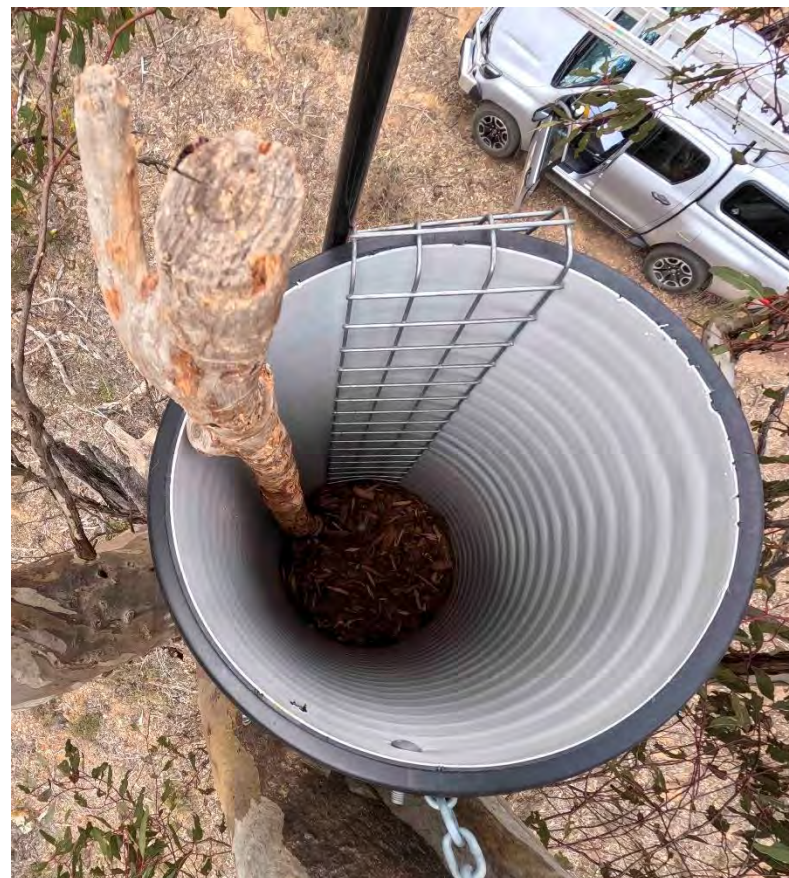
## Artificial Hollow BY21

| Hollow No | Comments | Chipping score 0-10 | Wood Chips | Tree condition | Fixings and Hollow condition | Recommended repairs |
|---|---|---|---|---|---|---|
| BY21 | Chewing on post no signs of Breeding | 2 | Nil | Good | Good | Nil |

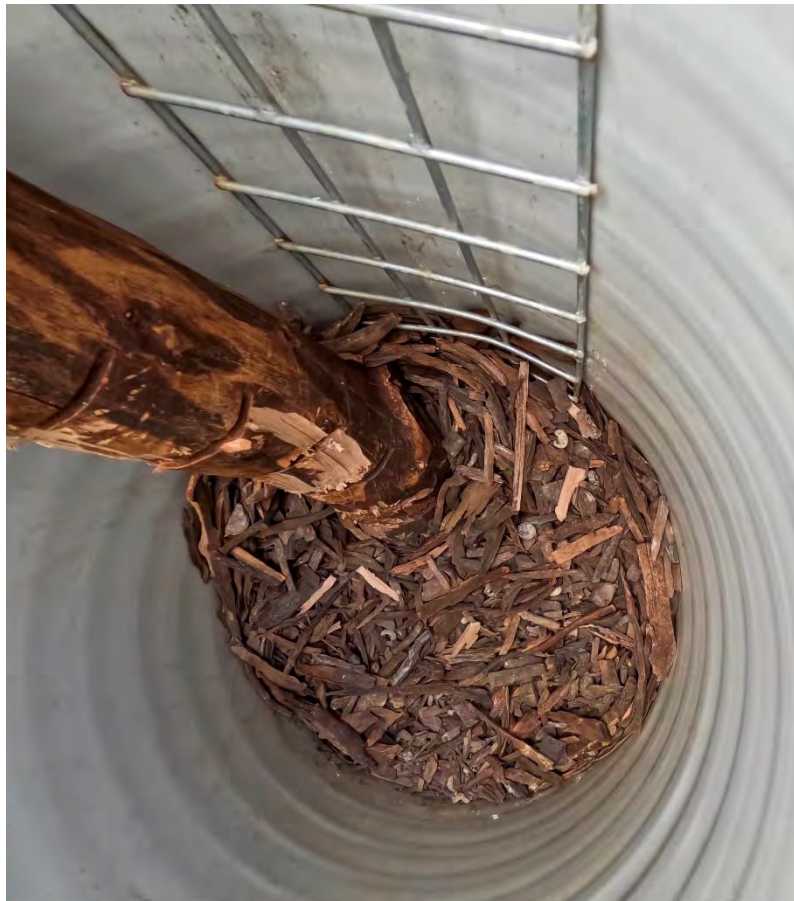
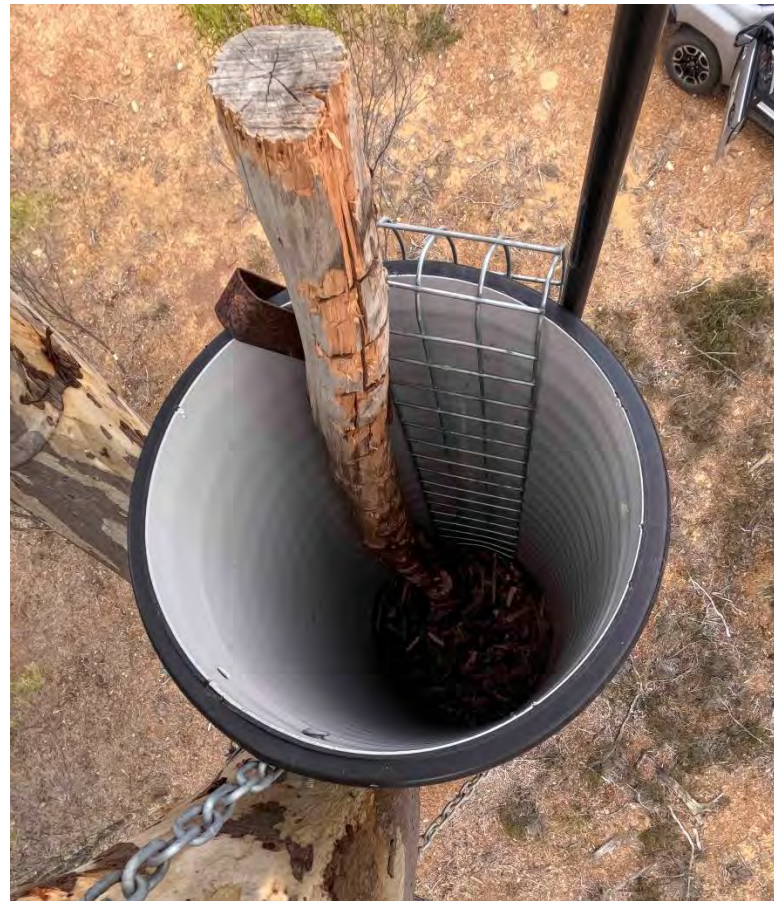
## Artificial Hollow BY22

| Hollow No | Comments | Chipping score 0-10 | Wood Chips | Tree condition | Fixings and Hollow condition | Recommended repairs |
|---|---|---|---|---|---|---|
| BY22 | Heavy Chewing on post no signs of Breeding | 3 | Nil | Good | Good | Nil |

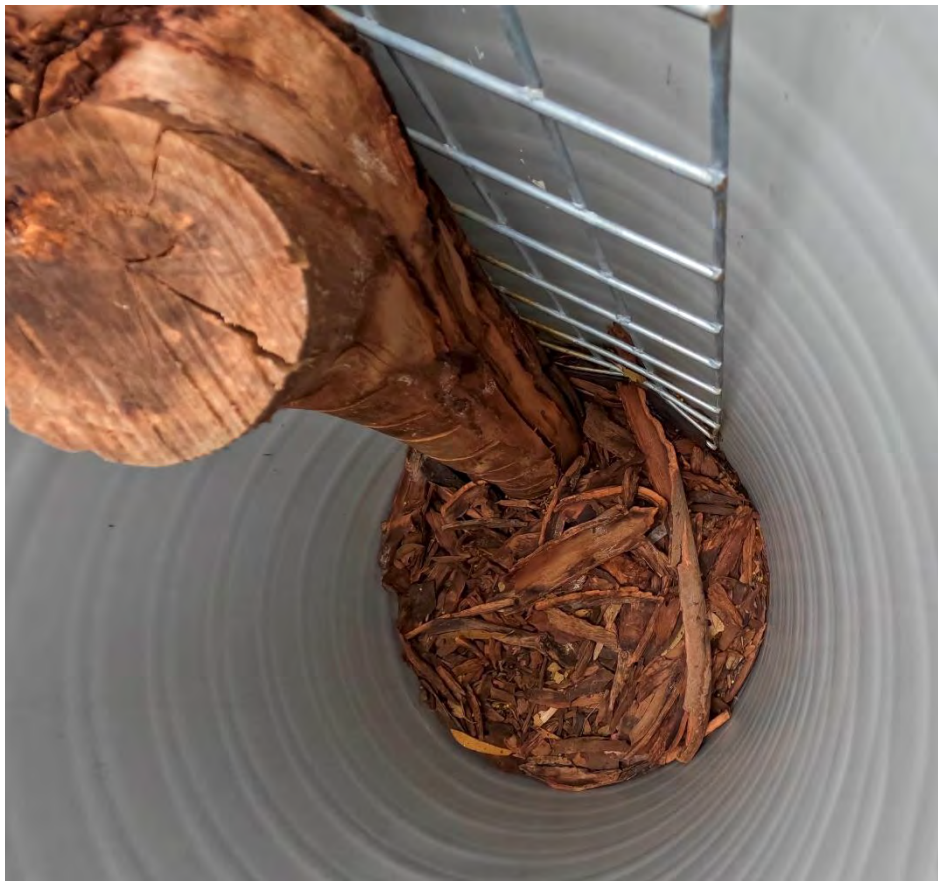
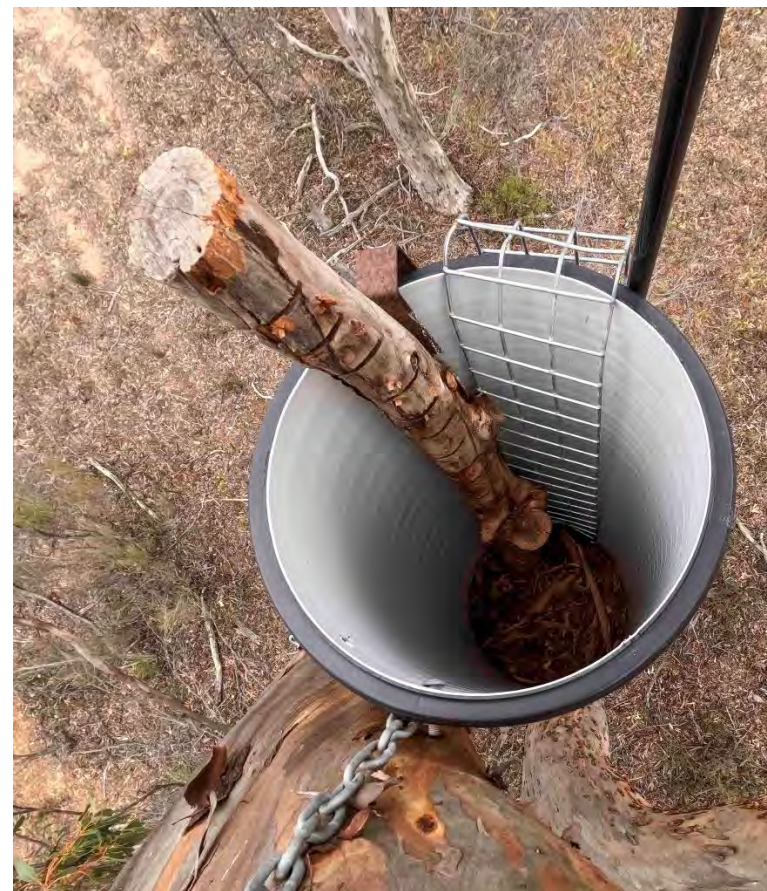
## Artificial Hollow BY23

| Hollow No | Comments | Chipping score 0-10 | Wood Chips | Tree condition | Fixings and Hollow condition | Recommended repairs |
|---|---|---|---|---|---|---|
| BY23 | Chewing on post, no signs of Breeding | 2 | Nil | Good | Good | Nil |

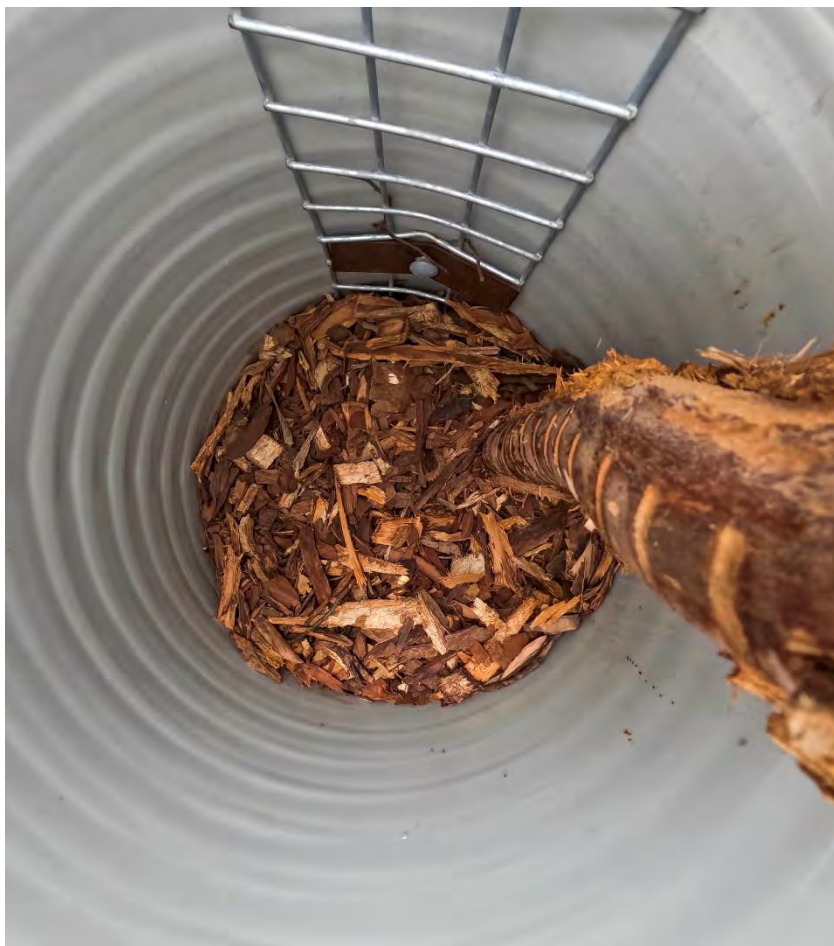
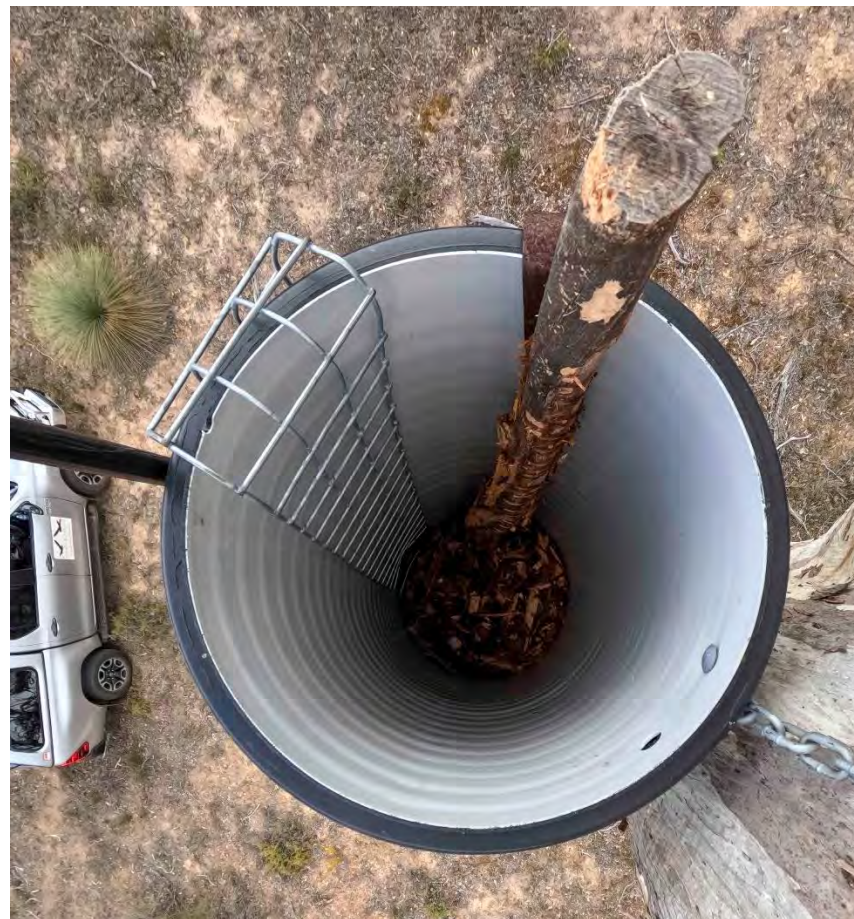
## Artificial Hollow BY24

| Hollow No | Comments | Chipping score 0-10 | Wood Chips | Tre condition | Fixings and Hollow condition | Recommended repairs |
|---|---|---|---|---|---|---|
| BY24 | Chewing on post no signs of Breeding | 2 | Nil | Good | Good | Nil |

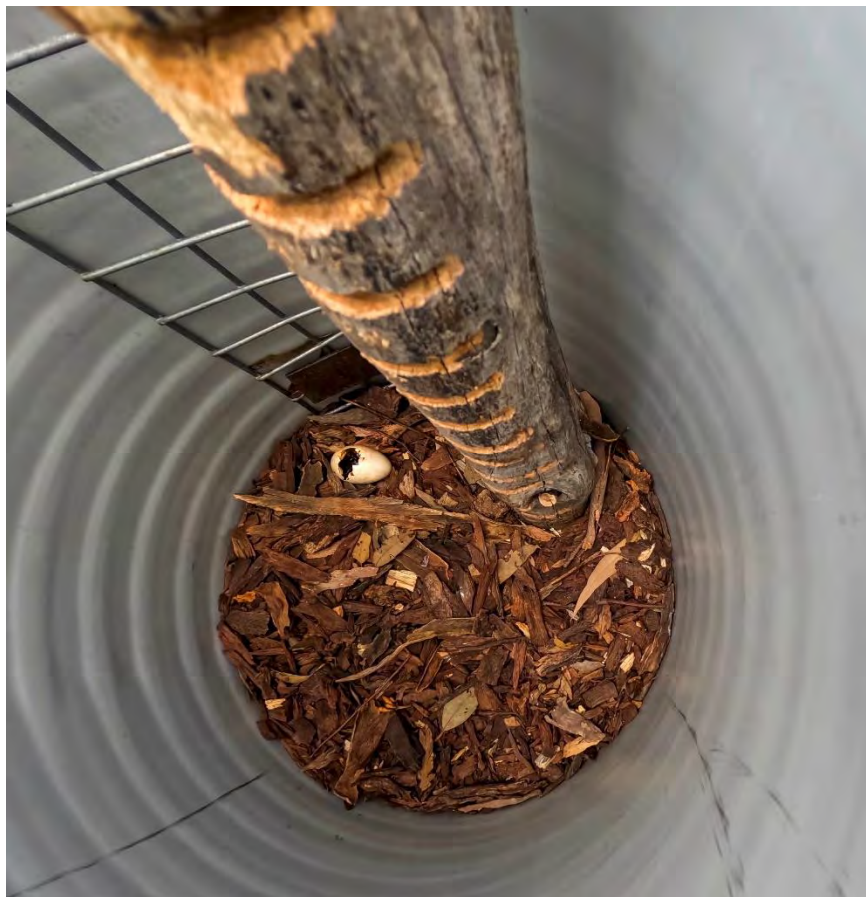
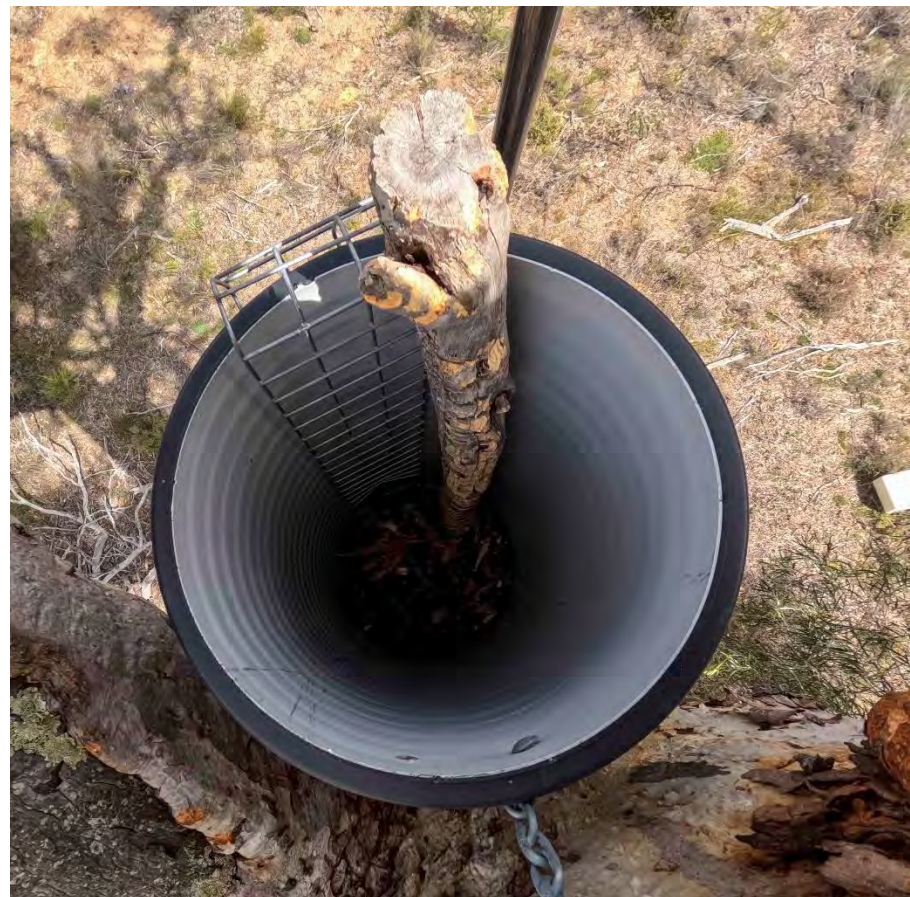
## Artificial Hollow BY25

| Hollow No | Comments | Chipping score 0-10 | Wood Chips | Tree condition | Fixings and Hollow condition | Recommended repairs |
|---|---|---|---|---|---|---|
| BY25 | One predated CC Egg, heaving chewing on post | 3 | Nil | Good | Good | Nil |

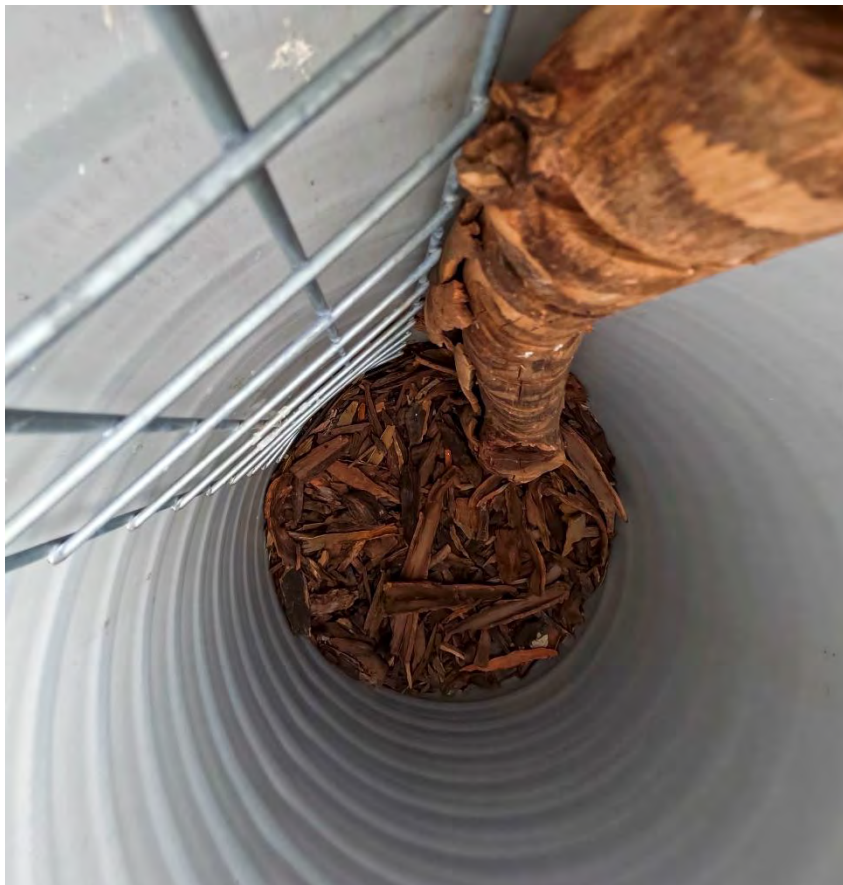
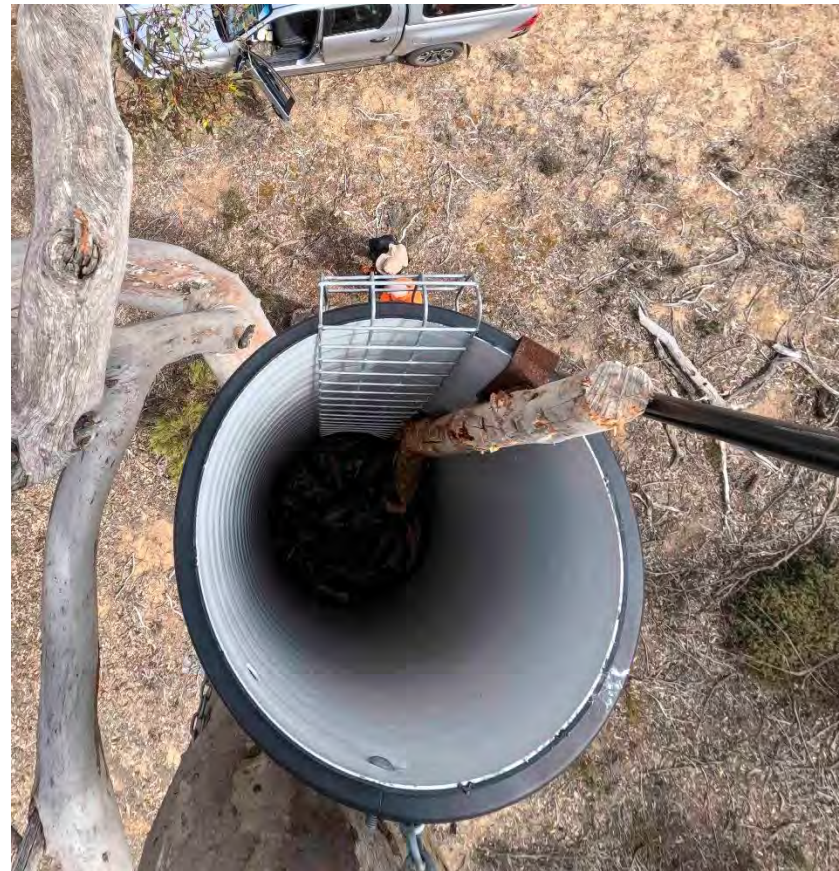
## Artificial Hollow BY26

| Hollow No | Comments | Chipping score 0-10 | Wood Chips | Tree condition | Fixings and Hollow condition | Recommended repairs |
|---|---|---|---|---|---|---|
| BY26 | Chewing on post no signs of Breeding | 2 | Nil | Good | Good | Nil |

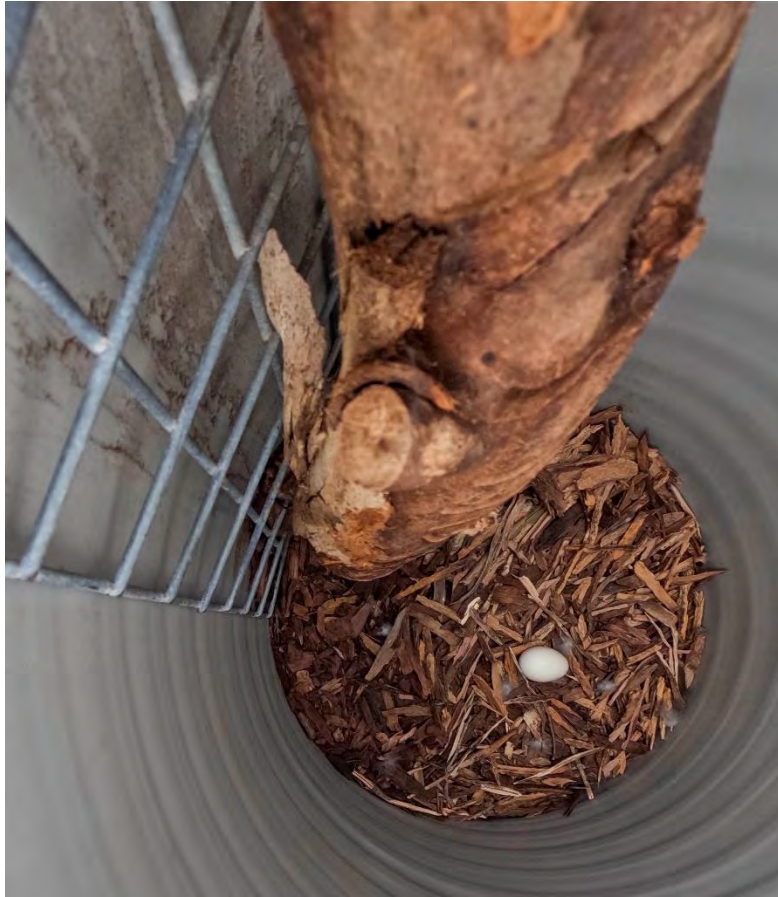
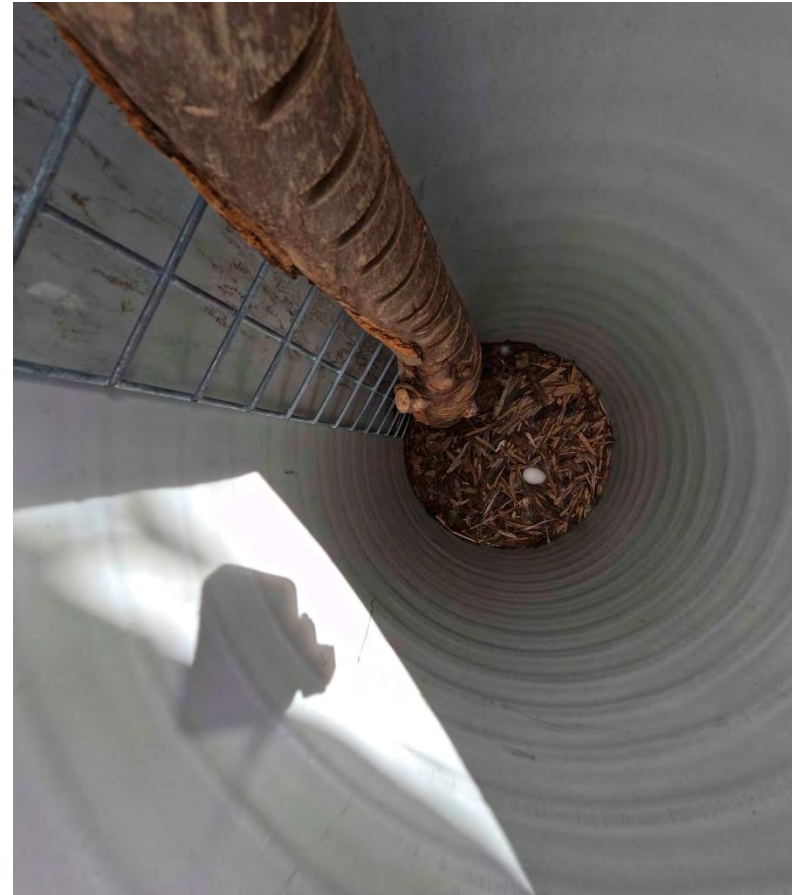
## Artificial Hollow BY27

| Hollow No | Comments | Chipping score 0-10 | Wood Chips | Tree condition | Fixings and Hollow condition | Recommended repairs |
|---|---|---|---|---|---|---|
| BY27 | Female CC flushed, 1 x CC eggs, chewing on post | 3 | Nil | Good | Good | Nil |

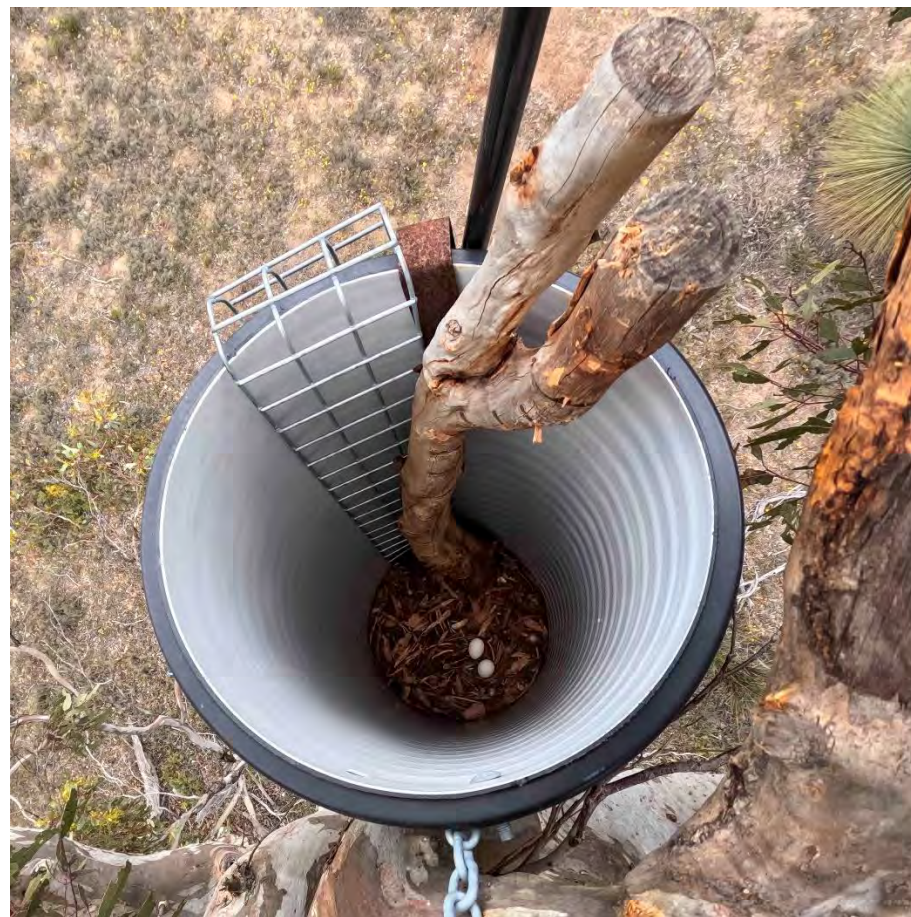
## Artificial Hollow BY28

| Hollow No | Comments | Chipping score 0-10 | Wood Chips | Tree condition | Fixings and Hollow condition | Recommended repairs |
|---|---|---|---|---|---|---|
| BY28 | Female CC flushed, 2 x CC eggs, chewing on post | 3 | Nil | Good | Good | Nil |

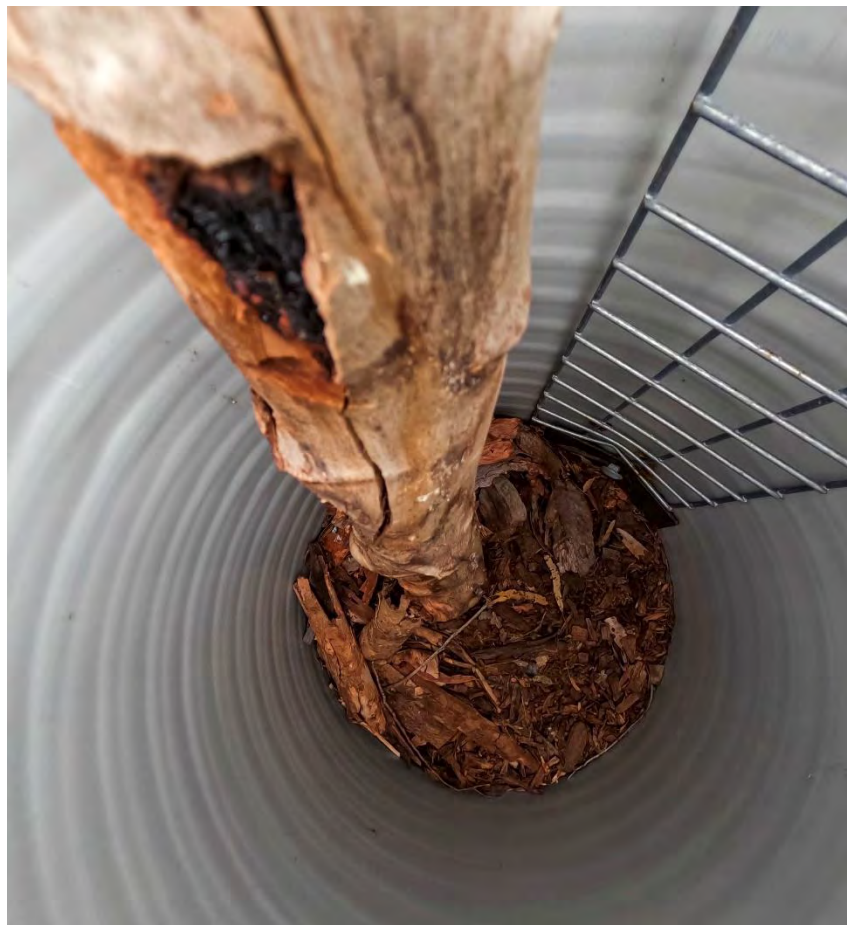
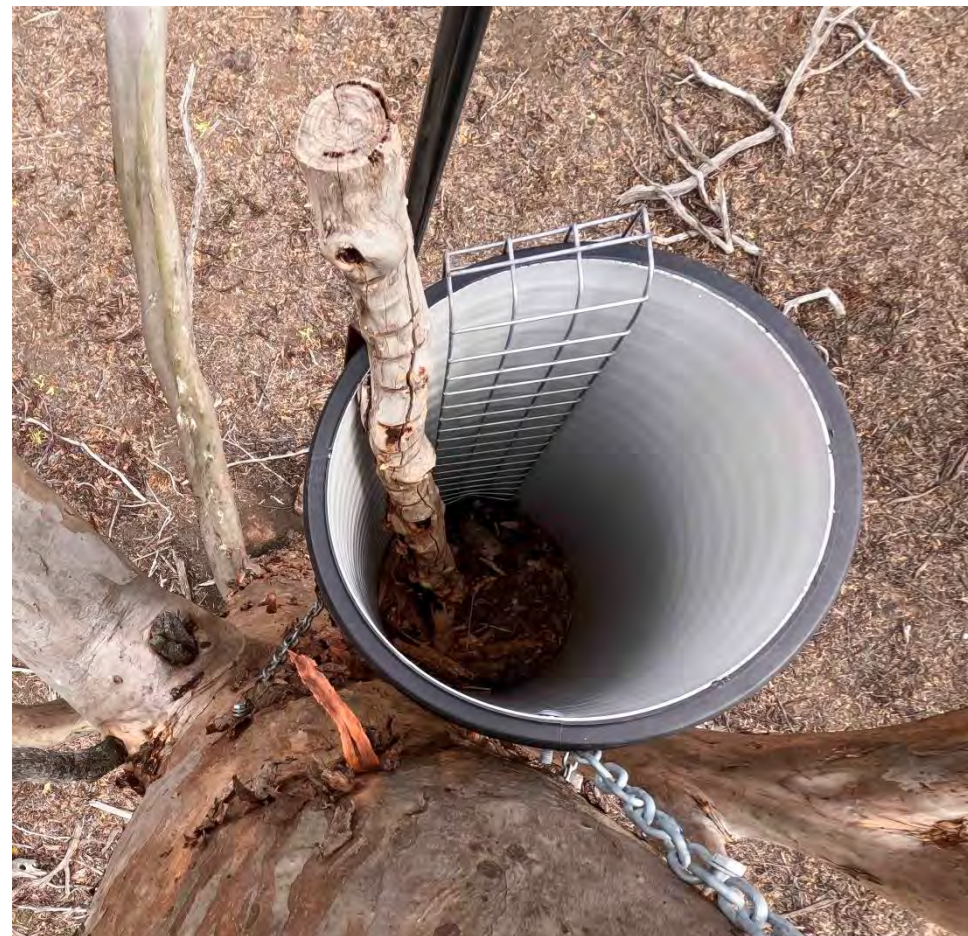
## Artificial Hollow BY29

| Hollow No | Comments | Chipping score 0-10 | Wood Chips | Tree condition | Fixings and Hollow condition | Recommended repairs |
|---|---|---|---|---|---|---|
| BY29 | Minor chewing on post, no signs of Breeding | 1 | Nil | Good | Good | Nil |

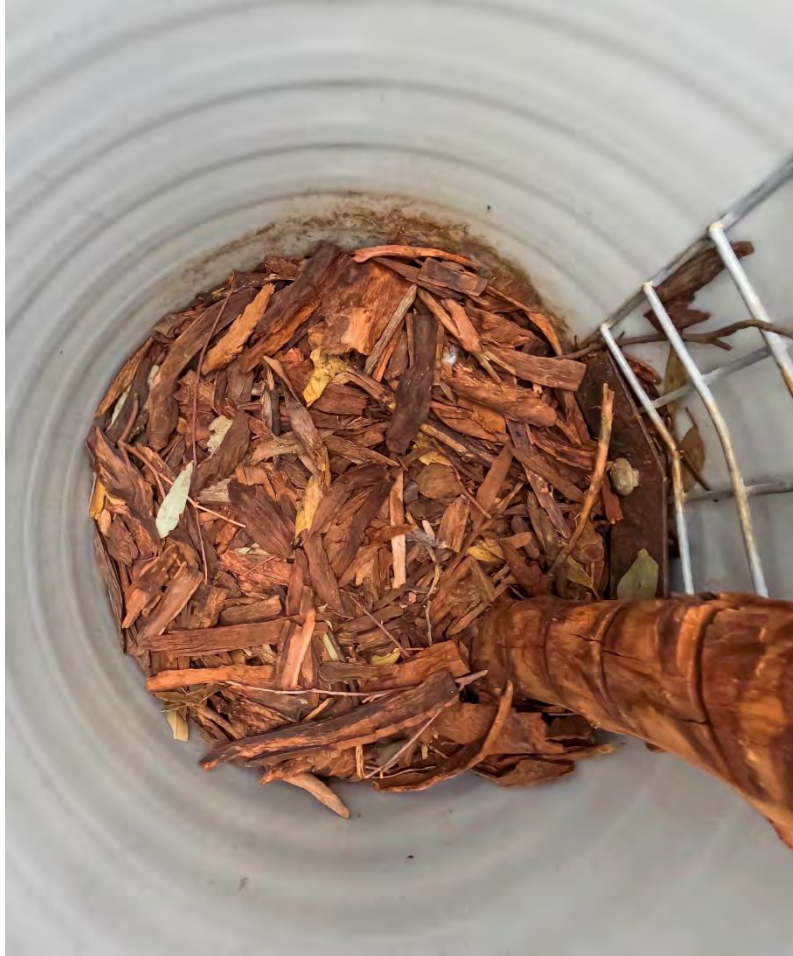
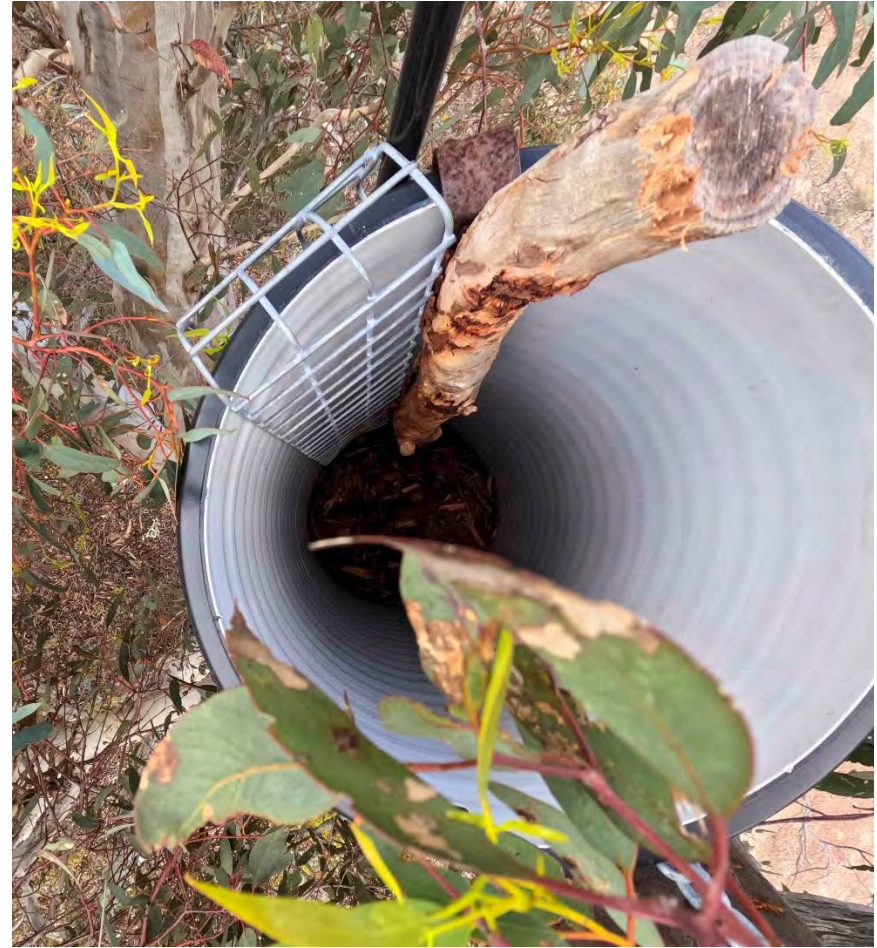
## Artificial Hollow BY30

| Hollow No | Comments | Chipping score 0-10 | Wood Chips | Tree condition | Fixings and Hollow condition | Recommended repairs |
|---|---|---|---|---|---|---|
| BY30 | Chewing on post no signs of Breeding | 2 | Nil | Good | Good | Nil |

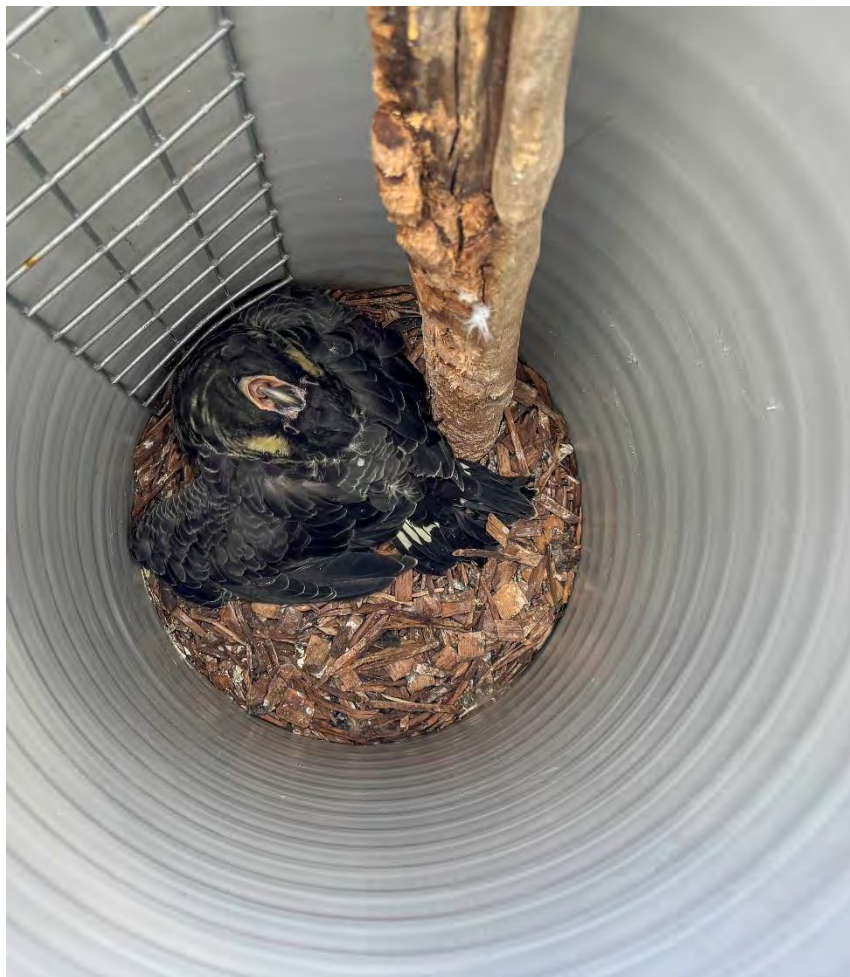
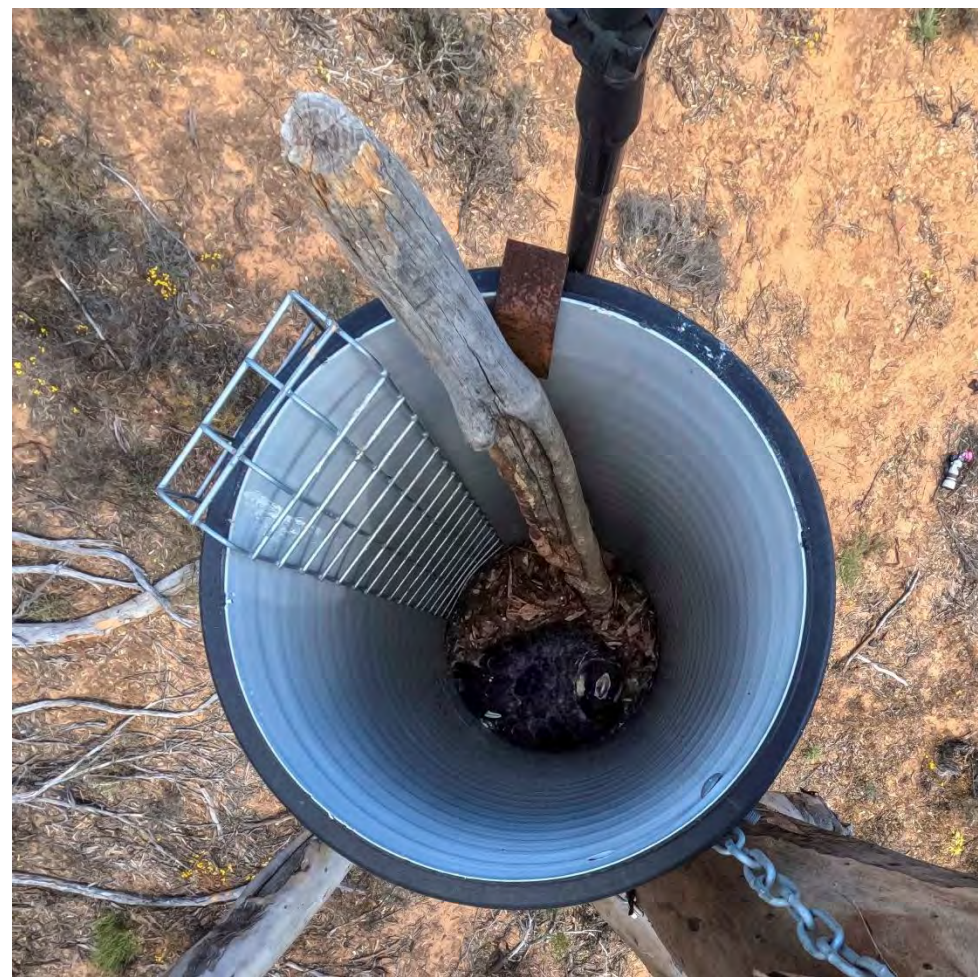
## Artificial Hollow BY31

| Hollow No | Comments | Chipping score 0-10 | Wood Chips | Tree condition | Fixings and Hollow condition | Recommended repairs |
|---|---|---|---|---|---|---|
| BY31 | Female Carnabys, 59 days old CC,<br>Chewing on post | 3 | Nil | Good | Good | Nil |
