# Ministerial Statement Compliance Assessment Report

**Bunbury Outer Ring Road - South  
Ministerial Statement 1191**

**2025 - 2026 Reporting Period**

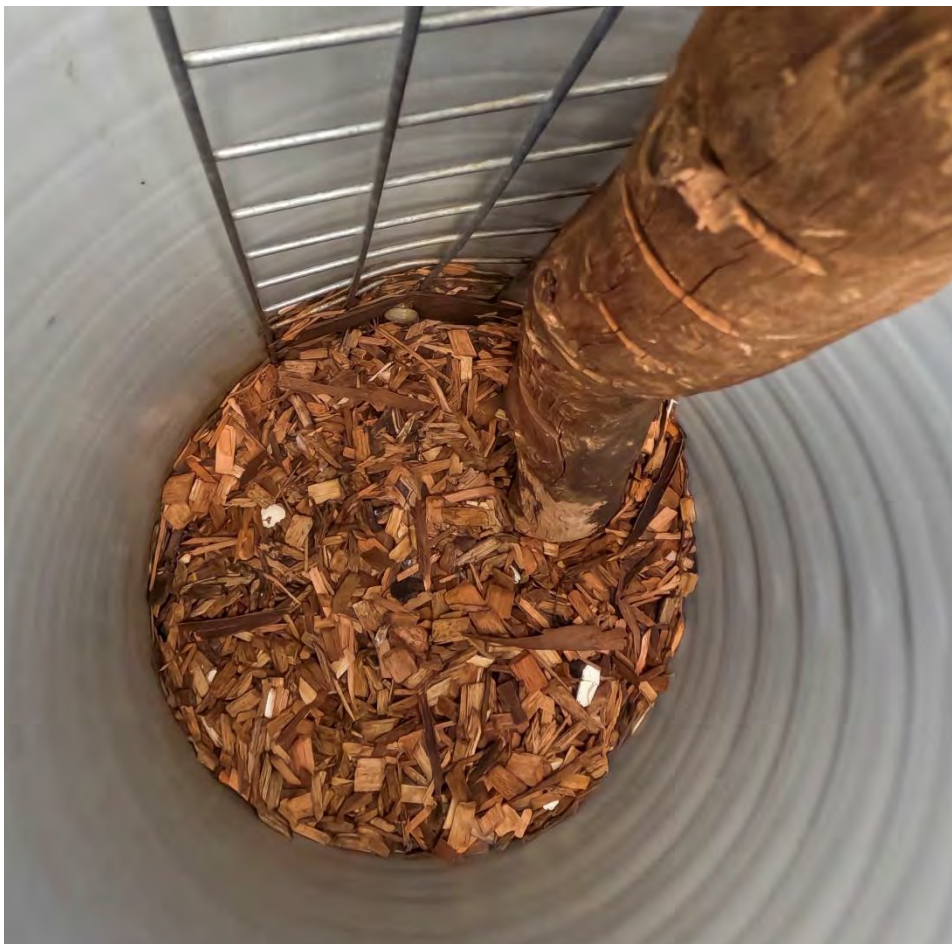
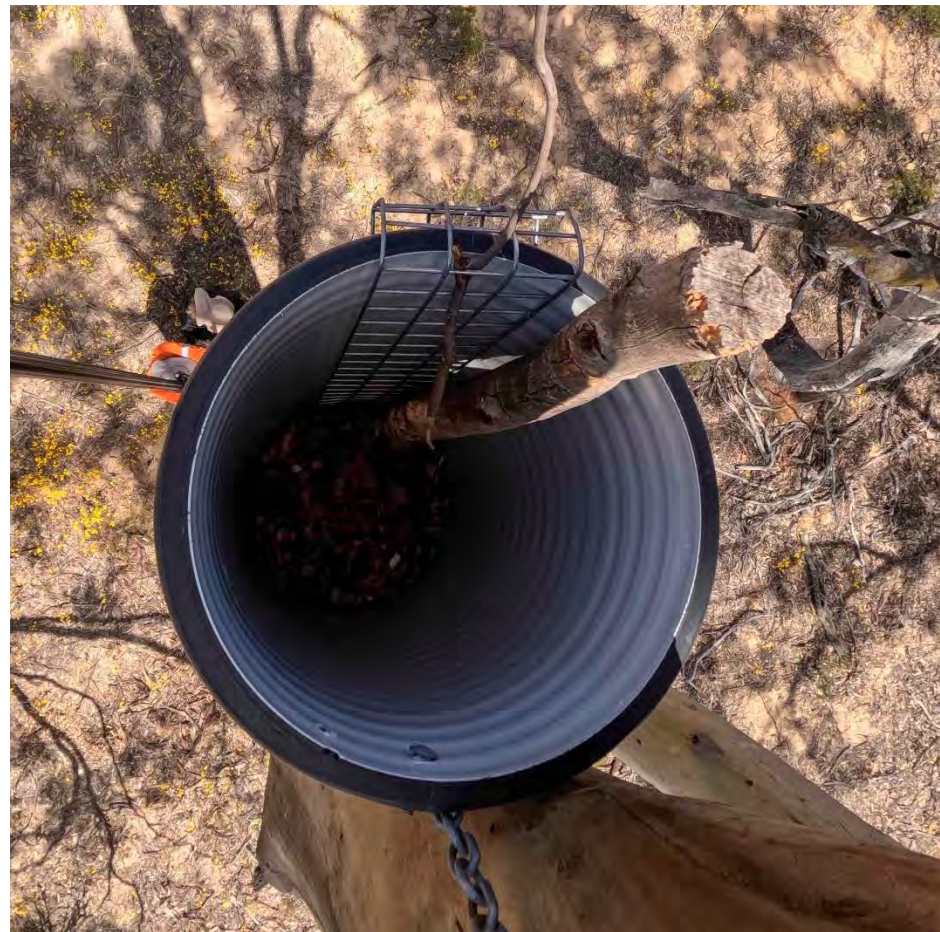
## Artificial Hollow BY32

| Hollow No | Comments | Chipping score 0-10 | Wood Chips | Tree condition | Fixings and Hollow condition | Recommended repairs |
|---|---|---|---|---|---|---|
| BY32 | Smashed CC egg in base of hollow | 3 | Nil | Good | Good | Nil |

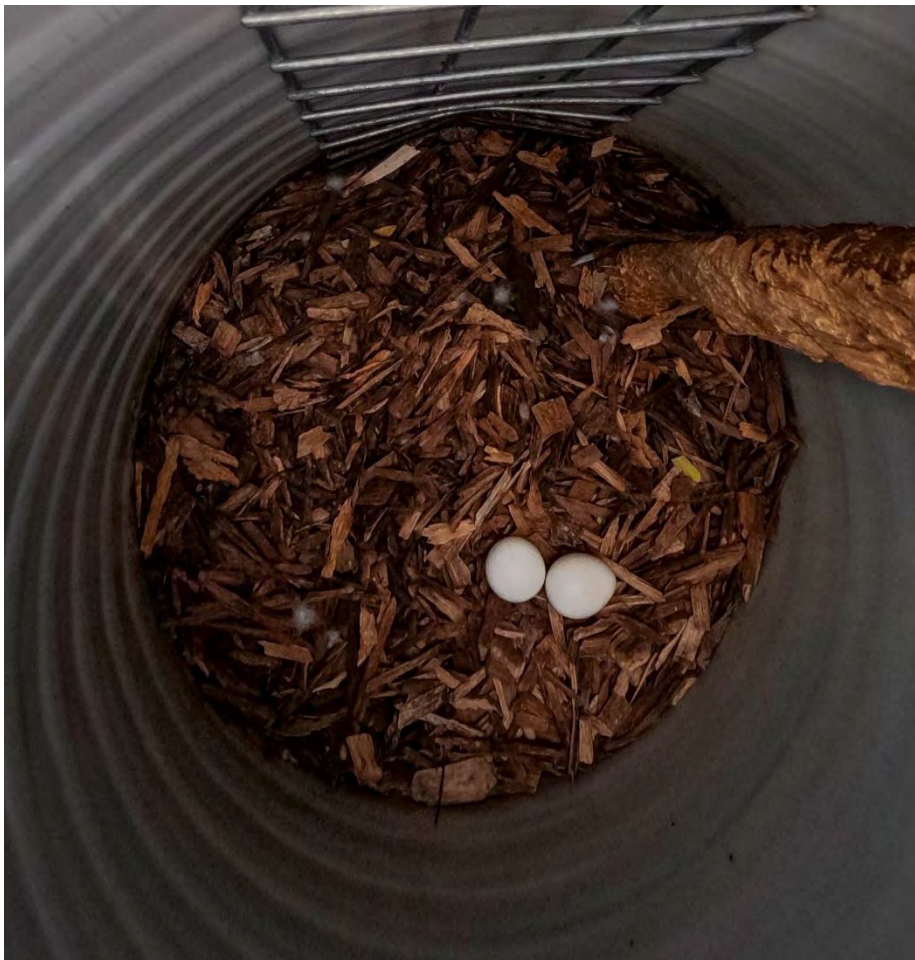
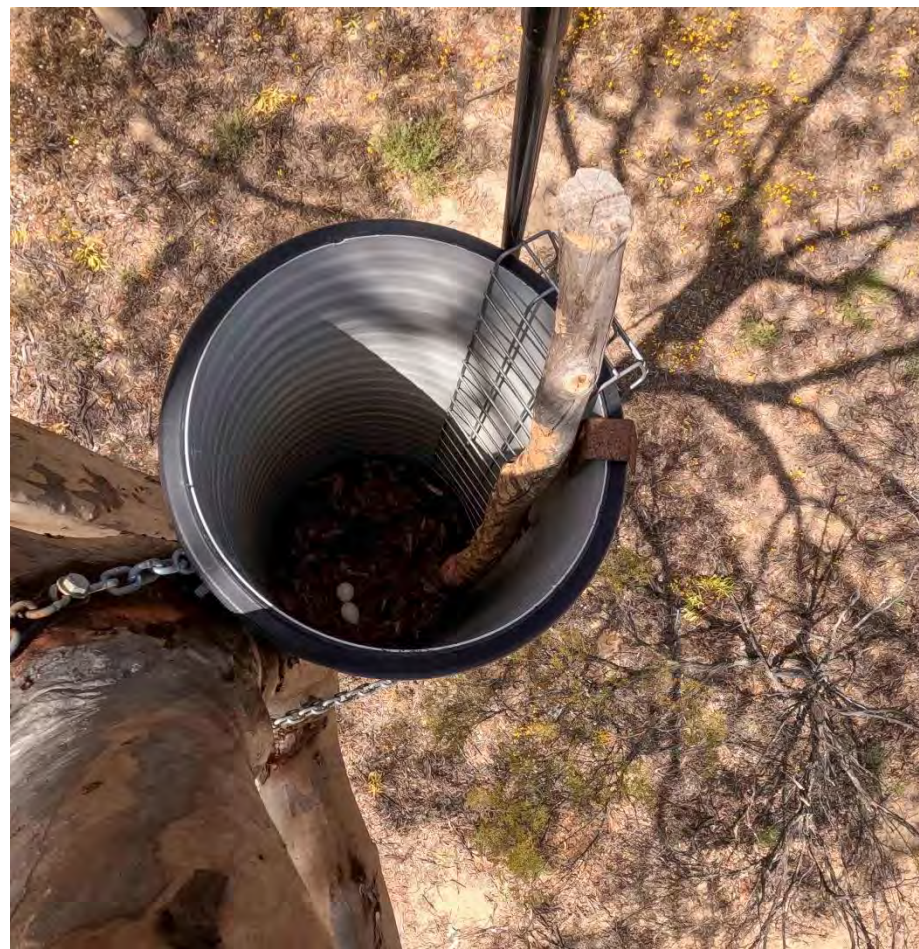
## Artificial Hollow BY33

| Hollow No | Comments | Chipping score 0-10 | Wood Chips | Tree condition | Fixings and Hollow condition | Recommended repairs |
|---|---|---|---|---|---|---|
| BY33 | Female CC flushed, 2 x CC eggs, chewing on post | 5 | Nil | Good | Good | Nil |

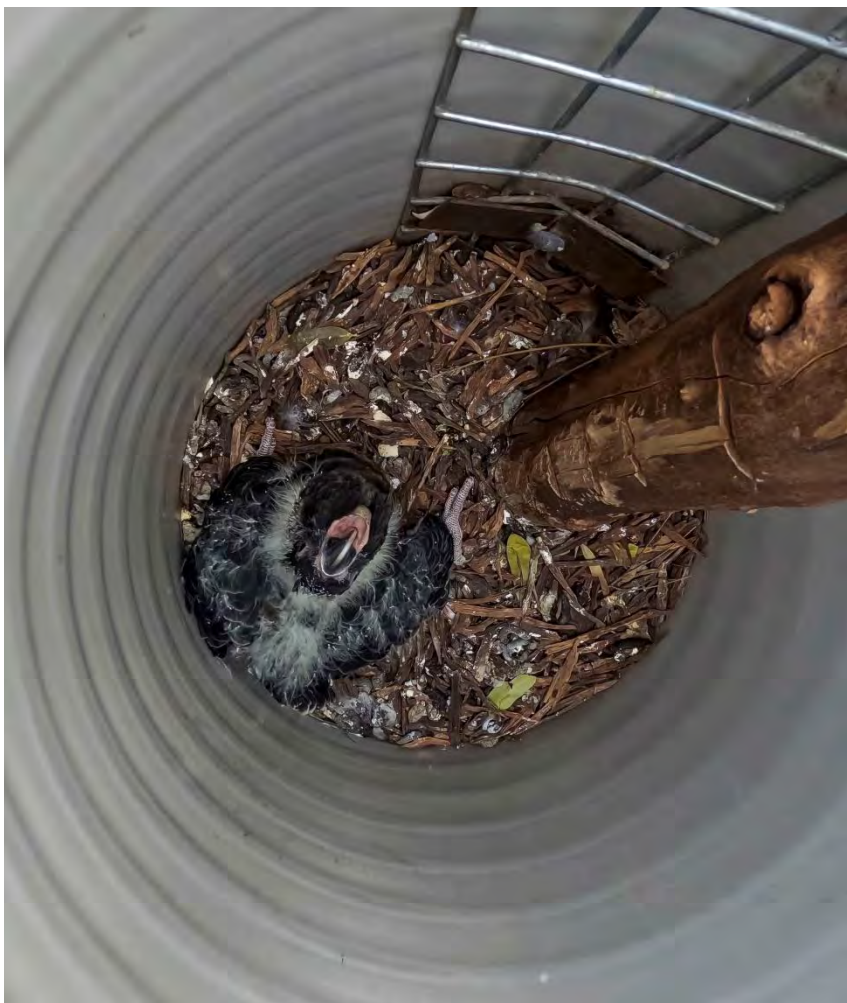
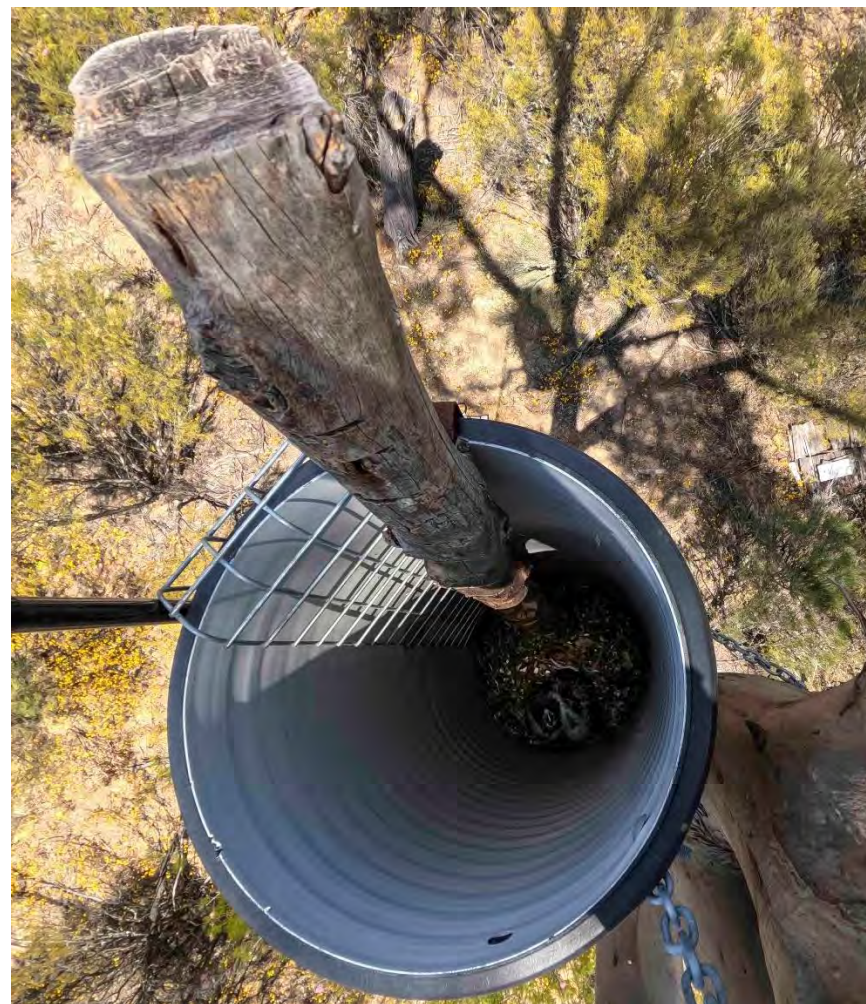
## Artificial Hollow BY34

| Hollow No | Comments | Chipping score 0-10 | Wood Chips | Tree condition | Fixings and Hollow condition | Recommended repairs |
|---|---|---|---|---|---|---|
| BY34 | Male Carnabys, 39 days old CC,<br>Chewing on post | 3 | Nil | Good | Good | Nil |

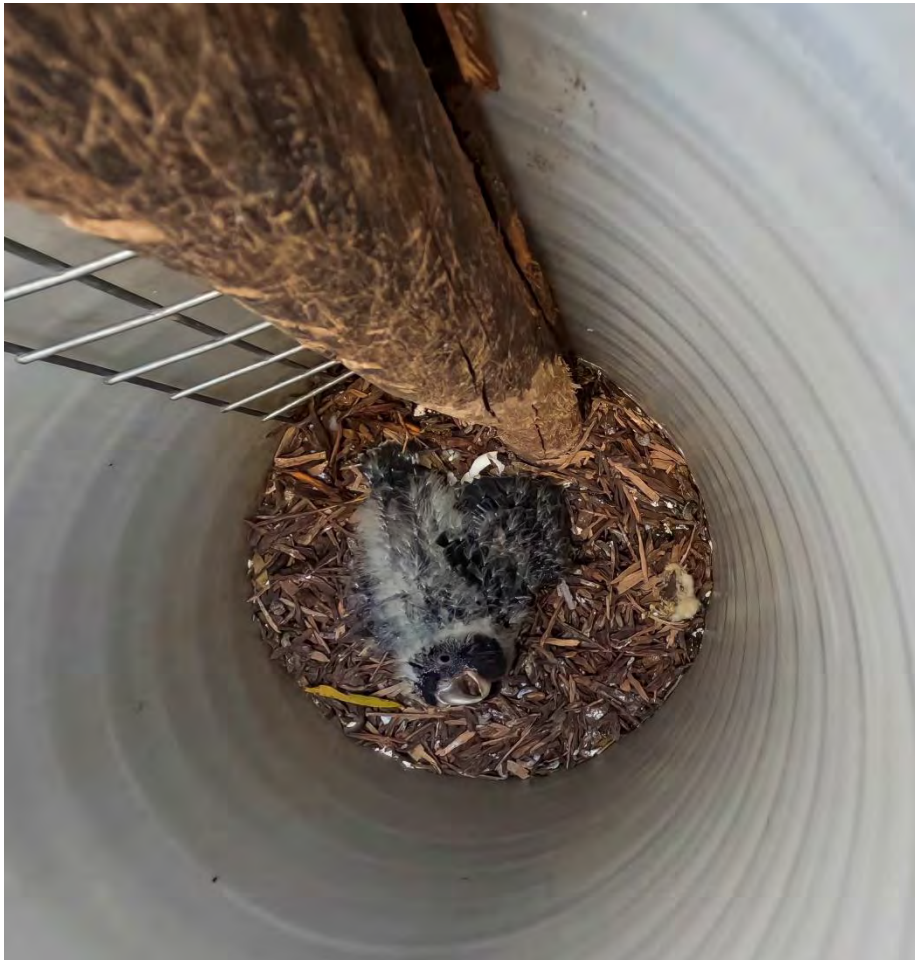
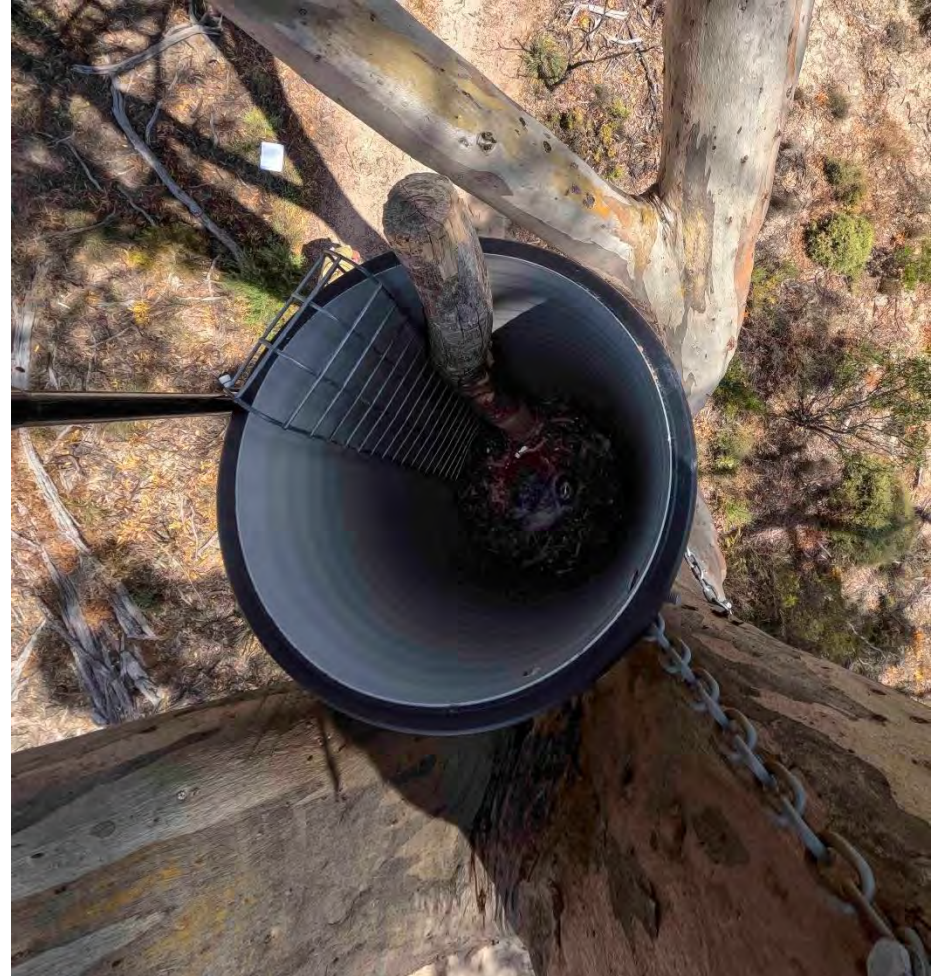
## Artificial Hollow BY35

| Hollow No | Comments | Chipping score 0-10 | Wood Chips | Tree condition | Fixings and Hollow condition | Recommended repairs |
|---|---|---|---|---|---|---|
| BY35 | Male Carnabys,35 days old CC,<br>Chewing on post | 3 | Nil | Good | Good | Nil |

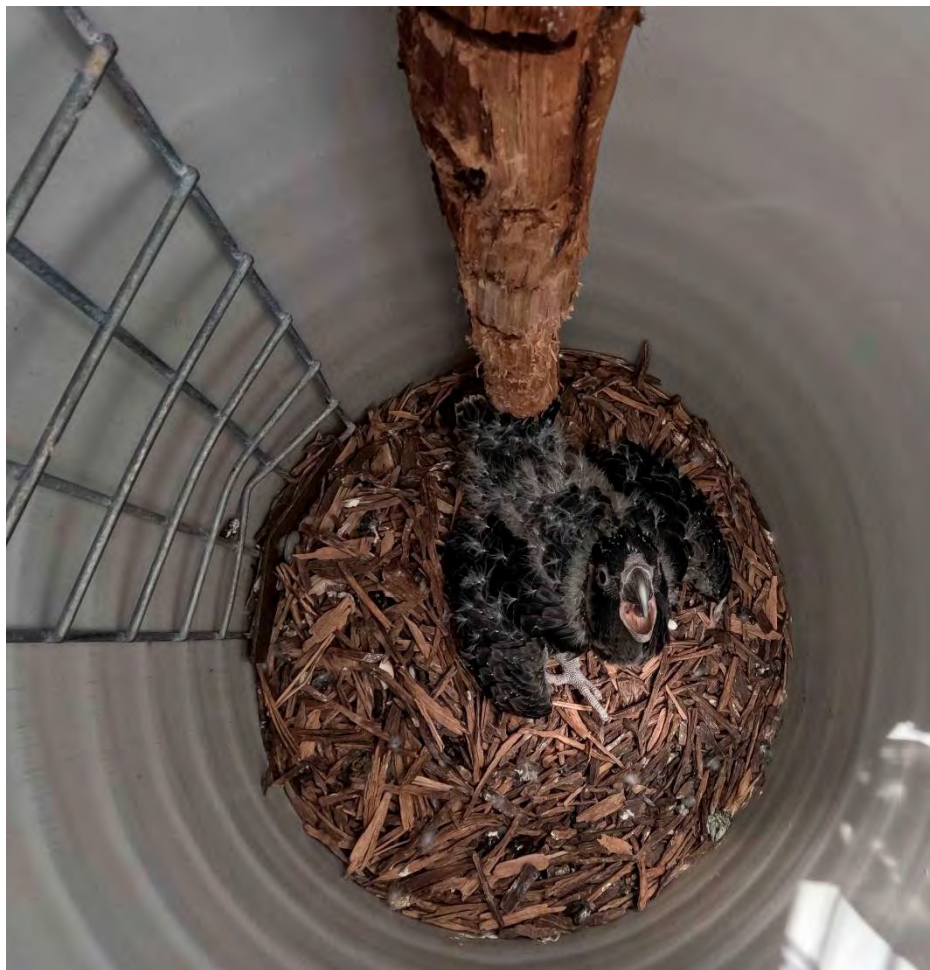
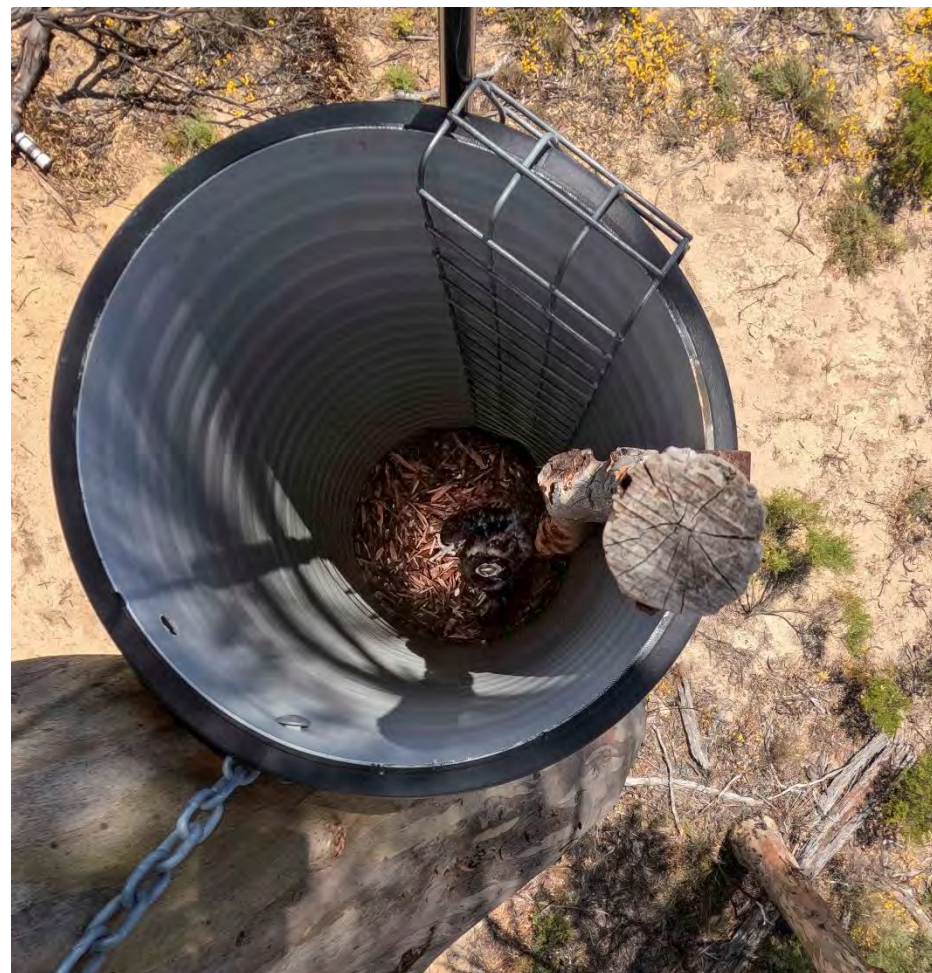
## Artificial Hollow BY36

| Hollow No | Comments | Chipping score 0-10 | Wood Chips | Tree condition | Fixings and Hollow condition | Recommended repairs |
|---|---|---|---|---|---|---|
| BY36 | Male Carnabys, 36 days old CC,<br>Chewing on post | 2 | Nil | Good | Good | Nil |

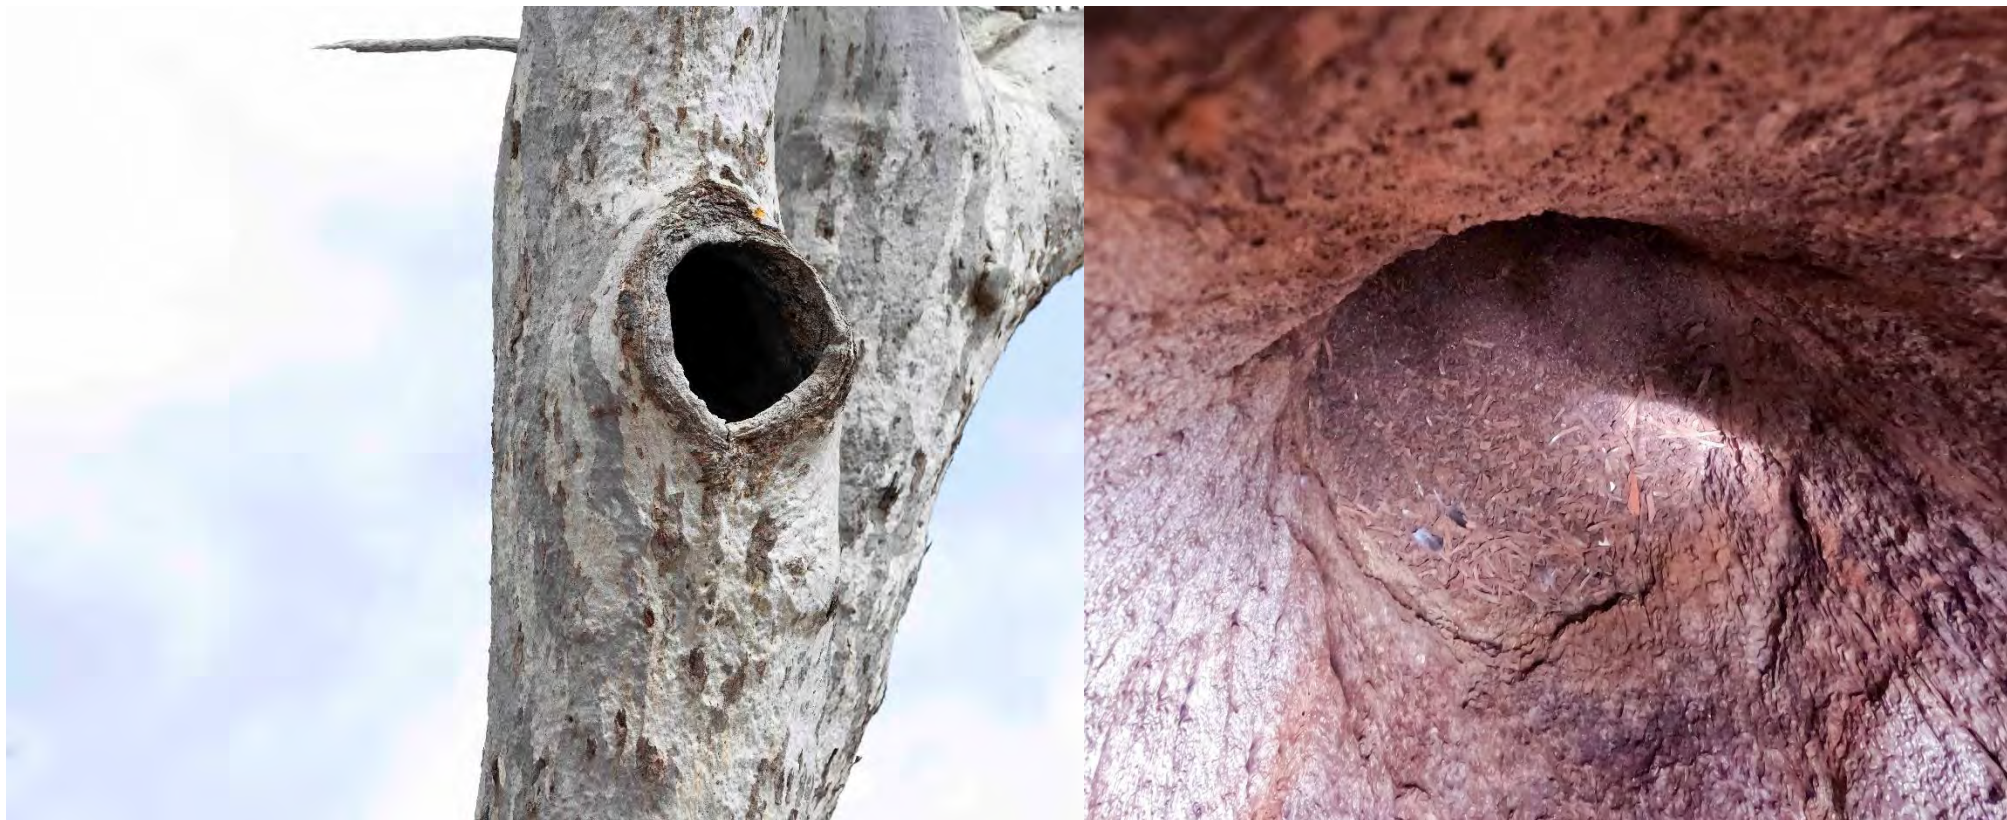
## Natural Hollow Repair One (Badgebup

| Hollow No | Comments | Chipping score 0-10 | Wood Chips | Tree condition | Fixings and Hollow condition | Recommended repairs |
|---|---|---|---|---|---|---|
| Badgebup 01 | 2 CC breast feathers on floor, Chewing in hollow no signs of Breeding | 2 | Nil | Good | N/A | Nil |

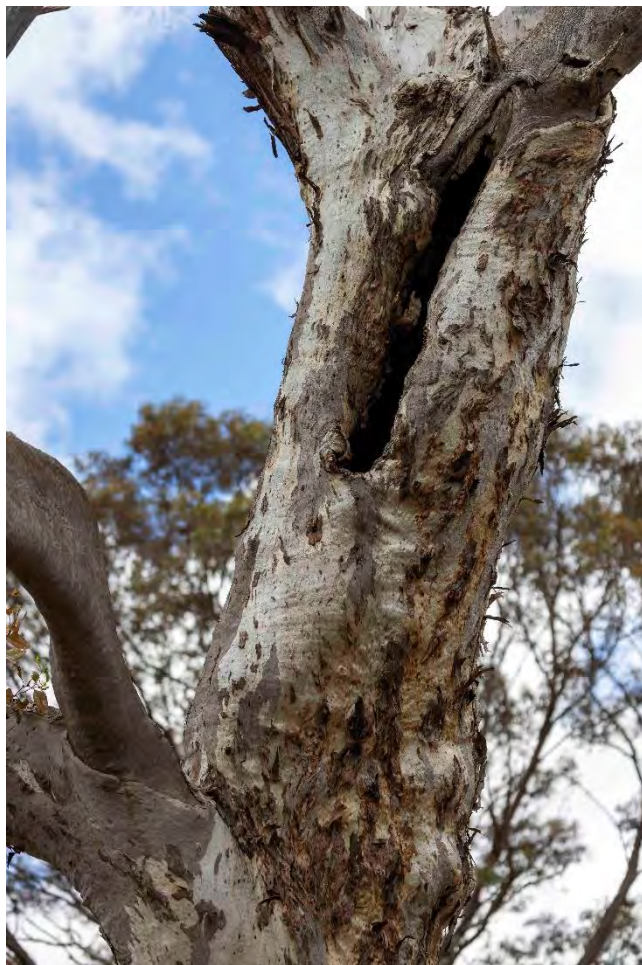
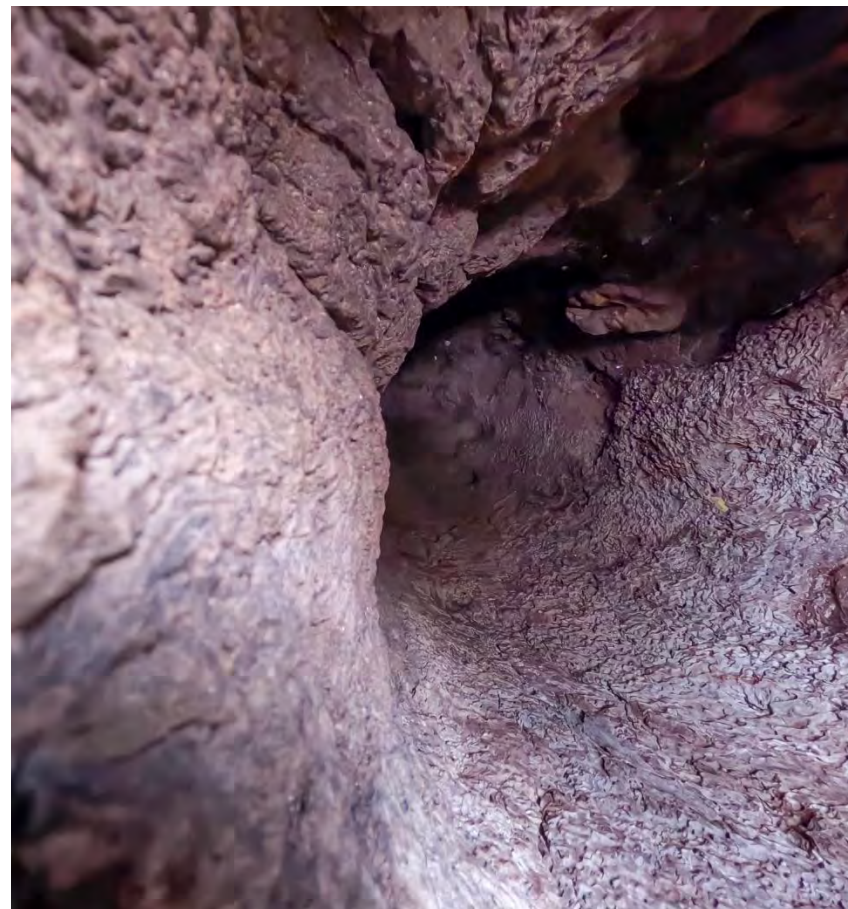
## Natural Hollow Repair Three (Kwobrup)

| Hollow No | Comments | Chipping score 0-10 | Wood Chips | Tree condition | Fixings and Hollow condition | Recommended repairs |
|---|---|---|---|---|---|---|
| Kwobrup 03 | No signs of nesting or inspection by Black Cockatoos. | 0 | 40 | Good | N/A | Hollow floor dropped need 40lts woodchips |

| <b>Kwobrup 03</b> | No signs of nesting or inspection by Black Cockatoos. | One dead regent parrot in base of hollow. Hollow is deep however even floor | 0 | nil | Good | N/A | NIL |

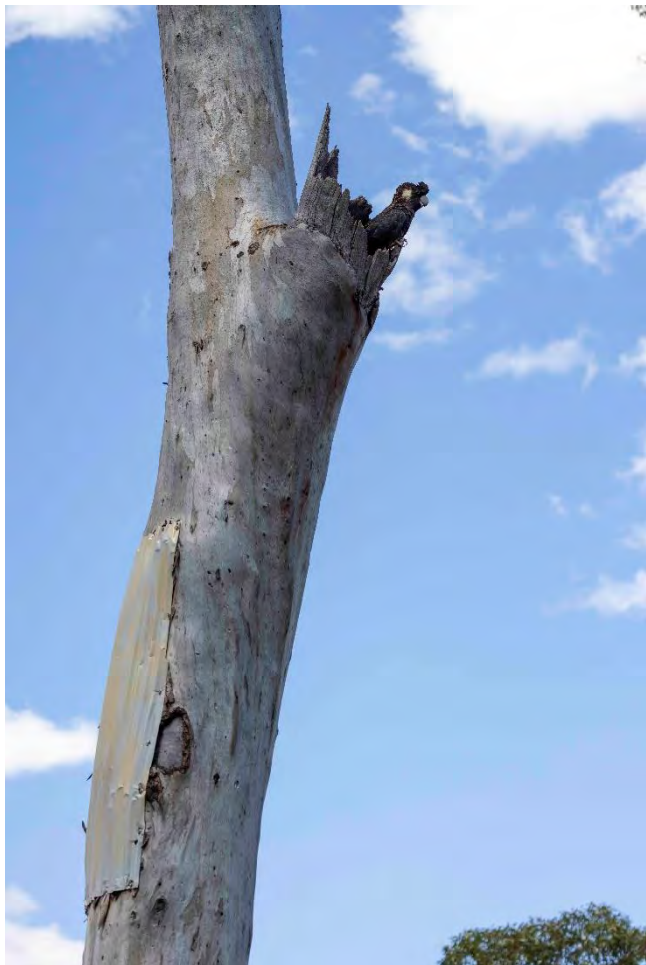
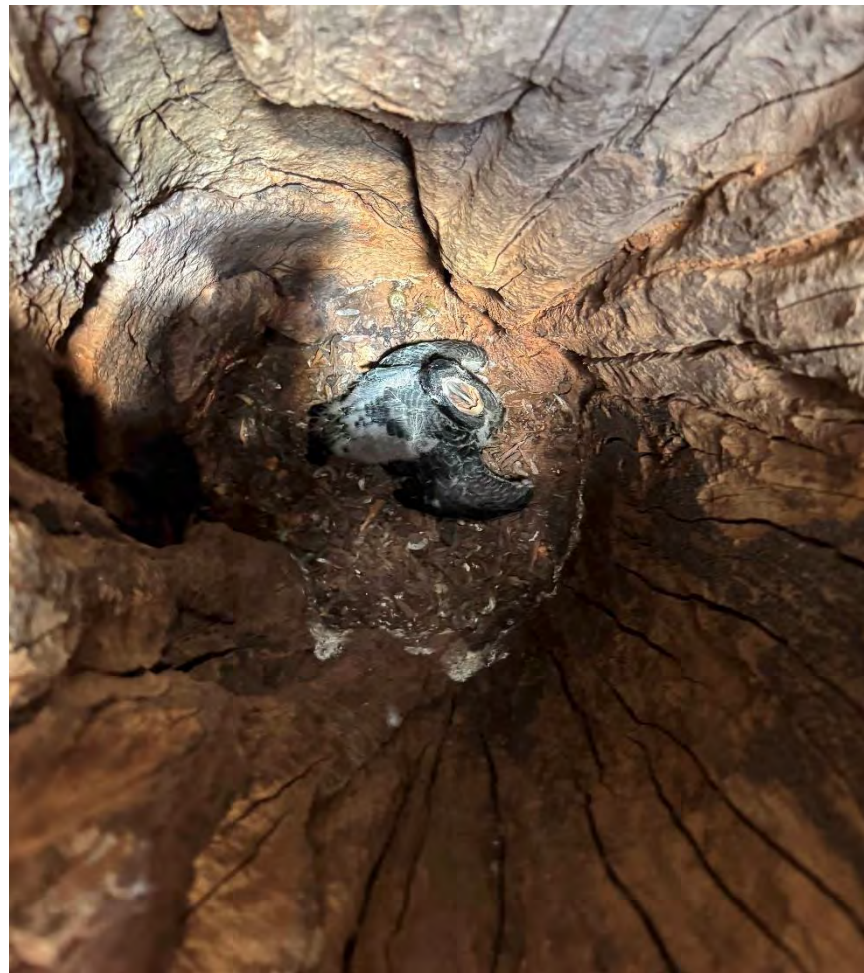
## Natural Hollow Repair One (Elphin)

| Hollow No | Comments | Chipping score 0-10 | Wood Chips | Tree condition | Fixings and Hollow condition | Recommended repairs |
|---|---|---|---|---|---|---|
| Elphin 01 | Female Carnaby's, 37 days old, female flushed | 2 | Nil | Good | N/A | Nil |

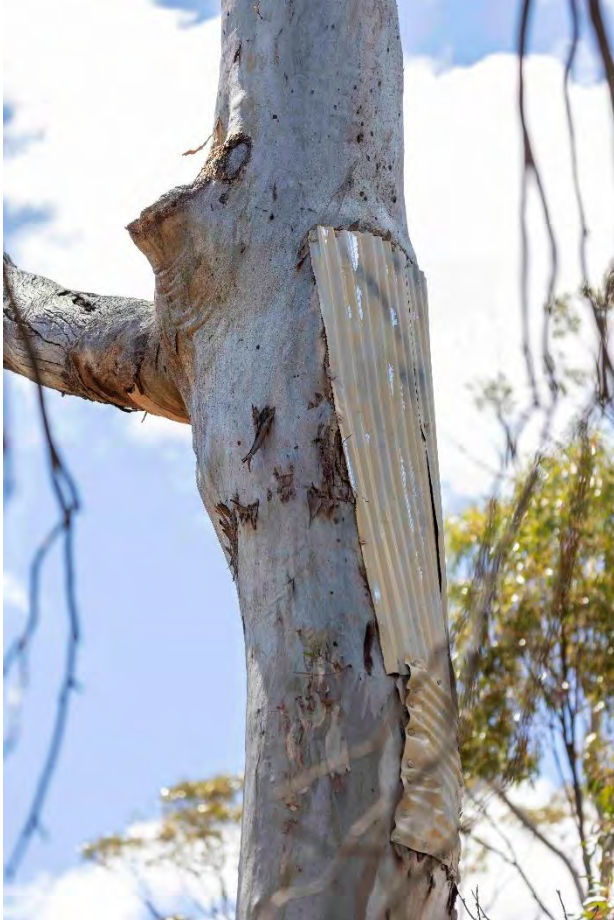
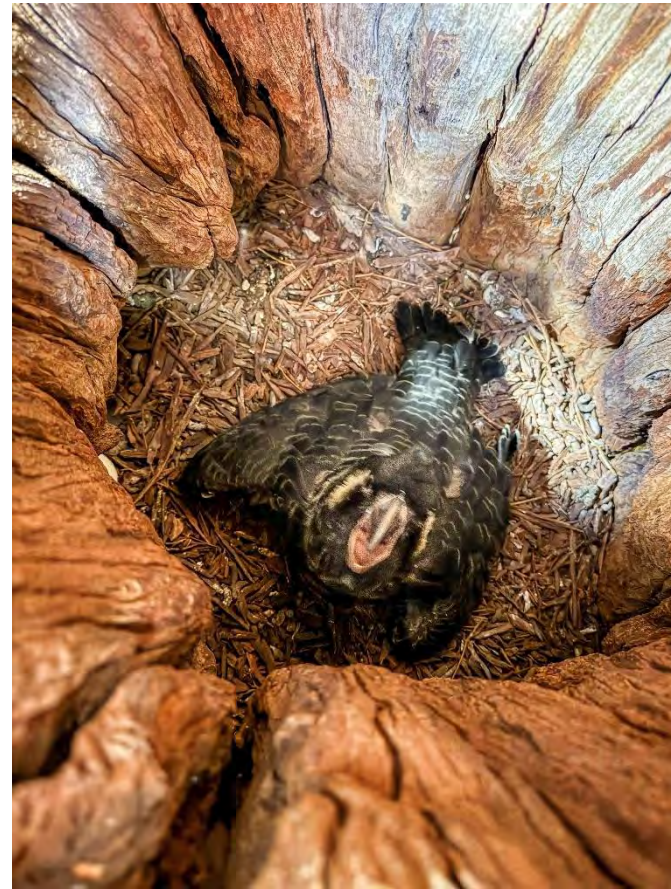
## Natural Hollow Repair Two (Elphin)

| Hollow No | Comments | Chipping score 0-10 | Wood Chips | Tree condition | Fixings and Hollow condition | Recommended repairs |
|---|---|---|---|---|---|---|
| Elphin 02 | Female Carnaby's 45 days old | 2 | Nil | Good | N/A | Nil |

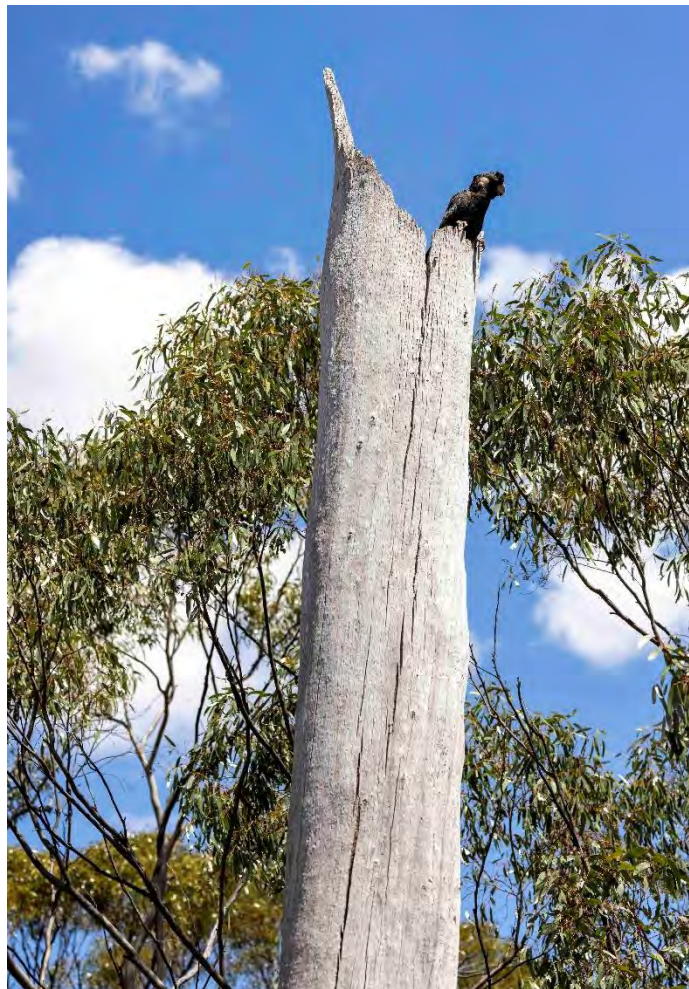
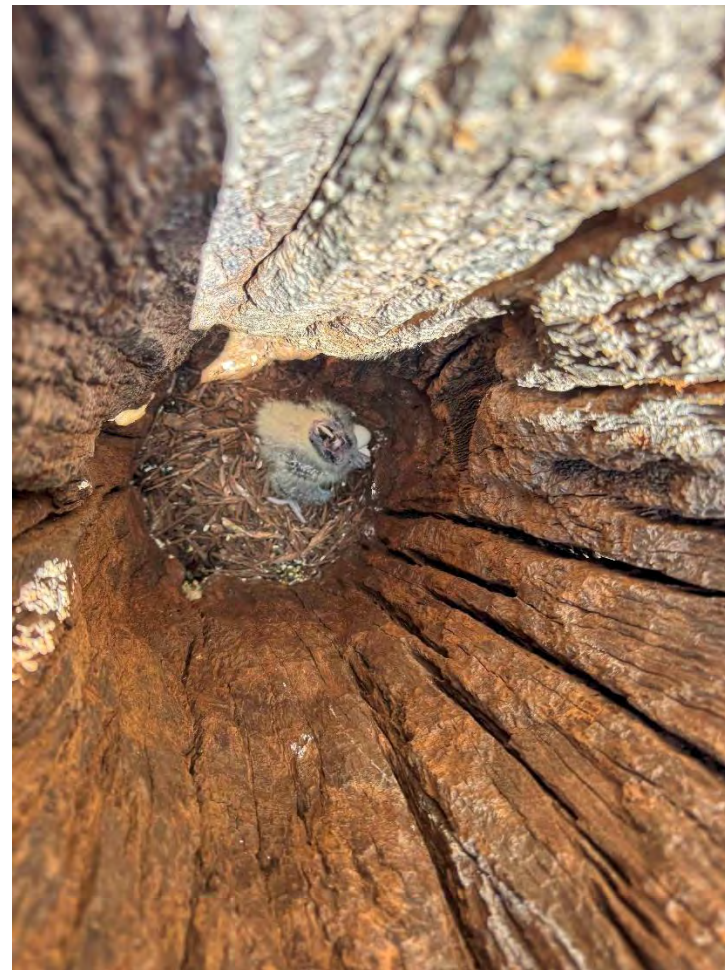
## Natural Hollow Repair Three (Elphin)

| Hollow No | Comments | Chipping score<br>0-10 | Wood<br>Chips | Tree condition | Fixings and<br>Hollow condition | Recommended repairs |
|---|---|---|---|---|---|---|
| Elphin 03 | Male Carnaby's 24 days old, female flushed heavy chewing on walls. | 5 | 0 | Dead stag | N/A | Nil |

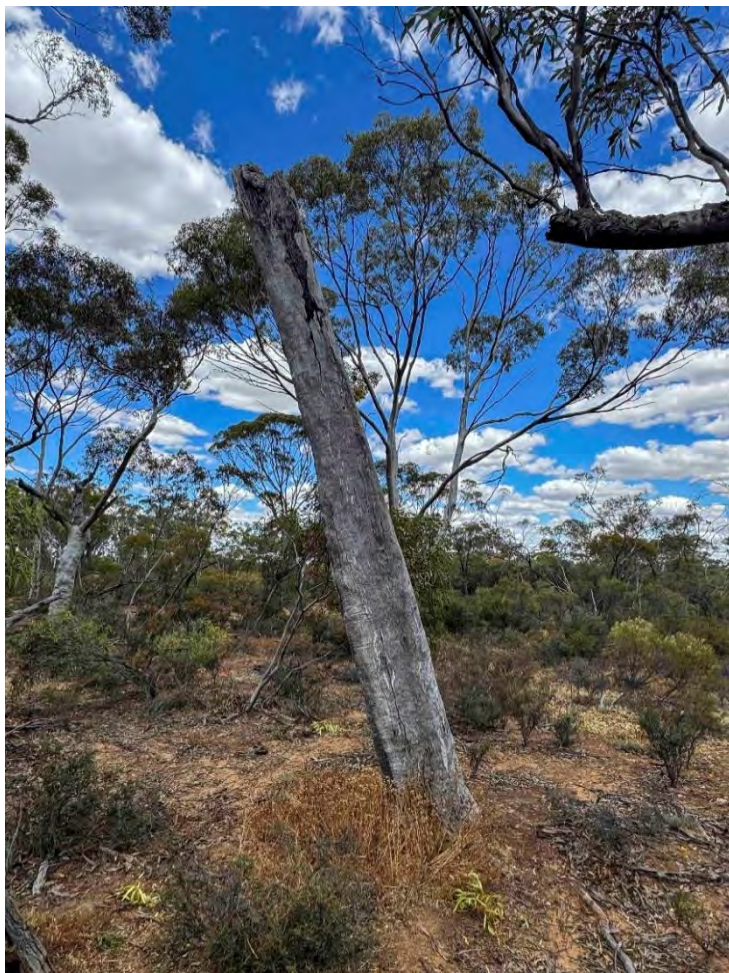
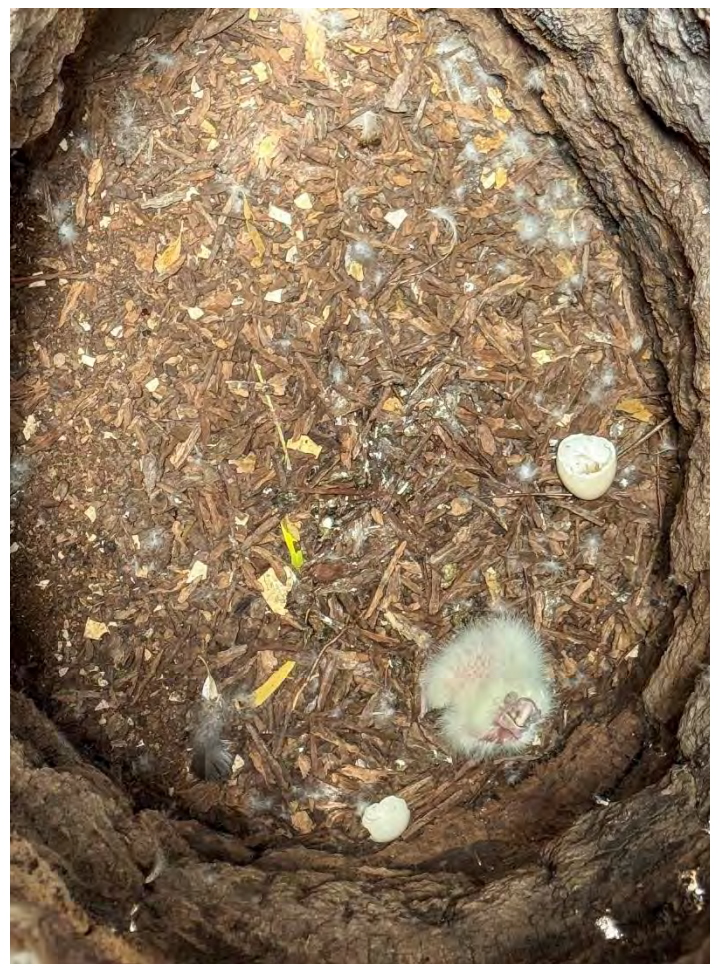
## Natural Hollow Repair Four (Elphin)

| Hollow No | Comments | Chipping score<br>0-10 | Wood<br>Chips | Tree<br>condition | Fixings and<br>Hollow condition | Recommended repairs |
|---|---|---|---|---|---|---|
| Elphin 04 | Five-day old CC and egg being incubated,<br>Chewing on post. Female flushed<br><br>S 30.866422 E 116.6929754 | 5 | 0 | Dead Stag | N/A | Camouflage tin to cover<br>splits in side of hollow |

- No repairs are required at this stage, as the artificial hollows were only installed last year and the Wandoo post and chips are proving to be very durable.
- Kowbrup 04 wood benefit from placing tin over the cracks, which will be done in October 2026 if not in use.

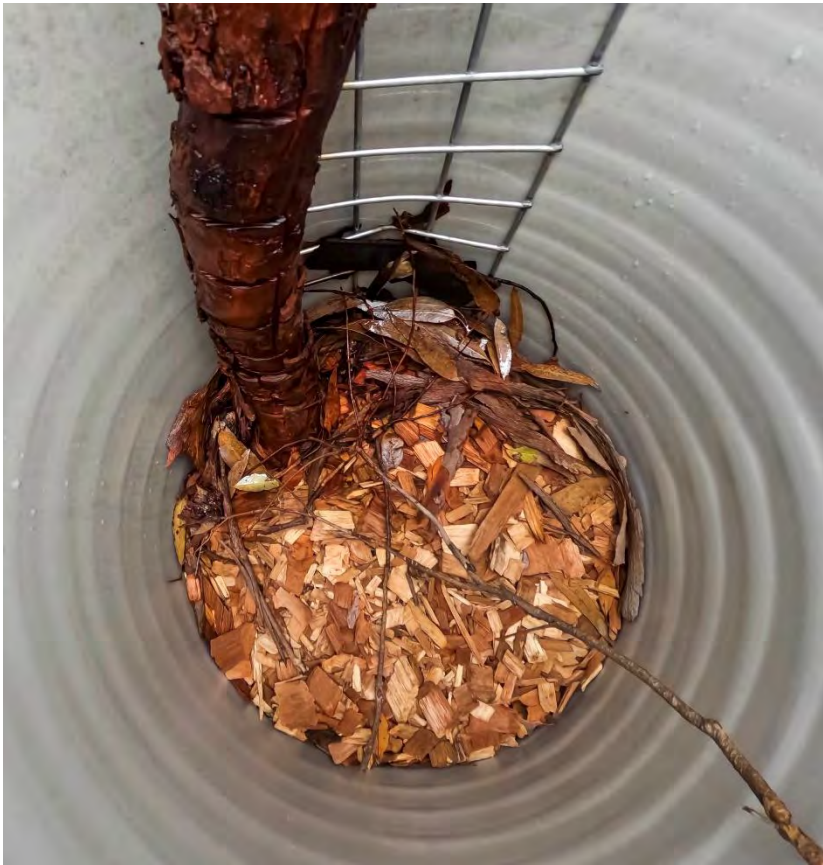
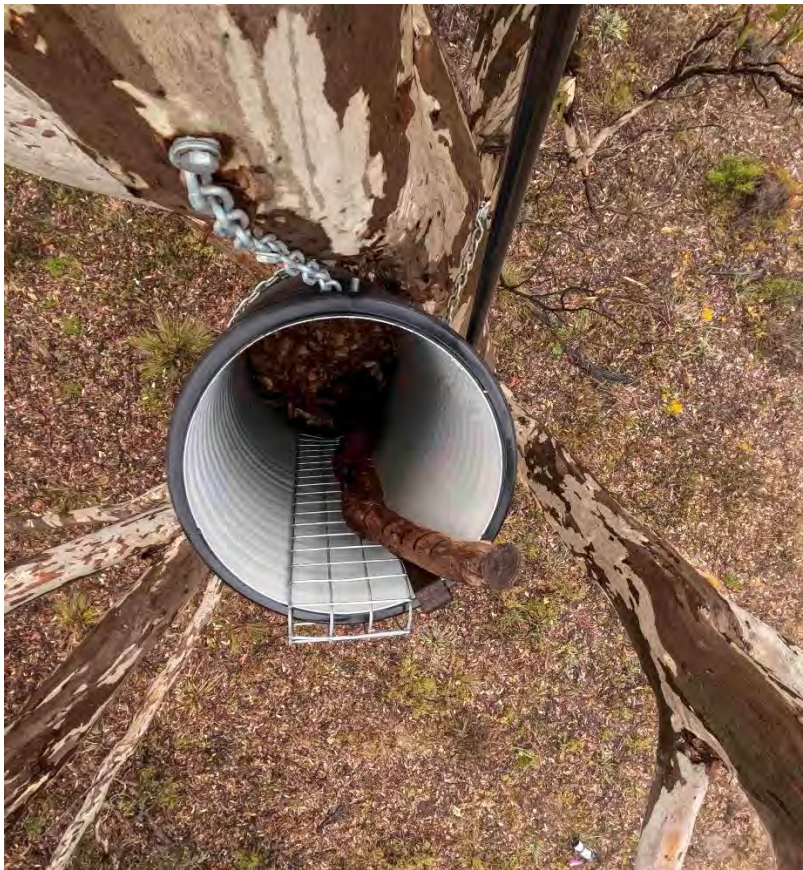
Artificial Hollow BY37

| Hollow No | Comments | Chipping score 0-10 | Wood Chips | Tree condition | Fixings and Hollow condition | Recommended repairs |
|---|---|---|---|---|---|---|
| BY37 | No signs of nesting or inspection by Black Cockatoos | 0 | Nil | Good | Good | Nil |

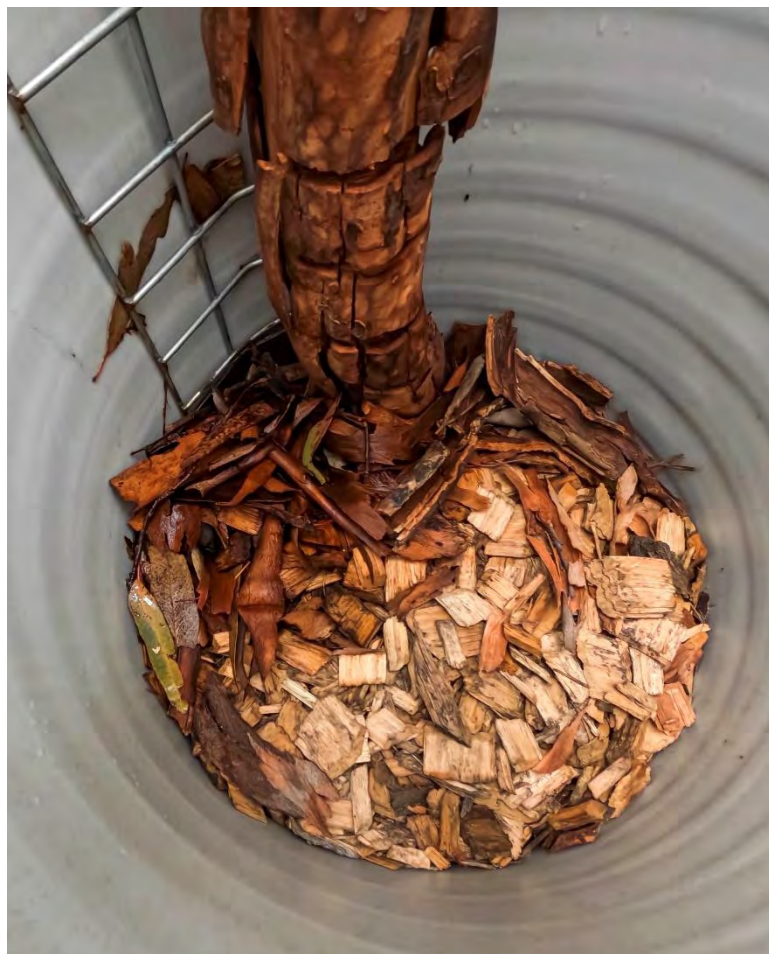
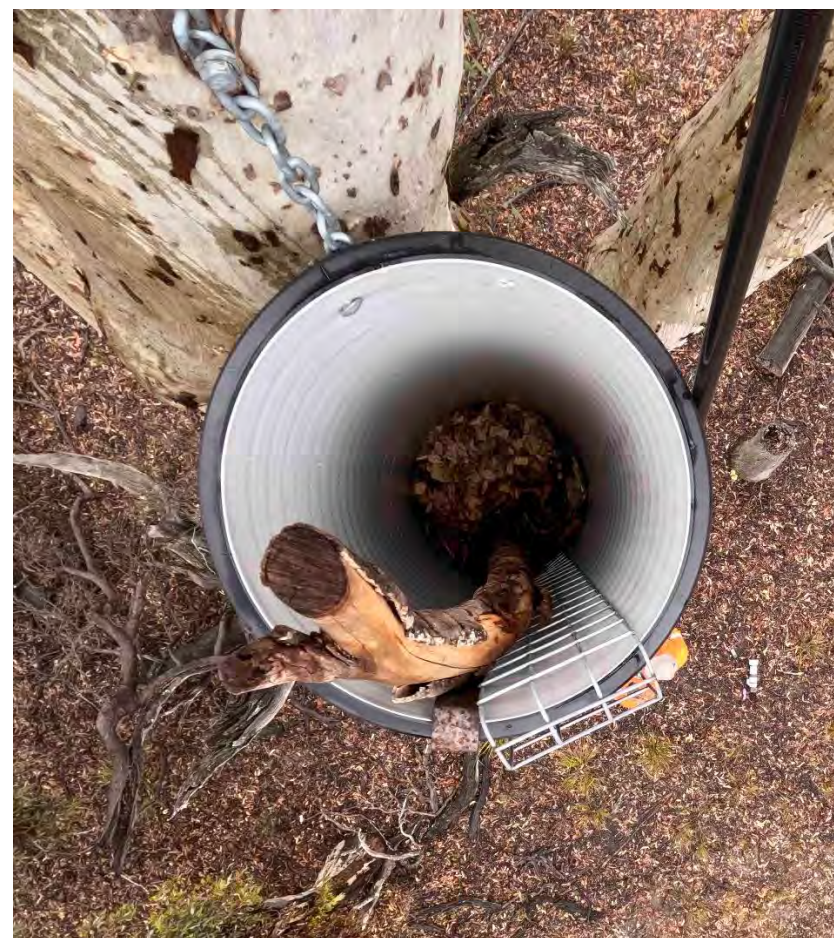
## Artificial Hollow BY38

| Hollow No | Comments | Chipping score 0-10 | Wood Chips | Tree condition | Fixings and Hollow condition | Recommended repairs |
|---|---|---|---|---|---|---|
| BY38 | No signs of nesting or inspection by Black Cockatoos | 0 | Nil | Good | Good | Nil |

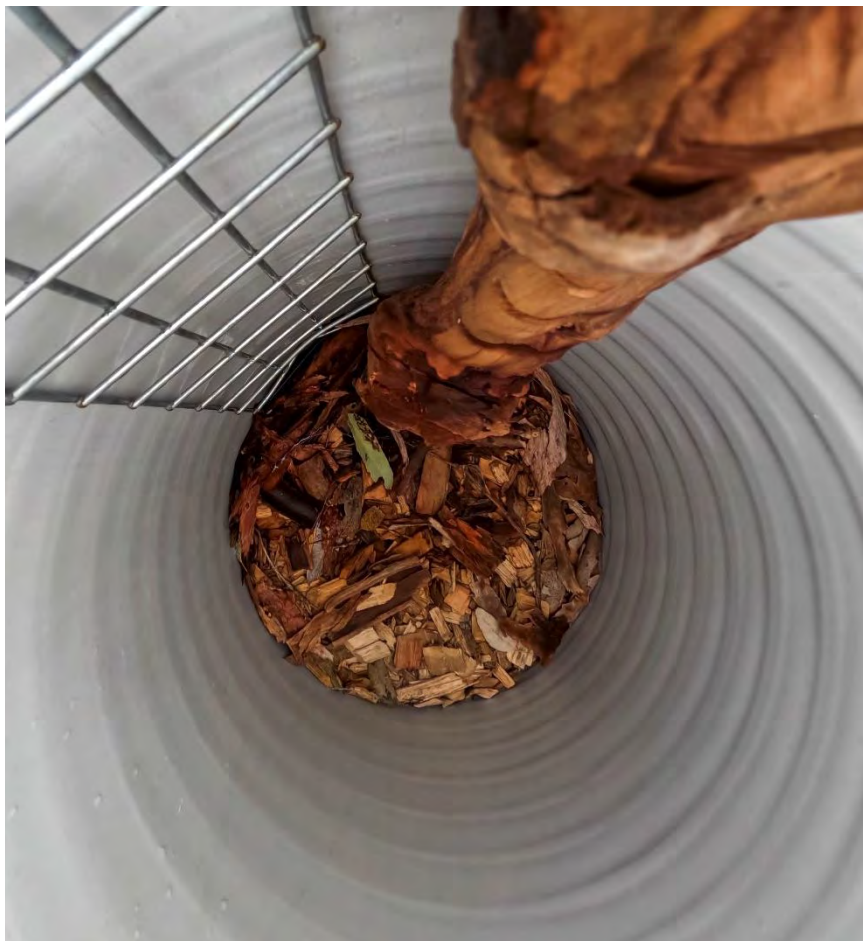
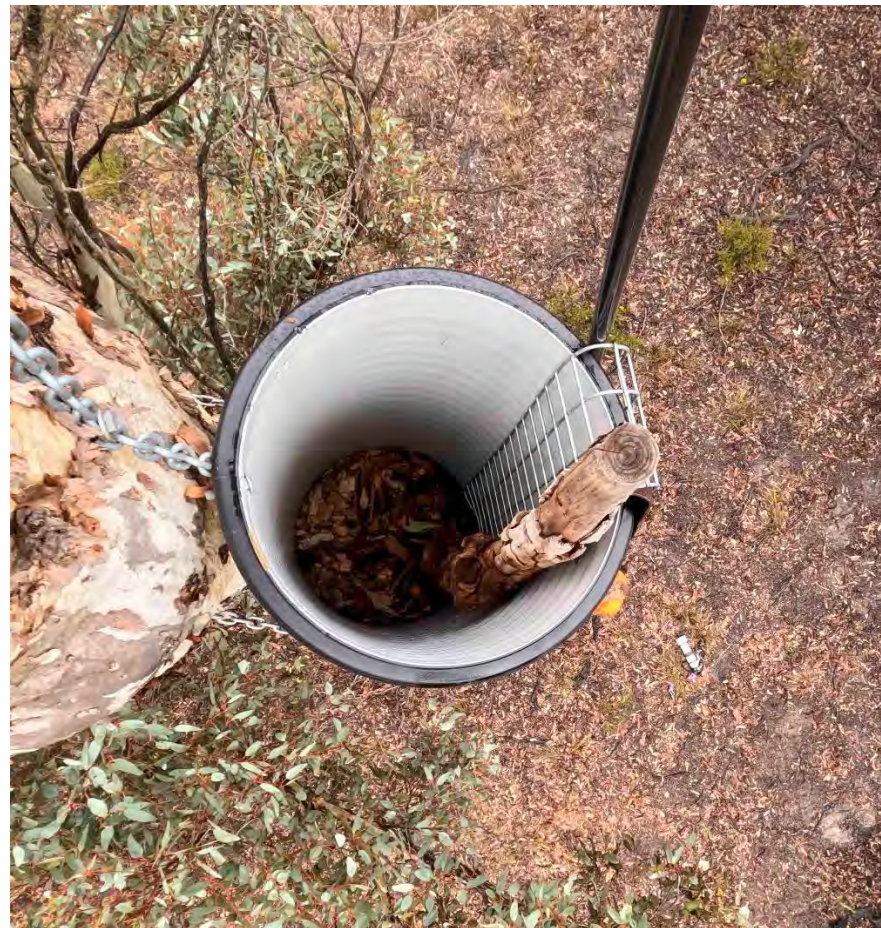
## Artificial Hollow BY39

| Hollow No | Comments | Chipping score<br>0-10 | Wood<br>Chips | Tree<br>condition | Fixings and<br>Hollow condition | Recommended<br>repairs |
|---|---|---|---|---|---|---|
| BY39 | No signs of nesting or inspection by Black<br>Cockatoos. <b>Corrected GPS Point</b><br><b>S33.29549 E117.059733</b> | 0 | Nil | Good | Good | Nil |
