# Ministerial Statement Compliance Assessment Report

**Bunbury Outer Ring Road - South  
Ministerial Statement 1191**

**2025 - 2026 Reporting Period**

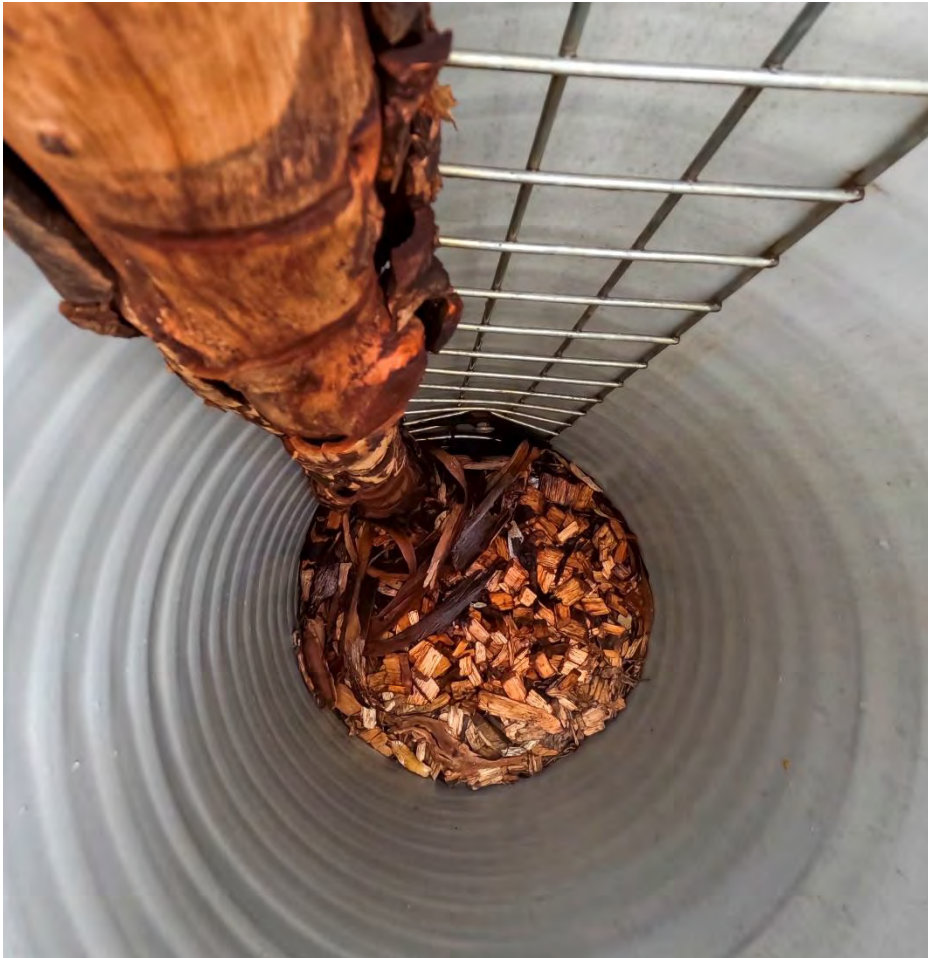
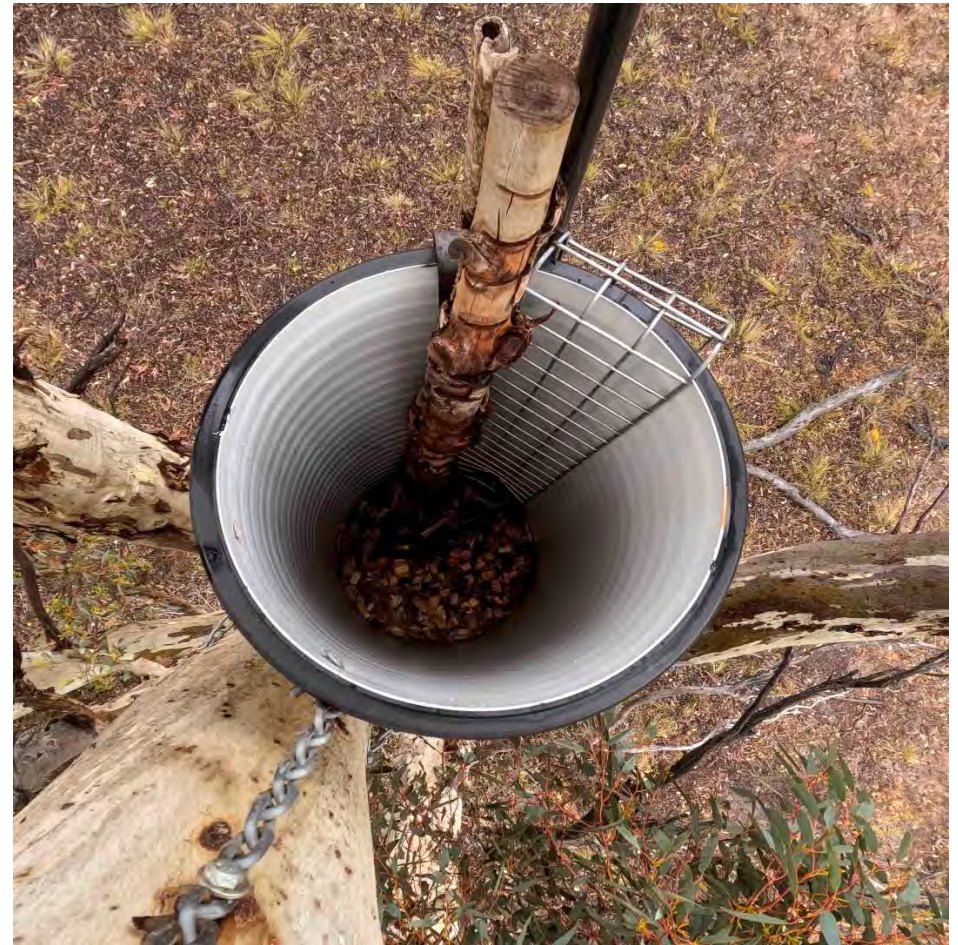
## Artificial Hollow BY40

| Hollow No | Comments | Chipping score 0-10 | Wood Chips | Tree condition | Fixings and Hollow condition | Recommended repairs |
|---|---|---|---|---|---|---|
| BY40 | No signs of nesting or inspection by Black Cockatoos | 0 | Nil | Good | Good | Nil |

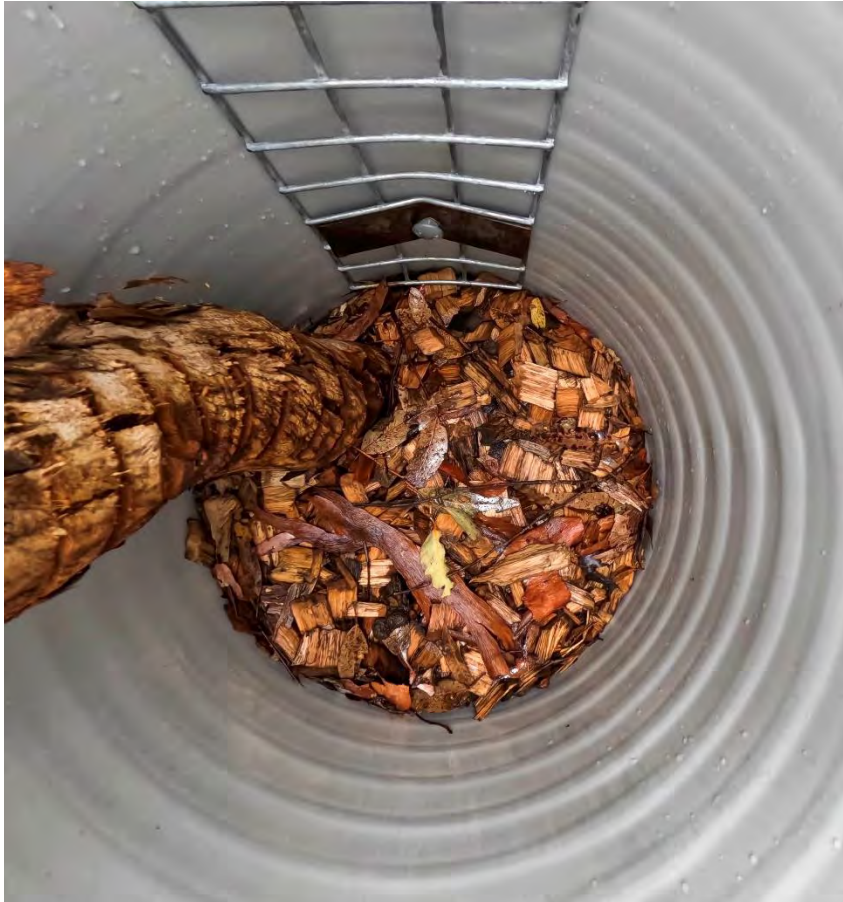
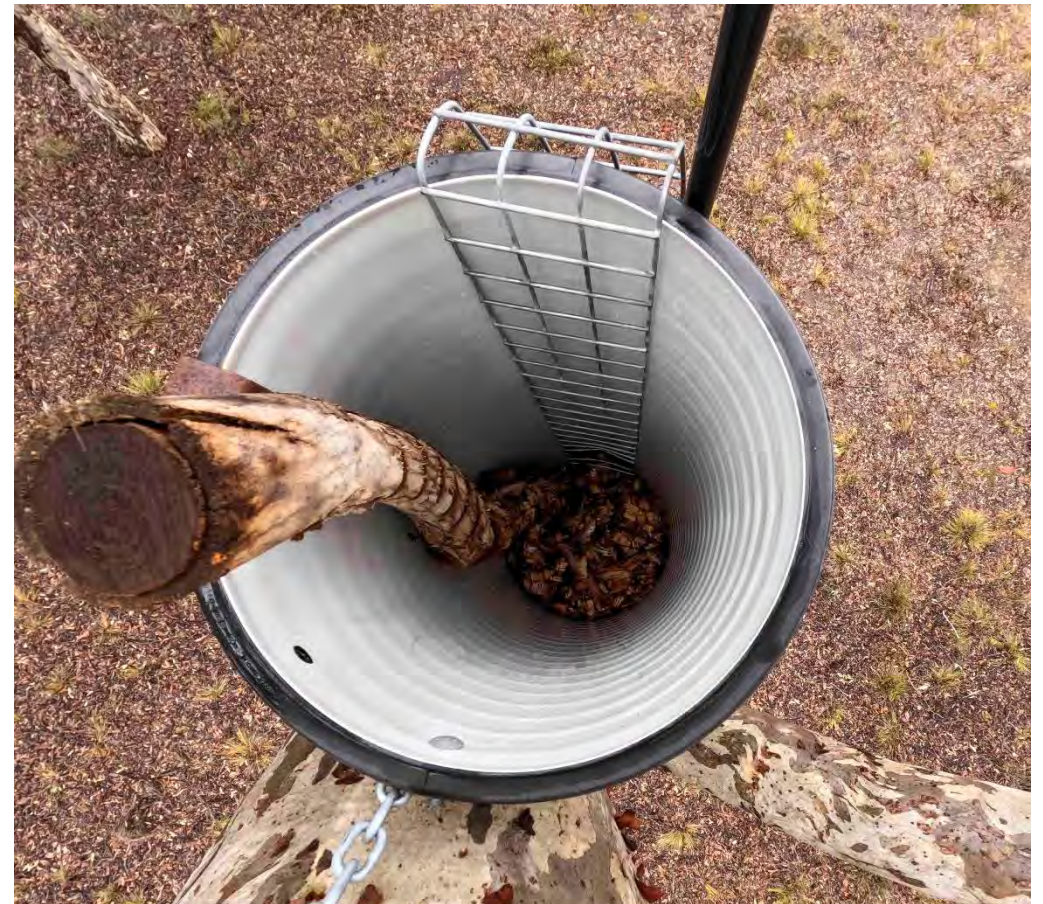
## Artificial Hollow BY41

| Hollow No | Comments | Chipping score 0-10 | Wood Chips | Tree condition | Fixings and Hollow condition | Recommended repairs |
|---|---|---|---|---|---|---|
| BY41 | No signs of nesting or inspection by Black Cockatoos | 0 | Nil | Good | Good | Nil |

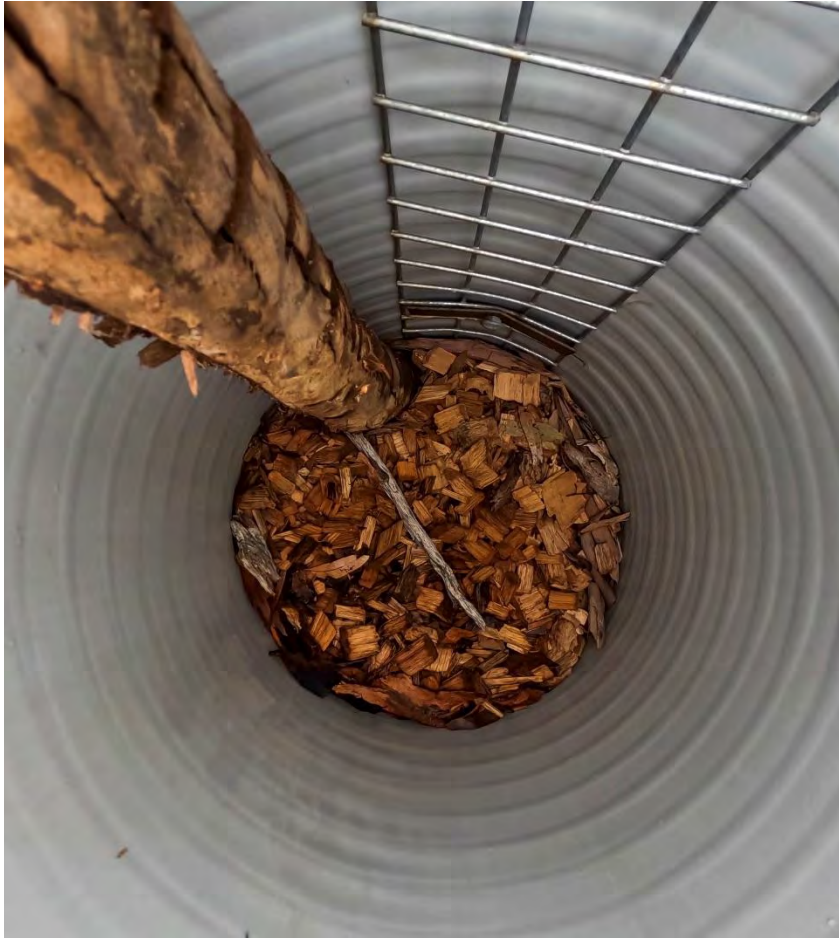
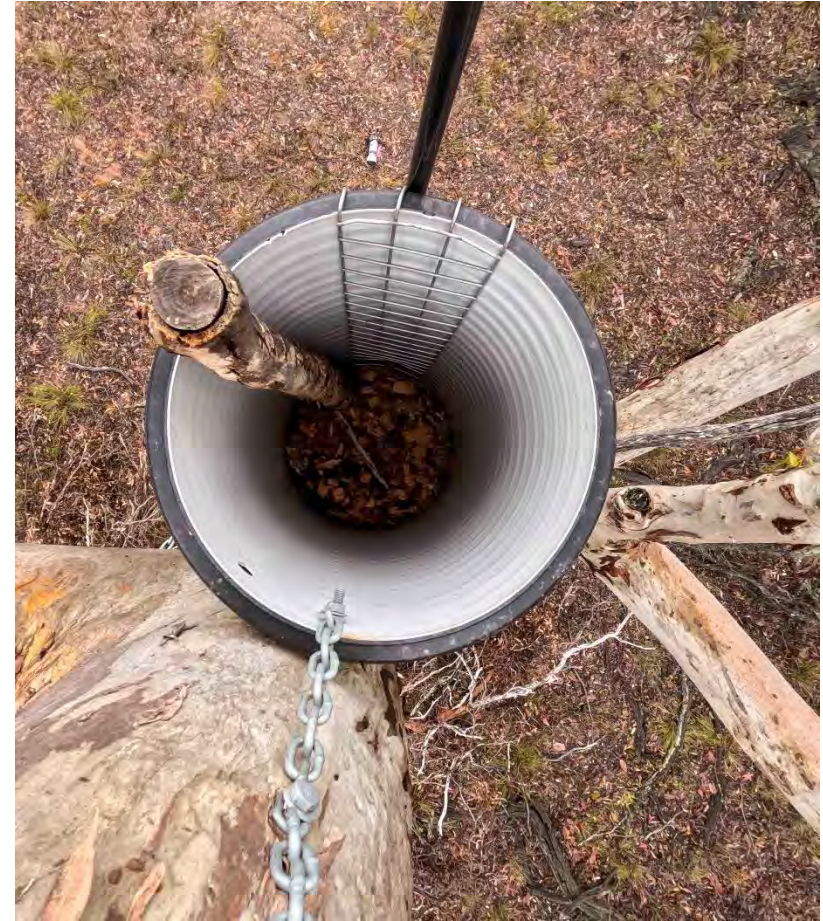
## Artificial Hollow BY42

| Hollow No | Comments | Chipping score 0-10 | Wood Chips | Tree condition | Fixings and Hollow condition | Recommended repairs |
|---|---|---|---|---|---|---|
| BY42 | No signs of nesting or inspection by Black Cockatoos | 0 | Nil | Good | Good | Nil |

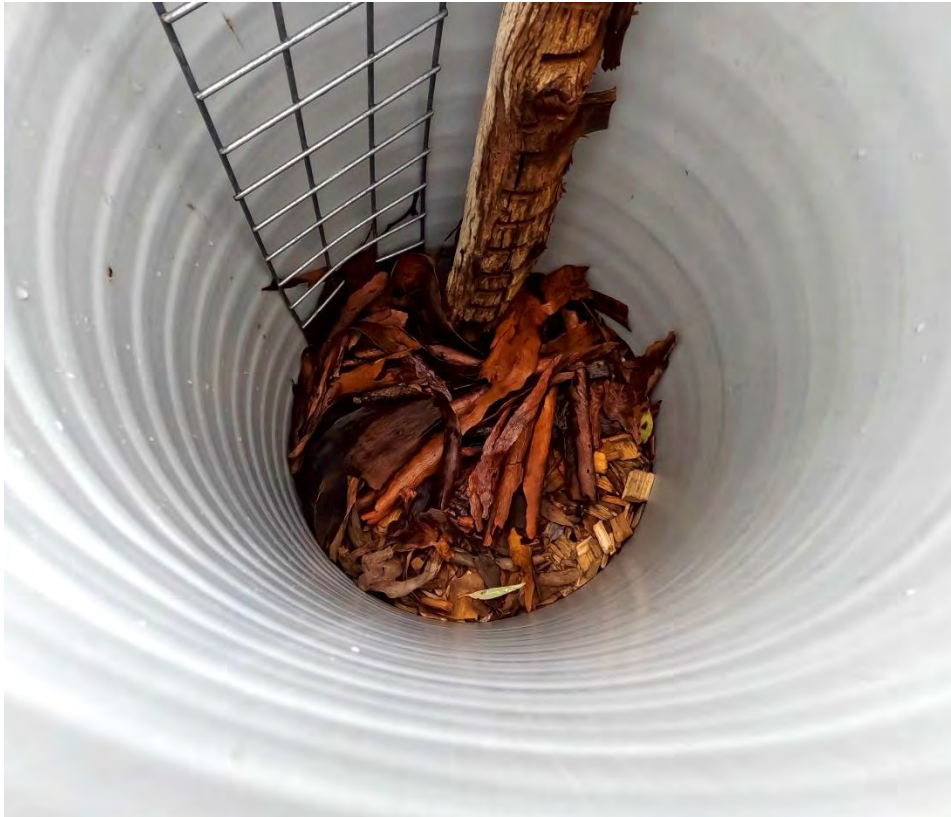
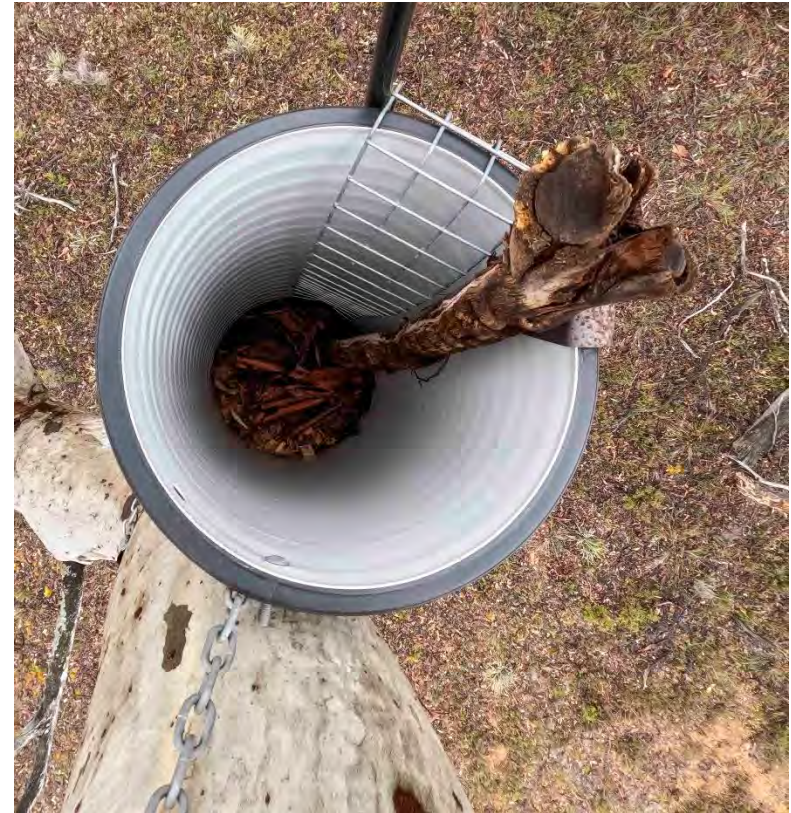
## Artificial Hollow BY43

| Hollow No | Comments | Chipping score 0-10 | Wood Chips | Tree condition | Fixings and Hollow condition | Recommended repairs |
|---|---|---|---|---|---|---|
| BY43 | No signs of nesting or inspection by Black Cockatoos | 0 | Nil | Good | Good | Nil |

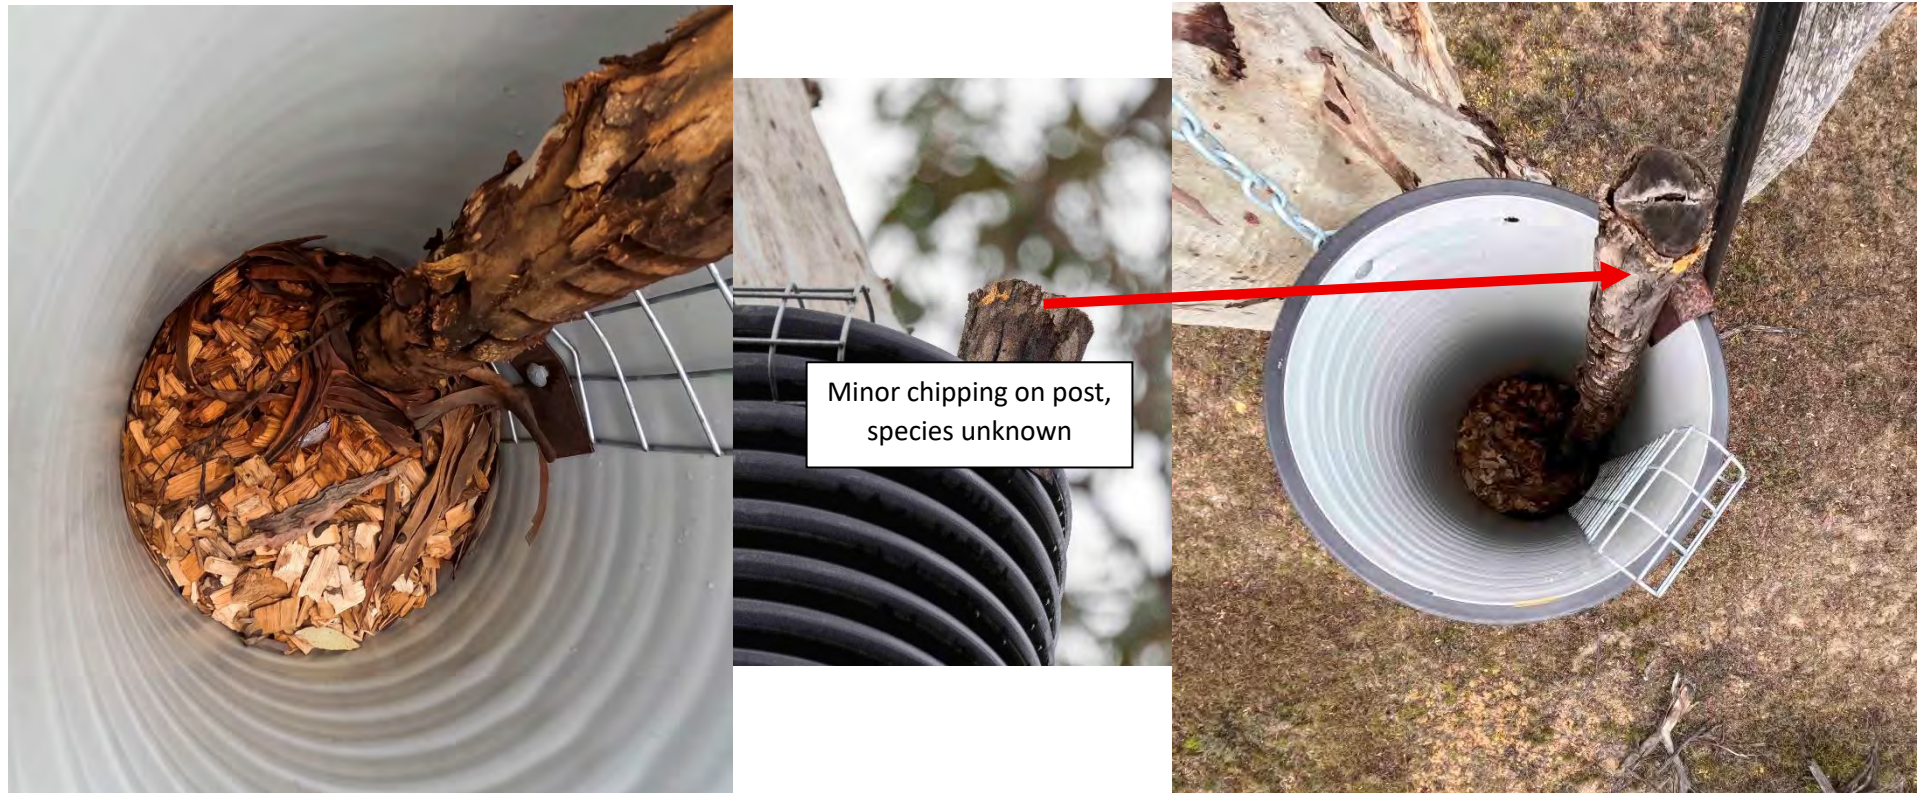
# Artificial Hollow BY44

| Hollow No | Comments | Chipping<br>score 0-10 | Wood<br>Chips | Tree condition | Fixings and Hollow<br>condition | Recommended repairs |
|---|---|---|---|---|---|---|
| BY44 | No signs of nesting or inspection by Black<br>Cockatoos, small amount of <b>unidentifiable</b><br>chipping on bark | 1 | Nil | Good | Good | Nil |

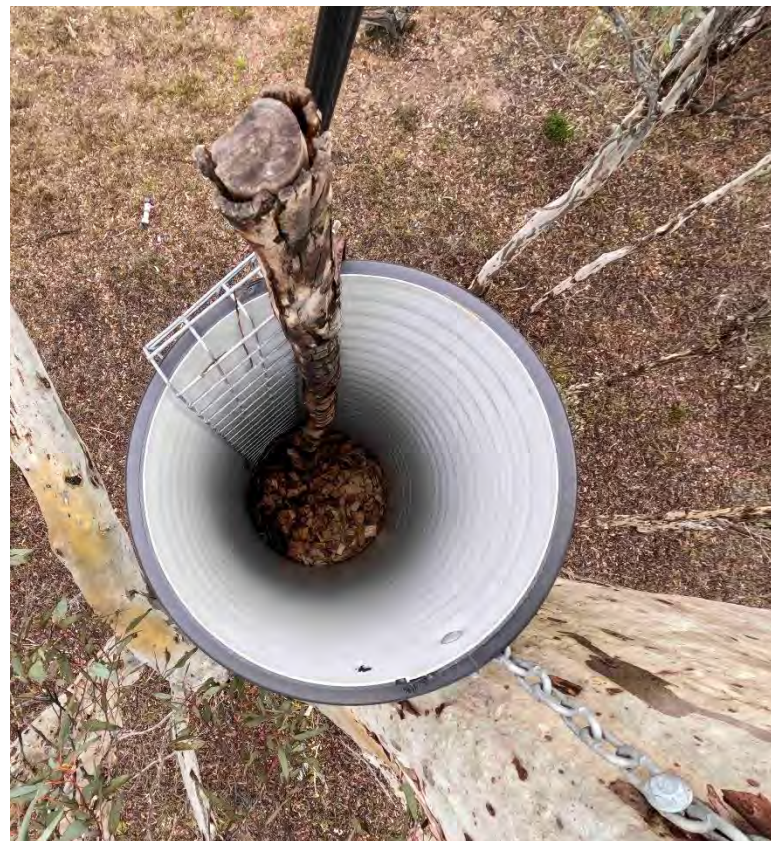
## Artificial Hollow BY45

| Hollow No | Comments | Chipping score 0-10 | Wood Chips | Tree condition | Fixings and Hollow condition | Recommended repairs |
|---|---|---|---|---|---|---|
| BY45 | No signs of nesting or inspection by Black Cockatoos | 0 | Nil | Good | Good | Nil |

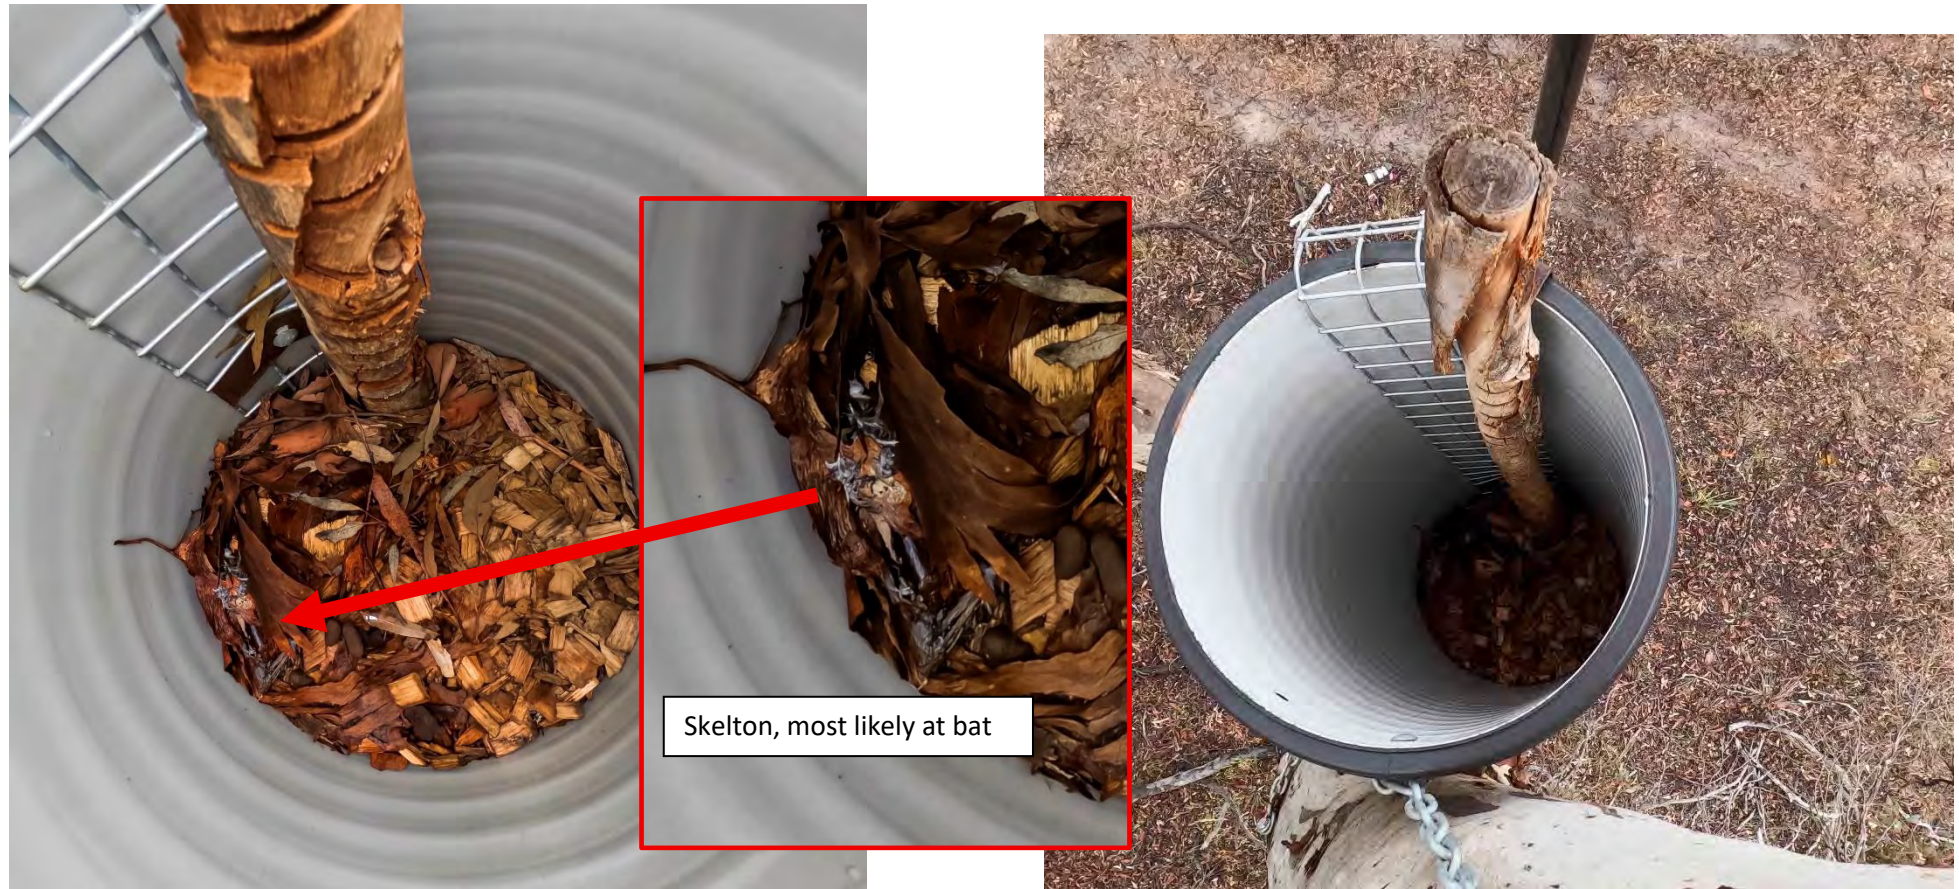
## Artificial Hollow BY46

| Hollow No | Comments | Chipping score 0-10 | Wood Chips | Tree condition | Fixings and Hollow condition | Recommended repairs |
|---|---|---|---|---|---|---|
| BY46 | No signs of nesting or inspection by Black Cockatoos, small Skelton half buried, most likely a bat | 0 | Nil | Good | Good | Nil |

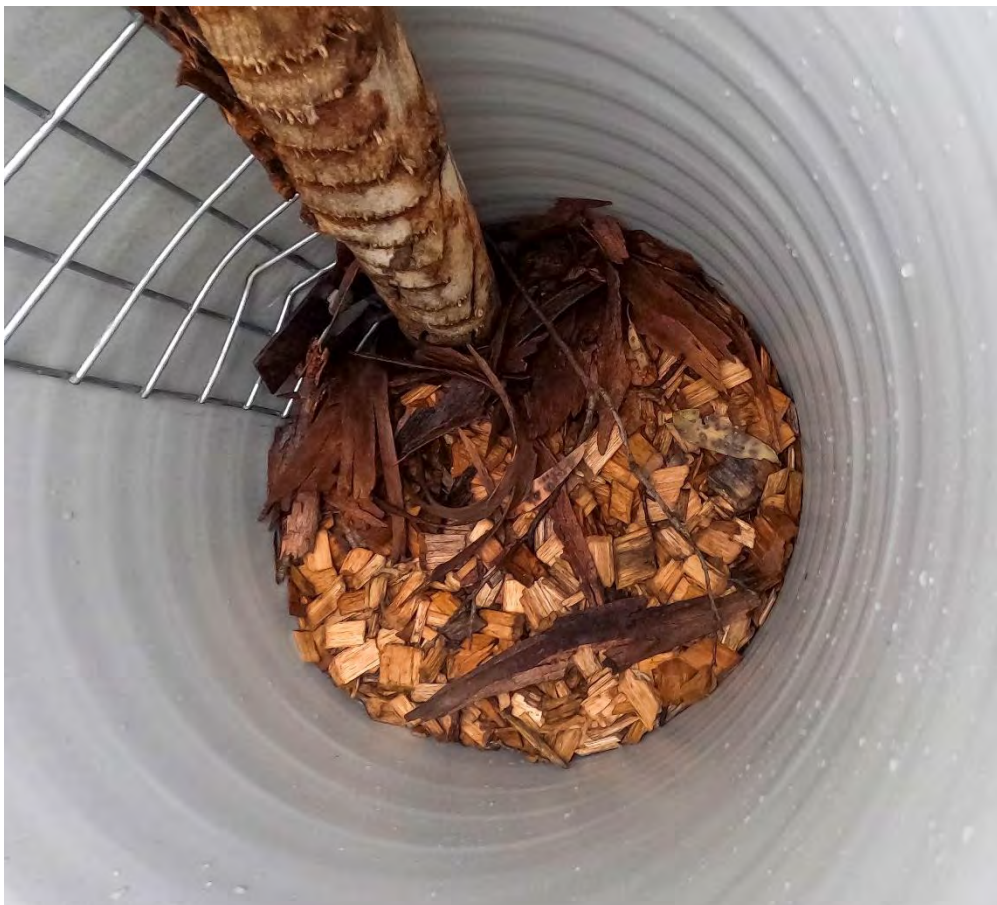
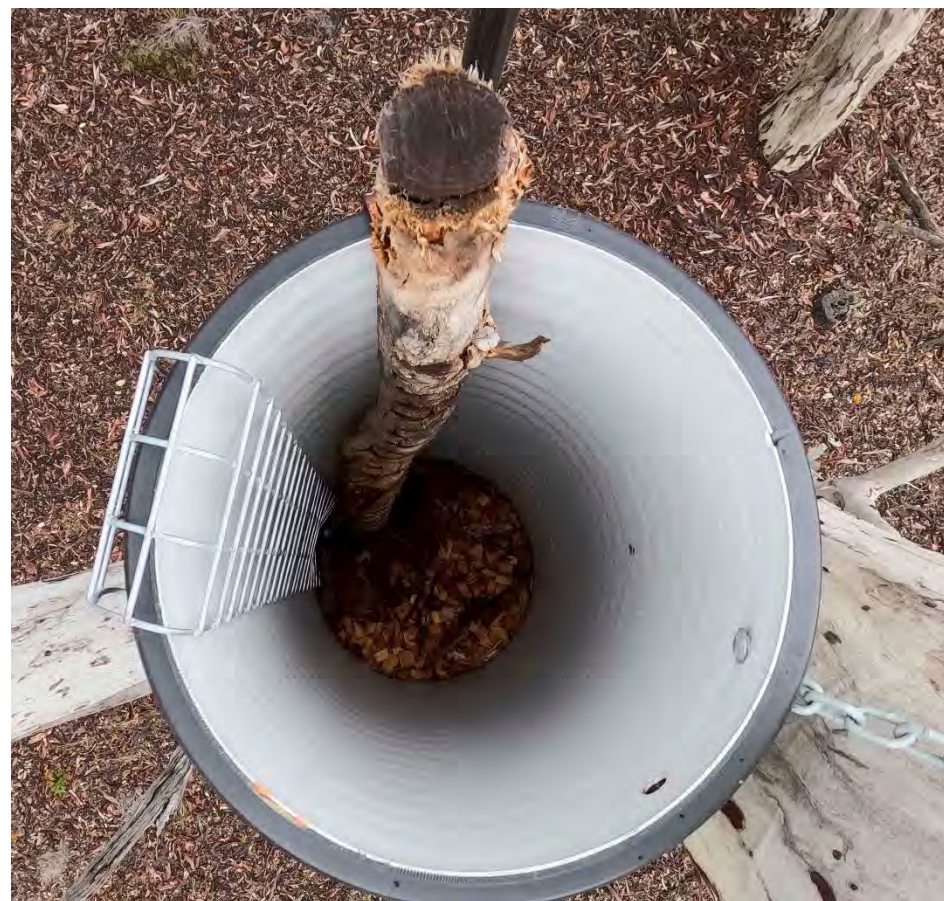
## Artificial Hollow BY47

| Hollow No | Comments | Chipping score 0-10 | Wood Chips | Tree condition | Fixings and Hollow condition | Recommended repairs |
|---|---|---|---|---|---|---|
| BY47 | No signs of nesting or inspection by Black Cockatoos | 0 | Nil | Good | Good | Nil |

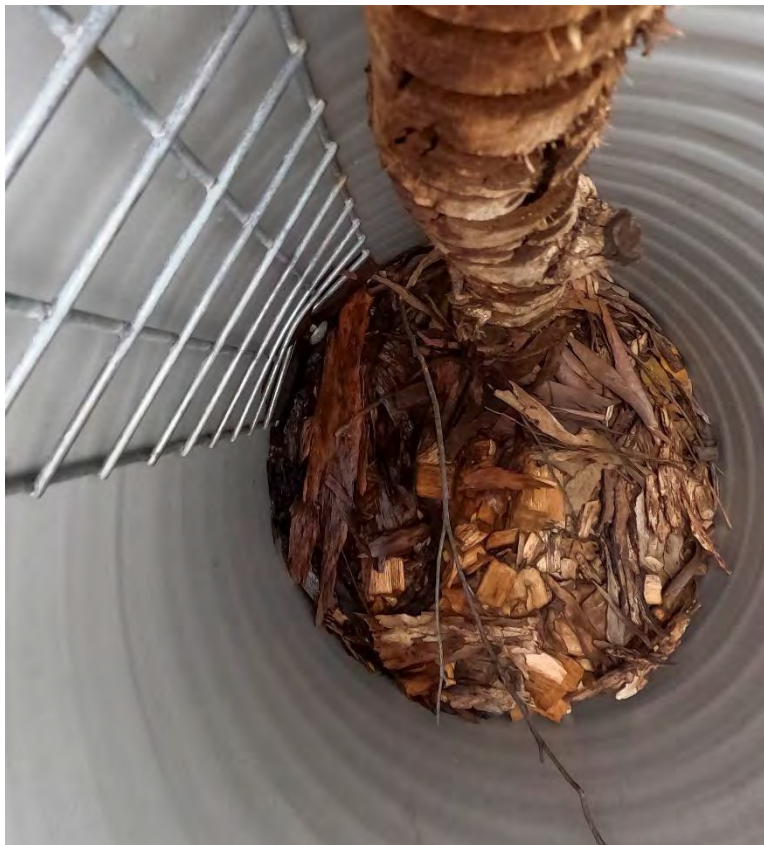
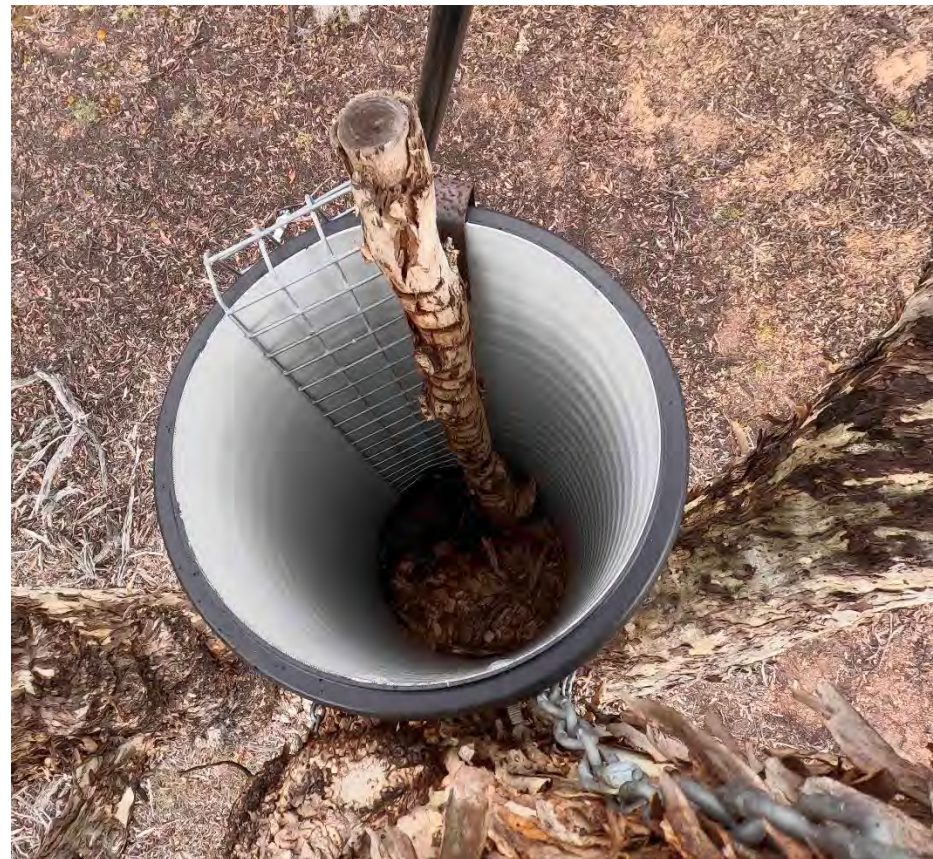
## Artificial Hollow BY48

| Hollow No | Comments | Chipping score 0-10 | Wood Chips | Tree condition | Fixings and Hollow condition | Recommended repairs |
|---|---|---|---|---|---|---|
| BY48 | No signs of nesting or inspection by Black Cockatoos | 0 | Nil | Good | Good | Nil |

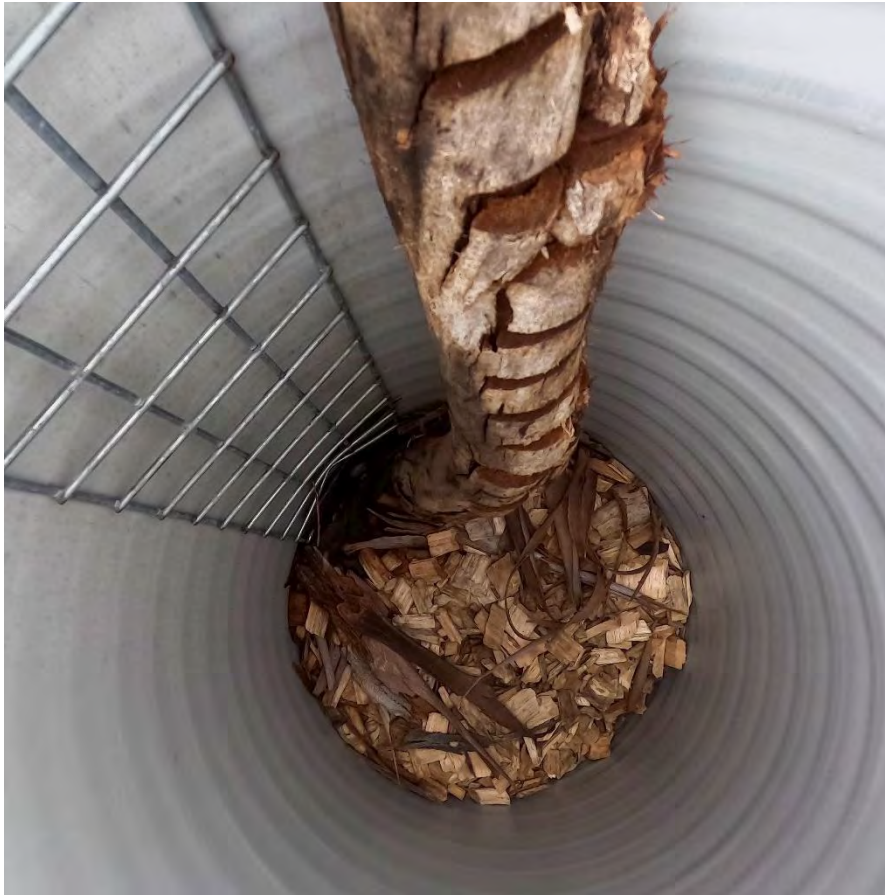
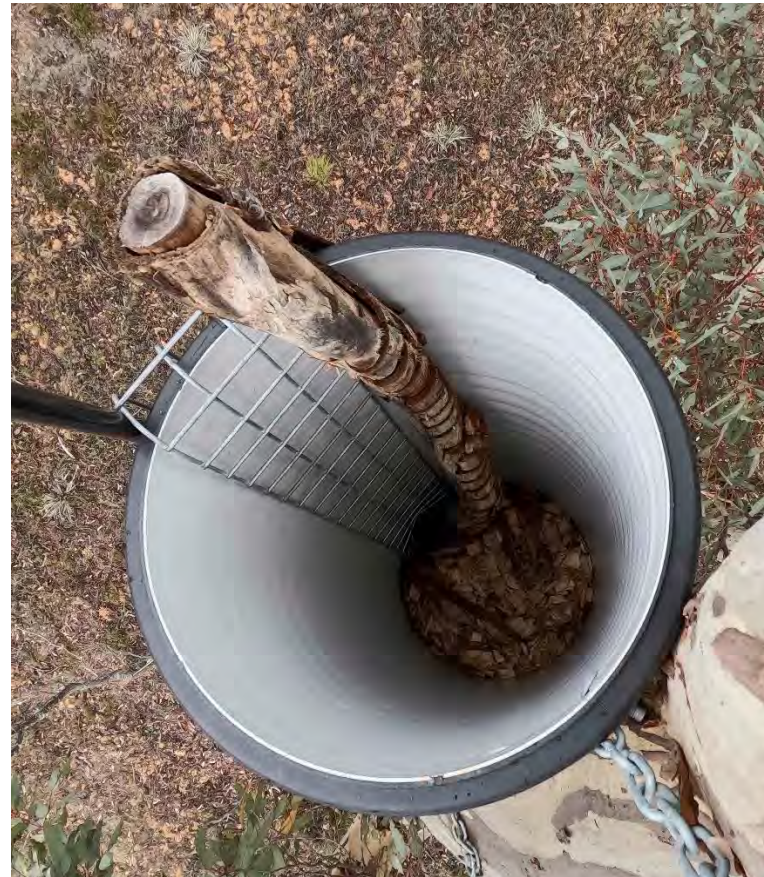
## Artificial Hollow BY49

| Hollow No | Comments | Chipping score 0-10 | Wood Chips | Tree condition | Fixings and Hollow condition | Recommended repairs |
|---|---|---|---|---|---|---|
| BY49 | No signs of nesting or inspection by Black Cockatoos | 0 | Nil | Good | Good | Nil |

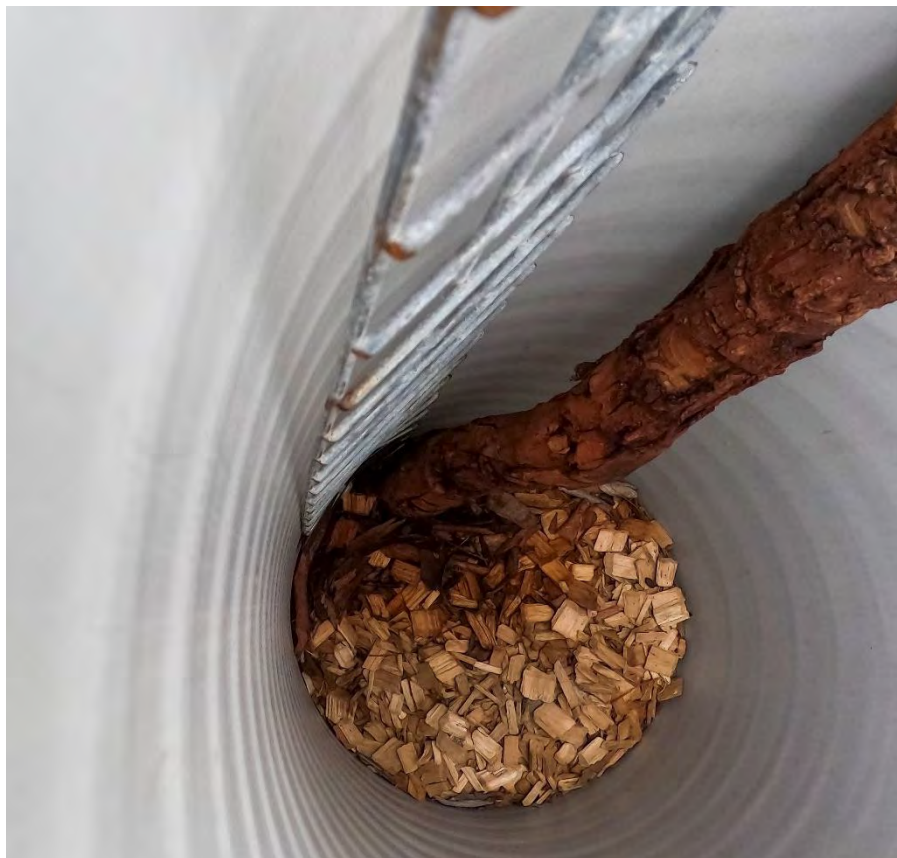
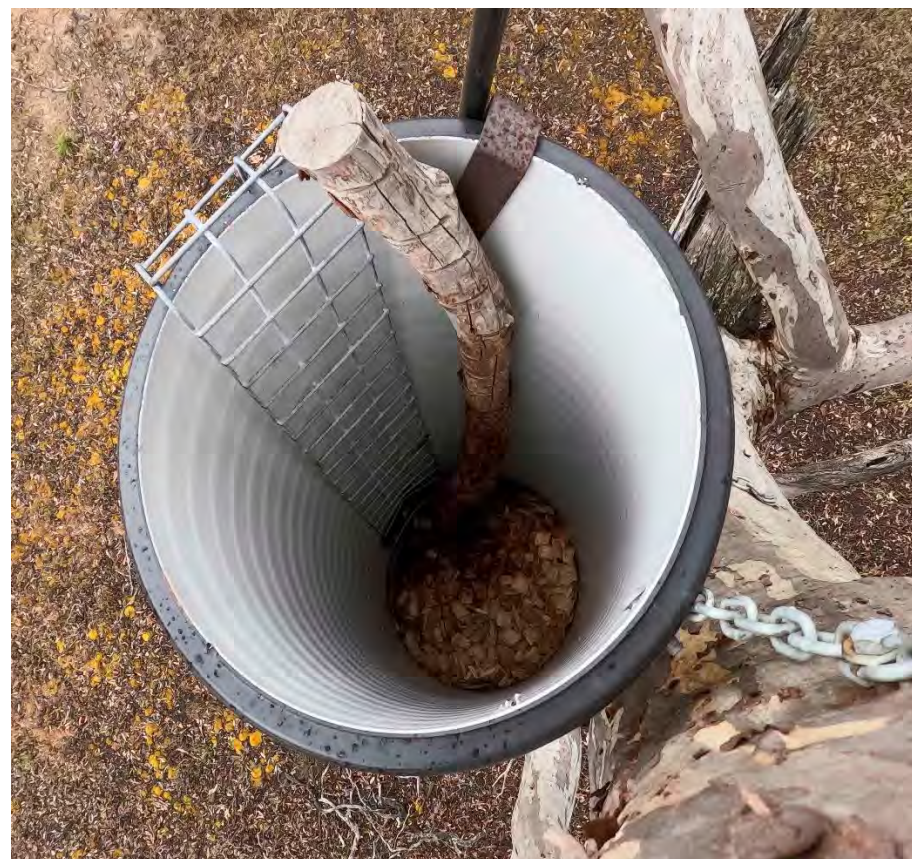
## Artificial Hollow BY50

| Hollow No | Comments | Chipping score 0-10 | Wood Chips | Tree condition | Fixings and Hollow condition | Recommended repairs |
|---|---|---|---|---|---|---|
| BY50 | No signs of nesting or inspection by Black Cockatoos | 0 | Nil | Good | Good | Nil |

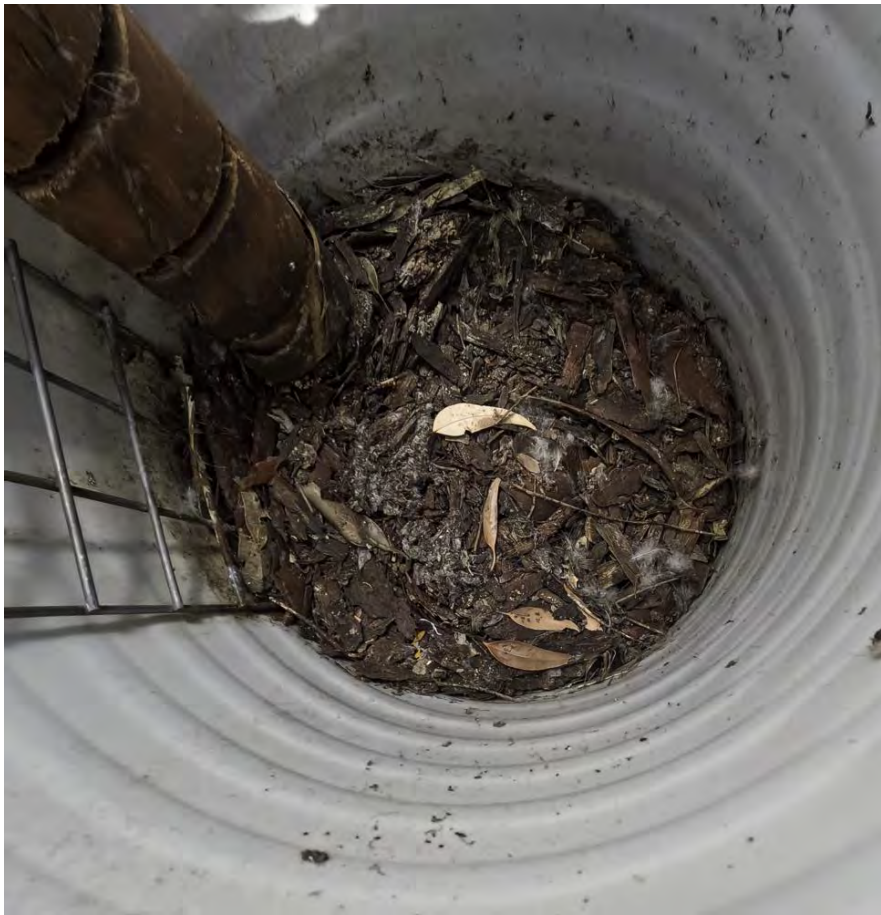
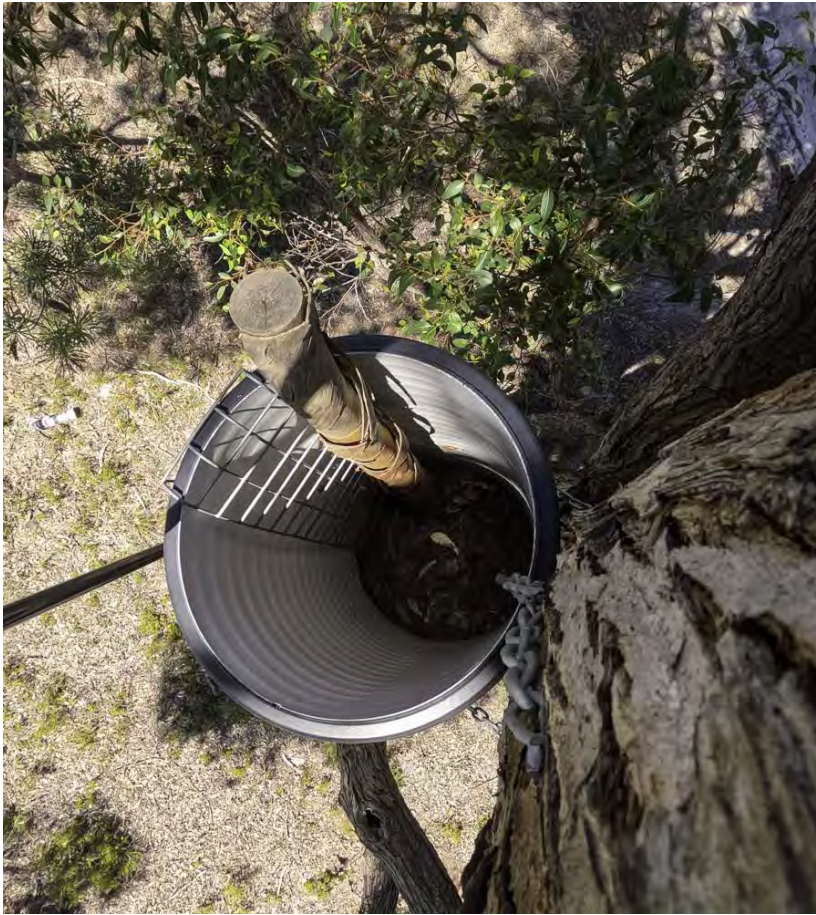
Artificial Hollow D01

| Hollow # | Observations Oct 2025 | Observations Dec 2025 | Chipping 0-10 | Wood Chips Lts | Tree condition | Fixings | Recommend repairs |
|---|---|---|---|---|---|---|---|
| D01 | No signs of nesting or inspection by Black Cockatoos. Duck at base of hollows | No signs of nesting or inspection by Black Cockatoos. Duck feathers at base of hollows | 0 | Nil | Good | Good | Nil |

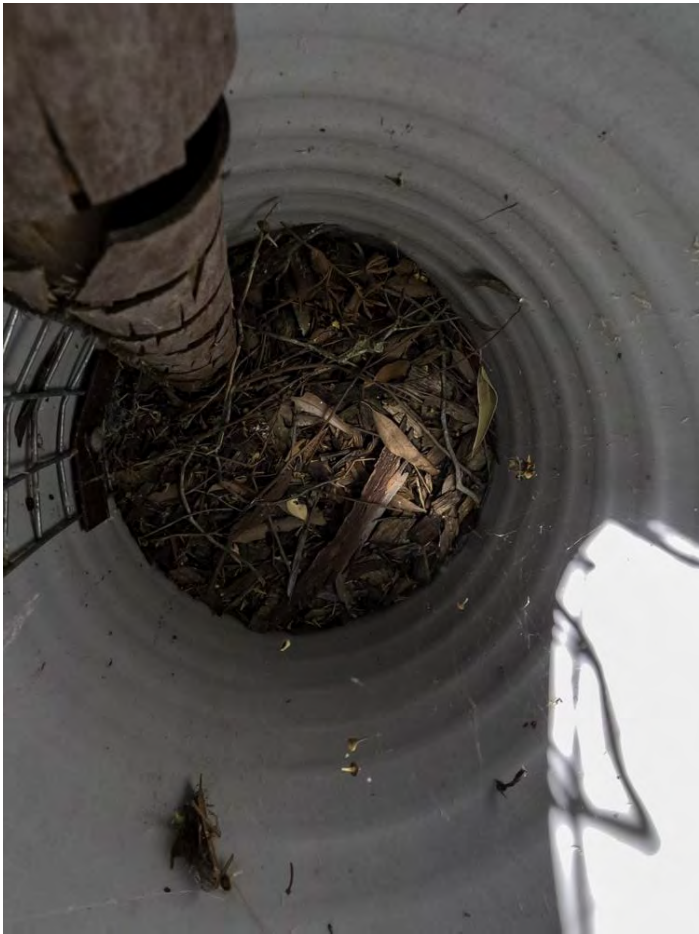
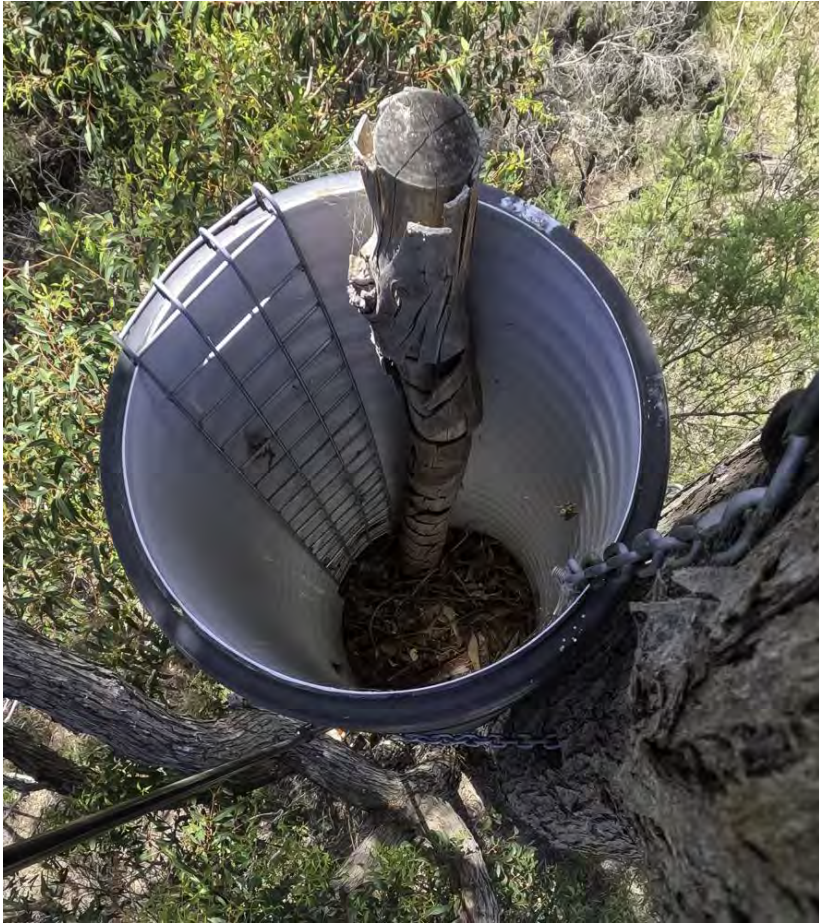
# Artificial Hollow D02

| Hollow # | Observations Oct 2025 | Observations Dec 2025 | Chipping 0-10 | Wood Chips Lts | Tree condition | Fixings | Recommend repairs |
|---|---|---|---|---|---|---|---|
| D02 | No signs of nesting or inspection by Black Cockatoos. Cobwebs | No signs of nesting or inspection by Black Cockatoos. Cobwebs | 0 | Nil | Good | Good | Nil |

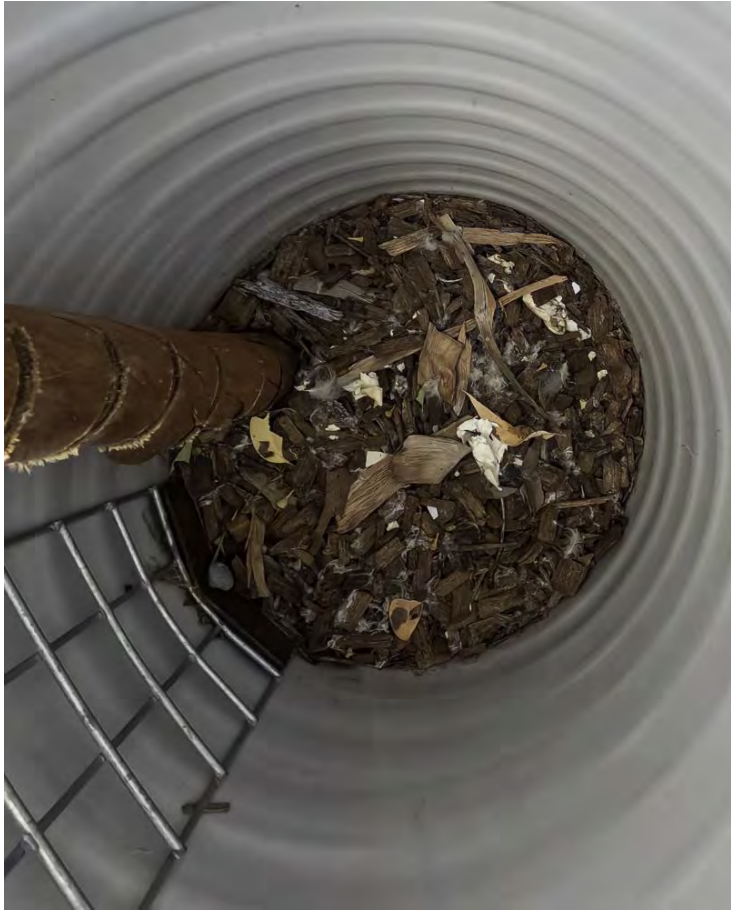
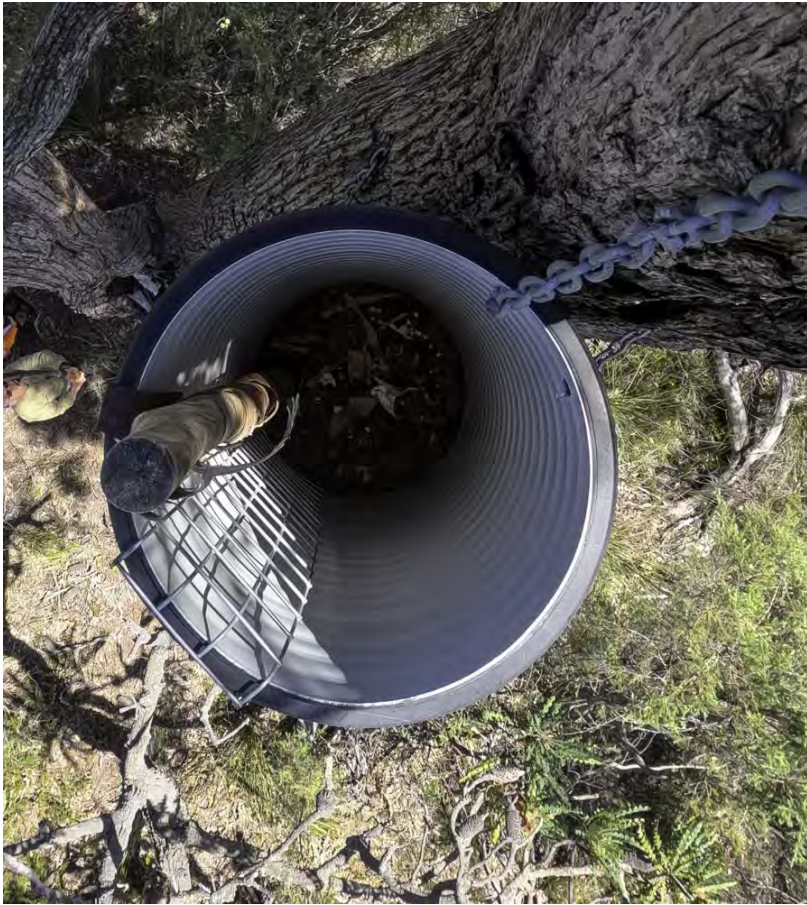
# Artificial Hollow D03

| Hollow # | Observations Oct 2025 | Observations Dec 2025 | Chipping 0-10 | Wood Chips Lts | Tree condition | Fixings | Recommend repairs |
|---|---|---|---|---|---|---|---|
| D03 | No signs of nesting or inspection by Black Cockatoos. Cobwebs at entry, duck down and one broken duck egg | No signs of nesting or inspection by Black Cockatoos. Cobwebs at entry, duck down and one broken duck egg | 0 | Nil | Good | Good | Nil |
