# Ministerial Statement Compliance Assessment Report

**Bunbury Outer Ring Road - South  
Ministerial Statement 1191**

**2025 - 2026 Reporting Period**

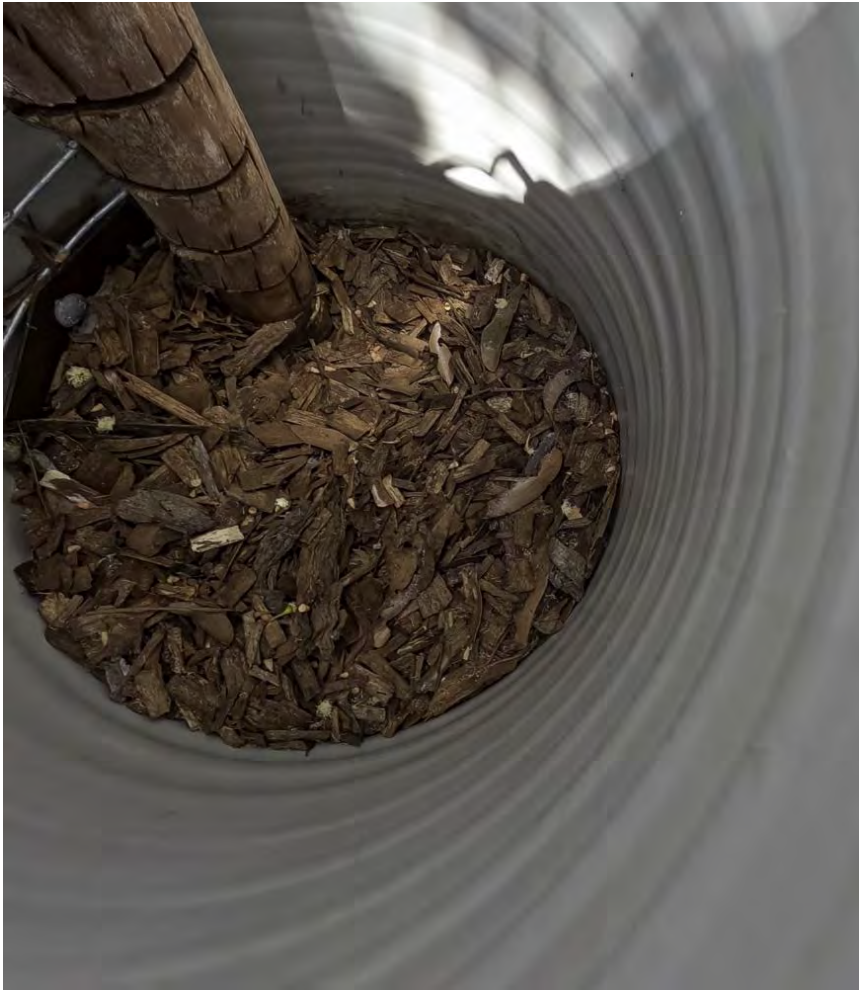
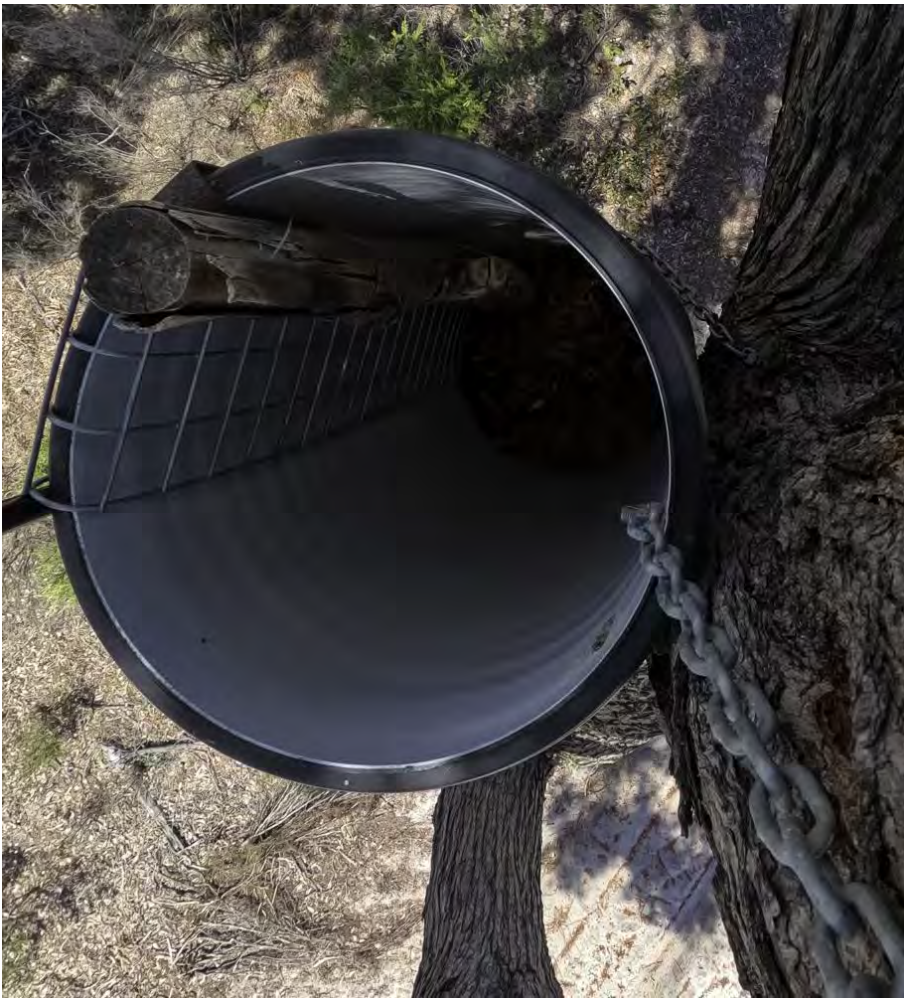
# Artificial Hollow D04

| Hollow # | Observations Oct 2025 | Observations Dec 2025 | Chipping 0-10 | Wood Chips Lts | Tree condition | Fixings | Recommend repairs |
|---|---|---|---|---|---|---|---|
| D04 | No signs of nesting or inspection by Black Cockatoos | No signs of nesting or inspection by Black Cockatoos | 0 | Nil | Good | Good | Nil |

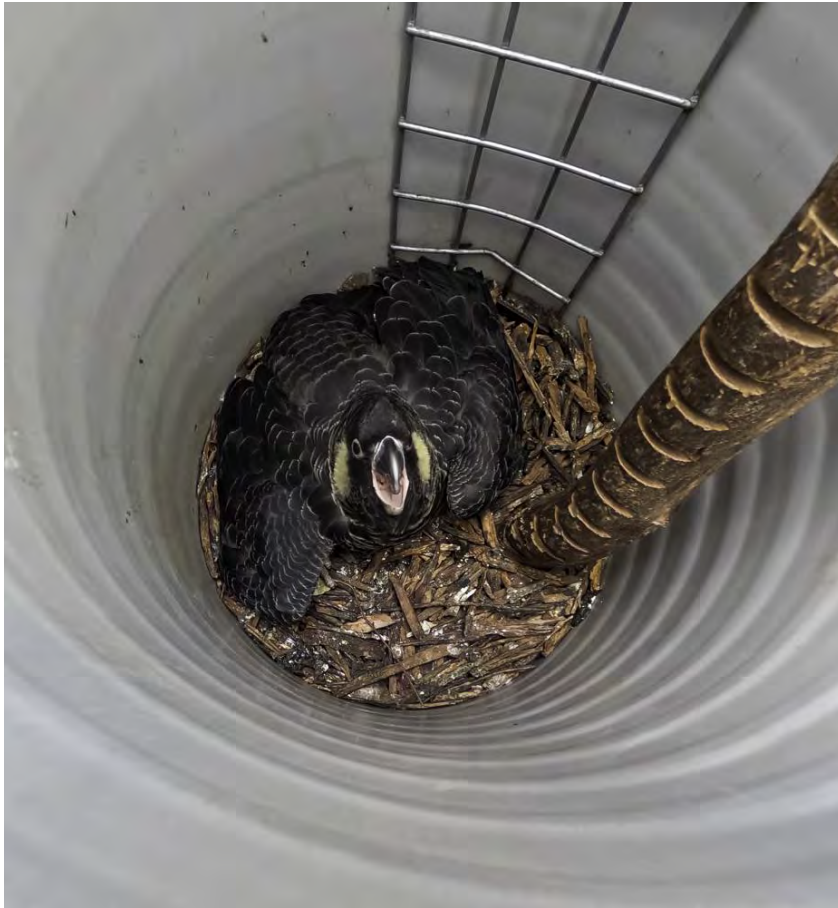
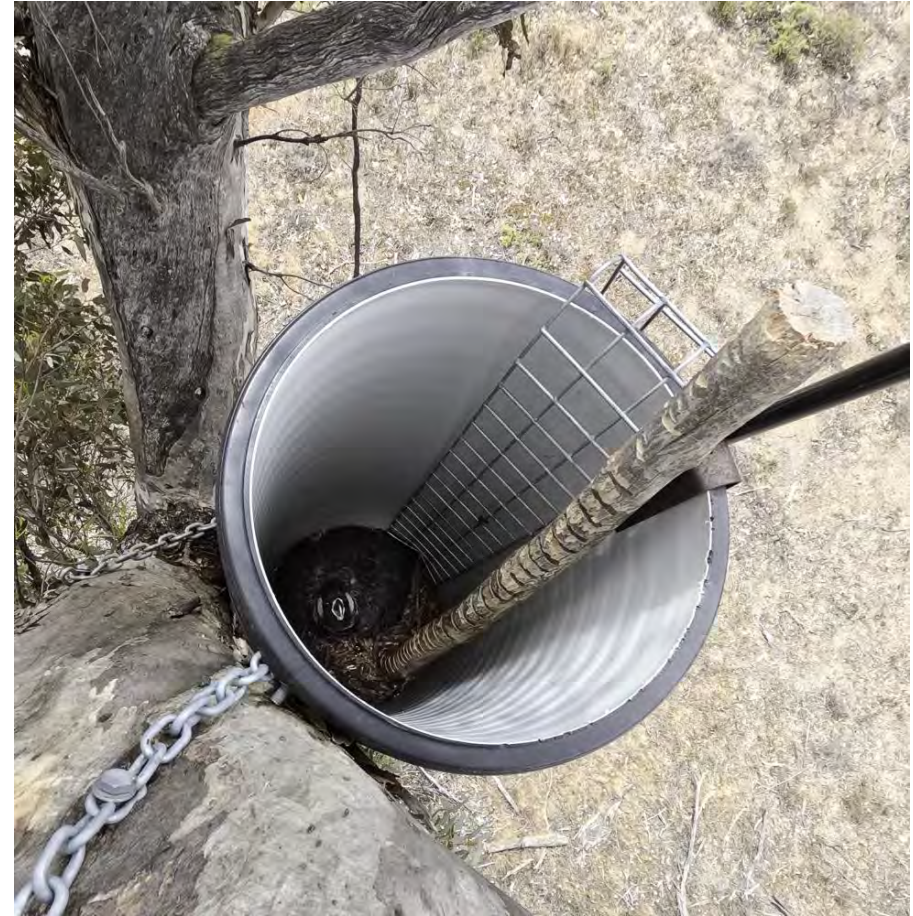
## Artificial Hollow BY01

| Hollow # | Observations Oct 2025 | Observations Dec 2025 | Chipping 0-10 | Wood Chips Lts | Tree condition | Fixings | Recommend repairs |
|---|---|---|---|---|---|---|---|
| BY01 | Female CC Flushed 1 x 8-10day old CC nestling, second CC nestling dead (48hrs) | One 58-day old female CC nestling | 3 | Nil | Good | Good | Nil |

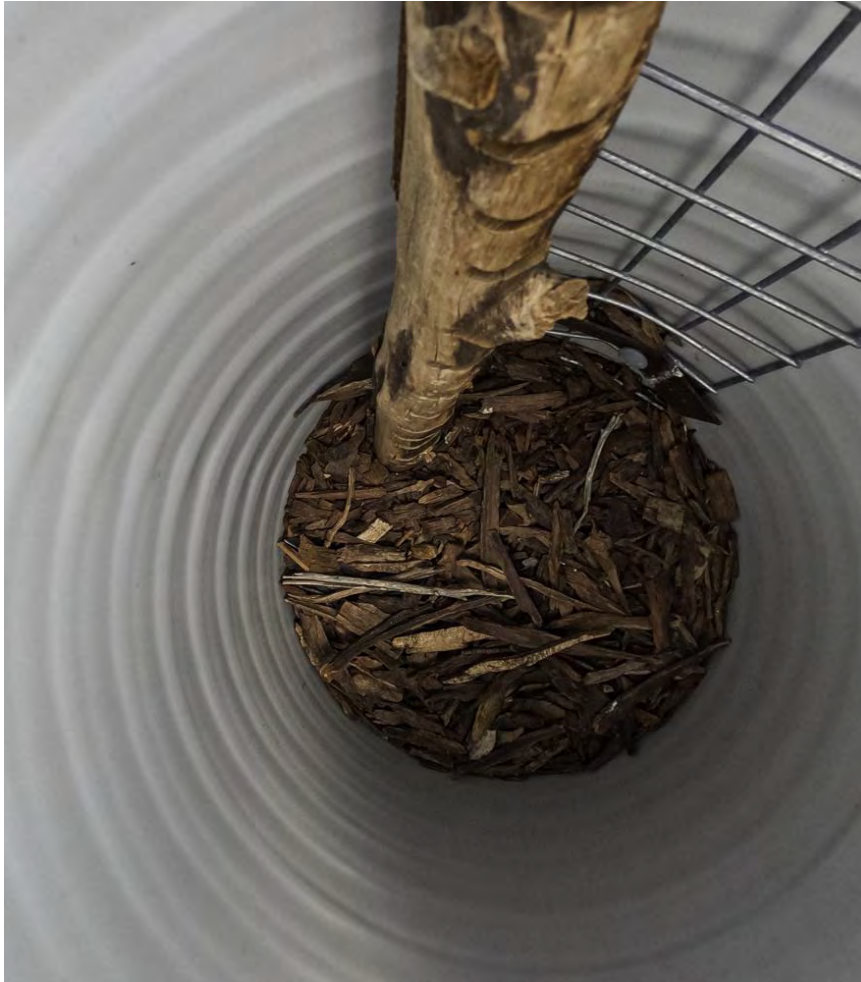
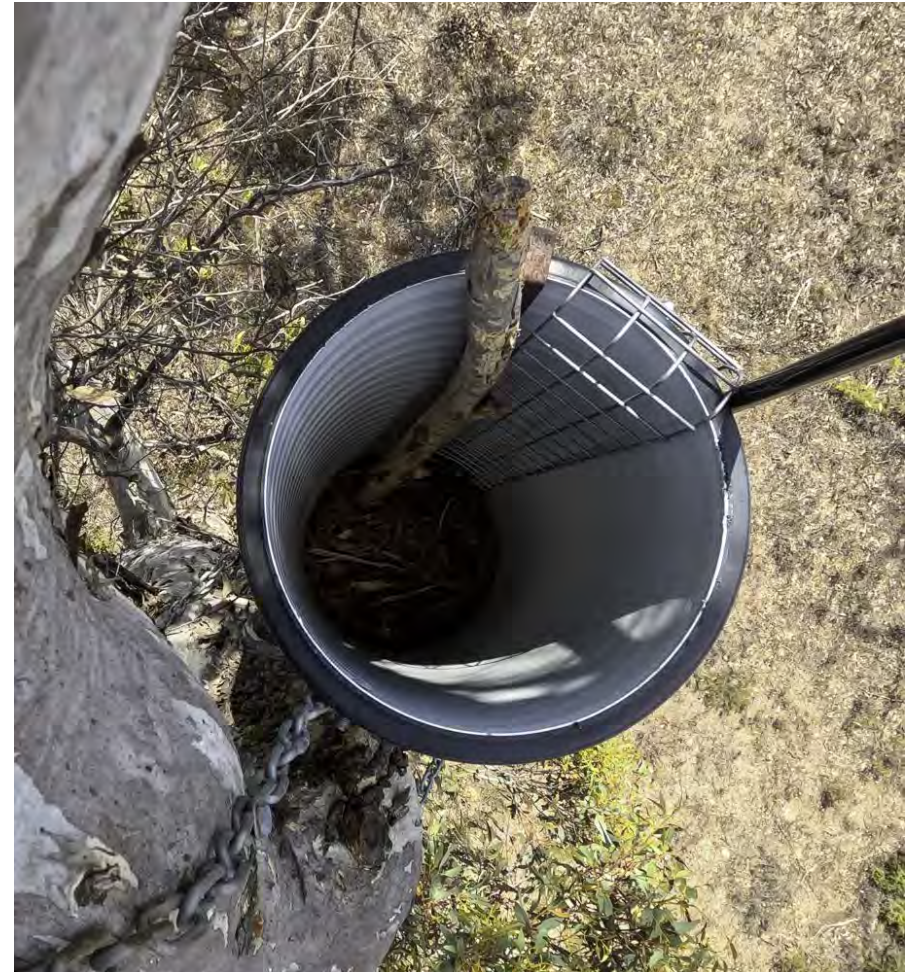
## Artificial Hollow BY02

| Hollow # | Observations Oct 2025 | Observations Dec 2025 | Chipping 0-10 | Wood Chips Lts | Tree condition | Fixings | Recommend repairs |
|---|---|---|---|---|---|---|---|
| BY02 | Chewing on post no signs of Breeding | Chewing on post no signs of Breeding | 2 | Nil | Good | Good | Nil |

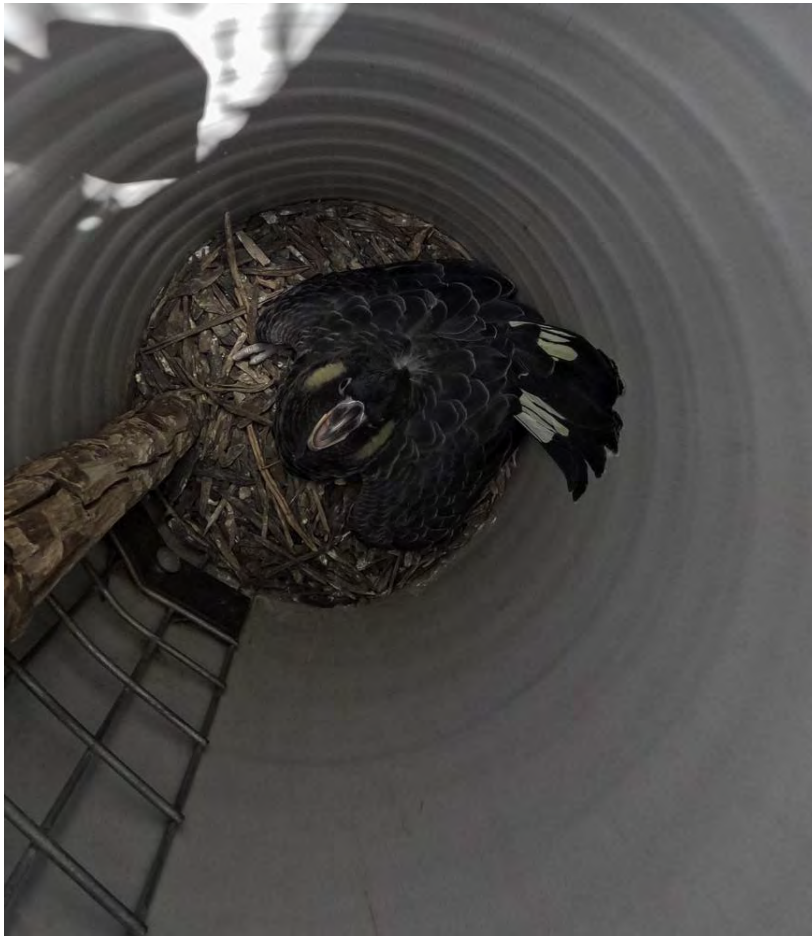
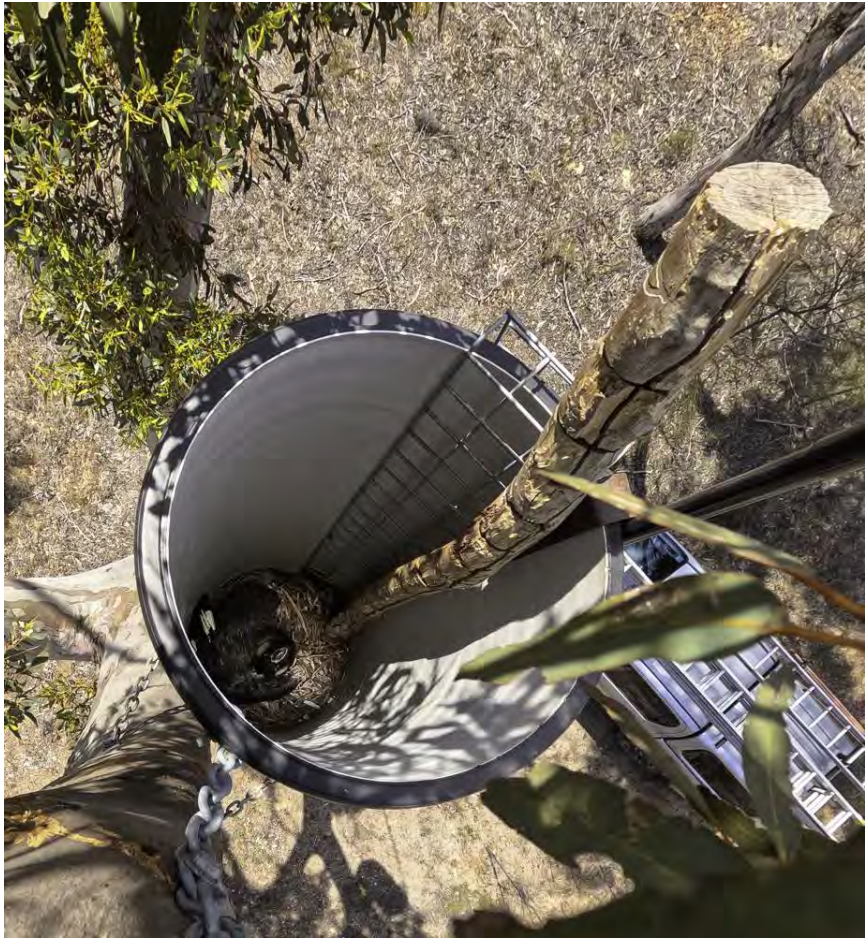
Artificial Hollow BY03

| Hollow # | Observations Oct 2025 | Observations Dec 2025 | Chipping 0-10 | Wood Chips Lts | Tree condition | Fixings | Recommend repairs |
|---|---|---|---|---|---|---|---|
| BY03 | Female CC flushed, One 13 to 15-day old CC nestling Chewing on post. | One 64-day old female CC nestling | 3 | Nil | Good | Good | Nil |

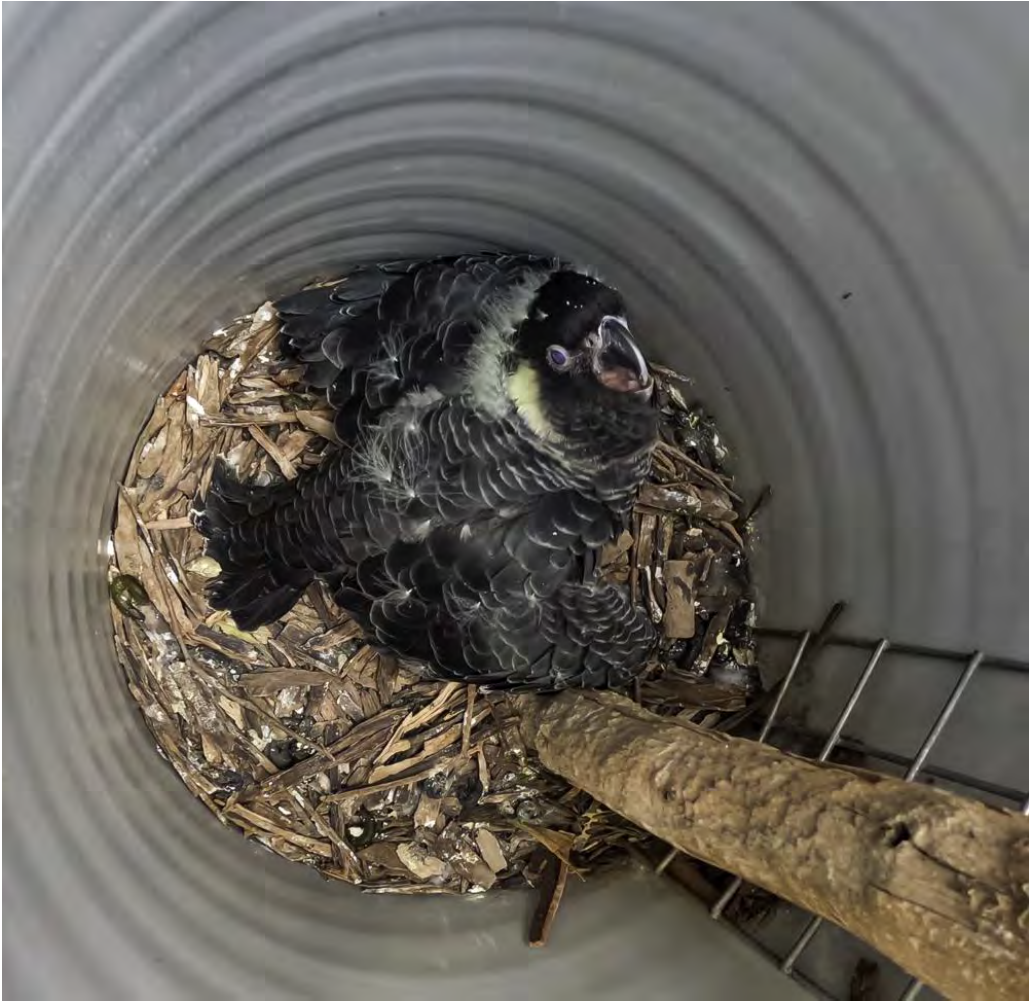
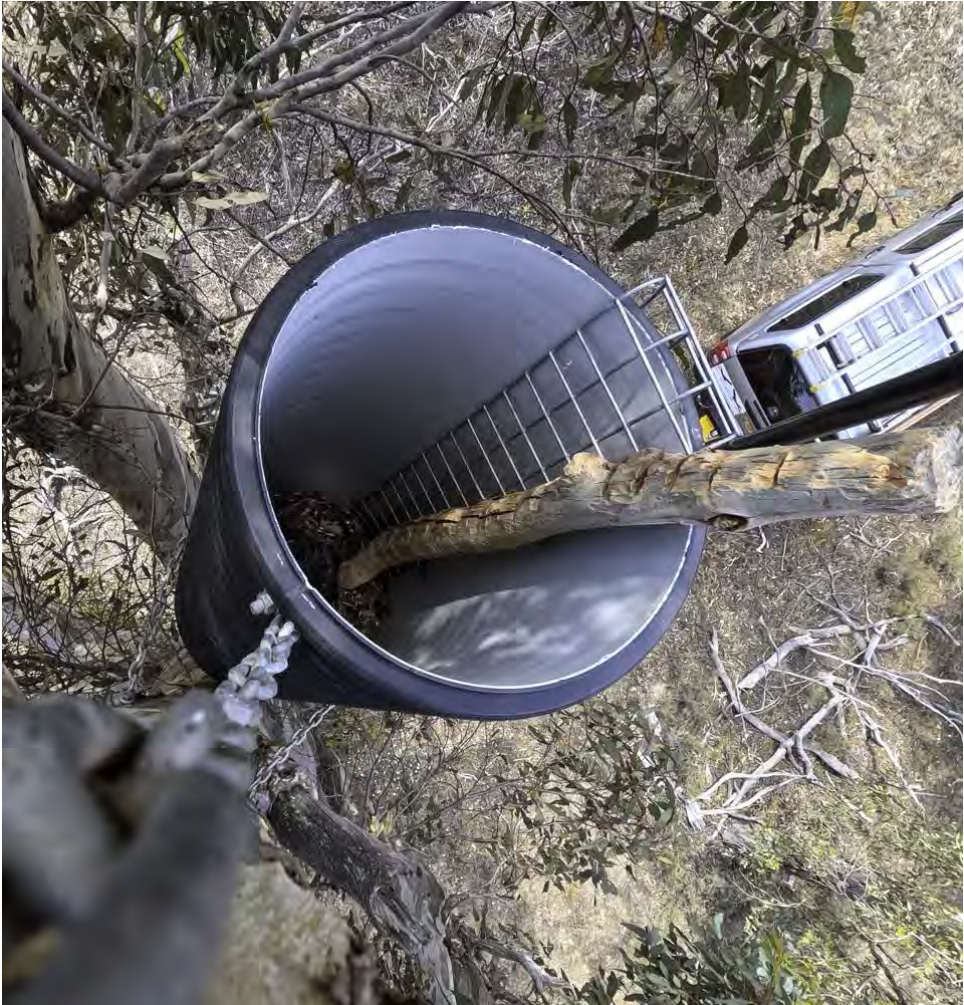
Artificial Hollow BY04

| Hollow # | Observations Oct 2025 | Observations Dec 2025 | Chipping 0-10 | Wood Chips Lts | Tree condition | Fixings | Recommend repairs |
|---|---|---|---|---|---|---|---|
| BY04 | Female CC flushed, 2 x CC eggs, chewing on post | One 47-day old female CC nestling | 3 | Nil | Good | Good | Nil |

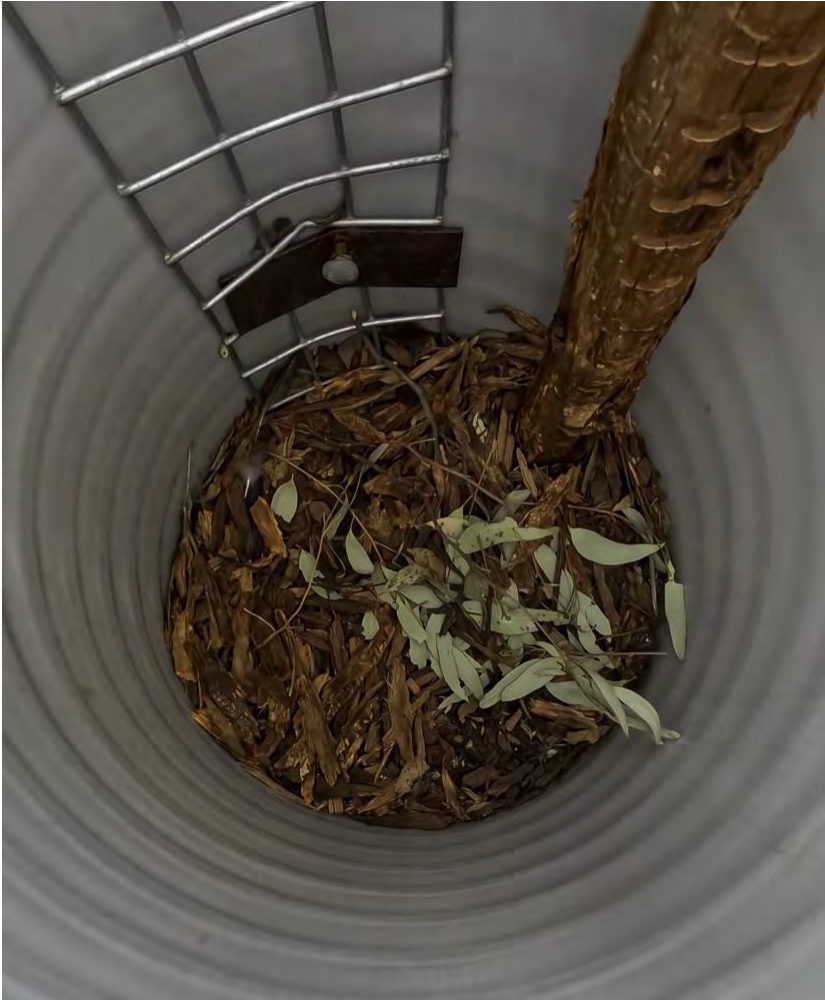
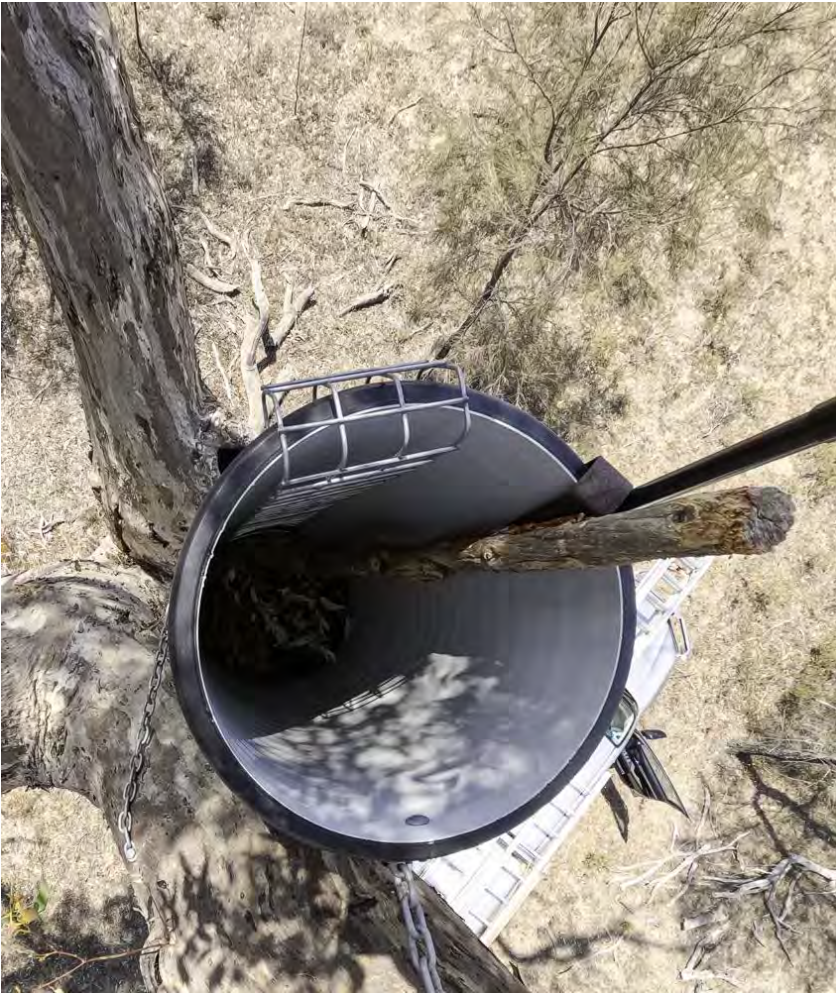
Artificial Hollow BY05

| Hollow # | Observations Oct 2025 | Observations Dec 2025 | Chipping 0-10 | Wood Chips Lts | Tree condition | Fixings | Recommend repairs |
|---|---|---|---|---|---|---|---|
| BY05 | Chewing on post no signs of Breeding | Chewing on post no signs of Breeding | 3 | Nil | Good | Good | Nil |

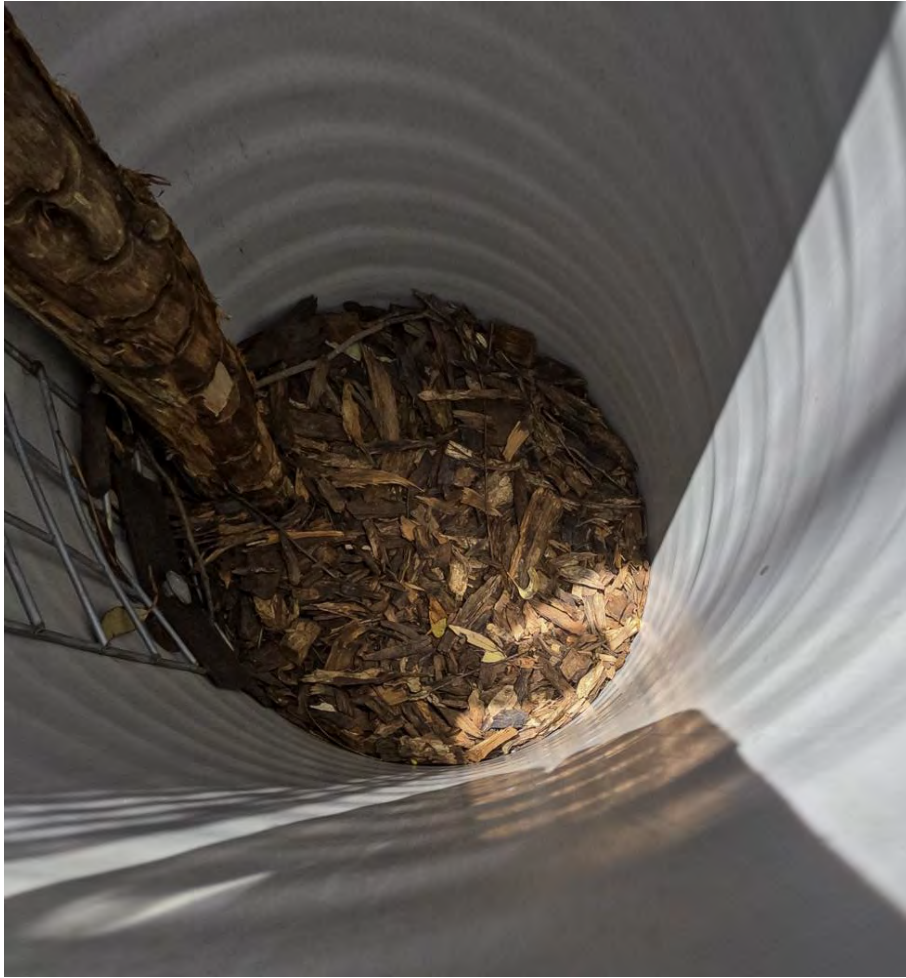
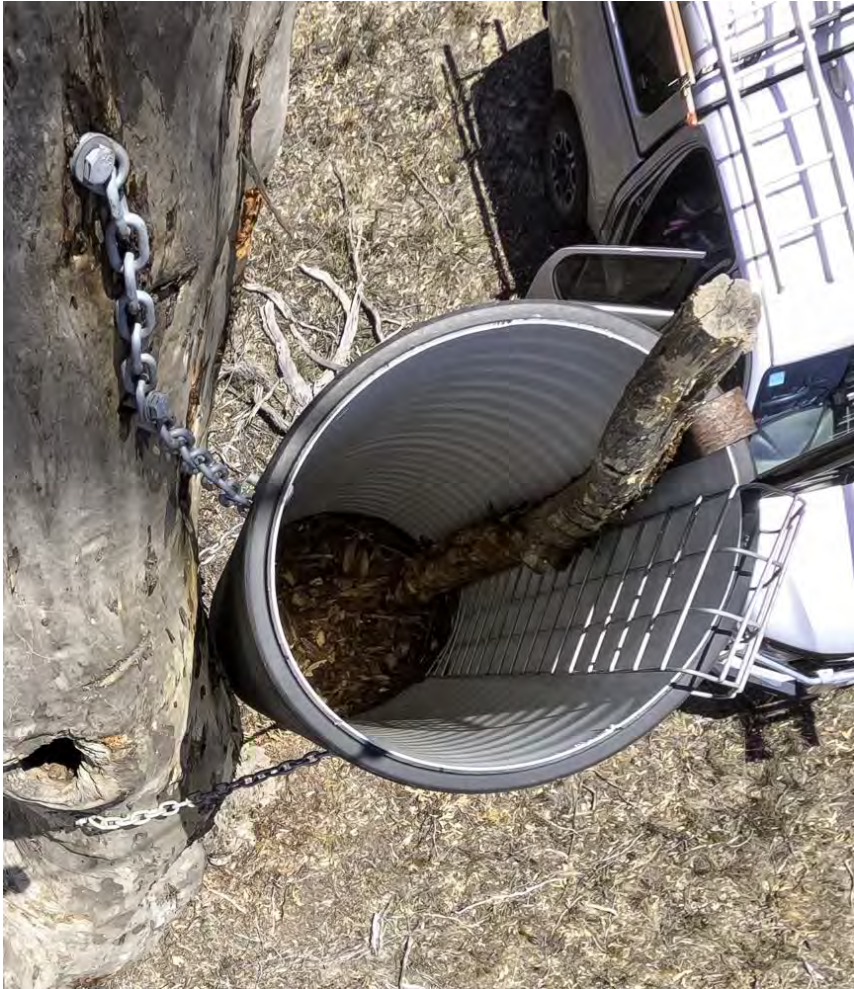
Artificial Hollow BY06

| Hollow # | Observations Oct 2025 | Observations Dec 2025 | Chipping 0-10 | Wood Chips Lts | Tree condition | Fixings | Recommend repairs |
|---|---|---|---|---|---|---|---|
| BY06 | Chewing on post no signs of Breeding | Chewing on post no signs of Breeding | 2 | Nil | Good | Good | Nil |

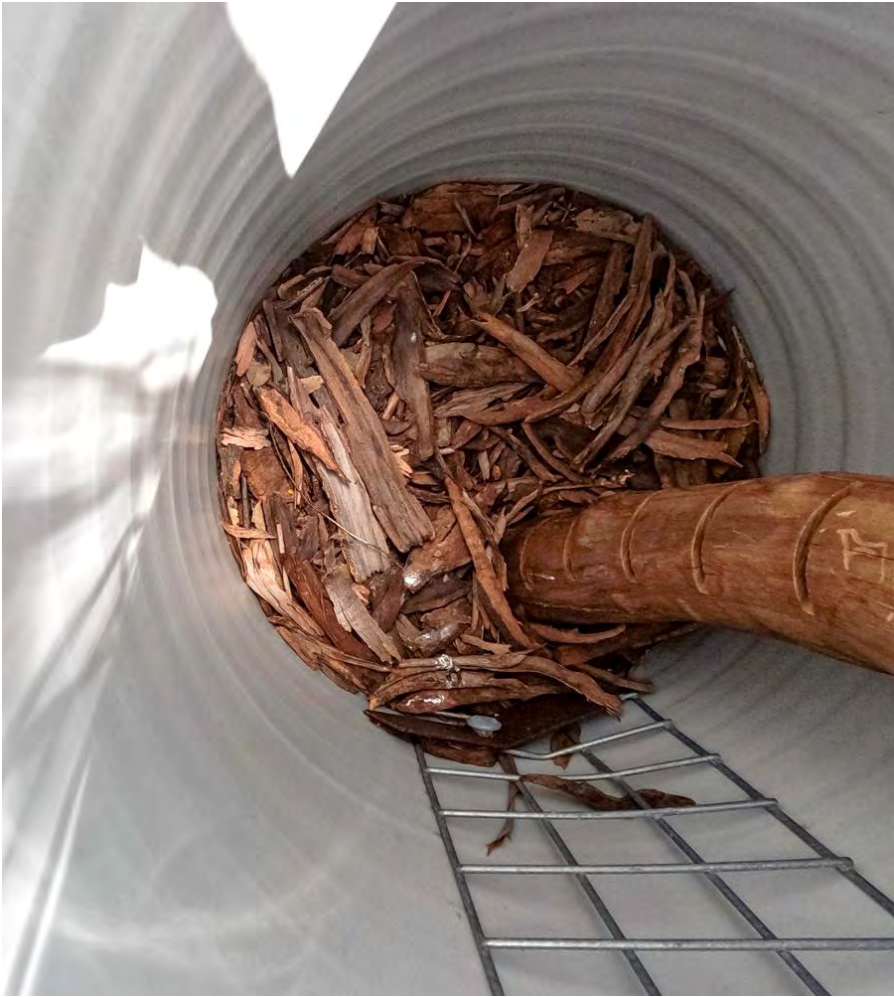
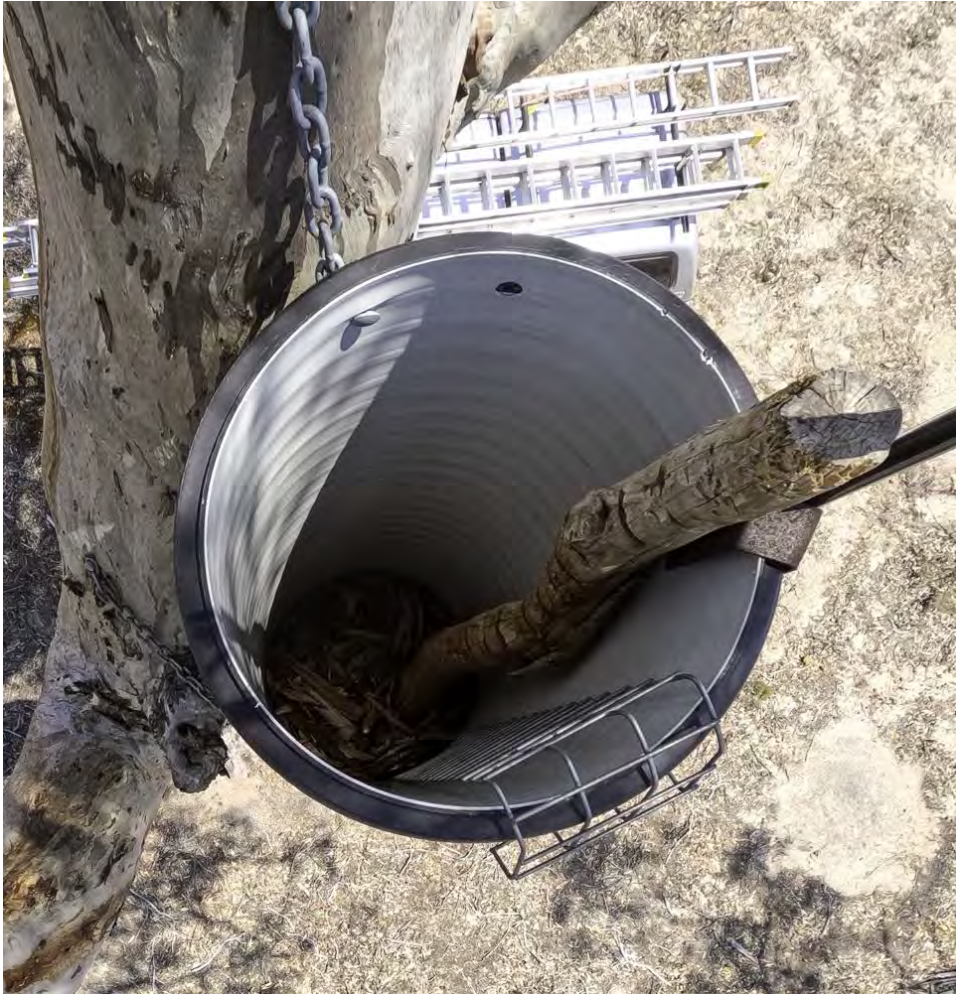
Artificial Hollow BY07

| Hollow # | Observations Oct 2025 | Observations Dec 2025 | Chipping 0-10 | Wood Chips Lts | Tree condition | Fixings | Recommend repairs |
|---|---|---|---|---|---|---|---|
| BY07 | Chewing on post no signs of Breeding | Chewing on post no signs of Breeding | 2 | Nil | Good | Good | Nil |

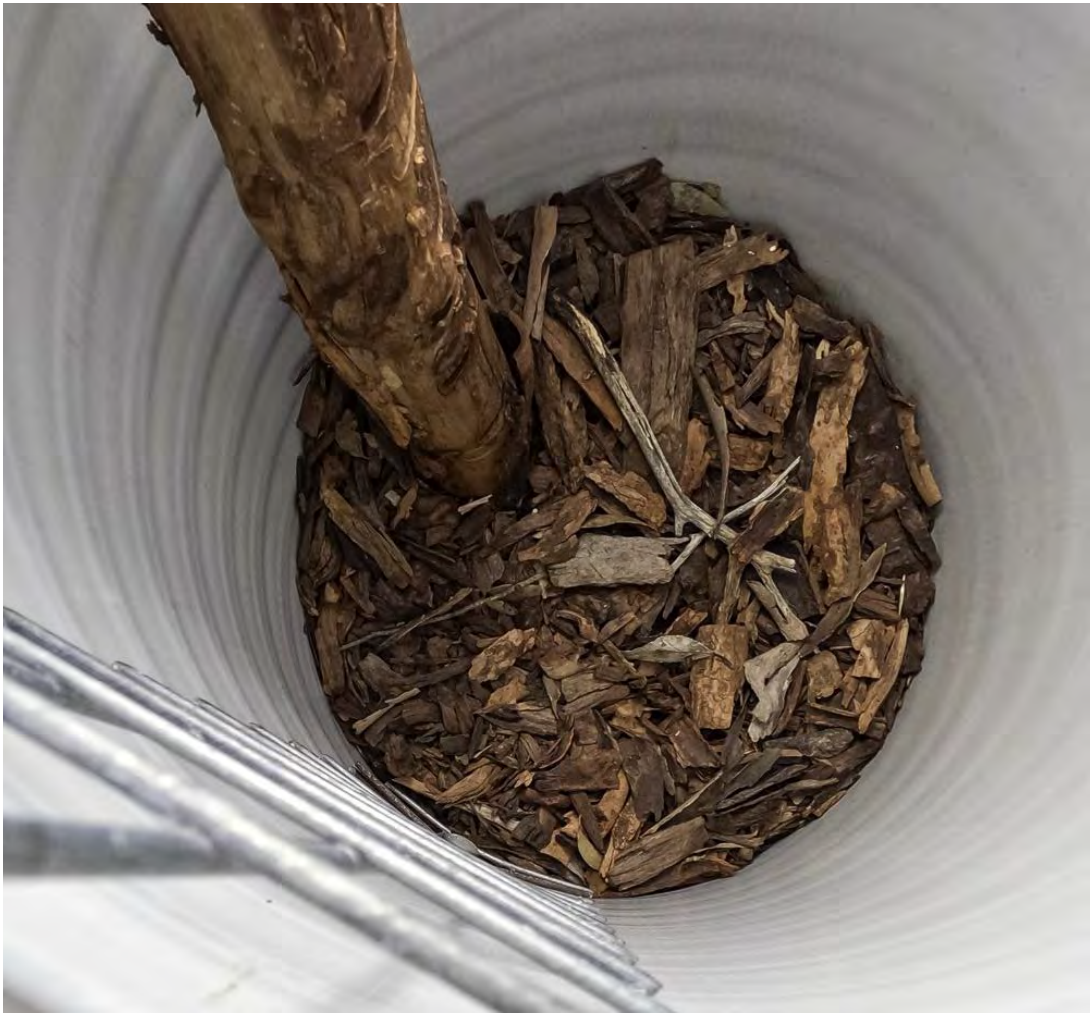
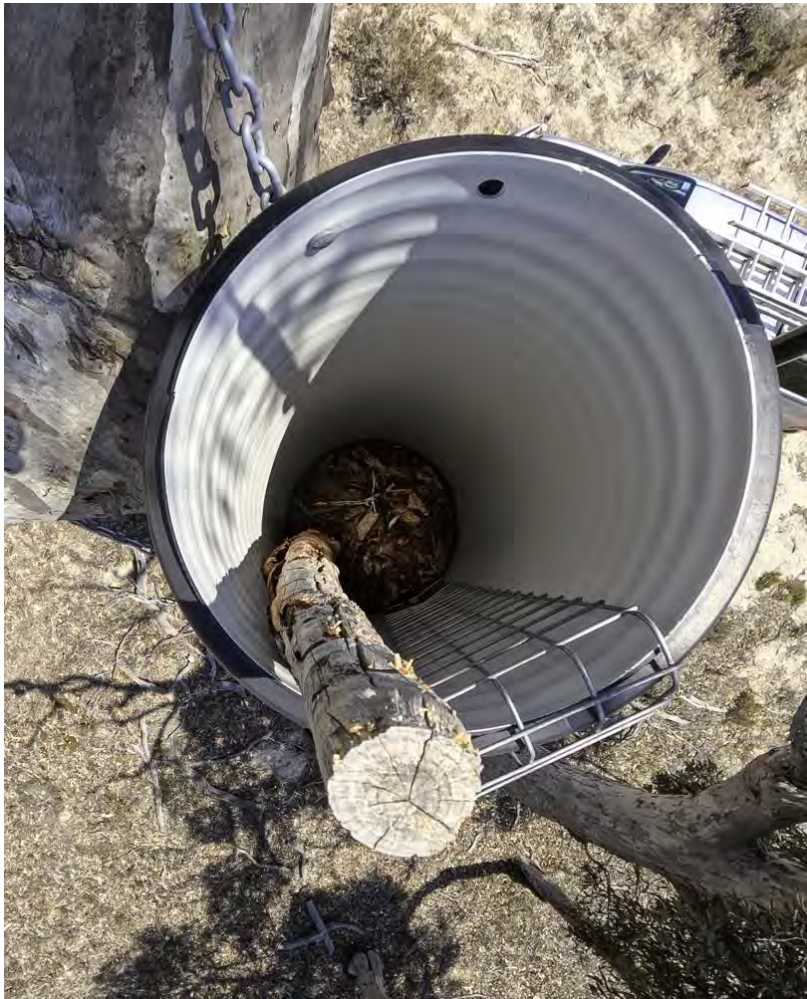
Artificial Hollow BY08

| Hollow # | Observations Oct 2025 | Observations Dec 2025 | Chipping 0-10 | Wood Chips Lts | Tree condition | Fixings | Recommend repairs |
|---|---|---|---|---|---|---|---|
| BY08 | Chewing on post no signs of Breeding | Chewing on post no signs of Breeding | 2 | Nil | Good | Good | Nil |

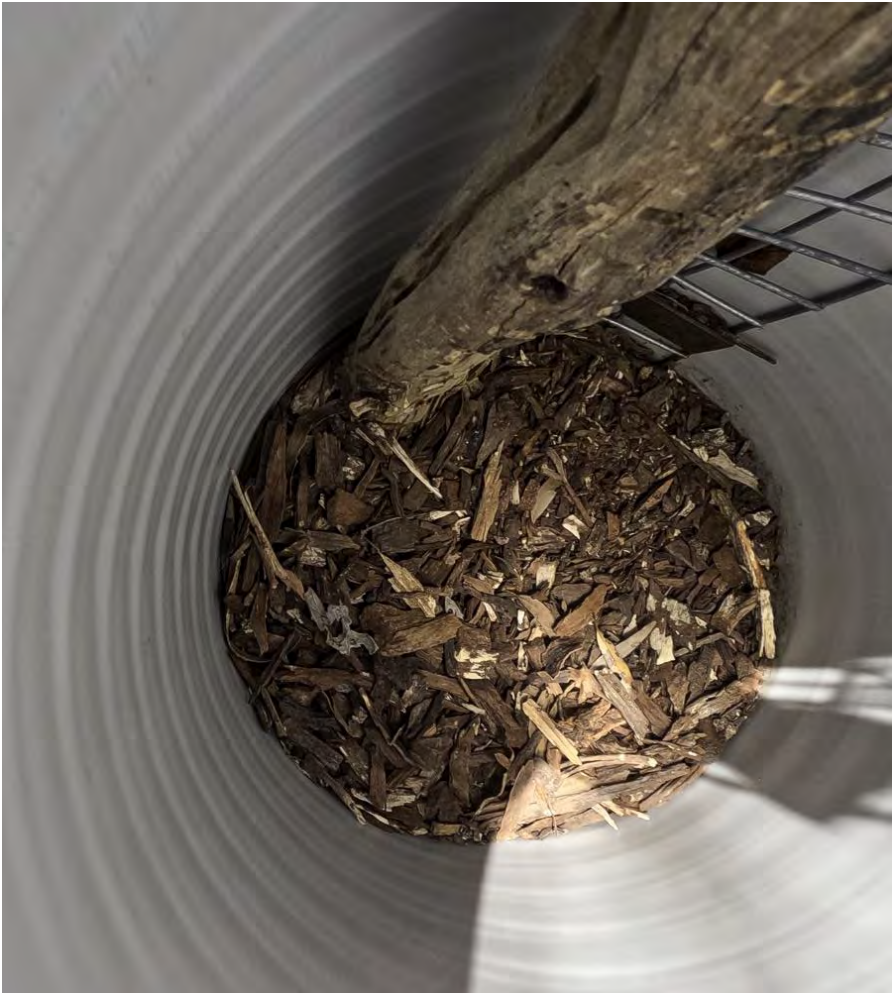
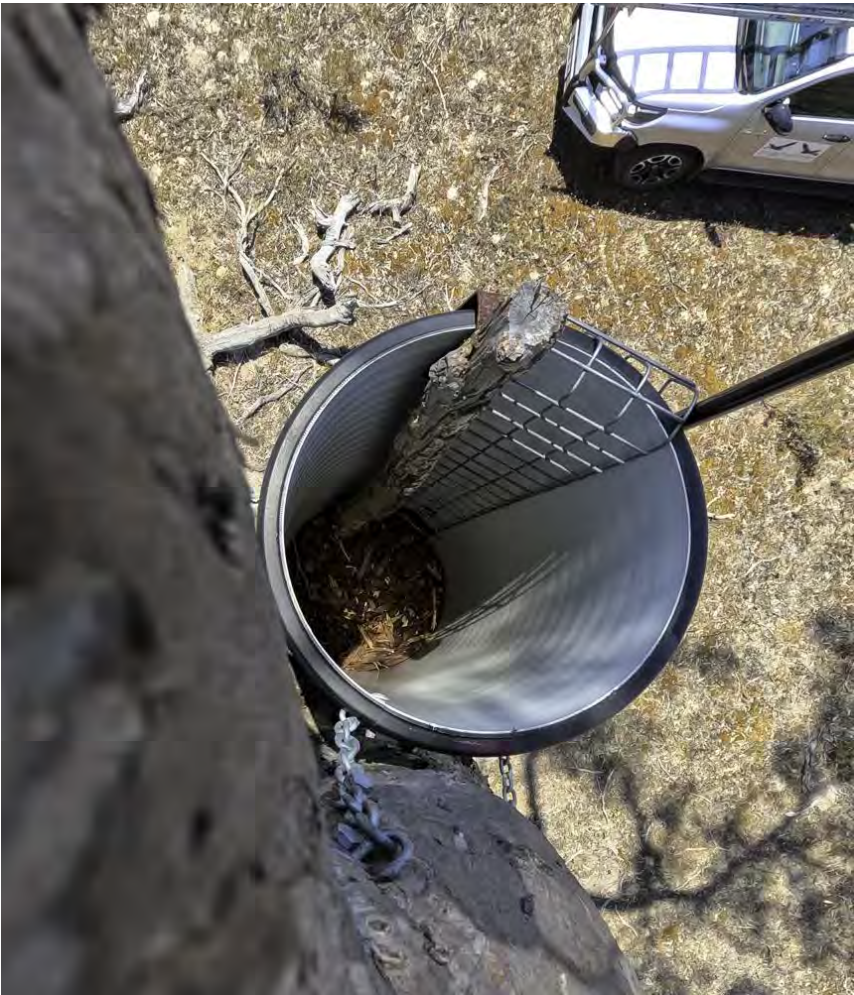
Artificial Hollow BY09

| Hollow # | Observations Oct 2025 | Observations Dec 2025 | Chipping 0-10 | Wood Chips Lts | Tree condition | Fixings | Recommend repairs |
|---|---|---|---|---|---|---|---|
| BY09 | Chewing on post no signs of Breeding | Chewing on post no signs of Breeding | 3 | Nil | Good | Good | Nil |

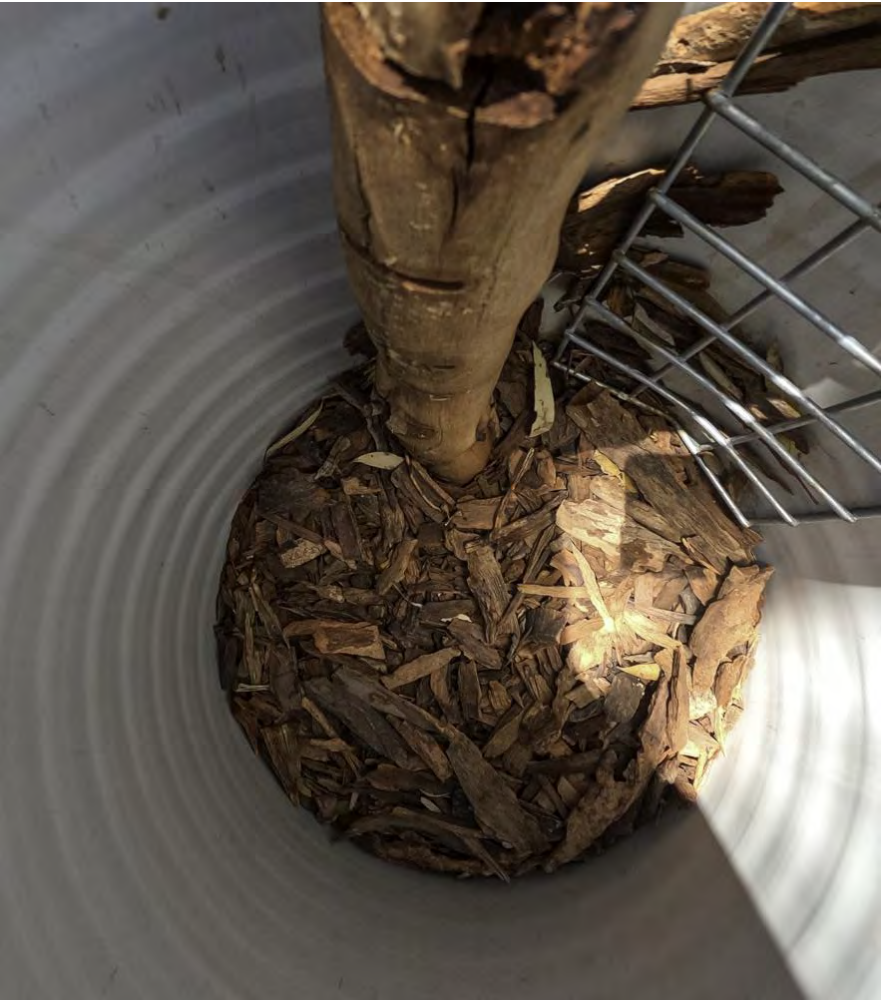
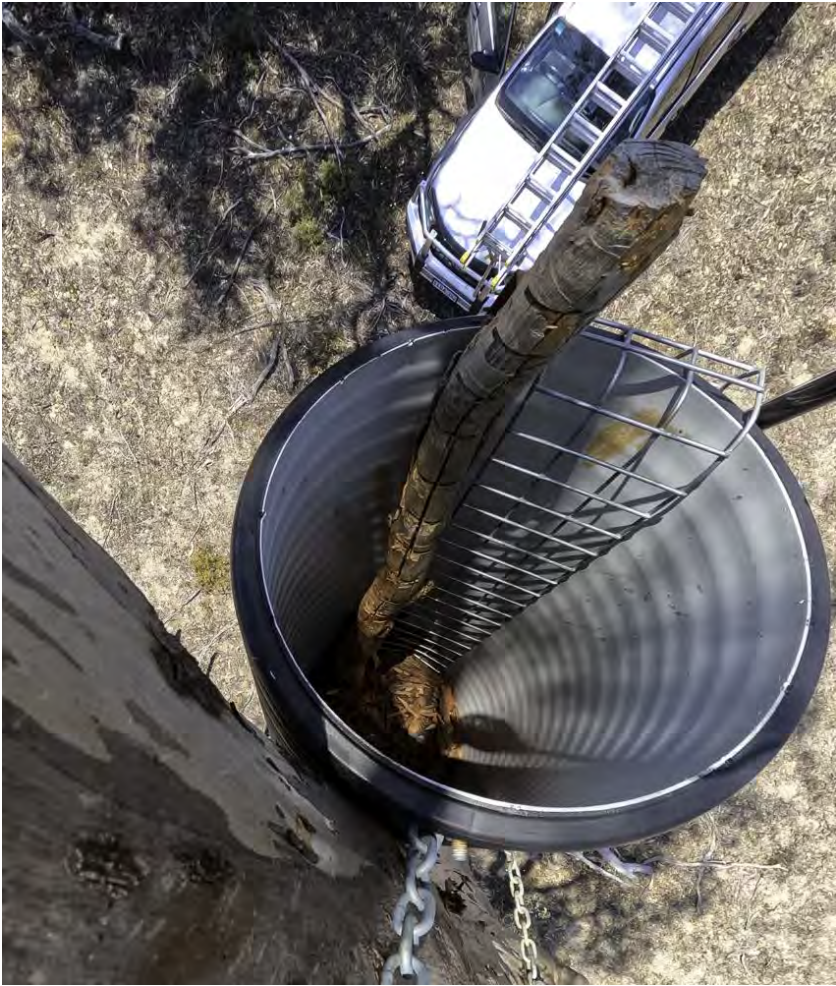
Artificial Hollow BY10

| Hollow # | Observations Oct 2025 | Observations Dec 2025 | Chipping 0-10 | Wood Chips Lts | Tree condition | Fixings | Recommend repairs |
|---|---|---|---|---|---|---|---|
| BY10 | Chewing on post no signs of Breeding | Chewing on post no signs of Breeding | 2 | Nil | Good | Good | Nil |

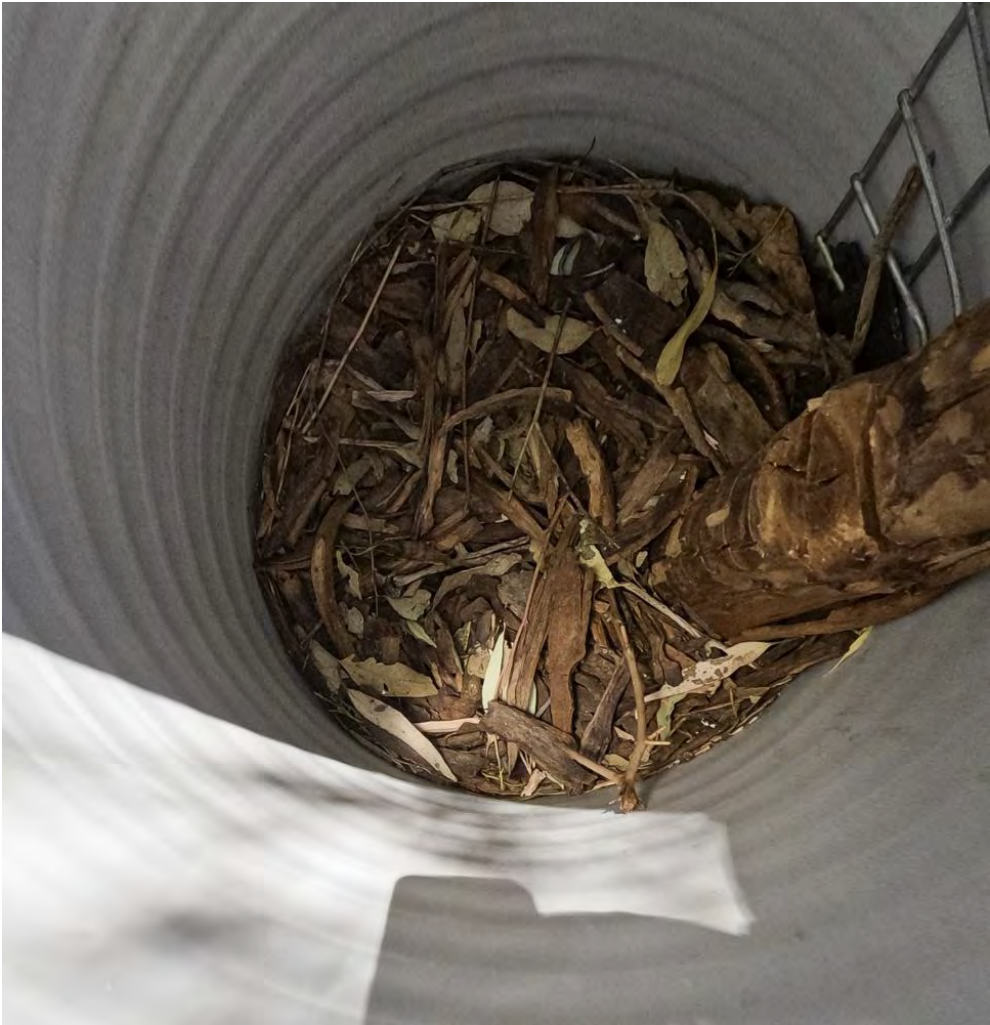
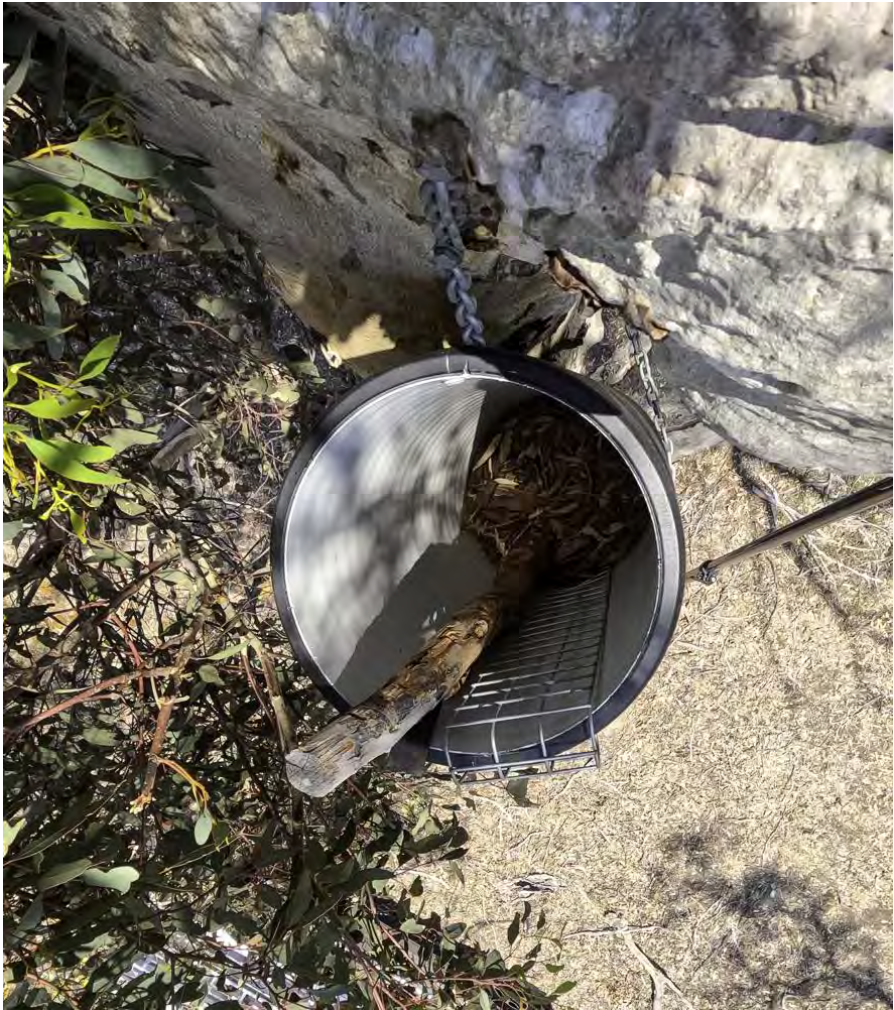
Artificial Hollow BY11

| Hollow # | Observations Oct 2025 | Observations Dec 2025 | Chipping 0-10 | Wood Chips Lts | Tree condition | Fixings | Recommend repairs |
|---|---|---|---|---|---|---|---|
| BY11 | Chewing on post no signs of Breeding | Chewing on post no signs of Breeding | 2 | Nil | Good | Good | Nil |
