# Ministerial Statement Compliance Assessment Report

**Bunbury Outer Ring Road - South  
Ministerial Statement 1191**

**2025 - 2026 Reporting Period**

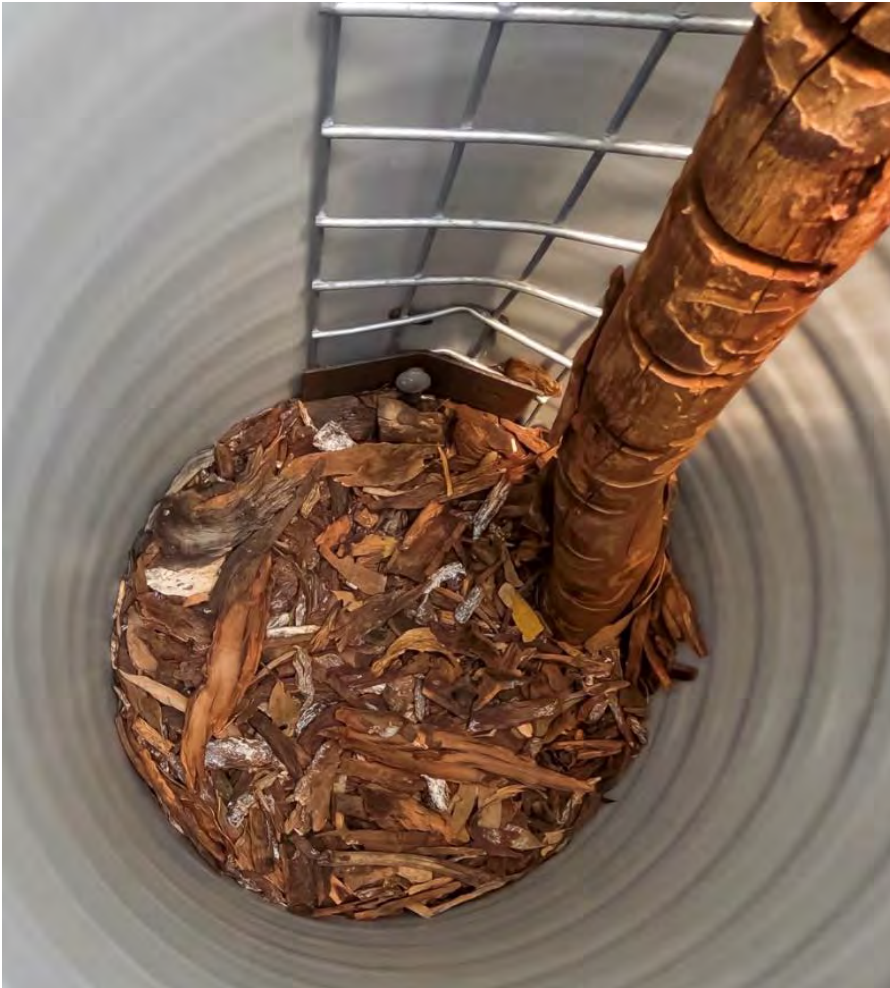
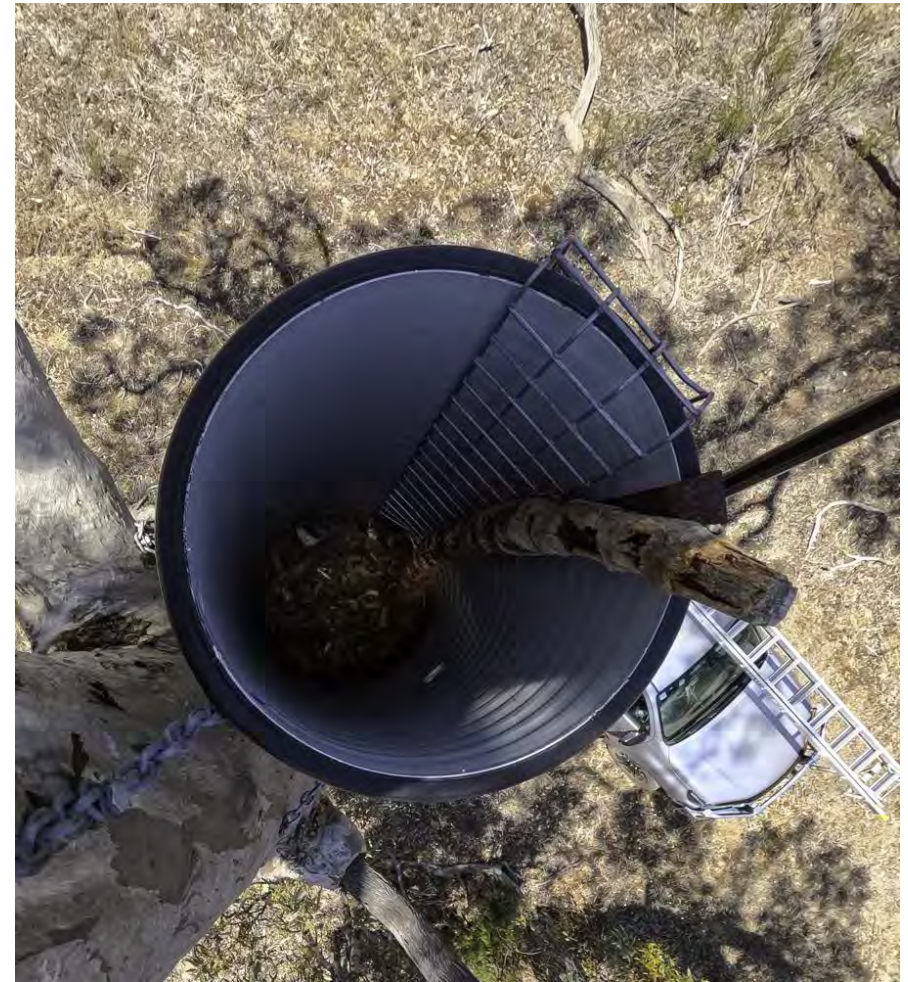
## Artificial Hollow BY12

| Hollow # | Observations Oct 2025 | Observations Dec 2025 | Chipping 0-10 | Wood Chips Lts | Tree condition | Fixings | Recommend repairs |
|---|---|---|---|---|---|---|---|
| BY12 | Female CC prospecting at hollow with Male, chewing on post no sign of Breeding | Chewing on post no signs of Breeding | 3 | Nil | Good | Good | Nil |

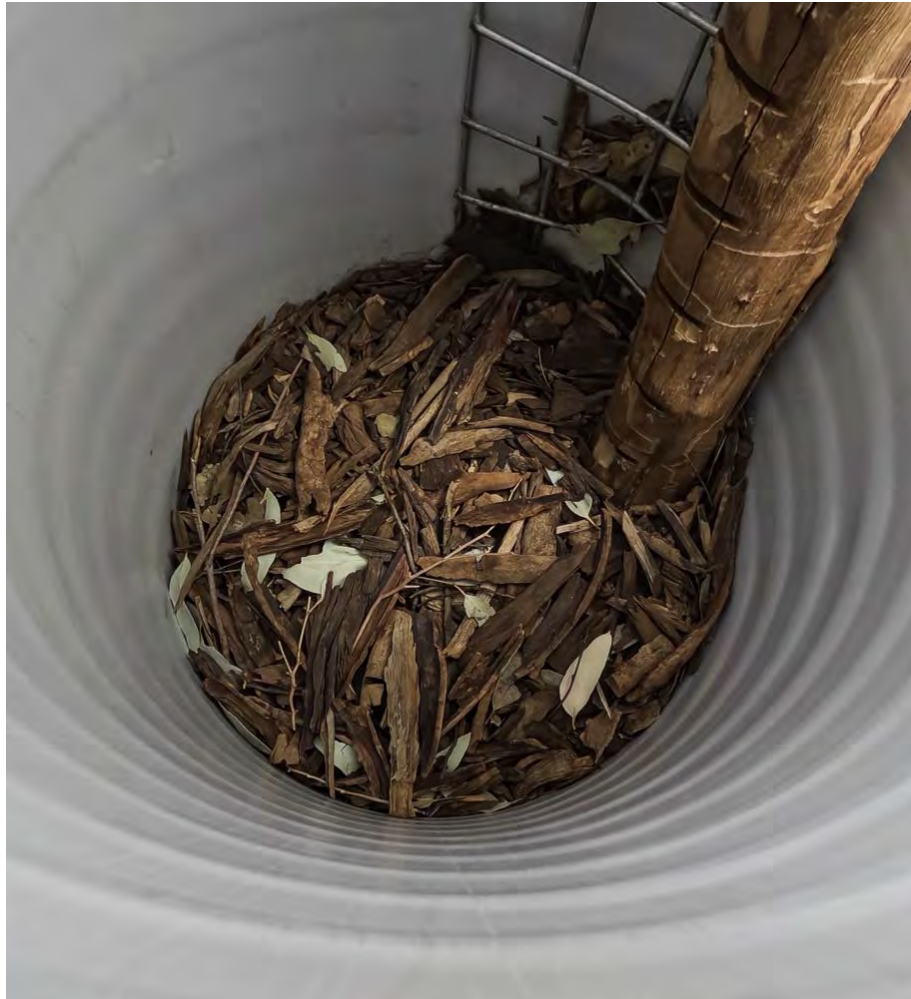
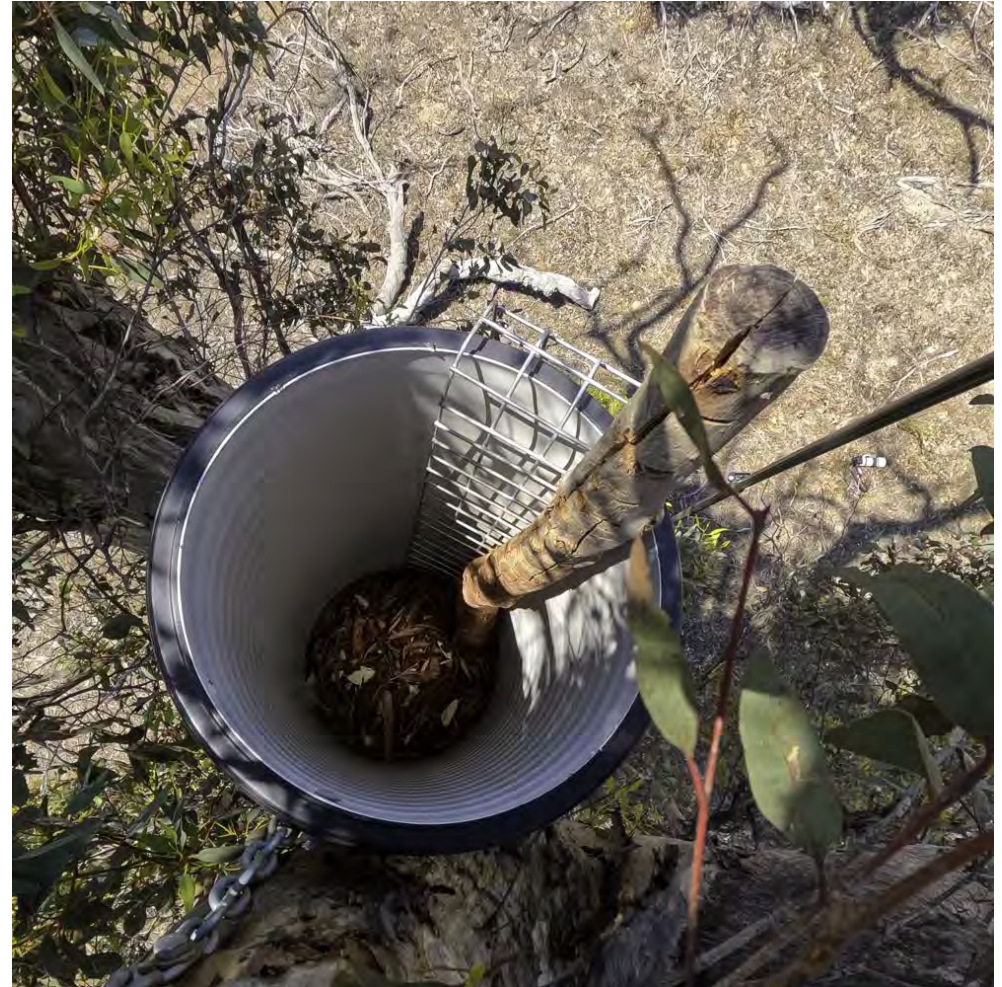
## Artificial Hollow BY13

| Hollow # | Observations Oct 2025 | Observations Dec 2025 | Chipping 0-10 | Wood Chips Lts | Tree condition | Fixings | Recommend repairs |
|---|---|---|---|---|---|---|---|
| BY13 | Chewing on post no signs of Breeding | Chewing on post no signs of Breeding | 1 | Nil | Good | Good | Nil |

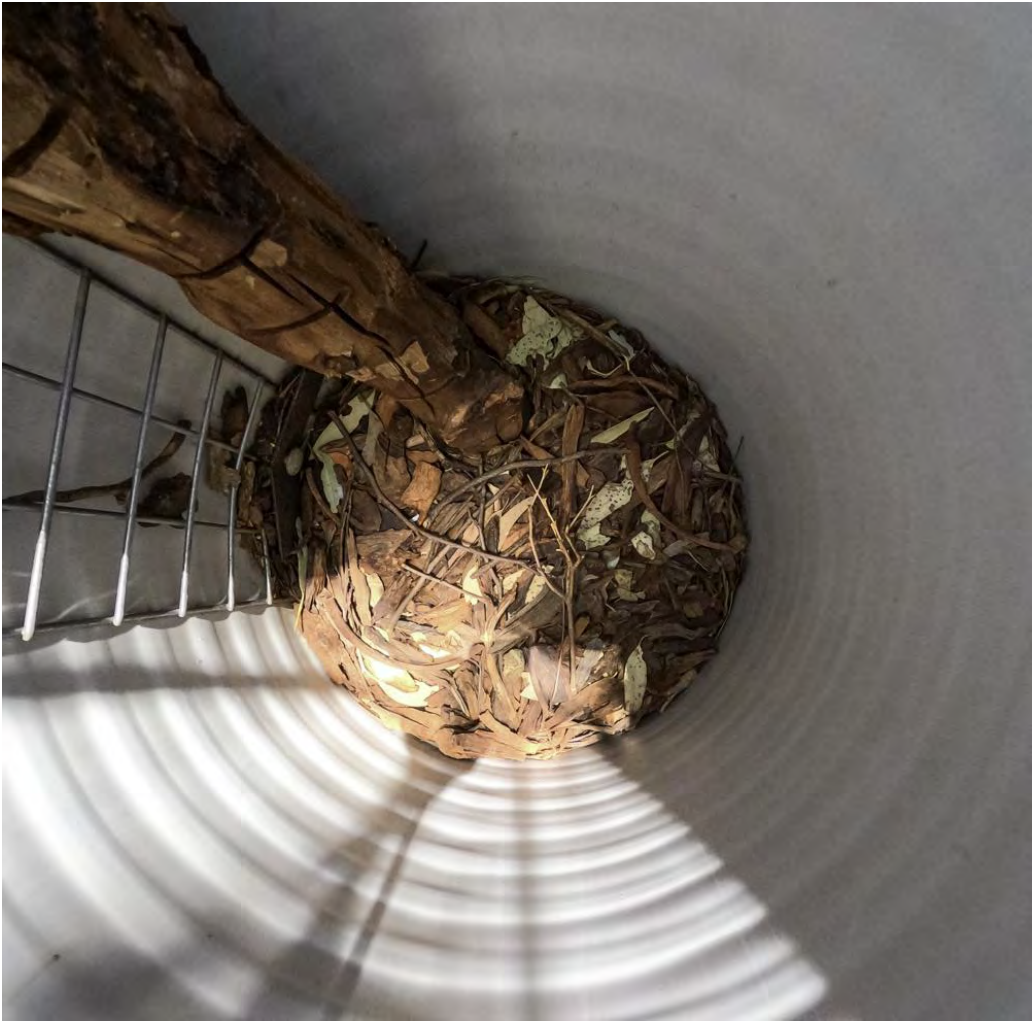
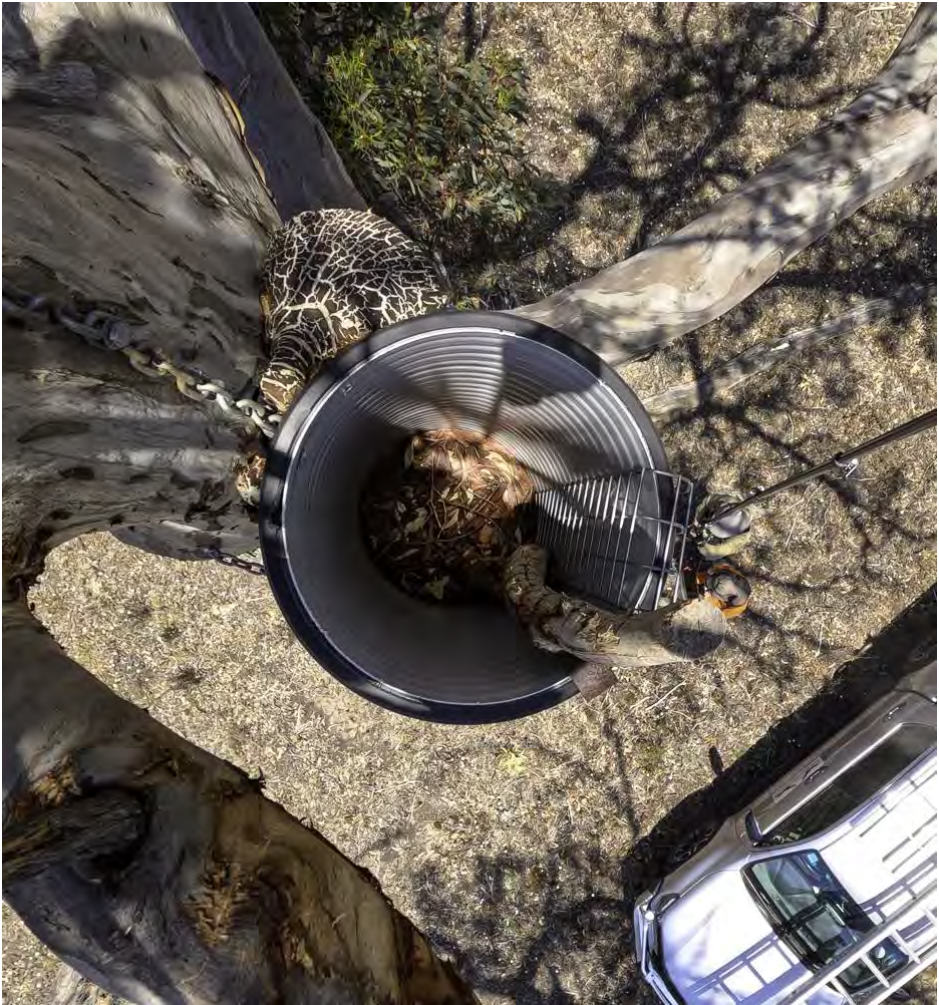
Artificial Hollow BY14

| Hollow # | Observations Oct 2025 | Observations Dec 2025 | Chipping 0-10 | Wood Chips Lts | Tree condition | Fixings | Recommend repairs |
|---|---|---|---|---|---|---|---|
| BY14 | Chewing on post no signs of Breeding | Chewing on post no signs of Breeding | 2 | Nil | Good | Good | Nil |

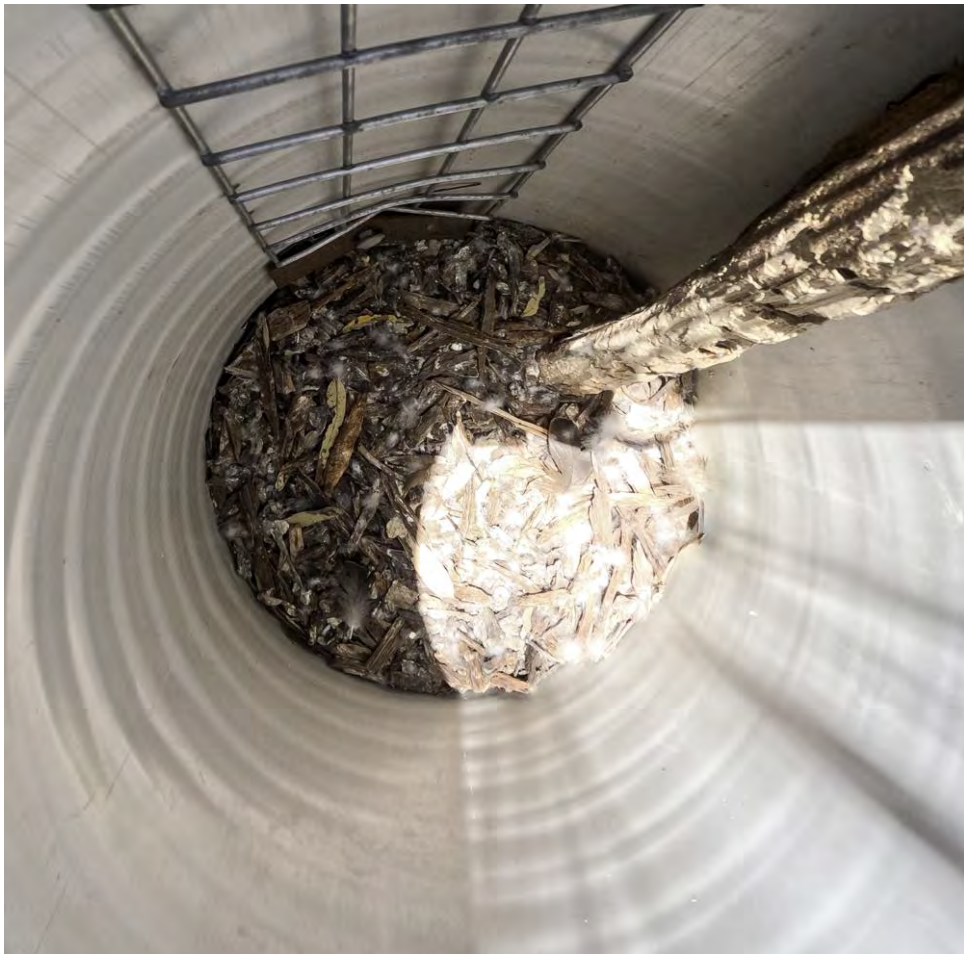
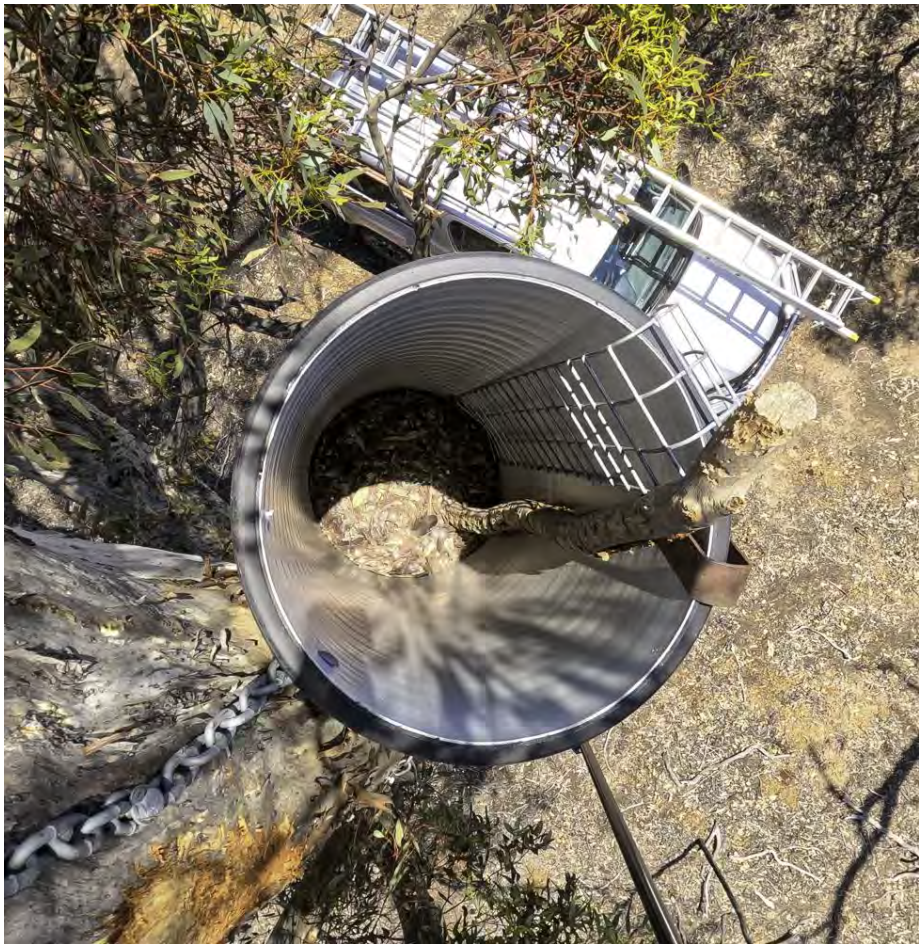
# Artificial Hollow BY15

| Hollow # | Observations Oct 2025 | Observations Dec 2025 | Chipping 0-10 | Wood Chips Lts | Tree condition | Fixings | Recommend repairs |
|---|---|---|---|---|---|---|---|
| BY15 | One Male 50 day old CC nestling. Leg banded | Nestling Fledged, heavy pooh load on floor | 5 | Nil | Good | Good | Nil |

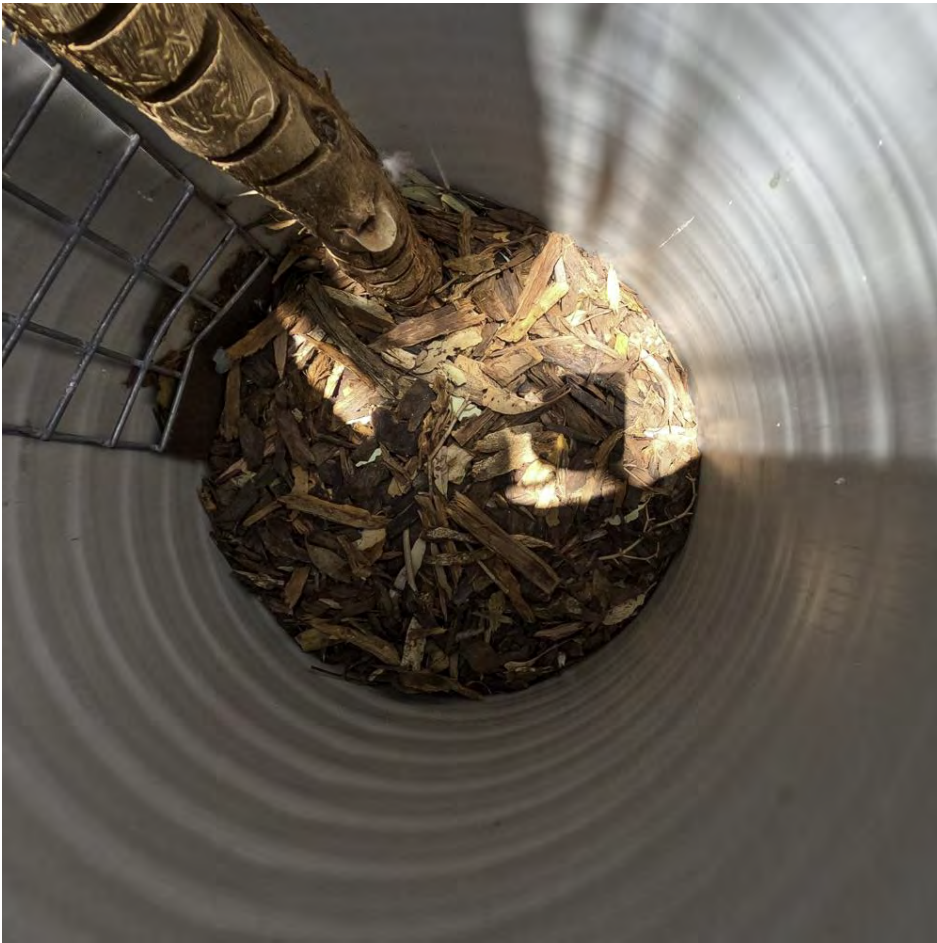
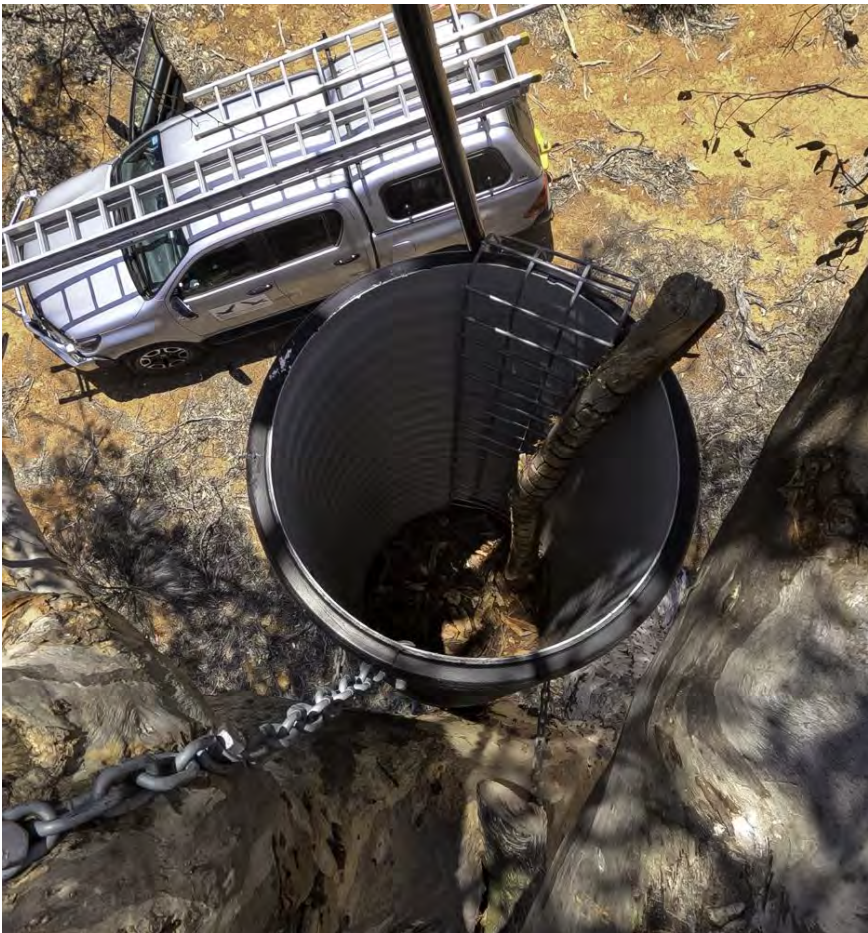
Artificial Hollow BY16

| Hollow # | Observations Oct 2025 | Observations Dec 2025 | Chipping 0-10 | Wood Chips Lts | Tree condition | Fixings | Recommend repairs |
|---|---|---|---|---|---|---|---|
| BY16 | Chewing on post no signs of Breeding | Chewing on post no signs of Breeding | 2 | Nil | Good | Good | Nil |

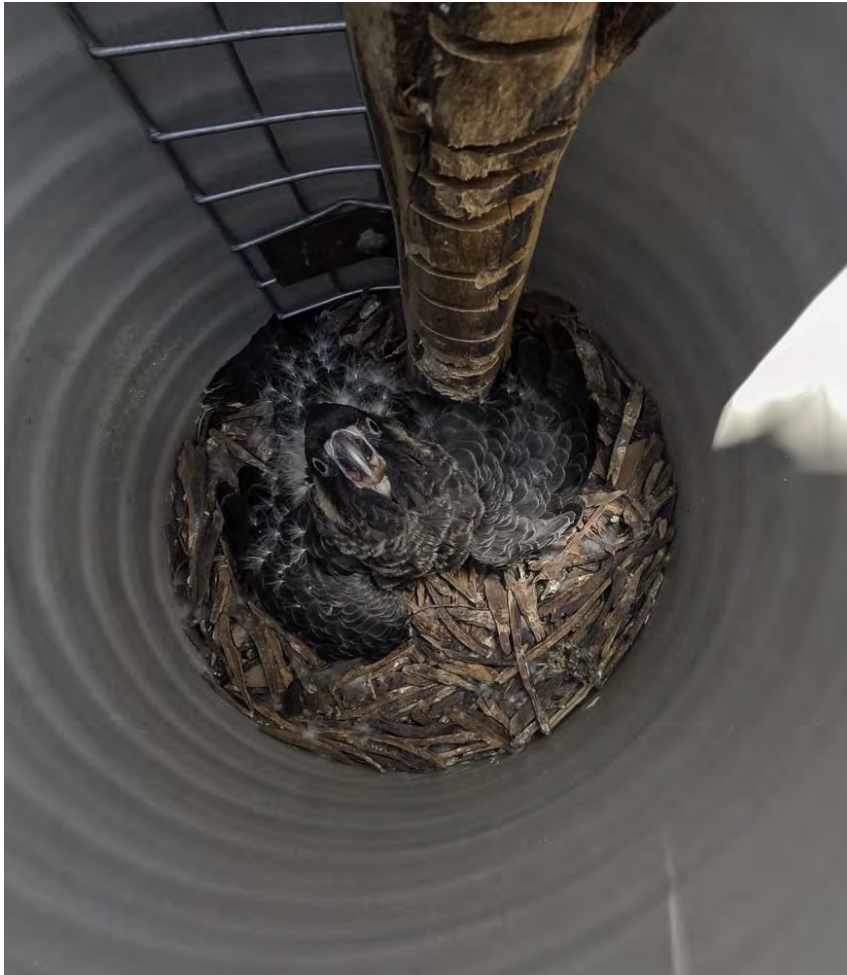
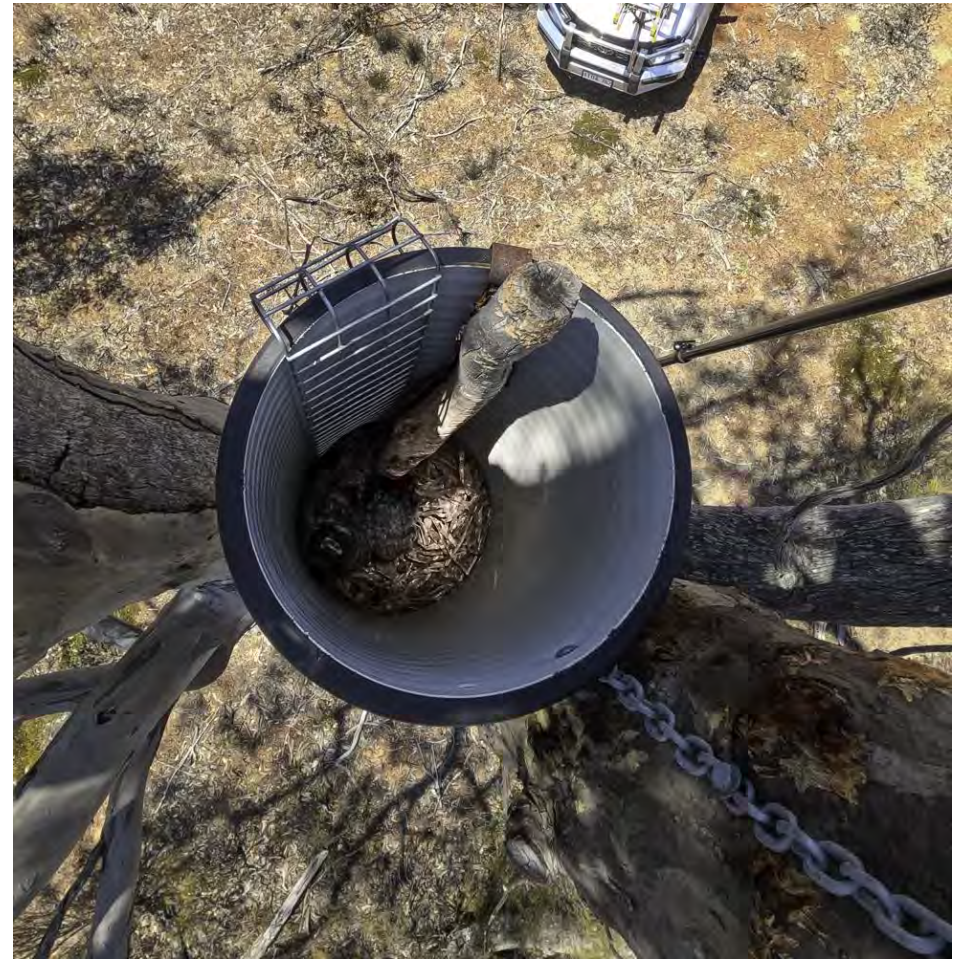
## Artificial Hollow BY17

| Hollow # | Observations Oct 2025 | Observations Dec 2025 | Chipping 0-10 | Wood Chips Lts | Tree condition | Fixings | Recommend repairs |
|---|---|---|---|---|---|---|---|
| BY17 | Female CC flushed, One 4-5-day old CC nestling, and still incubating second egg. | One 47-day old male CC nestling | 2 | Nil | Good | Good | Nil |

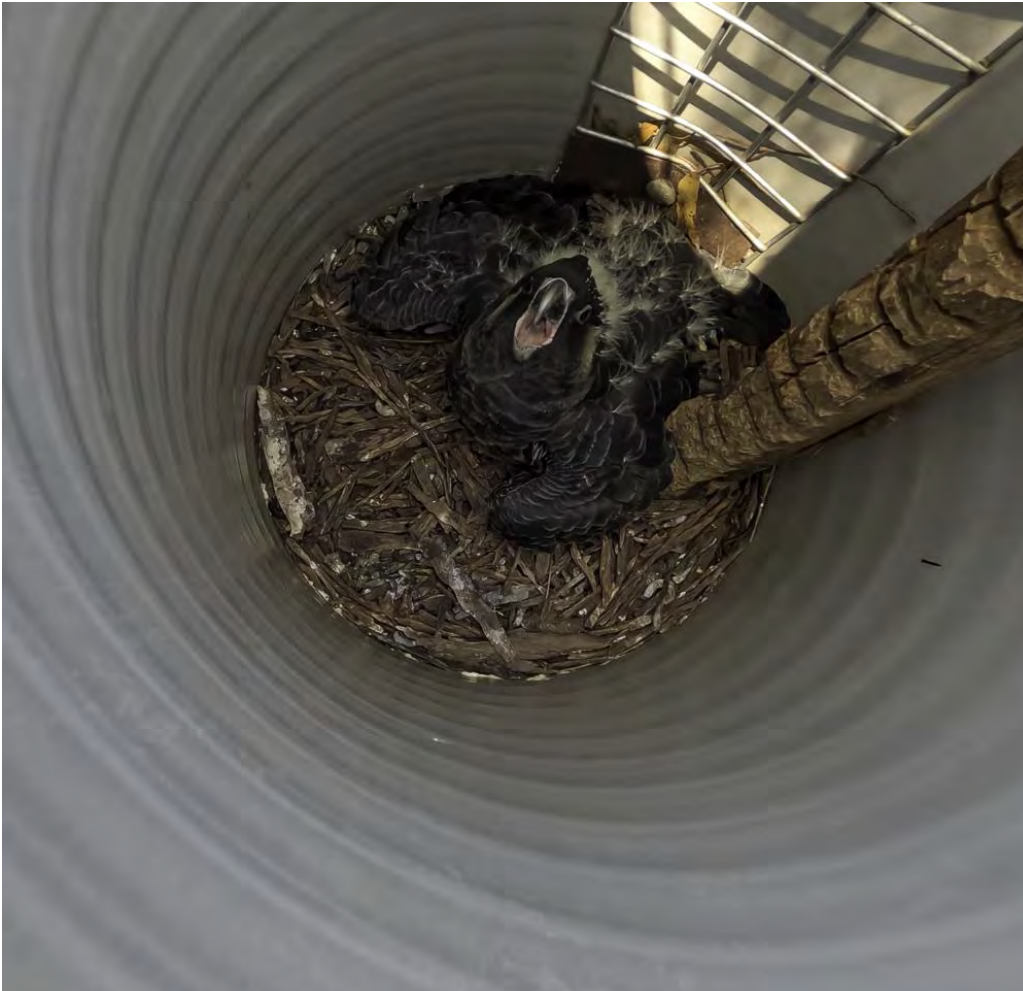
## Artificial Hollow BY18

| Hollow # | Observations Oct 2025 | Observations Dec 2025 | Chipping 0-10 | Wood Chips Lts | Tree condition | Fixings | Recommend repairs |
|---|---|---|---|---|---|---|---|
| BY18 | Female CC flushed, One 4-5-day old CC nestling, and still incubating second egg. | One 50-day old male CC nestling | 5 | Nil | Good | Good | Nil |

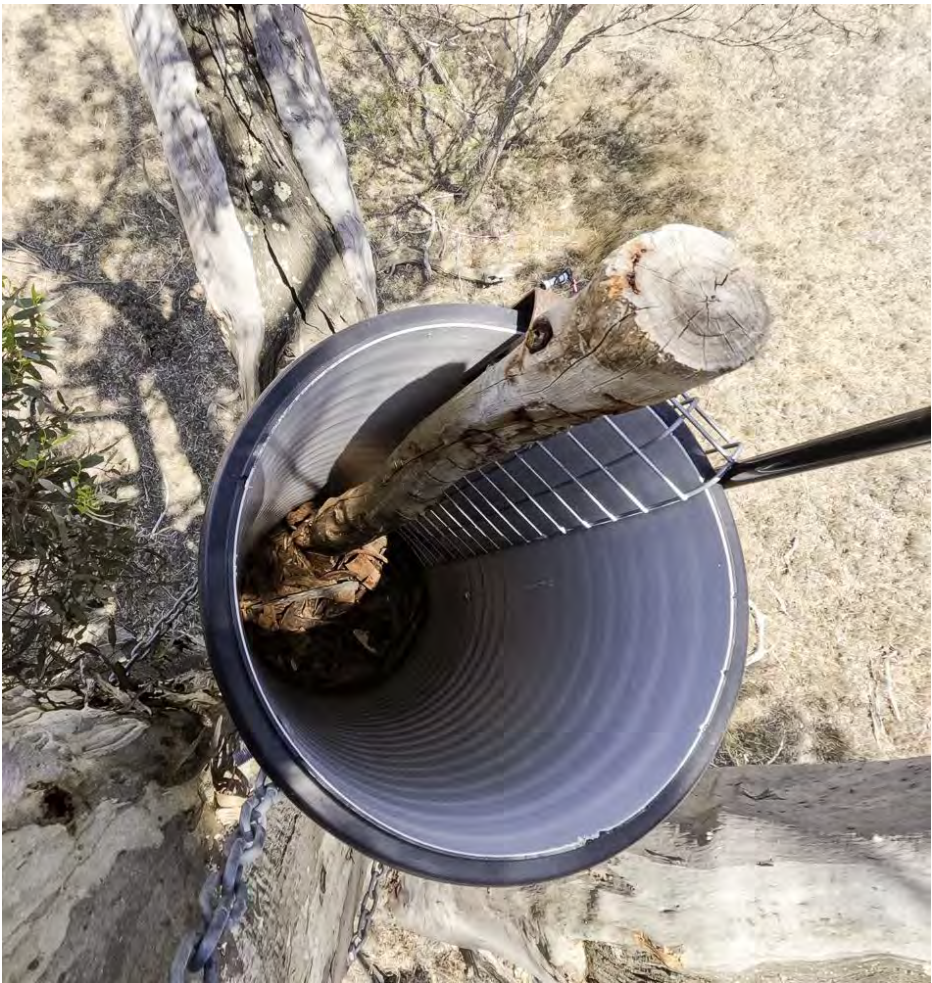
Artificial Hollow BY19

| Hollow # | Observations Oct 2025 | Observations Dec 2025 | Chipping 0-10 | Wood Chips Lts | Tree condition | Fixings | Recommend repairs |
|---|---|---|---|---|---|---|---|
| BY19 | Chewing on post no signs of Breeding | Chewing on post no signs of Breeding | 2 | Nil | Good | Good | Nil |

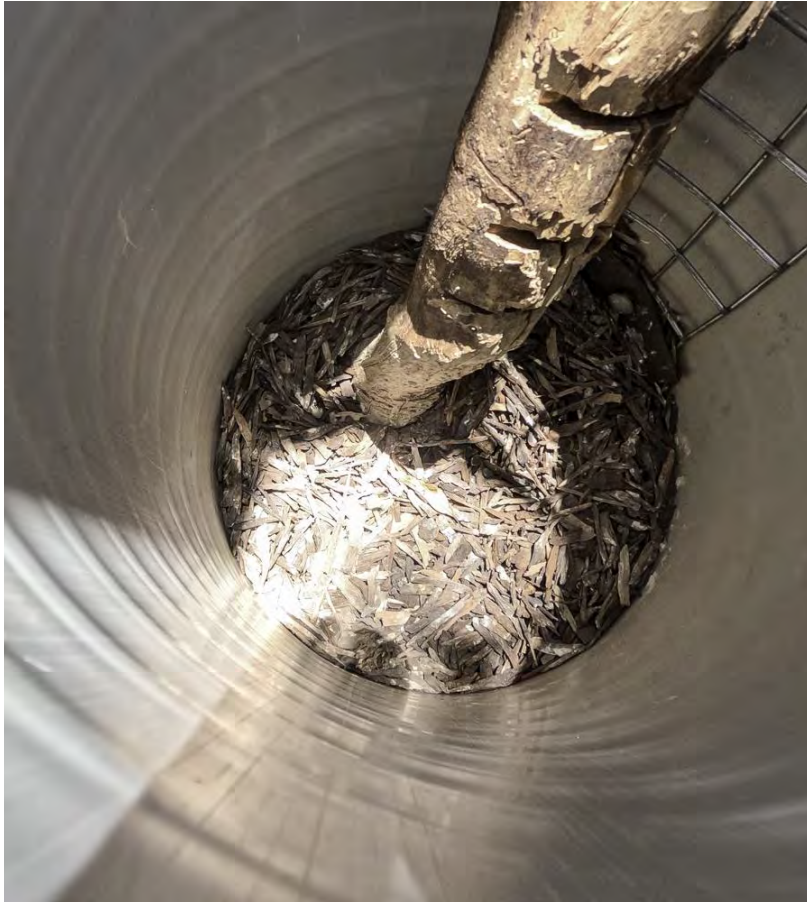
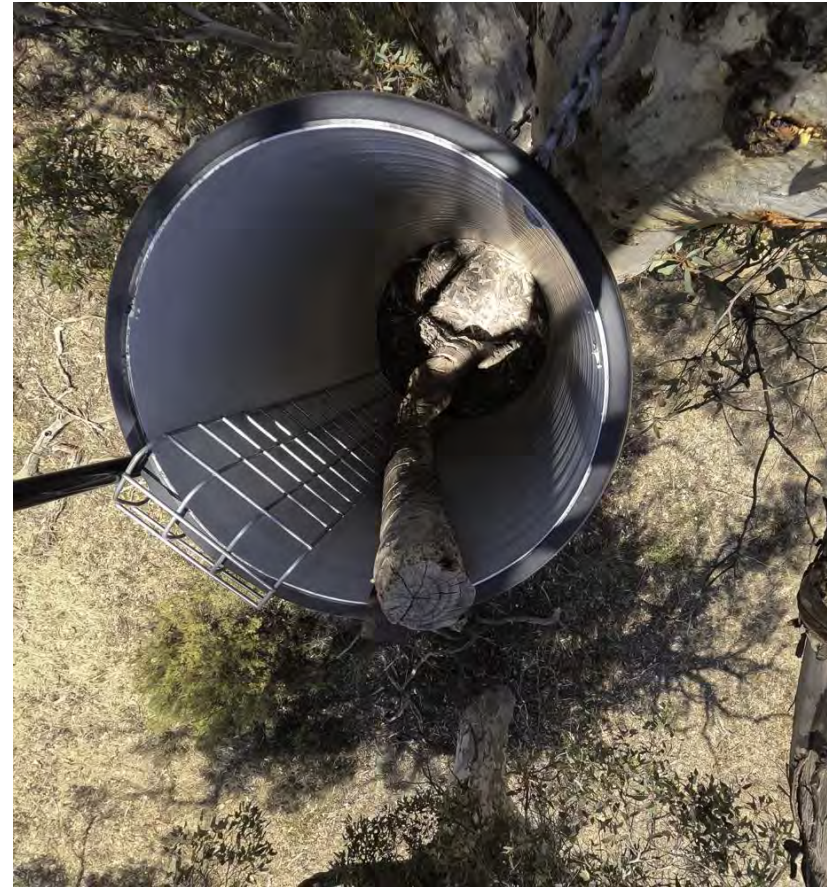
## Artificial Hollow BY20

| Hollow # | Observations Oct 2025 | Observations Dec 2025 | Chipping 0-10 | Wood Chips Lts | Tree condition | Fixings | Recommend repairs |
|---|---|---|---|---|---|---|---|
| BY20 | One Female CC nestling 35 days old.<br>Second nestling dead (48 hours). | Nestling Fledged, heavy poo load on floor | 4 | Nil | Good | Good | Nil |

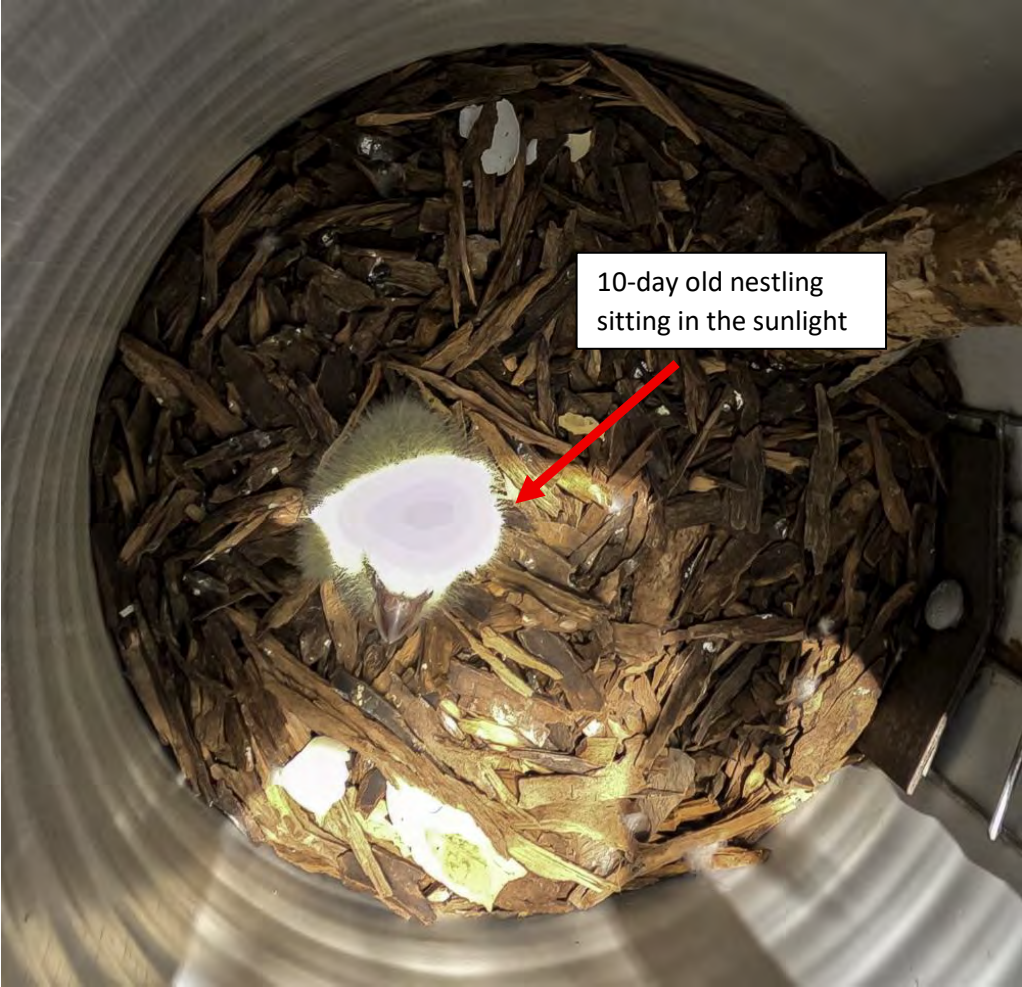
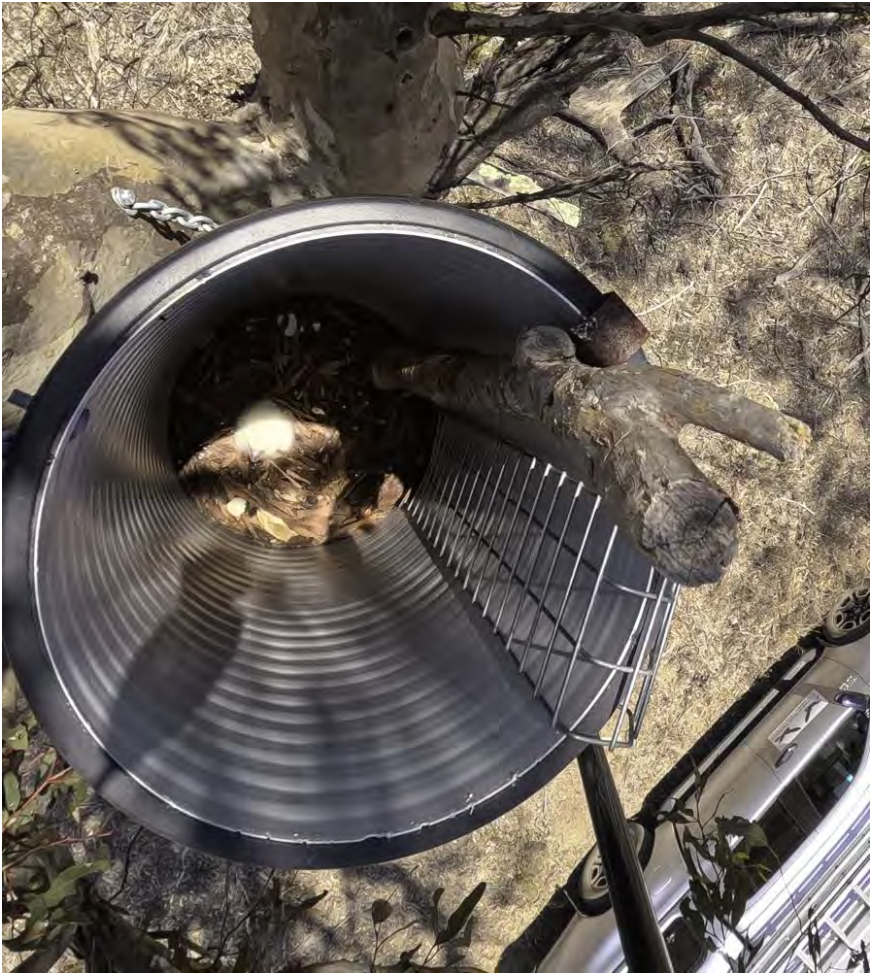
Artificial Hollow BY21

| Hollow # | Observations Oct 2025 | Observations Dec 2025 | Chipping 0-10 | Wood Chips Lts | Tree condition | Fixings | Recommend repairs |
|---|---|---|---|---|---|---|---|
| BY21 | Chewing on post no signs of Breeding | One 8-10-day old CC nestling | 2 | Nil | Good | Good | Nil |

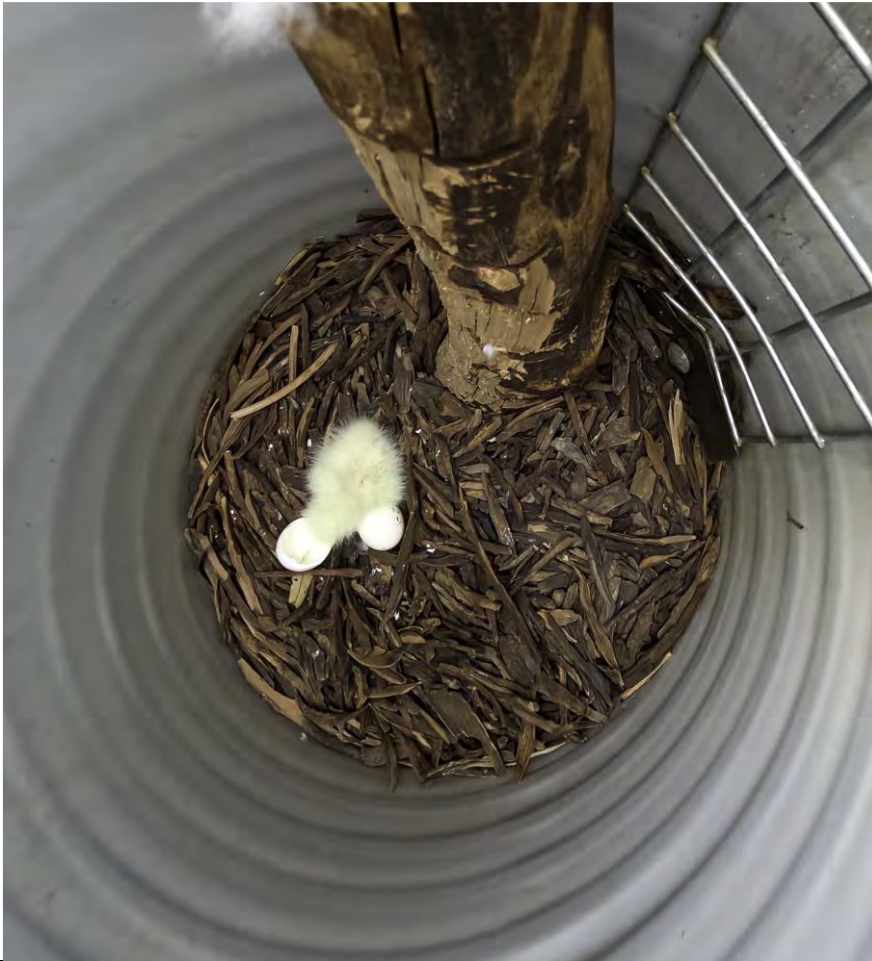
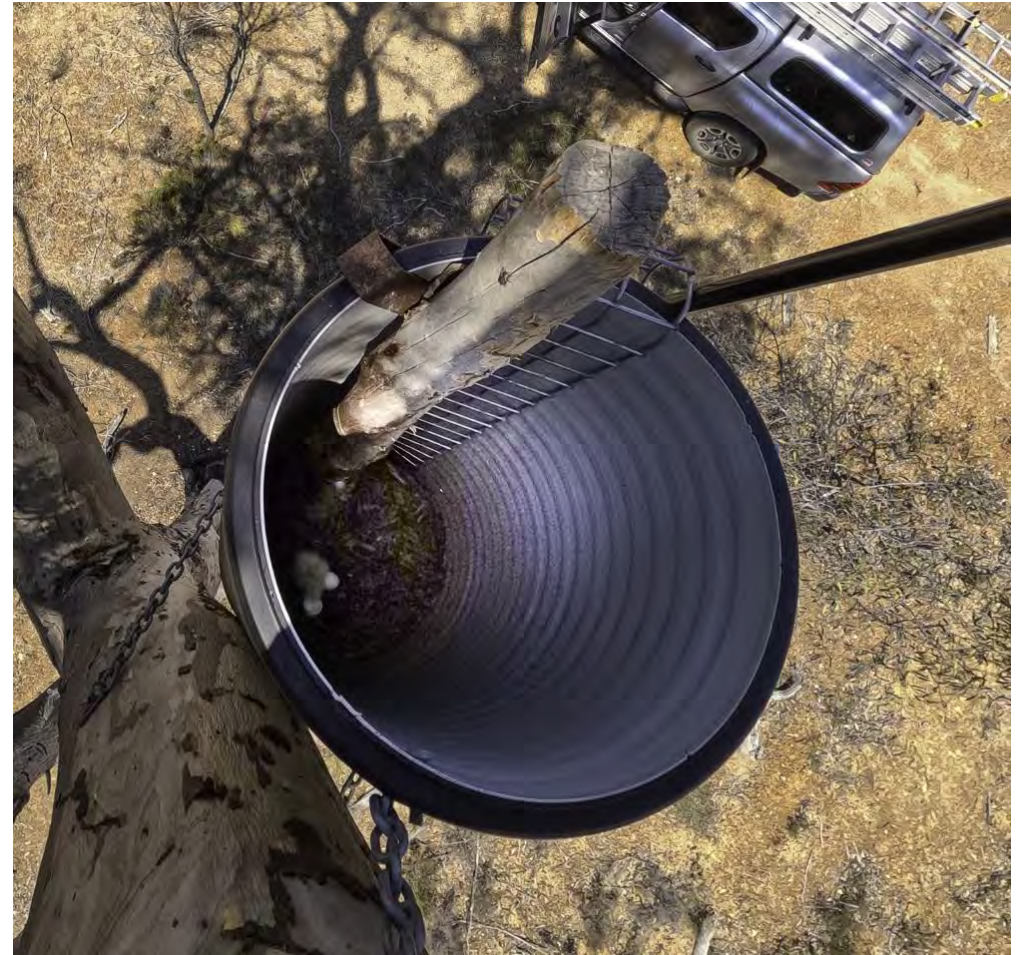
## Artificial Hollow BY22

| Hollow # | Observations Oct 2025 | Observations Dec 2025 | Chipping 0-10 | Wood Chips Lts | Tree condition | Fixings | Recommend repairs |
|---|---|---|---|---|---|---|---|
| BY22 | Heavy Chewing on post no signs of Breeding | Female flushed, One 4-day old CC nestling and egg being incubated | 4 | Nil | Good | Good | Nil |

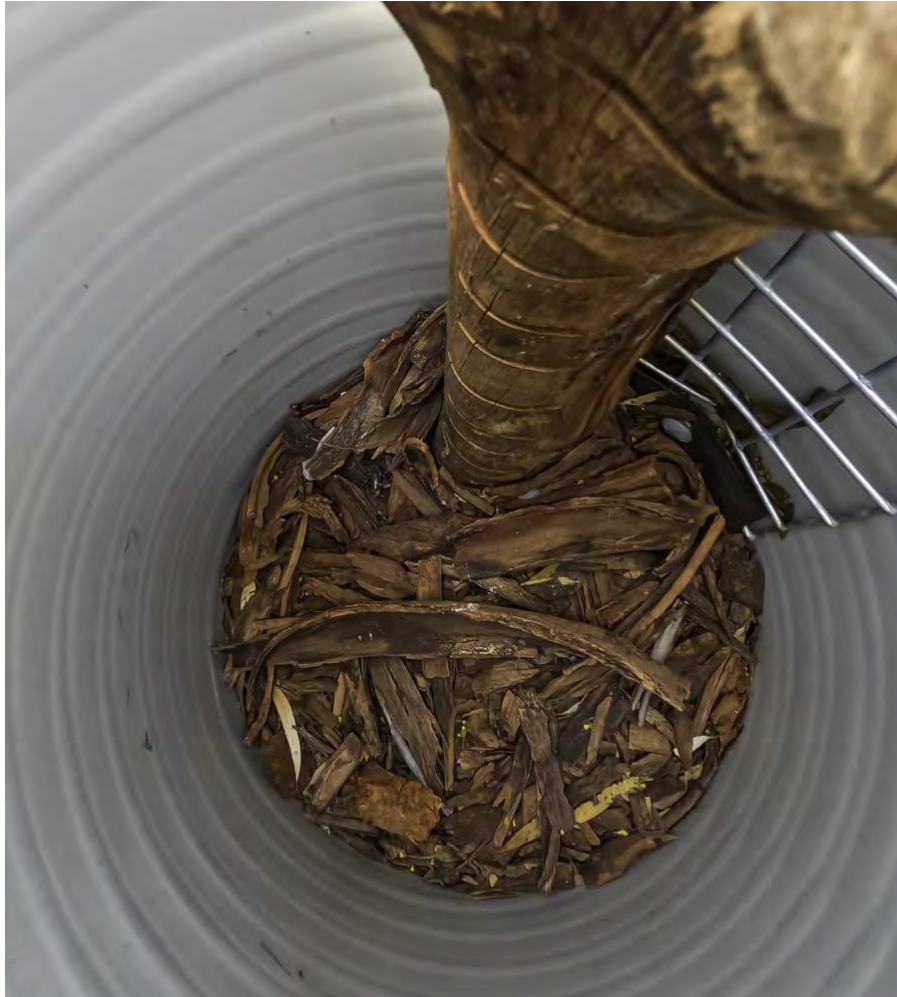
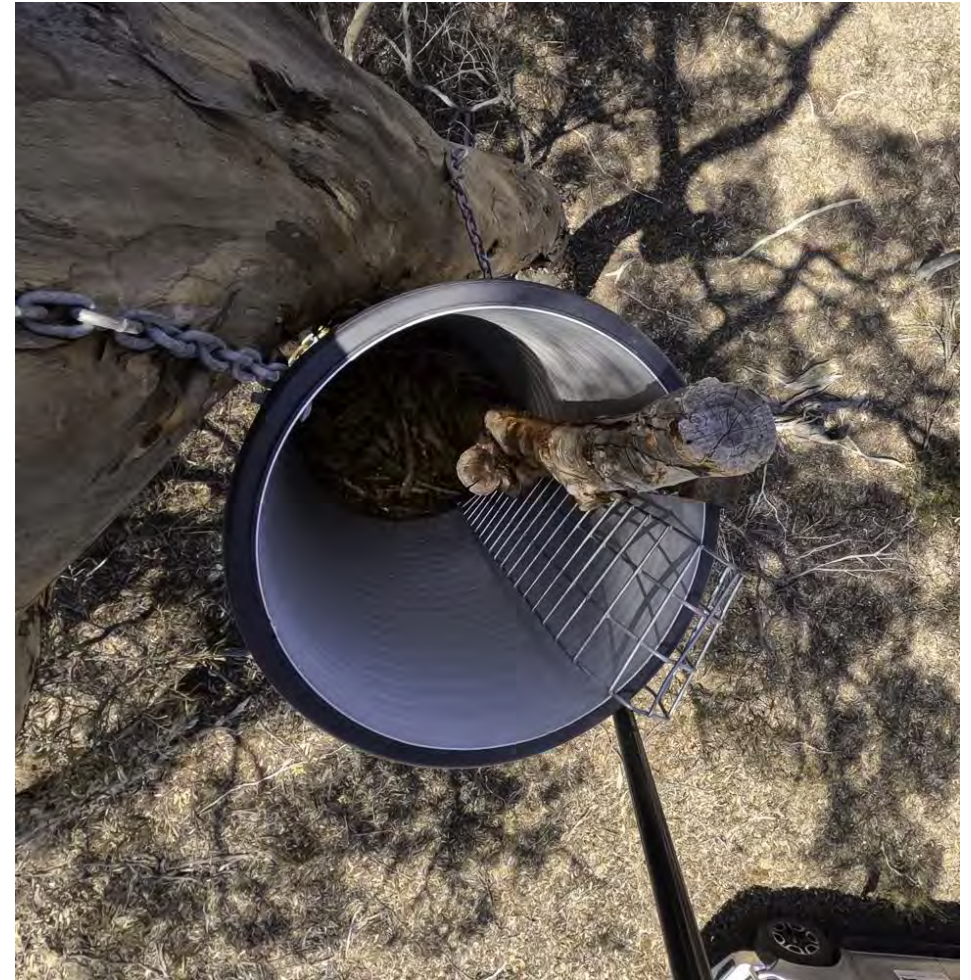
## Artificial Hollow BY23

| Hollow # | Observations Oct 2025 | Observations Dec 2025 | Chipping 0-10 | Wood Chips Lts | Tree condition | Fixings | Recommend repairs |
|---|---|---|---|---|---|---|---|
| BY23 | Chewing on post, no signs of Breeding | Chewing on post, no signs of Breeding | 2 | Nil | Good | Good | Nil |

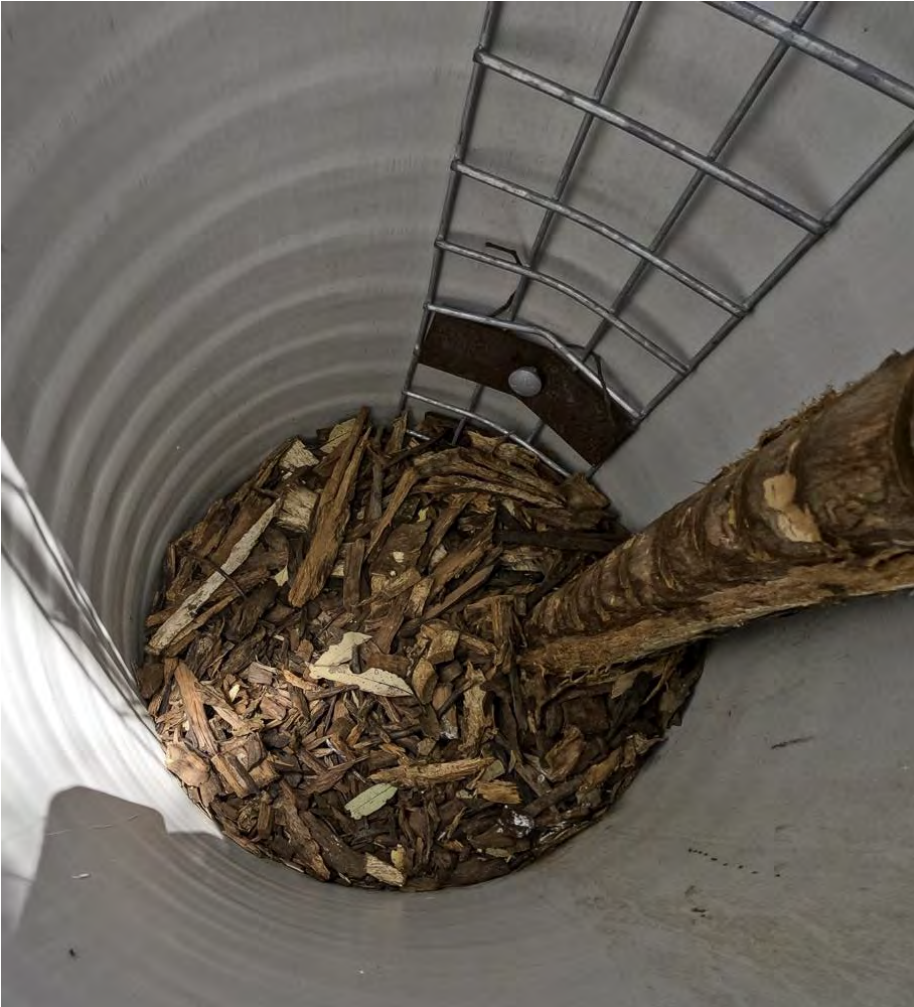
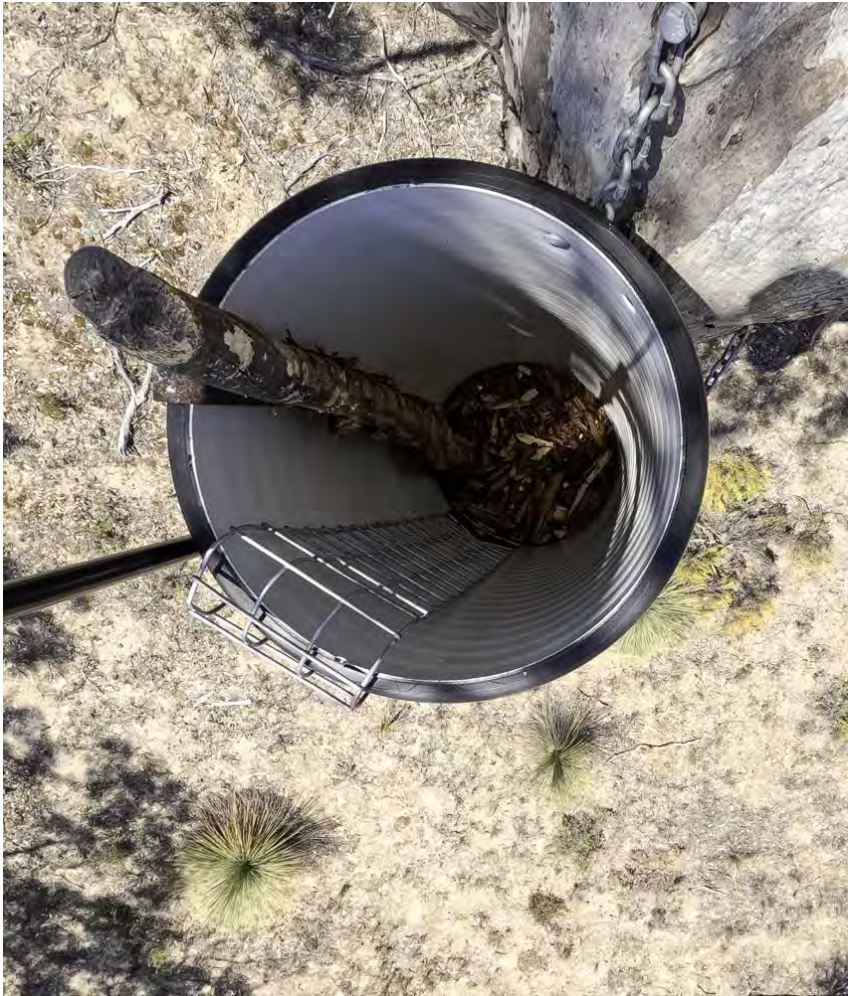
Artificial Hollow BY24

| Hollow # | Observations Oct 2025 | Observations Dec 2025 | Chipping 0-10 | Wood Chips Lts | Tree condition | Fixings | Recommend repairs |
|---|---|---|---|---|---|---|---|
| BY24 | Chewing on post no signs of Breeding | Chewing on post no signs of Breeding | 2 | Nil | Good | Good | Nil |
