# Ministerial Statement Compliance Assessment Report

**Bunbury Outer Ring Road - South  
Ministerial Statement 1191**

**2025 - 2026 Reporting Period**

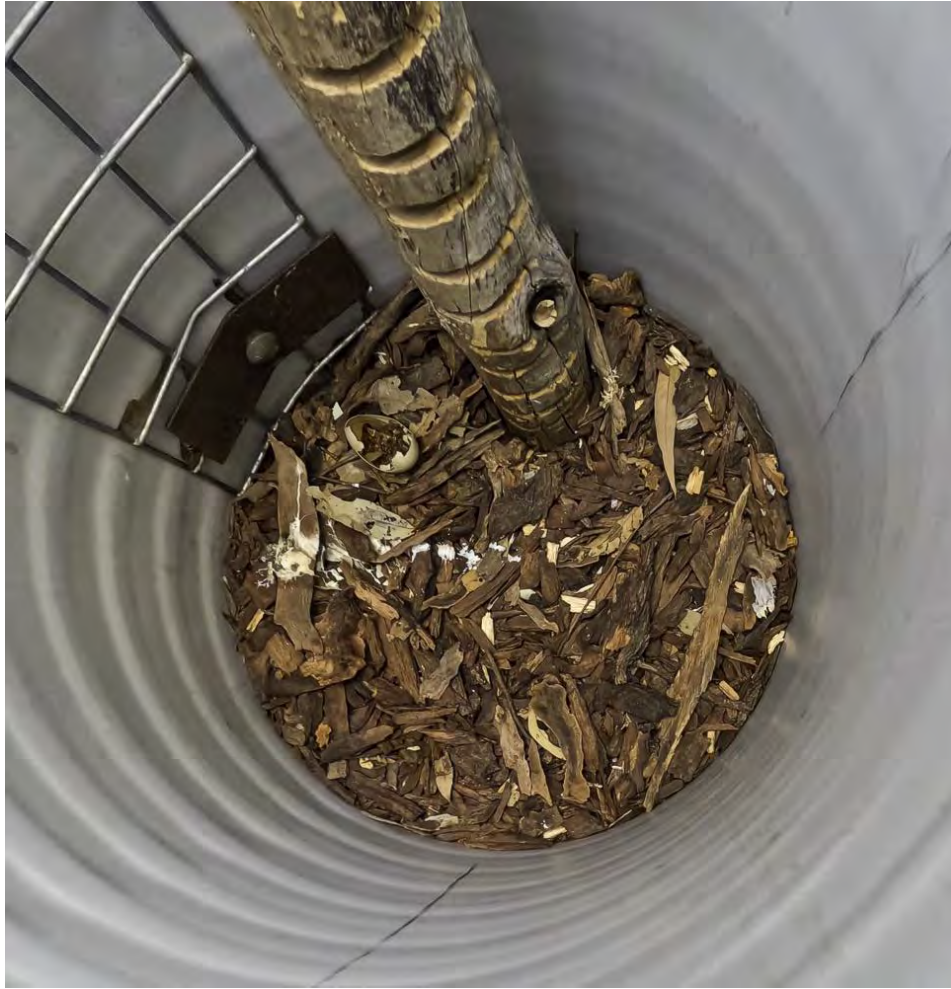
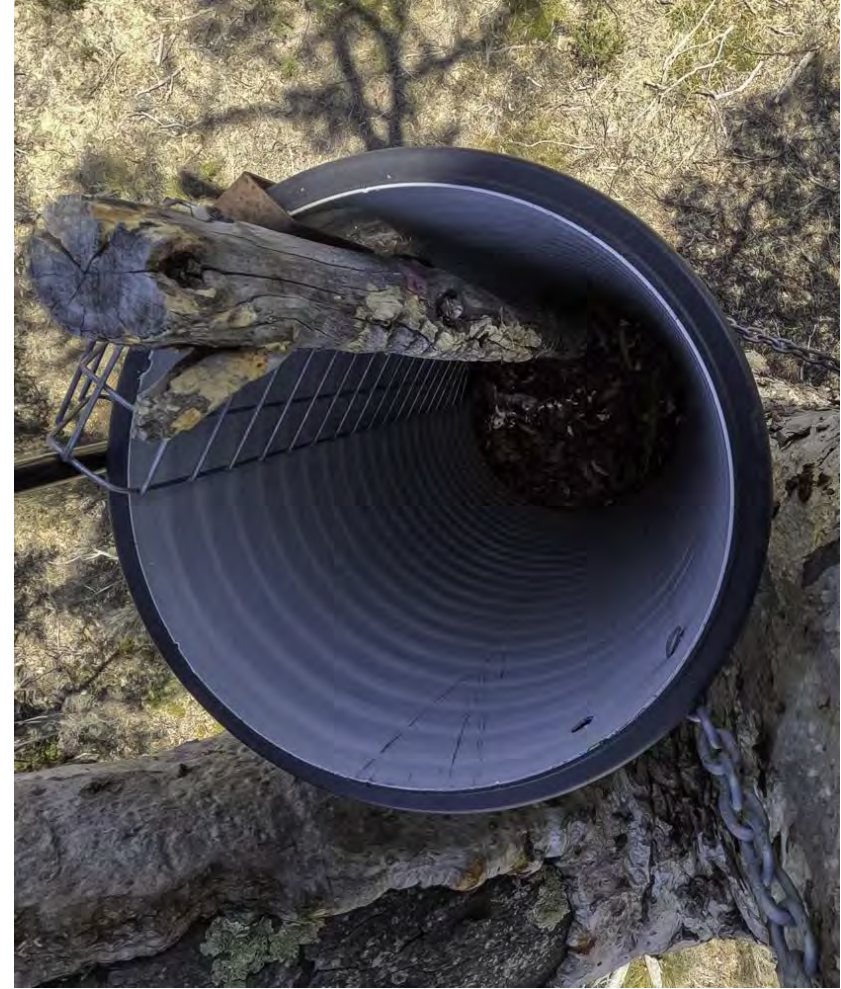
## Artificial Hollow BY25

| Hollow # | Observations Oct 2025 | Observations Dec 2025 | Chipping 0-10 | Wood Chips Lts | Tree condition | Fixings | Recommend repairs |
|---|---|---|---|---|---|---|---|
| BY25 | One predated CC Egg, heaving chewing on post | Chewing on post, no signs of second Breeding attempt | 3 | Nil | Good | Good | Nil |

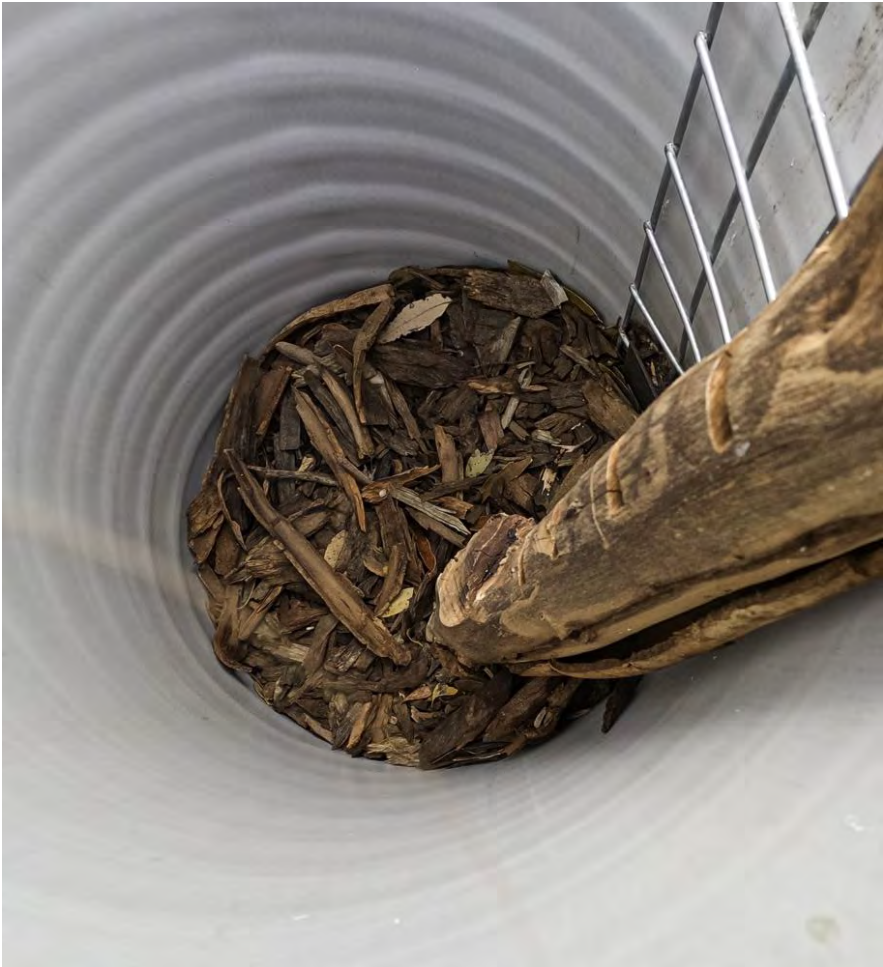
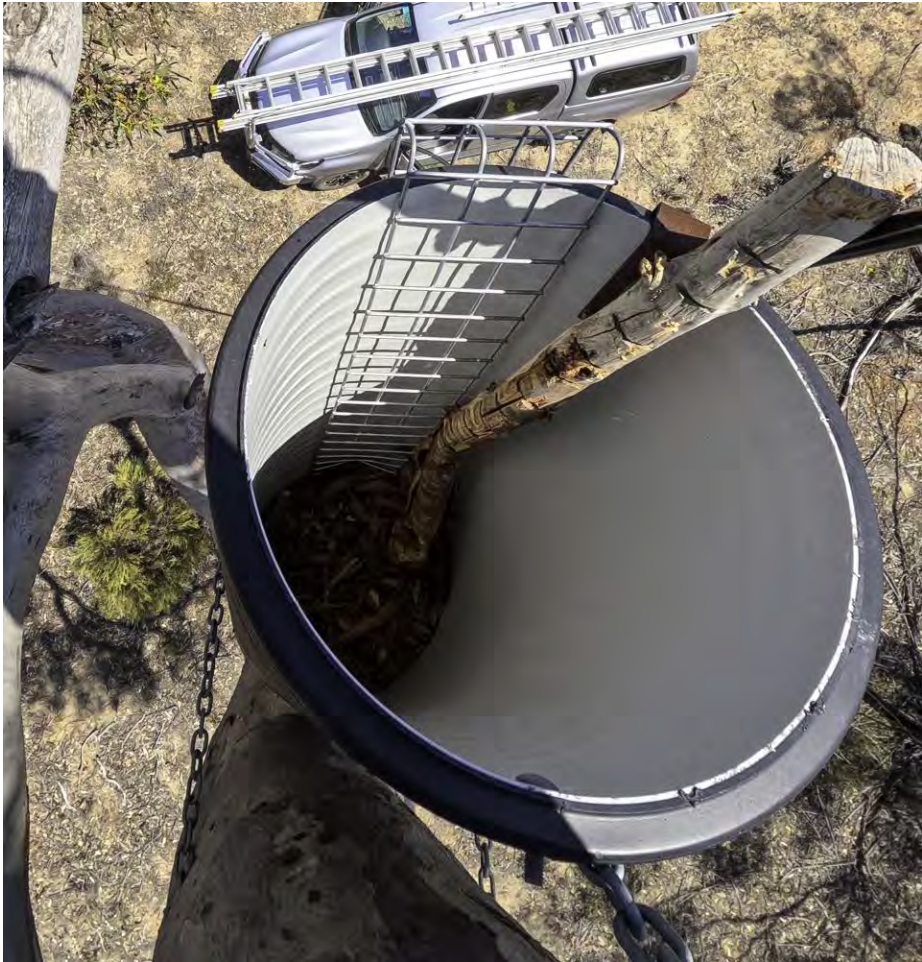
Artificial Hollow BY26

| Hollow # | Observations Oct 2025 | Observations Dec 2025 | Chipping 0-10 | Wood Chips Lts | Tree condition | Fixings | Recommend repairs |
|---|---|---|---|---|---|---|---|
| BY26 | Chewing on post no signs of Breeding | Chewing on post, no signs of Breeding | 3 | Nil | Good | Good | Nil |

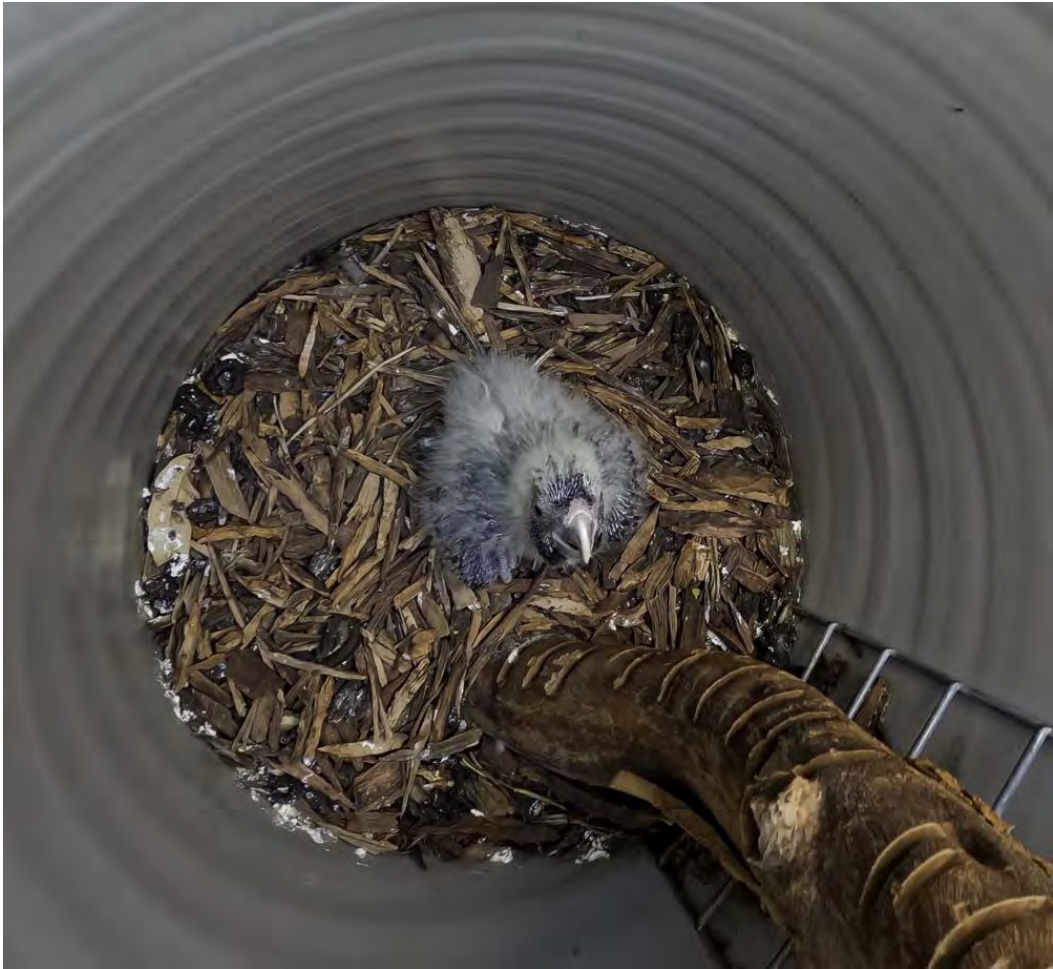
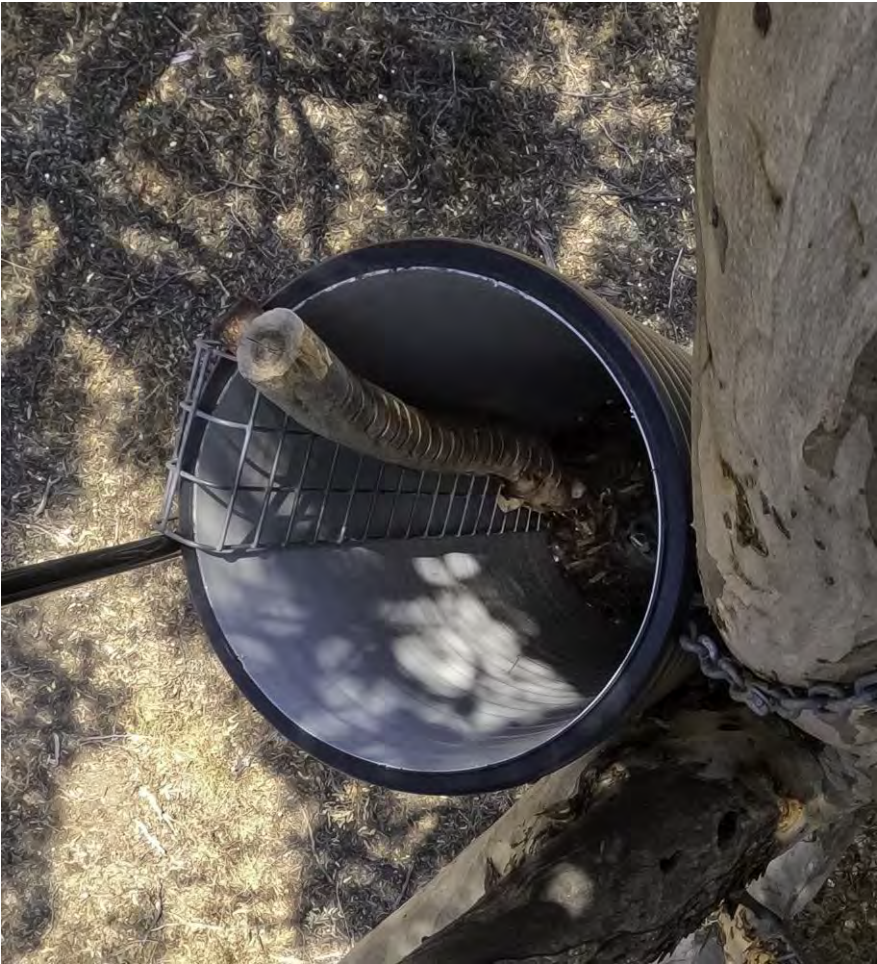
Artificial Hollow BY27

| Hollow # | Observations Oct 2025 | Observations Dec 2025 | Chipping 0-10 | Wood Chips Lts | Tree condition | Fixings | Recommend repairs |
|---|---|---|---|---|---|---|---|
| BY27 | Female CC flushed, 1 x CC eggs, chewing on post | One 25-day old female CC nestling | 3 | Nil | Good | Good | Nil |

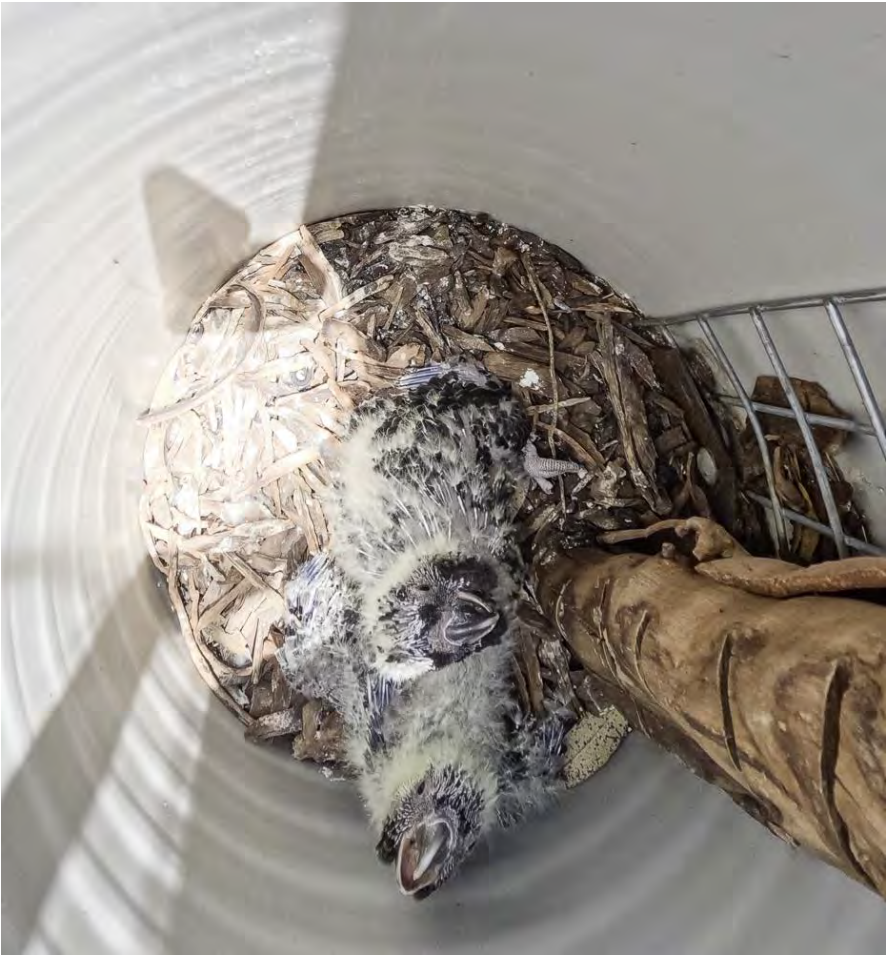
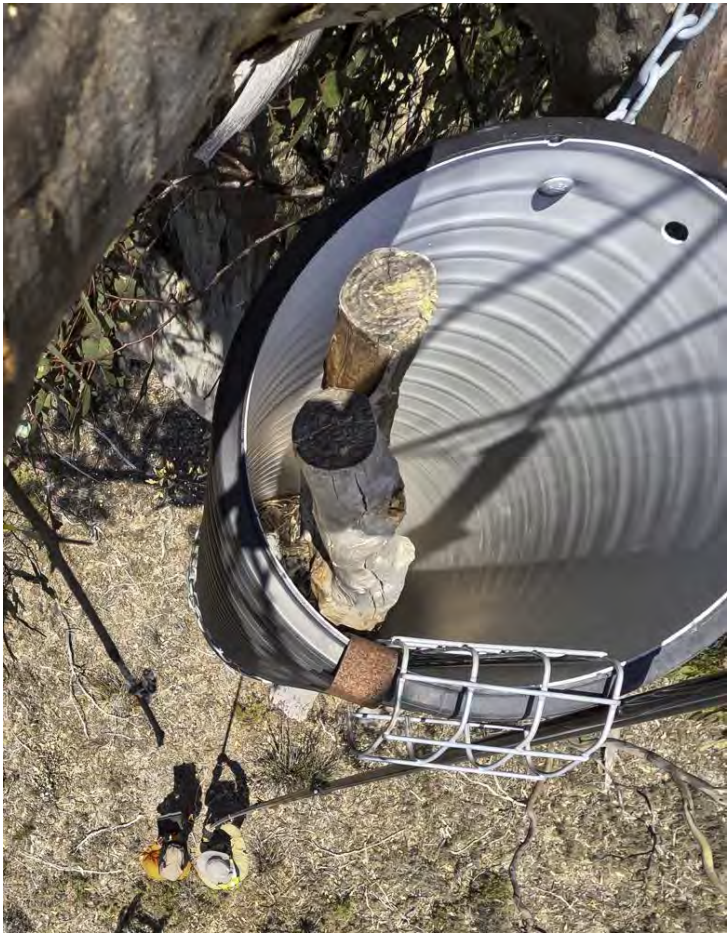
Artificial Hollow BY28

| Hollow # | Observations Oct 2025 | Observations Dec 2025 | Chipping 0-10 | Wood Chips Lts | Tree condition | Fixings | Recommend repairs |
|---|---|---|---|---|---|---|---|
| BY28 | Female CC flushed, 2 x CC eggs, chewing on post | One 31-day old male and one 29- day old female CC nestling | 3 | Nil | Good | Good | Nil |

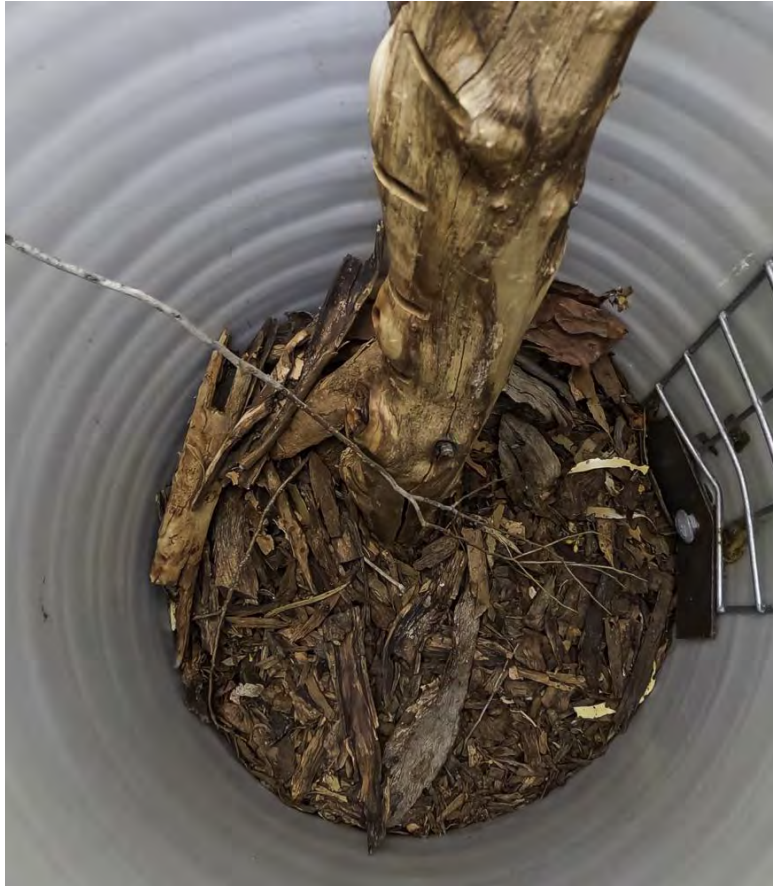
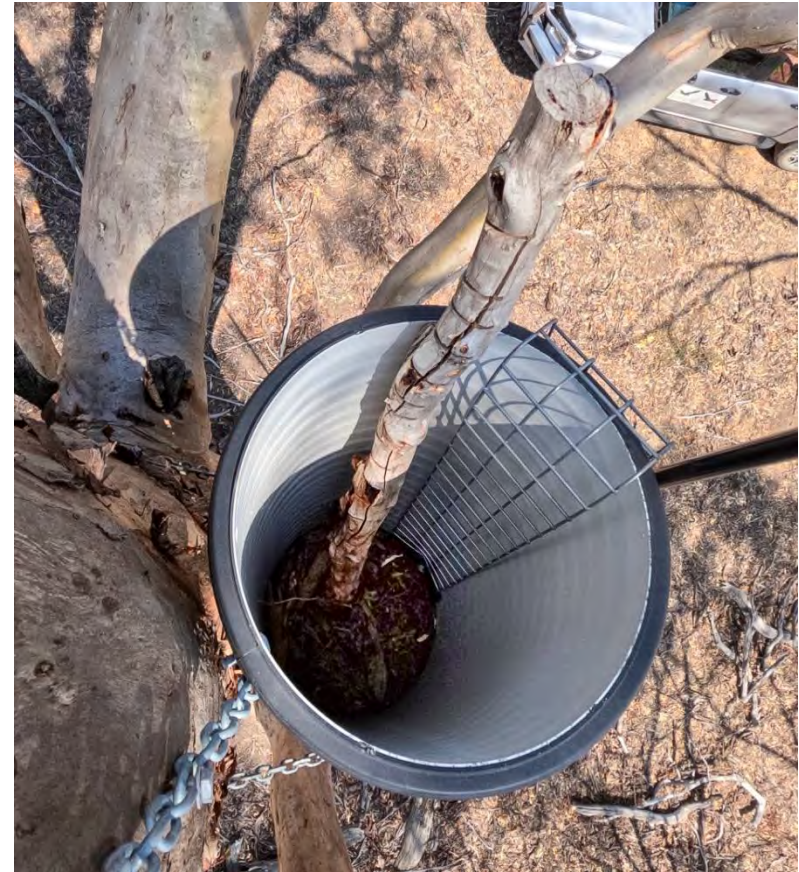
## Artificial Hollow BY29

| Hollow # | Observations Oct 2025 | Observations Dec 2025 | Chipping 0-10 | Wood Chips Lts | Tree condition | Fixings | Recommend repairs |
|---|---|---|---|---|---|---|---|
| BY29 | Minor chewing on post, no signs of Breeding | Chewing on post, no signs of Breeding | 1 | Nil | Good | Good | Nil |

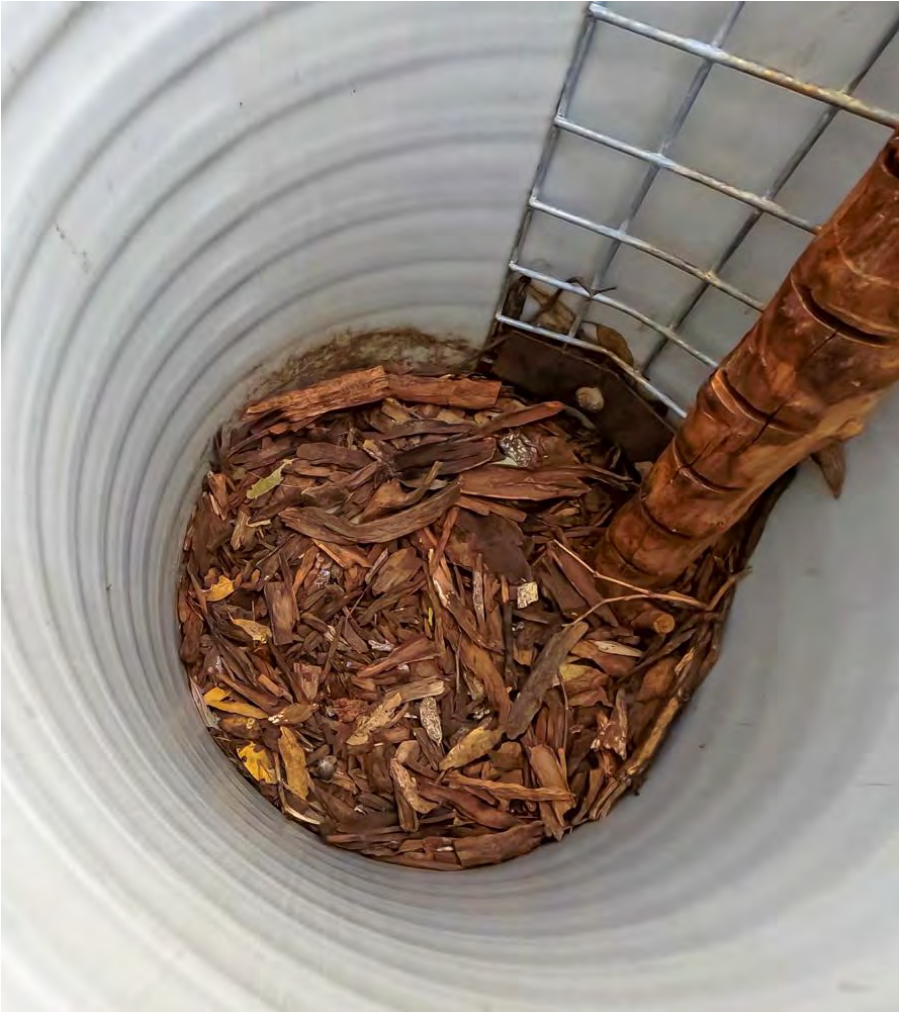
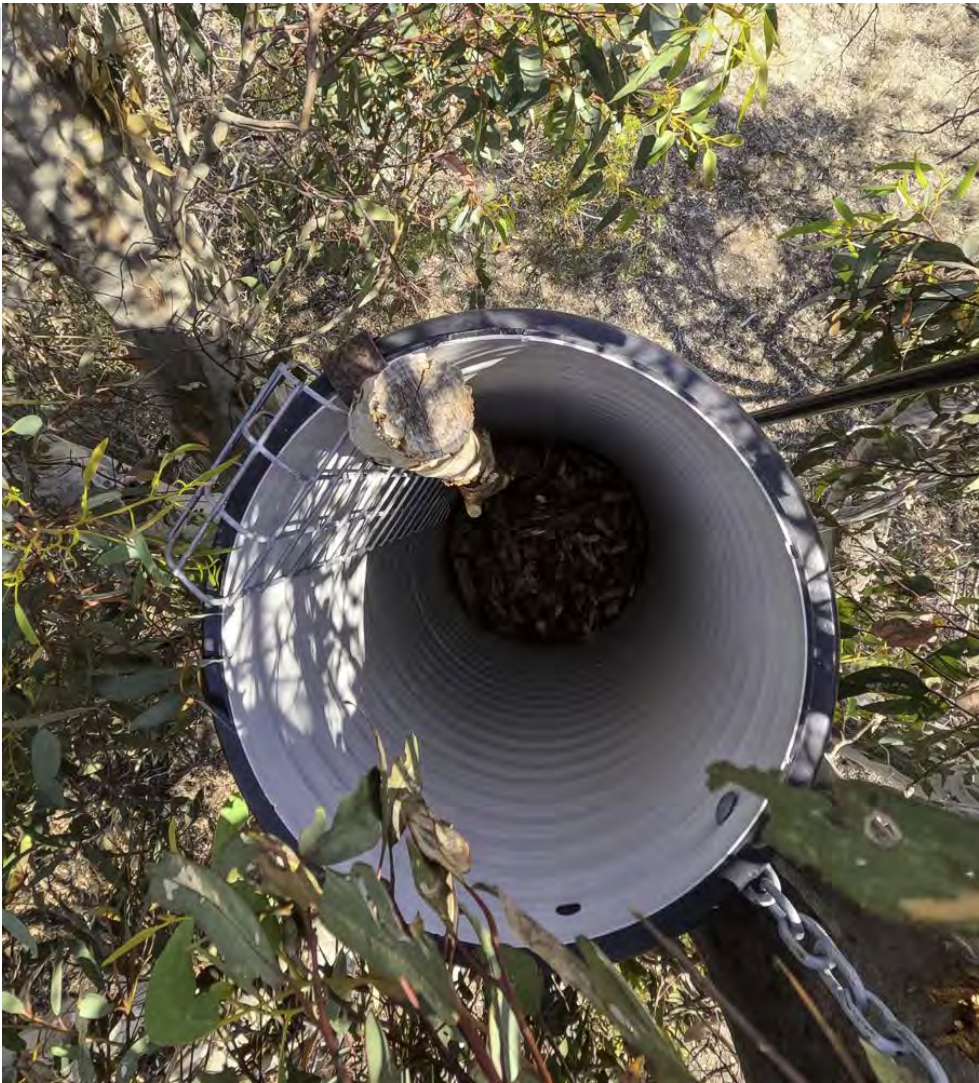
Artificial Hol

| Hollow # | Observations Oct 2025 | Observations Dec 2025 | Chipping 0-10 | Wood Chips Lts | Tree condition | Fixings | Recommend repairs |
|---|---|---|---|---|---|---|---|
| BY30 | Chewing on post no signs of Breeding | Chewing on post, no signs of Breeding | 2 | Nil | Good | Good | Nil |

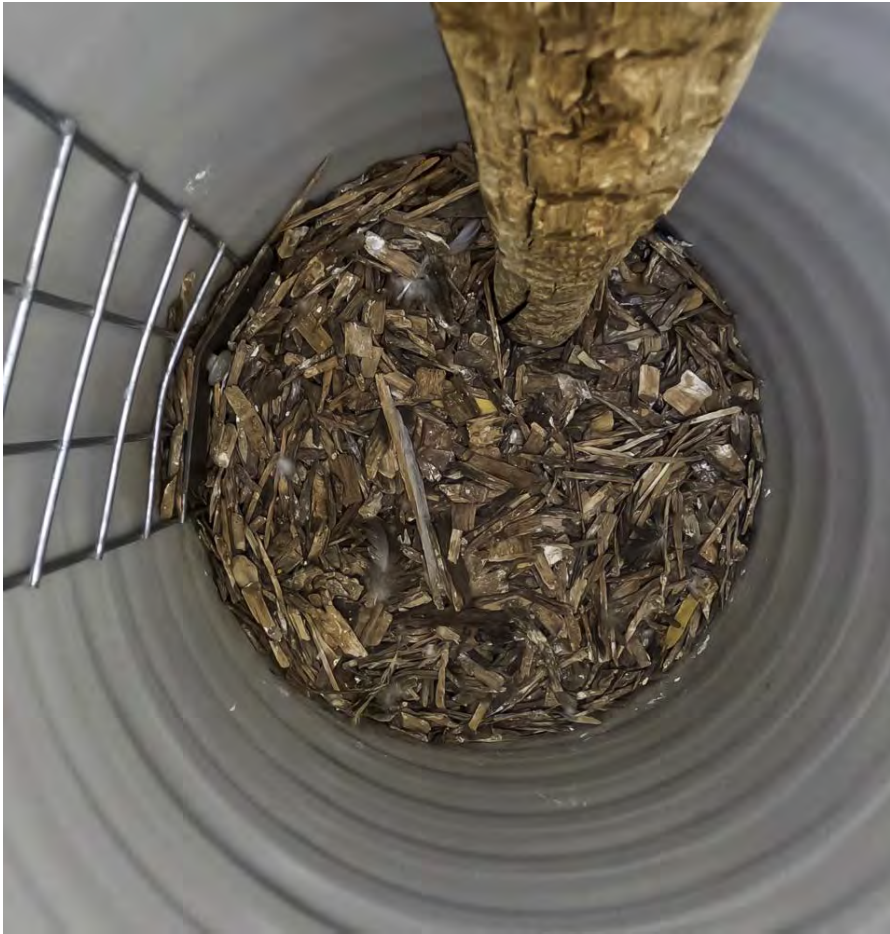
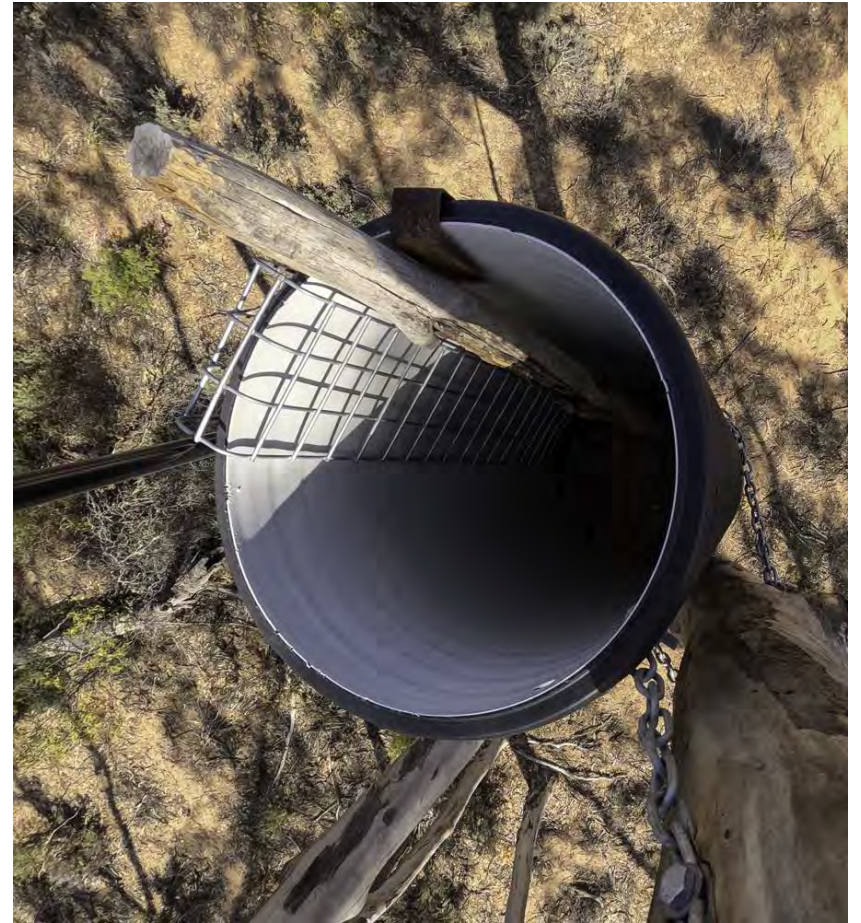
## Artificial Hollow BY31

| Hollow # | Observations Oct 2025 | Observations Dec 2025 | Chipping 0-10 | Wood Chips Lts | Tree condition | Fixings | Recommend repairs |
|---|---|---|---|---|---|---|---|
| BY31 | Female Carnabys, 59 days old CC,<br>Chewing on post | Fledged | 5 | Nil | Good | Good | Nil |

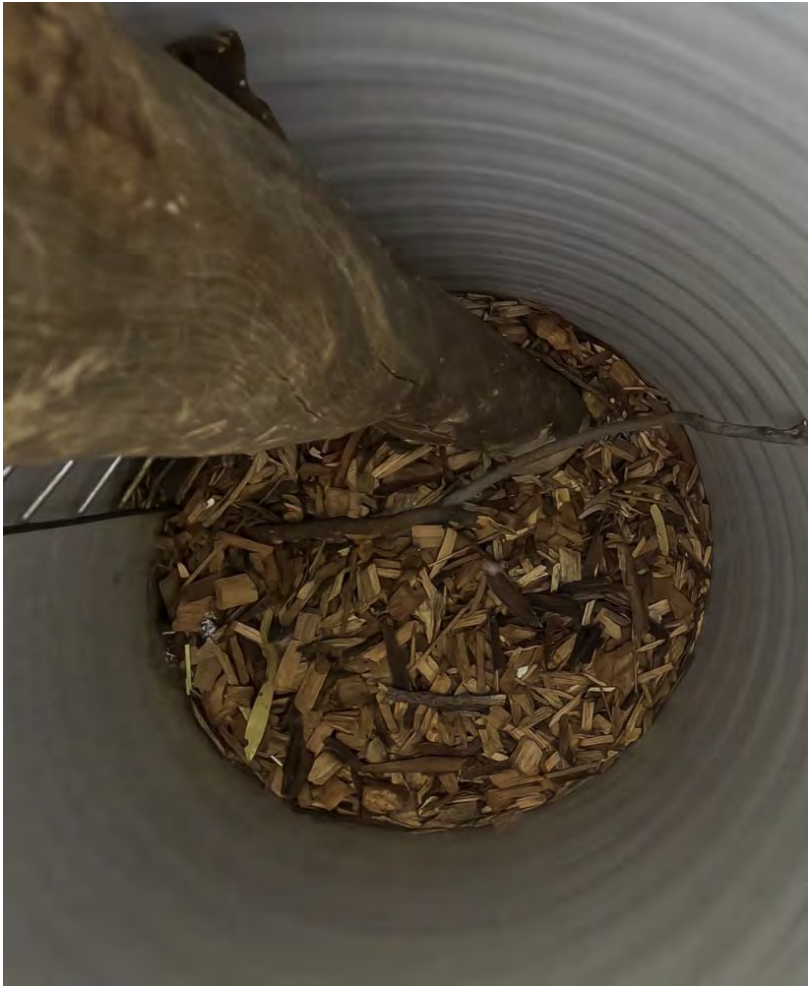
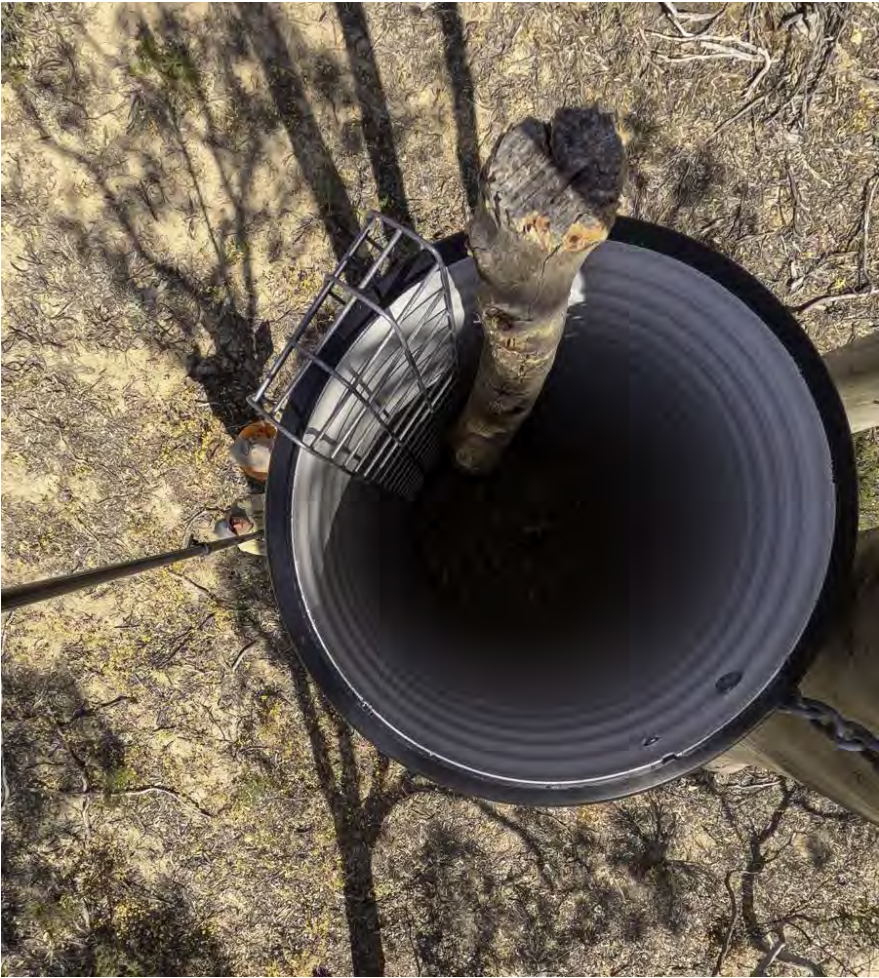
Artificial Hollow BY32

| Hollow # | Observations Oct 2025 | Observations Dec 2025 | Chipping 0-10 | Wood Chips Lts | Tree condition | Fixings | Recommend repairs |
|---|---|---|---|---|---|---|---|
| BY32 | Smashed CC egg in base of hollow | No sign of relay | 3 | Nil | Good | Good | Nil |

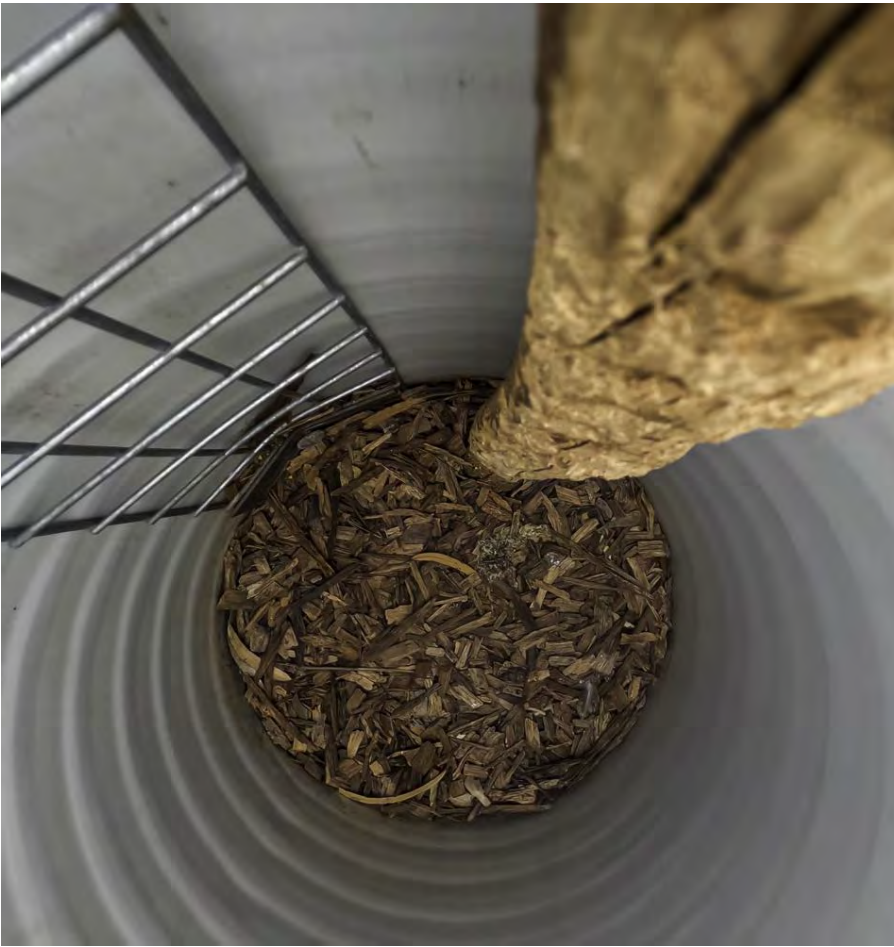
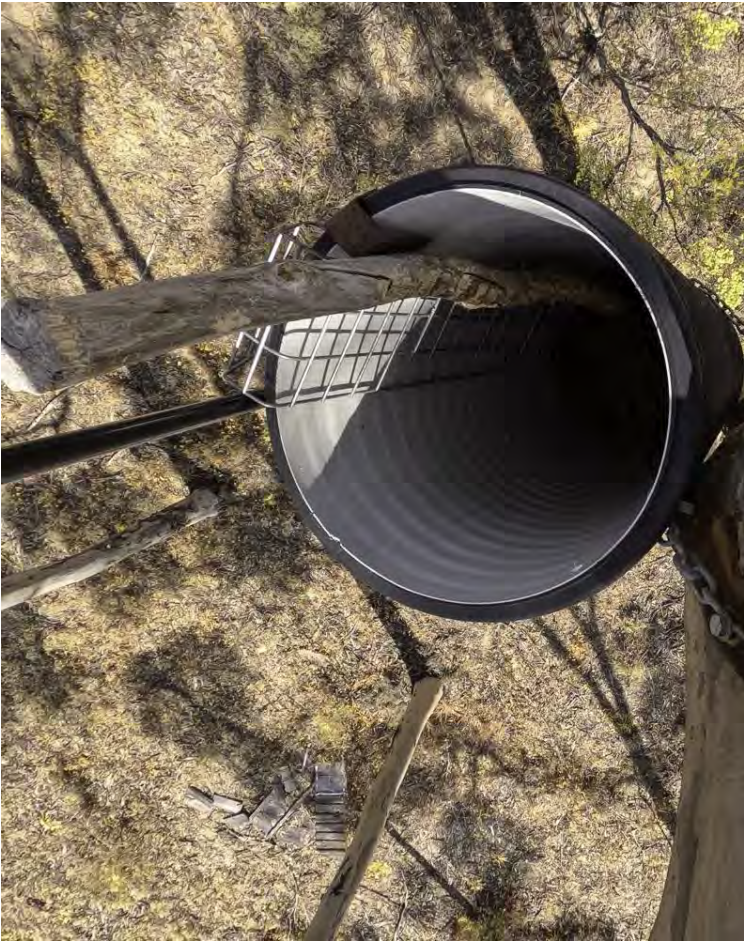
Artificial Hollow BY33

| Hollow # | Observations Oct 2025 | Observations Dec 2025 | Chipping 0-10 | Wood Chips Lts | Tree condition | Fixings | Recommend repairs |
|---|---|---|---|---|---|---|---|
| BY33 | Female CC flushed, 2 x CC eggs, chewing on post | Failure | 5 | Nil | Good | Good | Nil |

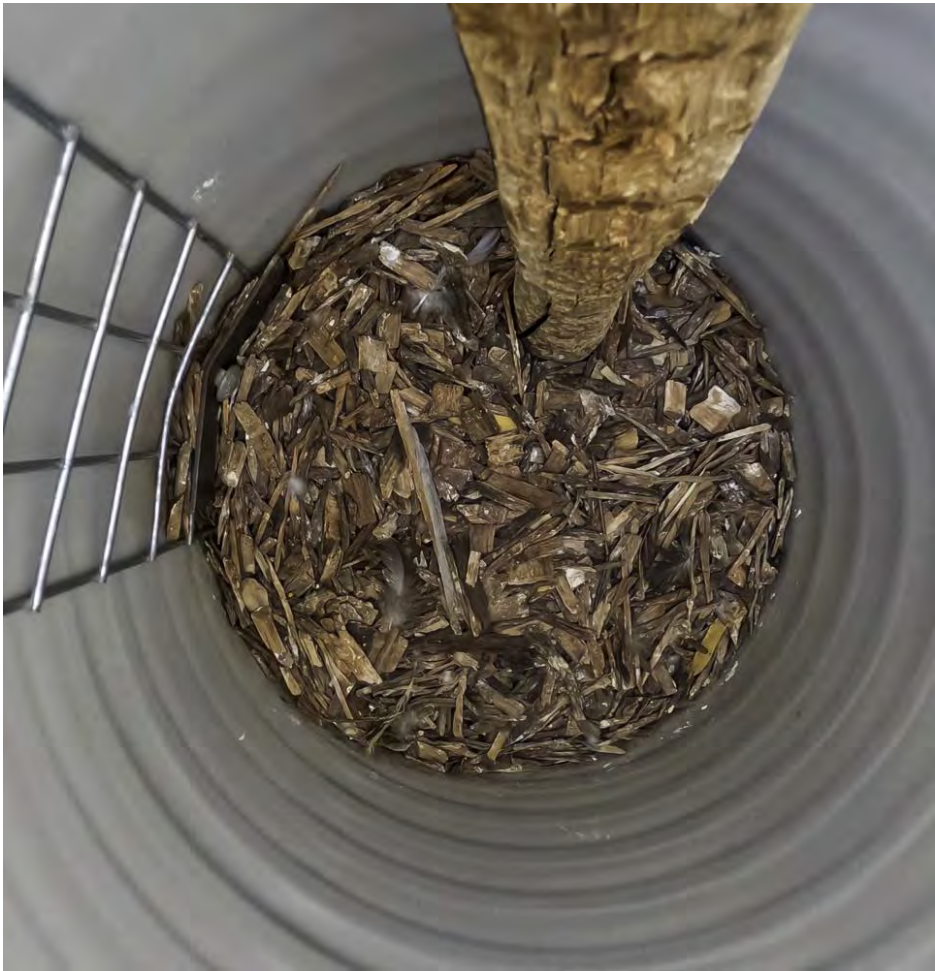
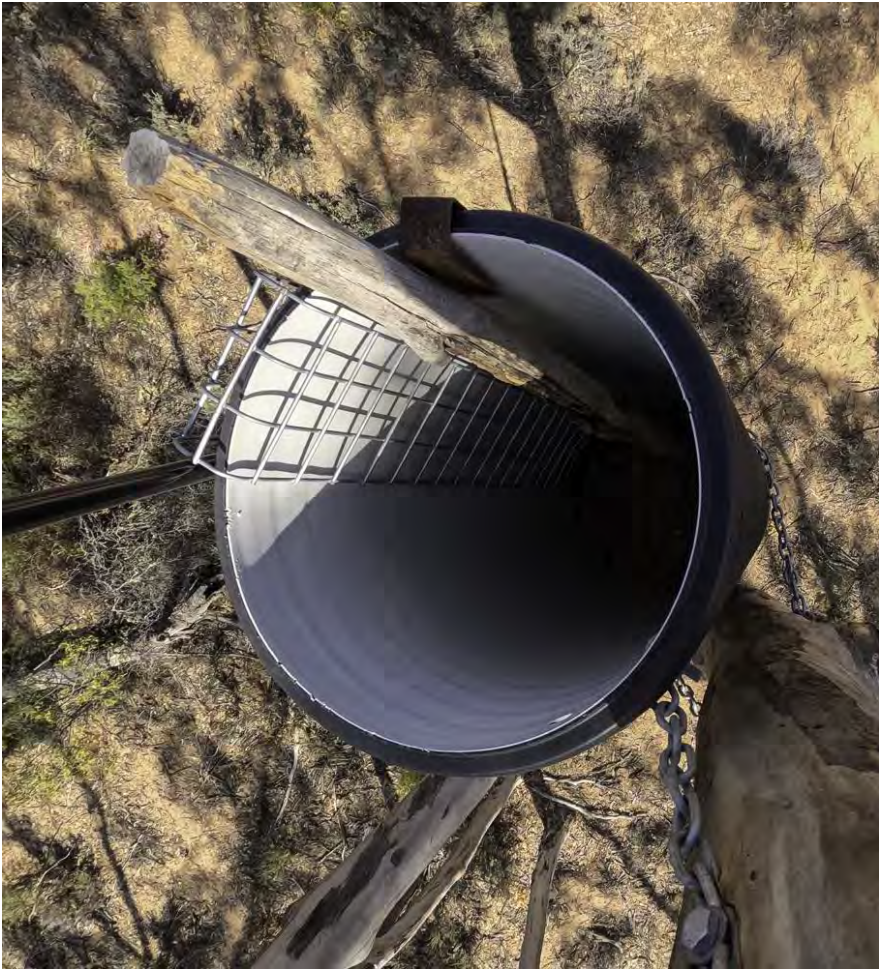
Artificial Hollow BY34

| Hollow # | Observations Oct 2025 | Observations Dec 2025 | Chipping 0-10 | Wood Chips Lts | Tree condition | Fixings | Recommend repairs |
|---|---|---|---|---|---|---|---|
| BY34 | Male Carnabys,39 days old CC, Chewing on post | Fledged | 3 | Nil | Good | Good | Nil |

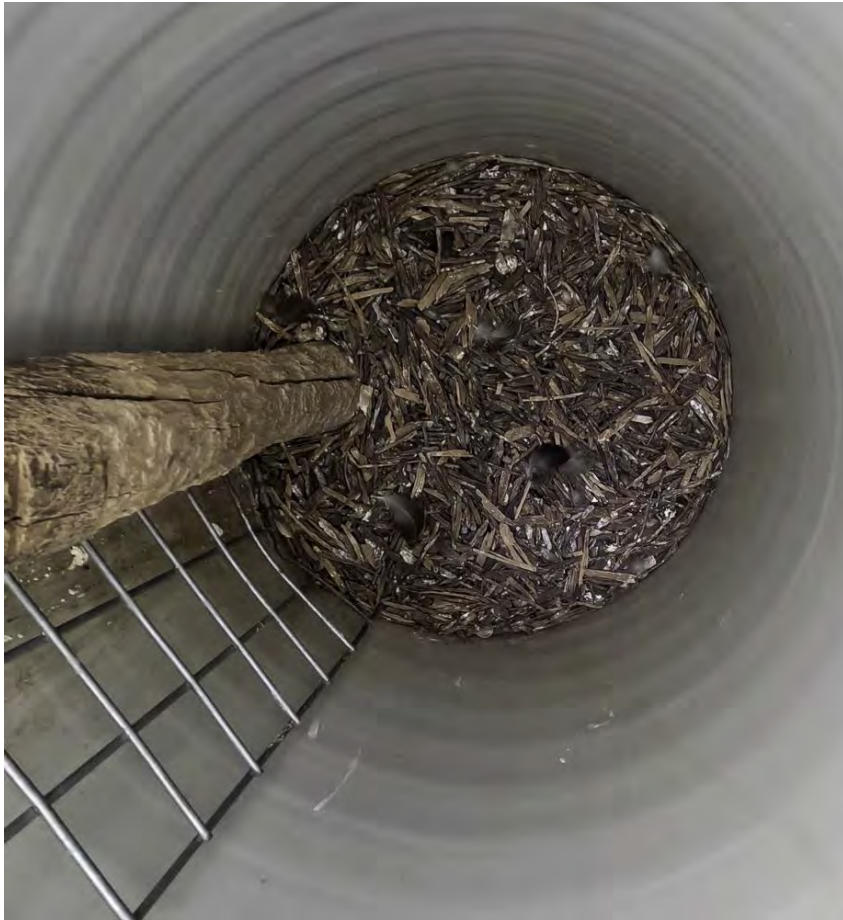
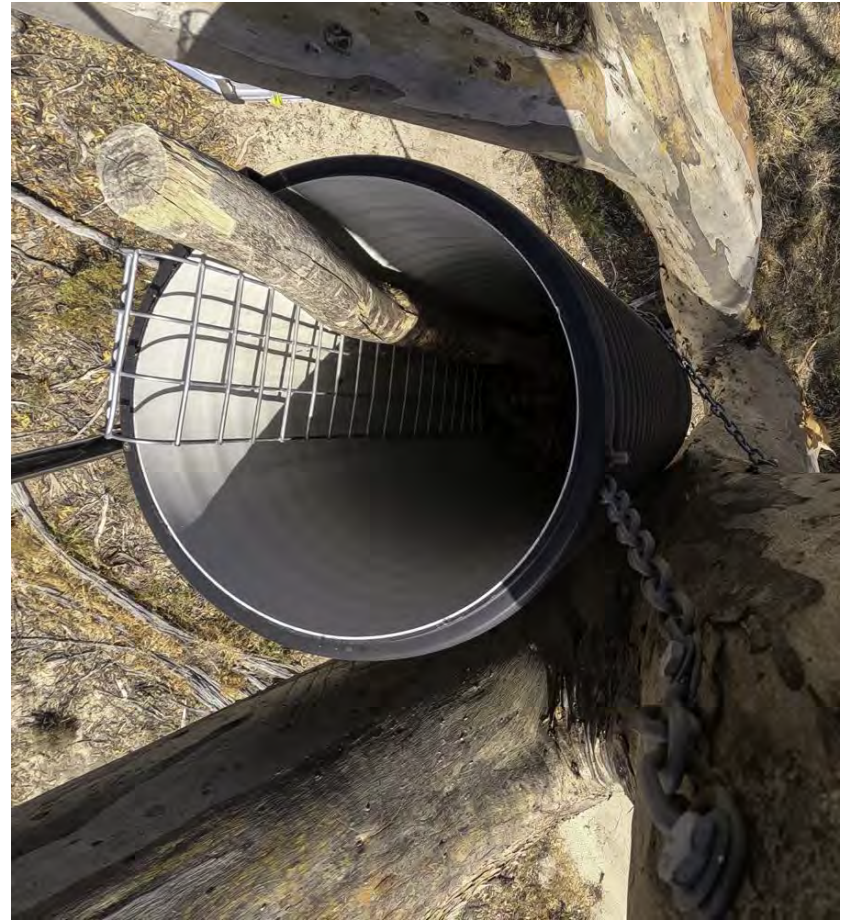
## Artificial Hollow BY35

| Hollow # | Observations Oct 2025 | Observations Dec 2025 | Chipping 0-10 | Wood Chips Lts | Tree condition | Fixings | Recommend repairs |
|---|---|---|---|---|---|---|---|
| BY35 | Male Carnabys, 35 days old CC, Chewing on post | Fledged | 3 | Nil | Good | Good | Nil |

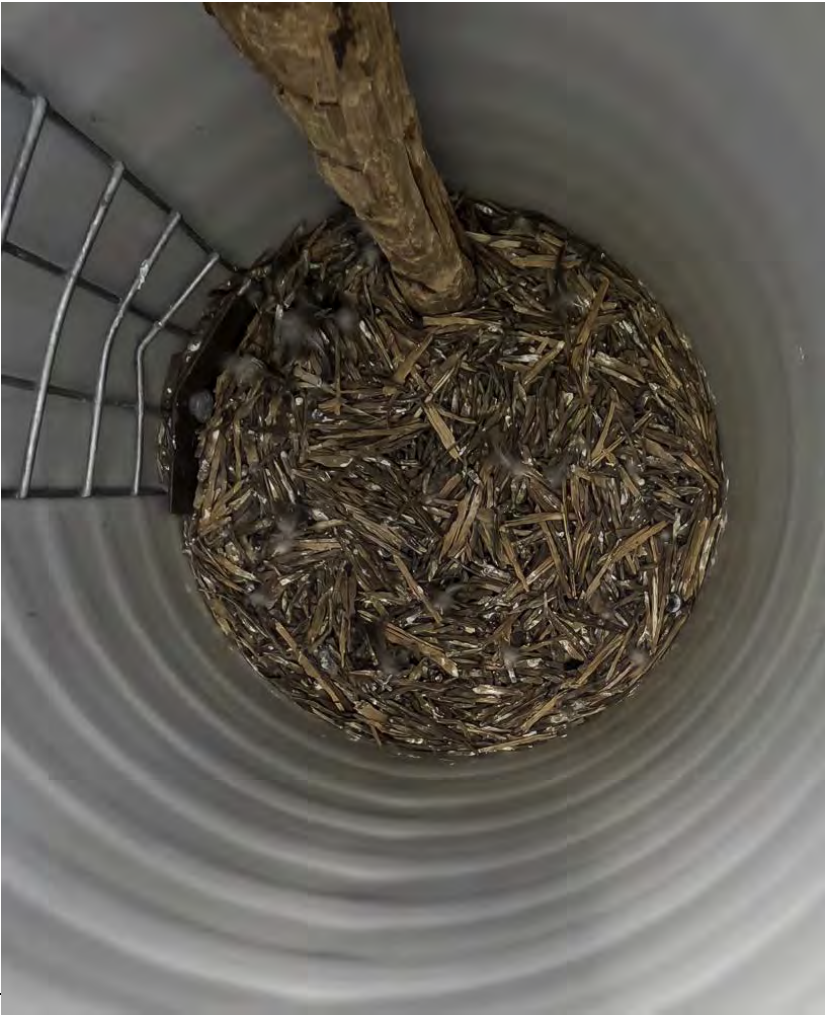
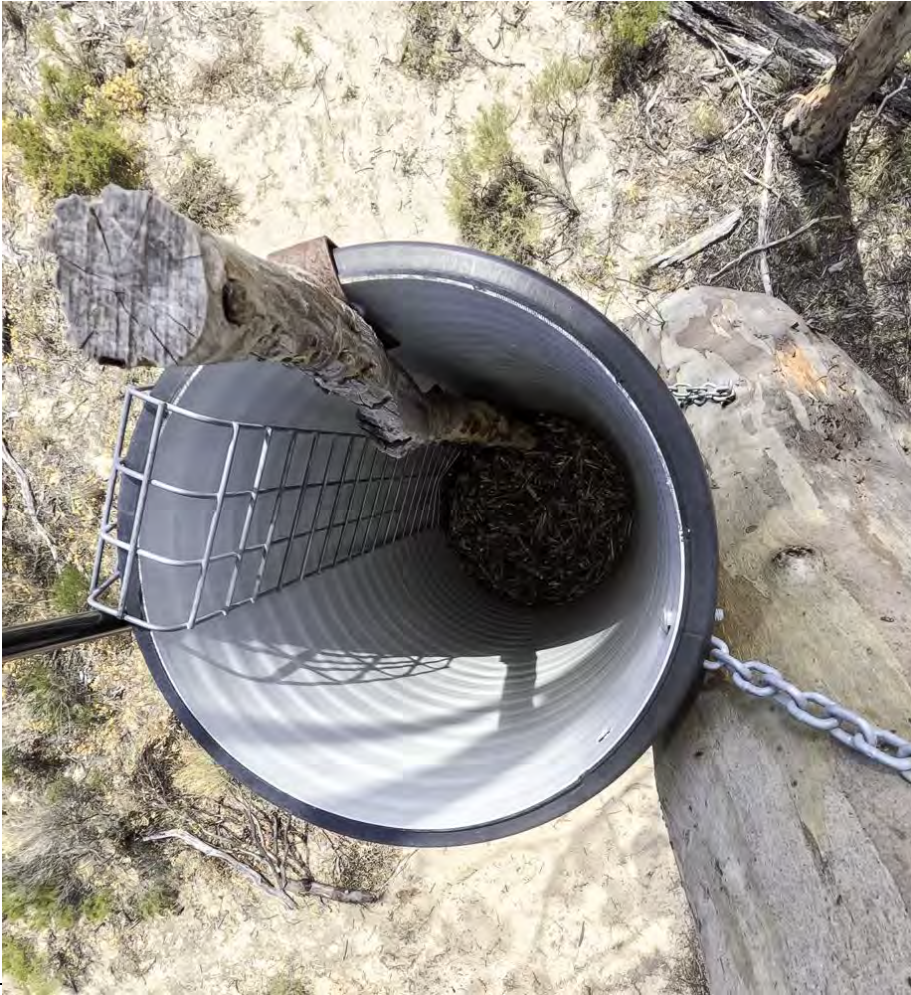
Artificial Hollow BY36

| Hollow # | Observations Oct 2025 | Observations Dec 2025 | Chipping 0-10 | Wood Chips Lts | Tree condition | Fixings | Recommend repairs |
|---|---|---|---|---|---|---|---|
| BY36 | Male Carnabys,36 days old CC, Chewing on post | Fledged | 2 | Nil | Good | Good | Nil |

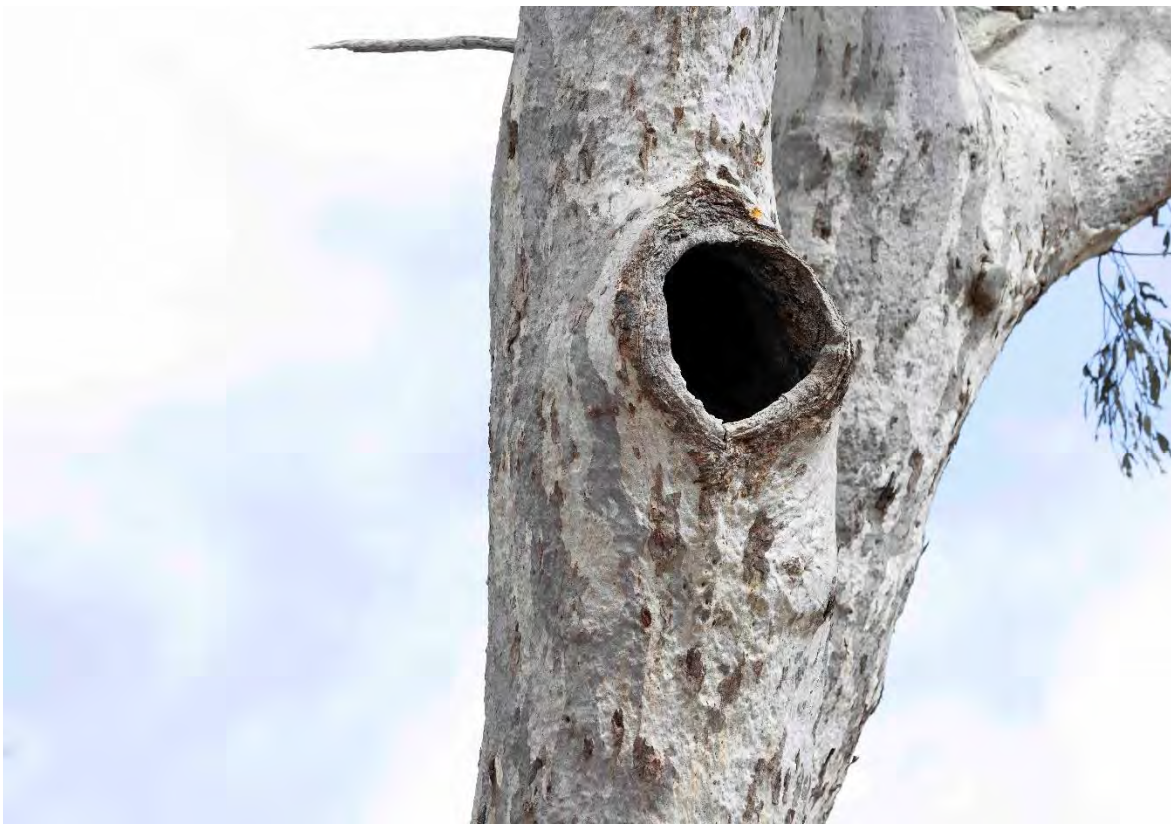
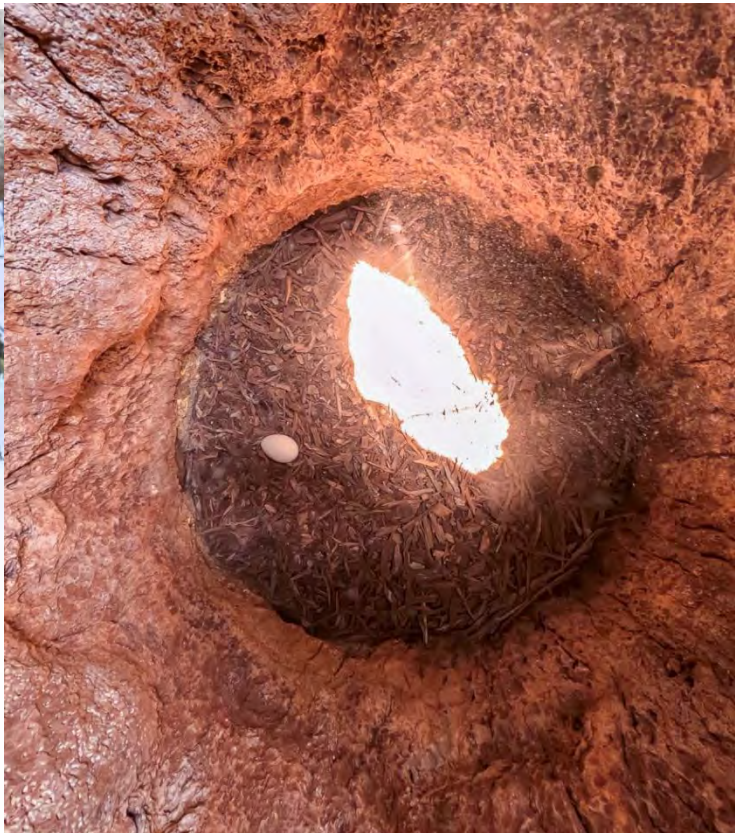
# Natural Hollow Repair One (Badgebup

| Hollow# | Observations Oct 2025 | Observations Dec 2025 | Chipping<br>0-10 | Wood<br>Chips<br>Lts | Tree<br>condition | Fixings | Recommend<br>repairs |
|---|---|---|---|---|---|---|---|
| Badgebup 01 | 2 CC breast feathers on floor, Chewing<br>in hollow no signs of Breeding | Female flushed, one CC egg | 2 | Nil | Good | N/A | Nil |
