# Ministerial Statement Compliance Assessment Report

**Bunbury Outer Ring Road - South  
Ministerial Statement 1191**

**2025 - 2026 Reporting Period**

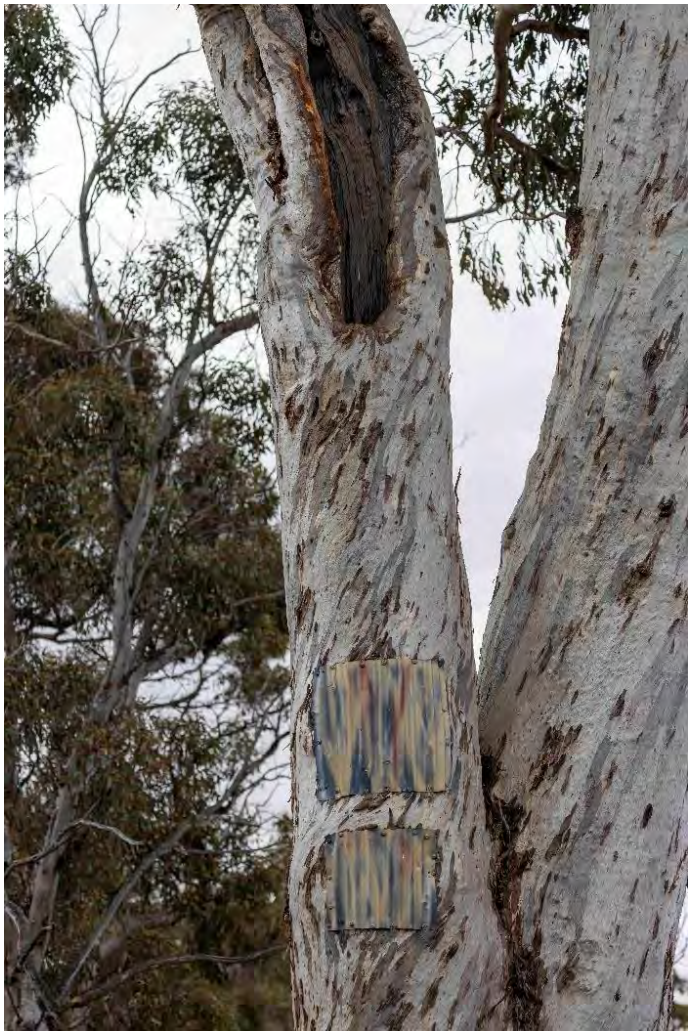
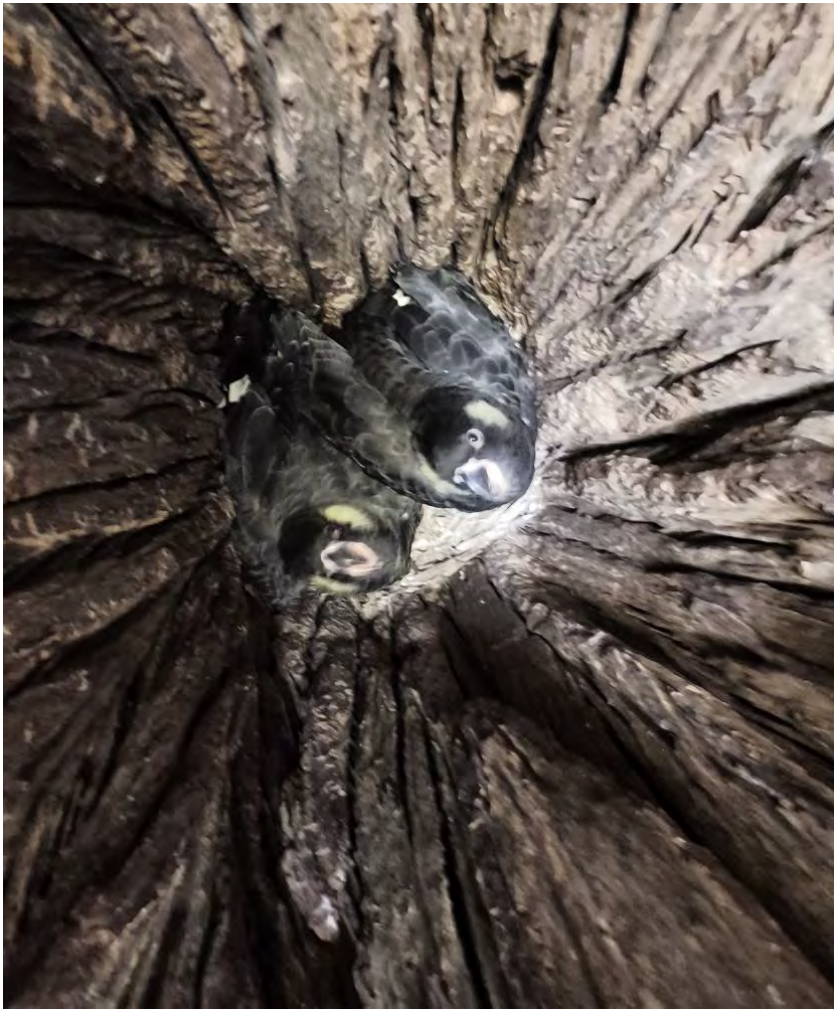
# Natural Hollow Repair Two (Kwobrup)

| Hollow# | Observations Oct 2025 | Observations Dec 2025 | Chipping<br>0-10 | Wood<br>Chips<br>Lts | Tree<br>condition | Fixings | Recommend<br>repairs |
|---|---|---|---|---|---|---|---|
| Kwobrup<br>02 | Heavy chewing hollow, 2 x CC nestlings<br>12-15 days old | One 64-day old female and one 58- day<br>old male CC nestling | 5 | Nil | Good | N/A | Nil |

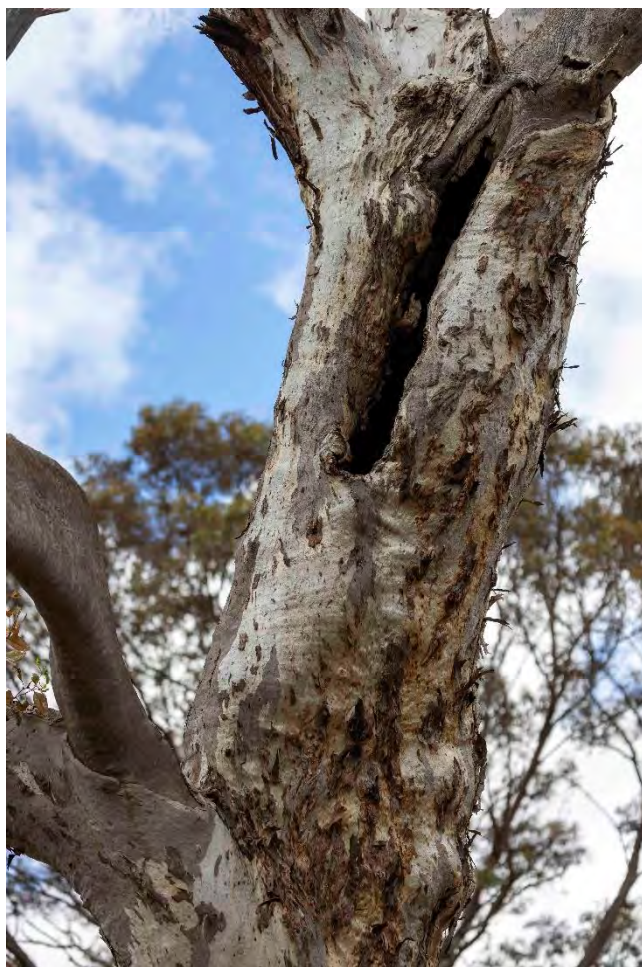
## Natural Hollow Repair Three (Kwobrup)

| Hollow# | Observations Oct 2025 | Observations Dec 2025 | Chipping<br>0-10 | Wood<br>Chips Lts | Tree<br>condition | Fixings | Recommend<br>repairs |
|---|---|---|---|---|---|---|---|
| <b>Kwobrup<br/>03</b> | <b>No signs of nesting or<br/>inspection by Black Cockatoos.</b> | <b>One dead regent parrot in base of hollow.<br/>Hollow is deep however even floor</b> | <b>0</b> | <b>nil</b> | <b>Good</b> | <b>N/A</b> | <b>NIL</b> |

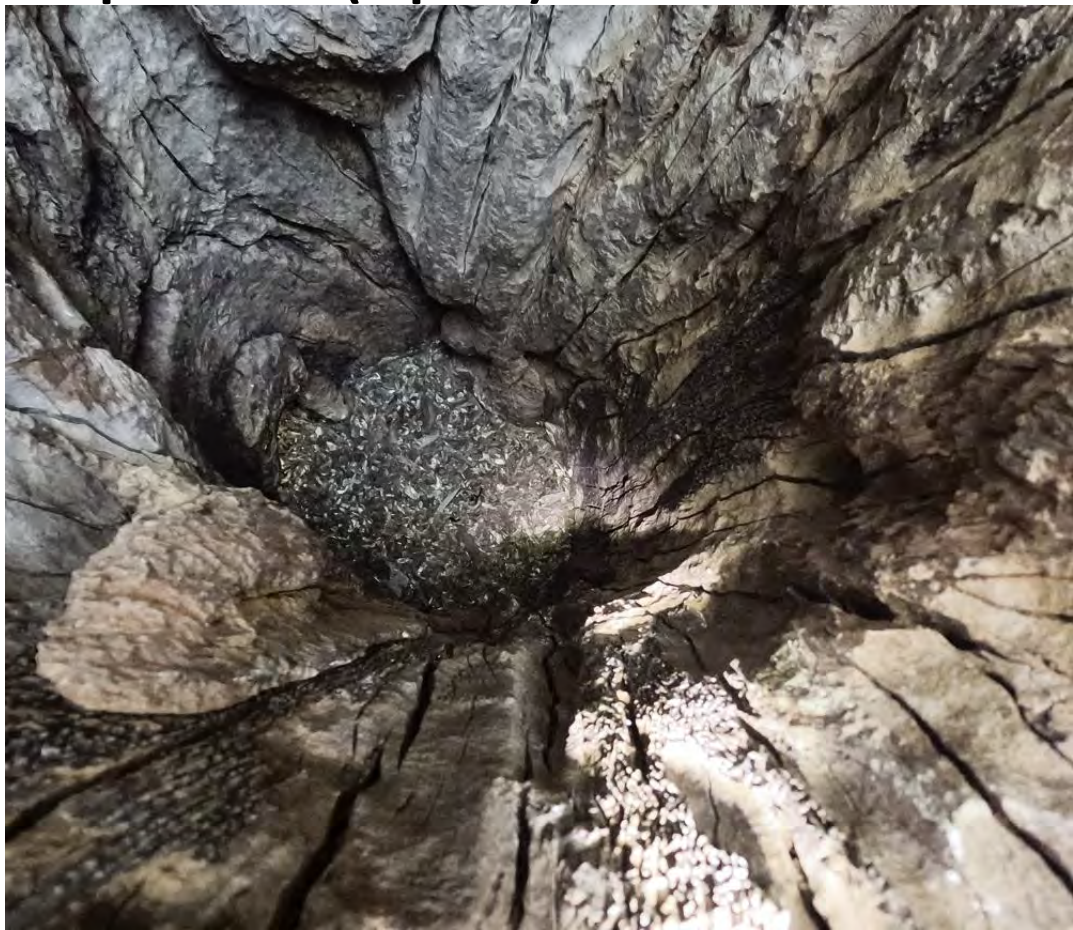
# Natural Hollow Repair One (Elphin)

| Hollow # | Observations Oct 2025 | Observations Dec 2025 | Chipping 0-10 | Wood Chips Lts | Tree condition | Fixings | Recommend repairs |
|---|---|---|---|---|---|---|---|
| Elphin 01 | Female Carnaby's, 37 days old, female flushed | Fledged | 2 | Nil | Good | N/A | Nil |

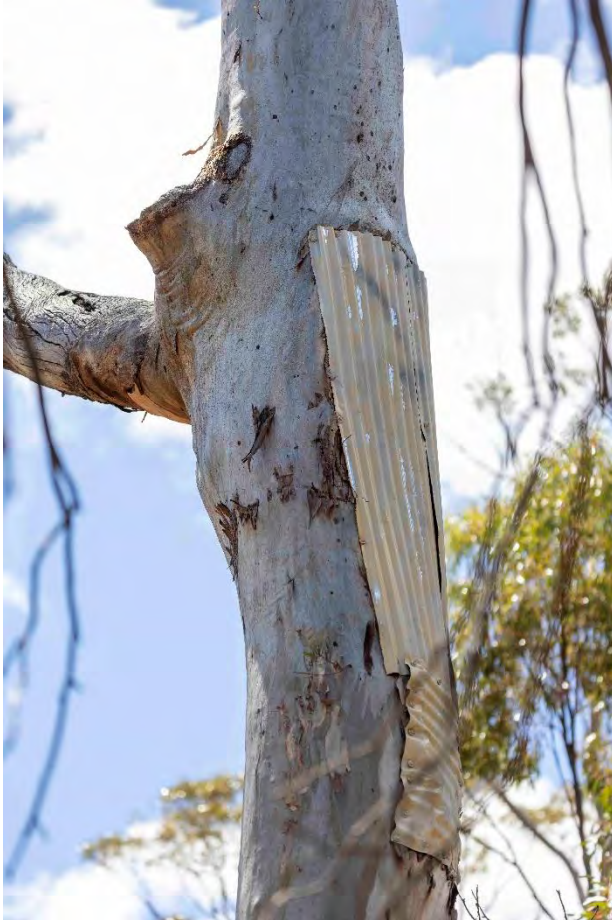
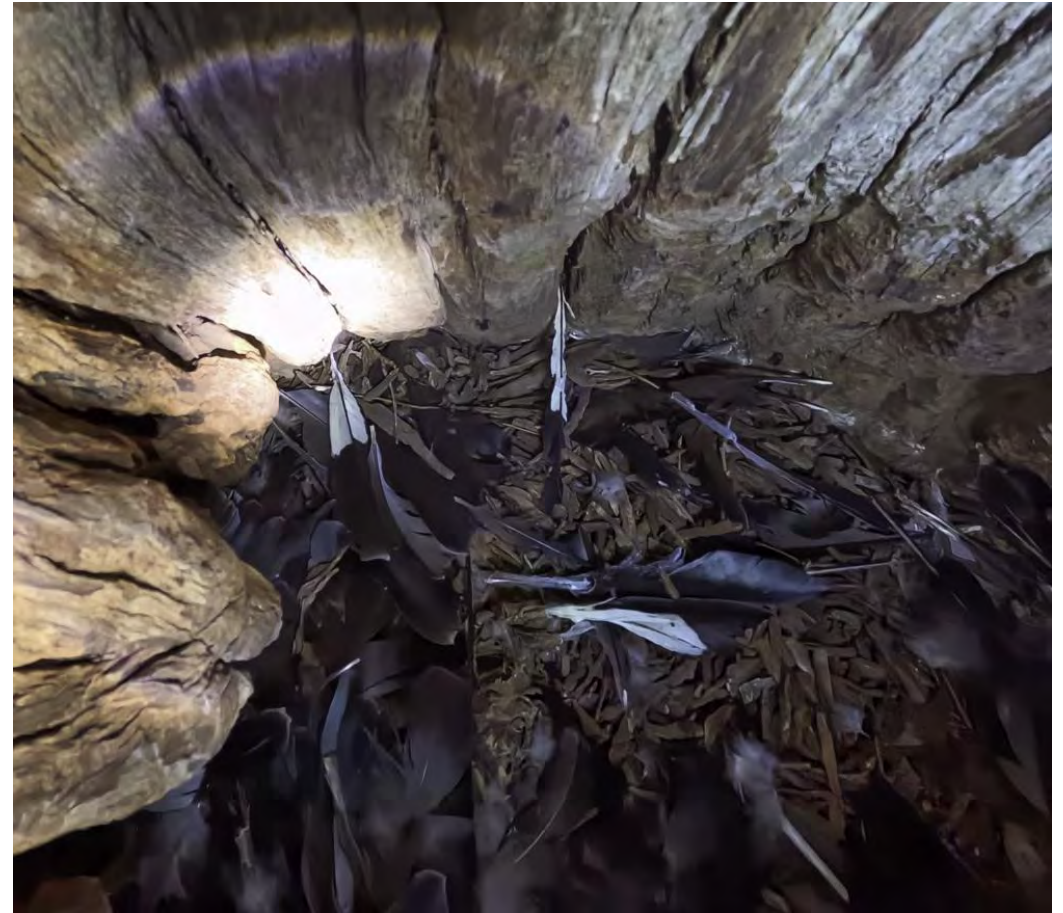
## Natural Hollow Repair Two (Elphin)

| Hollow # | Observations Oct 2025 | Observations Dec 2025 | Chipping 0-10 | Wood Chips Lts | Tree condition | Fixings | Recommend repairs |
|---|---|---|---|---|---|---|---|
| Elphin 02 | Female Carnaby's 45 days old | Dead nestling removed, died 60+ days | 2 | Nil | Good | N/A | Nil |

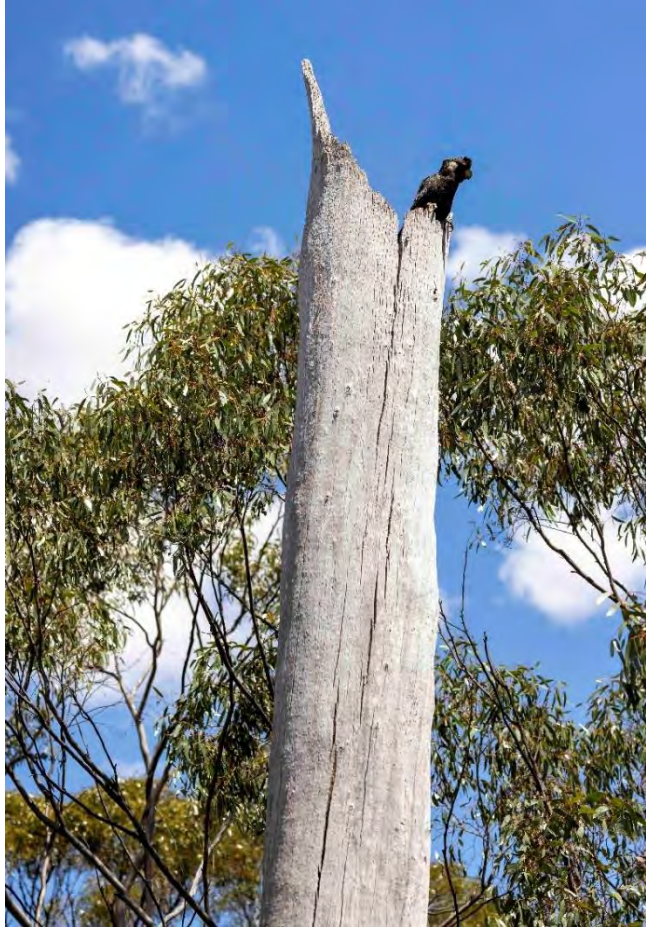
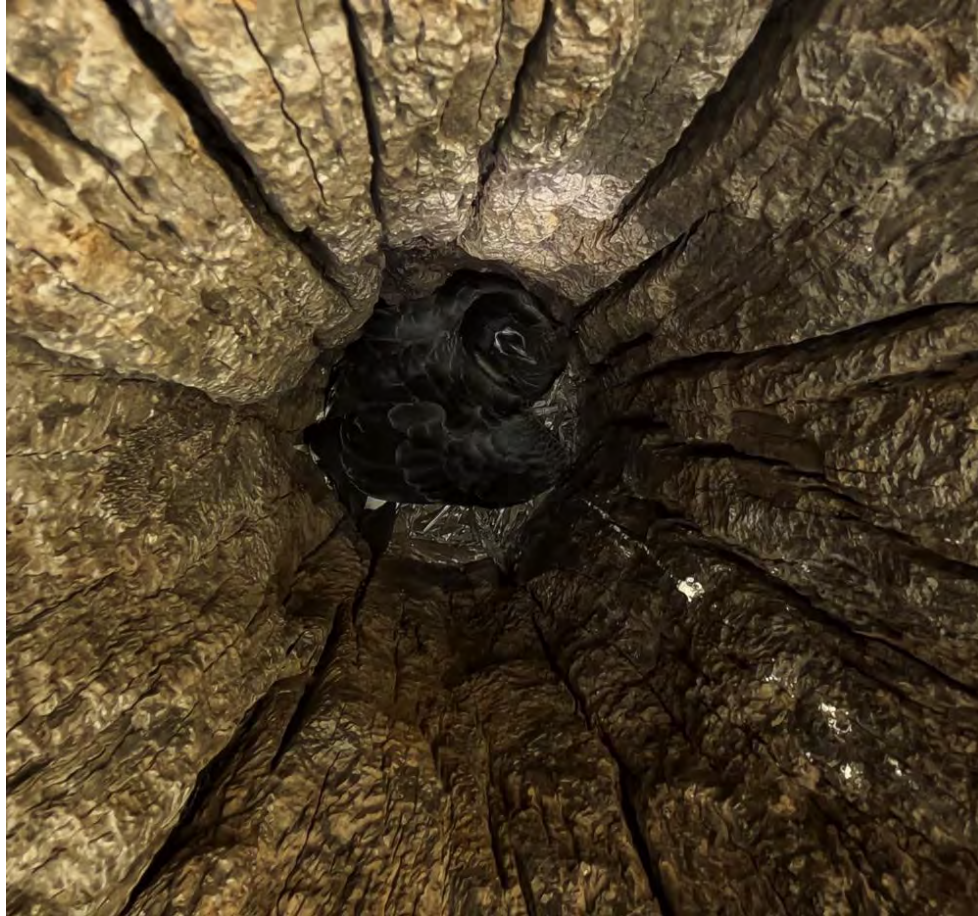
## Natural Hollow Repair Three (Elphin)

| Hollow # | Observations Oct 2025 | Observations Dec 2025 | Chipping 0-10 | Wood Chips Lts | Tree condition | Fixings | Recommend repairs |
|---|---|---|---|---|---|---|---|
| Elphin 03 | Male Carnaby's 24 days old, female flushed heavy chewing on walls. | Large nestling still present | 7 | 0 | Dead stag | N/A | Nil |

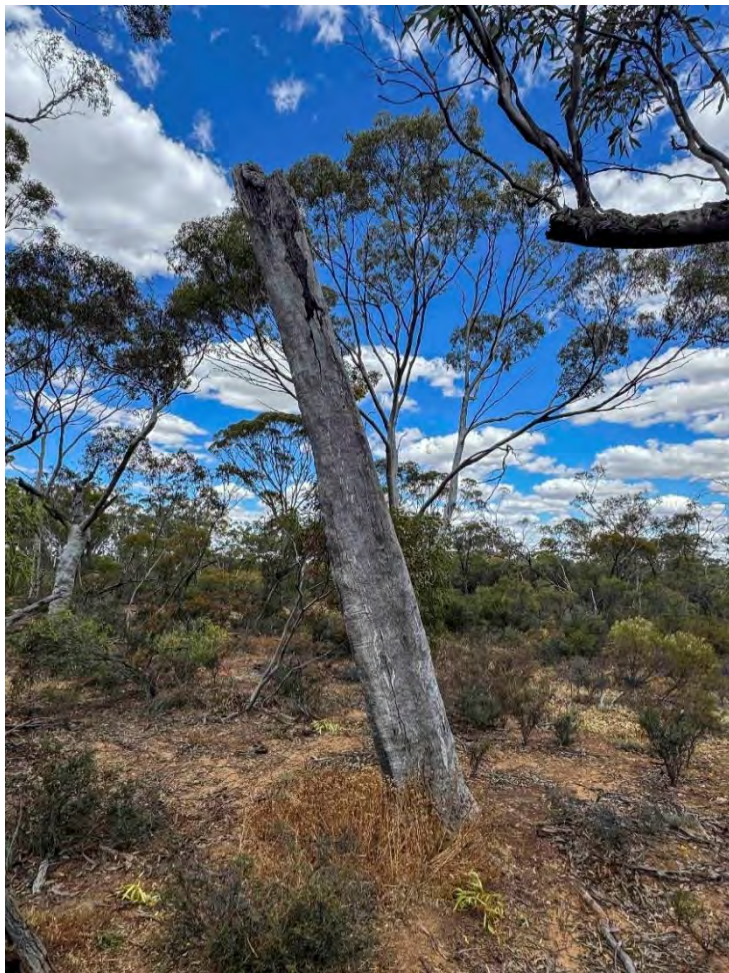
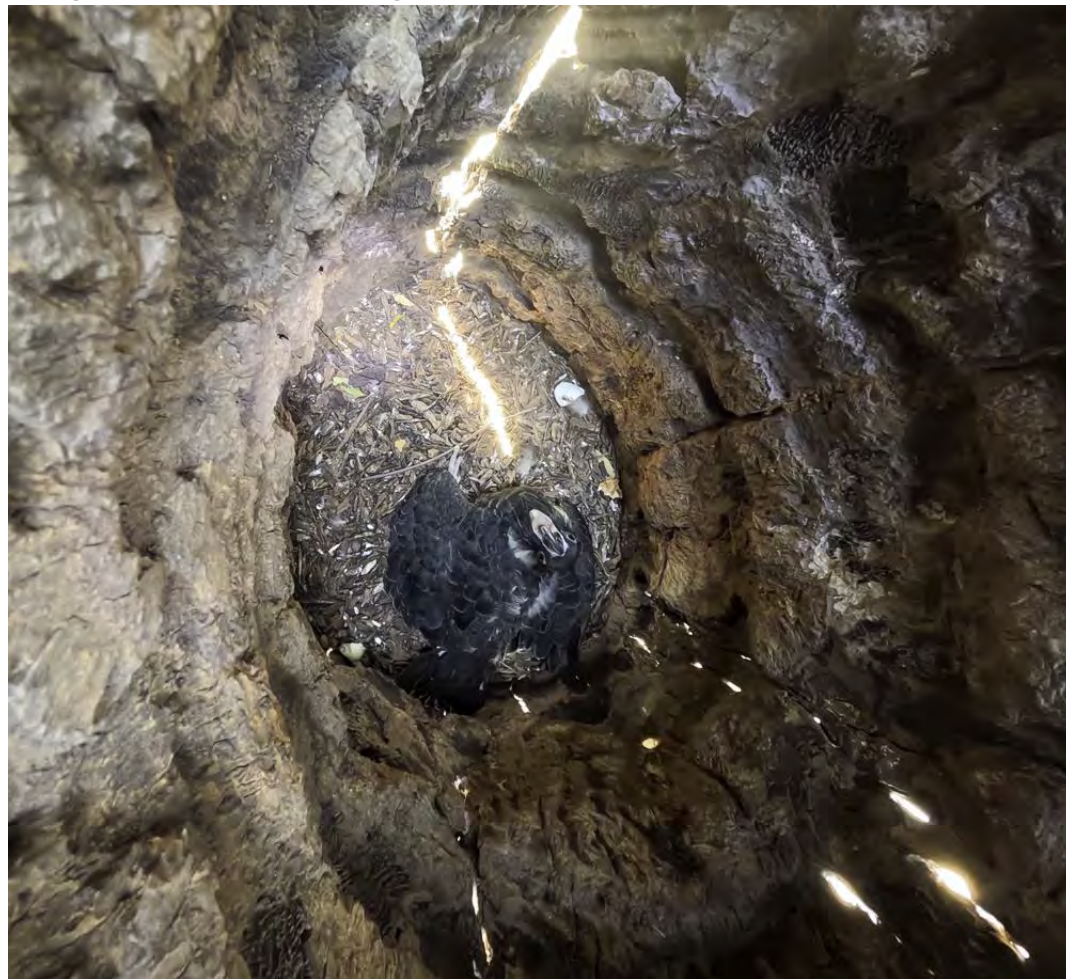
## Natural Hollow Repair Four (Elphin)

| Hollow # | Observations Oct 2025 | Observations Dec 2025 | Chipping 0-10 | Wood Chips Lts | Tree condition | Fixings | Recommend repairs |
|---|---|---|---|---|---|---|---|
| Elphin 04 | Five-day old CC and egg being incubated, Chewing on post. Female flushed | Male Carnaby's nestling 45 days old | 5 | 0 | Dead Stag | N/A | Tin to cover splits in side of hollow |

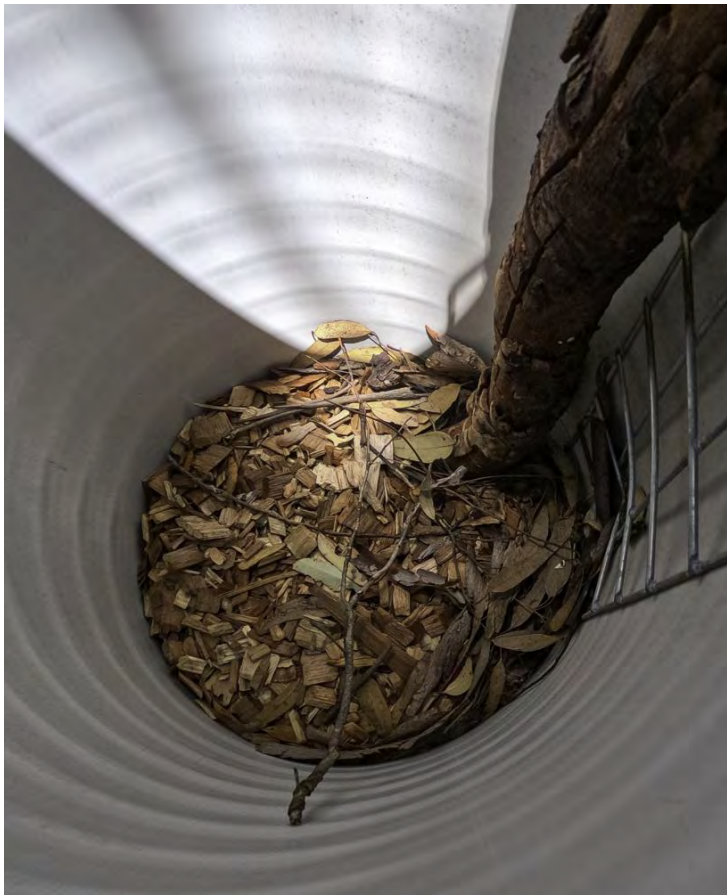
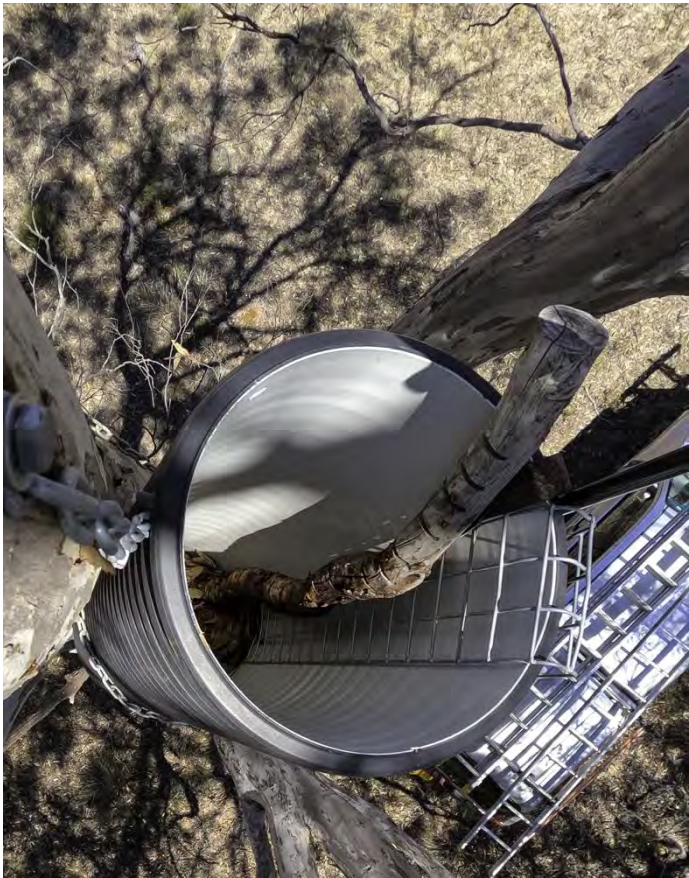
Artificial Hollow BY37

| Hollow # | Observations Oct 2025 | Observations Dec 2025 | Chipping 0-10 | Wood Chips Lts | Tree condition | Fixings | Recommend repairs |
|---|---|---|---|---|---|---|---|
| BY37 | No signs of nesting or inspection by Black Cockatoos | No signs of nesting or inspection by Black Cockatoos | 0 | Nil | Good | Good | Nil |

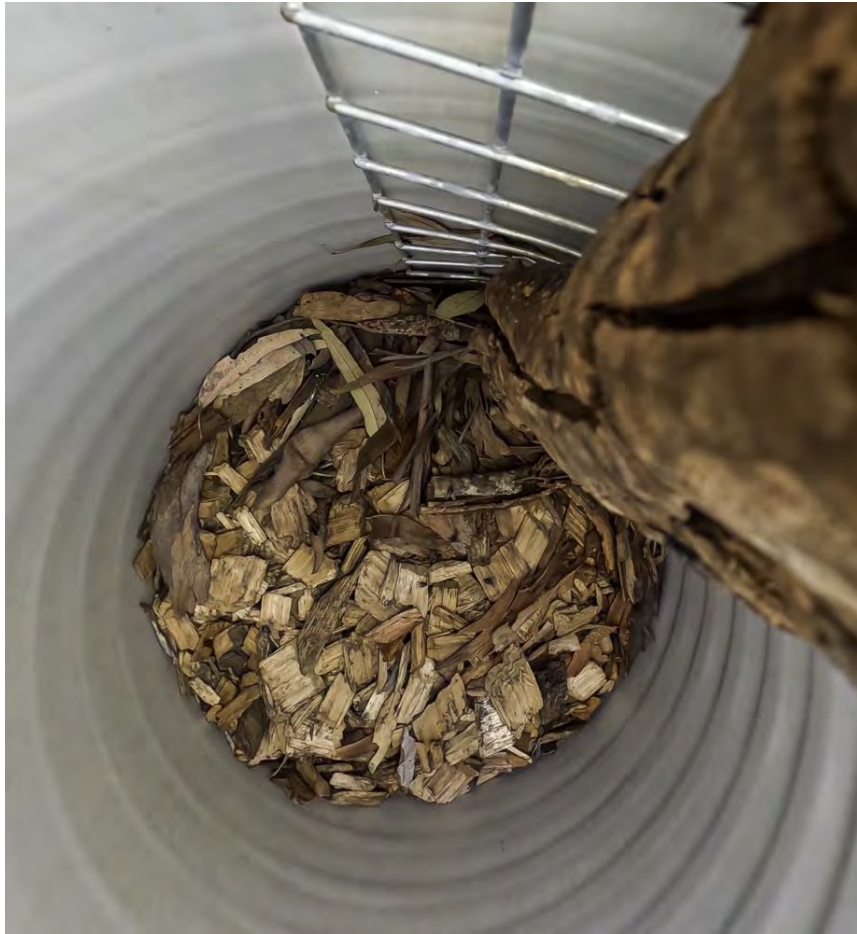
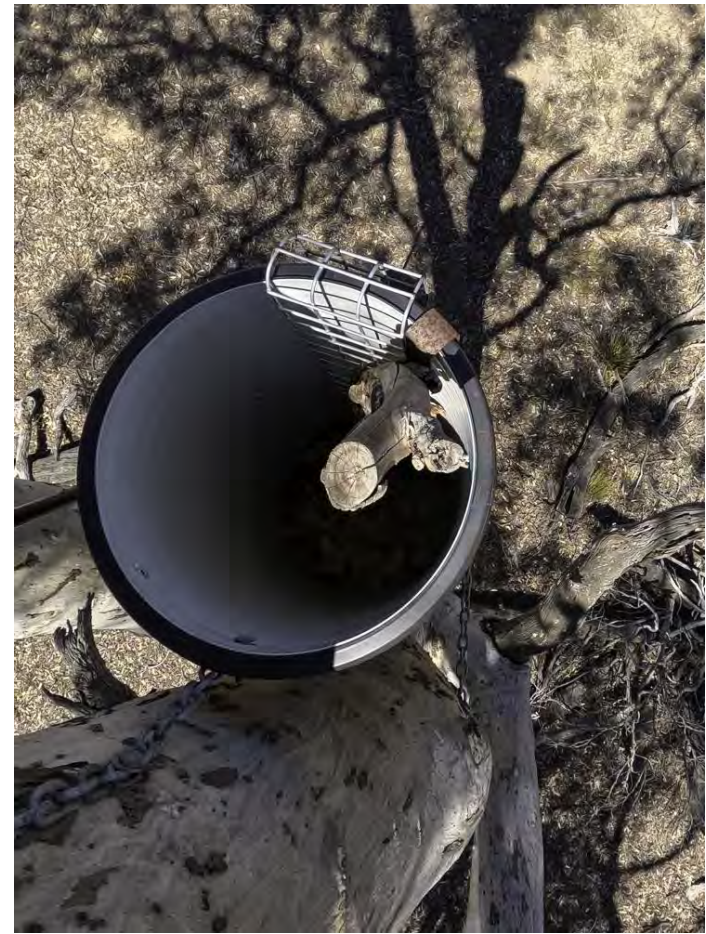
## Artificial Hollow BY38

| Hollow # | Observations Oct 2025 | Observations Dec 2025 | Chipping 0-10 | Wood Chips Lts | Tree condition | Fixings | Recommend repairs |
|---|---|---|---|---|---|---|---|
| BY38 | No signs of nesting or inspection by Black Cockatoos | No signs of nesting or inspection by Black Cockatoos | 0 | Nil | Good | Good | Nil |

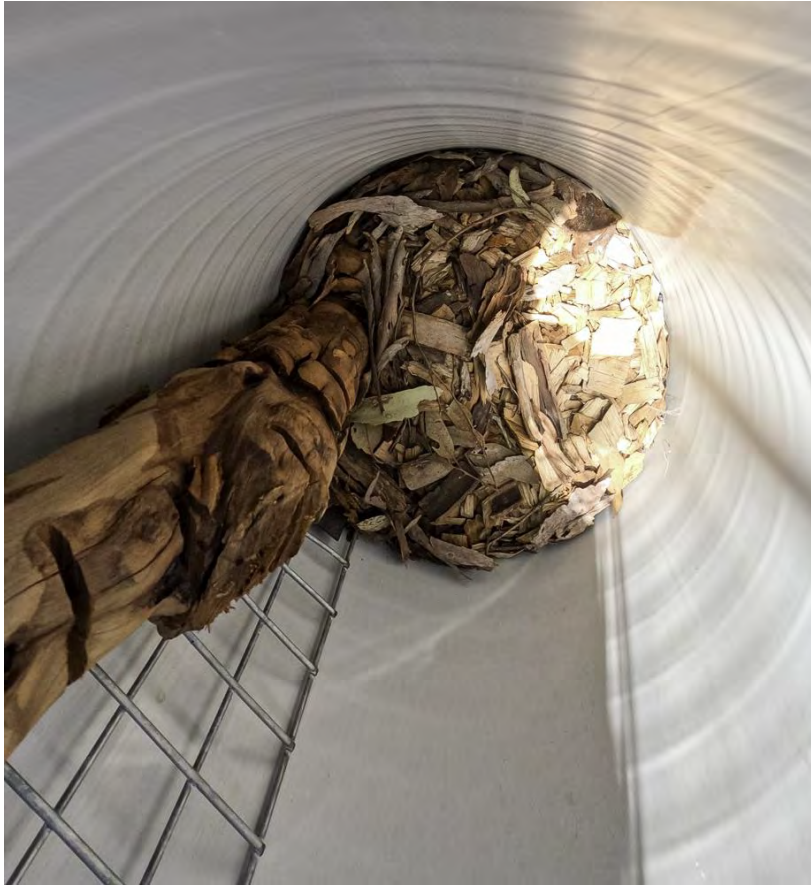
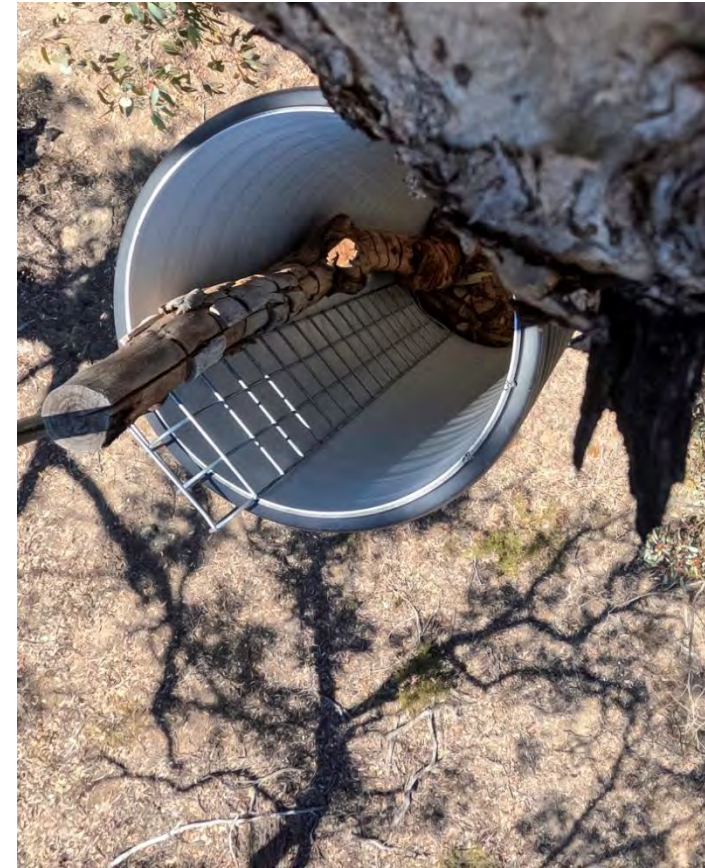
## Artificial Hollow BY39

| Hollow # | Observations Oct 2025 | Observations Dec 2025 | Chipping 0-10 | Wood Chips Lts | Tree condition | Fixings | Recommend repairs |
|---|---|---|---|---|---|---|---|
| BY39 | No signs of nesting or inspection by Black Cockatoos <b>Corrected GPS Point S33.29549 E117.059733</b> | No signs of nesting or inspection by Black Cockatoos | 0 | Nil | Good | Good | Nil |

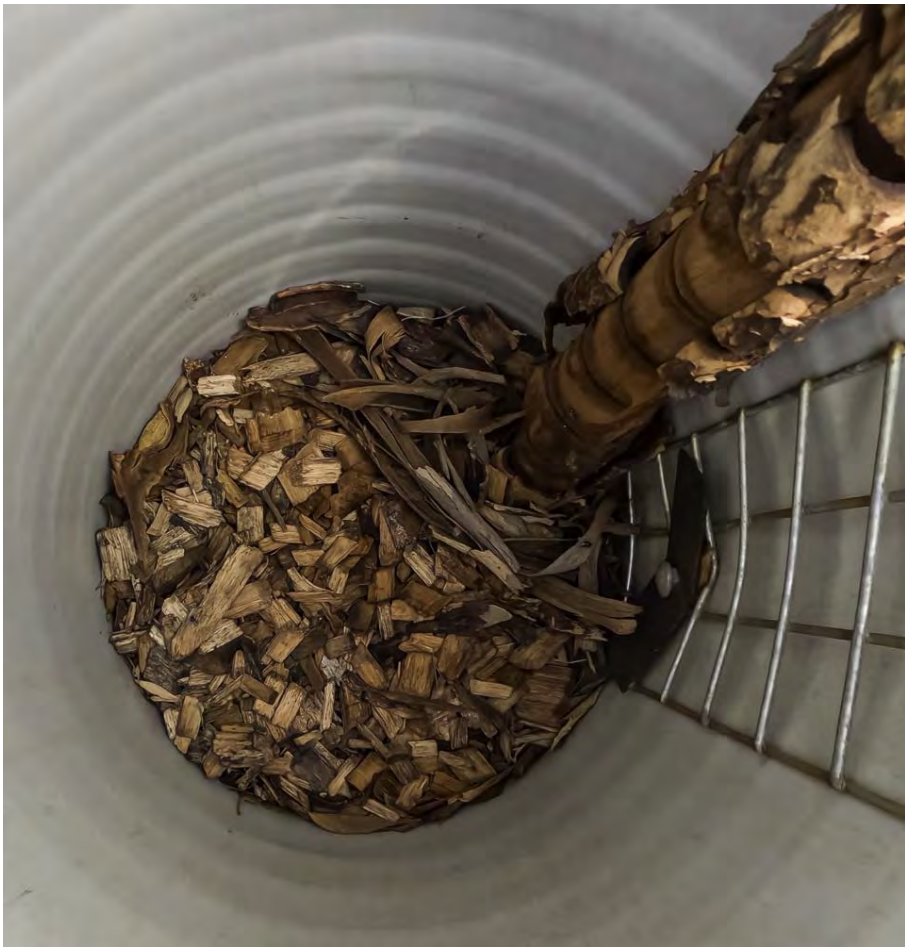
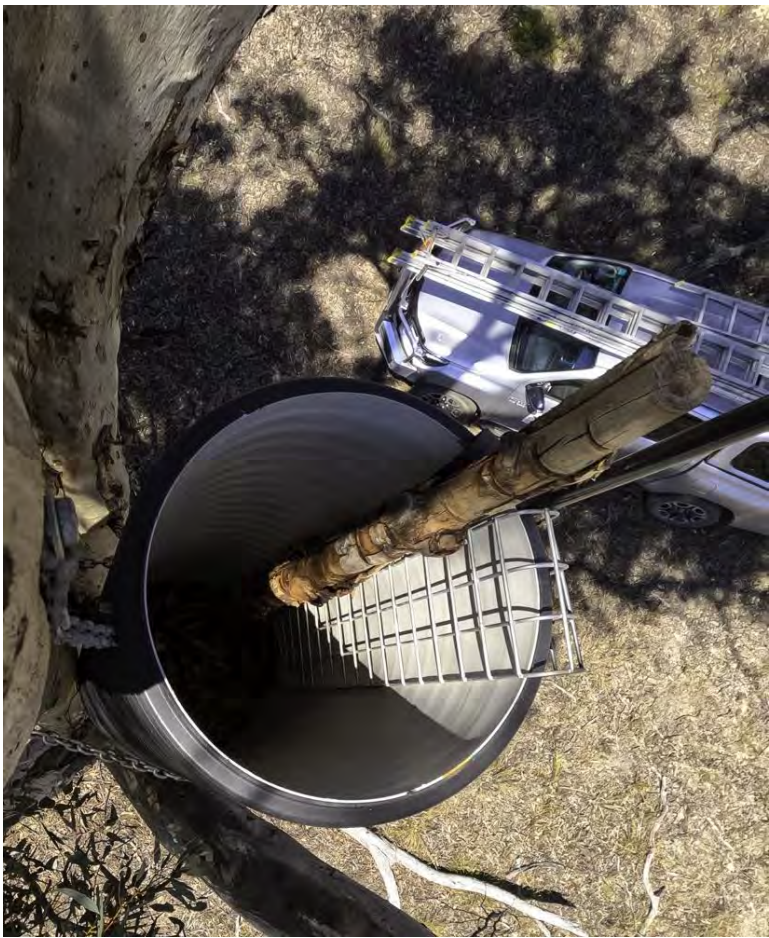
# Artificial Hollow BY40

| Hollow # | Observations Oct 2025 | Observations Dec 2025 | Chipping 0-10 | Wood Chips Lts | Tree condition | Fixings | Recommend repairs |
|---|---|---|---|---|---|---|---|
| BY40 | No signs of nesting or inspection by Black Cockatoos | No signs of nesting or inspection by Black Cockatoos | 0 | Nil | Good | Good | Nil |

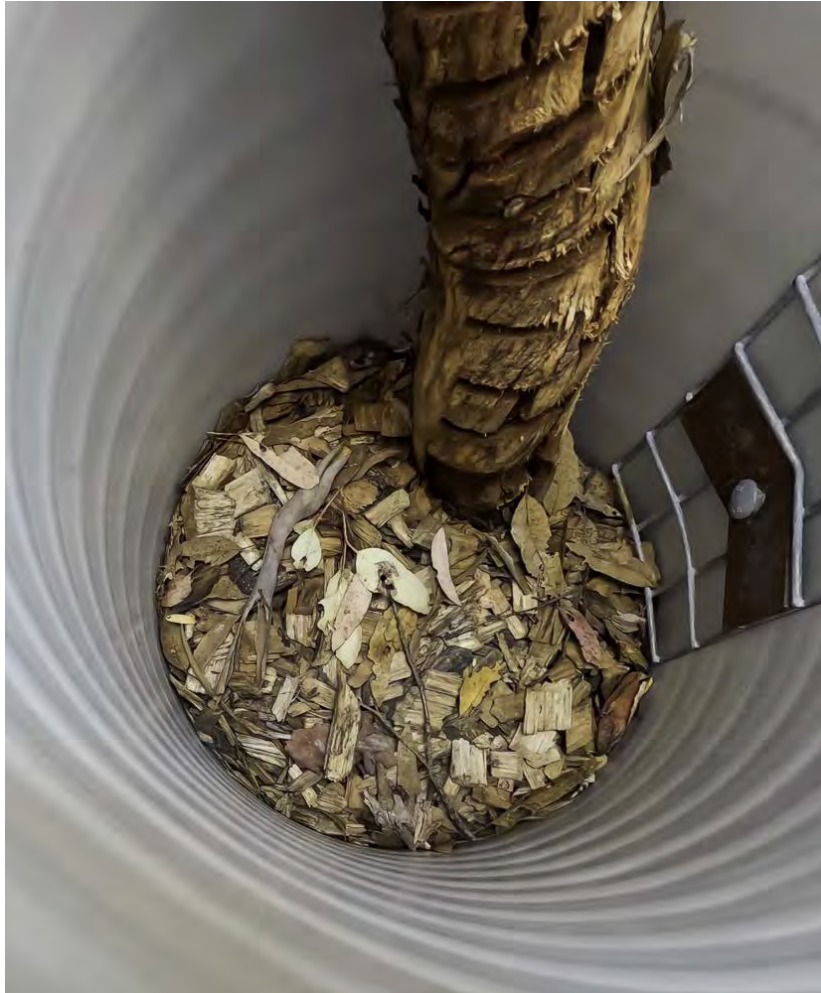
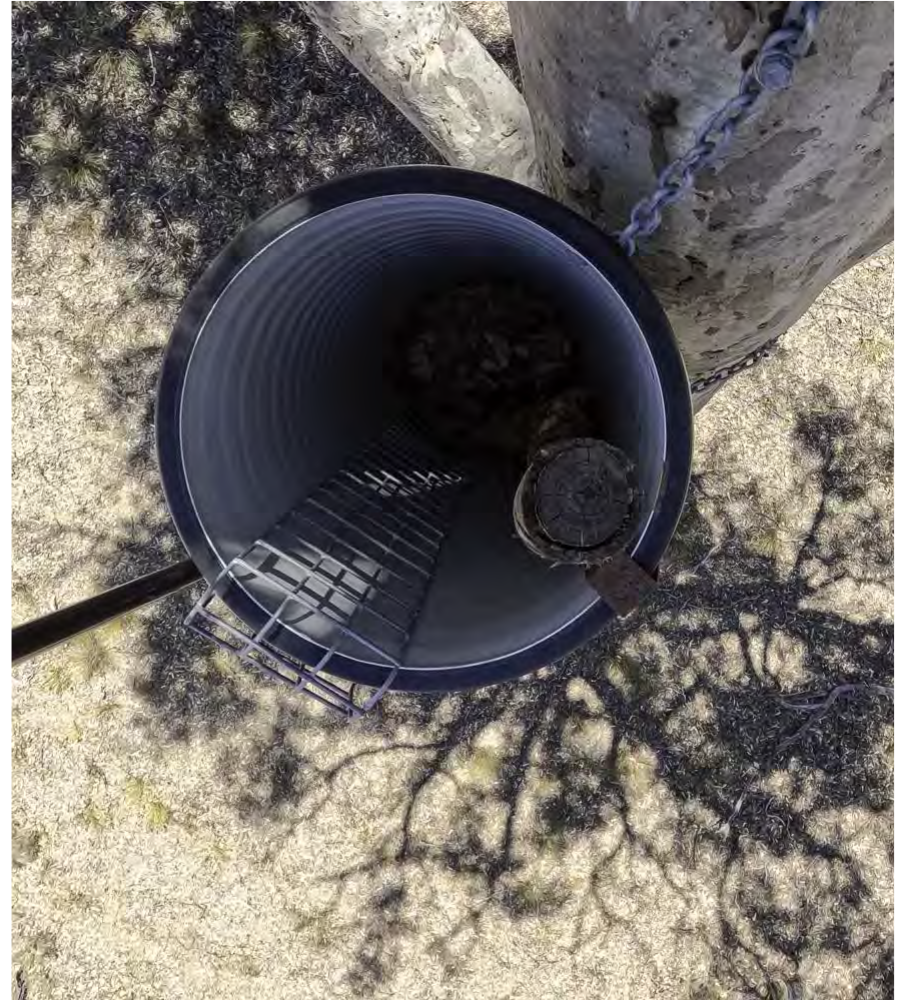
## Artificial Hollow BY41

| Hollow # | Observations Oct 2025 | Observations Dec 2025 | Chipping 0-10 | Wood Chips Lts | Tree condition | Fixings | Recommend repairs |
|---|---|---|---|---|---|---|---|
| BY41 | No signs of nesting or inspection by Black Cockatoos | No signs of nesting or inspection by Black Cockatoos | 0 | Nil | Good | Good | Nil |

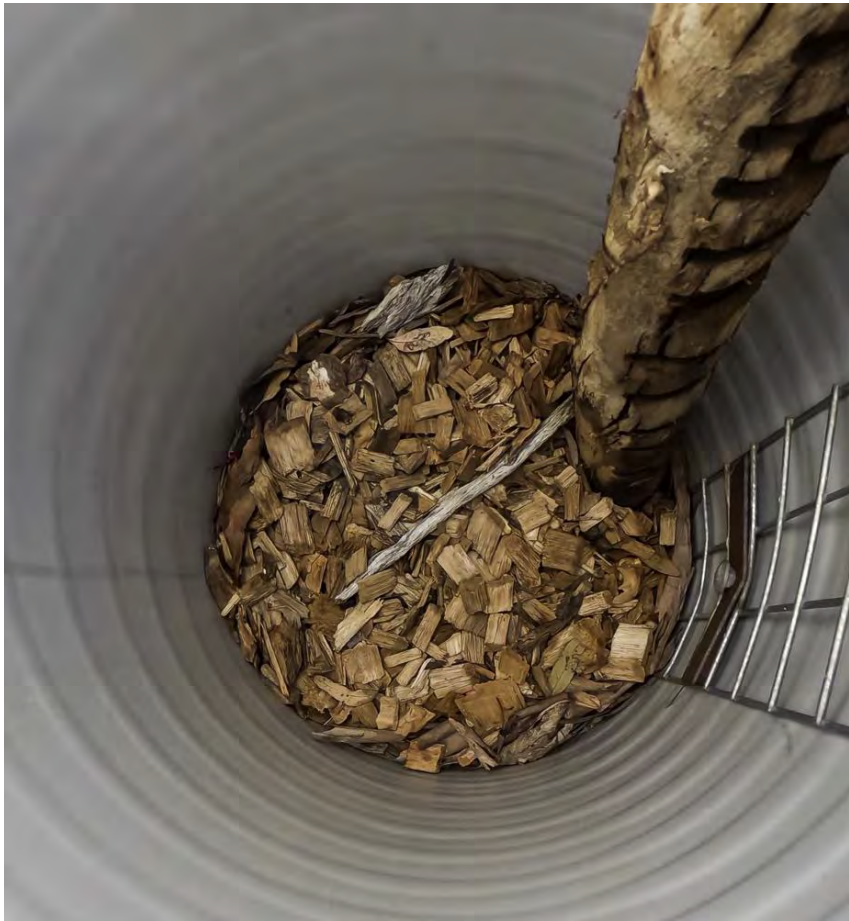
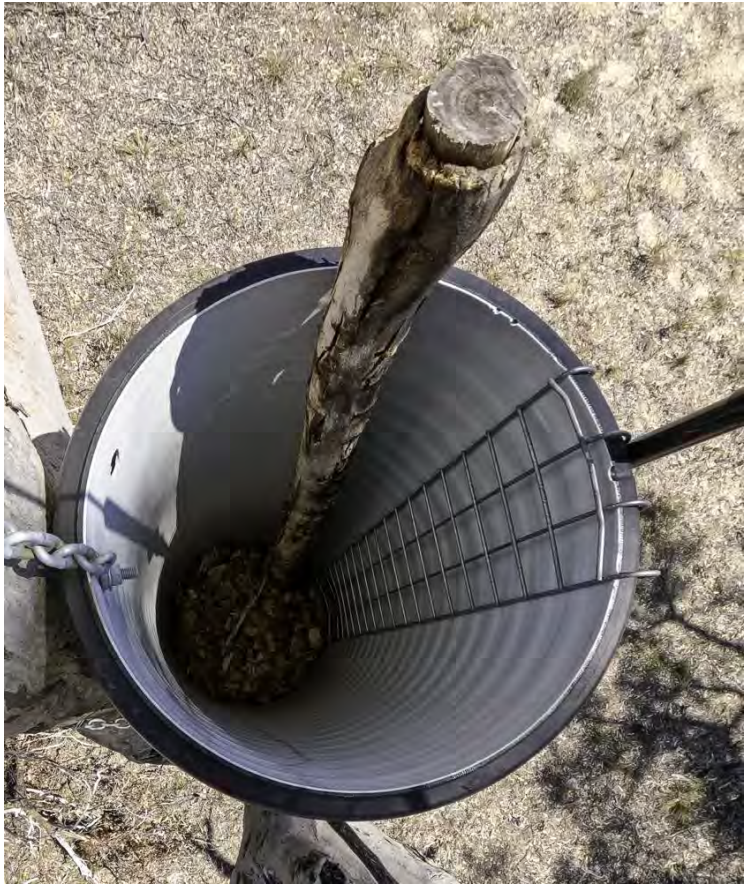
Artificial Hollow BY42

| Hollow # | Observations Oct 2025 | Observations Dec 2025 | Chipping 0-10 | Wood Chips Lts | Tree condition | Fixings | Recommend repairs |
|---|---|---|---|---|---|---|---|
| BY42 | No signs of nesting or inspection by Black Cockatoos | No signs of nesting or inspection by Black Cockatoos | 0 | Nil | Good | Good | Nil |

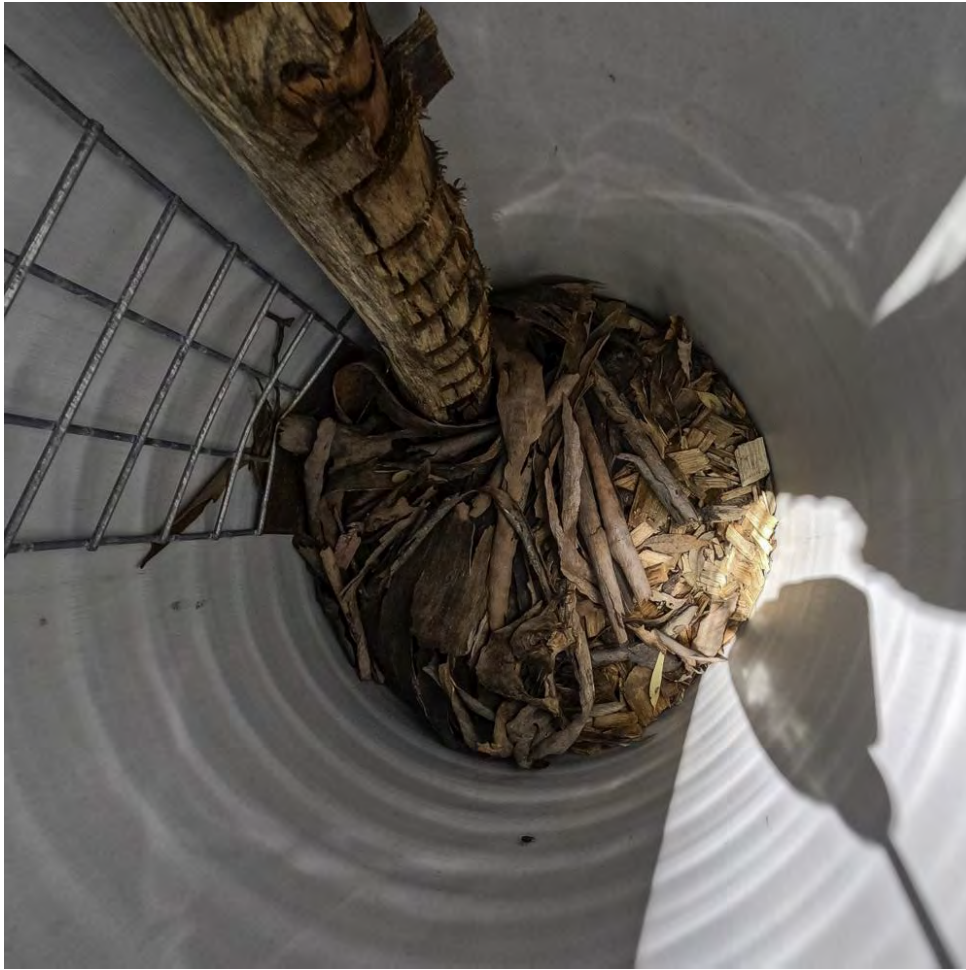
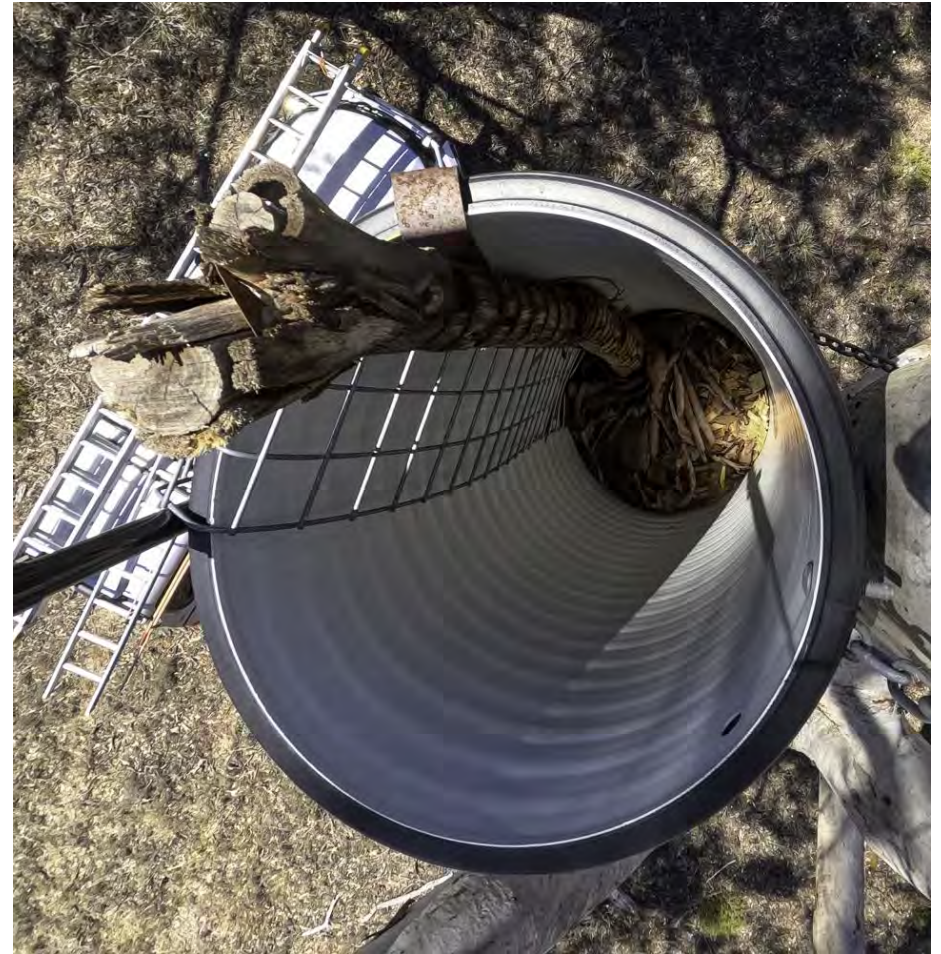
## Artificial Hollow BY43

| Hollow # | Observations Oct 2025 | Observations Dec 2025 | Chipping 0-10 | Wood Chips Lts | Tree condition | Fixings | Recommend repairs |
|---|---|---|---|---|---|---|---|
| BY43 | No signs of nesting or inspection by Black Cockatoos | No signs of nesting or inspection by Black Cockatoos | 0 | Nil | Good | Good | Nil |

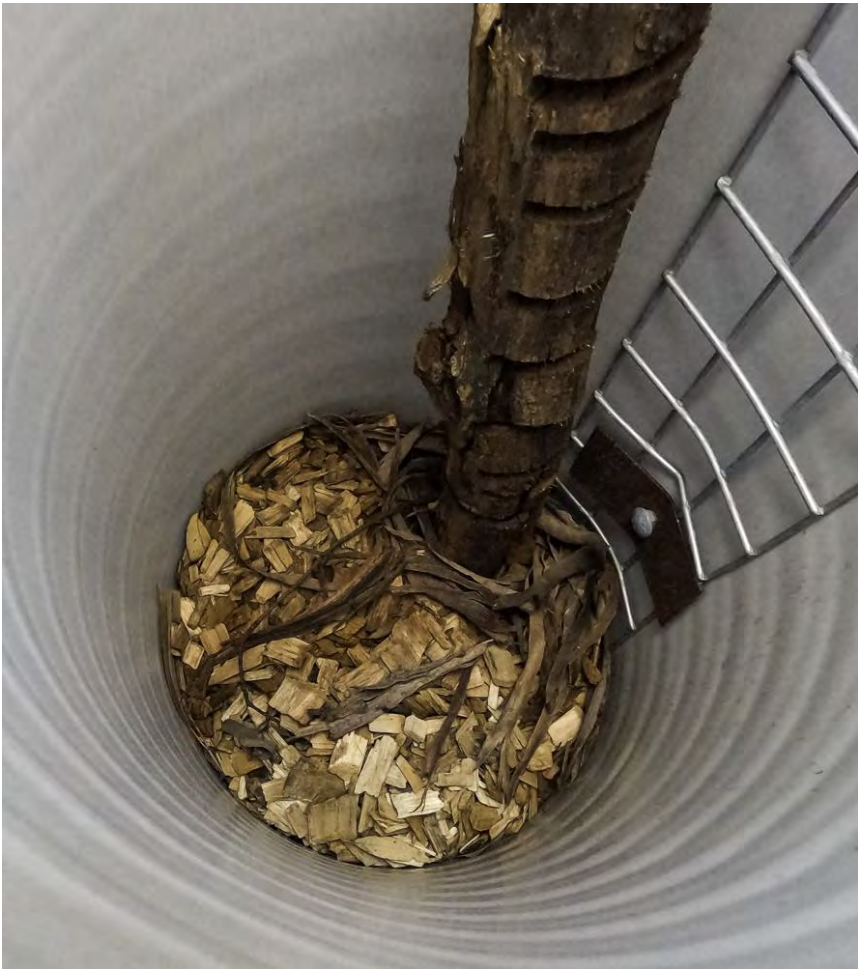
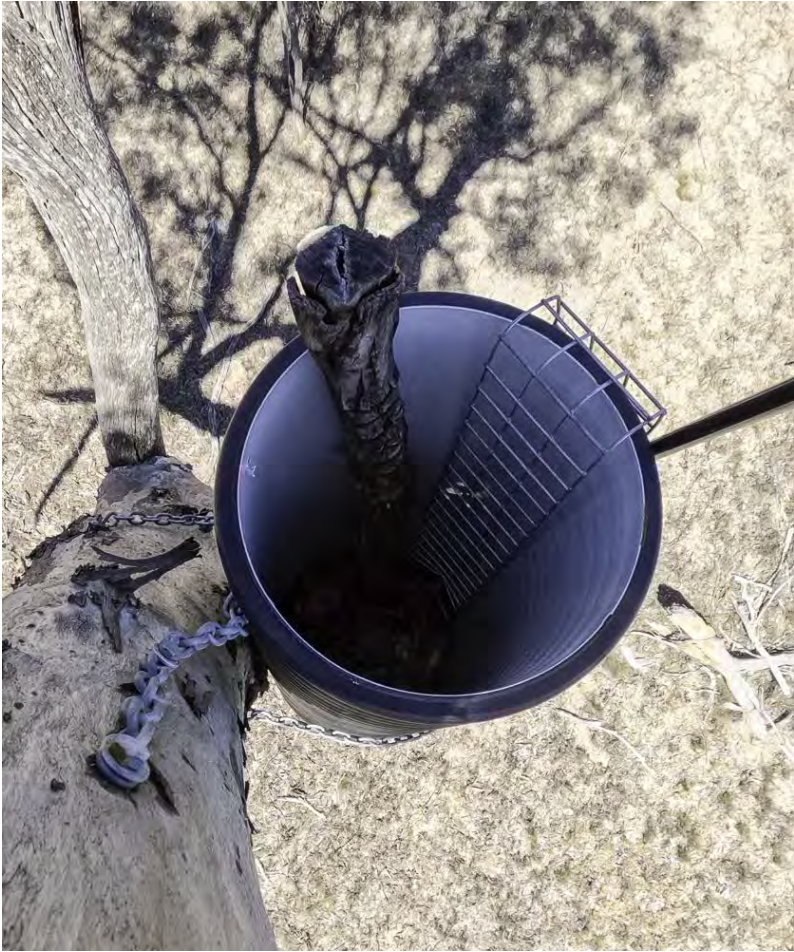
Artificial Hollow BY44

| Hollow # | Observations Oct 2025 | Observations Dec 2025 | Chipping 0-10 | Wood Chips Lts | Tree condition | Fixings | Recommend repairs |
|---|---|---|---|---|---|---|---|
| BY44 | No signs of nesting or inspection by Black Cockatoos | No signs of nesting or inspection by Black Cockatoos | 0 | Nil | Good | Good | Nil |
