# Ministerial Statement Compliance Assessment Report

**Bunbury Outer Ring Road - South  
Ministerial Statement 1191**

**2025 - 2026 Reporting Period**

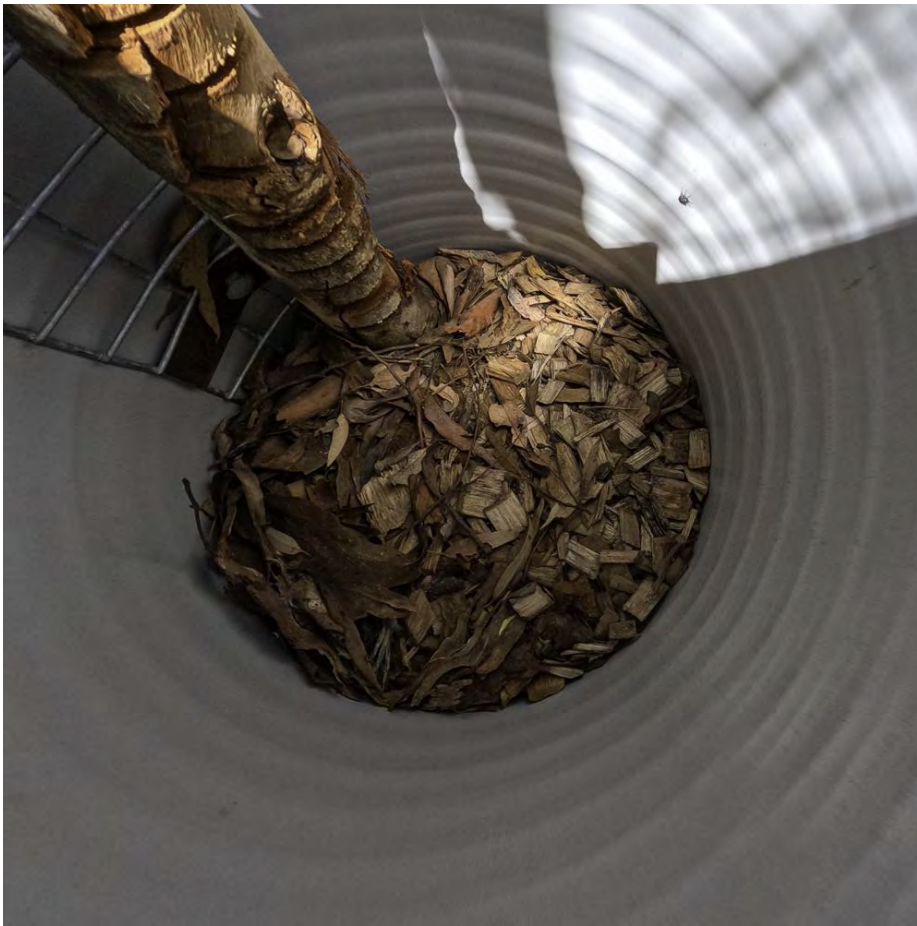
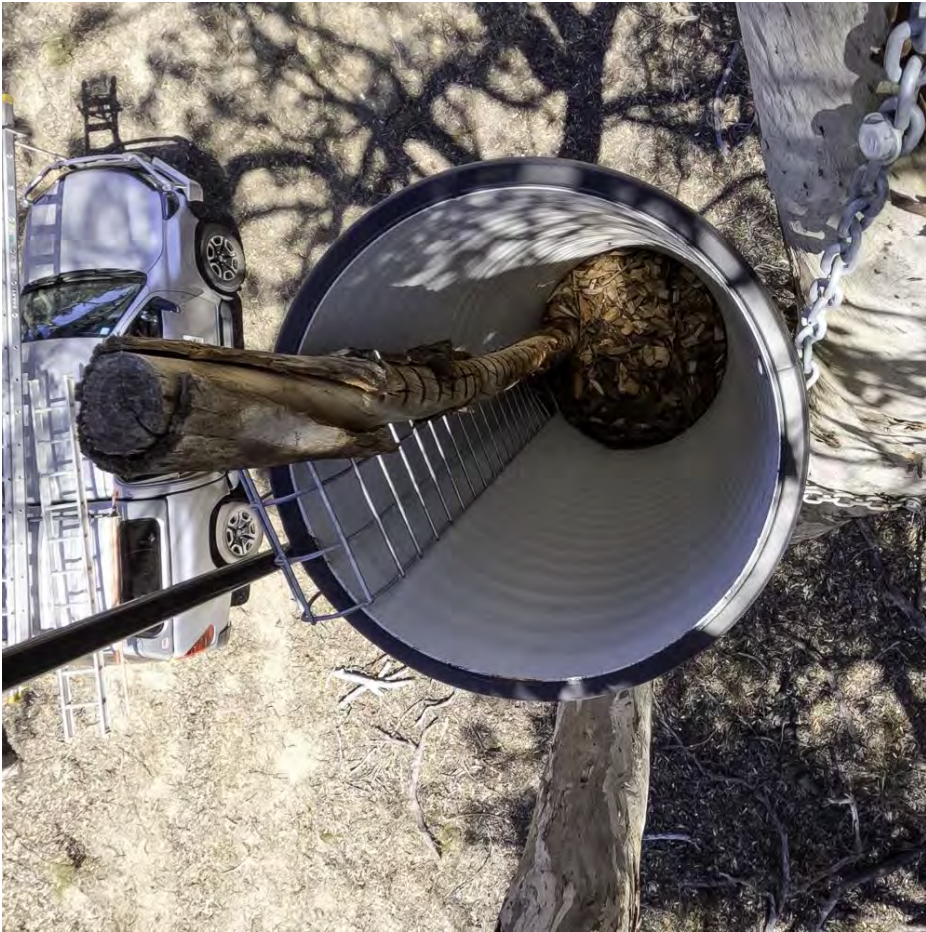
Artificial Hollow BY46

| Hollow # | Observations Oct 2025 | Observations Dec 2025 | Chipping 0-10 | Wood Chips Lts | Tree condition | Fixings | Recommend repairs |
|---|---|---|---|---|---|---|---|
| BY46 | No signs of nesting or inspection by Black Cockatoos | No signs of nesting or inspection by Black Cockatoos | 0 | Nil | Good | Good | Nil |

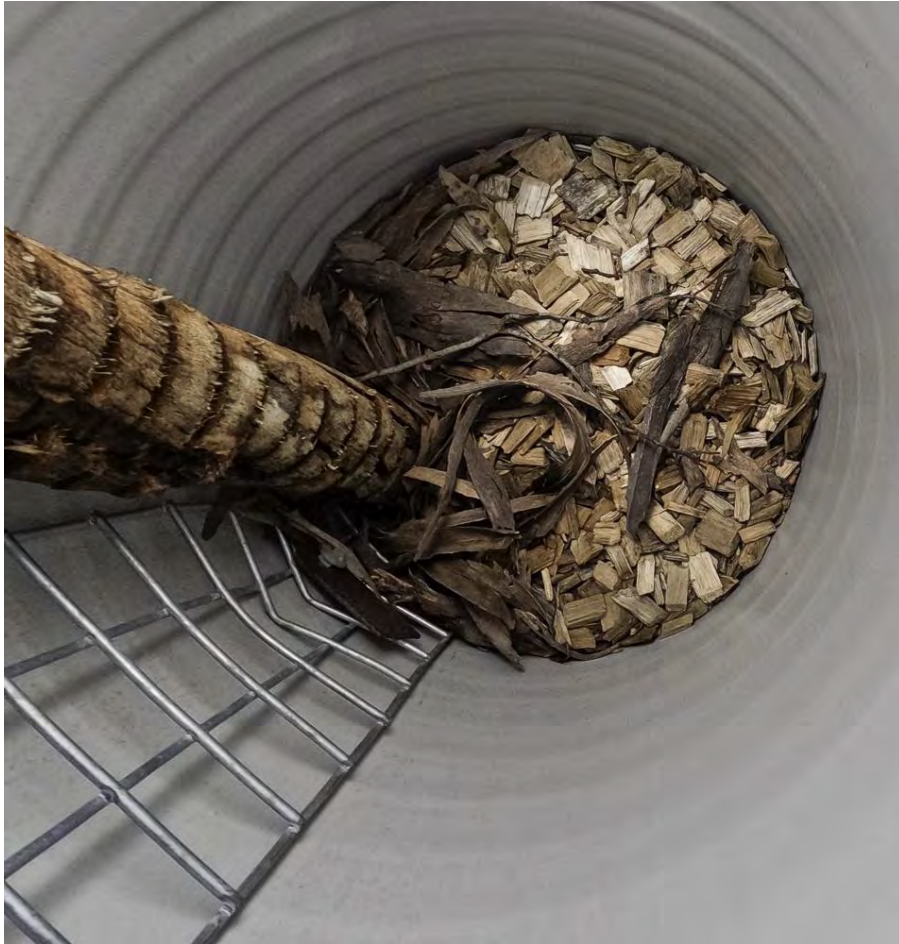
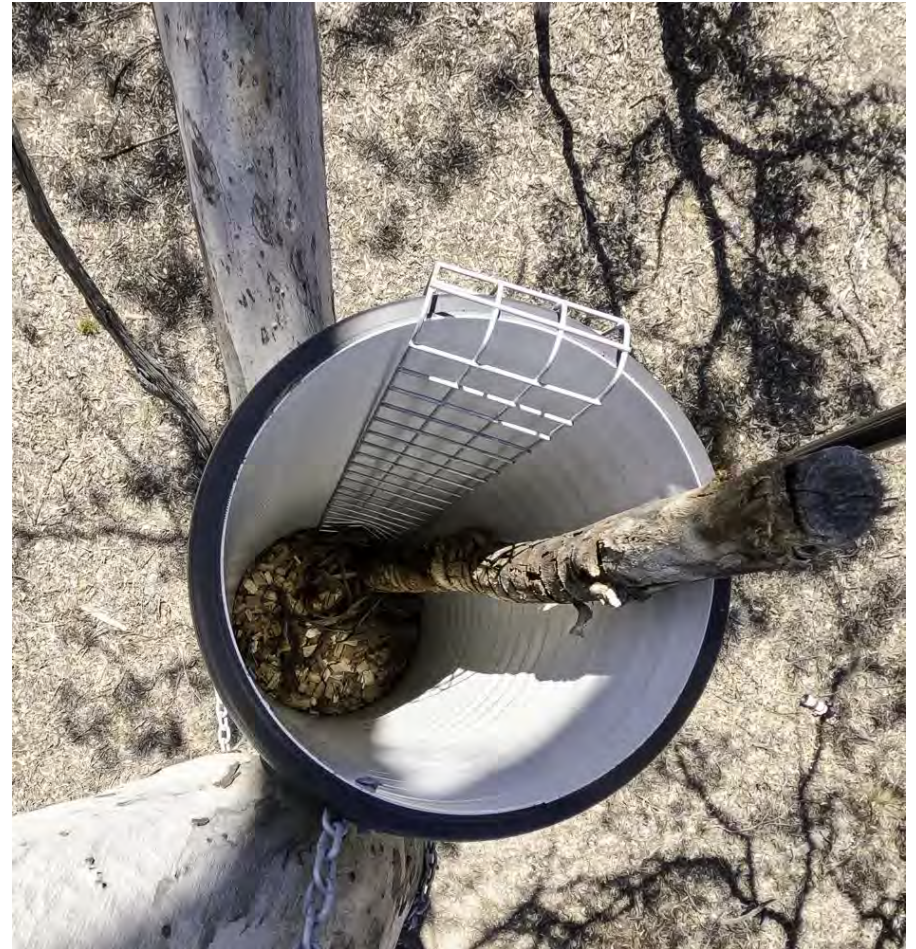
## Artificial Hollow BY47

| Hollow # | Observations Oct 2025 | Observations Dec 2025 | Chipping 0-10 | Wood Chips Lts | Tree condition | Fixings | Recommend repairs |
|---|---|---|---|---|---|---|---|
| BY47 | No signs of nesting or inspection by Black Cockatoos | No signs of nesting or inspection by Black Cockatoos | 0 | Nil | Good | Good | Nil |

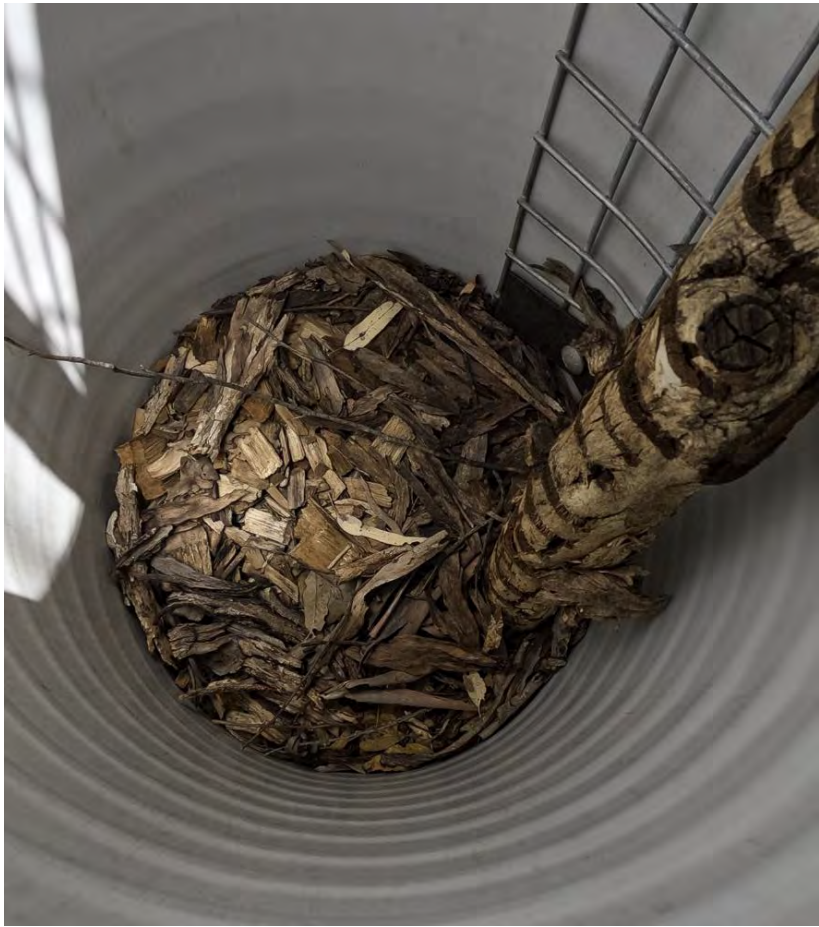
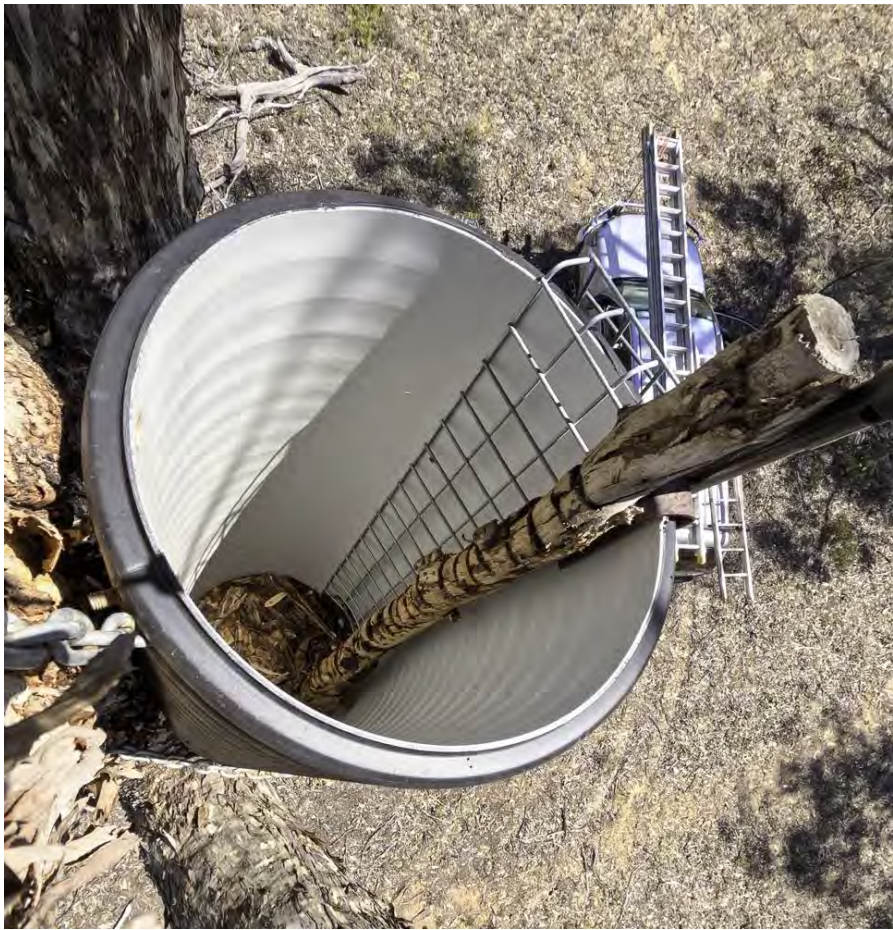
Artificial Hollow BY48

| Hollow # | Observations Oct 2025 | Observations Dec 2025 | Chipping 0-10 | Wood Chips Lts | Tree condition | Fixings | Recommend repairs |
|---|---|---|---|---|---|---|---|
| BY48 | No signs of nesting or inspection by Black Cockatoos | No signs of nesting or inspection by Black Cockatoos | 0 | Nil | Good | Good | Nil |

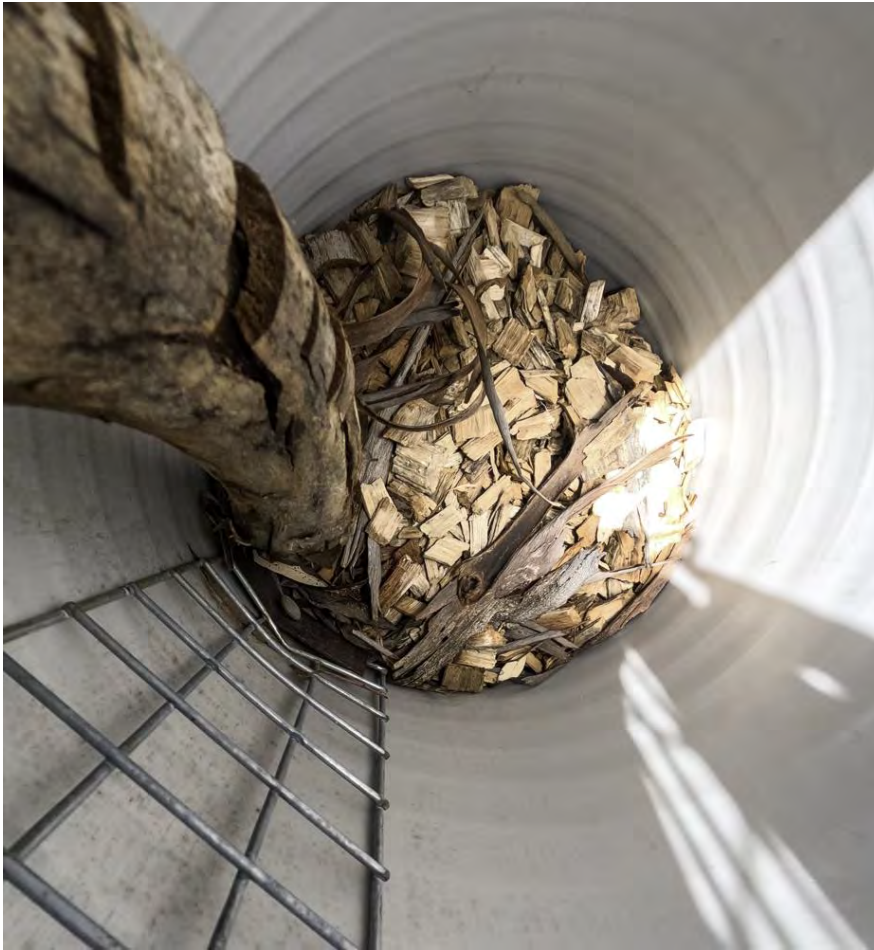
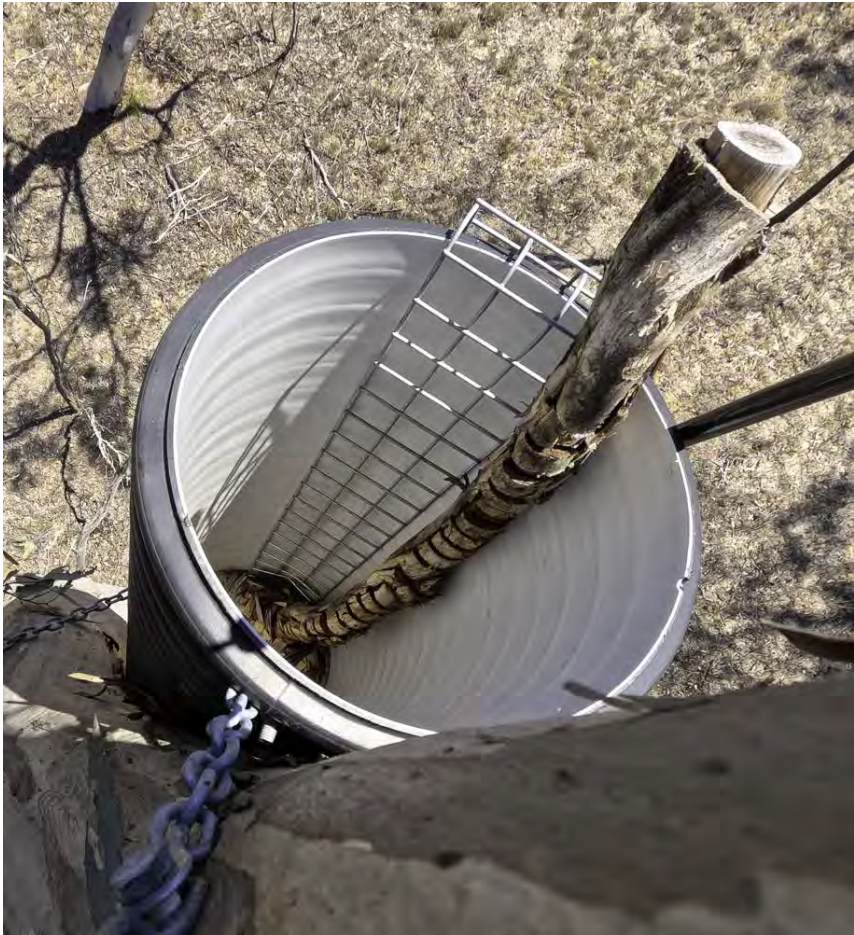
Artificial Hollow BY49

| Hollow # | Observations Oct 2025 | Observations Dec 2025 | Chipping 0-10 | Wood Chips Lts | Tree condition | Fixings | Recommend repairs |
|---|---|---|---|---|---|---|---|
| BY49 | No signs of nesting or inspection by Black Cockatoos | No signs of nesting or inspection by Black Cockatoos | 0 | Nil | Good | Good | Nil |

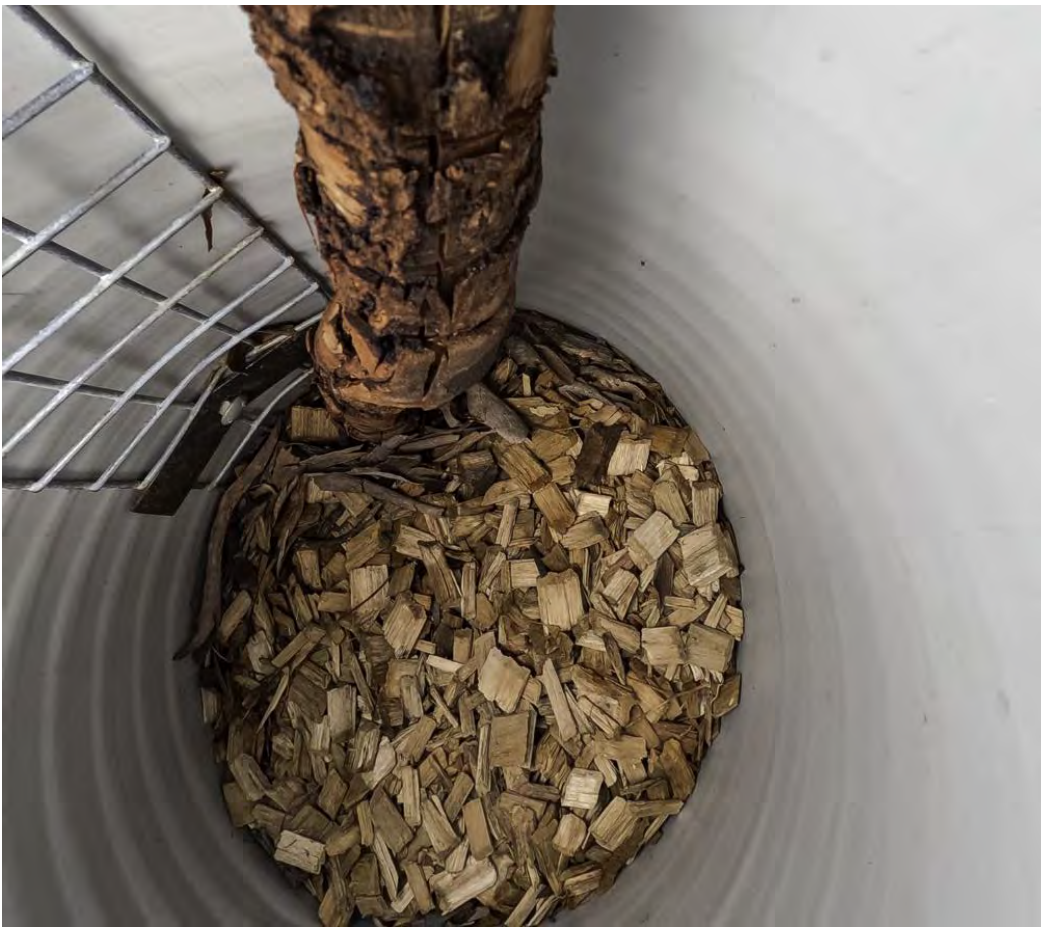
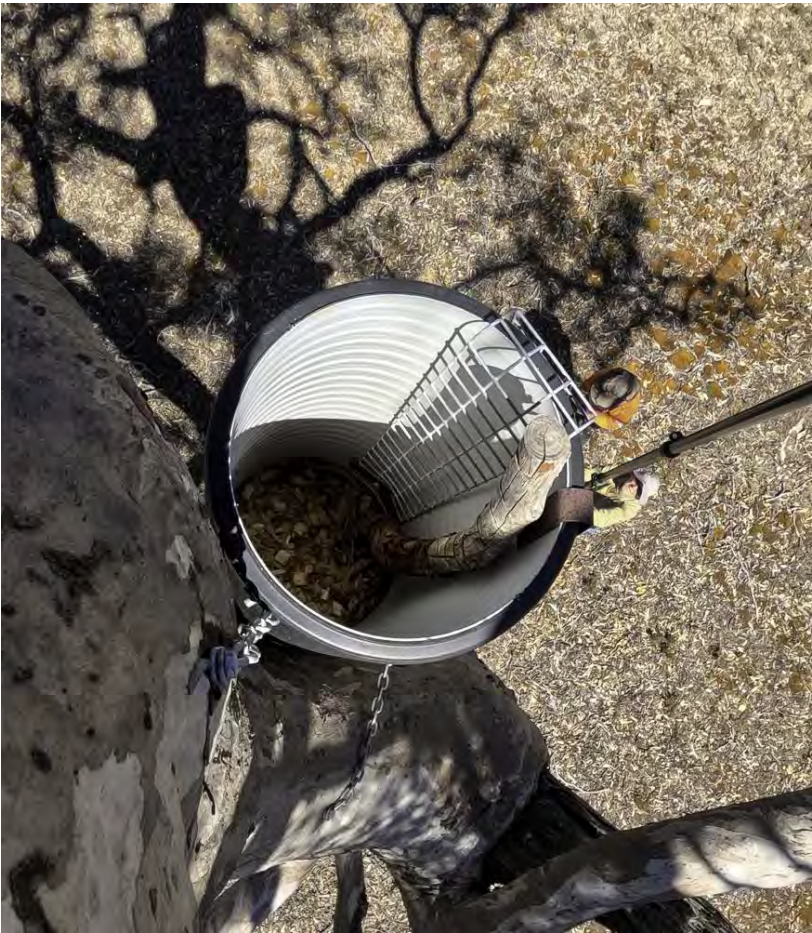
# Artificial Hollow BY50

| Hollow # | Observations Oct 2025 | Observations Dec 2025 | Chipping 0-10 | Wood Chips Lts | Tree condition | Fixings | Recommend repairs |
|---|---|---|---|---|---|---|---|
| BY50 | No signs of nesting or inspection by Black Cockatoos | No signs of nesting or inspection by Black Cockatoos | 0 | Nil | Good | Good | Nil |

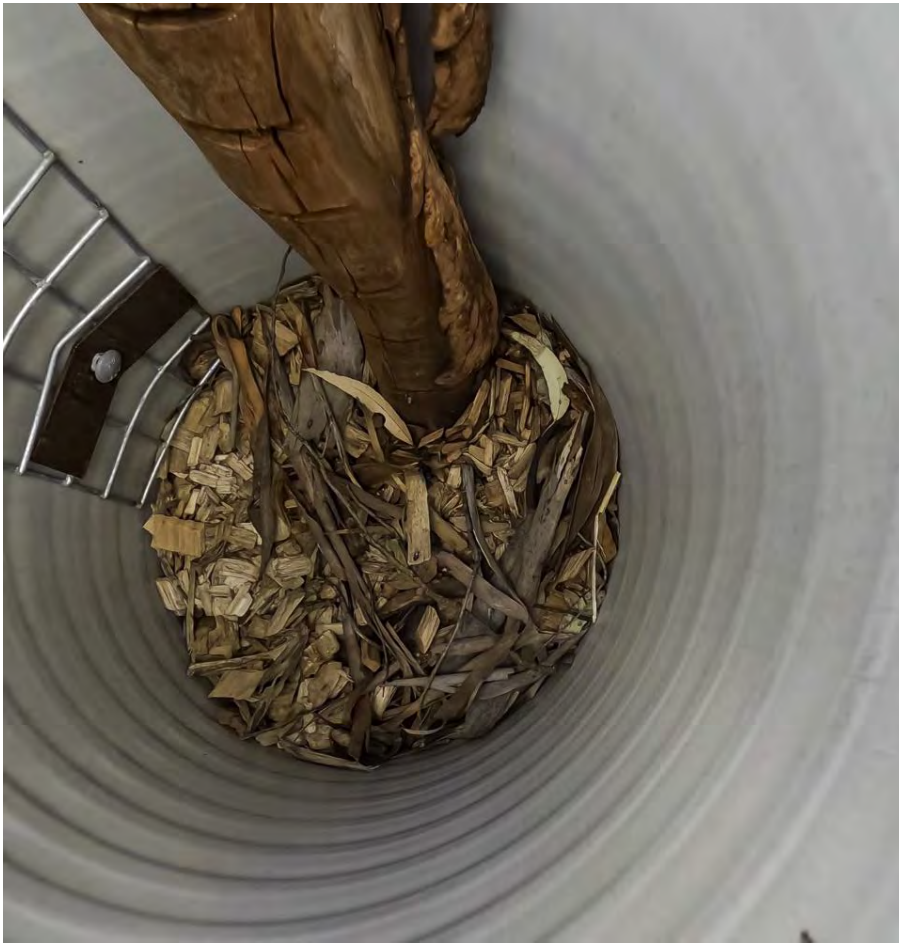
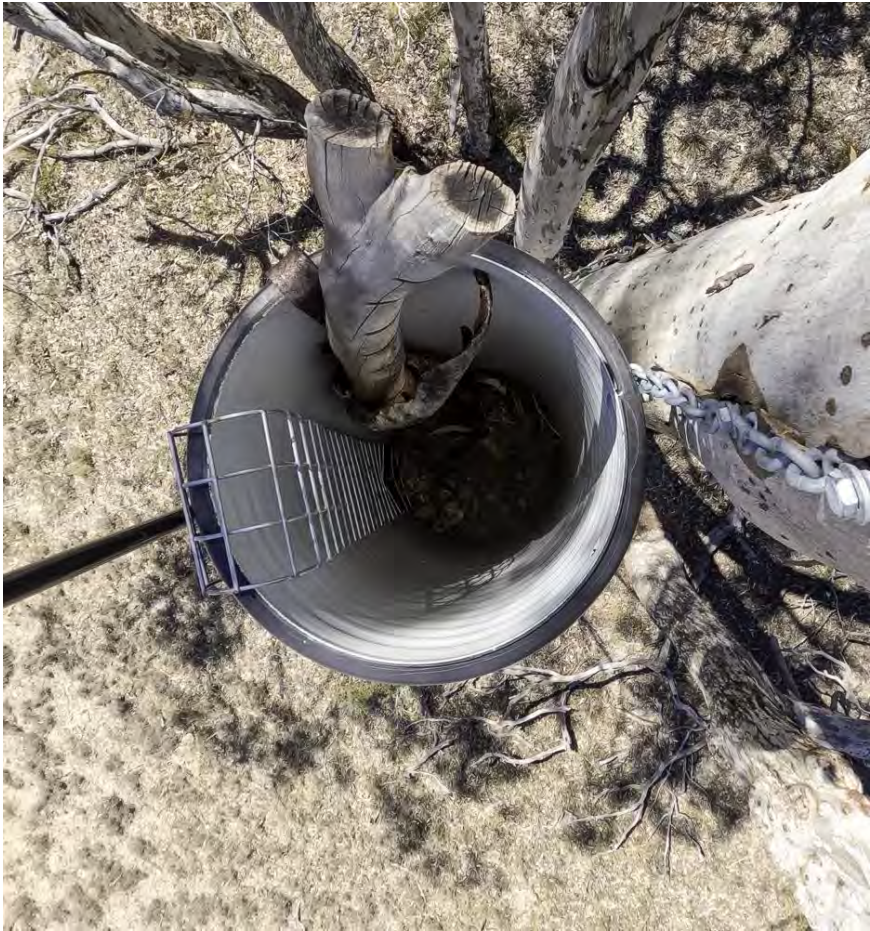
# Artificial Hollow BY51

| Hollow # | Observations Oct 2025 | Observations Dec 2025 | Chipping 0-10 | Wood Chips Lts | Tree condition | Fixings | Recommend repairs |
|---|---|---|---|---|---|---|---|
| BY51 | No signs of nesting or inspection by Black Cockatoos | No signs of nesting or inspection by Black Cockatoos | 0 | Nil | Good | Good | Nil |
