# Great Northern Highway Muchea to Wubin Upgrade - Stage 2

## Muchea North Construction Environmental Management Plan

<b>Document Number:</b>	GNH-CN03-EN01-RPT-0015
<b>Revision:</b>	4
<b>Phase:</b>	Stage 2
<b>Date:</b>	22 / 10 / 2018
<b>Contract Number:</b>	CN03-EN01
<b>Client Contract Number:</b>	187/15

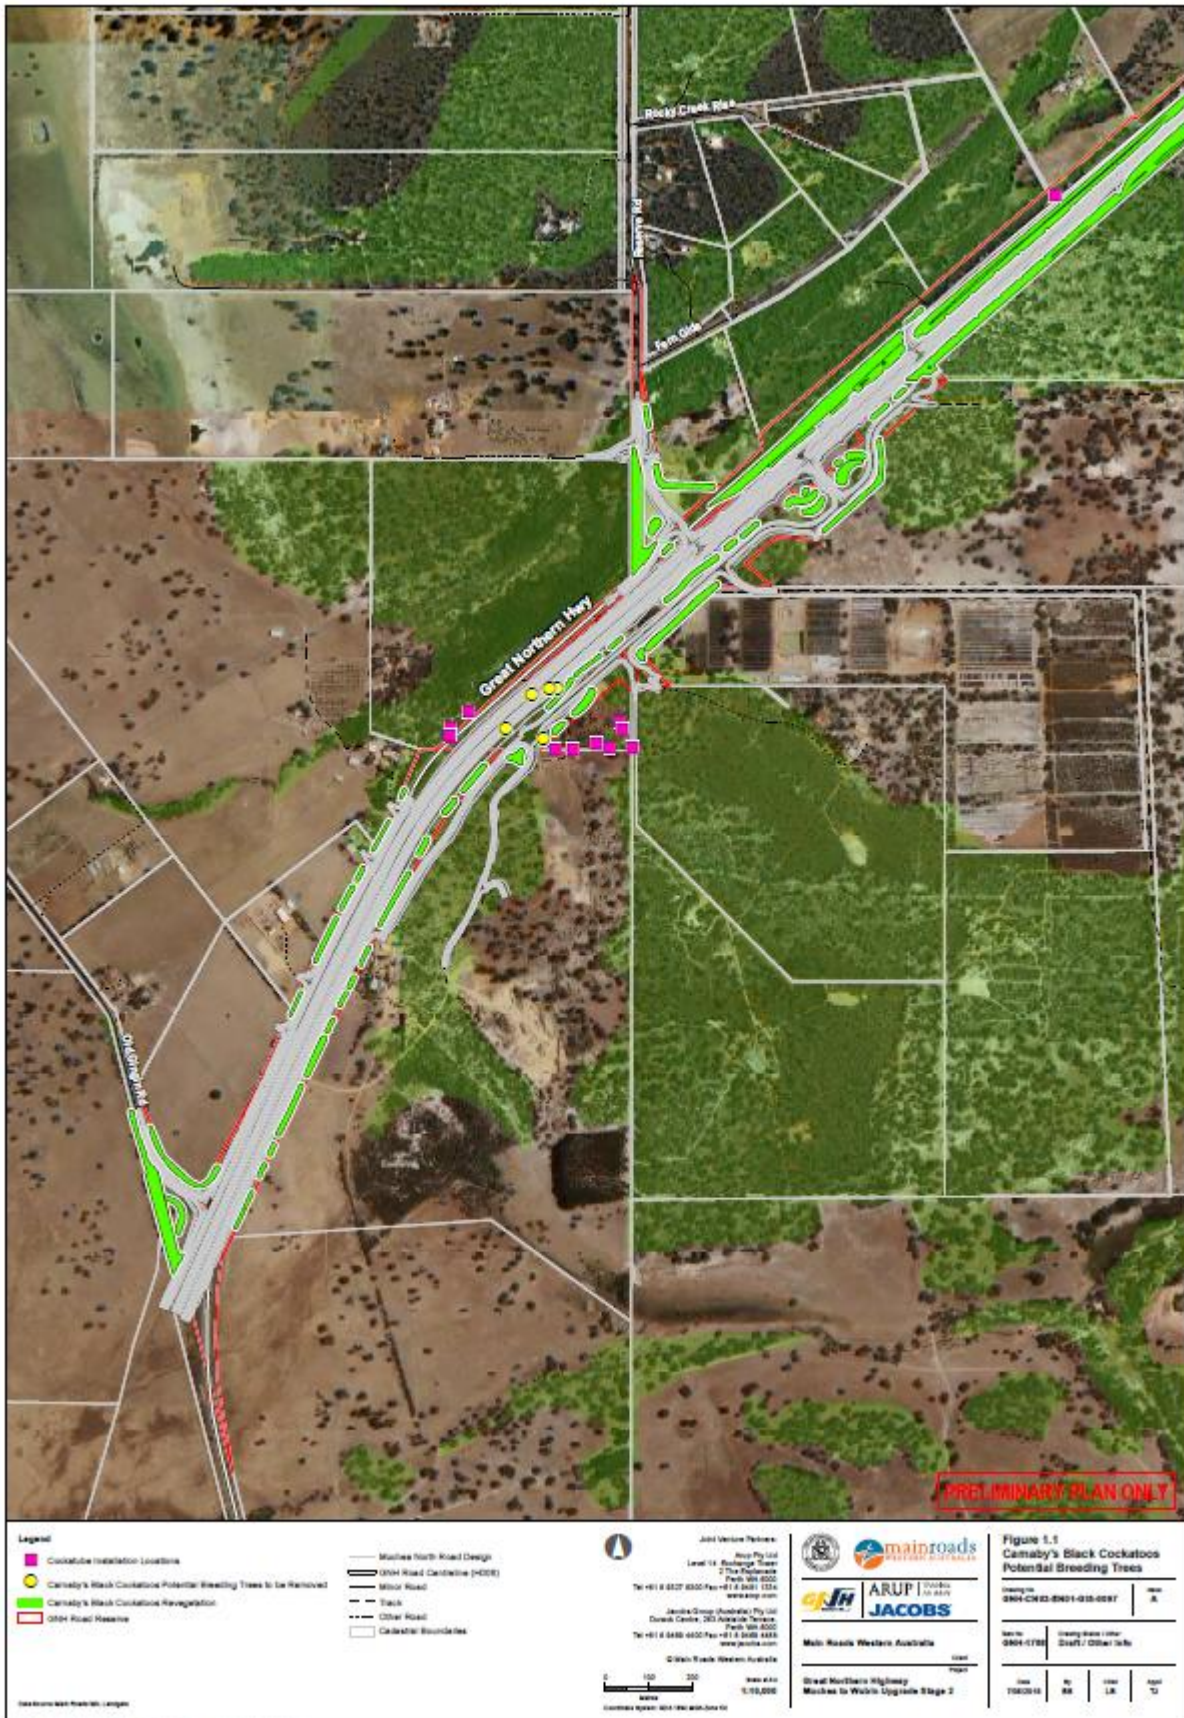
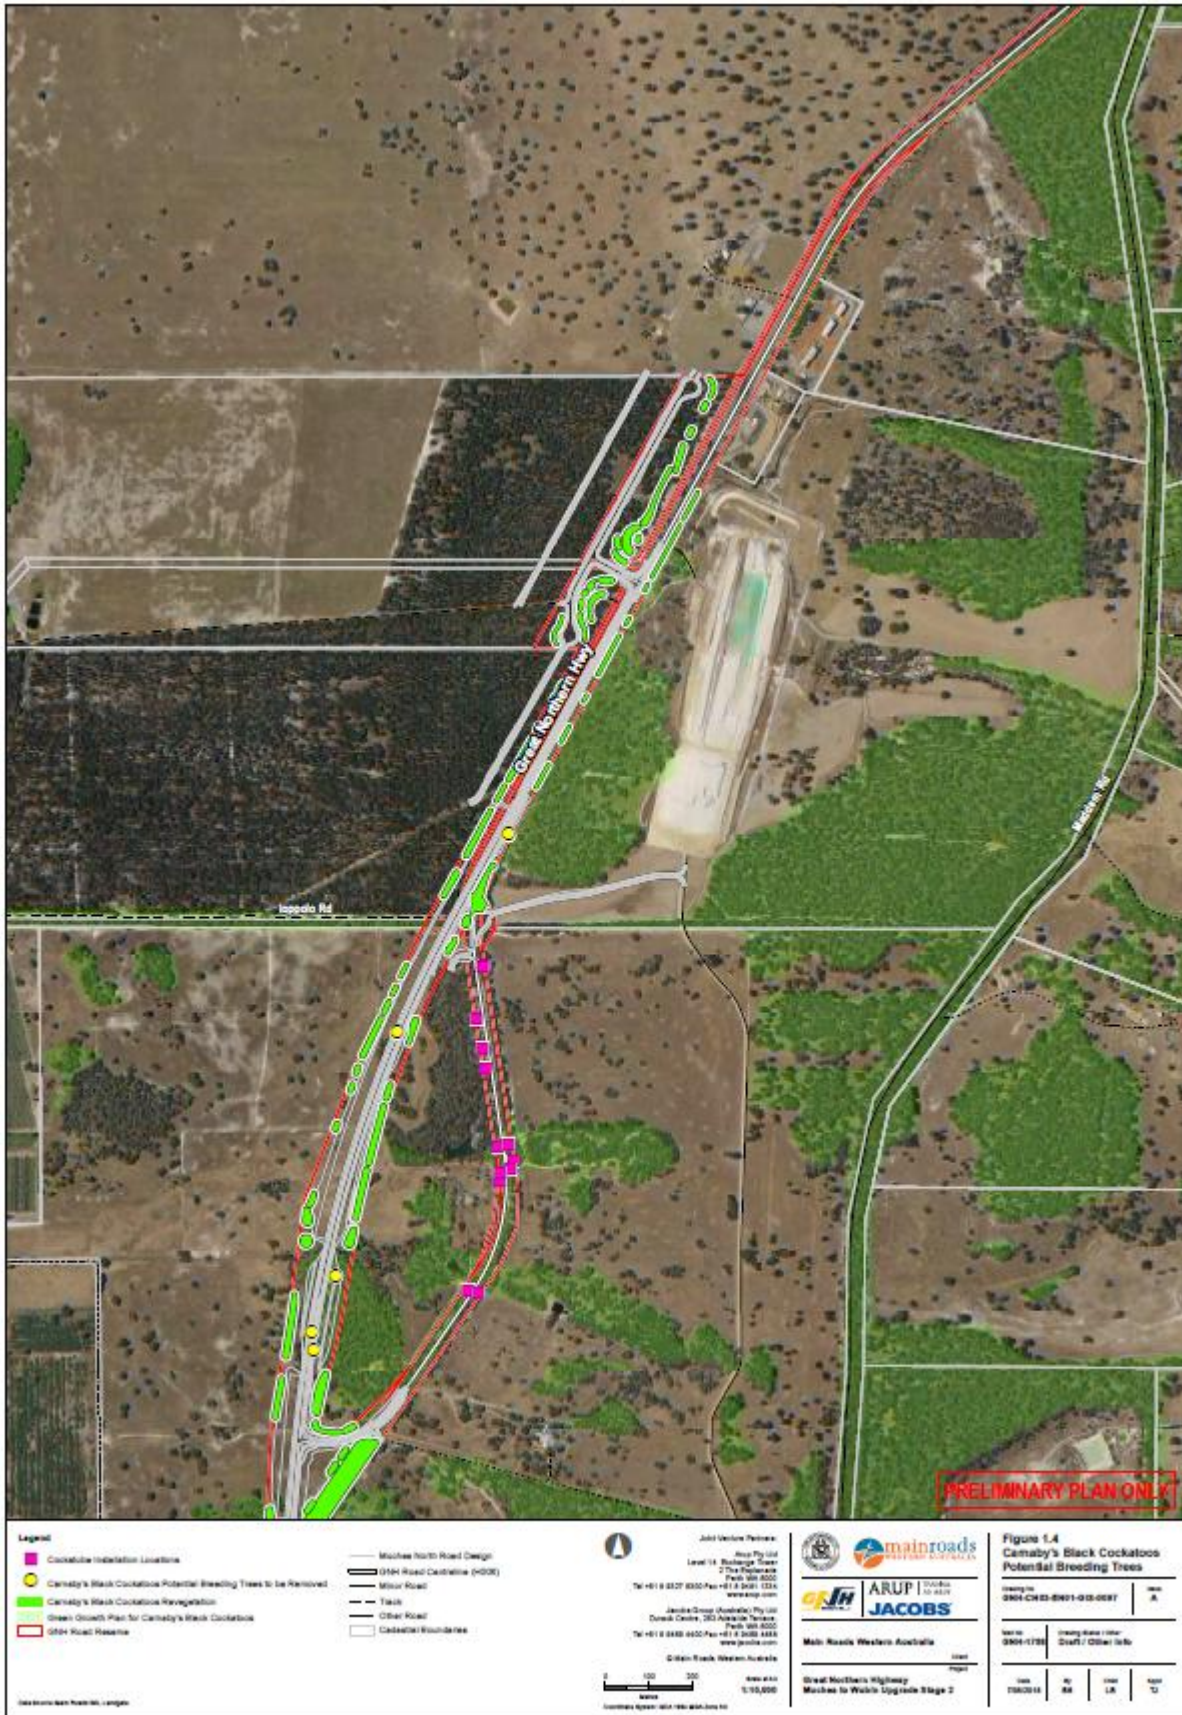
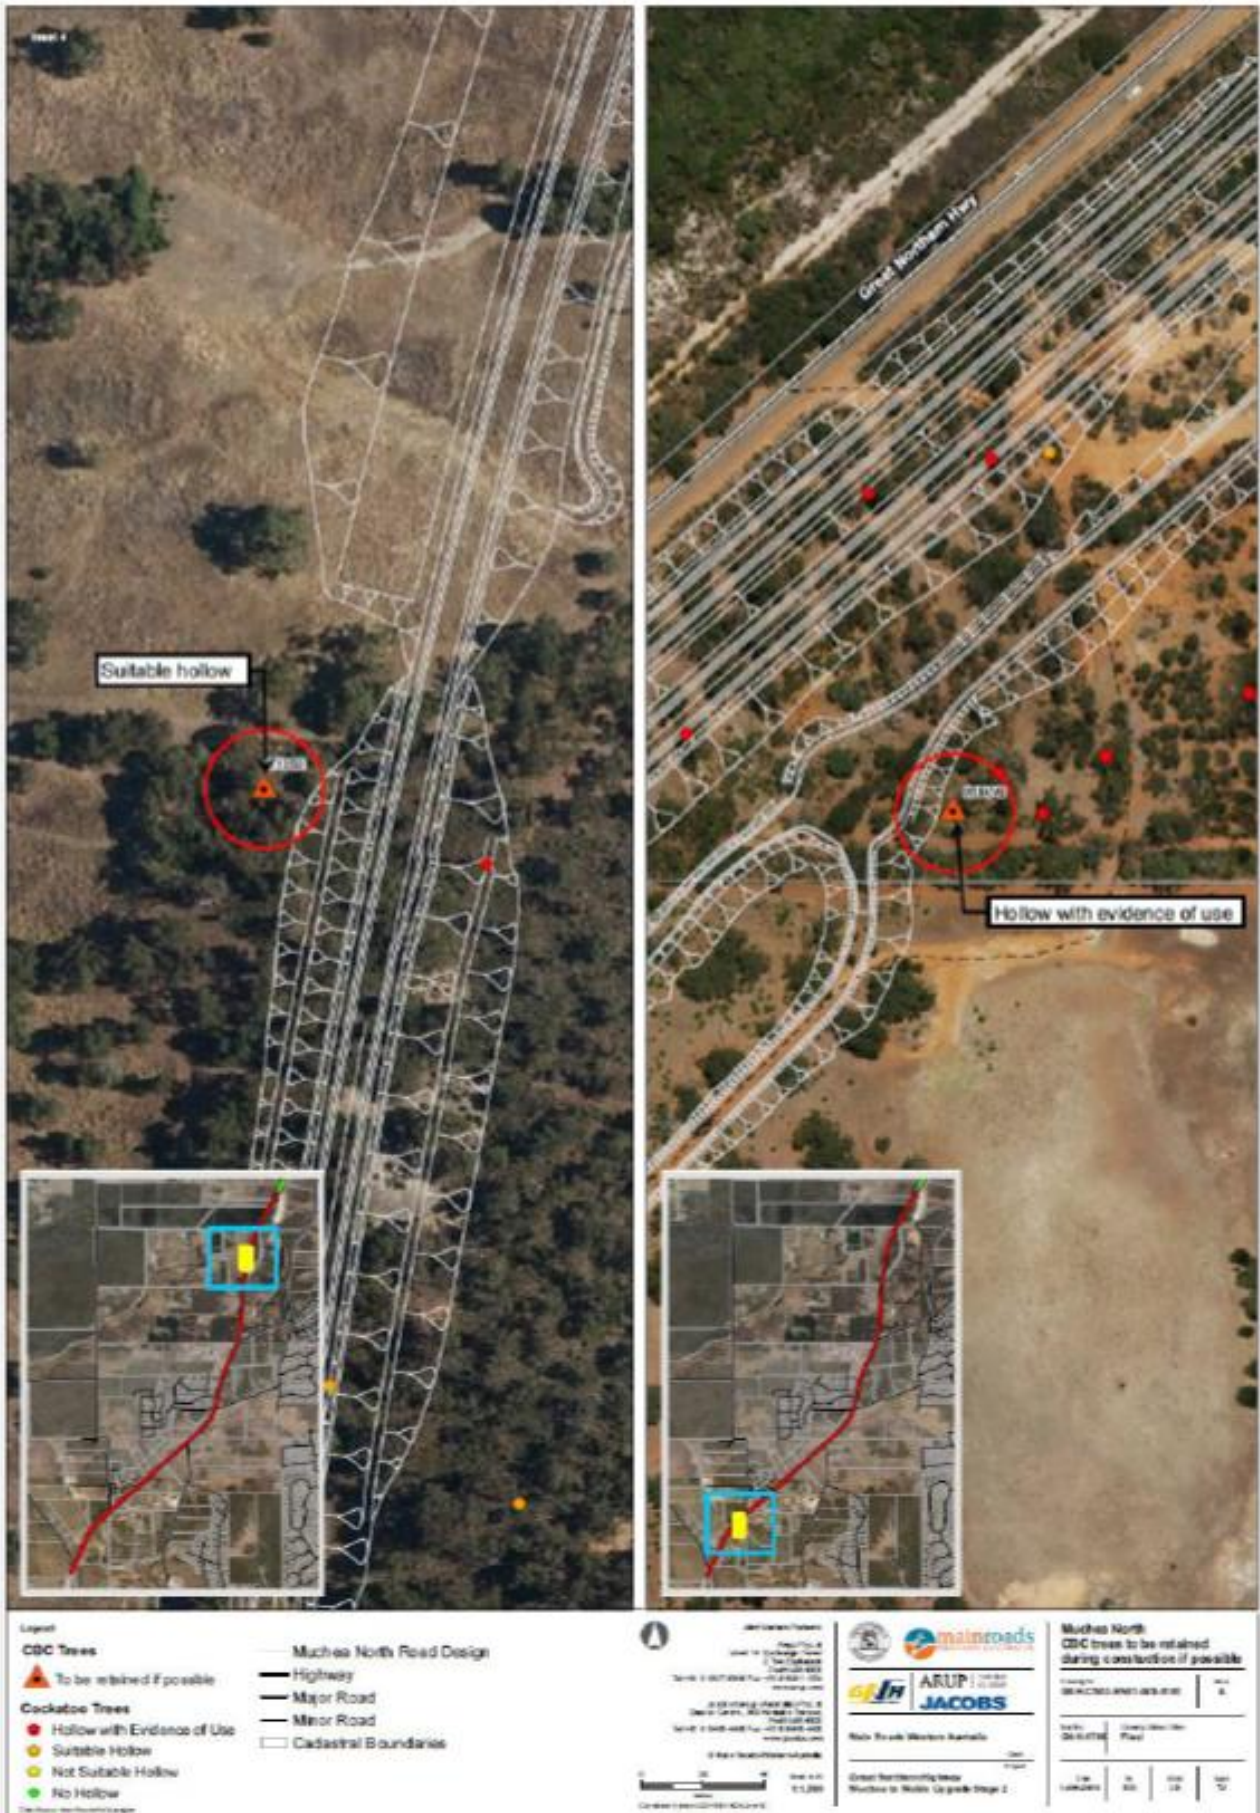
Figure 2-3 - Location of Nesting Hollows

1. HT00025 (406598E, 6510735N) – *Corymbia calophylla*, worn hollow
2. HT04059 (409566E, 6517603N) – *Eucalyptus wandoo*, nestbox with chewing on sacrificial post
3. HT05907 (40489E, 6508969N) – *Eucalyptus marginata*, slightly worn hollow, possible Carnaby's Black Cockatoo hollow but not much chewing at entrance
4. HT06071 (407871E, 6511728N) – *Eucalyptus wandoo*, well-worn hollow in large branch of large habitat tree
5. HT06261 (404998E, 6509195N) – *Eucalyptus wandoo*, good hollow at 10 metre (m) with chewing marks but Galahs present, hollow at 10 m.
6. HT06421 (408325E, 6512584N) – *Corymbia calophylla*, well chewed hollow at 10 m
7. HT08751 (404949E, 6509158N) – *Eucalyptus wandoo*
8. HT08752 (405059E, 6509287N) – *Eucalyptus wandoo*
9. HT08753 (409125E, 6516486N) – *Eucalyptus wandoo*.

The location of these hollows is depicted in Attachment 1, and 2 of 2016-7656 and reproduced in Figure 2.3.
