**NorthLinkWA**  
Perth-Darwin National Highway

# Ioppolo Road Site Land Acquisition and Management Plan

Perth-Darwin National Highway (Swan Valley Section)

**Linear *Phytophthora* Dieback Risk Assessment of  
M2091 Ioppolo Road, Chittering**

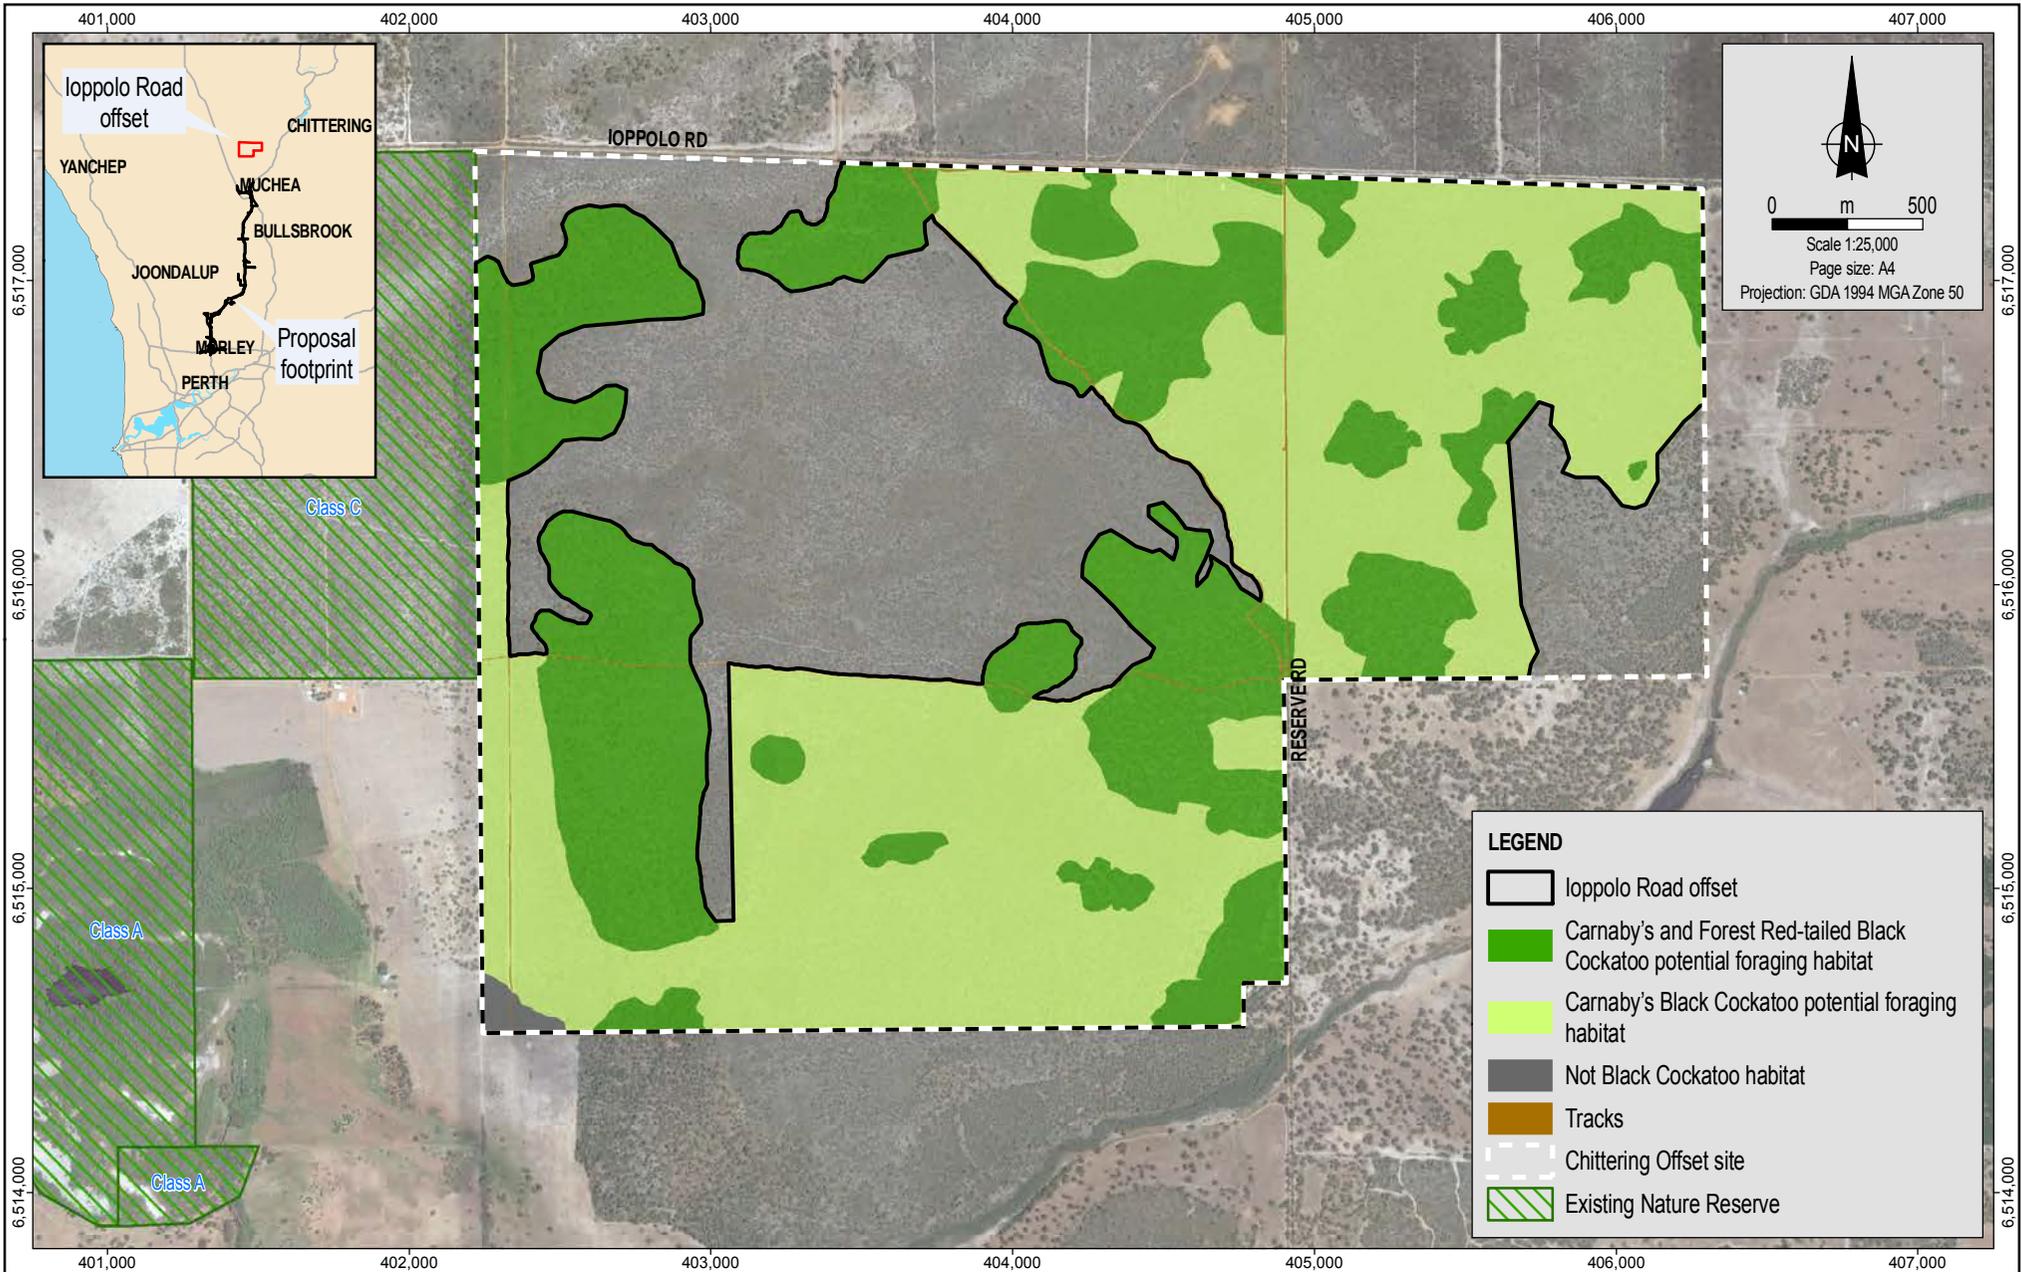
Figure No:  
 1

Source & Notes  
 Significant vegetation and broad habitat mapping from Coffey (February 2015).  
 Existing Nature Reserves from DPAW (January 2015).  
 Roads from MRWA (2012).  
 Aerial Imagery from Google Earth Pro (10 January 2015).

Ioppolo Road Offset Site

At least 673.5 ha of Carnaby's Black Cockatoo foraging habitat was identified in Ippolo Road (see Figure 1) associated with Eucalypt Woodland (279.2 ha) and Banksia Woodland (394.4 ha). The site contains 17 species of foraging resources, including the following dominant species: *Eucalyptus marginata*, *E. todtiana*, *Corymbia calophylla*, *Allocasuarina humilis*, *Banksia menziesii* and *B. attenuata*.

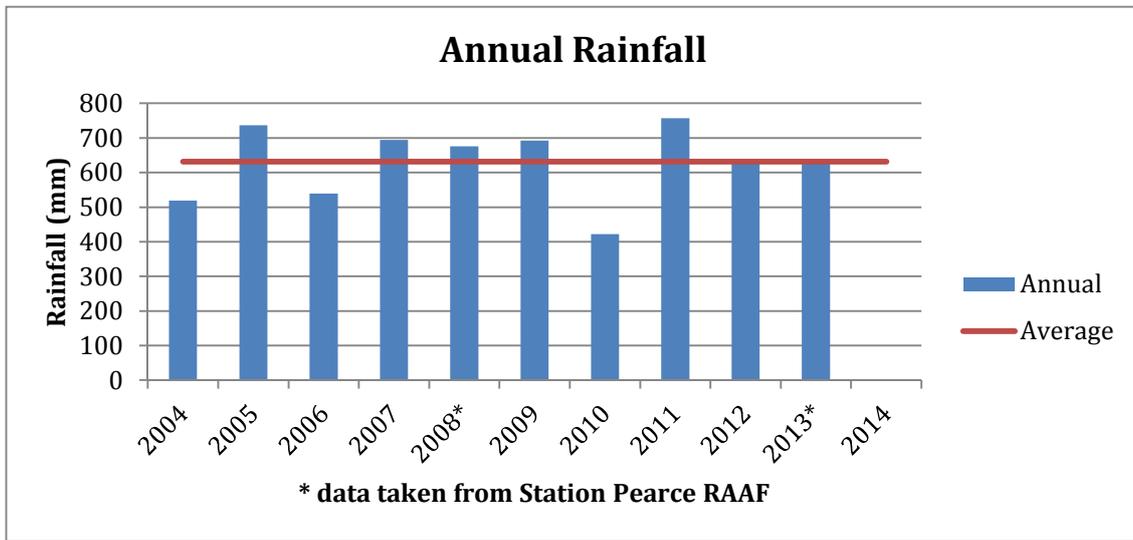
Graph 1: Annual rainfall at Gingin Aero station # 9178 (BoM, 2014)

Based on data from the Gingin Aero station (# 9178), the average annual rainfall for Muchea is 631.7 mm. The seasonal rainfall pattern for Muchea indicates an overall reduction in rainfall compared to historical averages, but exhibits variability in this trend, with years of significantly reduced rainfall interspersed with years of average to slightly above average rainfall (**Graph 1**). Significantly, the rainfall for 2010 was only 422 mm, which is 33% below average annual rainfall.

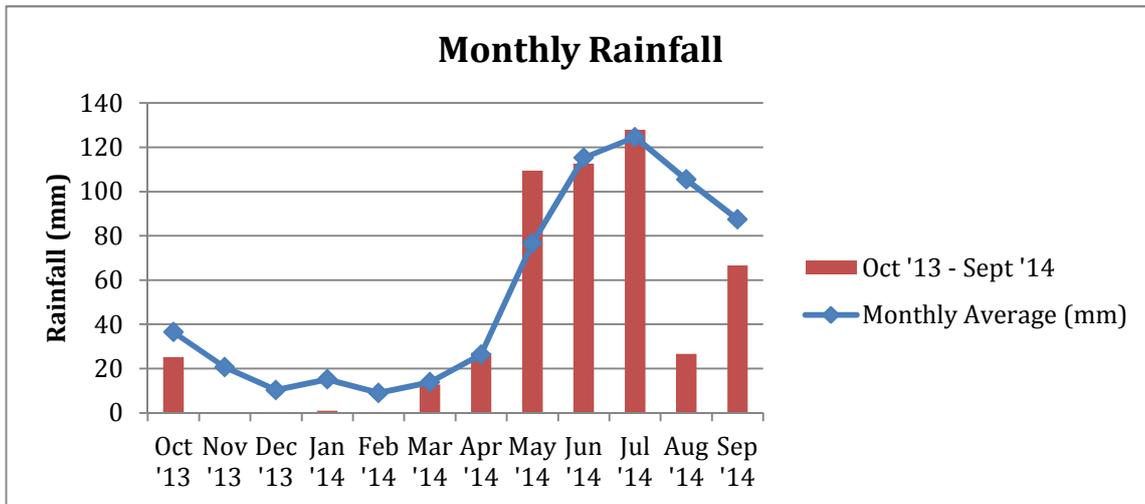
Graph 2: Monthly rainfall at Gingin Aero station (# 9178) (2013-14) (BOM, 2014)

Most rain falls in the cooler months of June-August. During winter 2014, this station received average or above-average rainfall until July, but a significant drop in rainfall was recorded during August and September compared to the long-term average.

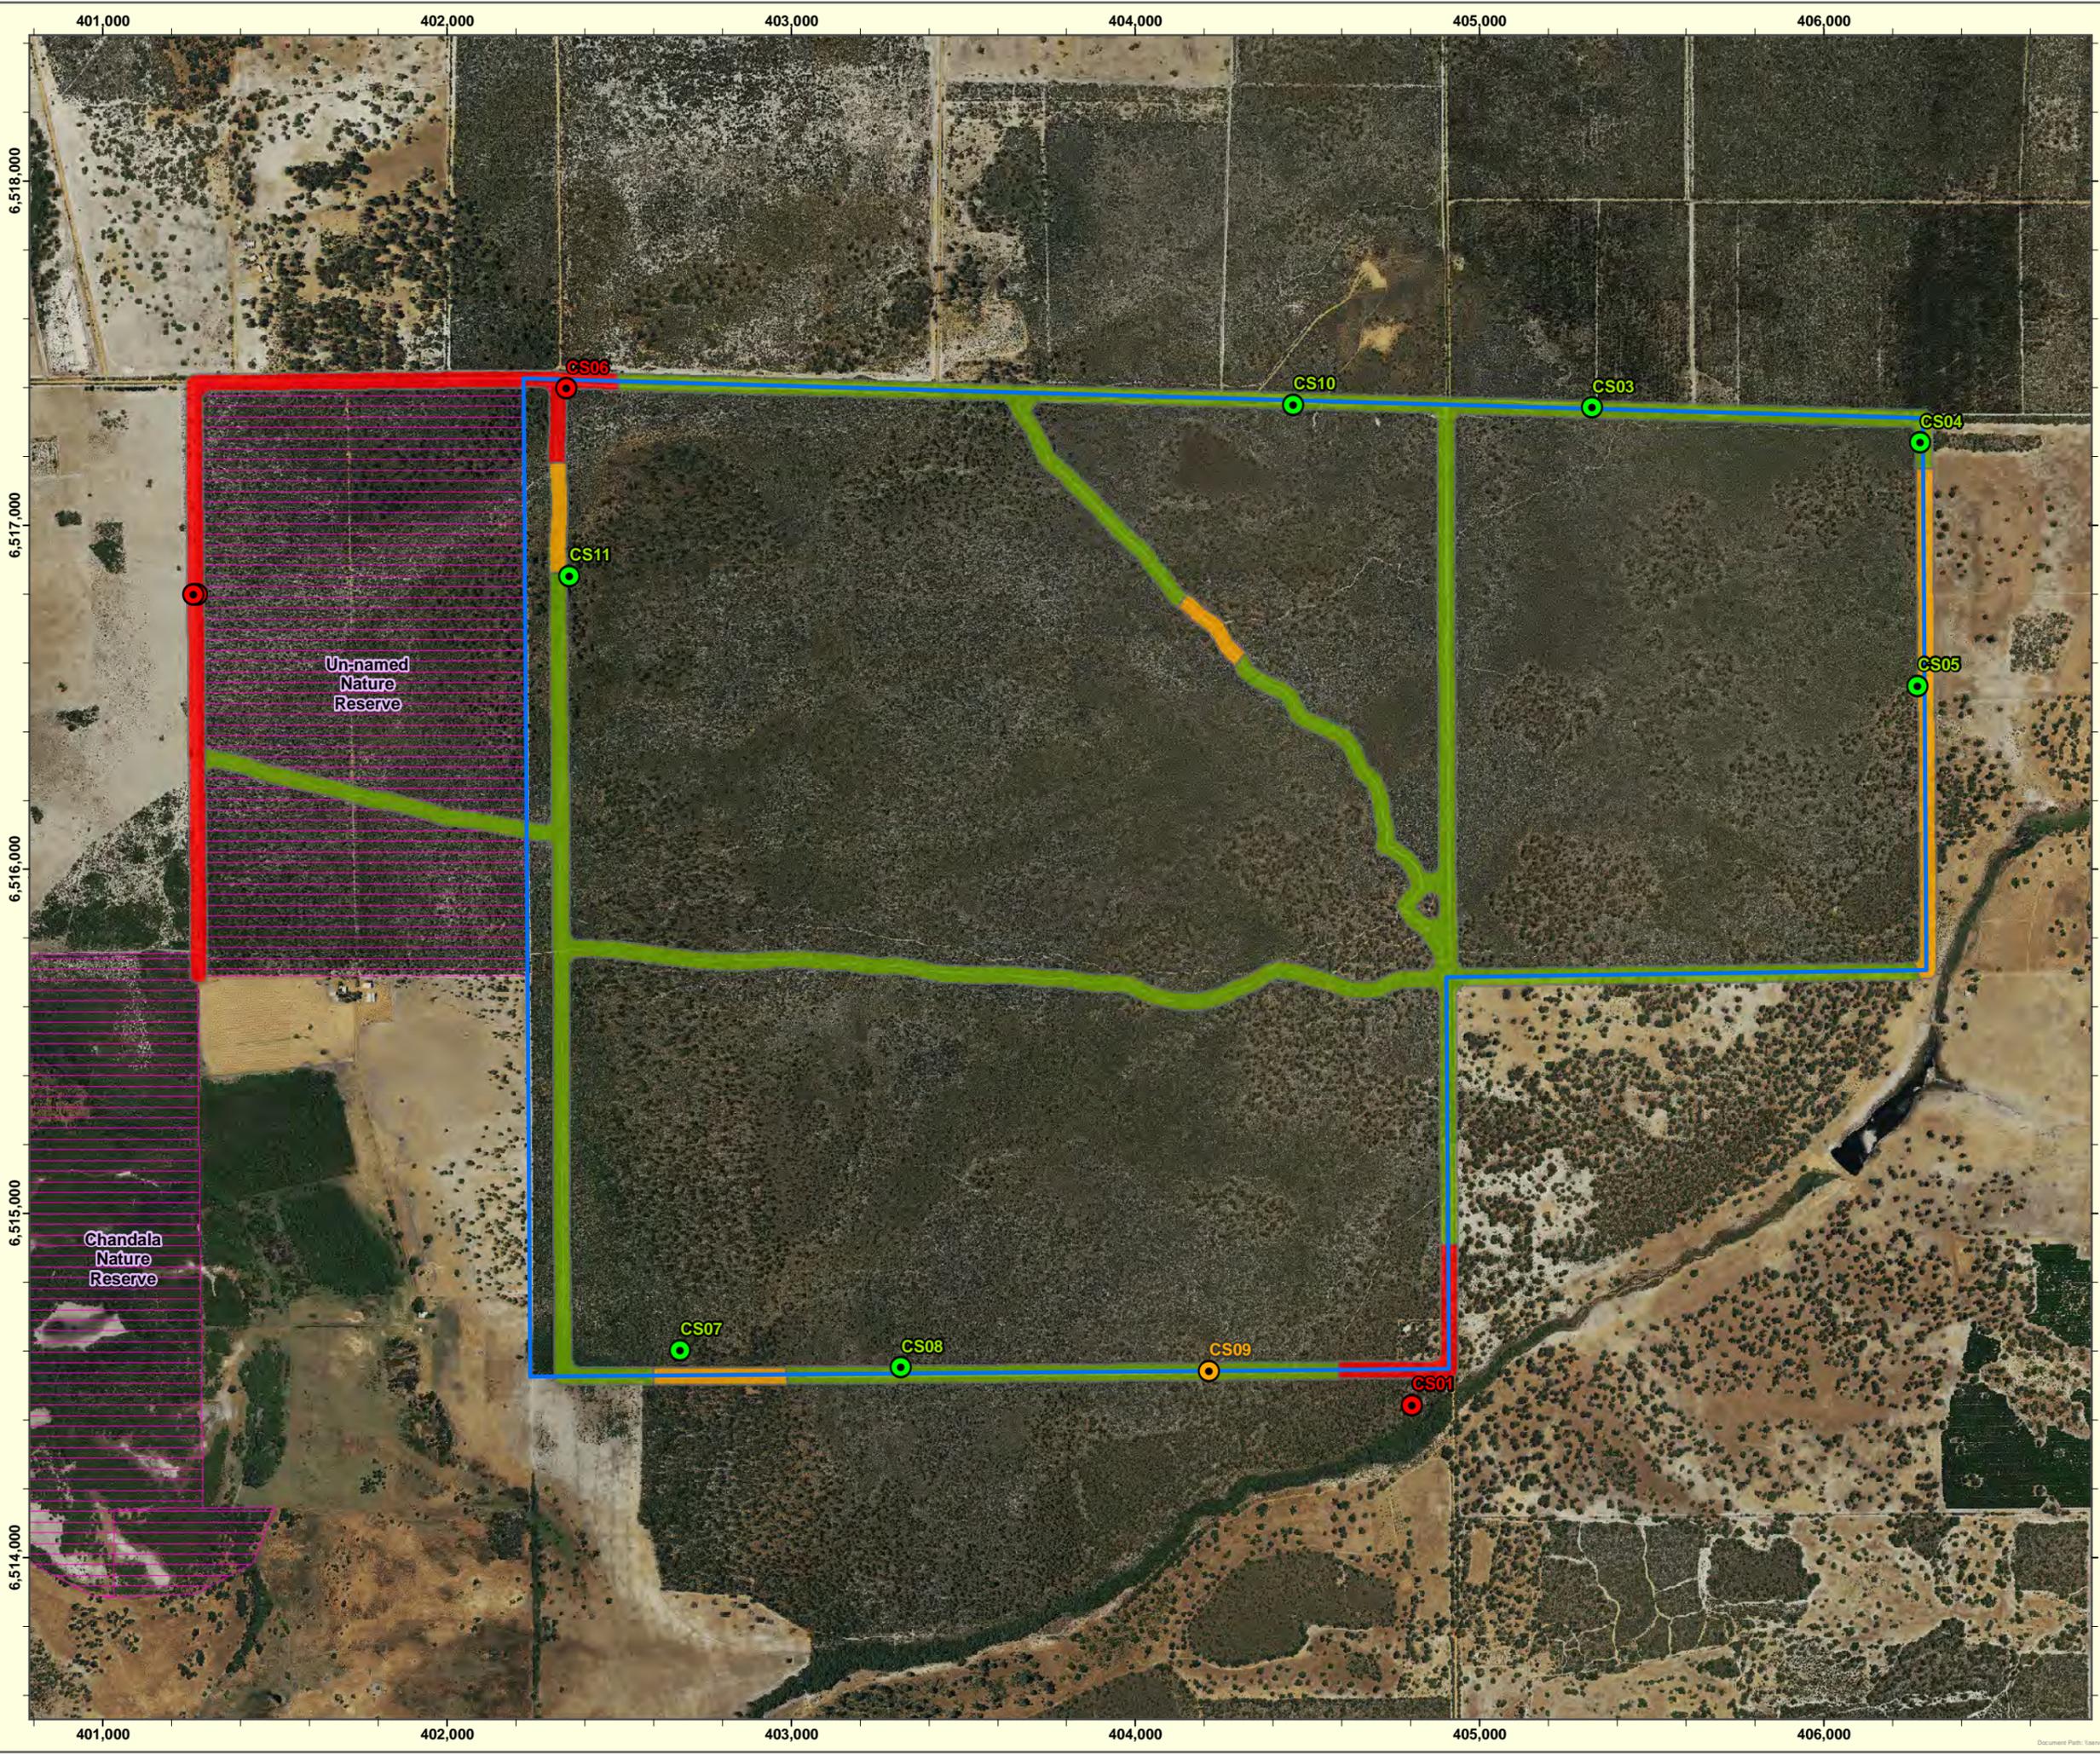
Scale @ A3: 1:17,500	Figure 02
Date: 22/09/2014	 
Revision: Rev C	
Project No: TS14013	
Prepared: R Cullen	
Checked: J Botterill	
Reviewed: N King

**Dieback risk assessment**

- High
- Moderate
- Low

**LINEAR DIEBACK RISK ASSESSMENT AND SAMPLE RESULTS**  
**Chittering Dieback Reconnaissance Survey**

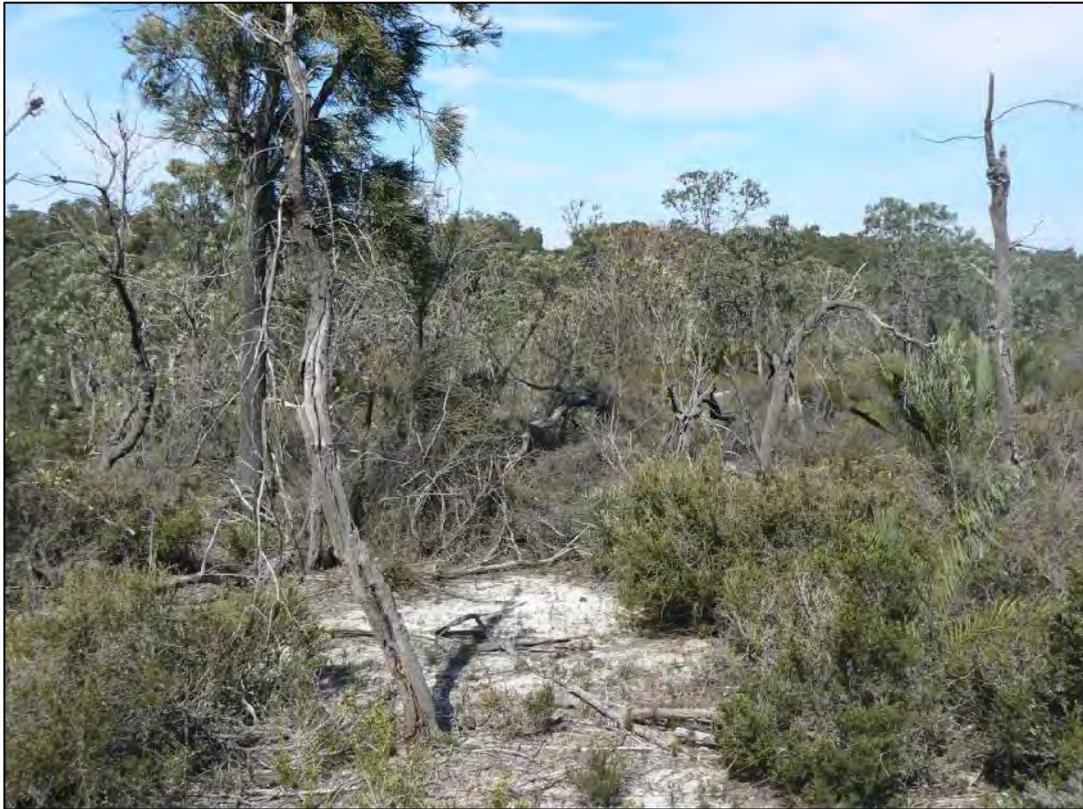
**Plate 1: High risk vegetation: Infested *Banksia* woodland with multiple indicator species deaths, disease pattern and chronology**

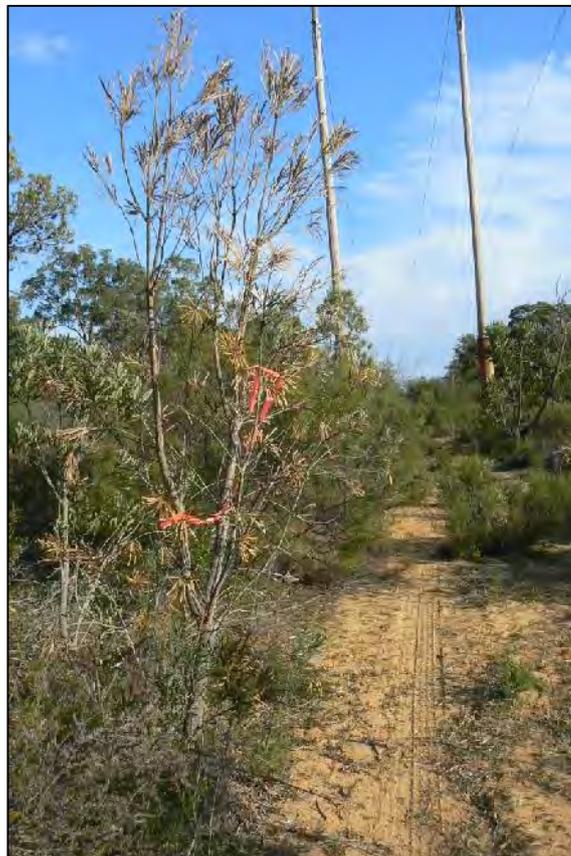
**Plate 2: Dead *Banksia attenuata* adjacent to disease vector (power line access track)**

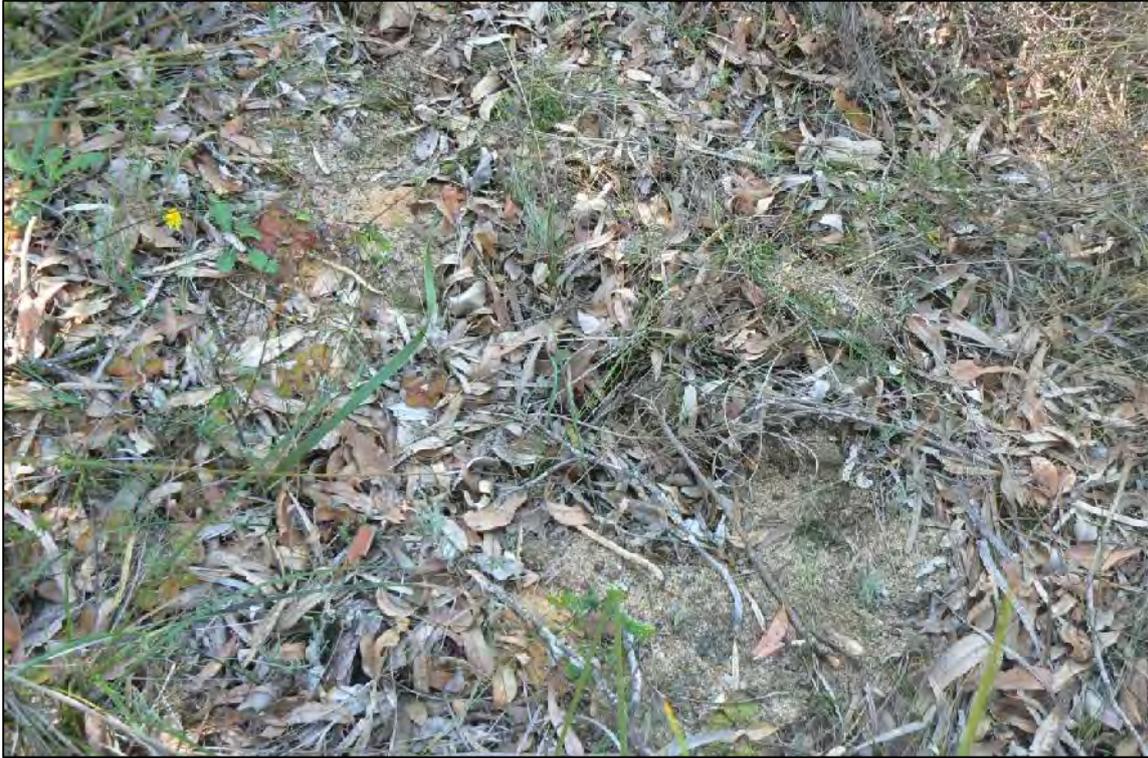
**Plate 3: Evidence of feral pig activity, a likely vector for the positive *P. cinnamomi* sample**

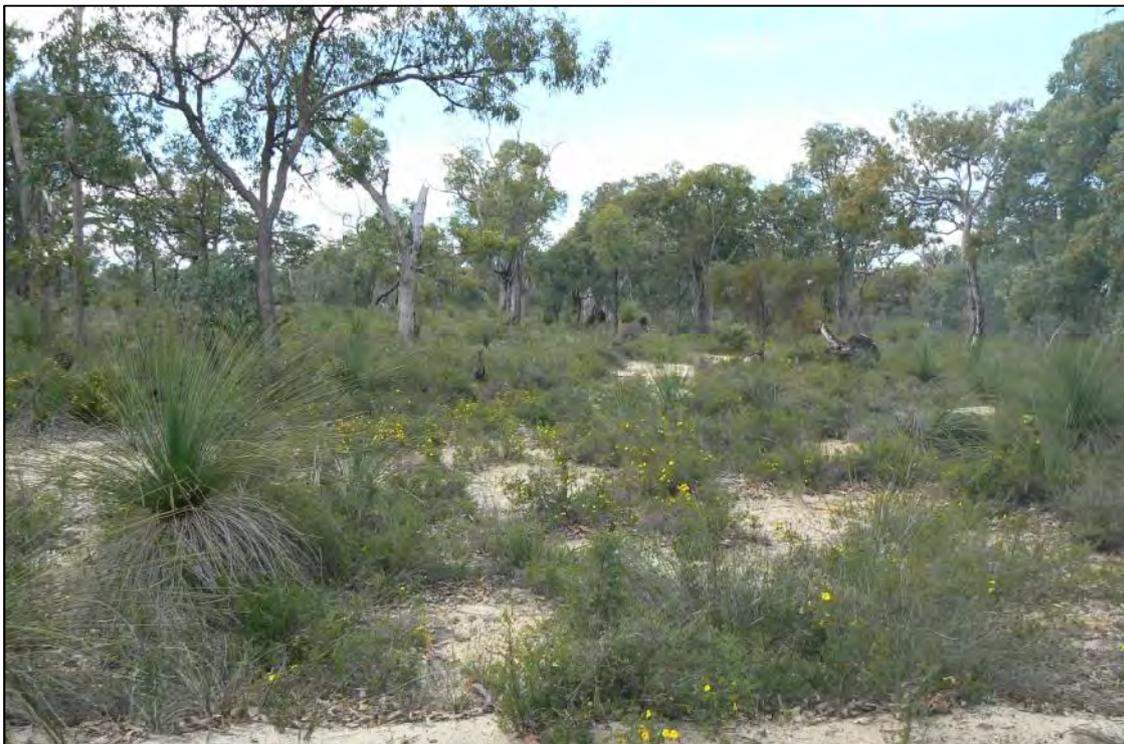
**Plate 4: Medium risk vegetation - Area at risk due to historical disturbance due to logging, nearby areas of Infested vegetation and indicator species deaths.**

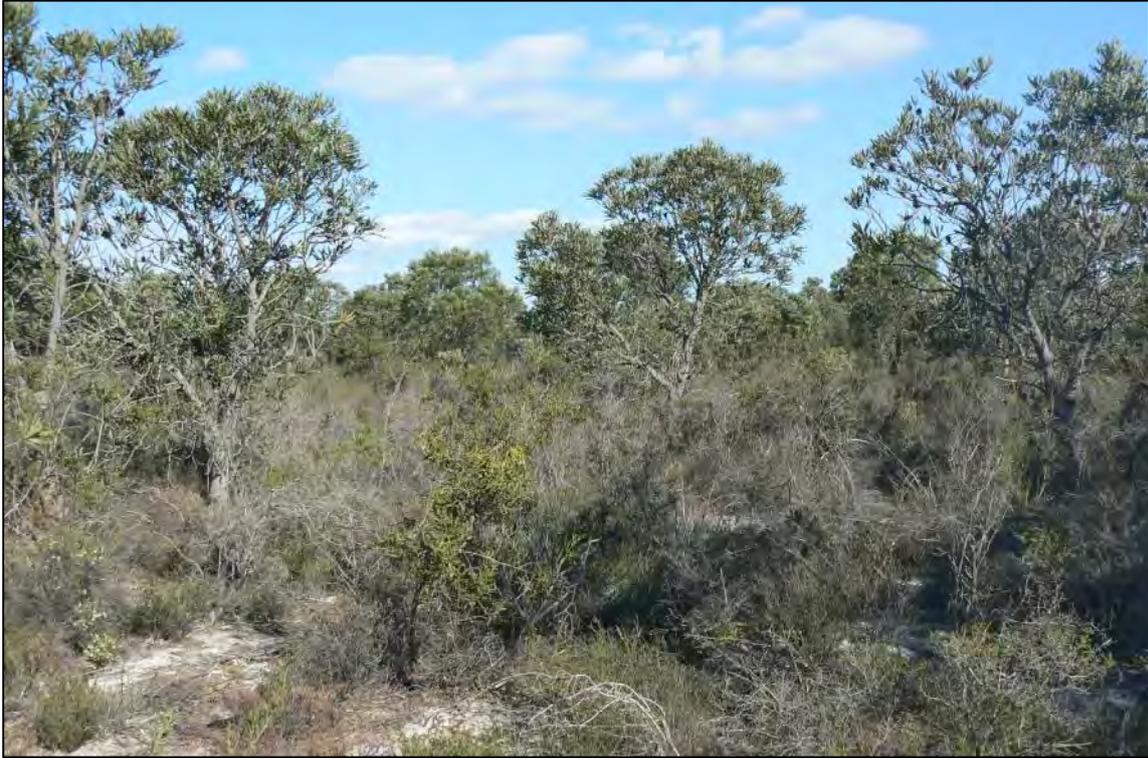
Plate 5: Low risk vegetation - Uninfested woodland with low levels of disturbance and intact vegetation in Excellent condition

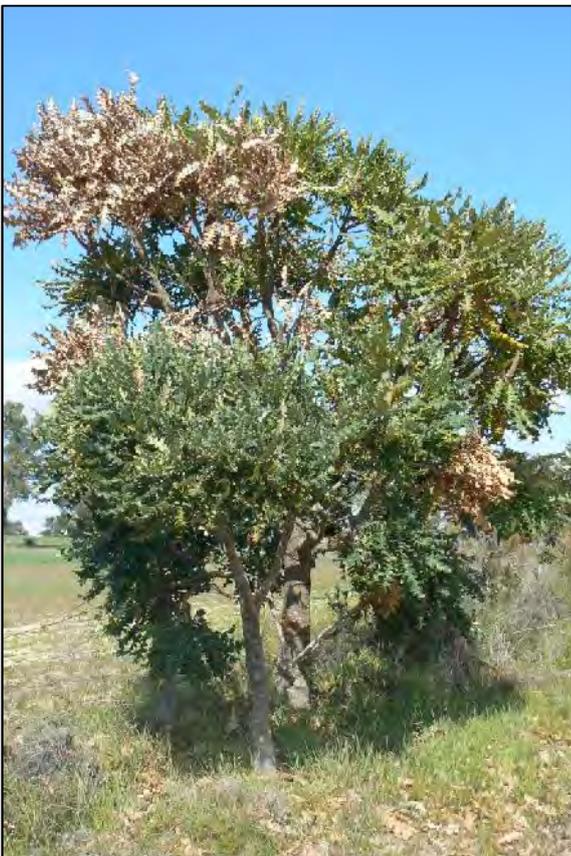
Plate 6: *Banksia grandis* exhibiting canker impacts

A tissue sample taken from a recently dead *Banksia grandis* was tested for the presence of canker at VHS. *Cytospora* sp. was recovered from the sample which is likely to indicate an inability of the plant to contain the fungi because this canker species can also be present on healthy plants (**Appendix 1**). *Banksia* species including *Banksia attenuata*, *B. grandis*, *B. prionotes* and *B. menziesii* displaying symptoms consistent with those described by Crane and Burgess, but not characteristic of *P. cinnamomi* disease expression, were observed throughout the study area. Canker impacts were observed throughout the study area and were generally discernible from Dieback symptoms by the death of single branches or lesions emanating above the trunk collar (**Plates 6, 7 & 8**).

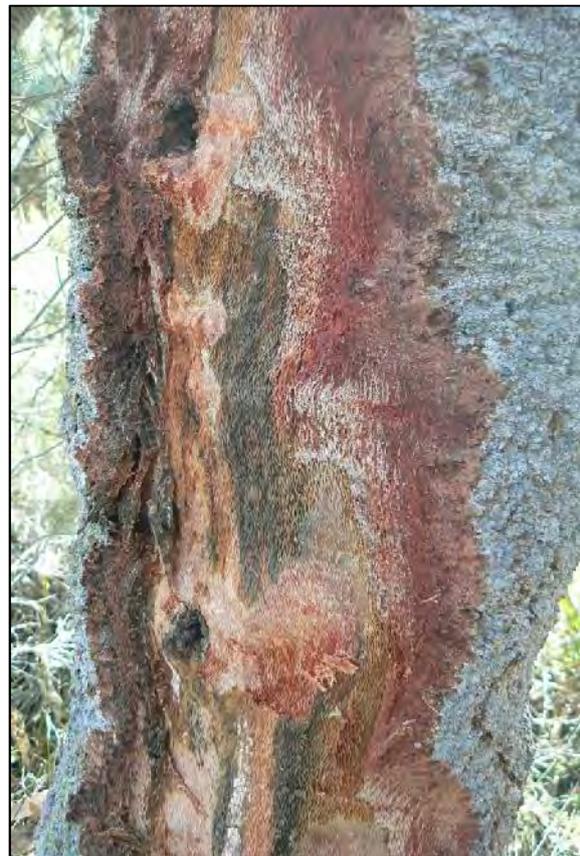
Plate 7: *Banksia* trunk exhibiting canker lesions on the cambium layer

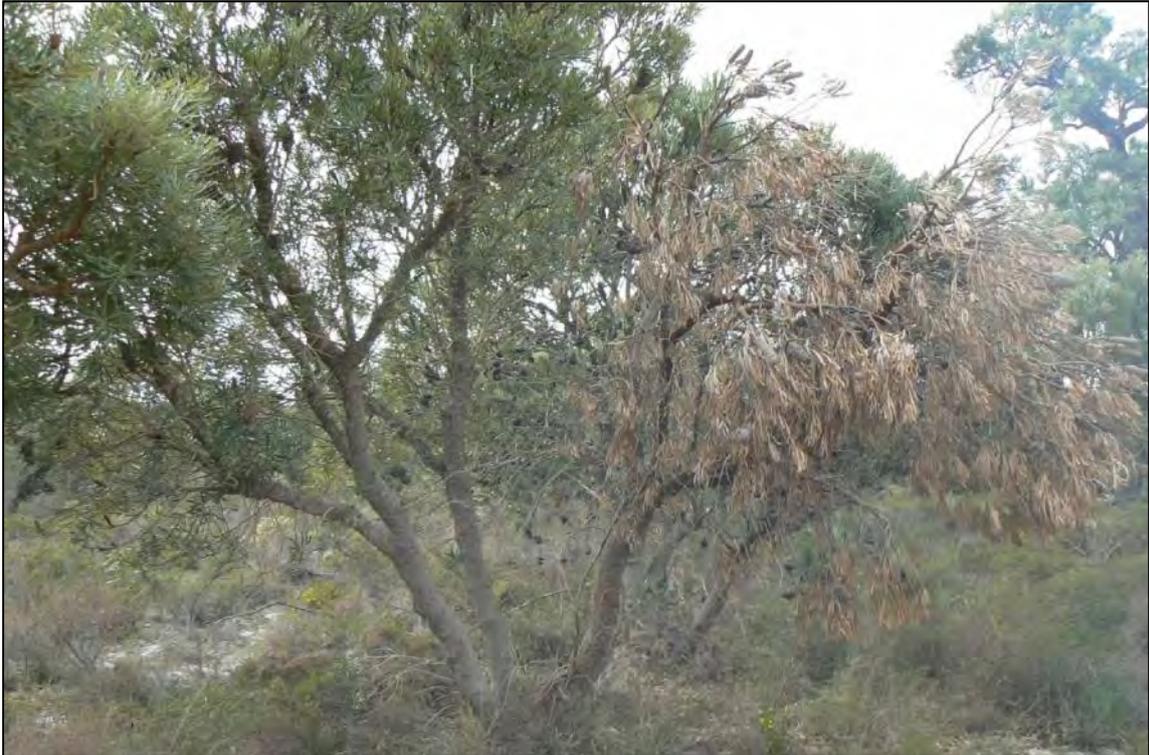
Plate 8: *Banksia attenuata* exhibiting partial death due to canker

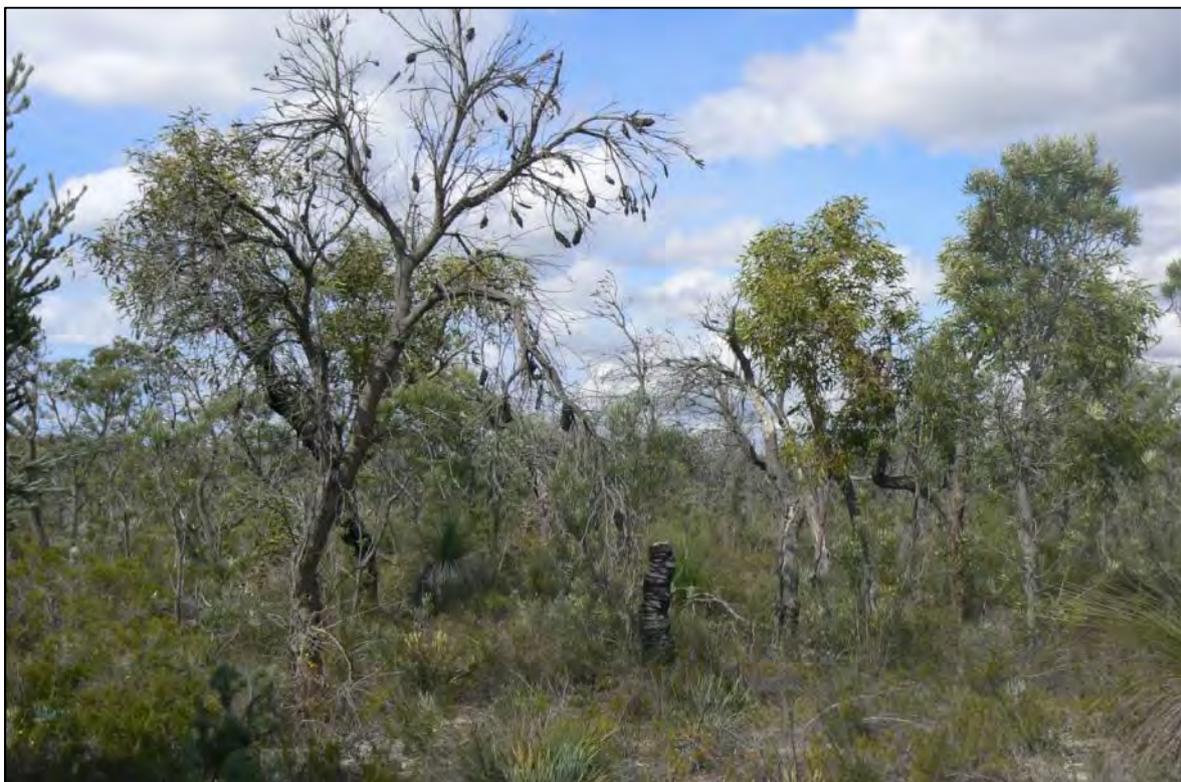
Plate 9: *Banksia* woodland exhibiting drought impacts

- No visible lesions or mycelium on the roots of the dead or dying plant.
- Re-shooting or epicormic growth visible on dying plants (**Plates 9 & 10**).

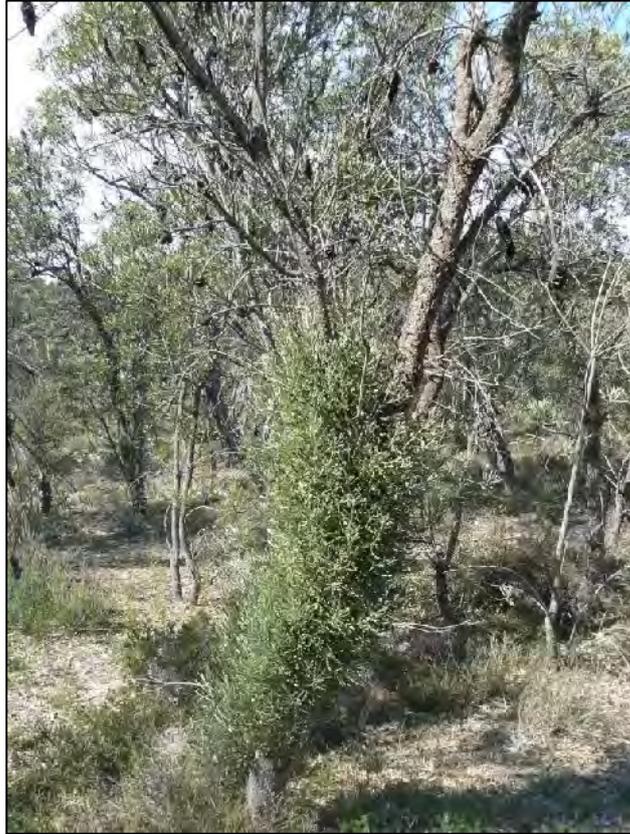
**Plate 10: *Banksia attenuata* re-shooting after drought impact**

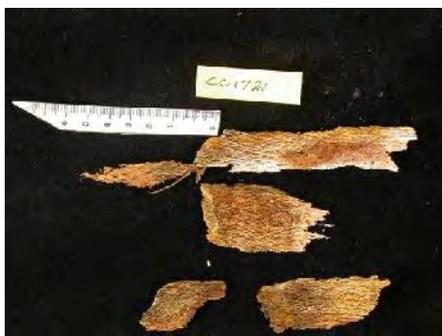
Fig. 1 sample

SAMPLE *Banksia grandis* canker CS 11 (canker) Fig. 1.

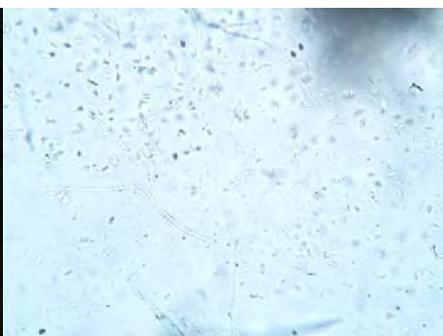
DIAGNOSIS A *Cytospora* sp. (Fig 2 & 3) was isolated and most likely indicates some inability of the plant to contain the fungi which can also be present on healthy plants.

Fig. 2 Curved conidia
