**MAIN ROADS WA**  
**Great Eastern Highway Bypass Interchanges Project: Targeted Carter's Freshwater Mussel Survey**  
**Figure 3.2: Carter's freshwater mussel sample sites and traverses**

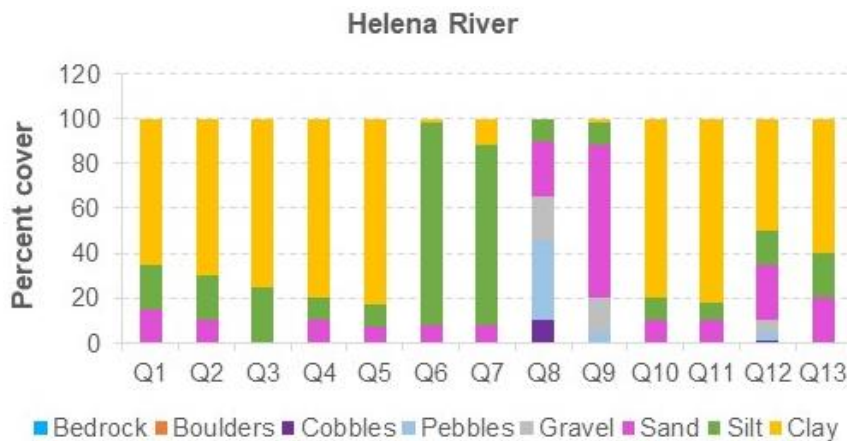
**Figure 3.3: Substrate composition within quadrats taken from the Helena River.**

Sediment composition was assessed within each quadrat for habitat suitability. The Helena River Survey Area was dominated by clay, with some silt (Figure 3.3). Quadrats 6 and 7, located just upstream of Roe Highway, were comprised almost exclusively of soft silt. Quadrat 8, located directly underneath the Roe Highway bridge, comprised a heterogenous mix of substrates, including cobbles, pebbles, gravel, sand, and silt. Quadrat 9 was dominated by sand, with some gravel, silt, pebbles, and clay. Sand was present throughout the Helena River, though in relatively low proportions.

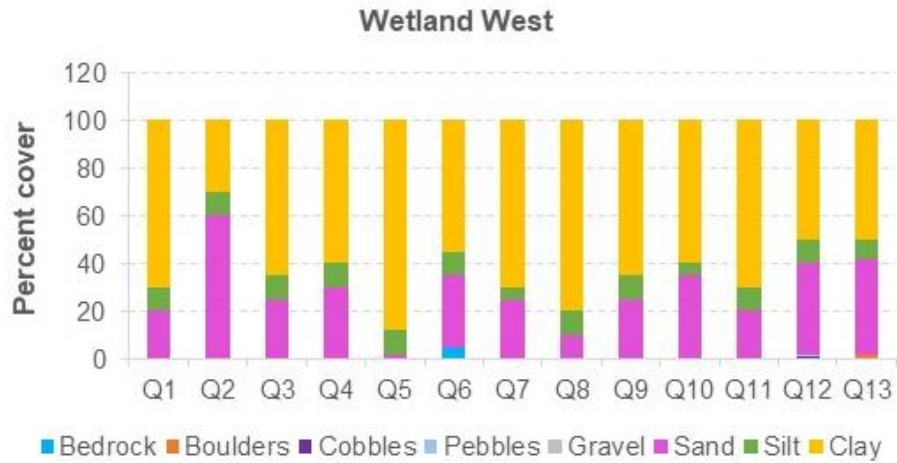
Figure 3.4: Substrate composition within quadrats taken from Wetland West.

Wetland West was relatively homogenous by comparison, being dominated by clay, with some sand and a small proportion of silt also present (Figure 3.4). The northern section of the wetland was covered in a soft, anoxic organic layer. Bedrock, boulders, cobbles, and gravel were present in very low amounts in some quadrats. At Wetland East, sediment substrates comprised clay and sand, with low amounts of silt (Figure 3.5). Bedrock was present within Quadrats 9 and 10, located towards the north-east side of the wetland.

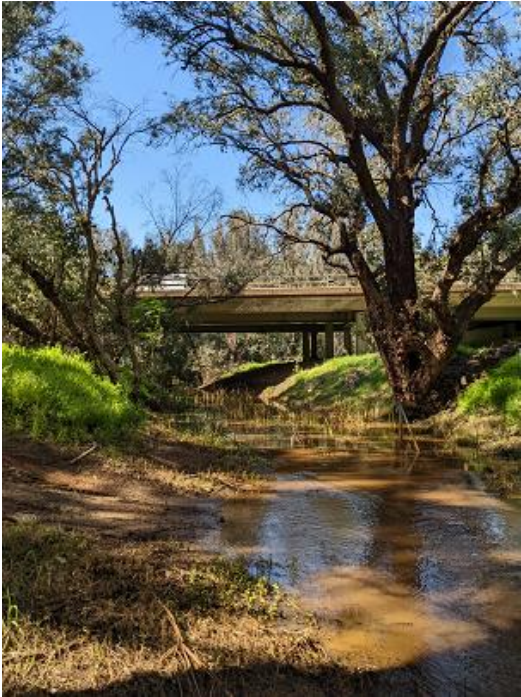
Site	Description	Site Photo
<p><b>Helena River</b></p>	<p>A ~500 m section of the Helena River covering the area beneath the Roe Highway bridge and ~200 m upstream and downstream of the NVCP application area. Water was fresh, with pH ranging from slightly acidic to circum-neutral. DO was below the ANZ (2018) DGV, but still considered suitable for supporting aquatic fauna. Sediment was generally dominated by clay, with some sections high in silt, while other sections comprised sand and gravel. Introduced grasses such as couch grass were observed throughout the stretch of river surveyed, particularly in the more upstream section. High amounts of large woody debris (LWD) were observed throughout. Water depth was highly variable throughout, ranging from 0.1 m up to &gt; 2 m.</p> <p>Although the water quality and sections of substrate were suitable for Carter's freshwater mussel, the fact that the reach does not hold permanent water indicates that overall, this section of the Helena River does not support suitable habitat.</p>

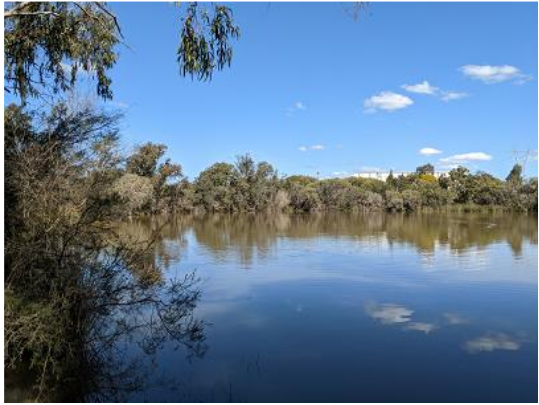
<p><b>Wetland West</b></p>	<p>A large, deep (estimated over 3 m deep) permanent wetland located west of Roe Highway. Water quality was fresh, with acidic pH, moderate DO, and generally clear waters. Sediments were dominated by clay, with some sand and silt. A thick layer of soft organics was present on the northern section of the wetland. Sedges and <i>Melaleuca</i> surrounded the wetland.</p> <p>The majority of the surveyed area of Wetland West supported suitable habitat for Carter's freshwater mussel, with the exception of a north-eastern portion where the substrate was too soft and anoxic, and</p>

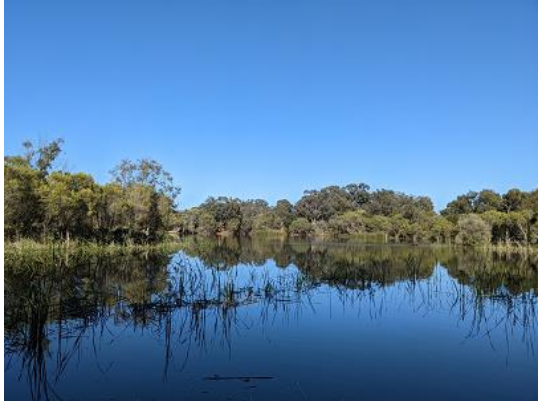
Site	Description	Site Photo
	<p>a north-western portion where the low, acidic pH was recorded.</p>	
<p><b>Wetland East</b></p>	<p>A large, deep (estimated over 2 m) permanent wetland located east of Roe highway. Spot measurements of water quality indicated slightly acidic to circum-neutral waters, which were fresh and clear. DO was below the ANZ (2018) DGVs. Sediments predominately comprised clay and sand, with some silt and bedrock also present. Sedges and submerged macrophytes were common throughout the wetland, along with LWD.</p> <p>The vast majority of Wetland East exhibited habitat suitable for Carter's freshwater mussel, with the exception of the western edge where substrates were too soft and anoxic.</p>

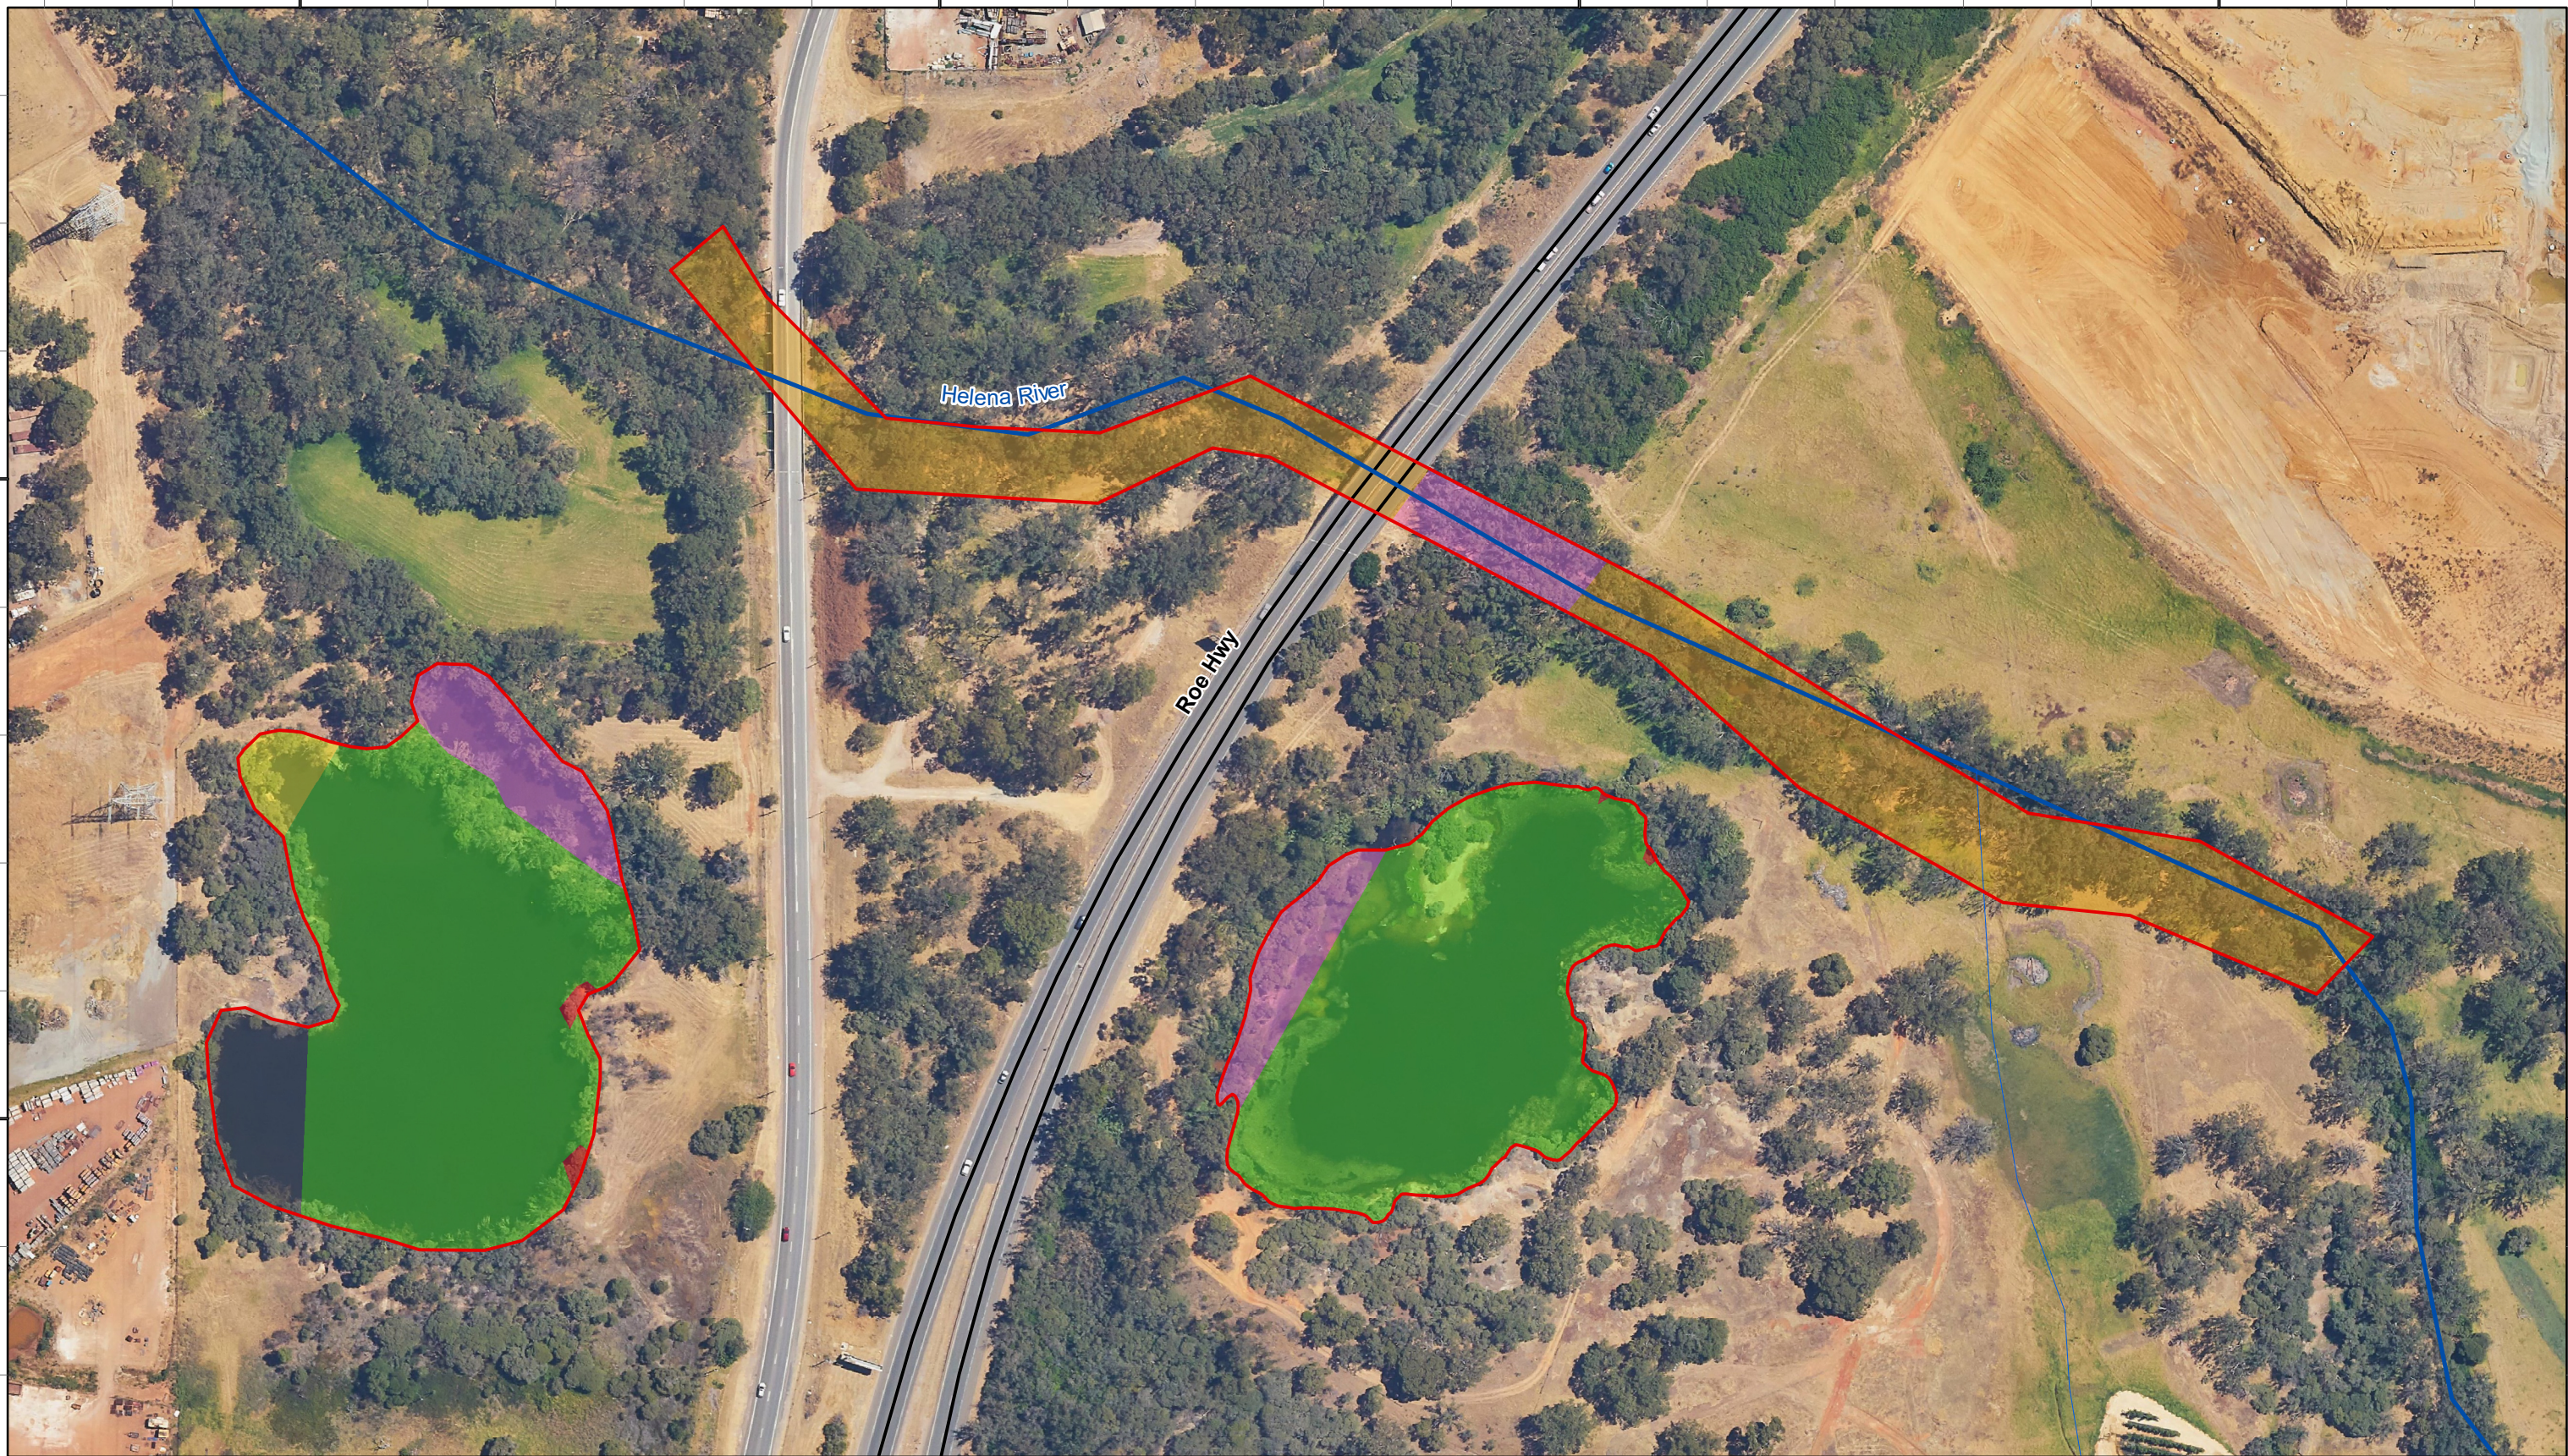
**MAIN ROADS WA**  
**Great Eastern Highway Bypass Interchanges Project: Targeted Carter's Freshwater Mussel Survey**  
**Figure 3.6: Habitat assessment of the Survey Area**

From the water quality results and habitat assessments, suitable habitat was identified within each location (see Figure 3.6). However, when persistence was considered, the Helena River within the Survey Area became unsuitable for Carter's freshwater mussel because no permanent pools exist in this reach.
