Swan River Crossings Fremantle Traffic Bridge Condition

In late 2020, we sought feedback from the community and stakeholders about the Swan River Crossings Project. Key issues raised included the current condition of the Fremantle Traffic Bridge and the impact on navigational safety.

The Fremantle Traffic Bridge was opened in 1939 with an expected 40 year life and has served its function well beyond that time. The bridge's structure has been deteriorating over a number of years and despite extensive strengthening and maintenance works, the bridge needs to be replaced.

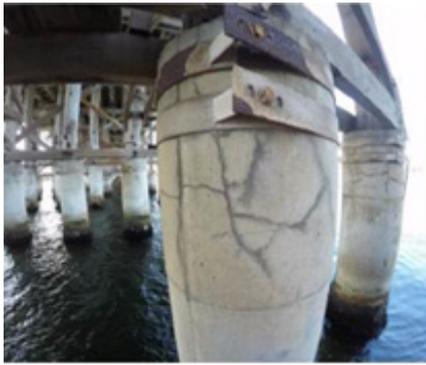
Cracks in concrete encapsulation due to reinforcement corrosion

Durability is a concern. In the past we have encapsulated the wooden piles with concrete. However, over time the concrete has been undermined and cracked, allowing access for the teredo (marine borers) to further deteriorate the wooden piles.

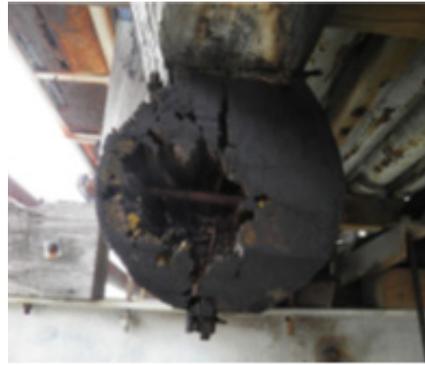
Multiple corbels split and large areas of deterioration/section loss

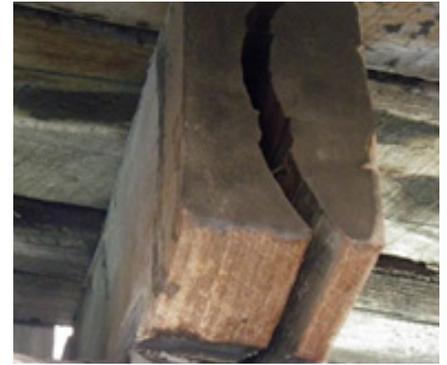
Poor condition of timber deck and timber bearers

There is ongoing deterioration of timber deck planks and timber bearers, resulting in large potholes on the deck, which have caused damage to vehicles.

In 1975, a 70mm deep concrete overlay was added to protect the bridge timber deck from water ingress. The concrete overlay has now deteriorated and needs attention.

Main Roads now installs 200mm concrete layers to bridge decks, which includes steel for reinforcement. The current traffic bridge deck would not support a new 200mm concrete layer.

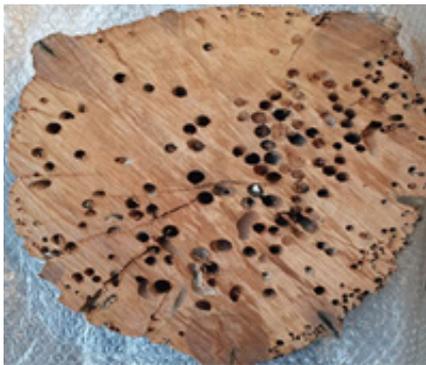
Teredo worm activity on exposed timber below failed concrete encapsulation

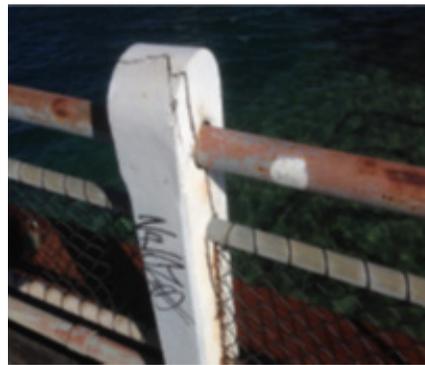
Pedestrian path too narrow, balustrade too low and in poor condition – high risks for cyclists using the shared path

Over time, the required repairs to the bridge have meant timber elements have been replaced/or strengthened by steel and concrete. The road lanes and footpath widths do not meet current design standards. Current traffic loading is heavier than the bridge was originally designed to carry.

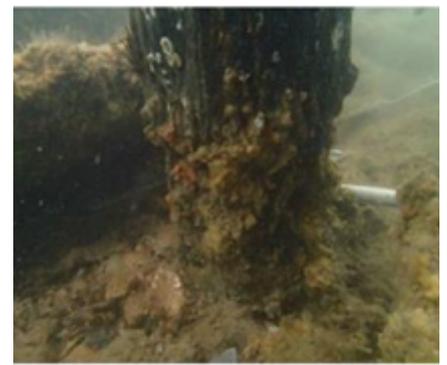
Exposed timber piles at river bed level – noticeable “necking”

Scour is impacting the stability of the timber piles and has created a hole in the riverbed - 12 metres and growing. Ongoing scour of the river bed has the potential to significantly reduce the load carrying capacity of the piles.

Since 1938, riverbed levels have reduced by almost four metres. This has compromised the existing timber pile embedment depth, resulting in a reduced structural capacity and the inability to resist impact loading from errant vessel impact.

The scouring is spreading upstream and in time, large portions of the bridge timber piers will no longer be supported.
