Archaeological
Aboriginal Heritage
Survey of the
Bunbury Outer Ring
Road Southern
Section (Brad Goode
and Associates 2020)

**REPORT OF AN ARCHAEOLOGICAL
ABORIGINAL HERITAGE SURVEY OF
BUNBURY OUTER RING ROAD,
SOUTHERN SECTION:
GREATER BUNBURY REGION,
WESTERN AUSTRALIA**

*A report prepared for BORR Integrated Planning
Team on behalf of Main Roads Western Australia*

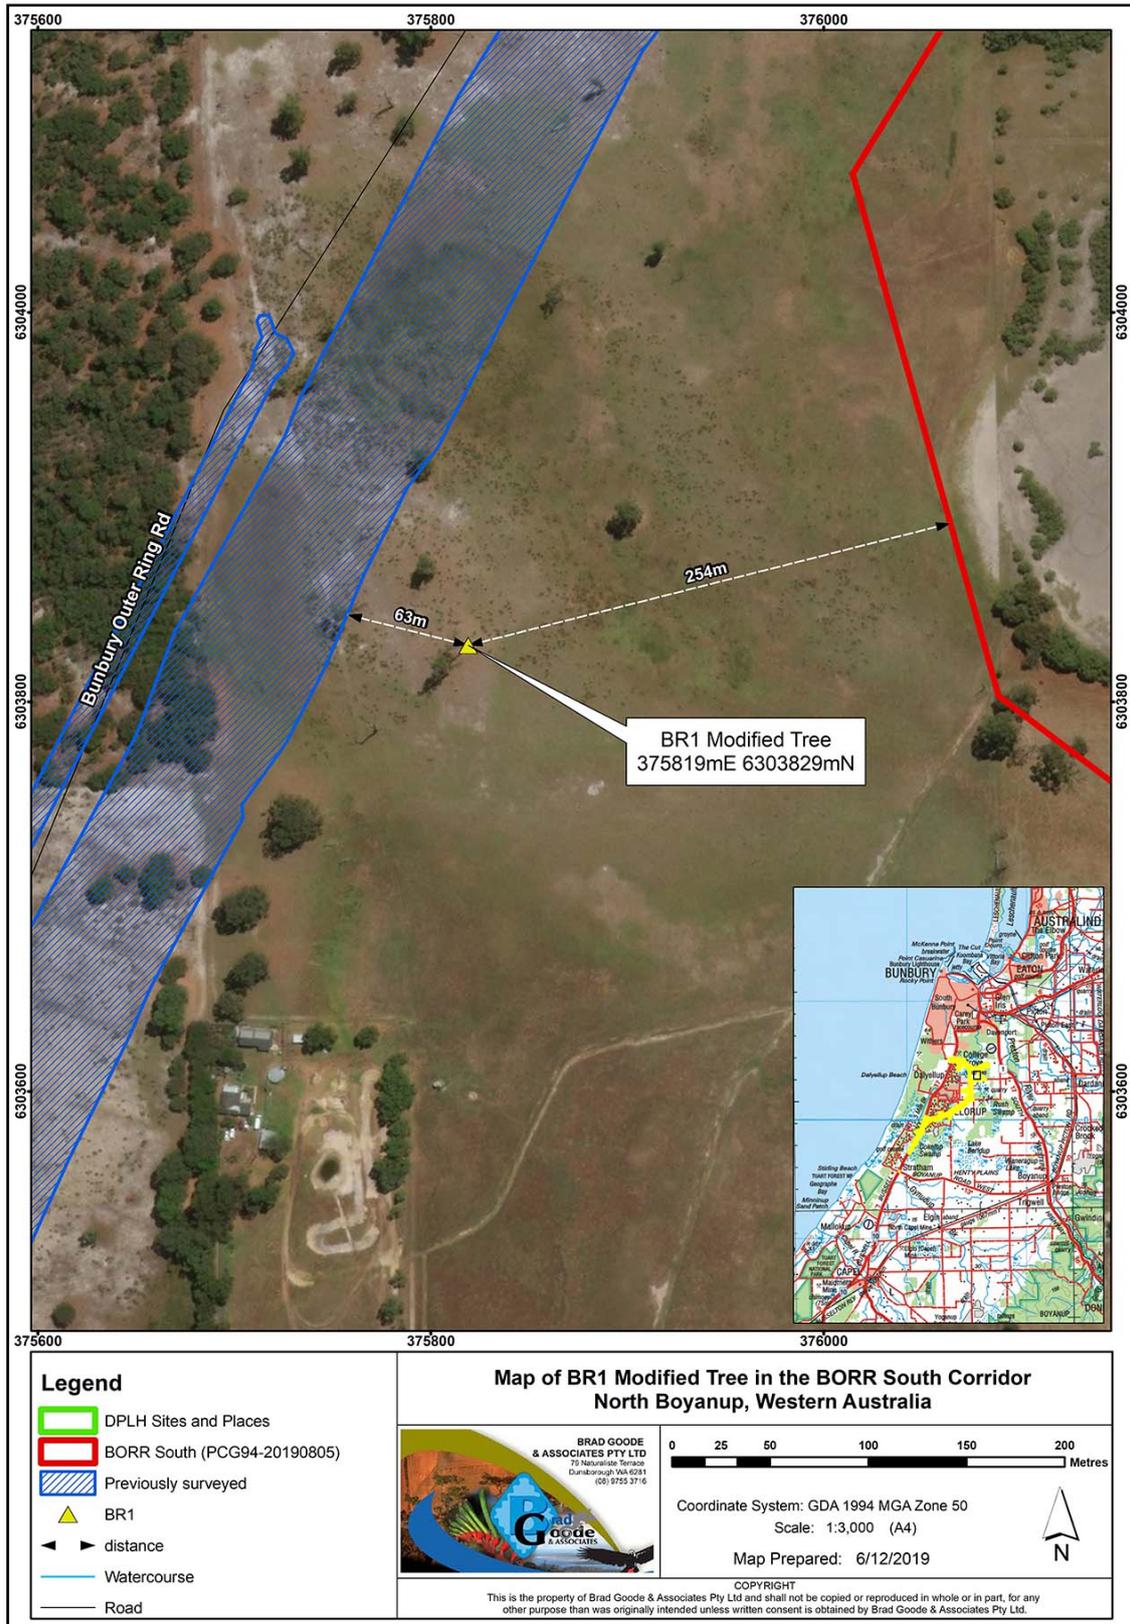
Figure 2: Map of BR1 Modified Tree in the BORR South Corridor.

As the jarrah tree is located some 63m outside the area of disturbance by the proposed BORR. It is unlikely to be either directly or indirectly impacted as a result of the construction and operation of the BORR Southern section.

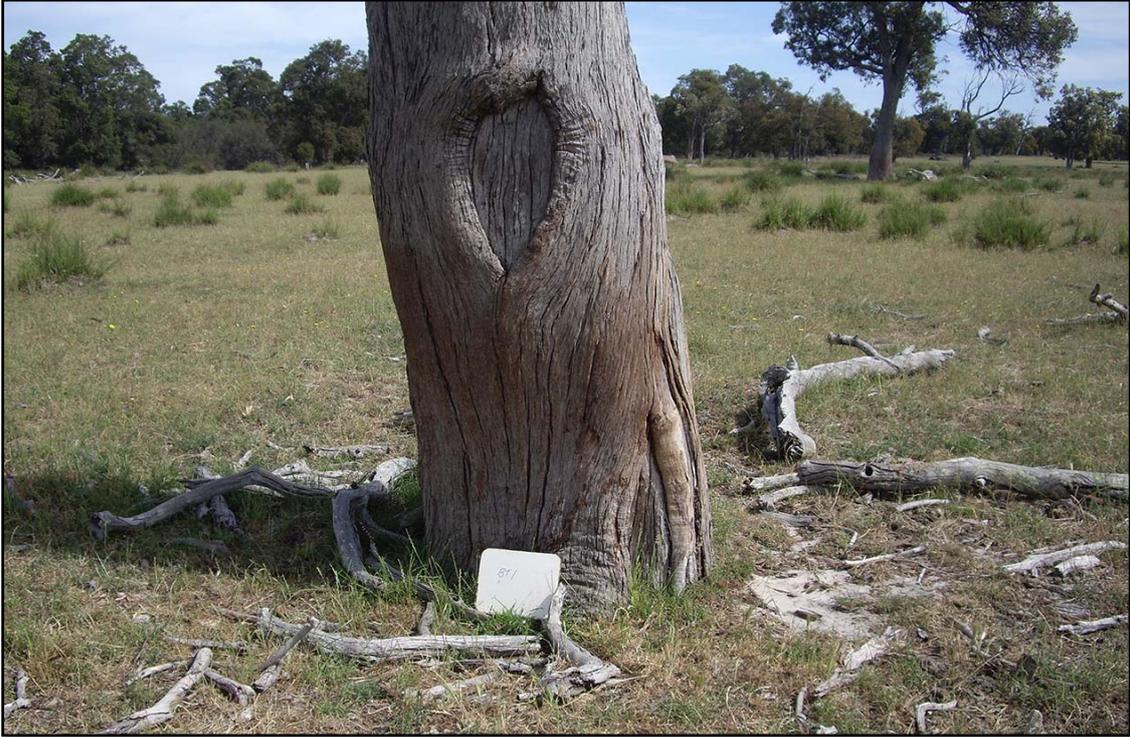
Figure 3: BR1 culturally modified jarrah tree at 375819mE 6303829mN.

The archaeological significance of the tree is considered moderate. As few culturally modified trees remain in the area from wholesale clearance and logging in the Bunbury region, the scar offers some research potential but the tree, itself, has a limited future due to its poor condition.

BR1, a modified tree, is a culturally modified scar on an old dead jarrah tree. While the prospect of a long life is limited, there are few similar examples in the area. As it holds moderate significance and some research potential **it is recommended** that the location be avoided.

If MRWA wish to disturb **BR1** then a Section 18 application under the AHA should be submitted to DPLH seeking permission. If permission is granted, this should be conditional on further recording and/or removal of the said trunk to a nominated repository.

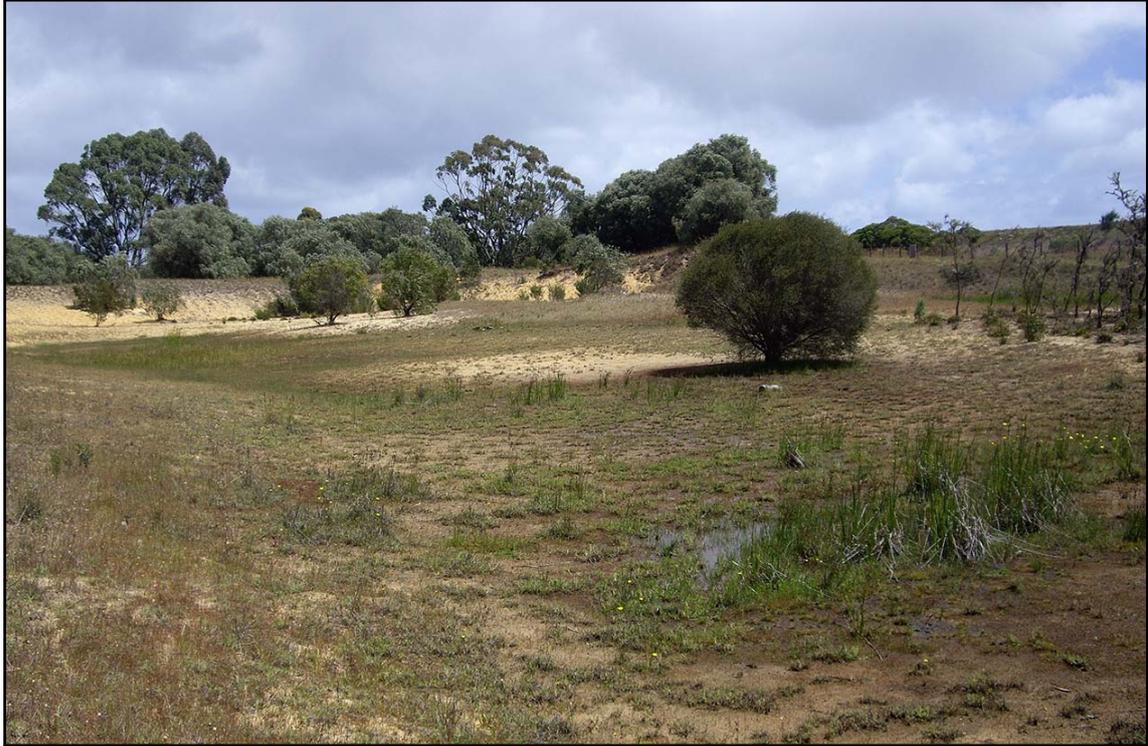
Figure 5: Looking E at heritage Place ID 18884 with yellow sand dune at rear where the artefacts are located.

Place ID 18884 is a highly disturbed small artefact scatter (Figure 5). It was recorded by Hammond and O'Reilly (1995) where 14 artefacts were located and reappraised in 2012 (Goode & O'Reilly) where 20 artefacts were located. The site was re-examined in the present archaeological survey in 2019 where only six artefacts were observed in the eastern end only. Road material debris was numerous and extended some 30m into the site at the central northern section alongside Hastie Road. A week later, another inspection occurred as part of this archaeological survey where some 11 artefacts were observed and measured, all in the eastern sector on the yellow sandy mound adjacent to the fence line on the corner of Hastie and Allenville Roads. These artefacts included three flakes (27%), six flaked pieces (55%) and two chips (18%) all manufactured on quartz or crystal quartz (Table 2). Each artefact's position was recorded within the mound that extended over an area 30mNS x 35mEW. The location of the site is shown in Figure 7.

Place ID 18884 Bunbury Bypass Archaeological Site 1 is a highly disturbed small artefact scatter. If MRWA wish to disturb **Place ID 18884**, then a Section 18 application under the AHA should be submitted to DPLH seeking permission. Because of its present condition due to extensive disturbance, low number of artefacts observed and subsequent reduced scientific research potential, **it is recommended** that permission be granted conditional upon all ground works at this location being monitored by two Aboriginal traditional custodians and any artefacts, if present, collected, measured and reburied in a safe repository.

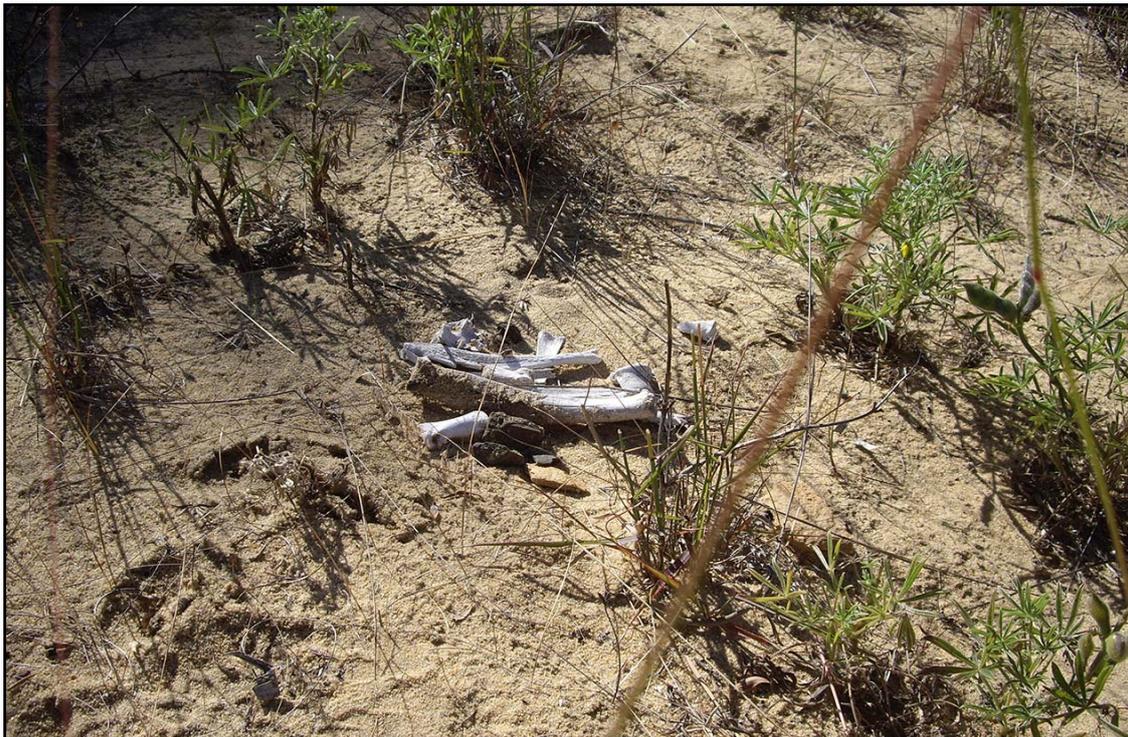
Figure 6: Looking at a cache of bones and stones on the inner side of dam at heritage Place ID 18884.

A pile of animal bones and stones have been collected for unknown purposes at grid reference 375254mE 6302418mN (see Figure 6) within this site. The wetland map produced by BORR IPT shows the heritage place is totally surrounded by wetland so this yellow sandy once high dune would have been a convenient temporary campsite and perhaps the only refuge of high ground in the immediate area. While low numbers of artefacts have been observed, the fact that three inspections over 24 years have continually revealed artefacts despite the site having been extensively modified by construction of a dam and adjacent road works suggests more artefacts may be recovered. There is no stratigraphic integrity remaining in the unstable highly disturbed sandy mound and therefore no research potential present. However the measurement and analysis of any artefacts recovered would assist in adding to the database of the region.
