Bunbury Outer Ring Road Northern and Central Sections

Vegetation and Flora Study

BORR-01-RP-EN-0002

30 January 2020

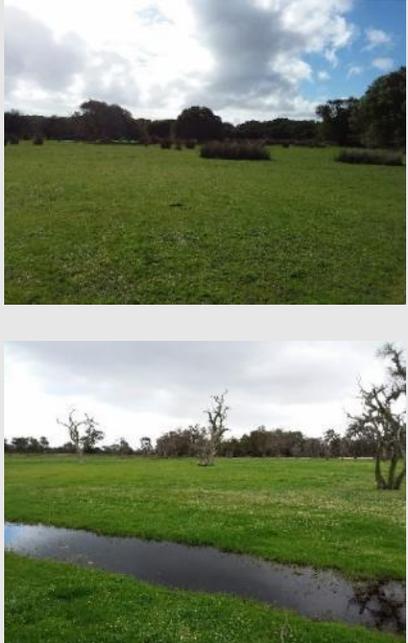
Vegetation type description	Photograph	Location, Condition and extent within survey area	Sample locations and FCT comparison
Highly Modified / Cleared / Non-Native and Revegetation			
<p>Highly Modified (HM –VT1) This includes areas such as existing roads, firebreaks and tracks, buildings, yards and agricultural paddocks. These areas are either devoid of vegetation or are dominated by introduced grasses and herbs. Paddocks include of mixture introduced grasses (<i>*Avena</i> spp., <i>*Bromus</i> sp. and <i>*Cenchrus clandestinus</i>) with a mixed herbland of <i>*Arctotheca calendula</i>, <i>*Cotula turbinata</i>, <i>*Trifolium</i> species and <i>*Lotus</i> species with occasional patches of <i>Pteridium esculentum</i> and <i>*Lotus cosentinii</i>. The lower lying areas (that would be seasonally inundated) and along the man made drains and dams may also contain <i>Juncus pallidus</i>, <i>J. kraussii</i>, <i>*Typha orientalis</i>, <i>*Rumex crispus</i>, <i>*Watsonia meriana</i> and <i>*Polypogon monspeliensis</i>. Some areas of open water had aquatic species including <i>*Callitriche stagnalis</i>, <i>Azolla rubra</i> and <i>Cycnogeton lineare</i>.</p>

<p>Occurs throughout the survey area. Extent: 820 ha Condition: Completely Degraded (7). Highly modified/cleared areas have been excluded and have not been assigned a condition score</p>	<p>Photo-points: PP28, BNA21, BNA26, BNA29, BNC5 and BNC7. FCT: N/A.</p>

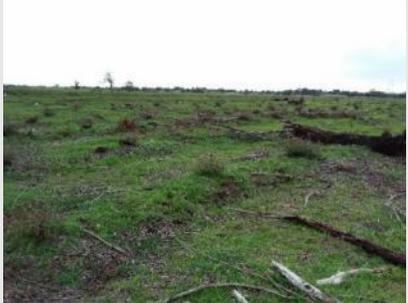
<p>Showing a recently felled area of Blue gums.</p>	<p>Extent: 123 ha Condition: Completely Degraded (7). Highly modified/cleared areas have been excluded and have not been assigned a condition score</p>	<p>Photo-points: PP4, PP5, PP7, PP10, BNB06 and BNB28. FCT: N/A.</p>
<p>Revegetation / Planted (R/P – VT3) This includes revegetation as well as areas planted with a mixture of native and non-native vegetation. There are scattered remnant trees occasionally present (including <i>Corymbia calophylla</i>, <i>Eucalyptus marginata</i>, <i>E. rudis</i>, <i>E. gomphocephala</i> (uncommon), <i>Agonis flexuosa</i>, <i>Casuarina obesa</i> and <i>Melaleuca</i> species) with revegetation undertaken in the understorey. Common shrubs include <i>Melaleuca nesophila</i>, <i>M. lanceolata</i>, <i>Kunzea glabrescens</i> and <i>Acacia saligna</i>. Non-endemic species present include: <i>*Corymbia citriodora</i>, <i>*Eucalyptus cladocalyx</i>, <i>*E. botryoides</i> and <i>E. lane-poolei</i> (native to South West but not naturally occurring in study area). The understorey was mostly dominated by introduced grasses and herbs.</p> <p>The area along the existing BORR central contains more recent revegetation works (typically less than 1 m in height).</p>

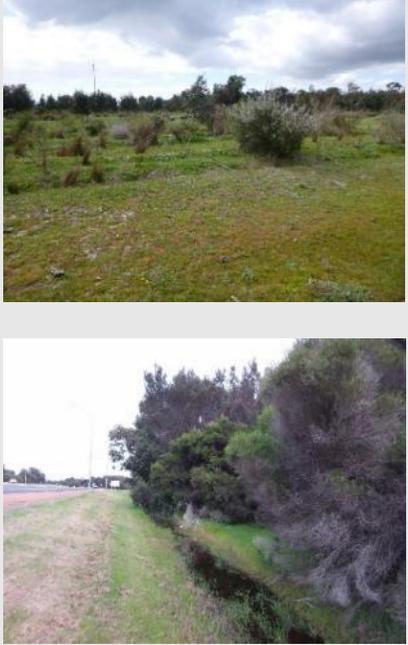
<p>Along existing sections of BORR Central, Forrest Highway and in road reserves throughout the survey area. Extent: 34 ha Condition: ranged from Good to Degraded (4 – 6).</p>	<p>Photo-points: BNB02, BNB03, BNB04, BNA27, BNA30, BNA31, BNA32, BNA33, BNA34, BNA45, BNA55 and BNC8. FCT: N/A.</p>

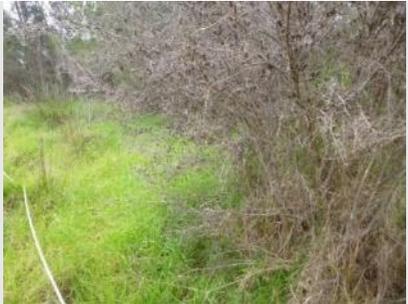
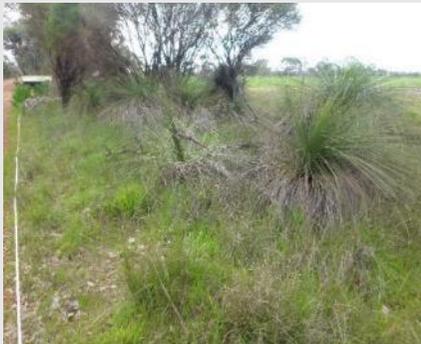
<p>ErMr at Quadrat BN27 – showing <i>X. preissii</i> and <i>M. viminea</i> in the shrub (mid) layer</p>	<p>Scattered throughout the survey area in drainage lines and low lying / seasonally wet areas. On brown to black sandy clay.</p> <p>Extent: 22 ha.</p> <p>Condition: Degraded to Completely Degraded (6-7).</p>	<p>Quadrats: BN22, BN27 and BN28.</p> <p>Photo-points: BNB09, BNB10, BNB16, BNB20, BNB23, BNB29, BNB30, BNB33, BNB34, BNB35, BNA35, BNA36, BNA37, BNC4 and BNC11.</p> <p>FCT: Difficult to assign FCT due to degraded nature. Likely to be FCT11. Mapped in Guildford Complex of which a minor component is noted as being <i>E. rudis</i> and <i>M. raphiophylla</i>.</p>

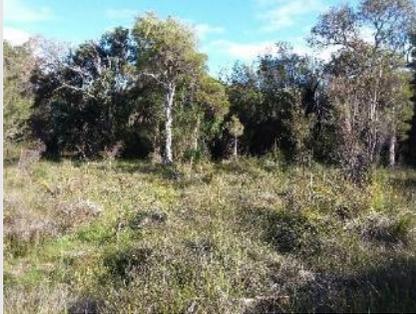
Vegetation type description	Photograph	Location, Condition and extent within survey area	Sample locations and FCT comparison
<p>Woodland of <i>Melaleuca preissiana</i> / <i>Kunzea glabrescens</i> over mixed sedgeland (MpKgS– VT5)</p> <p>Woodland of <i>Melaleuca preissiana</i> with scattered <i>Corymbia calophylla</i> in higher elevation areas. The shrubland to open shrubland is dominated by <i>Kunzea glabrescens</i>, <i>Xanthorrhoea brunonis</i> and <i>Acacia pulchella</i> var. <i>glaberrima</i> over sedgeland of <i>Lepidosperma longitudinale</i>, <i>L. pubisquameum</i> and <i>Schoenus efoliatus</i>. This unit transitions into a <i>Corymbia</i> woodland (14) with <i>Banksia attenuata</i> and <i>Nuytsia floribunda</i> present (near Quadrat BN01).</p>

<p>Occurs in one location in the southern extent of the survey area. On a low lying plain that would be seasonally wet with sand / clay substrates.</p> <p>Extent: 2 ha.</p> <p>Condition: Very Good to Degraded (3 – 6).</p>	<p>Quadrats: BN01 and BN02.</p> <p>Photo-points: BNA01, BNA02, BNA03, BNA04, BNA06, BNA07 and BNC18.</p> <p>FCT: Affinity to FCT4 – This vegetation type occurs on the Southern River Complex and has <i>M. preissiana</i> as dominant in the overstorey.</p>

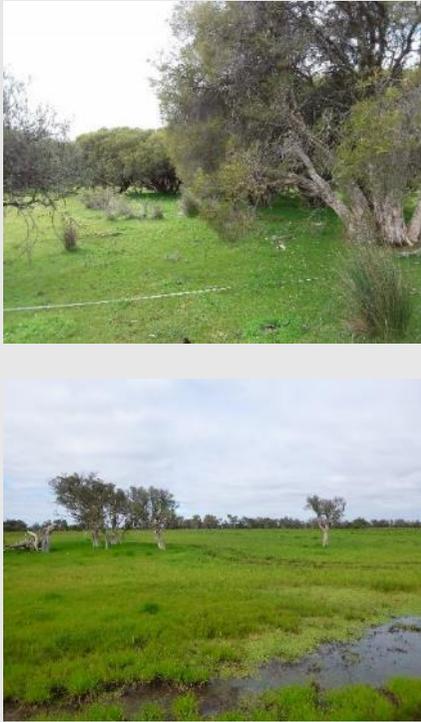
Vegetation type description	Photograph	Location, Condition and extent within survey area	Sample locations and FCT comparison
<p>Very open woodland of <i>Melaleuca raphiophylla</i> over introduced grasses and herbs in paddocks and road reserves (Mr – VT6)</p> <p>Woodland to very open woodland of <i>Melaleuca raphiophylla</i> (occasionally <i>M. preissiana</i>) over introduced grasses and herbs including <i>*Briza maxima</i> and <i>*Cynodon dactylon</i> over herbland of <i>*Cyperus eragrostis</i>, <i>*Cotula coronopifolia</i> and <i>*Callitriche stagnalis</i> with occasional <i>*Watsonia meriana</i> var. <i>bulbillifera</i>. Often present as scattered trees of <i>M. raphiophylla</i>.</p> <p>In some locations native sedges were present in the understorey including <i>Juncus pallidus</i> and <i>Lepidosperma longitudinale</i>. At Quadrat BN06 the vegetation was in Good to Degraded condition and included <i>M. teretifolia</i> in the upper layer with <i>J. pallidus</i> and introduced grasses and herbs in the ground layer.</p>

<p>Occurs throughout the survey area, often as scattered <i>M. raphiophylla</i> trees.</p> <p>Extent: 26 ha.</p> <p>Condition: Good – Completely Degraded (4-7).</p>	<p>Quadrats: BN06 (only one quadrat in Good-Degraded site). Remainder of locations in Degraded condition and surveyed via photo points.</p> <p>Photo-points: PP8, PP9, PP31, BNB14, BNB15, BNB19, BNB25, BNB26, BNC3, BNC9, BNC13, BNC14 and BNC15.</p> <p>FCT: It is difficult to assign this vegetation type to a FCT due to its Degraded to Completely Degraded condition. Likely to be degraded form of FCT11.</p>

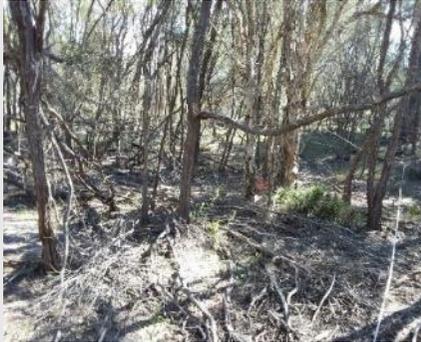
Vegetation type description	Photograph	Location, Condition and extent within survey area	Sample locations and FCT comparison
<p>Woodland of <i>Melaleuca preissiana</i> and <i>Kunzea glabrescens</i> in damplands (MpKg – VT7)</p> <p>Woodland to closed woodland of <i>Melaleuca preissiana</i> and <i>Kunzea glabrescens</i> over an open grassland / sedgeland of <i>*Ehrharta calycina</i>, <i>Lyginia imberbis</i> and <i>*Oxalis pes-caprae</i> and an open herbland of <i>Dasypogon bromeliifolius</i>, <i>Hypochaeris glabra</i> and <i>Daucus glochidiatus</i>.</p> <p>It is noted that at both locations there was no water present and tree death was evident.</p>

<p>Occurs in two locations in the northern extent of the survey area.</p> <p>Extent: 5 ha.</p> <p>Condition: Good – Degraded (4 - 6).</p>	<p>Quadrats: BN15 and BN17.</p> <p>Photo-points: PP24, BNA43, BNA40, BNA44, BNA57 and BNA58.</p> <p>FCT: This community lacked native species in the mid and ground layers. It may align with FCT4 based on the dominance of <i>M. preissiana</i> and <i>D. bromeliifolius</i>.</p>

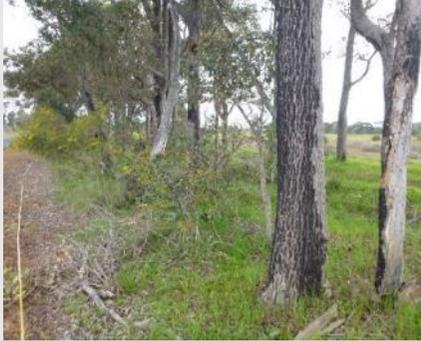
<p>Mosaic of <i>Melaleuca raphiophylla</i>, <i>Corymbia calophylla</i> and <i>Eucalyptus rudis</i> woodland (MrCcEr – VT8)</p> <p>Mosaic of vegetation types VT4 and VT17. This vegetation type occurs in road reserves where a mosaic of scattered trees of <i>Melaleuca raphiophylla</i>, <i>Corymbia calophylla</i> and <i>Eucalyptus rudis</i> occur over a ground-layer dominated by introduced grasses.</p>

<p>Extent: 4 ha.</p> <p>Condition: Degraded – Completely Degraded (6 - 7).</p>	<p>Quadrats: BN23</p> <p>Photo-points: BNB13, BNB17, BNB18, BNC10 and BNC12.</p> <p>FCT: possibly forms part of FCT11 (based on presence of <i>E. rudis</i> and <i>M. raphiophylla</i>). However, only present in Degraded to Completely Degraded condition in narrow road reserves making assigning an FCT difficult.</p>

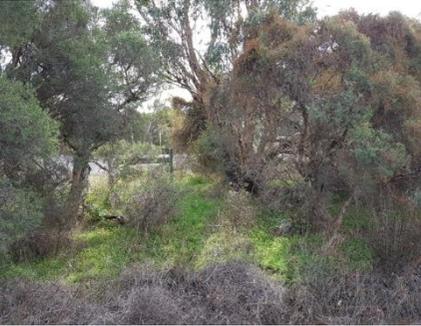
Vegetation type description	Photograph	Location, Condition and extent within survey area	Sample locations and FCT comparison
<p>Low closed forest of <i>Melaleuca raphiophylla</i> (sometimes with emergent <i>Eucalyptus rudis</i>) (MrAsVjXp – VT21) Ecoedge (2019)</p> <p>Low closed forest of <i>Melaleuca raphiophylla</i> (sometimes with emergent <i>Eucalyptus rudis</i>) over tall shrubland of <i>Acacia saligna</i>, <i>Viminaria juncea</i> and <i>Xanthorrhoea preissii</i> over herbland of <i>Cassytha racemosa</i> (climber) and <i>*Watsonia meriana</i>, sedgeland of <i>Leptocarpus roycei</i> and grassland of <i>*Briza maxima</i> and <i>*Ehrharta calycina</i> (Ecoedge 2019)</p>

<p>Extent: 0.2 ha. Condition: Good (4) to Degraded (6).</p>	<p>Quadrats: FCT: Possible forms part of FCT11 or FCT13 (Ecoedge 2019)</p>
<p>River / Creekline vegetation</p> <p>Woodland of <i>Eucalyptus rudis</i> and <i>Corymbia calophylla</i> over <i>Melaleuca raphiophylla</i> (ErCcMr – VT9)</p> <p>Woodland of <i>Eucalyptus rudis</i> and <i>Corymbia calophylla</i> over <i>Melaleuca raphiophylla</i> over grassland of <i>*Cenchrus clandestina</i>, <i>*Briza minor</i> and <i>*Bromus diandrus</i> and a herbland of <i>*Geranium molle</i>, <i>*Stellaria media</i> and <i>*Alisma lanceolatum</i> on red-brown clay loams.</p>

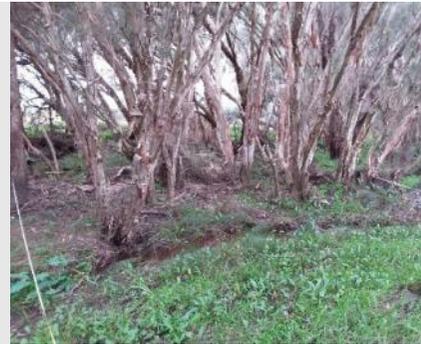
<p>Occurs in a main tributary leading into Preston River. Extent: 6 ha. Condition: Degraded – Completely Degraded (6 - 7).</p>	<p>Quadrats: BN31 and BN38. FCT: Degraded form of FCT11 (based on presence of <i>E. rudis</i> and <i>M. raphiophylla</i>). However, only present in Degraded or worse condition in narrow road reserves making assigning an FCT difficult.</p>

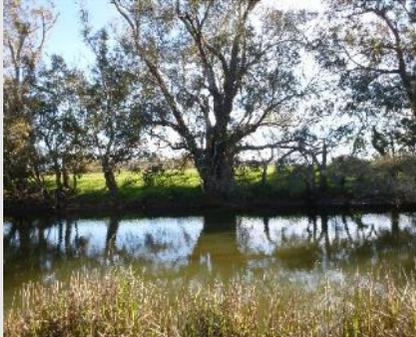
Vegetation type description	Photograph	Location, Condition and extent within survey area	Sample locations and FCT comparison
<p>Woodland of <i>Melaleuca raphiophylla</i>, <i>Eucalyptus rudis</i> and <i>Casuarina obesa</i>; fringing vegetation along Collie River (ErMrCo – VT10)</p> <p>Woodland of <i>Melaleuca raphiophylla</i>, <i>Eucalyptus rudis</i> and <i>Casuarina obesa</i> over sedgeland of <i>Juncus</i> species over grassland of introduced species including: <i>*Cynodon dactylon</i>, <i>*Lolium rigidum</i>, <i>*Avena barbata</i> and <i>*Bromus diandrus</i>.</p>

<p>Located along the Collie River.</p> <p>Extent: 2 ha.</p> <p>Condition: Good – Degraded (4 - 6).</p>	<p>Quadrats: BN21.</p> <p>Photo-points: BNB07.</p> <p>FCT: Form of FCT11 (based on presence of <i>E. rudis</i> and <i>M. raphiophylla</i>). However, Gibson <i>et al.</i> (1994) notes that further information on riverine communities was needed.</p>

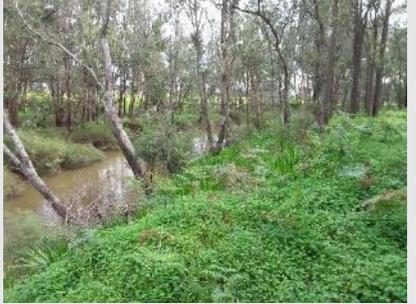
<p>Open forest of <i>Corymbia calophylla</i> and <i>Eucalyptus rudis</i> over <i>Agonis flexuosa</i> along the Preston River (CcErAf – VT11)</p> <p>Open forest of <i>Corymbia calophylla</i> and <i>Eucalyptus rudis</i> over <i>Agonis flexuosa</i> over scattered shrubs of <i>Acacia pulchella</i>, <i>Hardenbergia comptoniana</i> and <i>Macrozamia riedlei</i> over herbland of <i>*Oxalis pes-caprae</i> and <i>Pteridium esculentum</i> and open grassland of <i>*Ehrharta longiflora</i> on grey-brown sandy loam.</p>

<p>Occurs along the Preston River.</p> <p>Extent: 22 ha.</p> <p>Condition: Good – Completely Degraded (4 - 7).</p>	<p>Quadrats: BN30, BN33 and BN34.</p> <p>Photo-points: PP2, PP3, PP6, PP11, BNC16 and BNC17.</p> <p>FCT: undescribed, affinity to FCT1b (see notes in section 5.3.6).</p>
<p>Open forest of <i>Eucalyptus rudis</i> on the floodplain / upper banks of the Brunswick River (VT11a)</p> <p>Open forest of <i>Eucalyptus rudis</i> over introduced grasses on the upper banks / floodplain of the Brunswick River.</p>

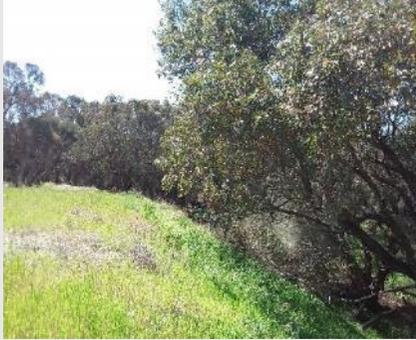
<p>Occurs adjacent to the Brunswick River.</p> <p>Extent: 0.3 ha.</p> <p>Condition: Good – Degraded (4 - 6).</p>	<p>Photo-points: BNA54.</p> <p>FCT: N/A, only occurred as emergent trees over weeds.</p>

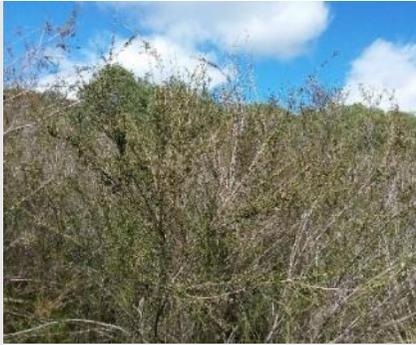
Vegetation type description	Photograph	Location, Condition and extent within survey area	Sample locations and FCT comparison
Shrublands			
<p><i>Astartea scoparia</i> shrubland (As – VT13)</p> <p>Shrubland of <i>Astartea scoparia</i> over open sedgeland of <i>Juncus pallidus</i>, <i>Isolepis marginata</i> and <i>Isolepis ? stellata</i> over grassland of <i>Avena barbata</i>, <i>Lotus subbiflorus</i> and <i>Cynodon dactylon</i>.</p> <p>Occurs in a low lying / seasonally inundated area adjacent to cleared agricultural land. Scattered <i>Melaleuca raphiophylla</i> and <i>Agonis flexuosa</i> woodlands occur nearby.</p>

<p>Occurs in one location in the northern extent of the survey area.</p> <p>Extent: 0.2 ha.</p> <p>Condition: Good (4).</p>	<p>Quadrats: BN05.</p> <p>FCT: N/A, likely to have formed part of a broader <i>Melaleuca raphiophylla</i> dampland given the small extent and surrounding disturbed landscape. An FCT cannot be drawn.</p>

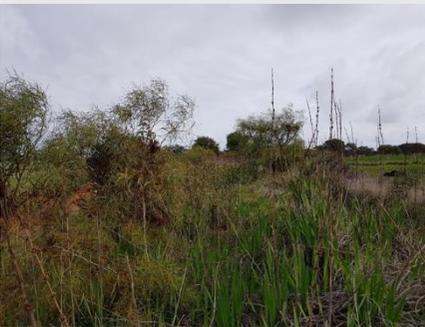
<p>Open tall shrubland of <i>Acacia saligna</i>, (<i>Melaleuca viminea</i>) over herbland (AsMvGt - VT13b) Ecoedge (2019)</p> <p>Open tall shrubland of <i>Acacia saligna</i>, (<i>Melaleuca viminea</i>) over herbland of <i>Cynogeton lineare</i> (in drains), <i>Oxalis glabra</i>, <i>O. pes-caprae</i> and <i>Watsonia meriana</i> and grassland of <i>Cenchrus clandestinus</i> and <i>Cynodon dactylon</i> and open sedgeland of <i>Gahnia trifida</i> on red-brown clay-loam.</p>

<p>(Ecoedge 2019)</p>	<p>Extent: 0.3 ha.</p> <p>Condition: Degraded – Completely Degraded (6 - 7).</p>	<p>Quadrats: Ecoedge (2019)</p> <p>FCT: Too degraded to be determined by FCT analysis.</p>

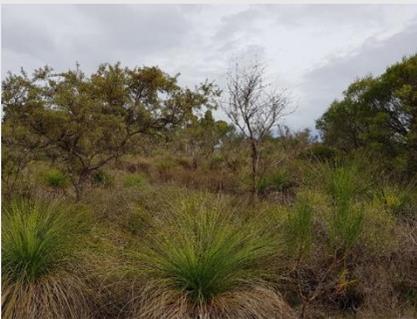
Vegetation type description	Photograph	Location, Condition and extent within survey area	Sample locations and FCT comparison
<p>Shrubland of <i>Acacia incurva</i>, <i>A. saligna</i>, <i>Hakea varia</i>, <i>Hypocalymma angustifolium</i>, <i>Melaleuca lateritia</i>, <i>M. pauciflora</i>, <i>Olearia elaeophila</i> and <i>Xanthorrhoea preissii</i> (HvMlMpVjXp - VT13c) Ecoedge (2019)</p> <p>Shrubland of <i>Acacia incurva</i>, <i>A. saligna</i>, <i>Hakea varia</i>, <i>Hypocalymma angustifolium</i>, <i>Melaleuca lateritia</i>, <i>M. pauciflora</i>, <i>Olearia elaeophila</i> and <i>Xanthorrhoea preissii</i> with emergent tall shrubs of <i>Viminaria juncea</i> over sedgeland of <i>Leptocarpus roycei</i> and <i>Schoenus</i> sp. and open herbland of <i>Agrostocrinum scabrum</i> subsp. <i>scabrum</i>, <i>Borya sphaerocephala</i>, <i>Cycnogeton lineare</i>, <i>Drosera erythrorhiza</i>, <i>Haemodorum simplex</i> and <i>Opercularia vaginata</i> on yellow-brown clay.</p>

<p>(Ecoedge 2019)</p>	<p>Extent: 0.7 ha. Condition: Excellent (2), Very Good (3) Good to Degraded (4 - 6).</p>	<p>Quadrats: Ecoedge (2019) FCT: FCT08 Herb rich shrublands in clay pans – State Vulnerable TEC</p>

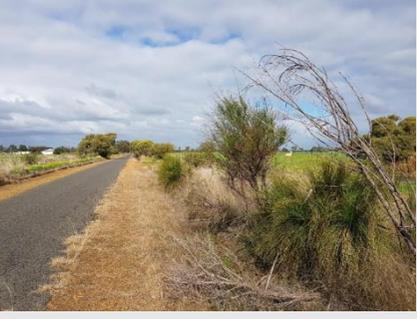
<p>Scattered tall shrubs of <i>Acacia saligna</i>, <i>Viminaria juncea</i> and <i>Xanthorrhoea preissii</i> (AsVjXp - VT13d) Ecoedge (2019)</p> <p>Scattered tall shrubs of <i>Acacia saligna</i>, <i>Viminaria juncea</i> and <i>Xanthorrhoea preissii</i>, with occasional <i>Melaleuca raphiophylla</i> trees over grassland of <i>*Briza maxima</i>, <i>*Cenchrus clandestina</i> and <i>*Ehrharta calycina</i> on yellow-brown clay loam.</p>

<p>(Ecoedge 2019)</p>	<p>Extent: 0.4 ha. Condition: Degraded – Completely Degraded (6 - 7).</p>	<p>Quadrats: Ecoedge (2019) FCT: Probably degraded areas of FCT08 and FCT11</p>

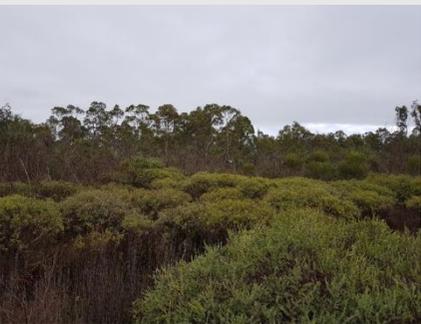
Vegetation type description	Photograph	Location, Condition and extent within survey area	Sample locations and FCT comparison
<p>Shrubland of <i>Melaleuca lateritia</i>, <i>Astartea affinis</i> and <i>Olearia elaeophila</i> over sedgeland of <i>Lepyrodia glauca</i> (MIMpAfOI - VT13e) Ecoedge (2019)</p> <p>Shrubland of <i>Melaleuca lateritia</i>, <i>Astartea affinis</i> and <i>Olearia elaeophila</i> over sedgeland of <i>Lepyrodia glauca</i> and (small sedge) over very open herbland of <i>Aponogeton hexatepalus</i> and <i>Cycnogeton linearis</i> on yellow-brown clay – the <i>M. lateritia</i> dominated claypans may be surrounded by a tall shrubland of <i>Acacia saligna</i>, <i>Hakea varia</i>, <i>Melaleuca viminea</i> and <i>Viminaria juncea</i>. Near Wireless road this community also includes <i>Melaleuca pauciflora</i> and the sedge <i>Leptocarpus roycei</i> on yellow-brown clay.</p>

<p>(Ecoedge 2019)</p>	<p>Extent: 0.1 ha. Condition: Excellent to Very Good (2 - 3).</p>	<p>Quadrats: Ecoedge (2019) FCT: FCT09 Dense shrublands on clay flats State Vulnerable TEC</p>

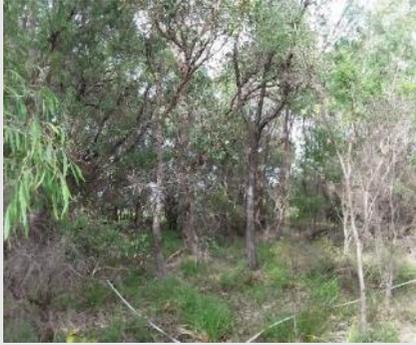
Woodlands			
<p>Woodland of <i>Corymbia calophylla</i> and <i>Agonis flexuosa</i> over weedy grass and herbland (CcAf – VT 14)</p> <p>Woodland of <i>Corymbia calophylla</i> and <i>Agonis flexuosa</i> with occasional <i>Eucalyptus marginata</i> typically over introduced grasses and herbs. At quadrat BN13 native structure remains with woodland <i>C. calophylla</i>, <i>E. marginata</i> and <i>A. flexuosa</i> over <i>Jacksonia furcellata</i>, <i>Xanthorrhoea brunonis</i> and <i>Hypocalymma angustifolium</i> over a herbland / sedgeland of <i>Opercularia hispidula</i>, <i>Dasypogon bromeliifolius</i> and <i>Lepidosperma pubisquameum</i>.</p>

<p>Occurs throughout the survey area, mostly within road reserves. Extent: 7 ha. Condition: Good – Completely Degraded (4 - 7).</p>	<p>Quadrats: BN13 , BN37. BN39 and BN40 Photo-points: BNA38, BNA39, BNA52 and BNA63. FCT: affinity to 25. However, <i>C. calophylla</i> is dominant and Tuart was not observed.</p>

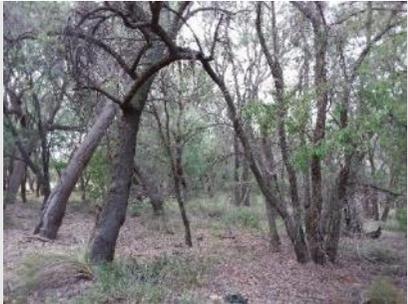
<p>BN03 in Very Good condition</p>

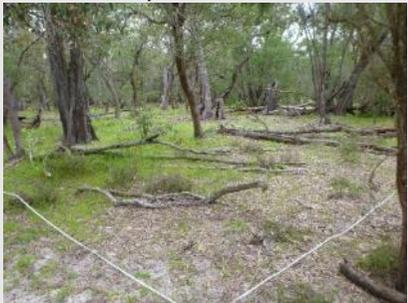
<p>BN08 in Degraded condition</p>	<p>Extent: 23 ha. Condition: Very Good – Completely Degraded (3 - 7).</p>	<p>Quadrats: BN03, BN08, BN09, BN10, BN11, BN12 and BN32. Photo-points: PP1, PP25, PP27, PP30, PP36, PP37, PP38, PP50, PP52, BNA10, BNA17, BNA17, BNA28, BNA56, BNA59, BNA60, BNA61, BNA62 and BNA65. FCT: FCT21a.</p>

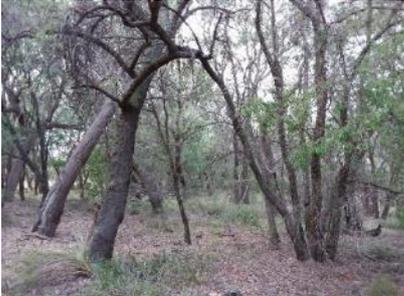
Showing minor disturbances and very few weeds. Vegetation structure is intact, native shrubs, herbs, sedges and rushes present.

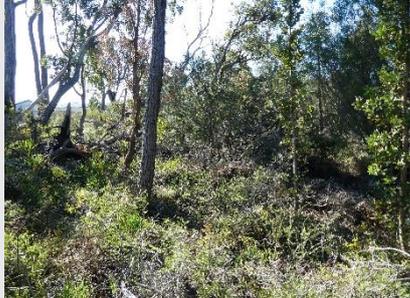
Showing on minor disturbances (e.g. weeds / dieback/ edge effect from nearby roads and land uses). Vegetation structure is intact, native shrubs, herbs, sedges and rushes present.
Good (4): 19 ha (1.63 % of the survey area)

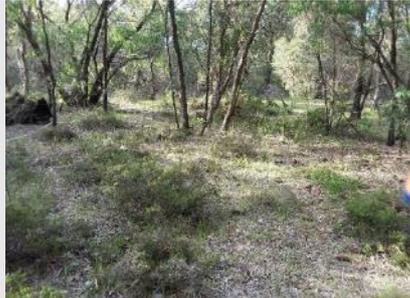
Showing native vegetation in the upper, mid and ground layers resembling native structure. Obvious disturbances including weeds and dieback (rated Good).
Good (4) to Degraded (6): 57 ha (4.88 % of the survey area)

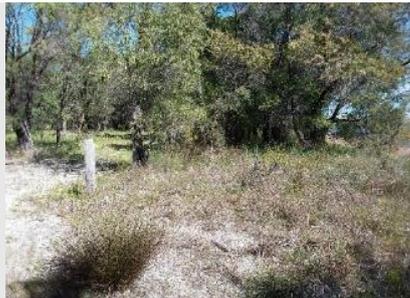
Good – Degraded was assigned when some structure and native species remained in the mid and ground layers but introduced species were dominant.
Degraded (6): 92 ha (7.90 % of the survey area)

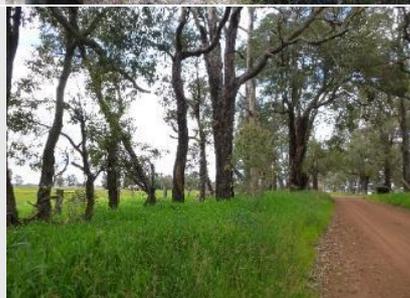
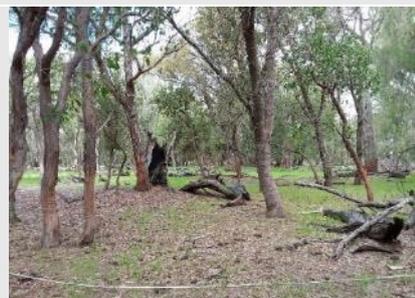
<p data-bbox="882 1592 1437 1731">Showing a woodland with a tree layer but absence of any mid storey and a ground layer dominated by introduced grasses and herbs.</p>

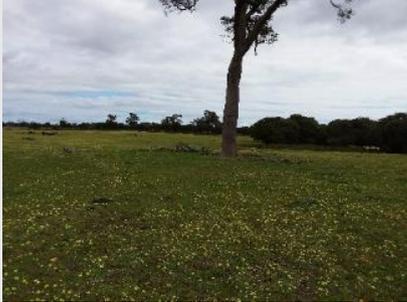
Paddock – cleared of native vegetation and dominated by pasture grasses. Isolated trees occasionally present.
