# TEC Vegetation Monitoring Program

## APPENDIX G TEC VEGETATION MONITORING PROGRAM

Main Roads Western Australia  
 Bunbury Outer Ring Road Northern and Central Section  
 Response to EPA Notice of Decision to Assess:  
 Additional Information Request

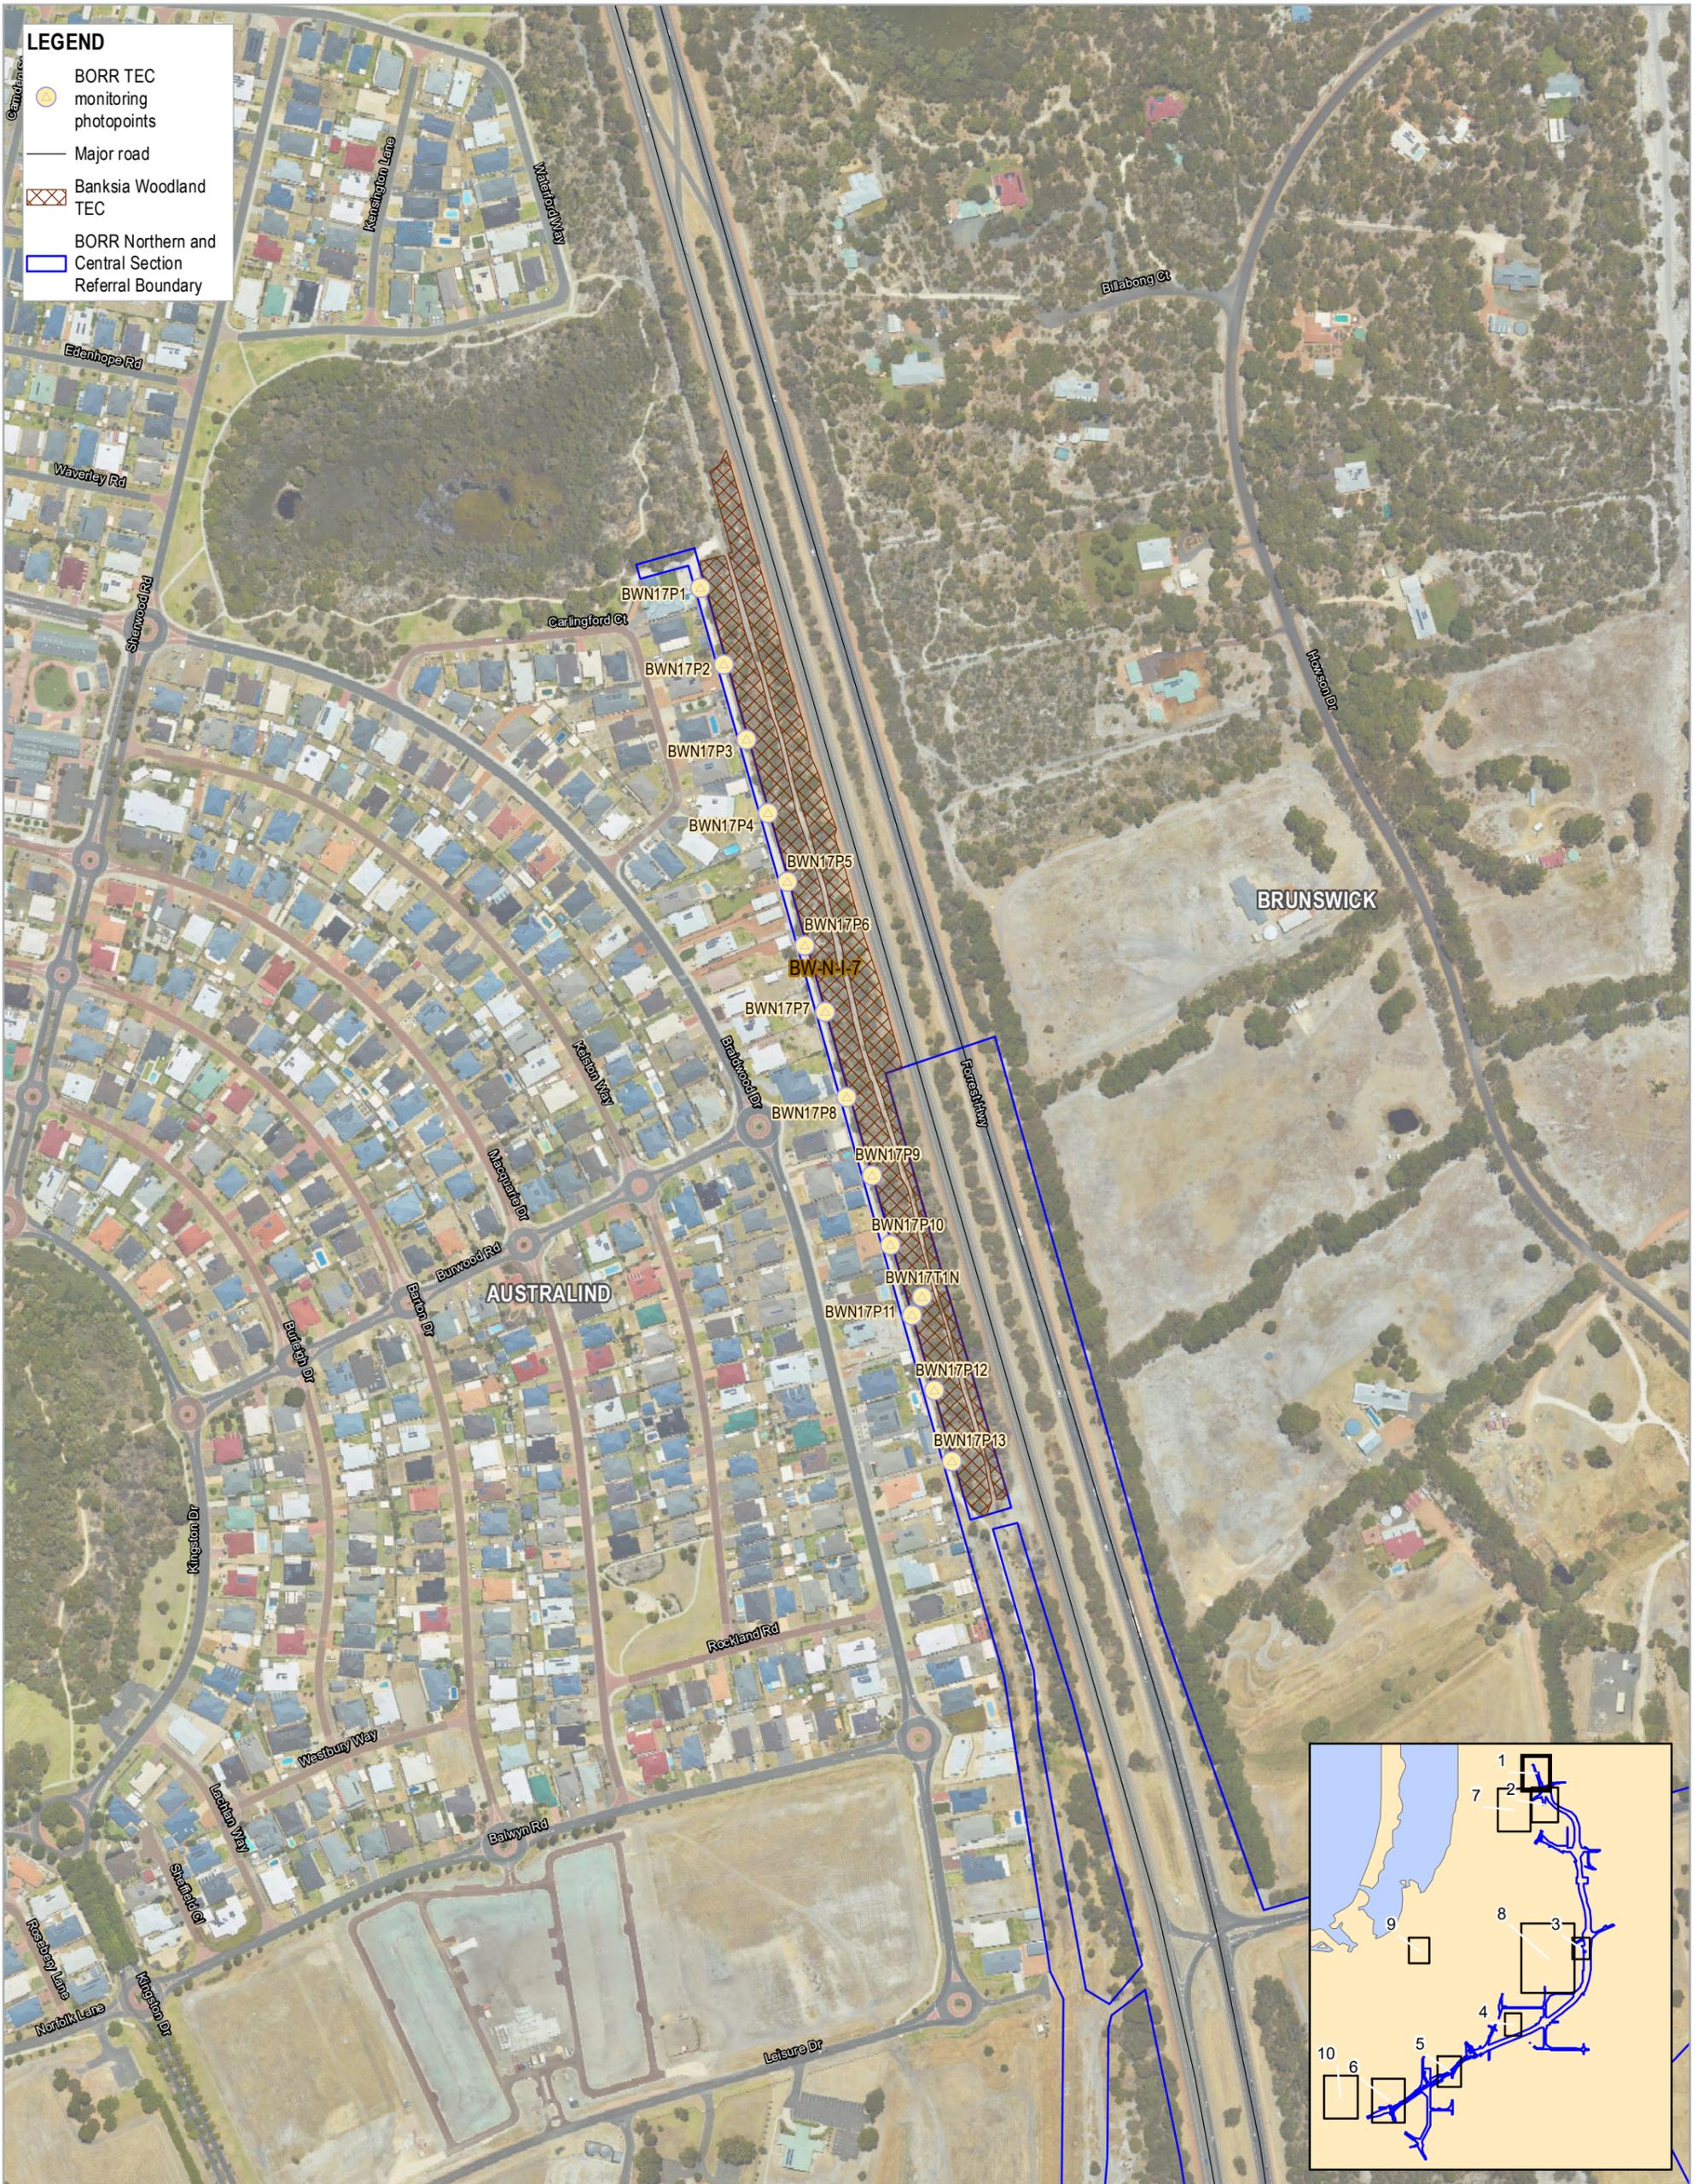
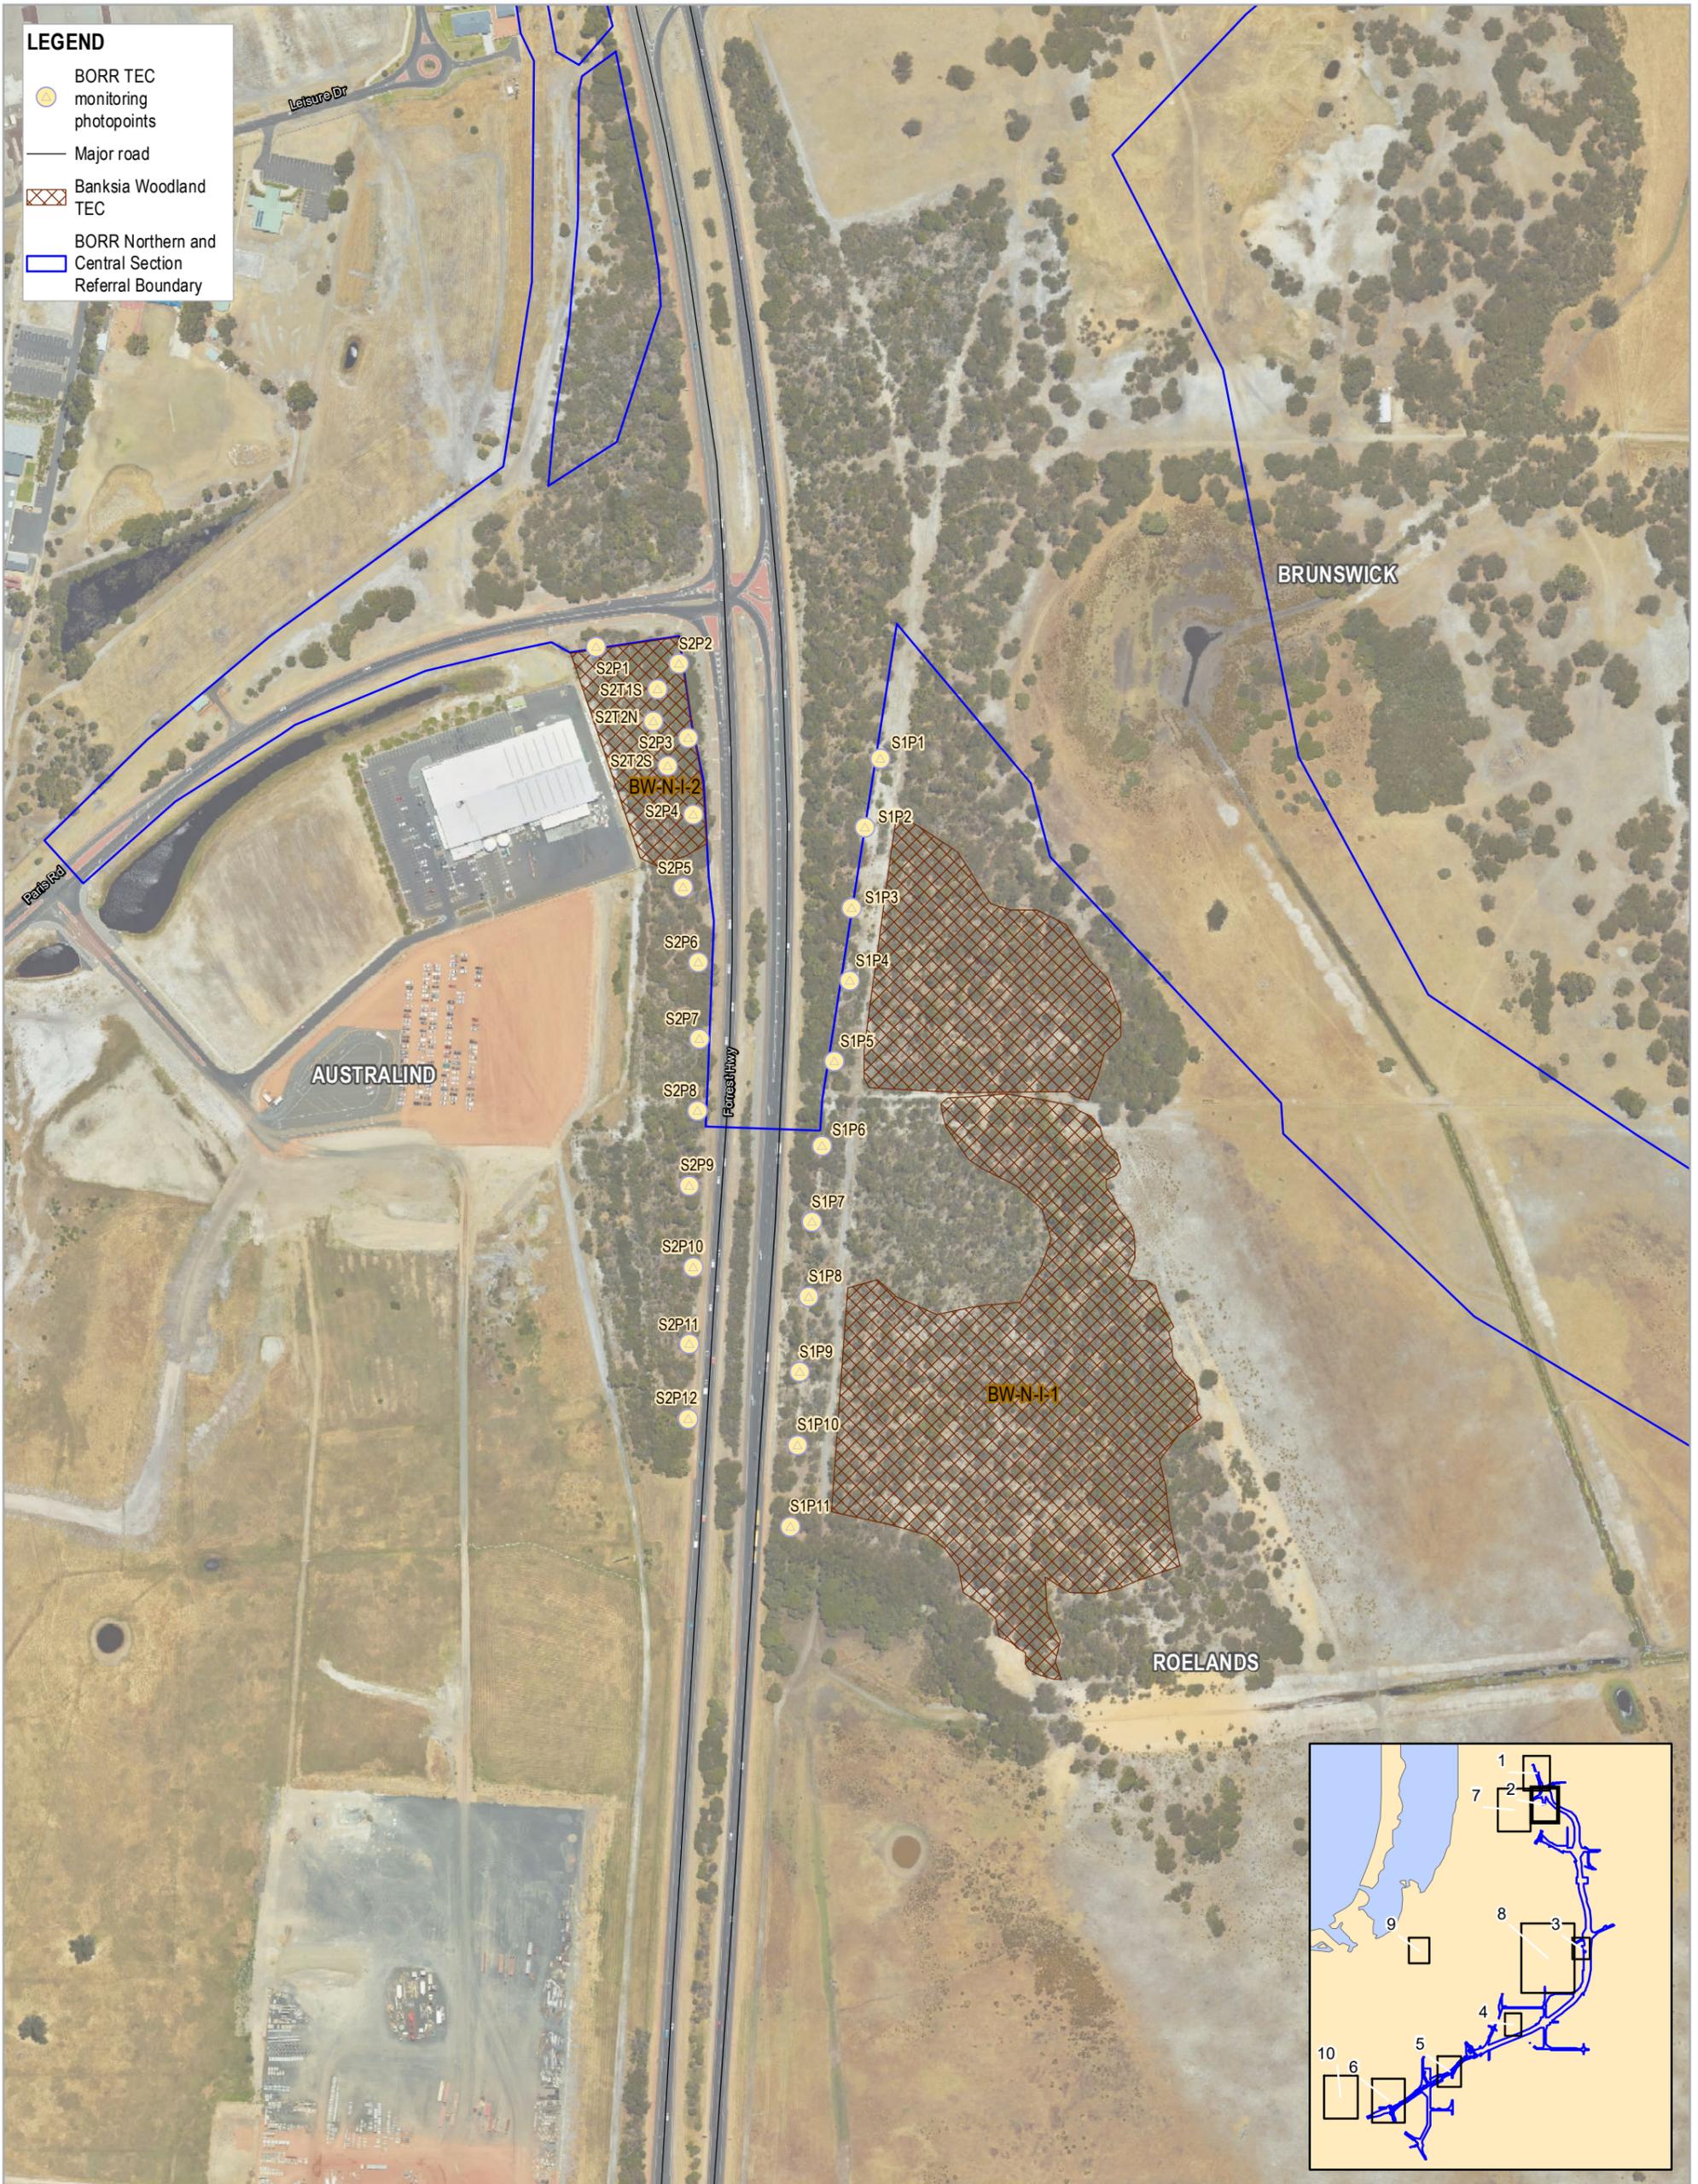
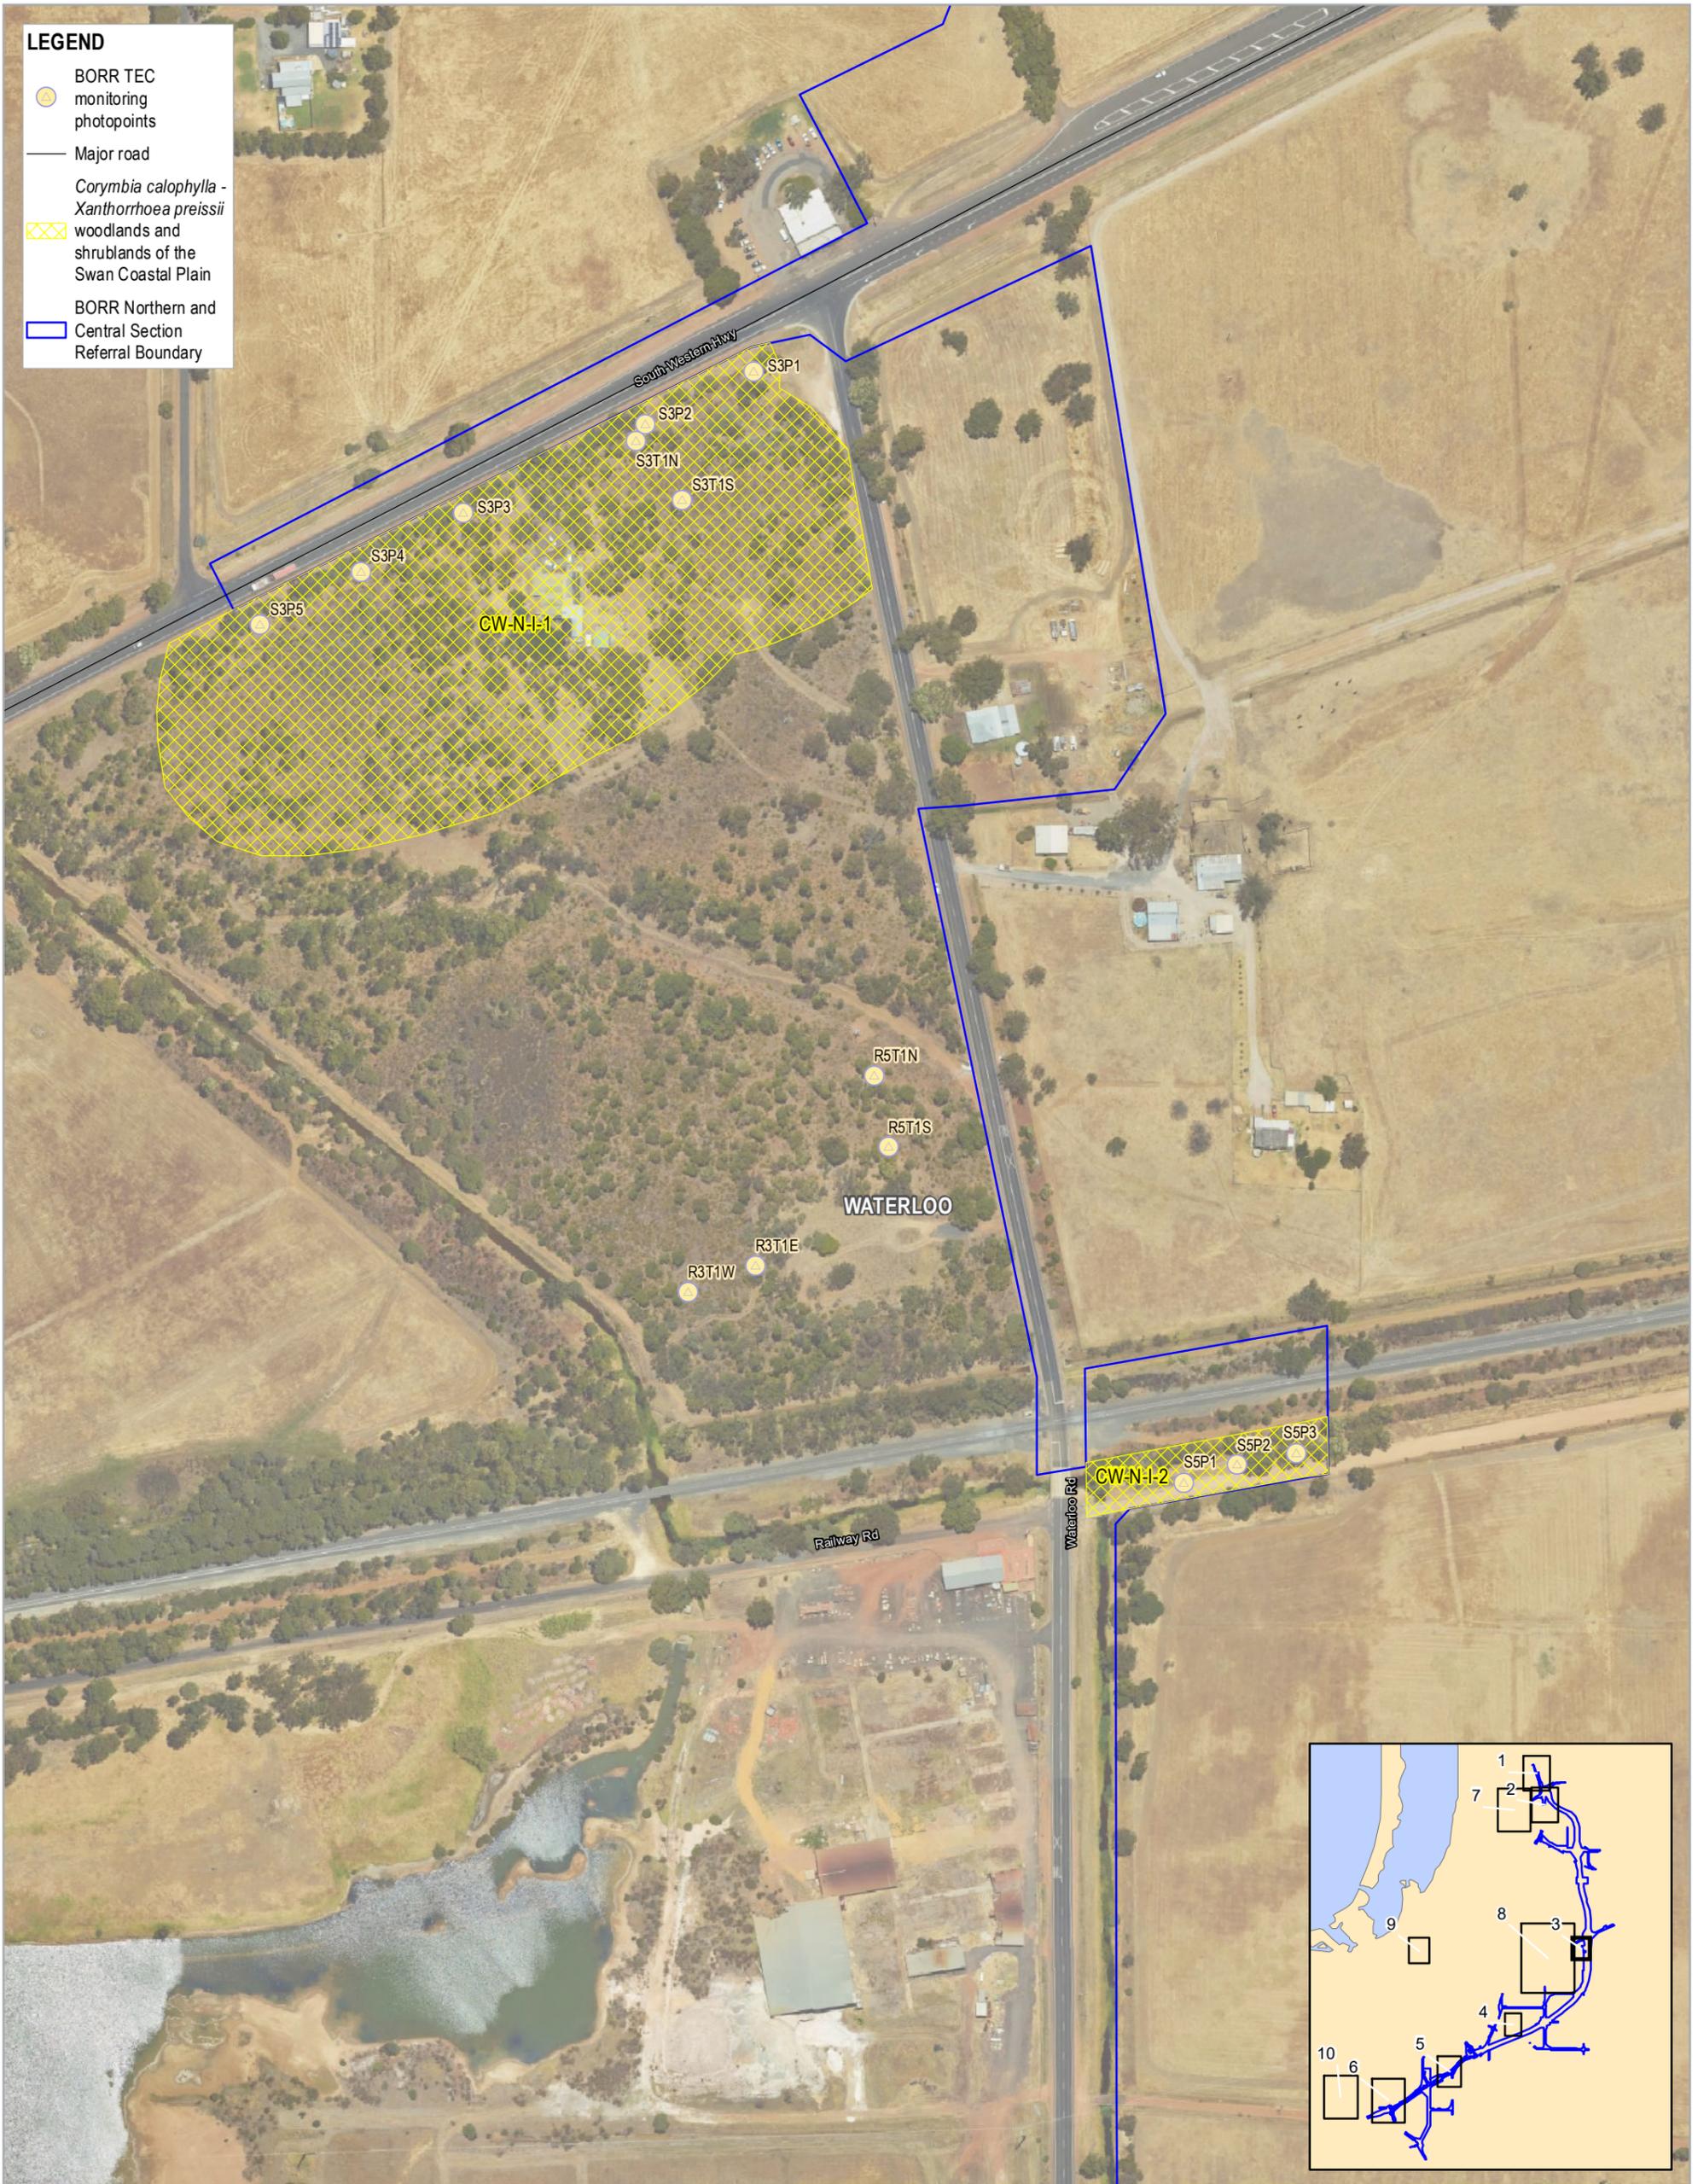
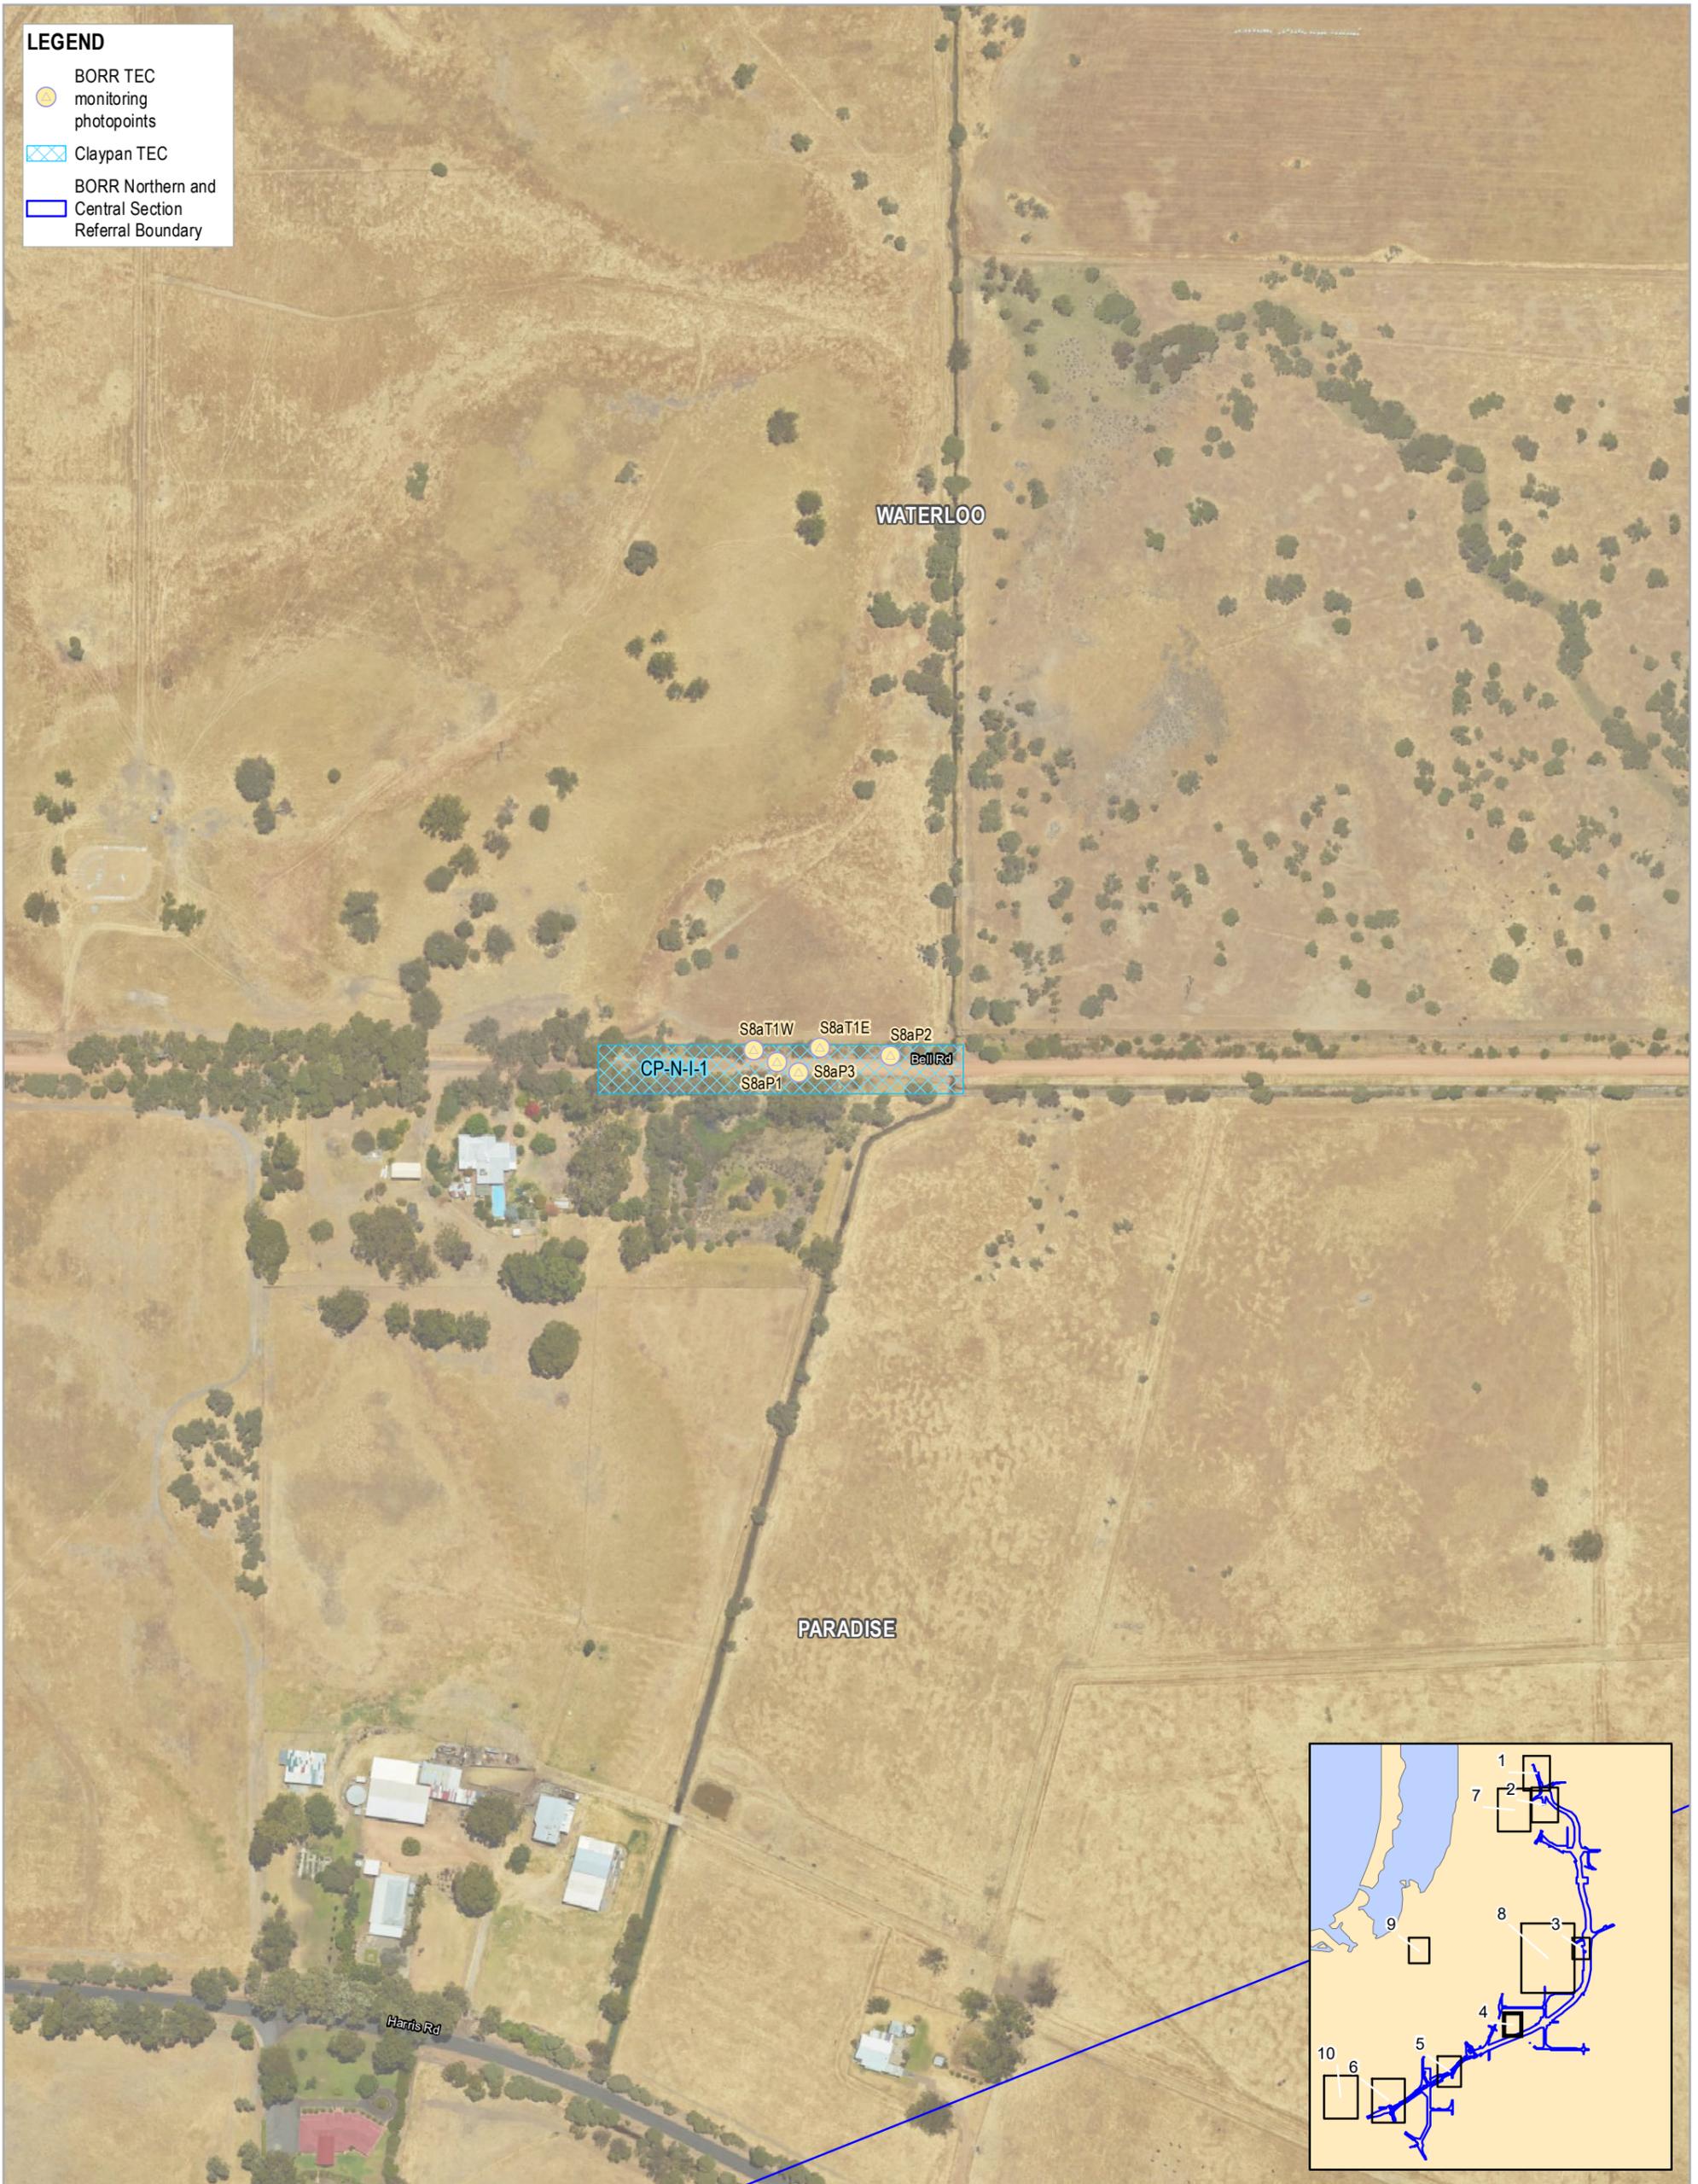
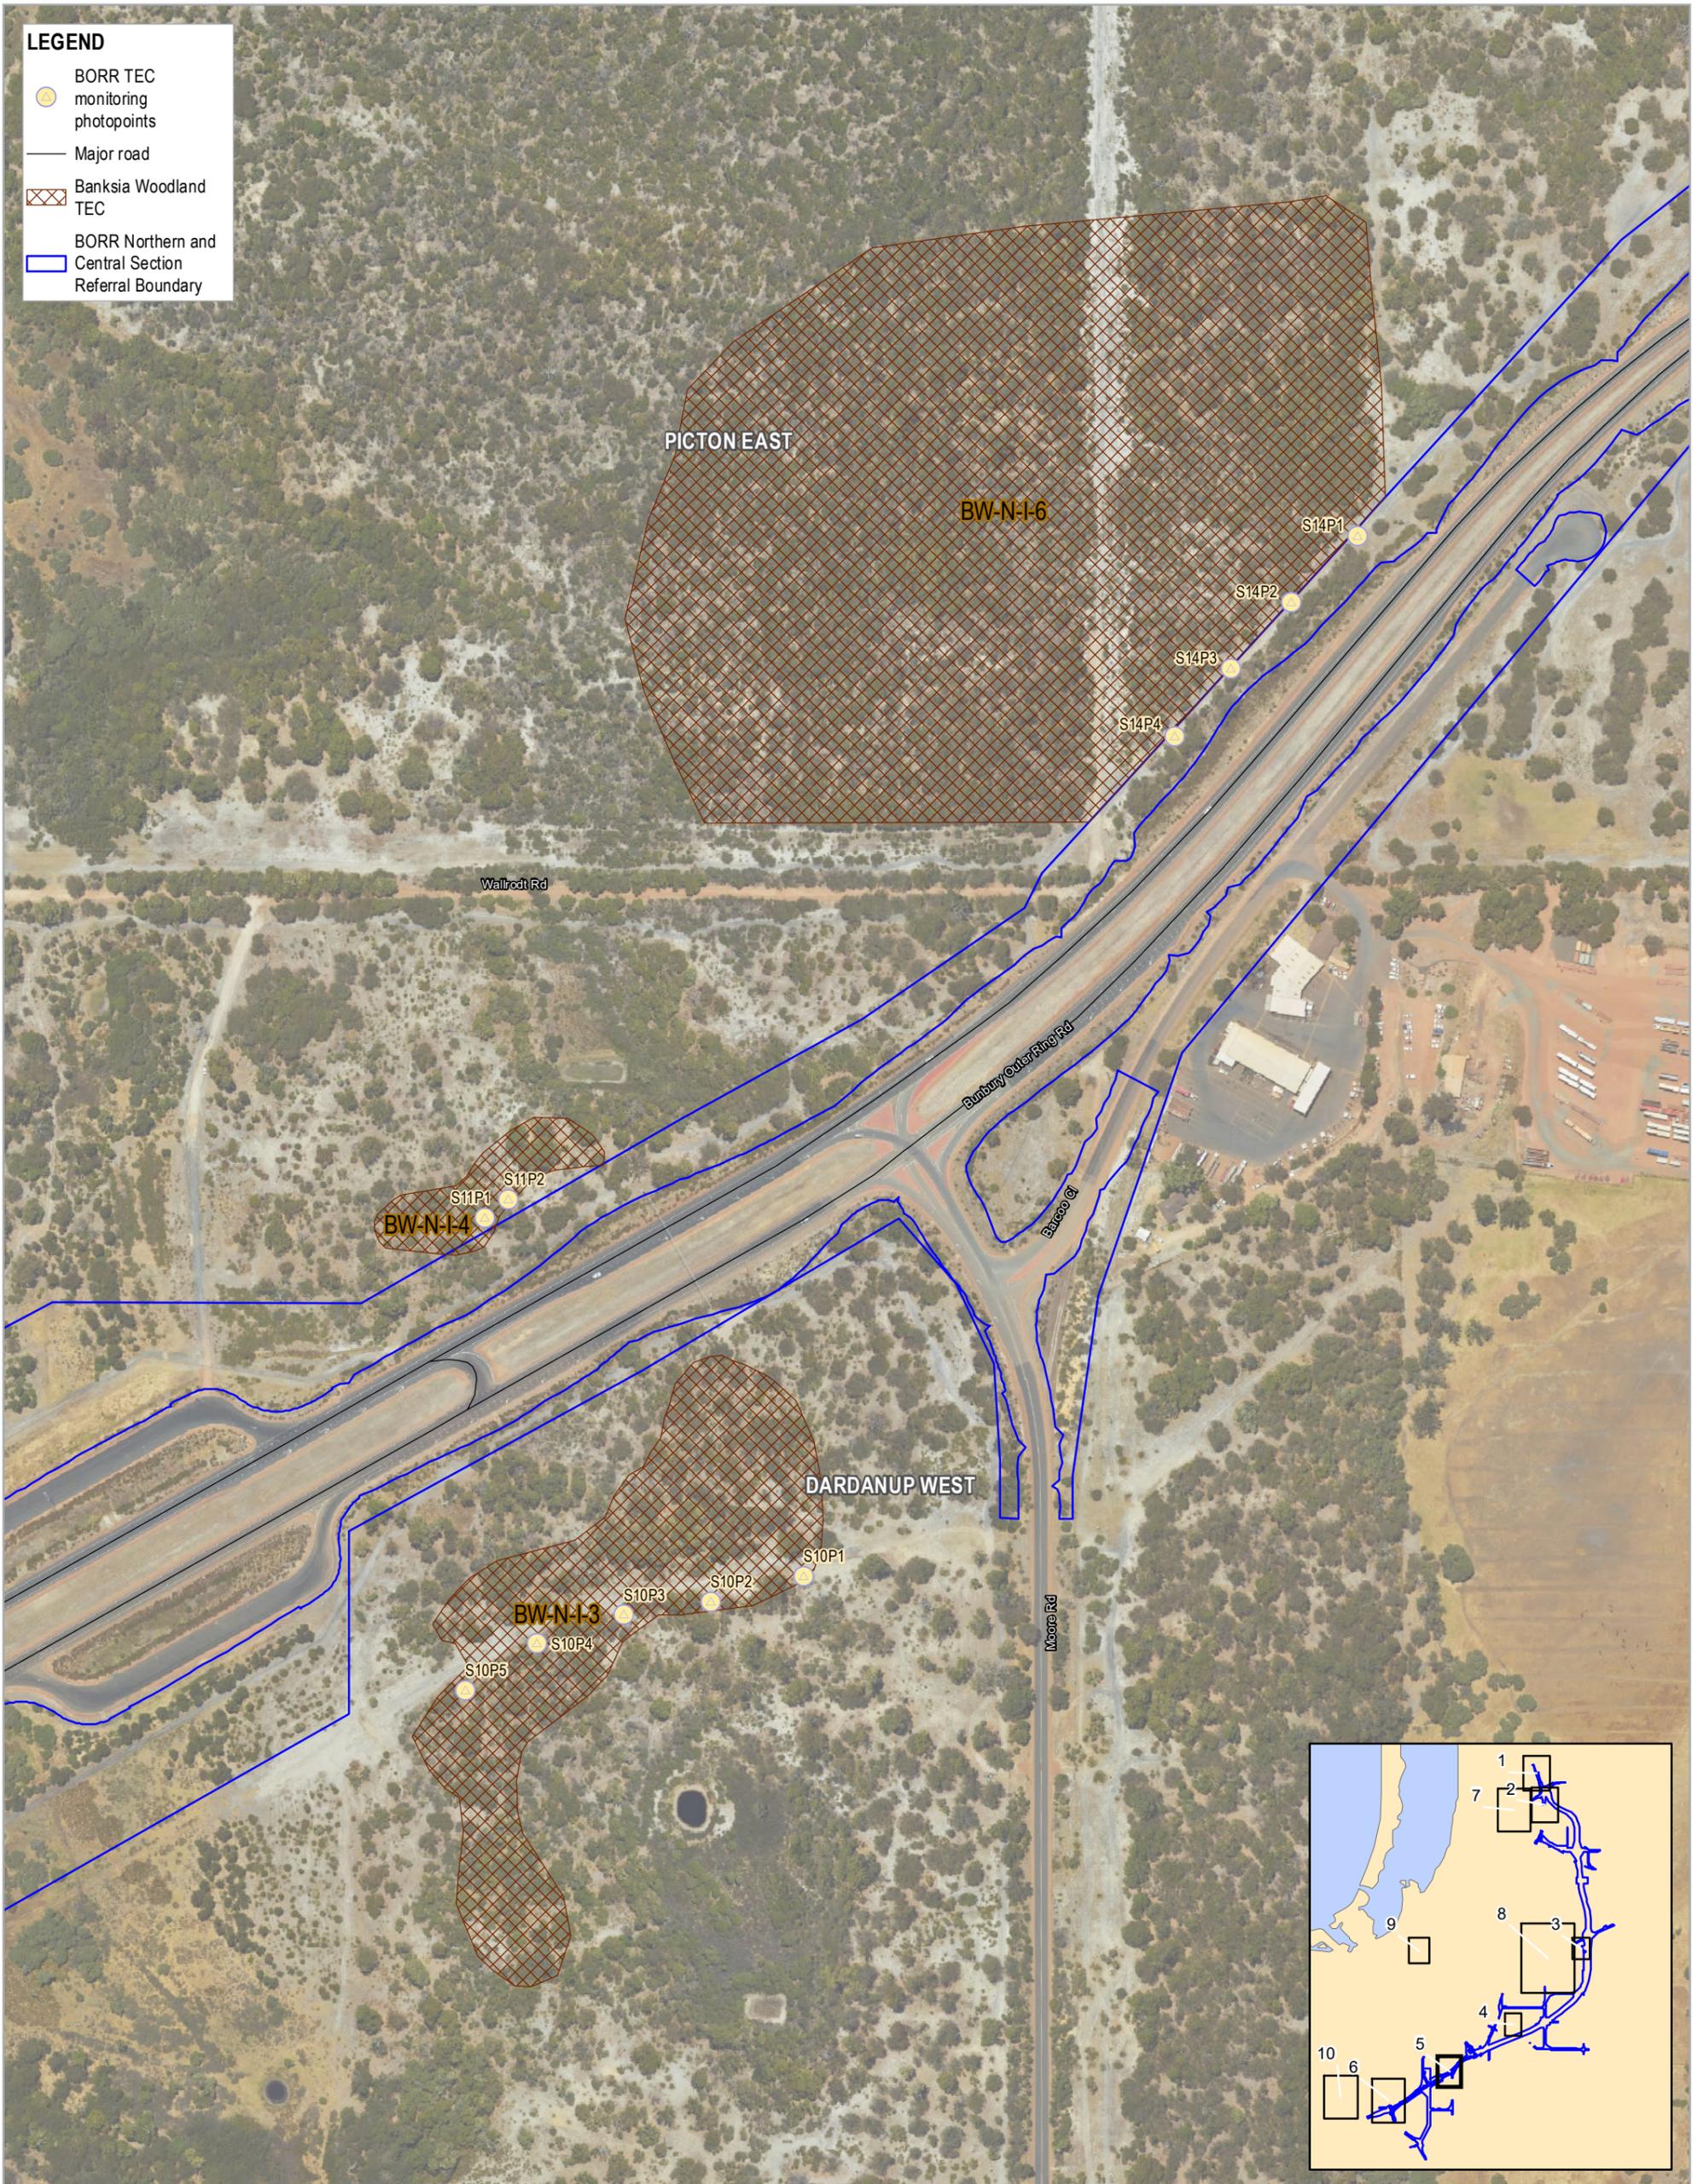
Page 3 of 10  
**FIGURE 1**

Potential impact (Monitoring) sites as listed in sections 2.4.1, 2.4.2 and 2.4.3 of BORR IPT (2020a) and shown on Figure 1 will be monitored in comparison to Reference Sites.

Monitoring Sites and Reference Sites are listed in Table 1 and Table 2 respectively, and are shown on Figure 1.

Vegetation monitoring is comprised of monitoring transects and photopoints. The methodologies for each approach are detailed below. Transect start and end points (denoted by inclusion of 'T' in the site name) and photopoint locations are shown on Figure 1.

As detailed above, suitable monitoring Reference Site locations have been determined through desktop assessment and local knowledge of the vegetation surrounding the Proposal Area. DBCA have indicated the selected sites are suitable for use as Reference Sites in the monitoring program (pers. comm. Andrew Webb, 12/08/2019; 20/08/2019). Reference site locations are shown in Figure 1.

Two transects 30 m in length were established within Site BW-N-I-2 (Figure 1). Three reference transects, also 30 m in length, were established as follows:

One transect of 30 m in length was established at Site CP-N-I-2 (Manea Park) (Figure 1). One reference transect 30 m in length was established in Claypan vegetation at the Waterloo Nature Reserve (R46108) Reference Site (CP-N-R-1) and one at Manea Park Reference Site (CP-N-R-2) (Figure 1). Transect locations were finalised during an initial site visit prior to commencing the first round of monitoring, and are located within Claypan TEC.

One transect 30 m in length was established at Site CW-N-I-1 in the South Western Highway road reserve (Figure 1). Two reference transects were established in vegetation meeting the description of this TEC; one at the Waterloo Nature Reserve (R46108) Reference Site (CW-N-R-1) and one in vegetation in the Railway Road reserve Reference Site CW-N-R-2 (Figure 1). Transect locations were finalised during an initial site visit prior to commencing the first round of monitoring, and are located within the TEC vegetation.

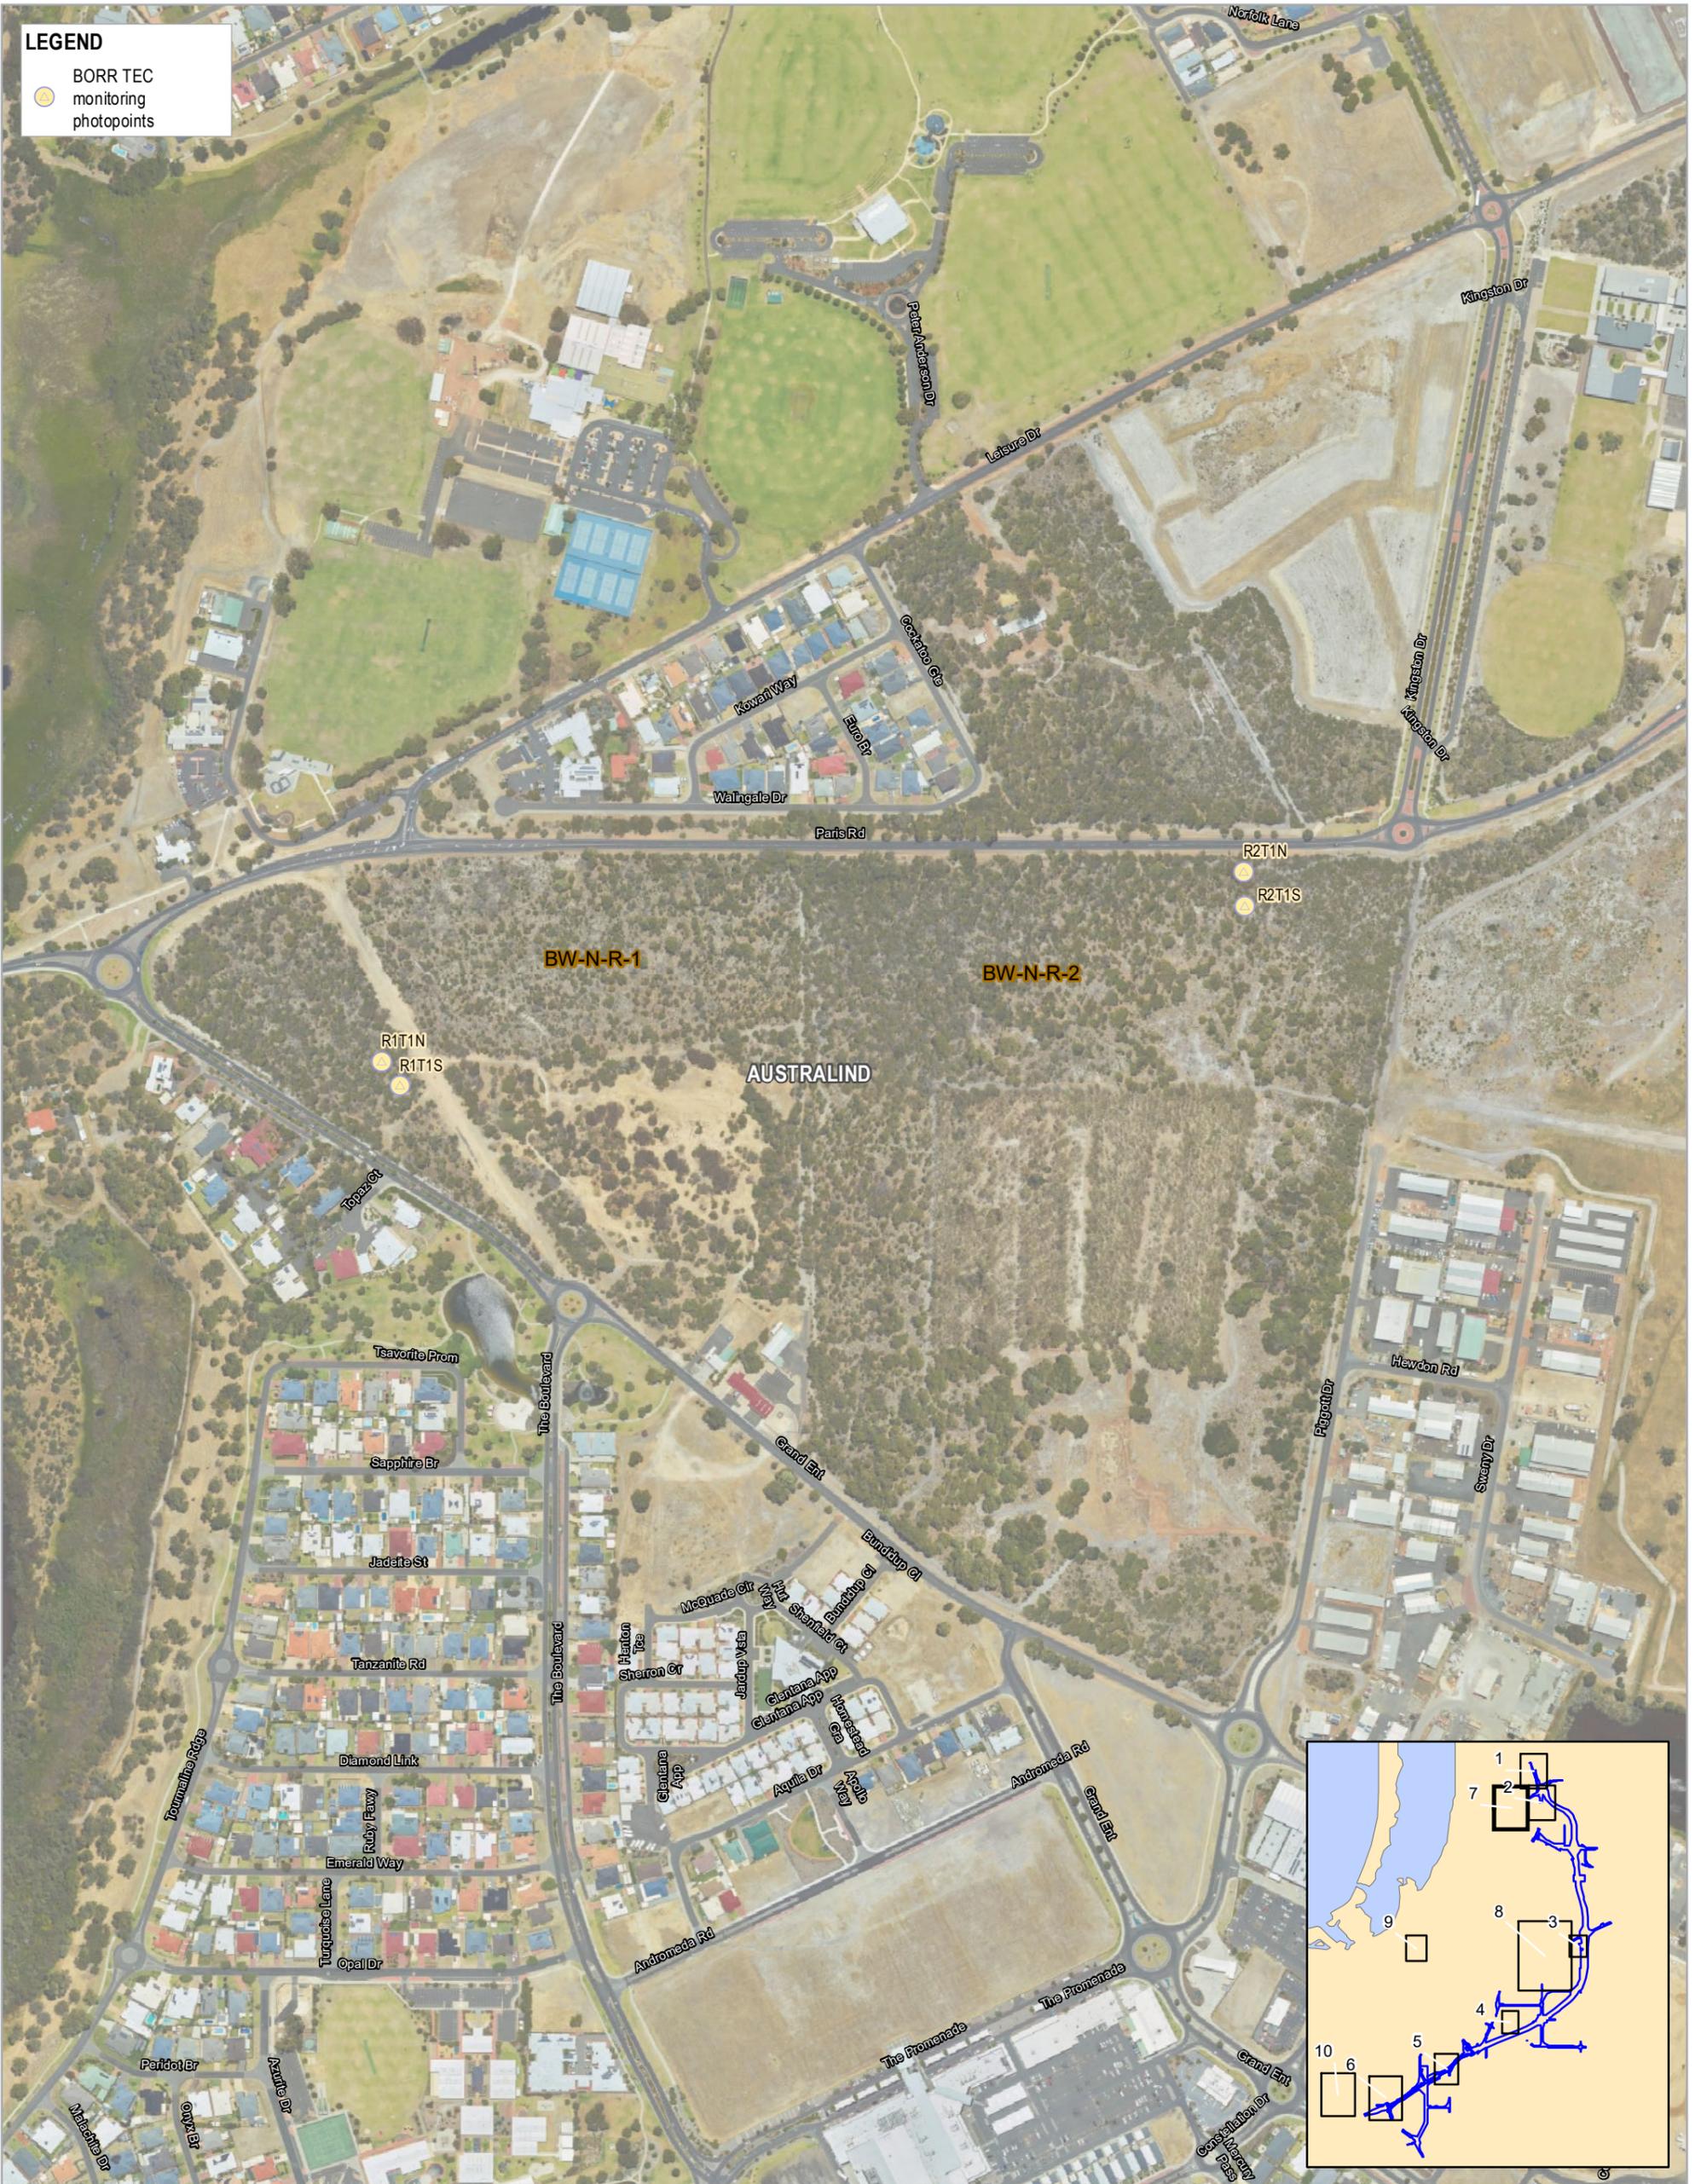
Page 6 of 10  
**FIGURE 1**

**LEGEND**  
 BORR TEC monitoring photopoints
