# TEC Vegetation Monitoring Program

## APPENDIX G TEC VEGETATION MONITORING PROGRAM

Main Roads Western Australia  
 Bunbury Outer Ring Road Northern and Central Section  
 Response to EPA Notice of Decision to Assess:  
 Additional Information Request

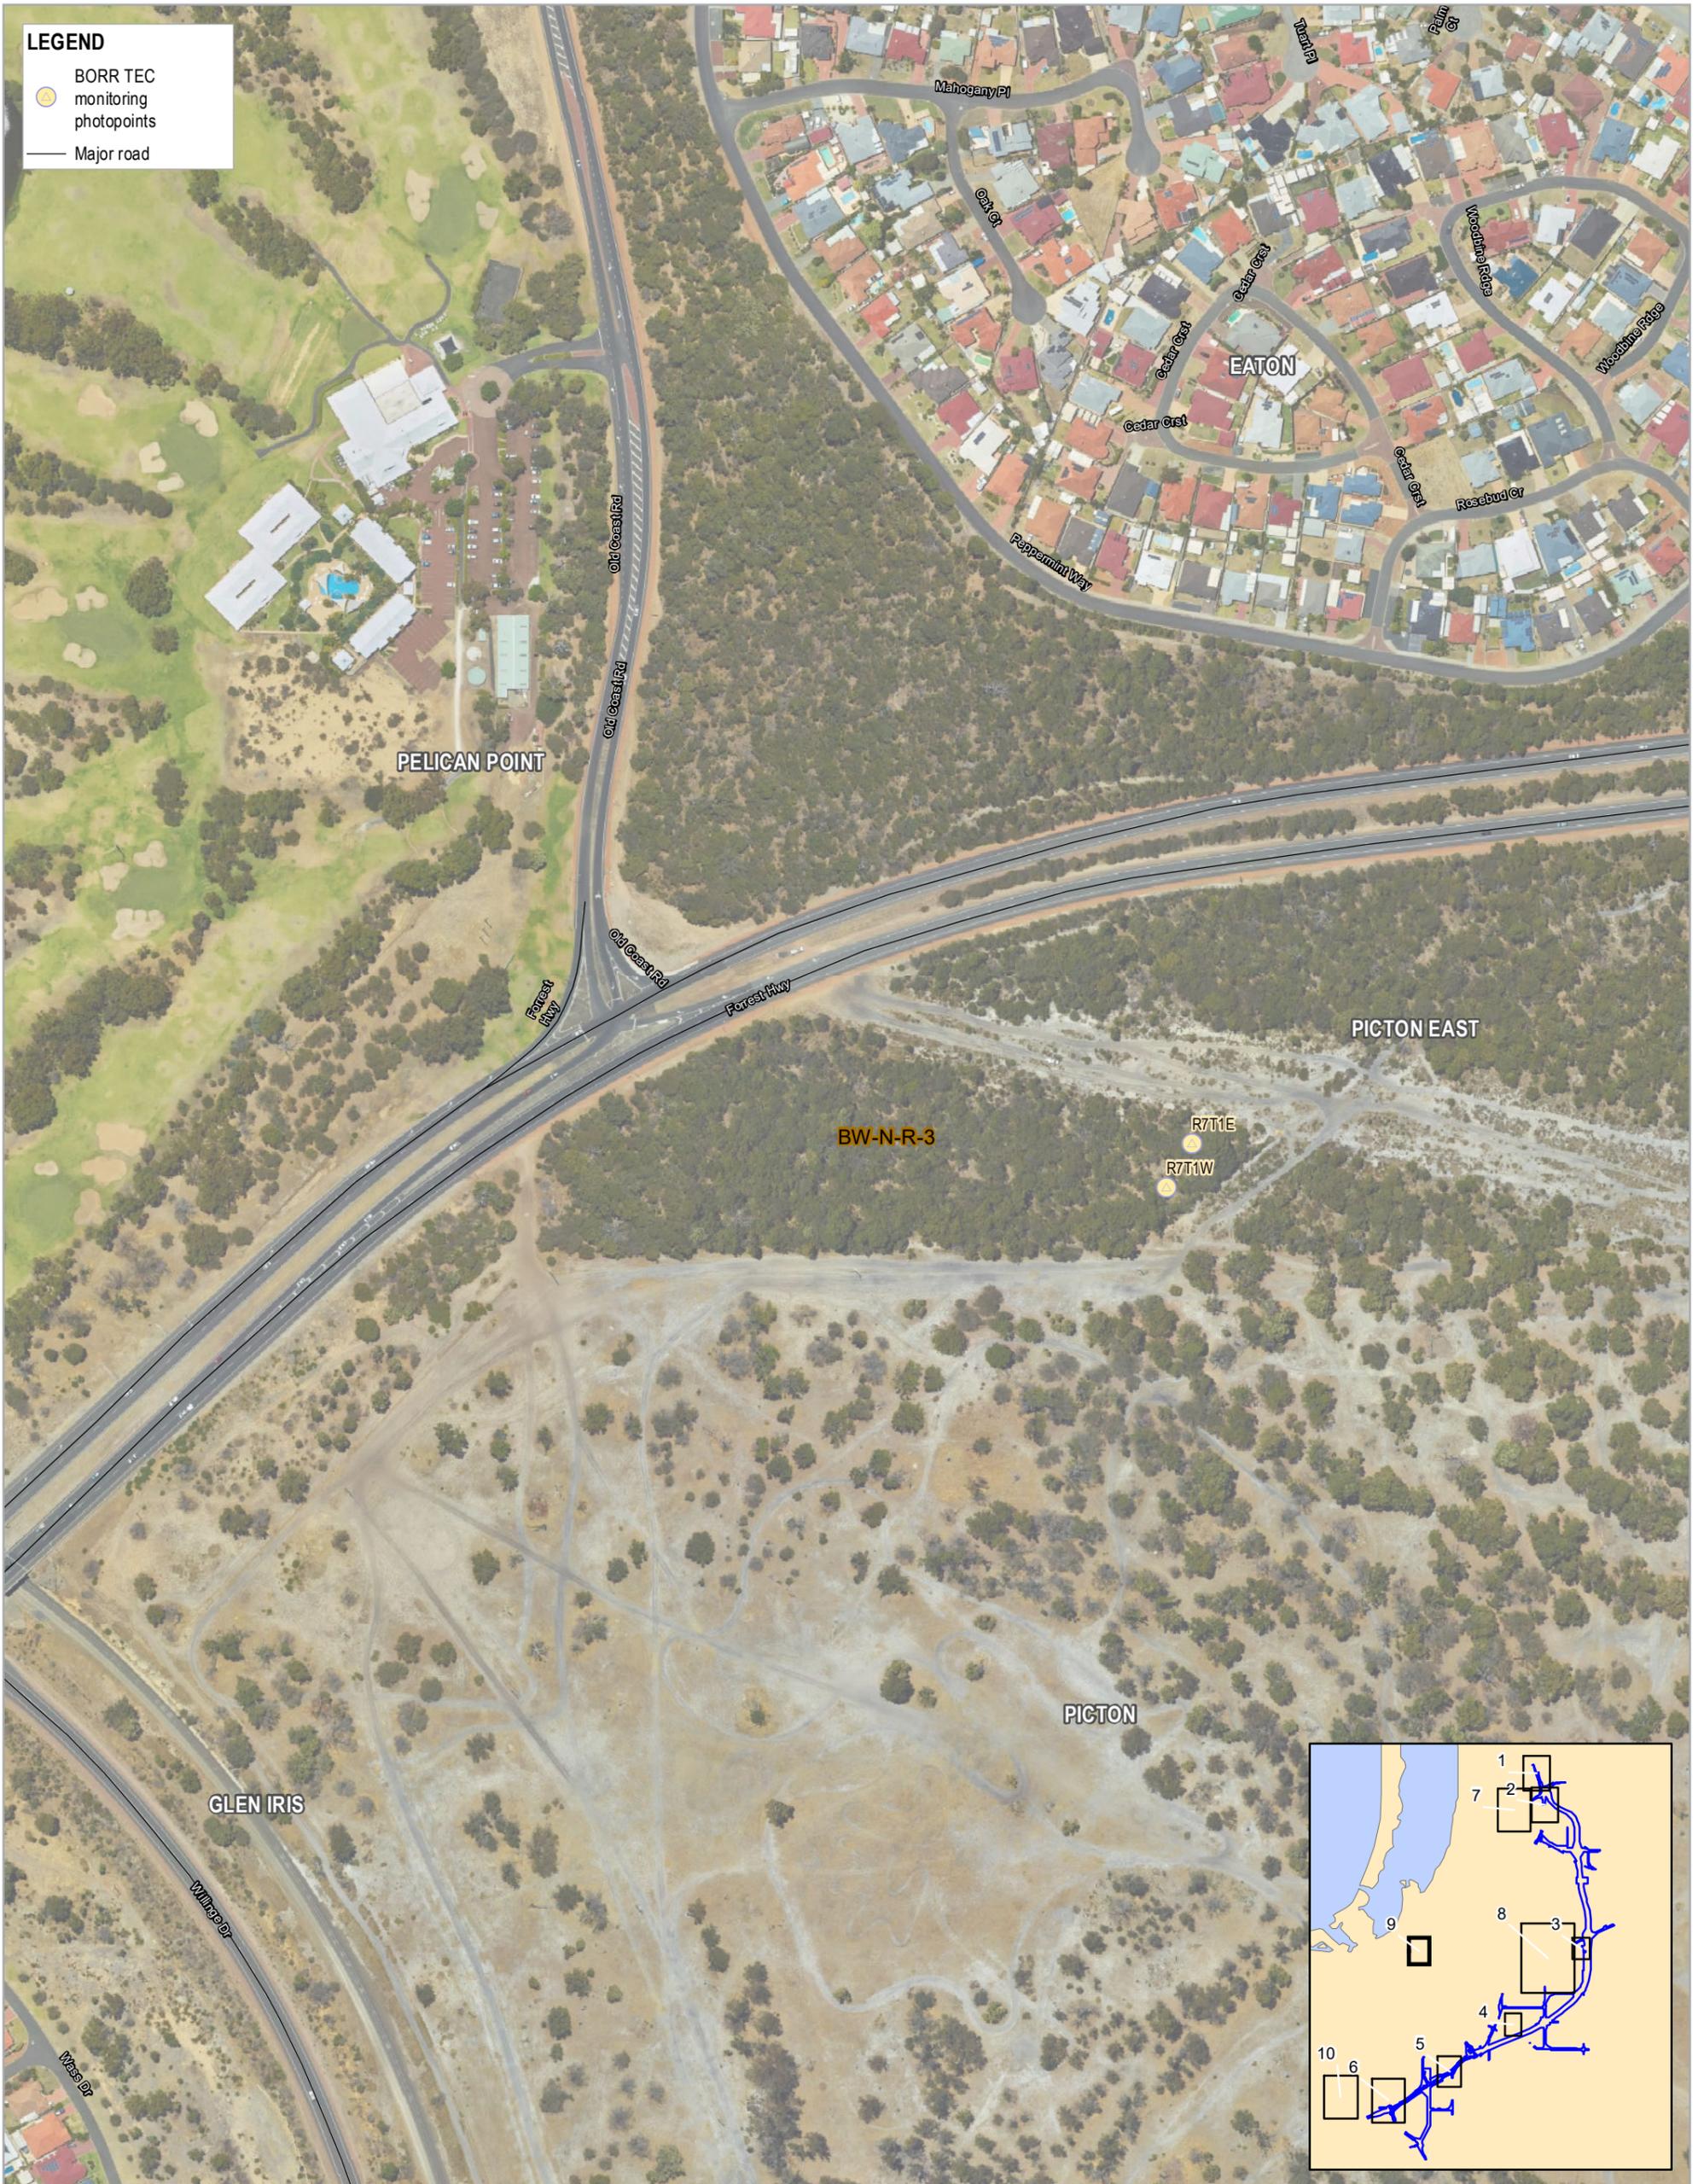
**TEC monitoring and reference sites**

- BORR TEC monitoring photopoints
- Major road

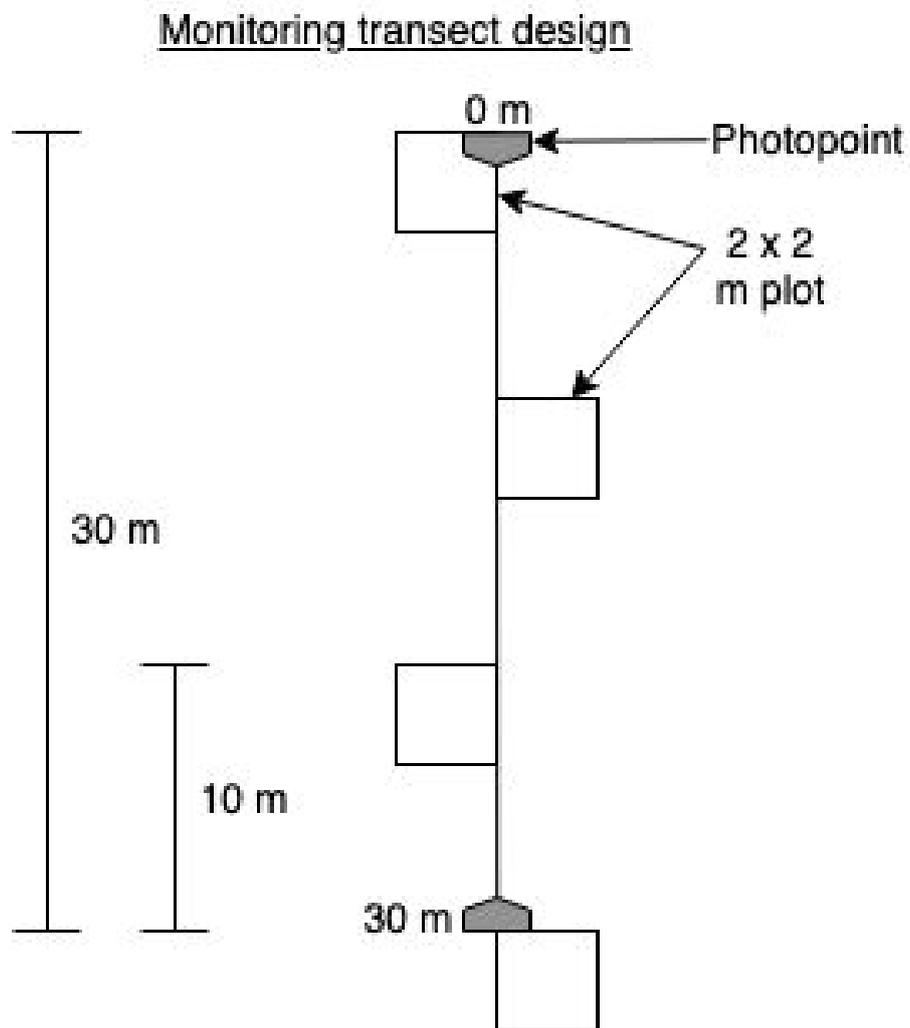
Figure 2      Layout of a monitoring transect

Monitoring transects 30 m in length were established within both Monitoring and Reference Sites. Along each transect, 2 x 2 m plots were established at 10 m intervals, the first at 0 m and the last at 30 m. Each plot was placed alternately left and right of the transect line. A total of 4 plots were established per transect.

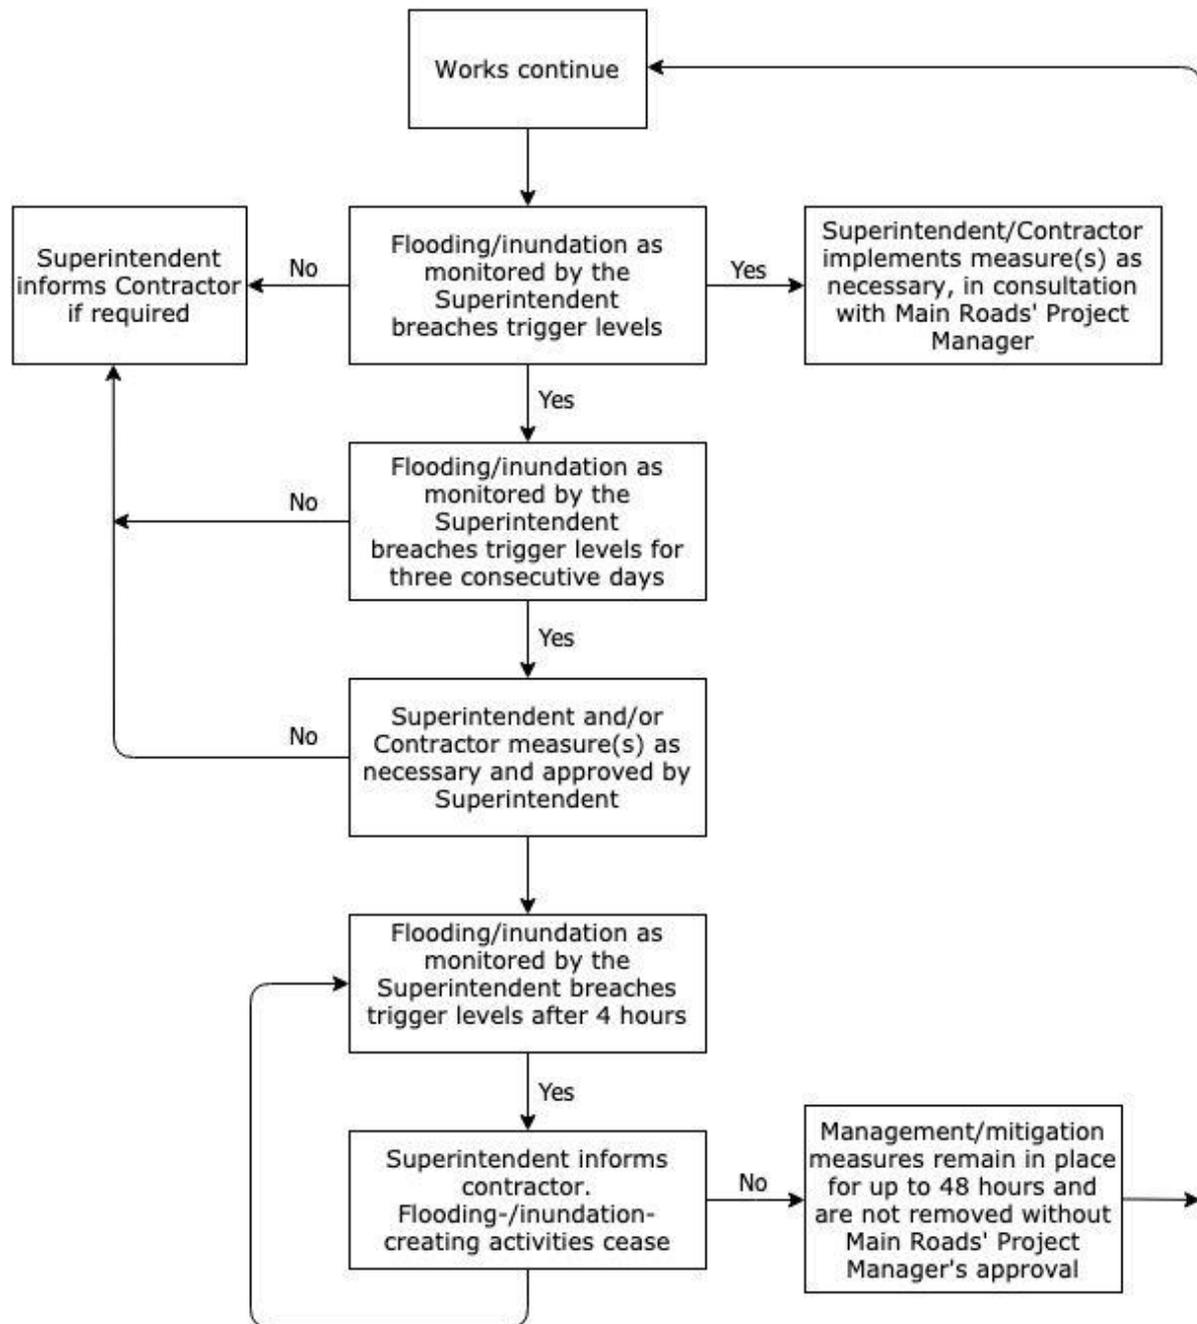
Figure 4 Threshold breach response process

A reportable decline is considered where monitoring shows a 20 per cent decline in the species composition and / or health attributes of the TEC Monitoring Sites against the change at Reference Sites.
