Bridge 1762 - Bussell Highway Over Abba River

Geotechnical Factual, Interpretive and Design Report

Client: Main Roads Western Australia

02-Dec-2016

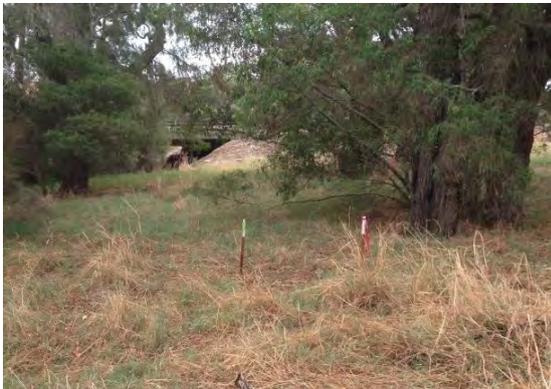
Plate 1 – Abutment 1 (East abutment) looking north

The natural ground level at the crest of the river bank is approximately 7.2 m AHD. The site is located within an area of relatively flat grassland with a dense stand of eucalypt trees and bushes along the river edge. A slight depression in the terrain is evident within approximately 80 m west and 40 m east of the channel centre and represents the zone of the historic meandering of the river. The existing channel is approximately 12 m wide in the vicinity of the proposed bridge, between river banks.

At the time of the investigation the river channel was damp but not flowing. The base of the channel was estimated to lie at approximately 4.7 m AHD based on available LiDAR data.

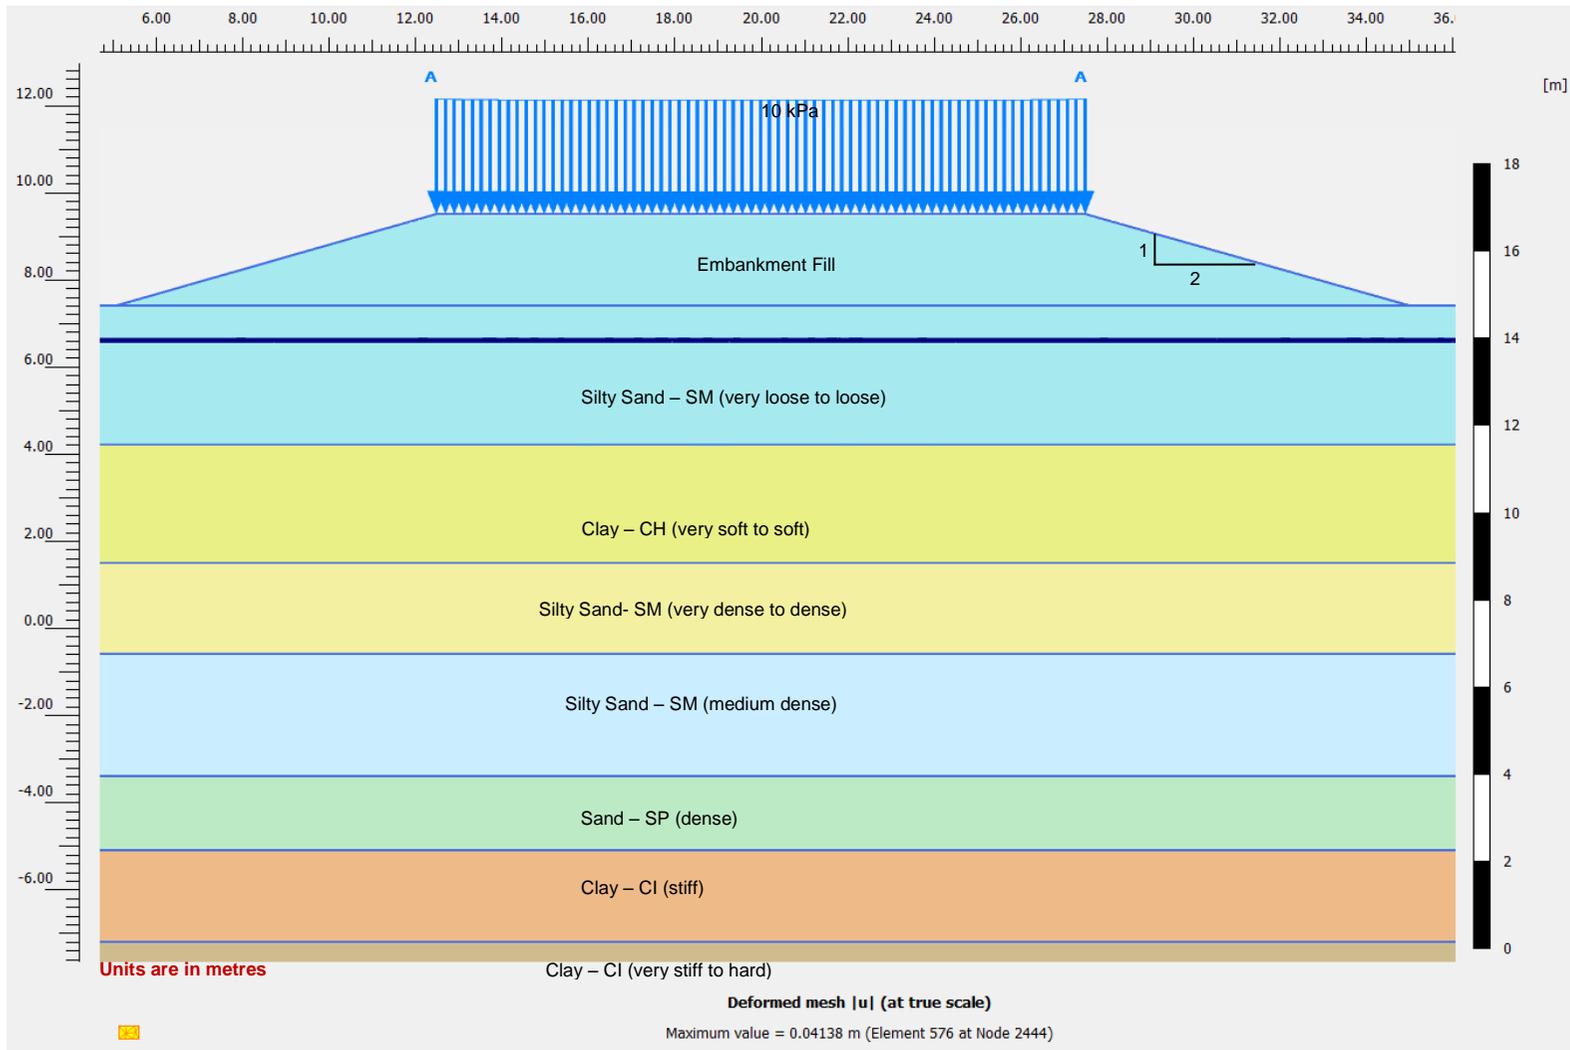
Plate 1 Soil Model for Eastern Approach Embankment of Bridge 1762

The soil profile and soil parameters adopted for PLAXIS analysis are presented in Plate 1 and Table 8, respectively. Mohr-Coulomb and 'Soft Soil Creep' (time dependent behaviour model as described in Plaxis manual) models were used for sandy soils and cohesive soils, respectively.

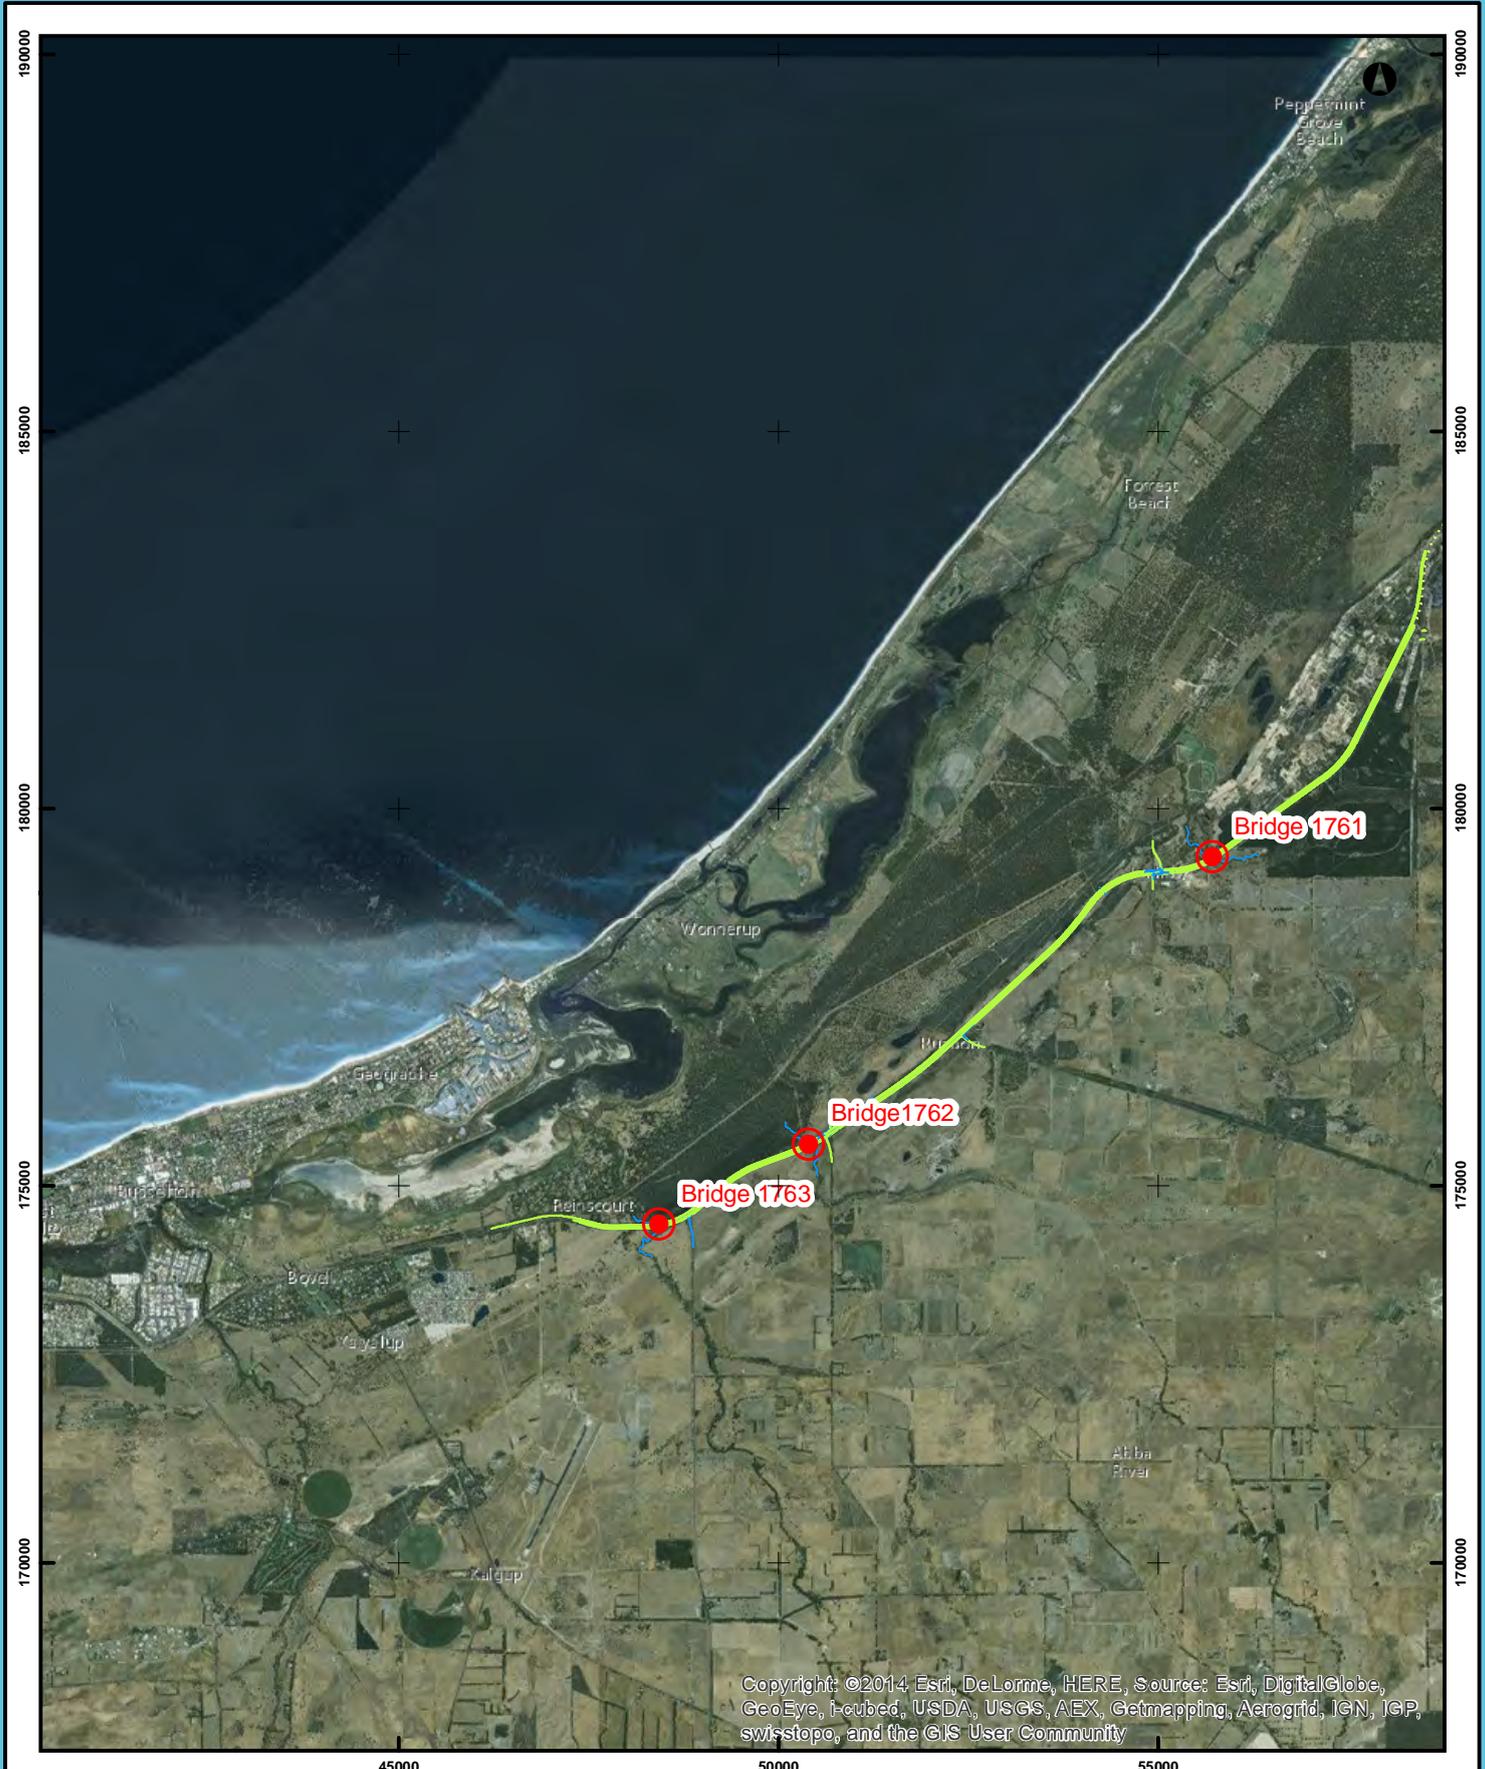
A site location plan is presented in Figure 1 of **Appendix A**, showing the proposed bridge, road alignment and site environs.

**Bussell Highway Duplication
Bridge Locations**

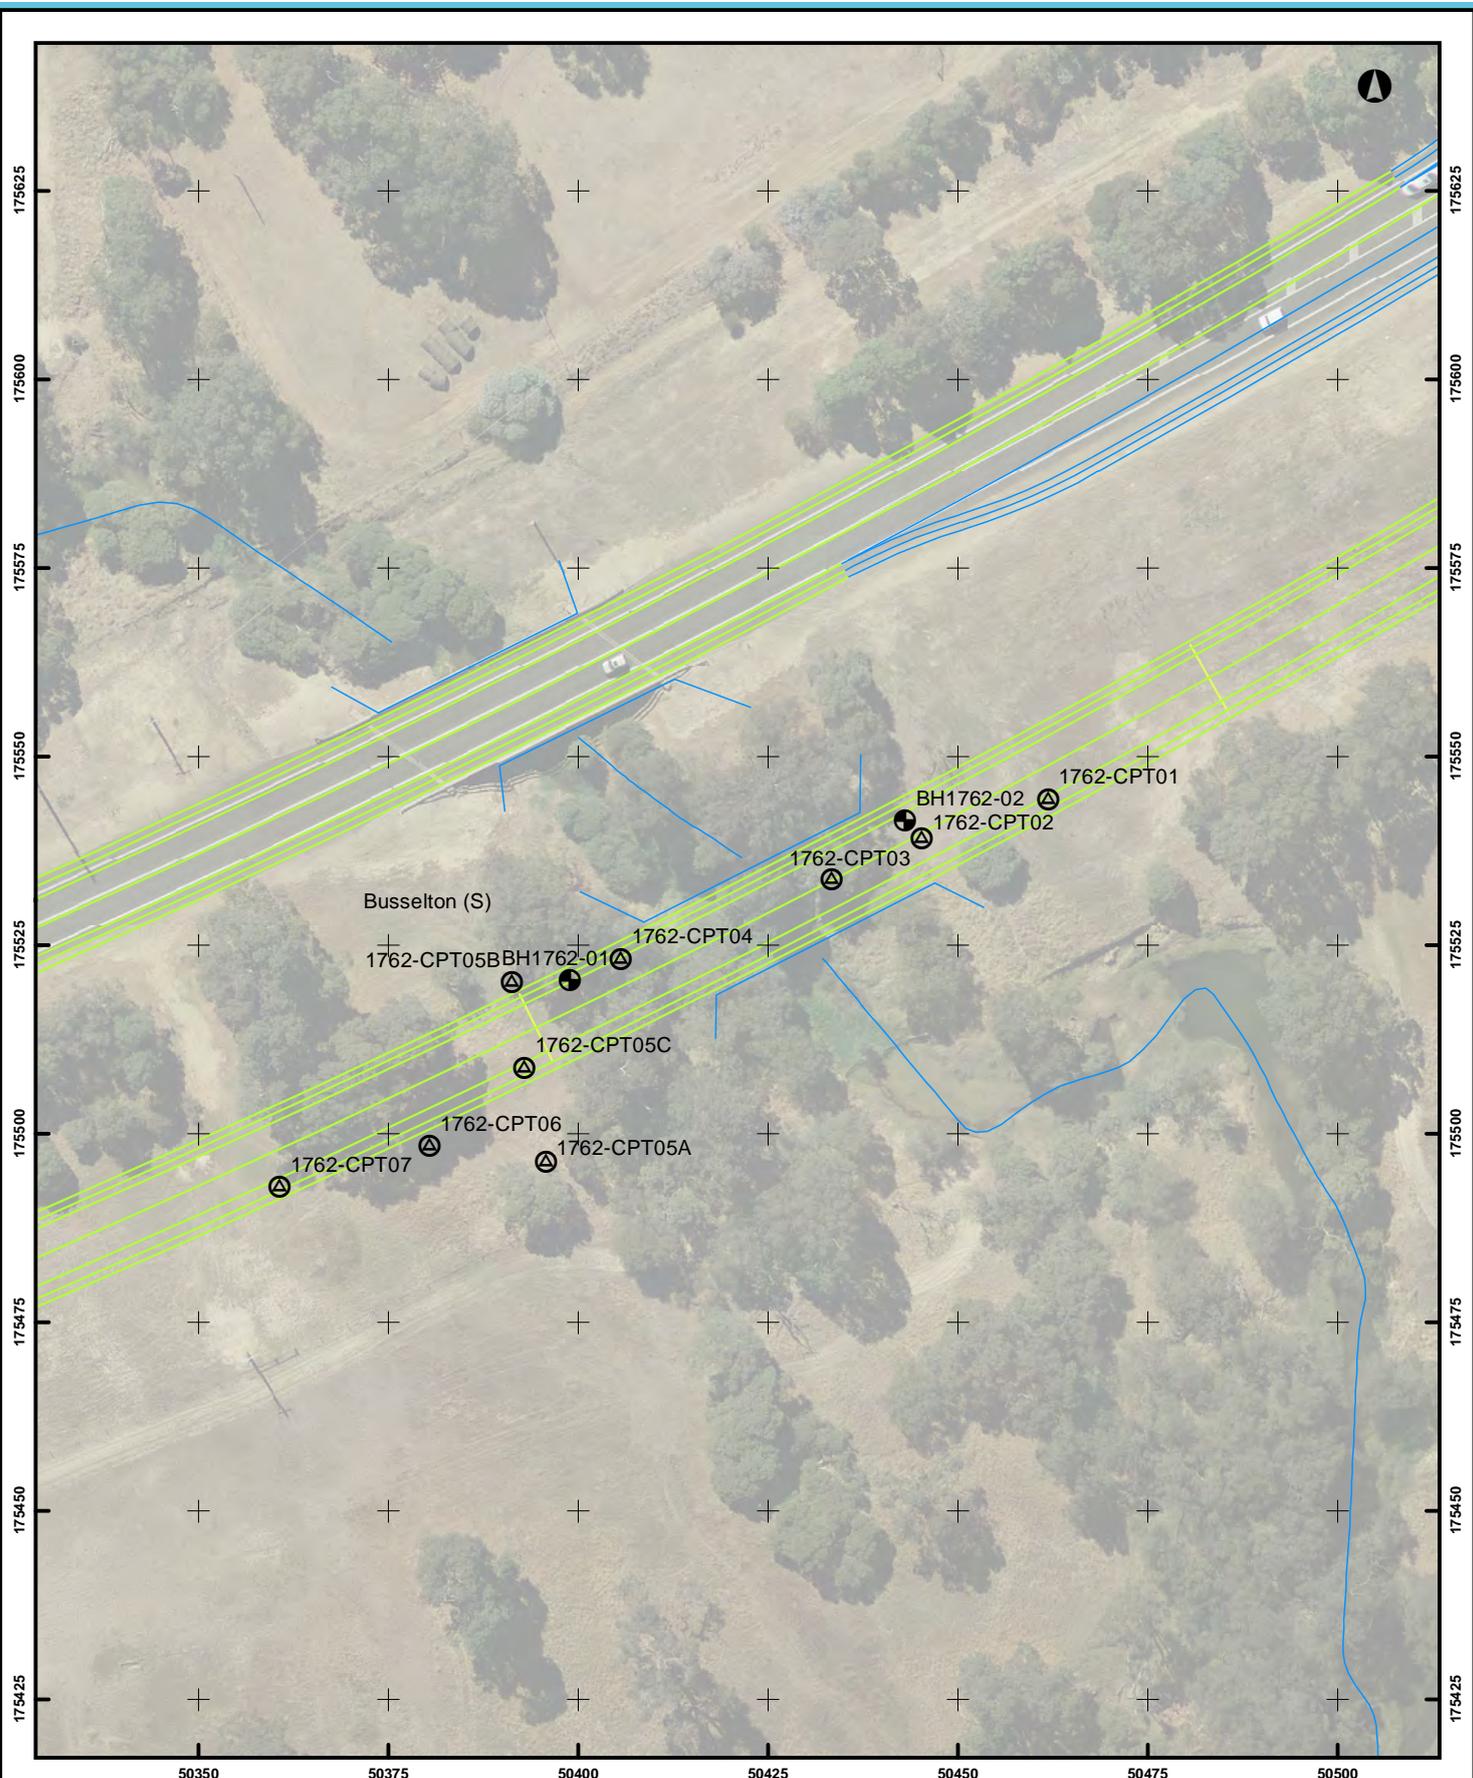
Figure 2 of **Appendix A** presents the investigation locations in relation to the concept design. Efforts were made to undertake investigation holes as close as possible to the likely bridge and approach foundations, taking into account all three concept designs. The actual locations were constrained by:

**Bridge 1762
Geotechnical
Investigation Locations**

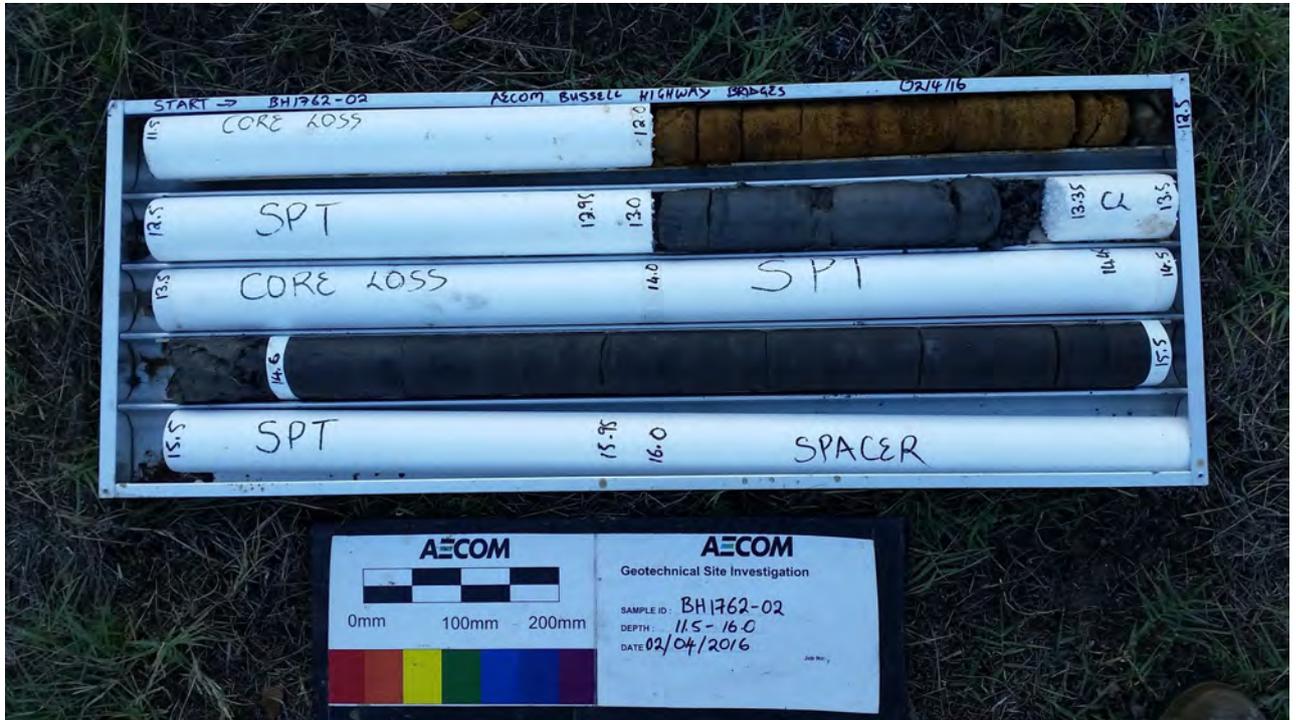
BH1762-02 11.50m - 16.00m

One horizon of coffee rock was found in BH1762-02 and inferred to mark the boundary between the Recent Alluvium and underlying Guildford Formation, this was a red-brown silty sand containing a trace of gravel. Coffee rock horizons may also be indicated by the shallow refusals in 1762-CPT01, 1762-CPT01A and 1762-CPT05.

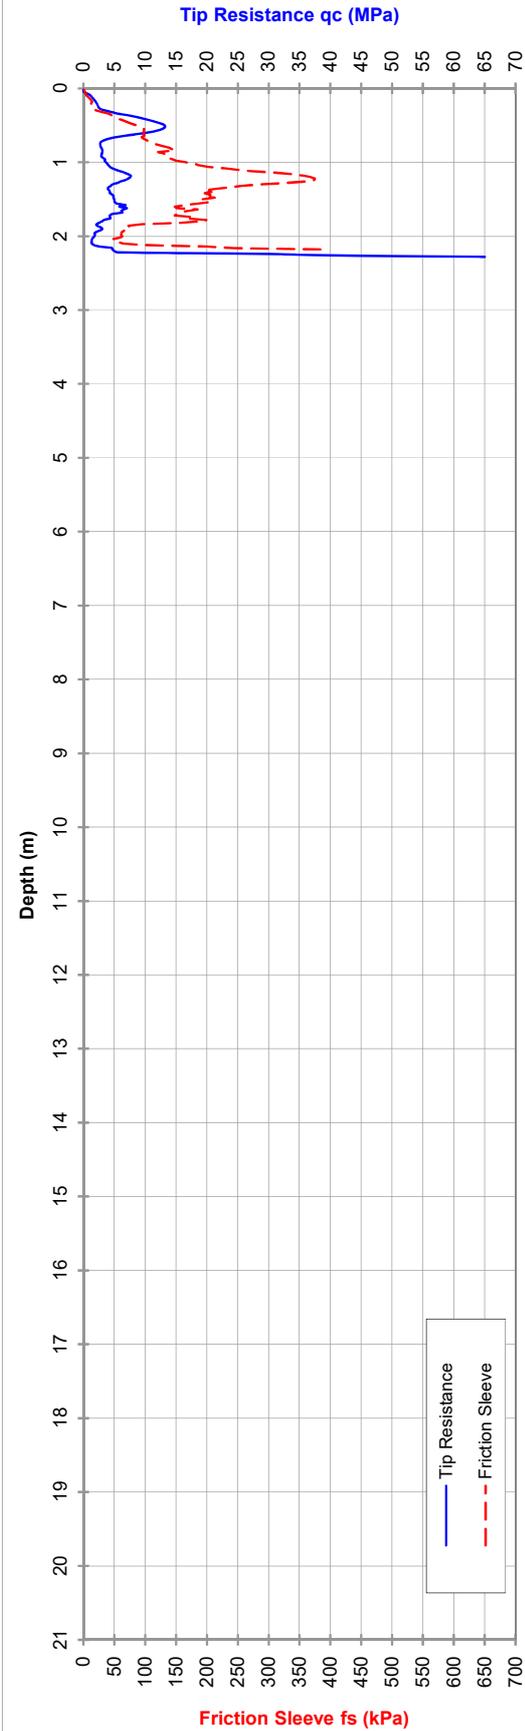
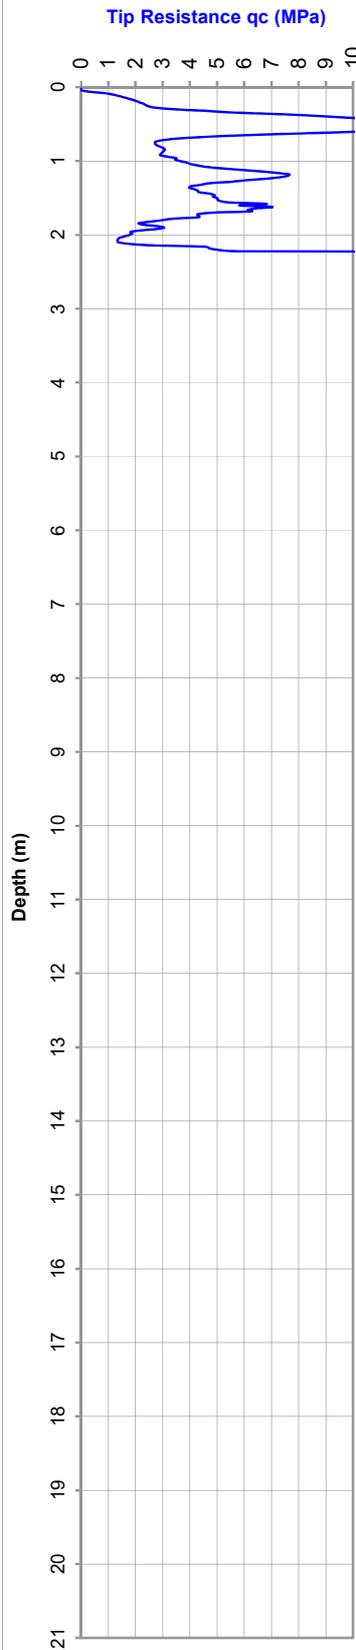
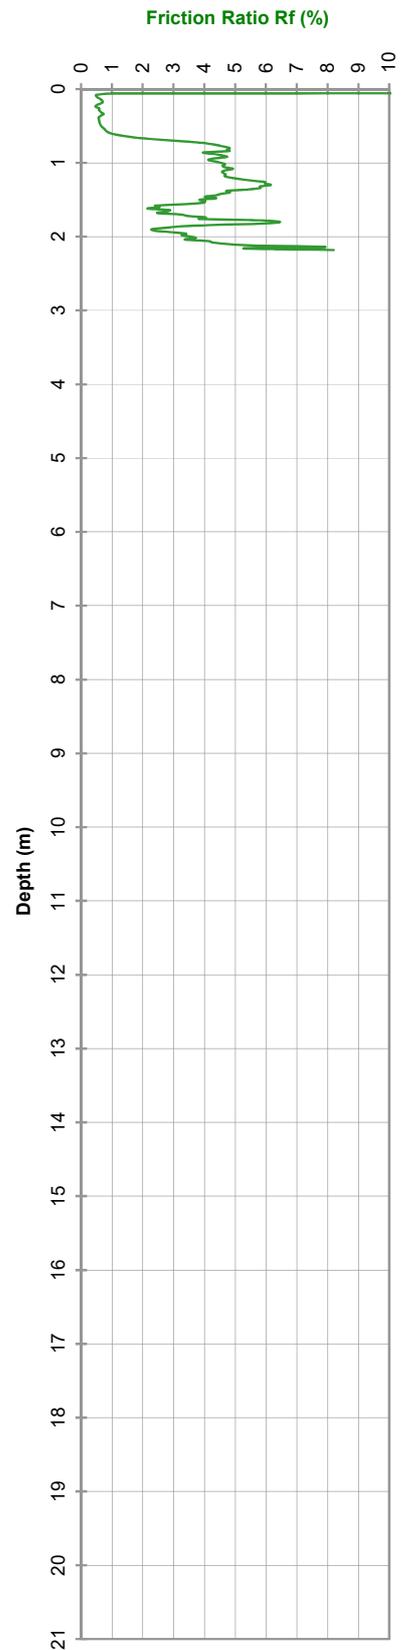
Tested in accordance with AS 1289.6.5.1-1999 and IRTP 2001 for friction reducer

Approx. Water (m): 1.9

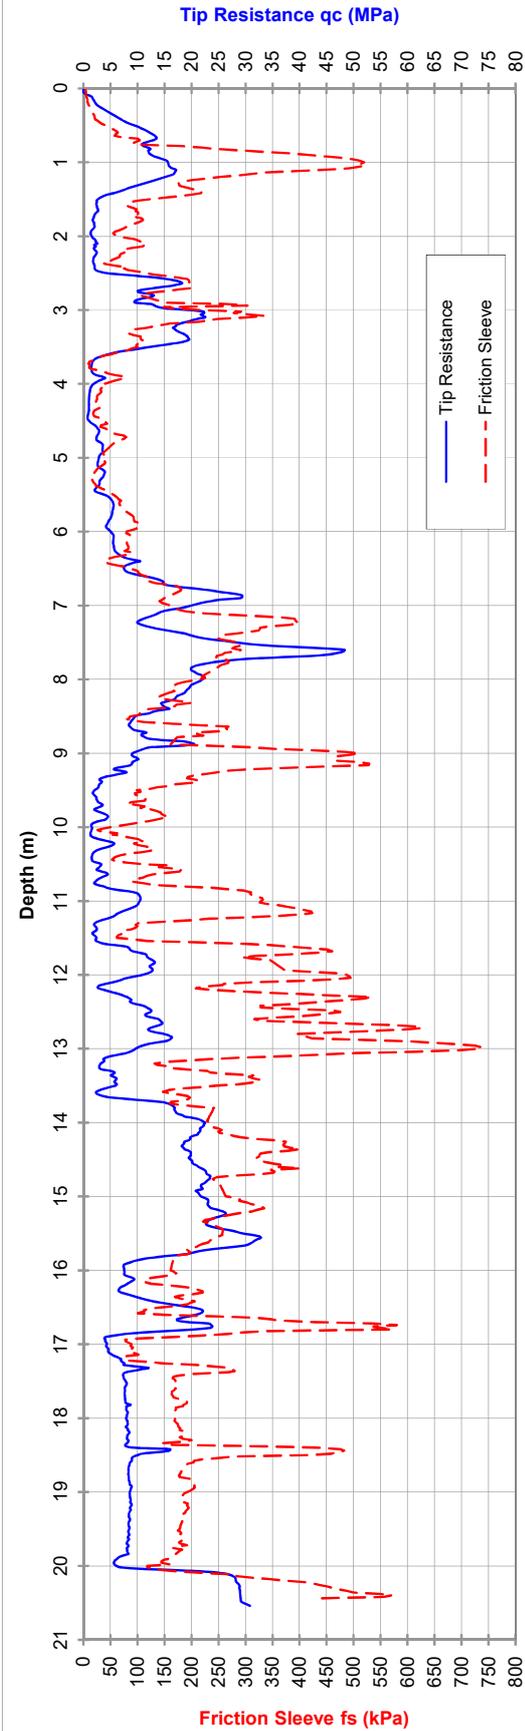
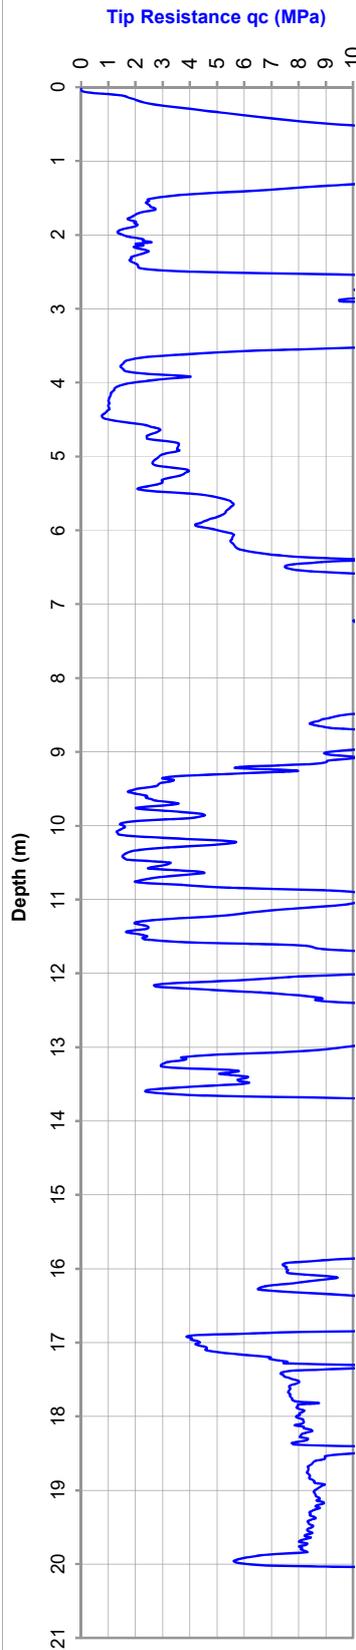
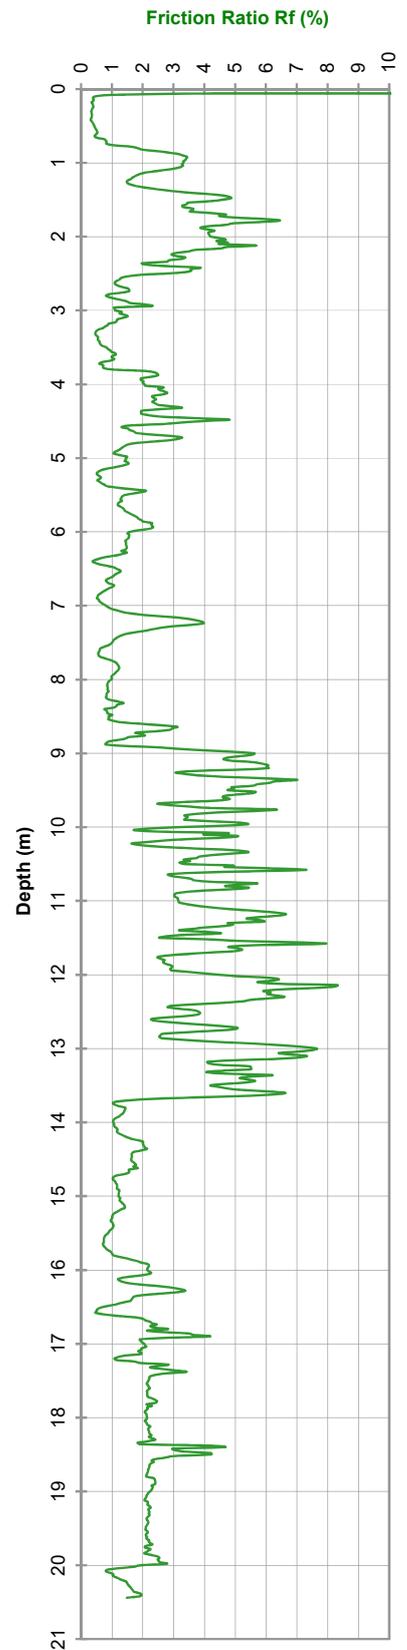
1762-CPT01UB

Tested in accordance with AS 1289.6.5.1-1999 and IRTF 2001 for friction reducer

Approx. Water (m): 1.8
 Dummy probe to (m):
 Refusal: 30MPa + Rod Friction

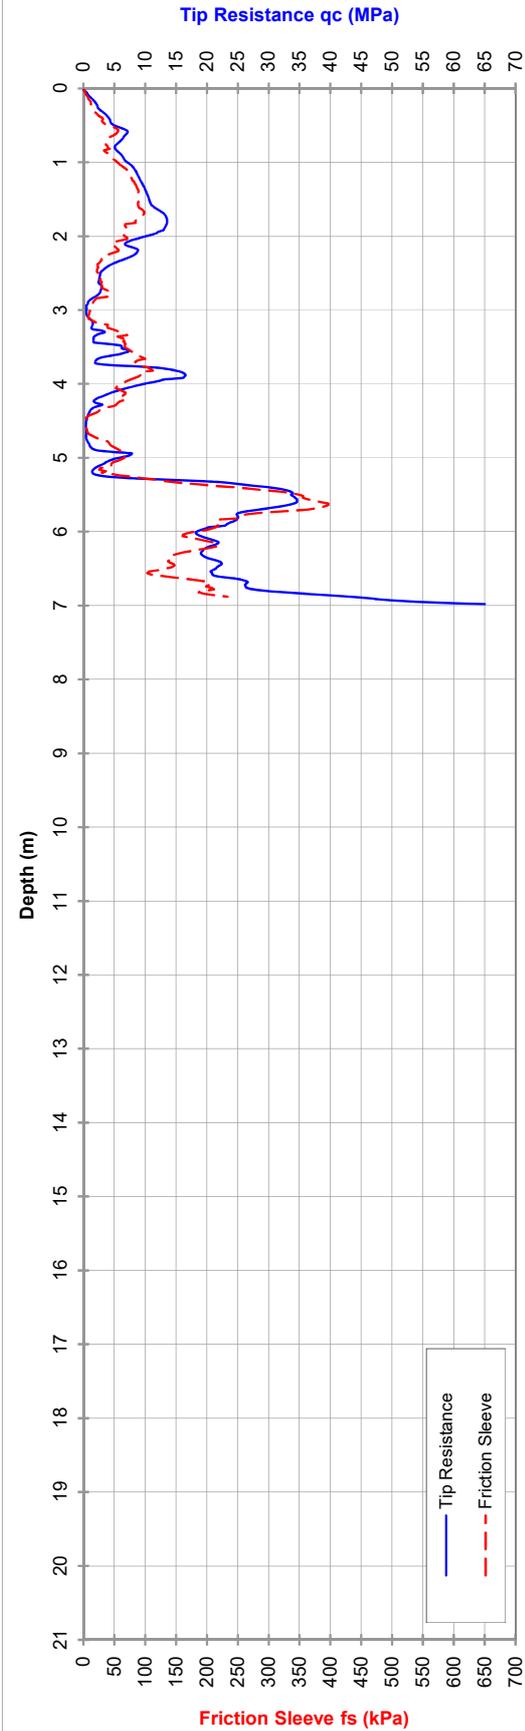
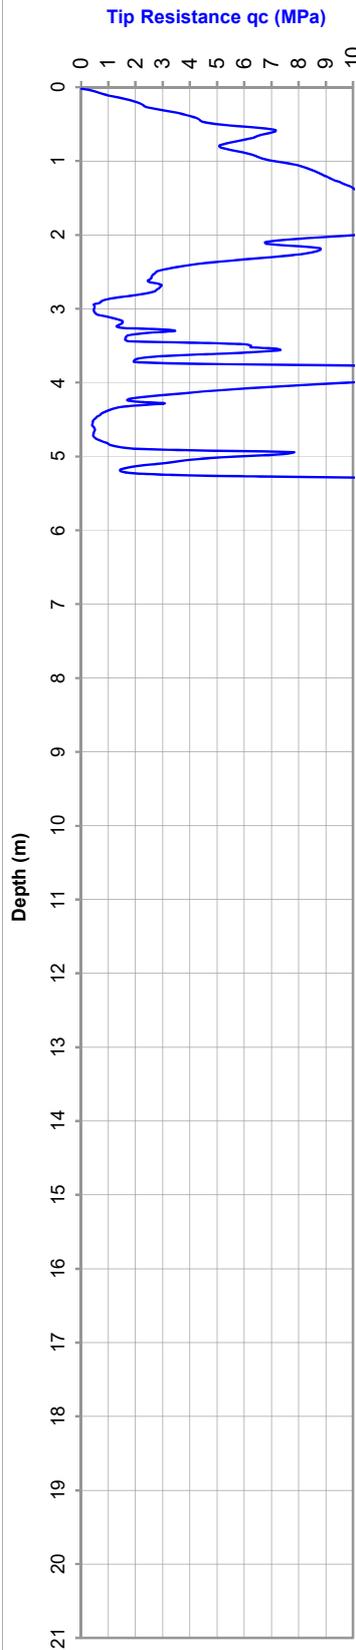
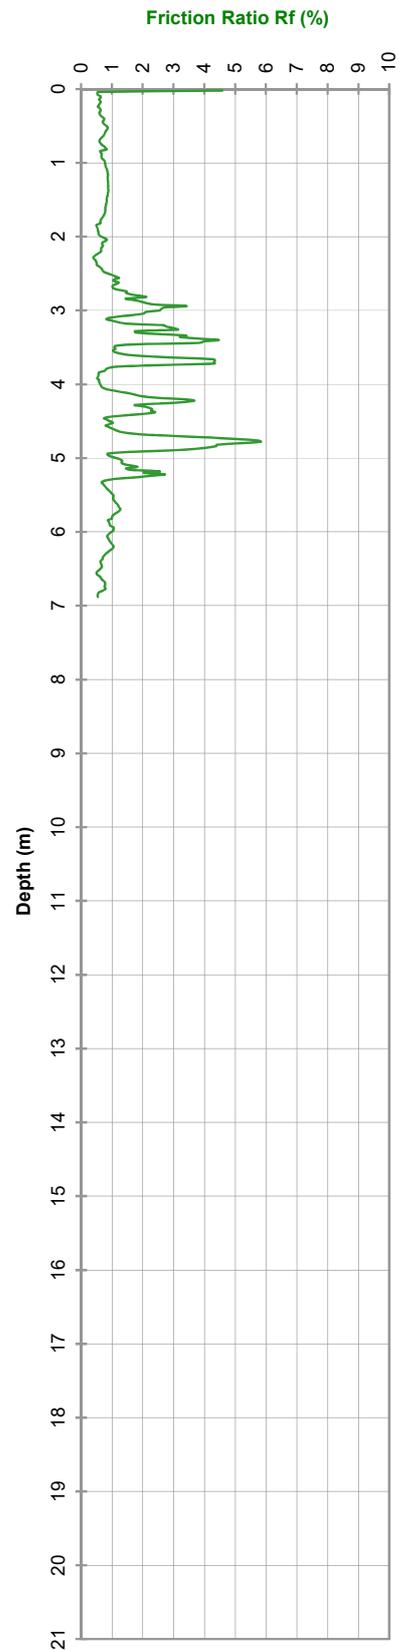
Probe I.D
1762-CPT03U
 30-Mar-16

Tested in accordance with AS 1289.6.5.1-1999 and IRTP 2001 for friction reducer

Approx. Water (m): 1.8
 Dummy probe to (m):
 Refusal: 65MPa

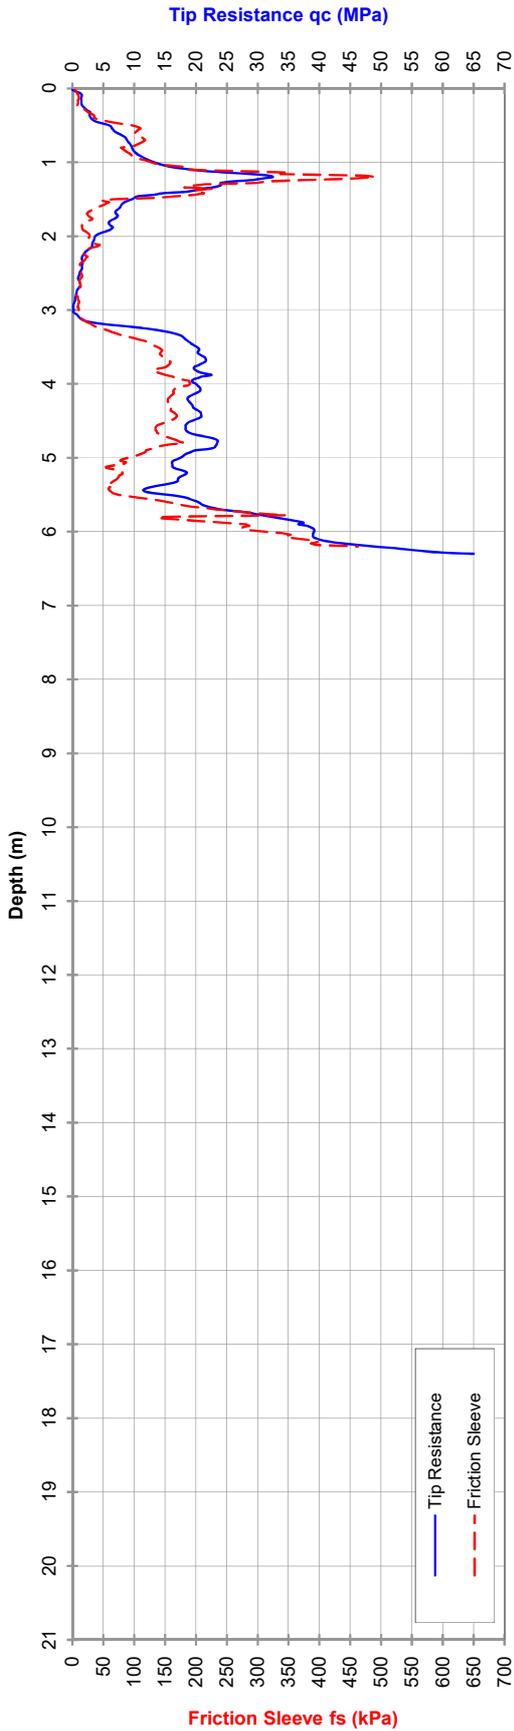
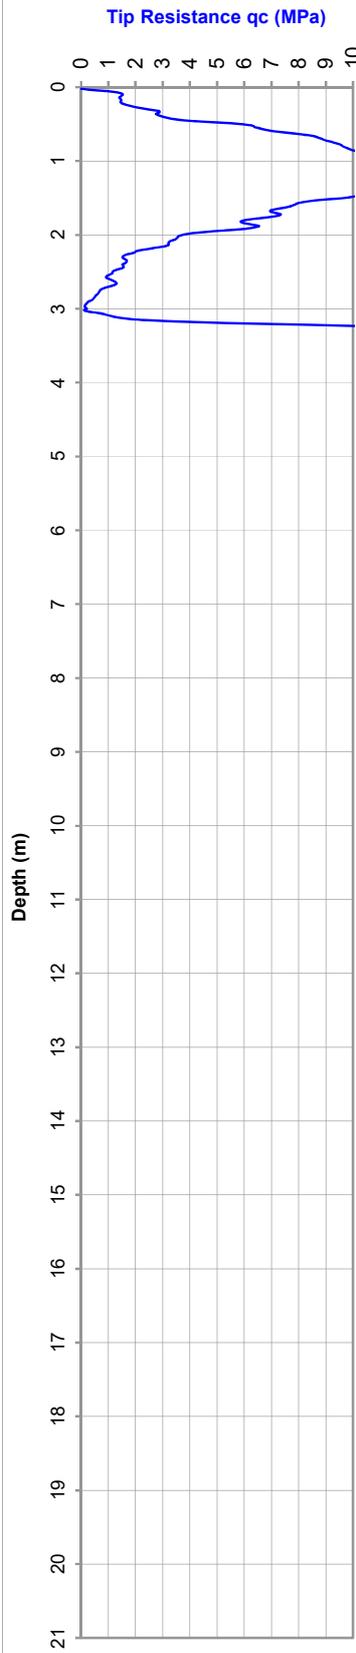
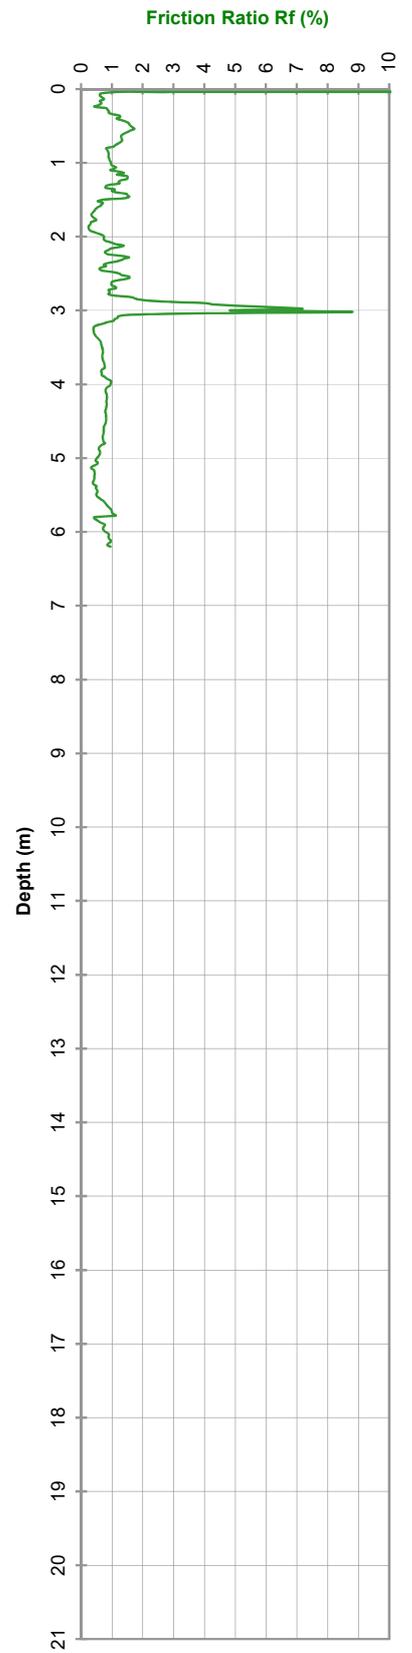
Probe I.D
1762-CPT05UB
 30-Mar-16

Tested in accordance with AS 1289.6.5.1-1999 and IRTP 2001 for friction reducer

Approx. Water (m): -
 Dummy probe to (m):
 Refusal: 65MPa

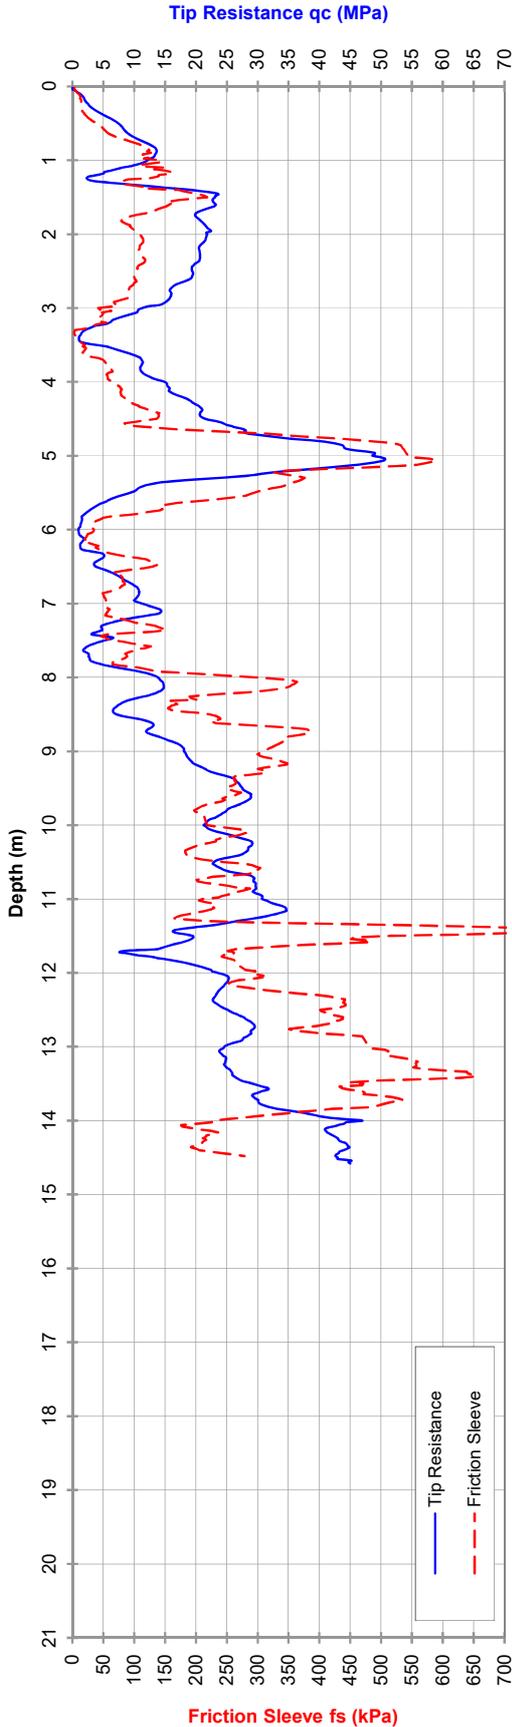
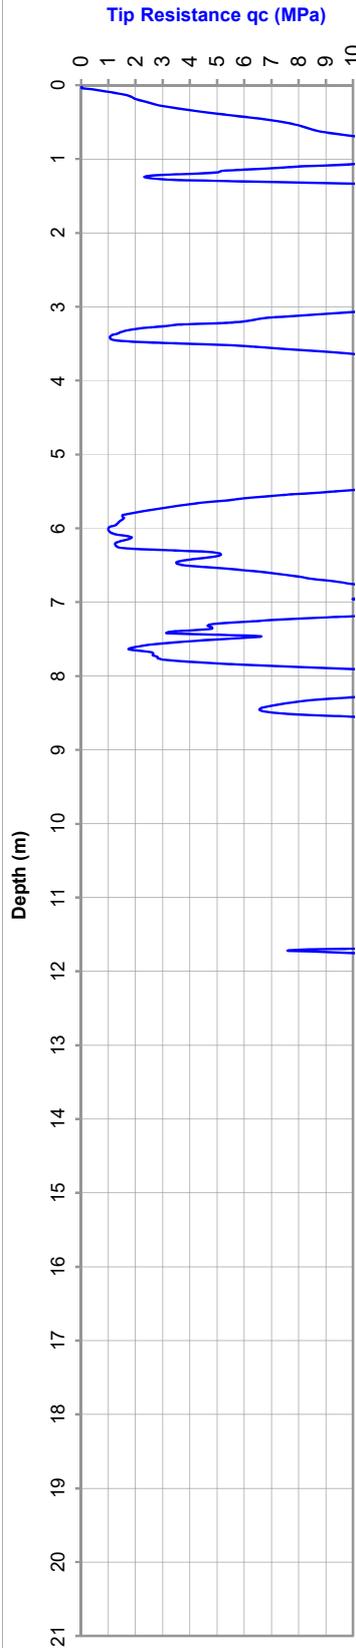
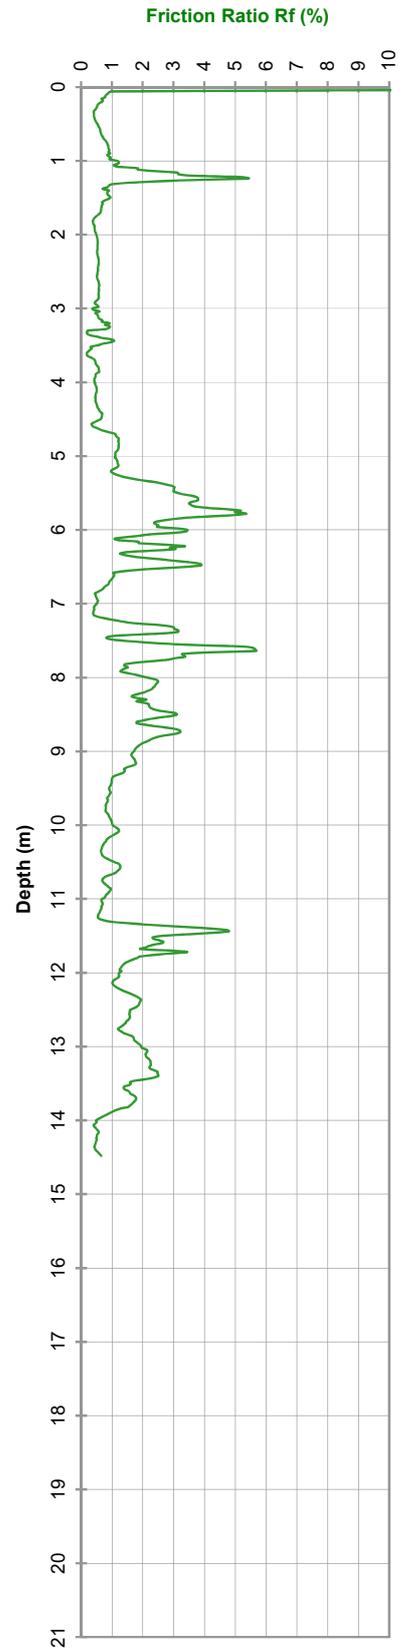
1762-CPT05UC

Tested in accordance with AS 1289.6.5.1-1999 and IRTP 2001 for friction reducer

Approx. Water (m): 1.6
 Dummy probe to (m):
 Refusal: 45MPa + Rod Friction

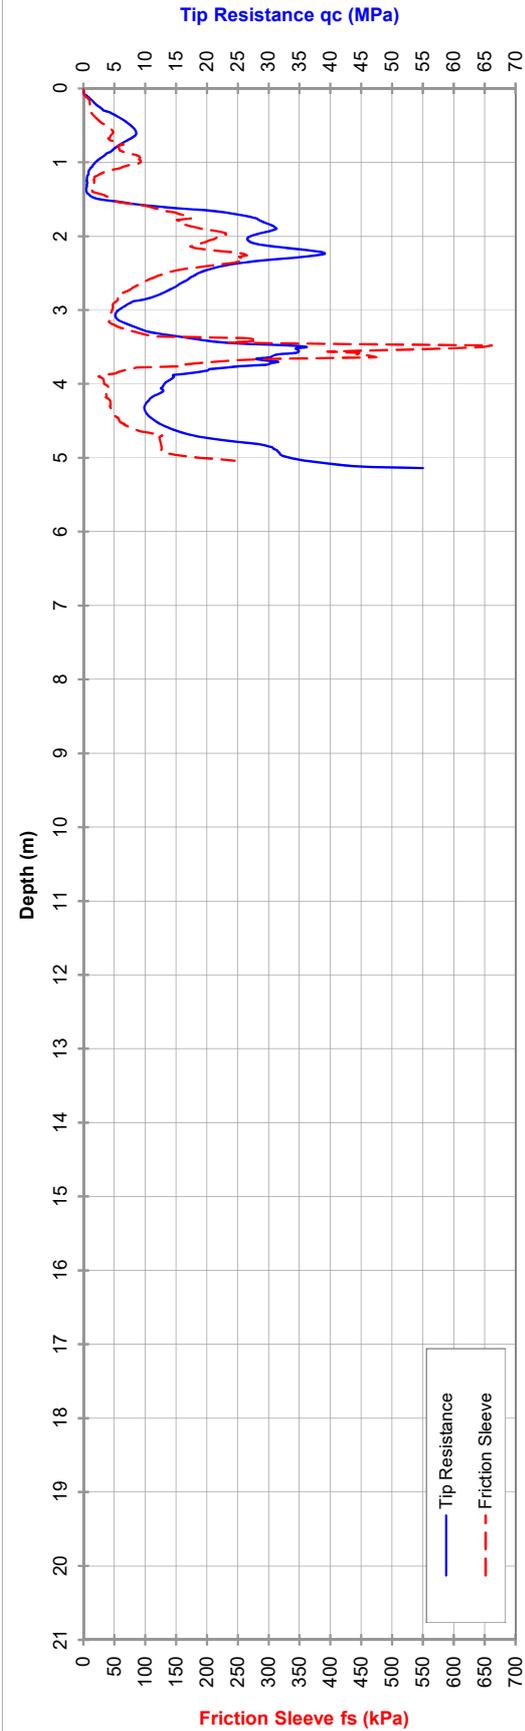
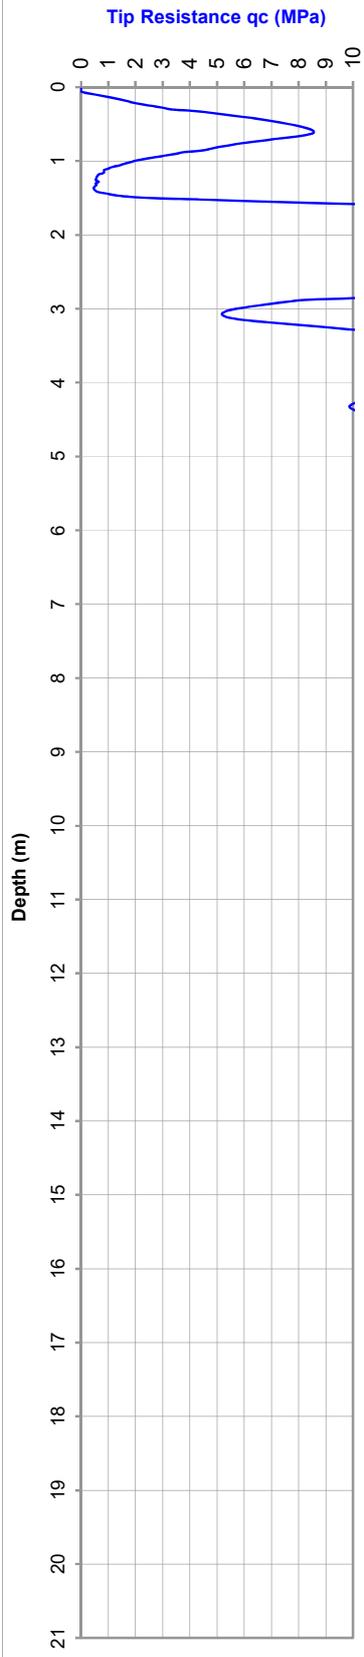
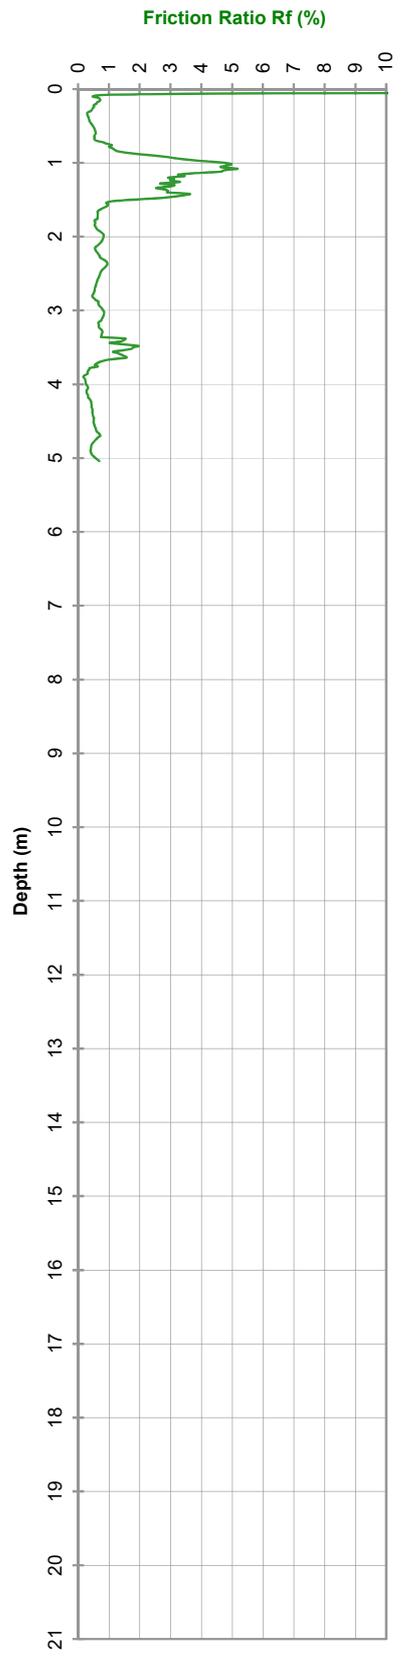
Probe I.D
1762-CPT06U
 30-Mar-16

ELECTRIC FRICTION-CONE PENETROMETER
