Bridge 1762 - Bussell Highway Over Abba River

Geotechnical Factual, Interpretive and Design Report

Client: Main Roads Western Australia

02-Dec-2016

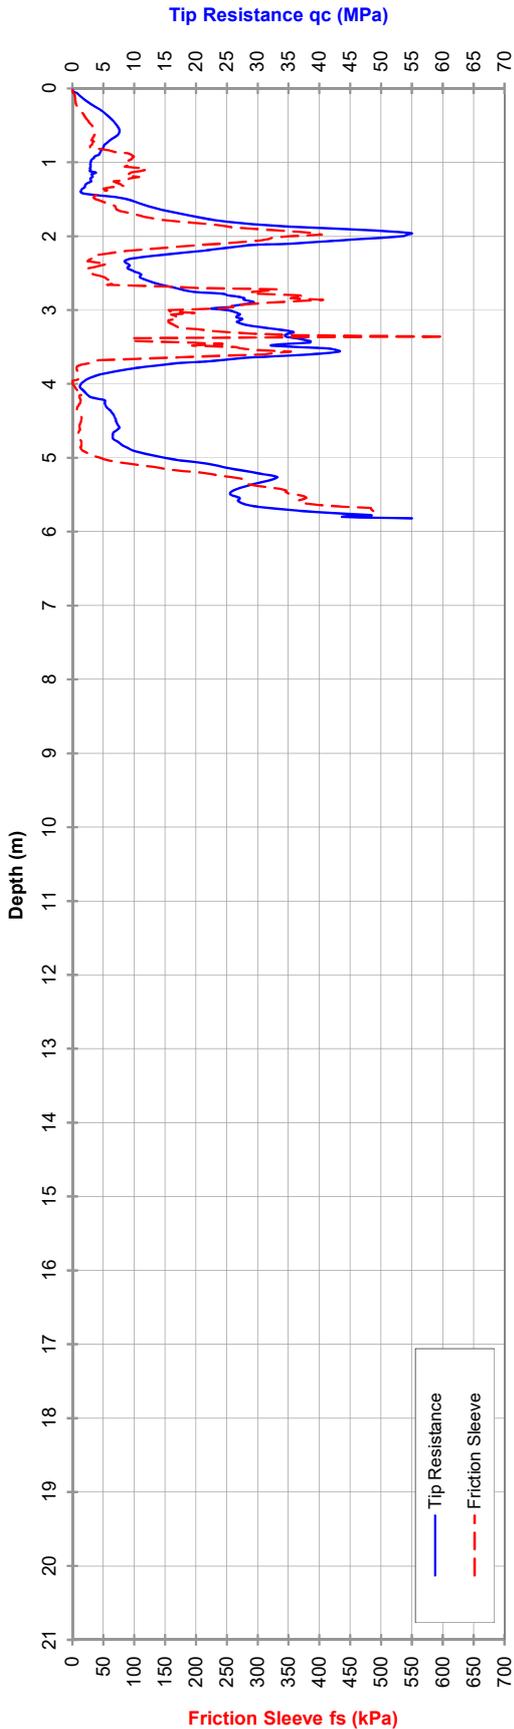
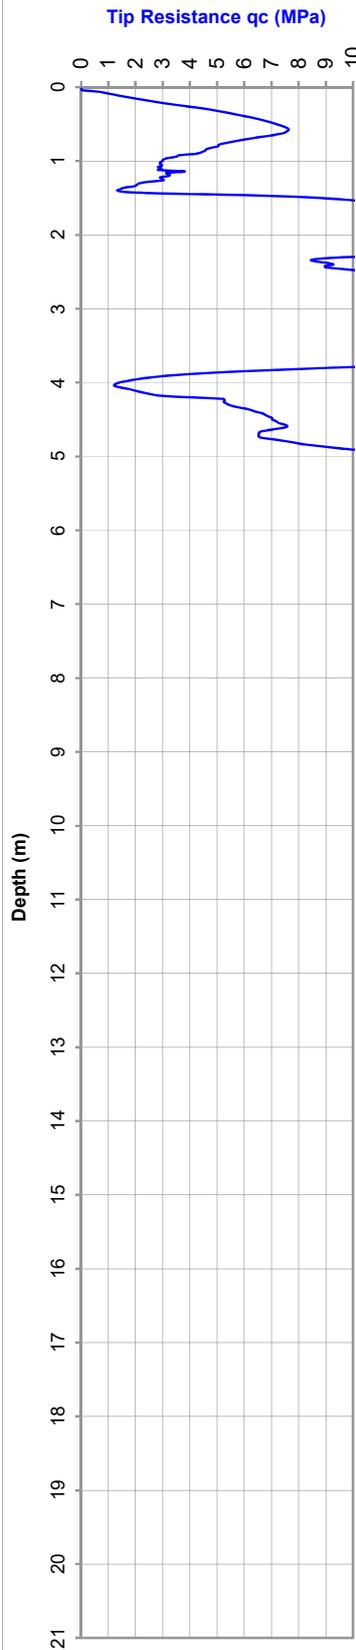
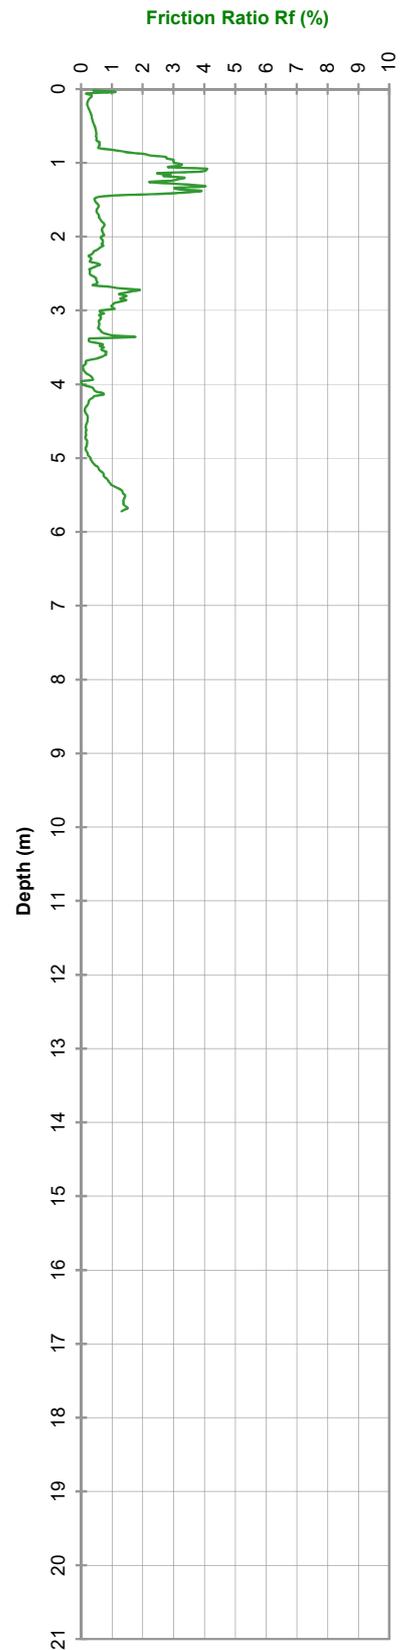
Probe I.D
1762-CPT06UA
 30-Mar-16

Tested in accordance with AS 1289.6.5.1-1999 and IRTP 2001 for friction reducer

Approx. Water (m): 1.4
 Dummy probe to (m):
 Refusal: 55MPa

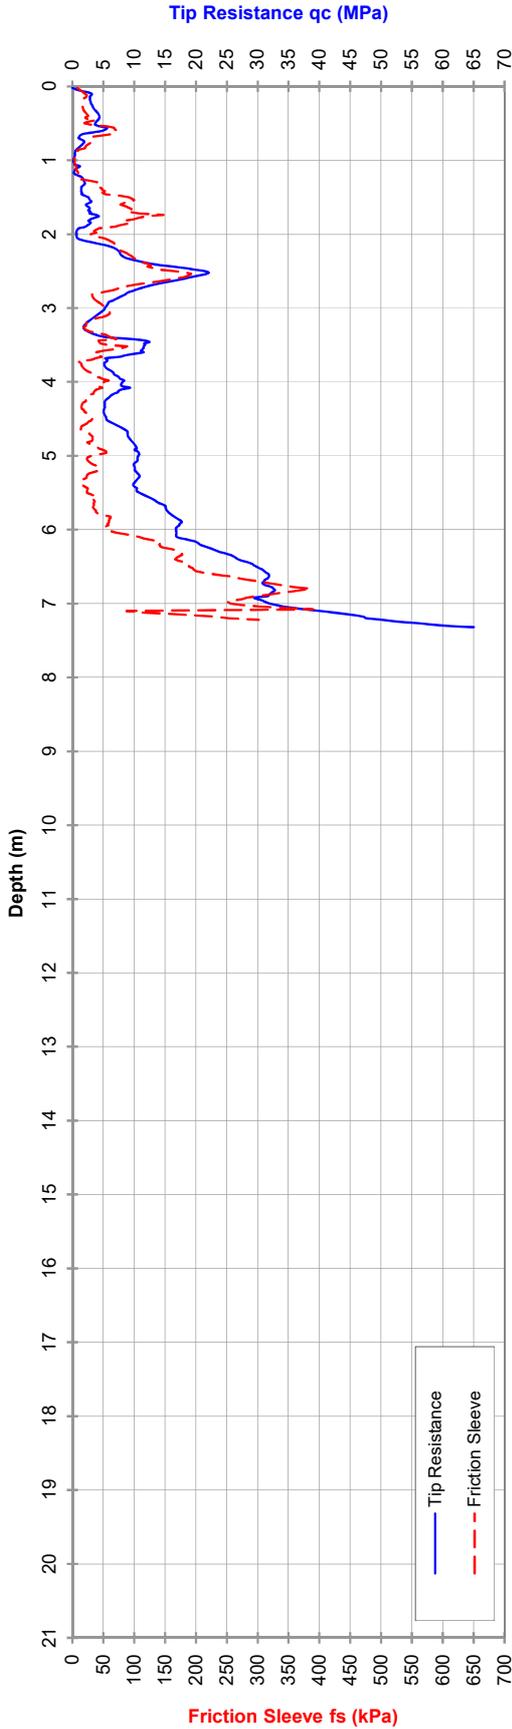
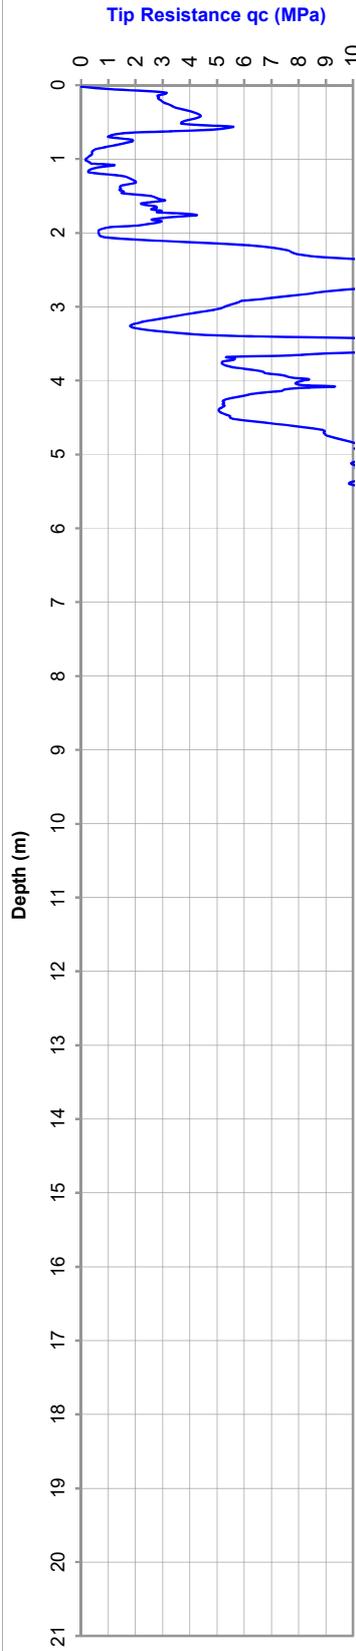
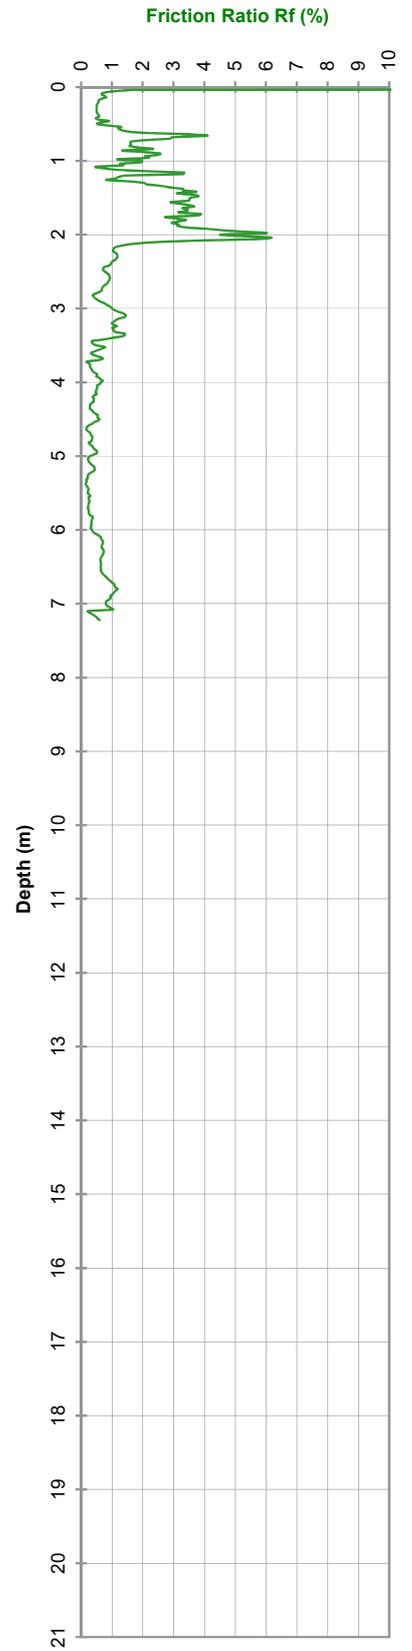
1762-CPT07U

Tested in accordance with AS 1289.6.5.1-1999 and IRTP 2001 for friction reducer

Approx. Water (m): 1.2

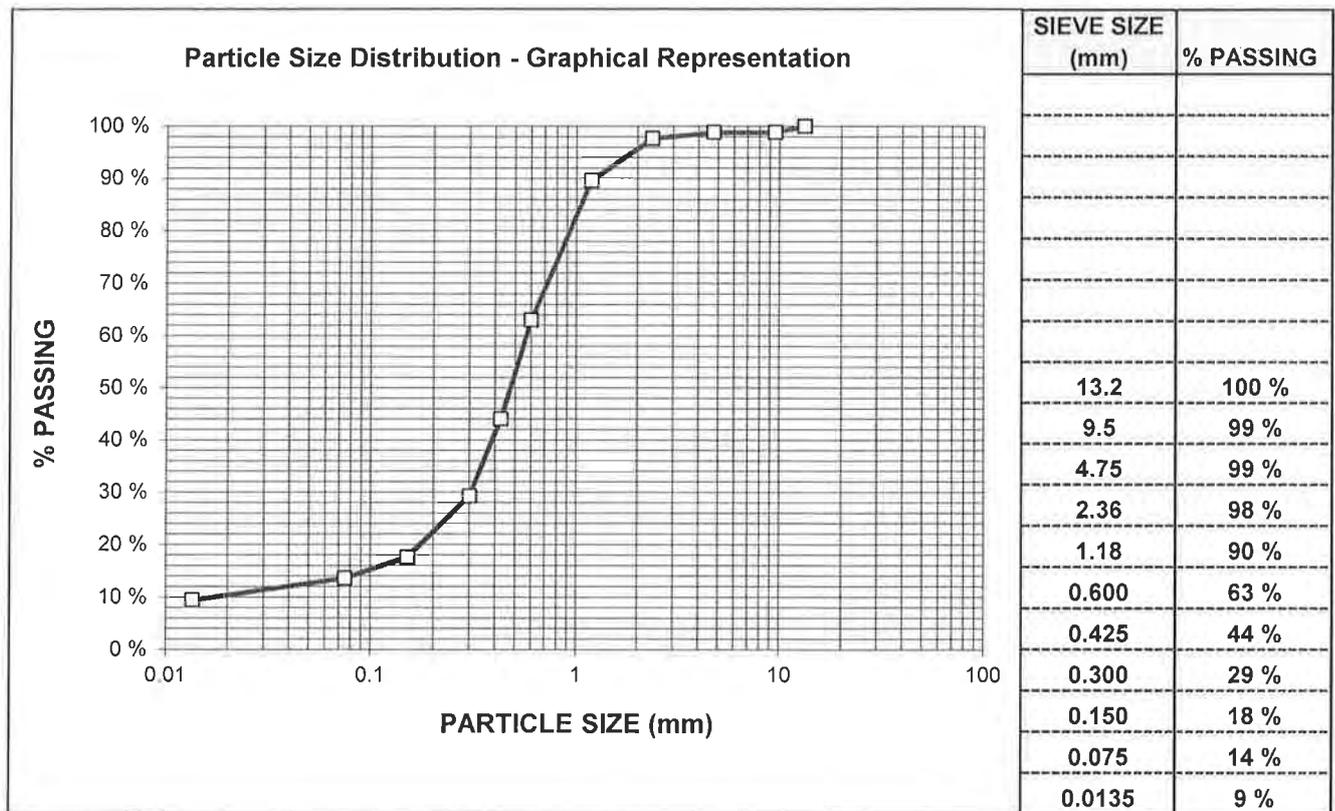
SIEVING AND DECANTATION METHOD : WA 115.1

CLIENT AECOM Australia Pty Ltd, GPO Box B59, Perth, WA
 JOB NO. 64_230
 SAMPLE NO. 929
 CLIENT REFERENCE BH1762-01, 10.5m to 10.95m
 DATE TESTED 27.04 2016 & 29.04 2016
 SAMPLE DESCRIPTION Silty Sand
 FEATURE -
 PROJECT Bridge 1761-1763, Busselton - Project No. 60344161.100-243.01.1761.EN

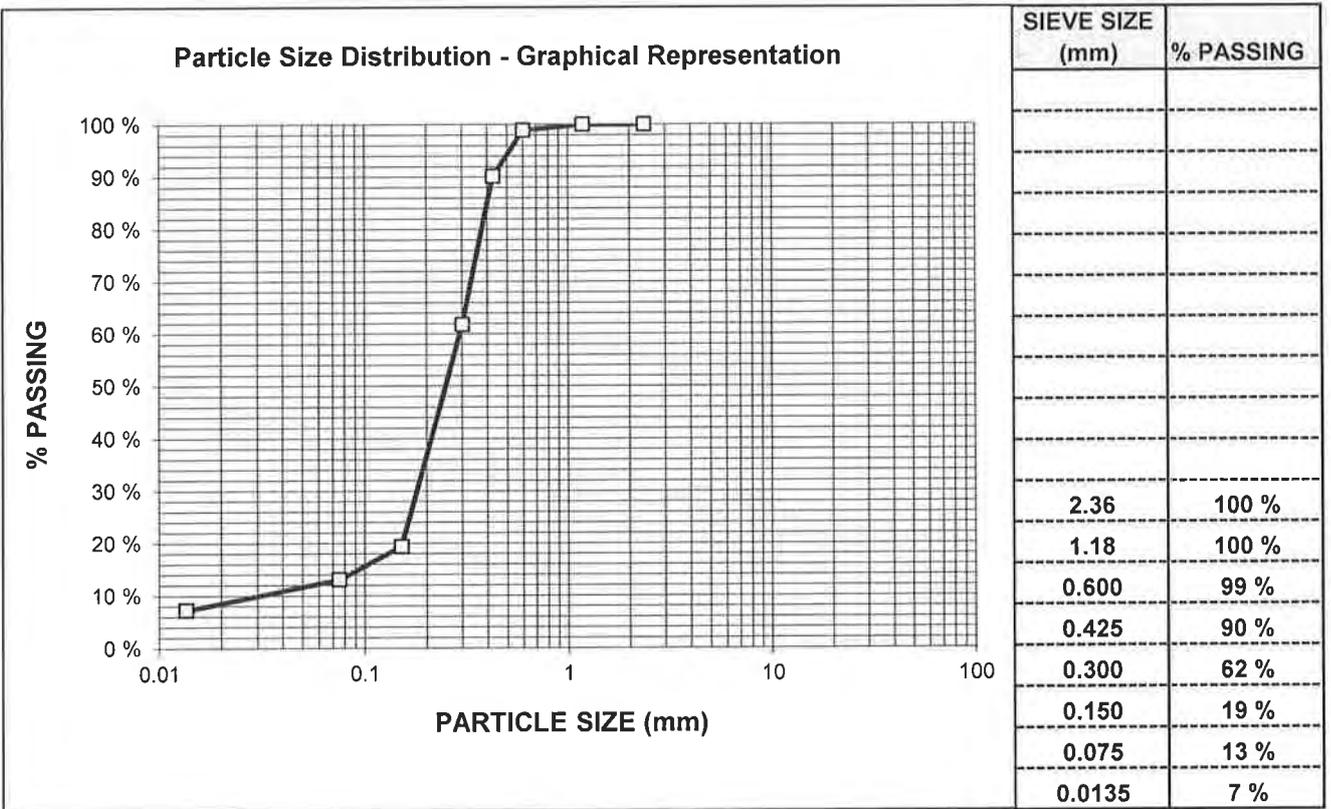
SIEVING AND DECANTATION METHOD : WA 115.1

CLIENT AECOM Australia Pty Ltd, GPO Box B59, Perth, WA
 JOB NO. 64_232
 SAMPLE NO. 931
 CLIENT REFERENCE BH1762-01, 15.0m to 15.45m
 DATE TESTED 27.04.2016 & 29.04.2016
 SAMPLE DESCRIPTION Silty Sand
 FEATURE -
 PROJECT Bridge 1761-1763, Busselton - Project No. 60344161.100-243.01.1761.EN

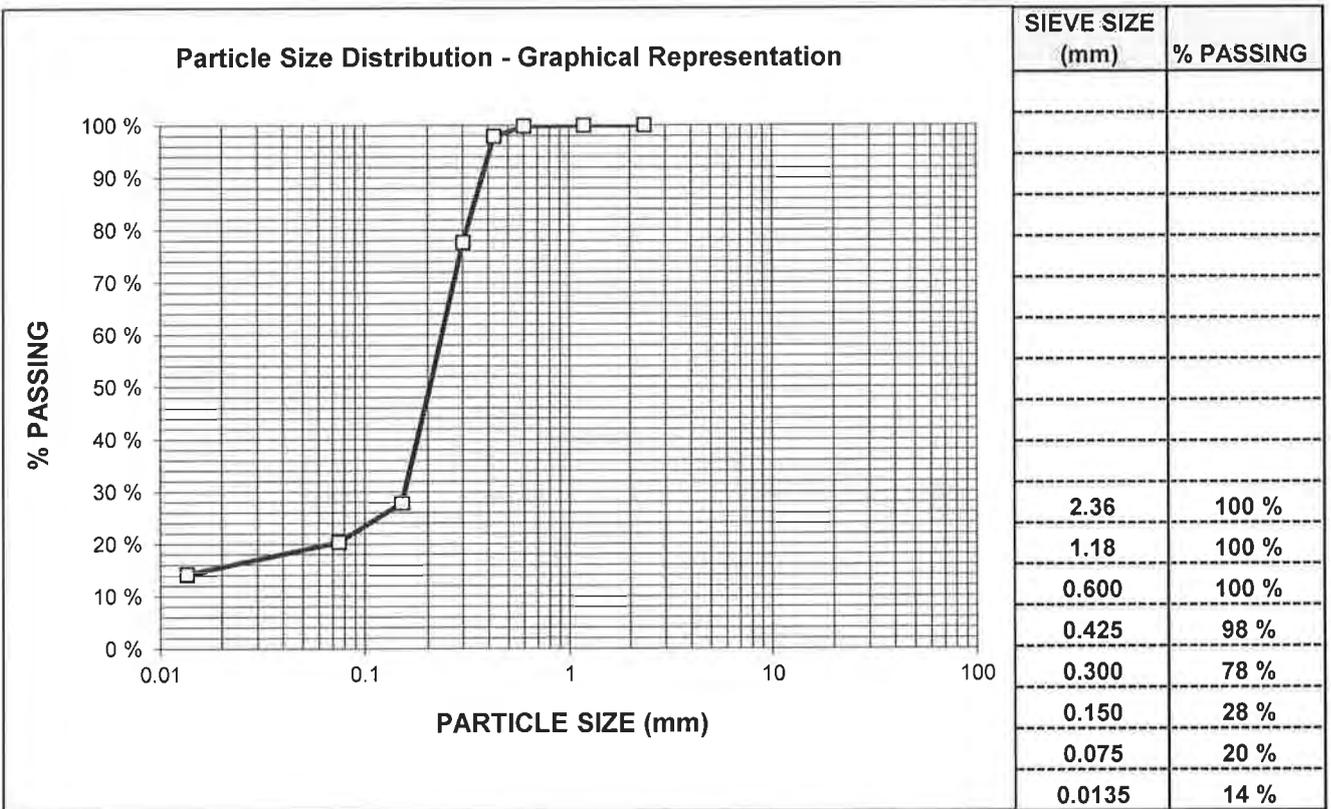
SIEVING AND DECANTATION METHOD : WA 115.1

CLIENT AECOM Australia Pty Ltd, GPO Box B59, Perth, WA
 JOB NO. 64_234
 SAMPLE NO. 933
 CLIENT REFERENCE BH1762-01, 18.0m to 18.45m
 DATE TESTED 27.04.2016 & 29.04.2016
 SAMPLE DESCRIPTION Silty Sand
 FEATURE -
 PROJECT Bridge 1761-1763, Busselton - Project No. 60344161.100-243.01.1761.EN

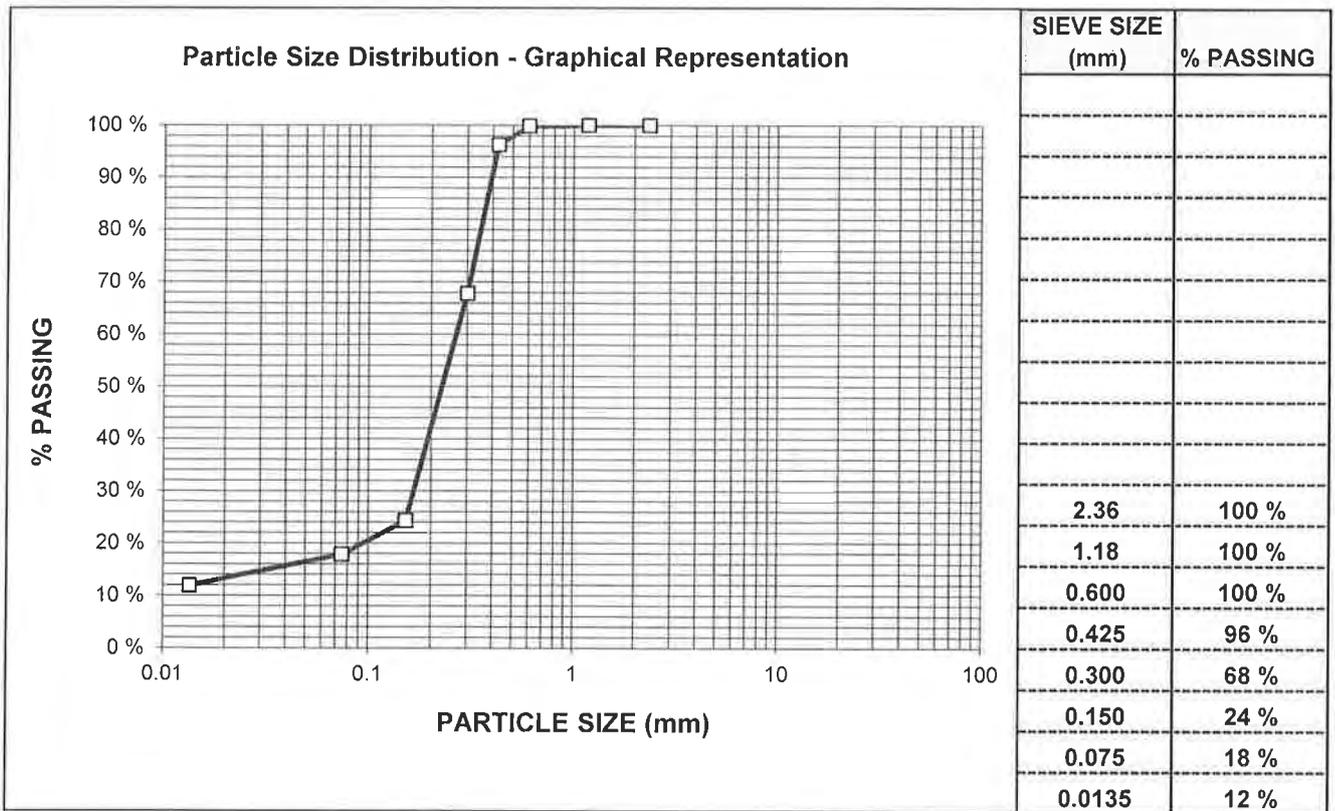
SIEVING AND DECANTATION METHOD : WA 115.1

CLIENT AECOM Australia Pty Ltd, GPO Box B59, Perth, WA
 JOB NO 64_235
 SAMPLE NO. 934
 CLIENT REFERENCE BH1762-01, 21.0m to 21.45m
 DATE TESTED 27.04.2016
 SAMPLE DESCRIPTION Silty Sand
 FEATURE -
 PROJECT Bridge 1761-1763, Busselton - Project No. 60344161.100-243.01.1761.EN

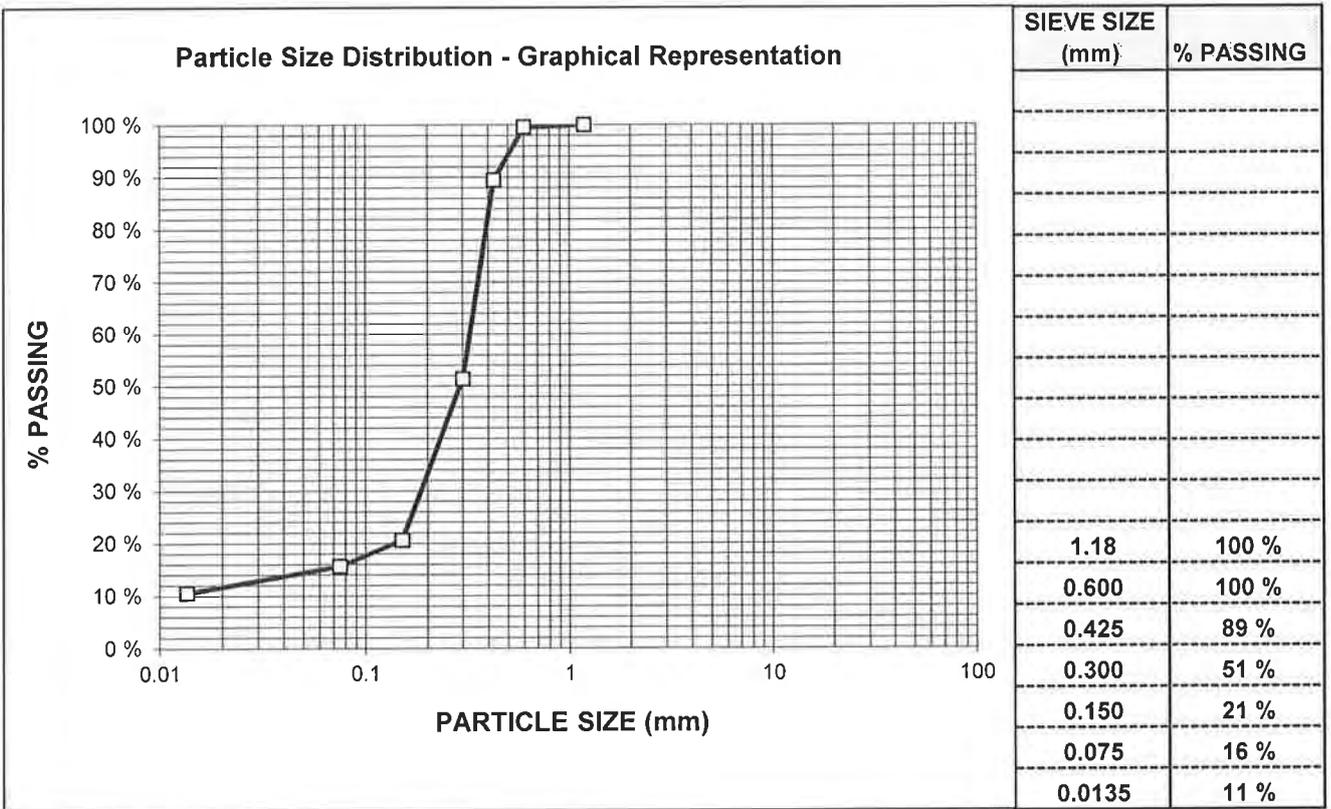
SIEVING AND DECANTATION METHOD : WA 115.1

CLIENT AECOM Australia Pty Ltd, GPO Box B59, Perth, WA
 JOB NO. 64_237
 SAMPLE NO. 936
 CLIENT REFERENCE BH1762-01, 24.5m to 24.95m
 DATE TESTED 27.04.2016 & 29.04.2016
 SAMPLE DESCRIPTION Silty Sand
 FEATURE -
 PROJECT Bridge 1761-1763, Busselton - Project No. 60344161.100-243.01.1761.EN

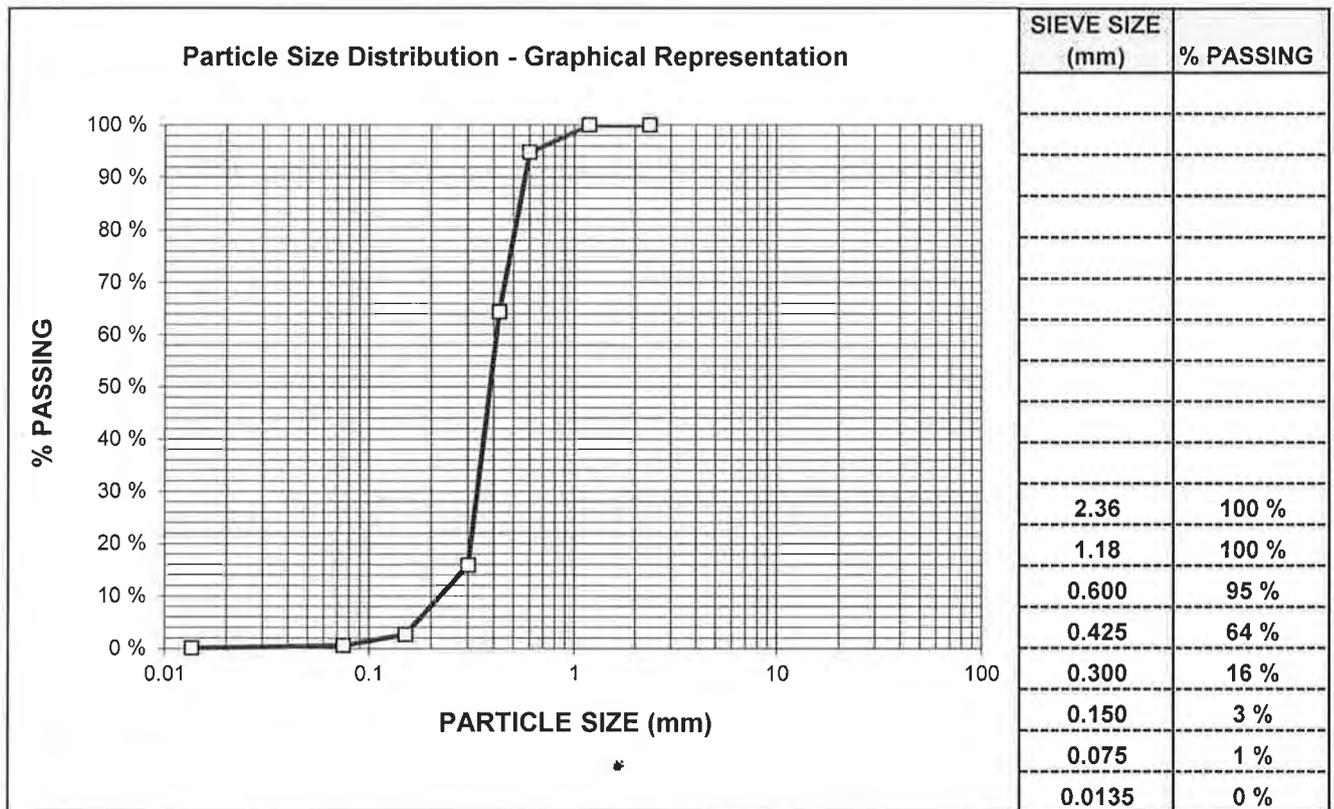
SIEVING AND DECANTATION METHOD : WA 115.1

CLIENT AECOM Australia Pty Ltd, GPO Box B59, Perth, WA
 JOB NO. 64_226
 SAMPLE NO. 925
 CLIENT REFERENCE BH1762-01, 3.0m to 3.45m
 DATE TESTED 27.04.2016 & 29.04.2016
 SAMPLE DESCRIPTION Silty Sand
 FEATURE -
 PROJECT Bridge 1761-1763, Busselton - Project No. 60344161.100-243.01.1761.EN

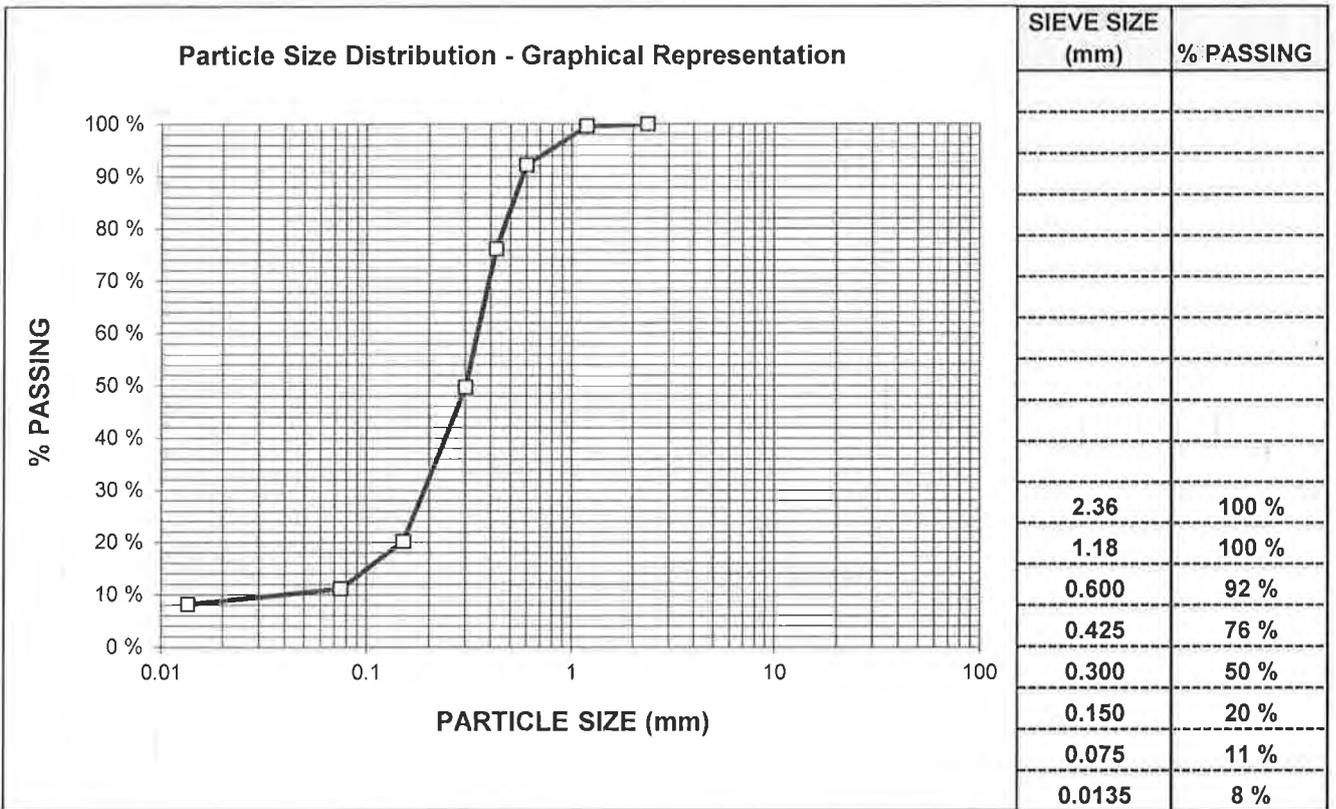
SIEVING AND DECANTATION METHOD : WA 115.1

CLIENT AECOM Australia Pty Ltd, GPO Box B59, Perth, WA
 JOB NO. 64_238
 SAMPLE NO. 937
 CLIENT REFERENCE BH1762-02, 1.5m to 1.95m
 DATE TESTED 27.04.2016 & 04.05.2016
 SAMPLE DESCRIPTION Sandy Silt
 FEATURE -
 PROJECT Bridge 1761-1763, Busselton - Project No. 60344161.100-243.01.1761.EN

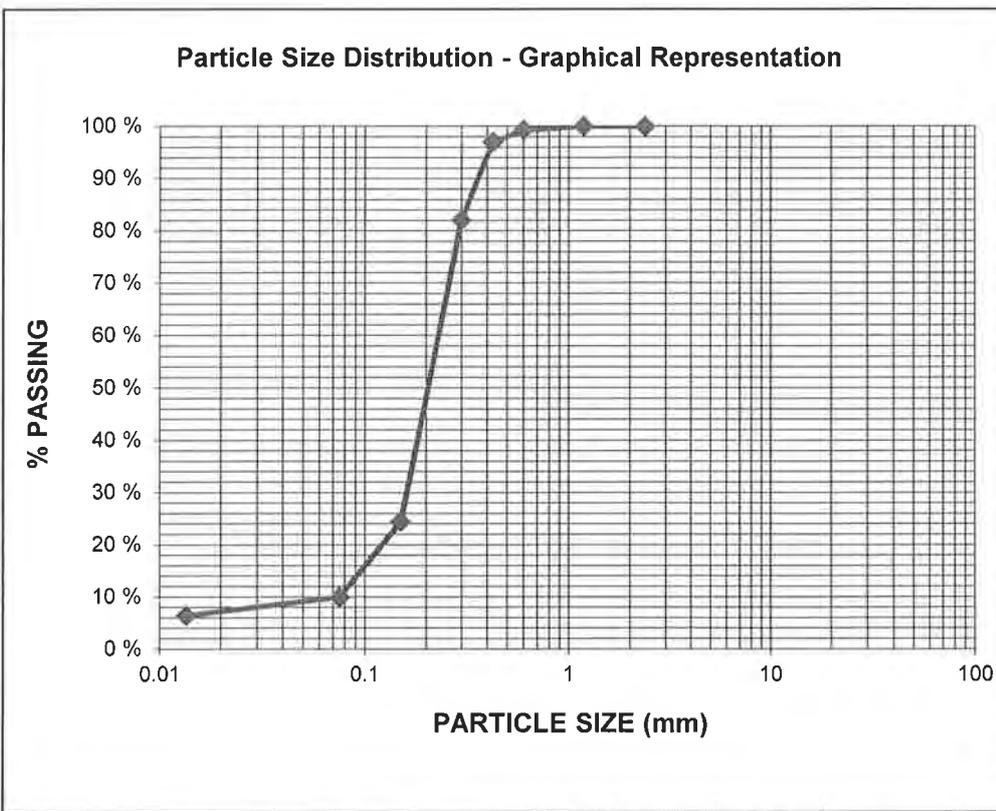
CLIENT AECOM Australia Pty Ltd, GPO Box B59, Perth, WA
 JOB NO. 64_239
 SAMPLE NO. 938
 CLIENT REFERENCE BH1762-02, 6.0m to 6.45m
 DATE TESTED PSD tested 28.04.2016 & 29.04.2016 Consistency Limit tested 02.05.2016
 SAMPLE DESCRIPTION Silty Sand
 FEATURE -
 PROJECT Bridge 1761-1763, Busselton - Project No. 60344161.100-243.01.1761.EN

SIEVE SIZE (mm)	% PASSING
2.36	100 %
1.18	100 %
0.600	99 %
0.425	97 %
0.300	82 %
0.150	24 %
0.075	10 %
0.0135	6 %

CONSISTENCY LIMIT - CONE PENETROMETER APPARATUS	
LIQUID LIMIT WA 120.2	Not Obtainable
PLASTIC LIMIT WA 121.1	Non Plastic
PLASTICITY INDEX WA 122.1	Non Plastic
LINEAR SHRINKAGE WA 123.1	0.0

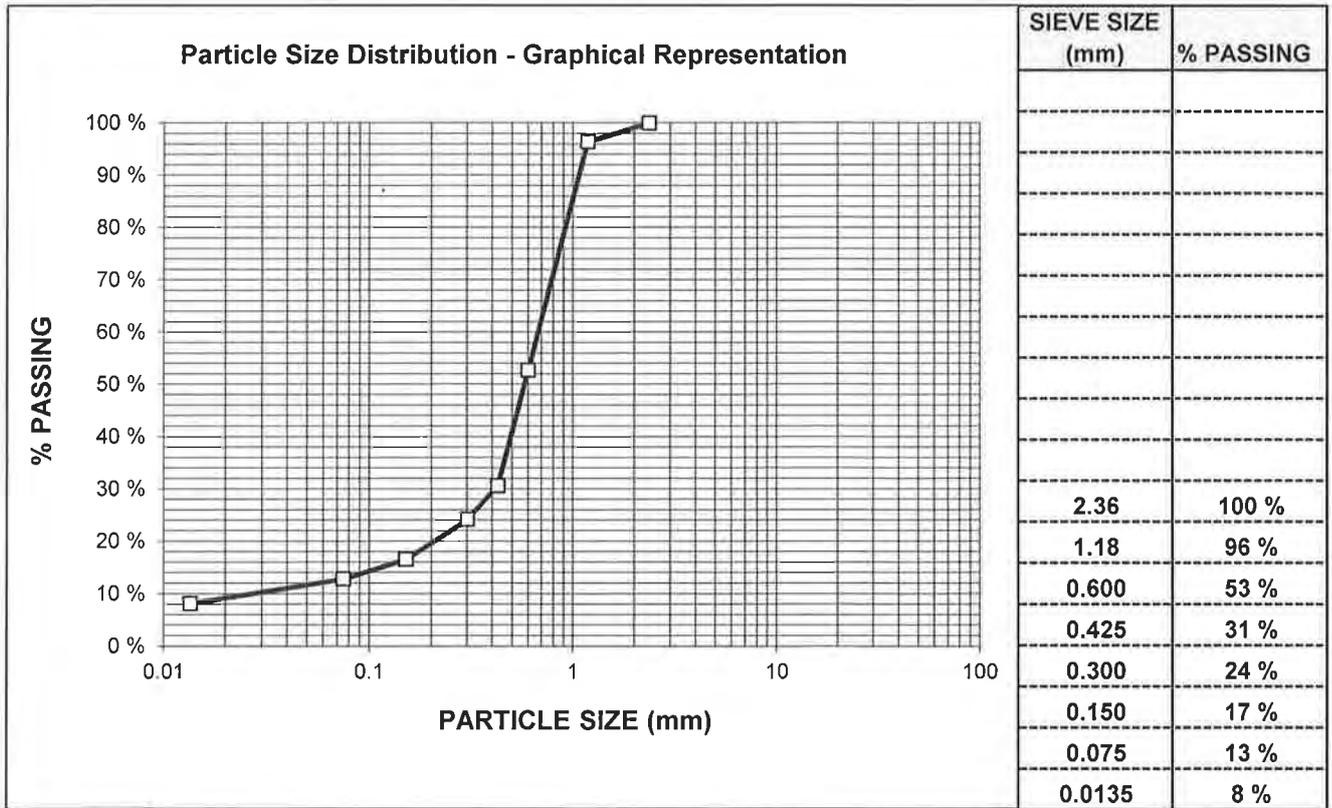
CLIENT AECOM Australia Pty Ltd, GPO Box B59, Perth, WA
 JOB NO. 64_240
 SAMPLE NO. 939
 CLIENT REFERENCE BH1762-02 - 11.0m to 11.45m
 DATE TESTED 28.04.2016 & 29.04.2016
 SAMPLE DESCRIPTION Sand
 FEATURE -
 PROJECT Bridge 1761-1763, Busselton - Project No. 60344161.100-243.01.1761.EN

Sampling procedures: Tested as received.
 Remarks: % RETAINED on 37.5 mm SIEVE: 0 %
 Sample received by Materials Consultants Pty Ltd on the 07.04.2016

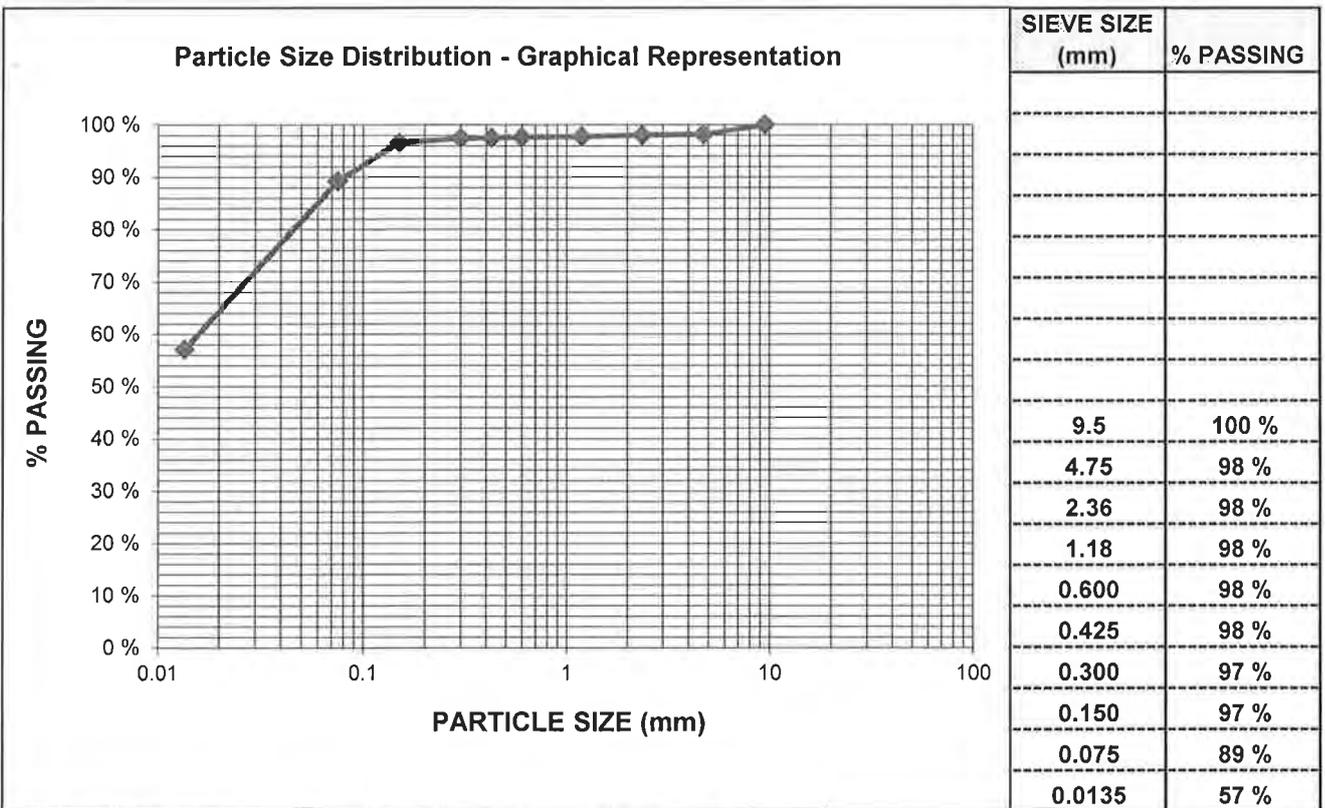
CLIENT AECOM Australia Pty Ltd, GPO Box B59, Perth, WA
 JOB NO. 64_241
 SAMPLE NO. 940
 CLIENT REFERENCE BH1762-02, 15.5m to 15.95m
 DATE TESTED PSD tested 28.04.2016 & 02.05.2016 Consistency Limit tested 02.05.2016
 SAMPLE DESCRIPTION Silty Clay
 FEATURE -
 PROJECT Bridge 1761-1763, Busselton - Project No. 60344161.100-243.01.1761.EN

CONSISTENCY LIMIT - CONE PENETROMETER APPARATUS	
LIQUID LIMIT WA 120.2	61.7
PLASTIC LIMIT WA 121.1	27.2
PLASTICITY INDEX WA 122.1	34.5
LINEAR SHRINKAGE WA 123.1	14.4

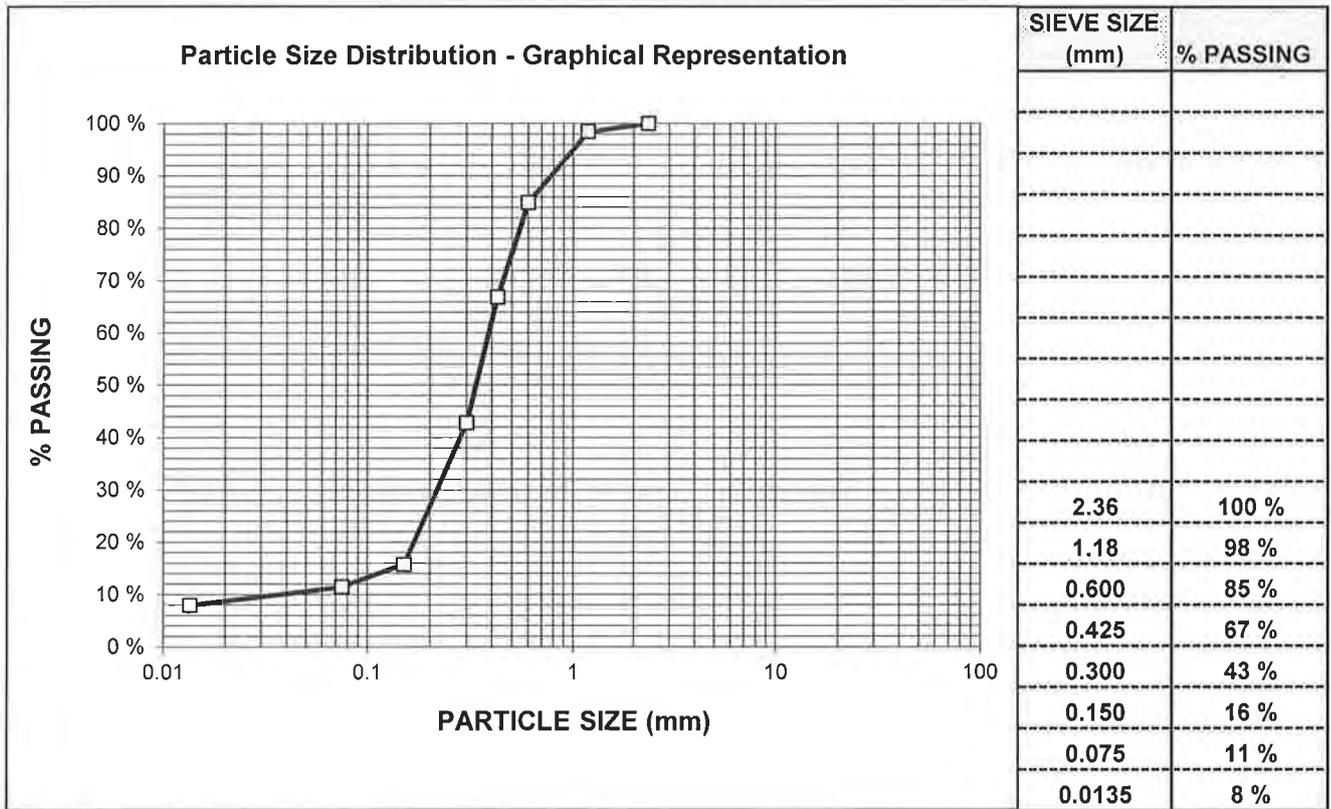
CLIENT AECOM Australia Pty Ltd, GPO Box B59, Perth, WA
 JOB NO. 64_242
 SAMPLE NO. 941
 CLIENT REFERENCE BH1762-02 - 18.05m to 18.45m
 DATE TESTED 28.04.2016 & 29.04.2016
 SAMPLE DESCRIPTION Silty Sand
 FEATURE -
 PROJECT Bridge 1761-1763, Busselton - Project No. 60344161.100-243.01.1761.EN

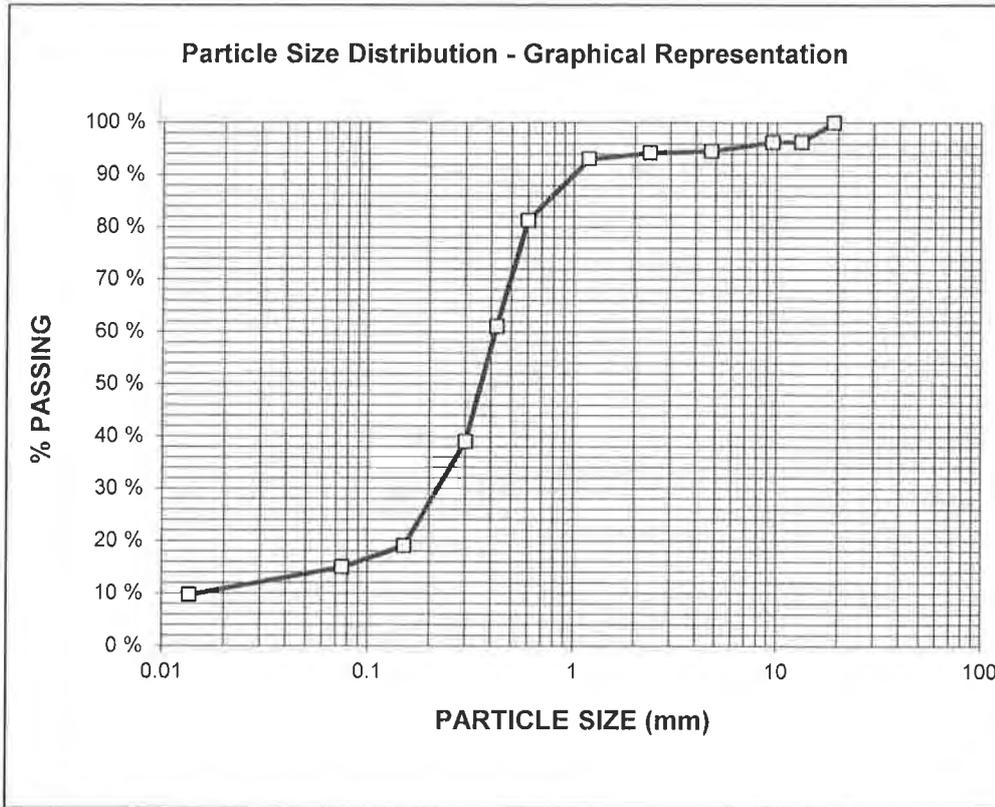
CLIENT AECOM Australia Pty Ltd, GPO Box B59, Perth, WA
 JOB NO. 64_243
 SAMPLE NO. 942
 CLIENT REFERENCE BH1762-02, 21.0m to 21.45m
 DATE TESTED 28.04 2016 & 29.04.2016
 SAMPLE DESCRIPTION Silty Sand
 FEATURE -
 PROJECT Bridge 1761-1763, Busselton - Project No. 60344161.100-243.01.1761.EN

SIEVE SIZE (mm)	% PASSING
19.0	100 %
13.2	96 %
9.5	96 %
4.75	95 %
2.36	94 %
1.18	93 %
0.600	81 %
0.425	61 %
0.300	39 %
0.150	19 %
0.075	15 %
0.0135	10 %

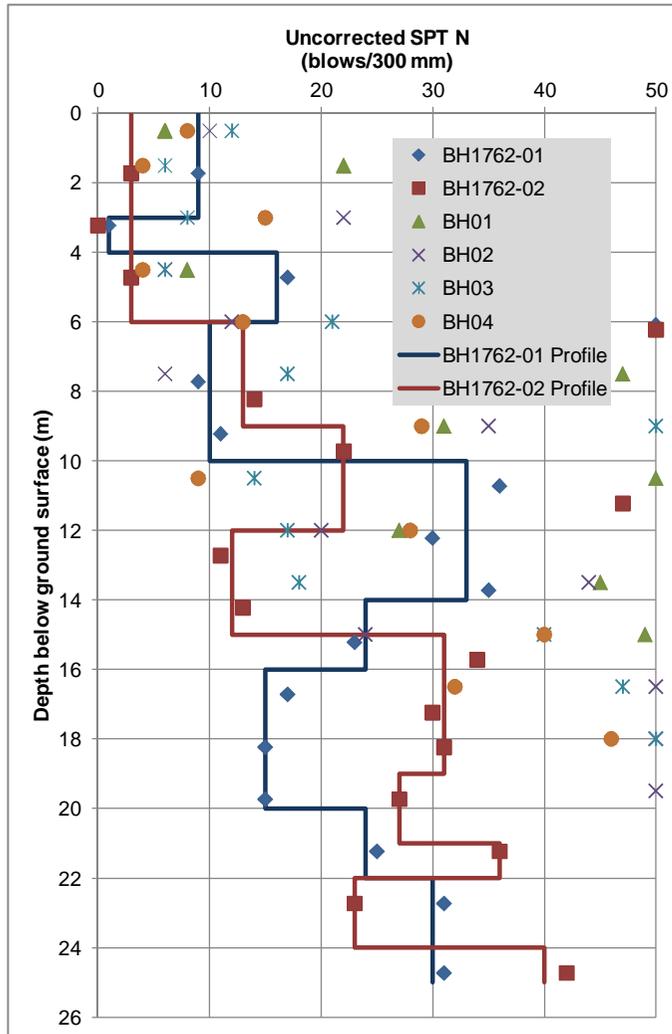
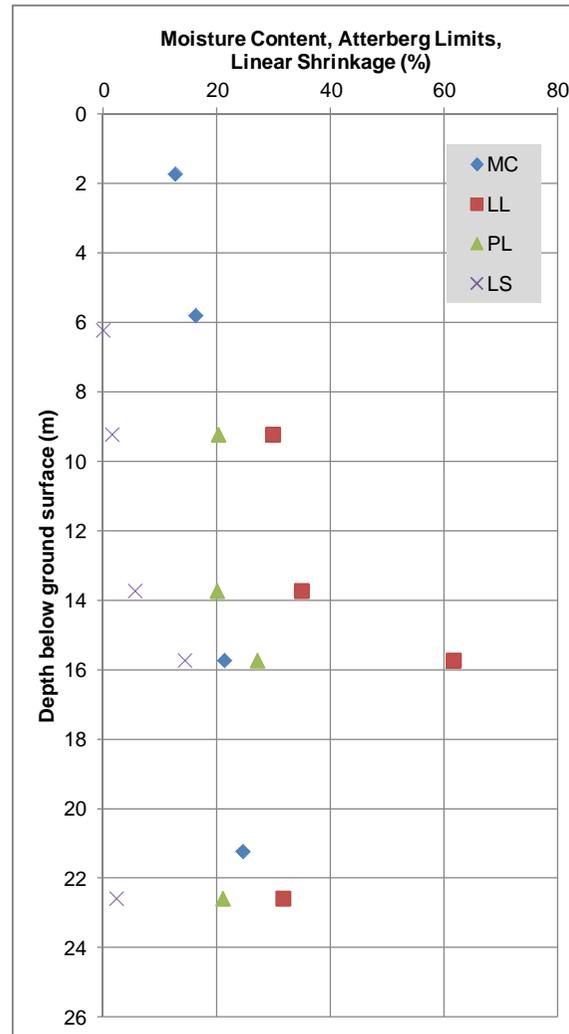
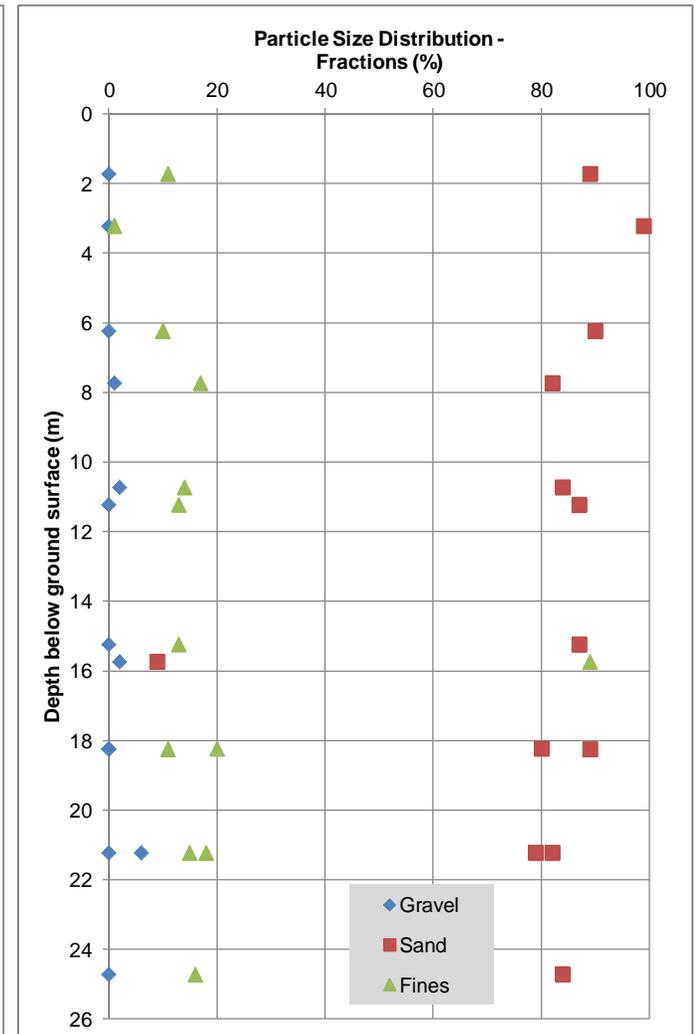
LOCATION: Western Australia
 SUBJECT: Summary of Geotechnical Investigation Results

Note: Boreholes BH1762-01 and BH1762-02 are from the 2016 site investigation. Data for boreholes BH01 to BH04 taken from historic drawings for existing bridge 1368.

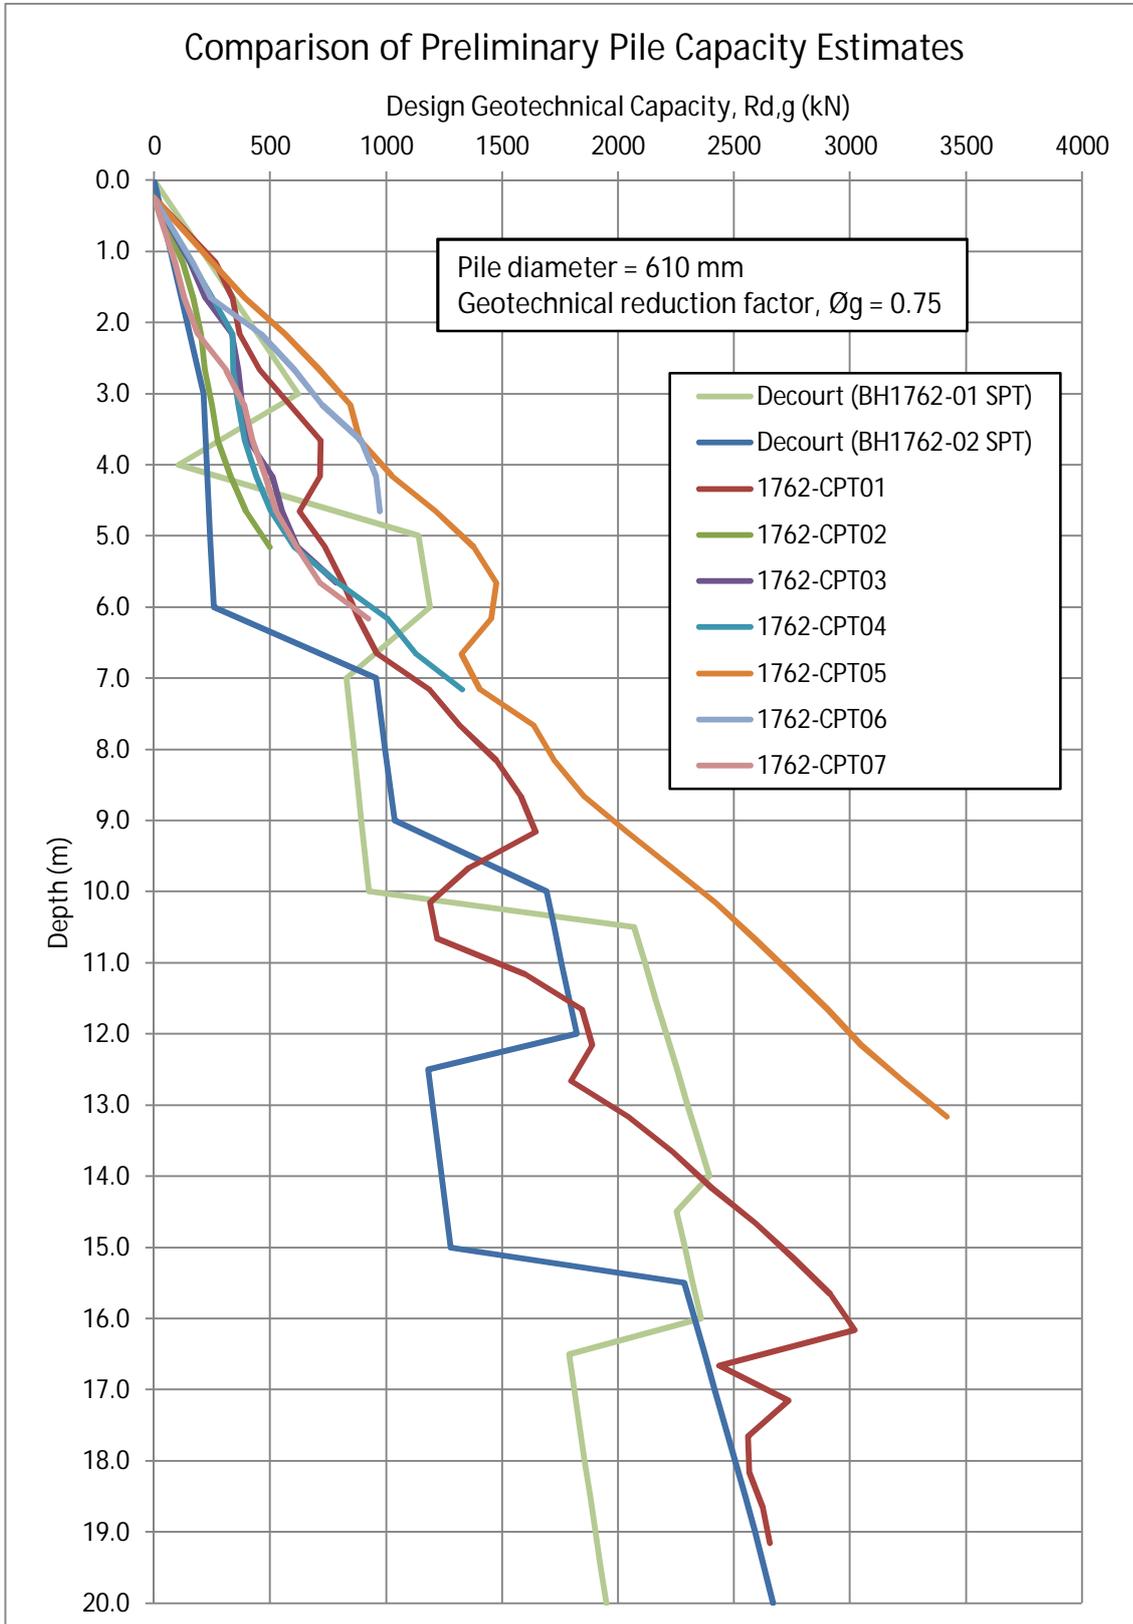
SUBJECT Comparison of pile capacity estimates from SPT and CPT data
