Bridge 1762 - Bussell Highway Over Abba River

Geotechnical Factual, Interpretive and Design Report

Client: Main Roads Western Australia

02-Dec-2016

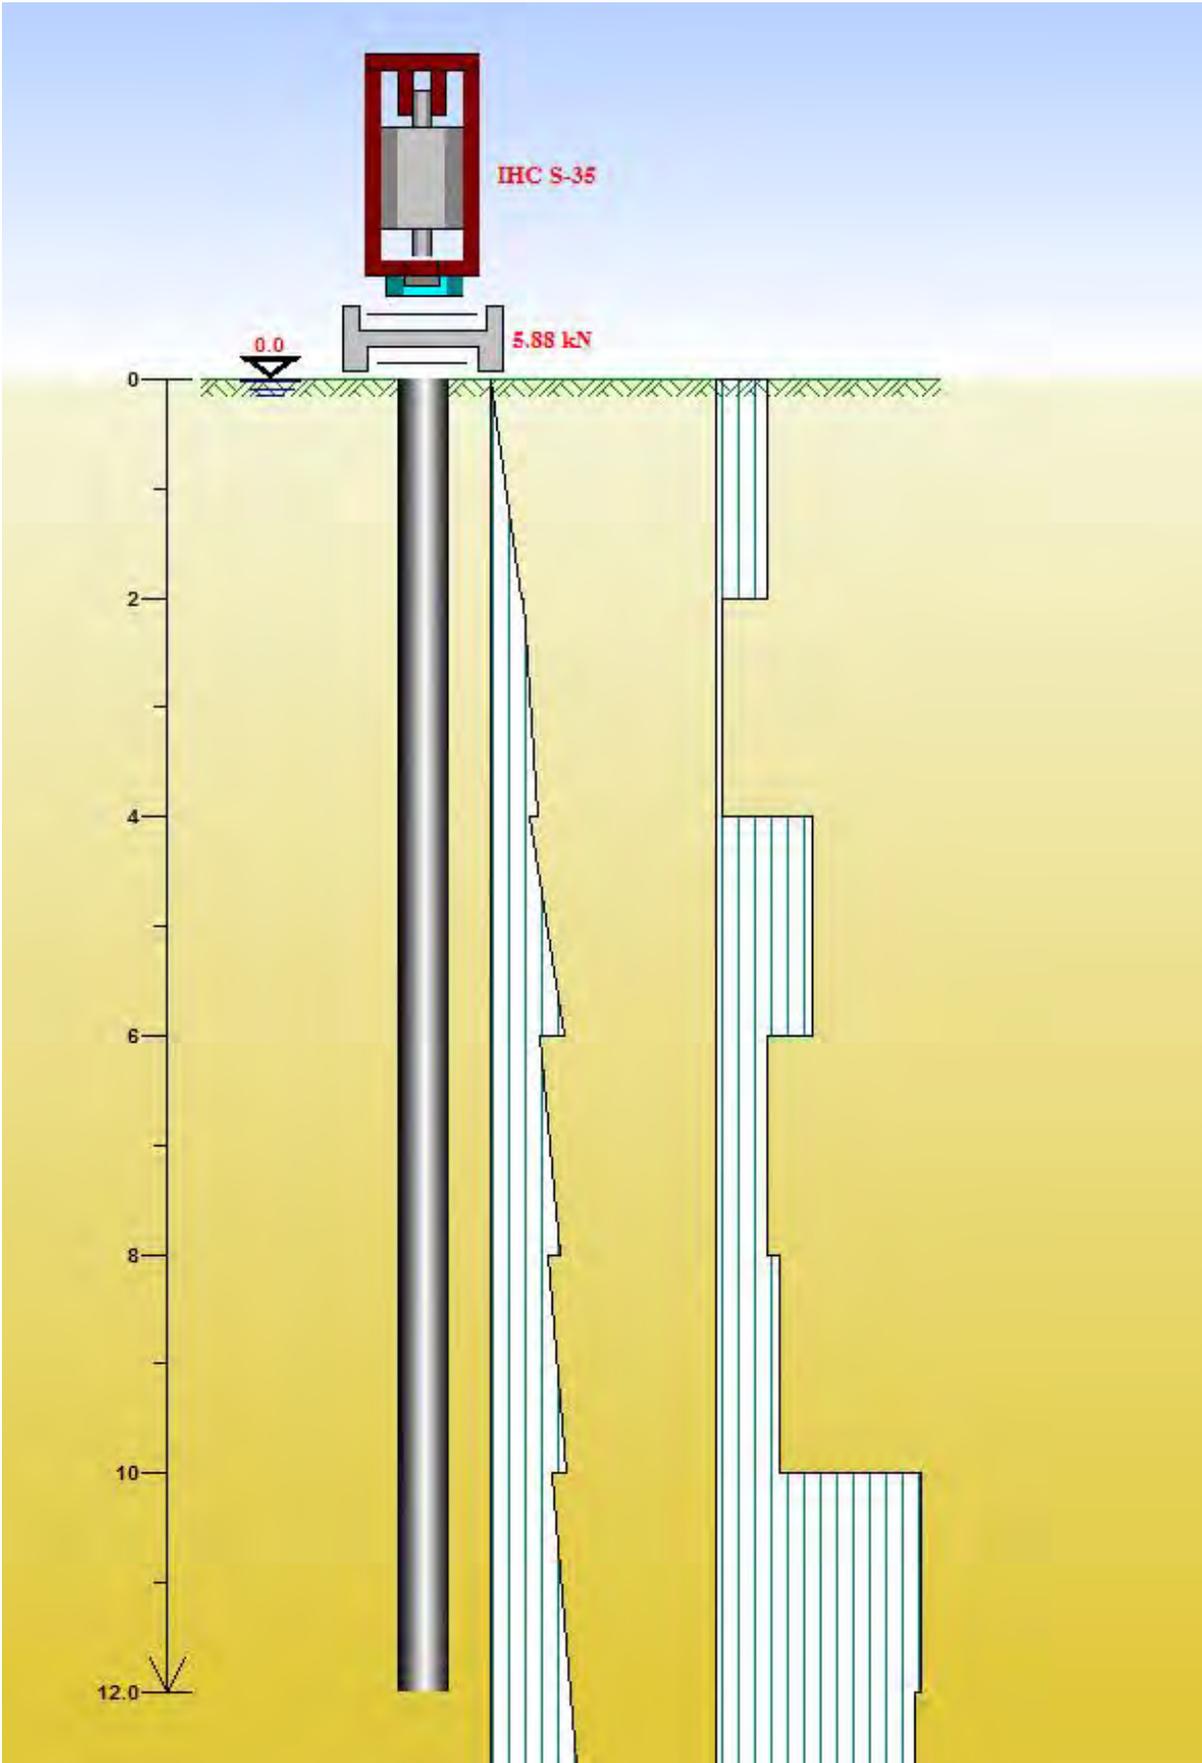
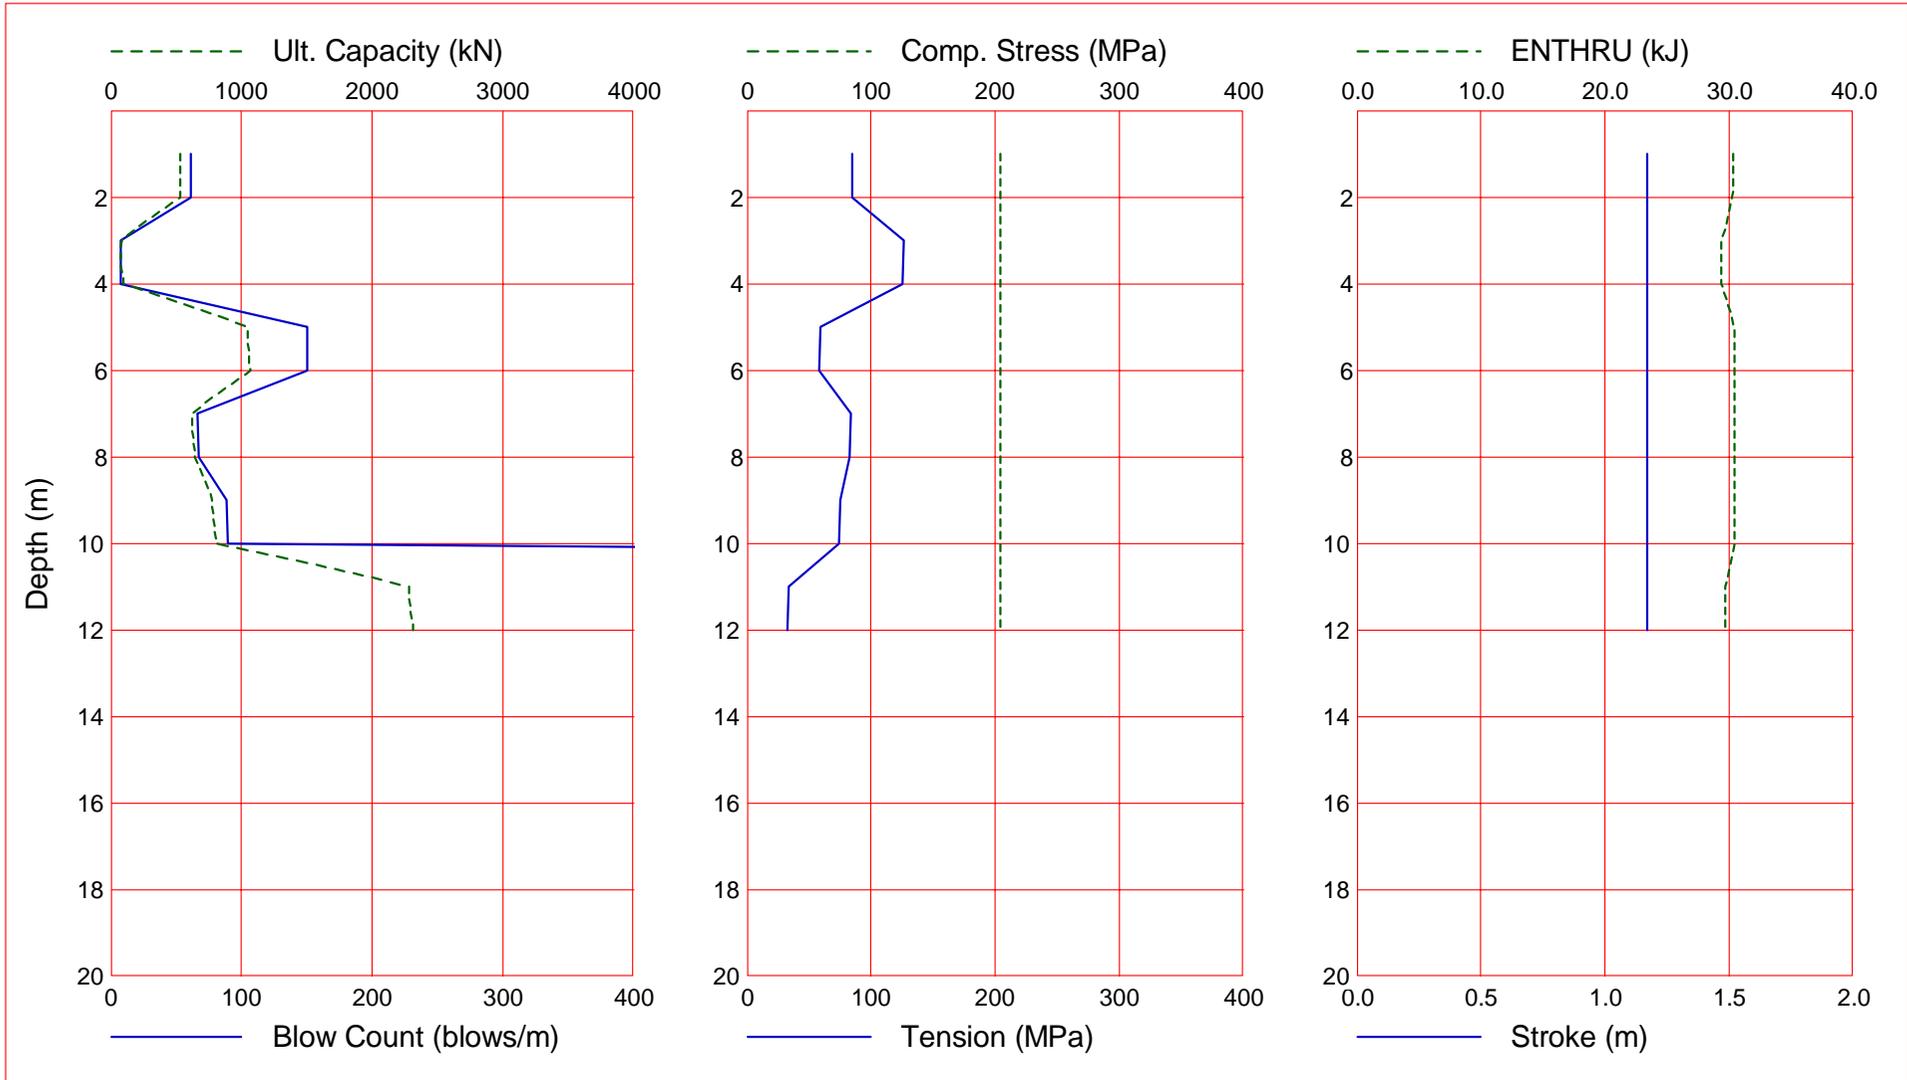
Bridge 1762 – Borehole BH-01 – 610mm CHS casing

Depth m	Ultimate Capacity kN	Friction kN	End Bearing kN	Blow Count blows/m	Comp. Stress MPa	Tension Stress MPa	Stroke m	ENTHRU kJ
1.0	528.6	2.6	526.0	60.8	204.070	-85.112	1.17	30.3
2.0	536.3	10.2	526.0	61.3	204.070	-85.150	1.17	30.2
3.0	81.0	22.5	58.5	7.4	204.070	-126.239	1.17	29.4
4.0	95.3	36.9	58.5	8.0	204.070	-125.501	1.17	29.4
5.0	1046.4	52.8	993.6	150.4	204.070	-59.101	1.17	30.5
6.0	1068.1	74.5	993.6	150.8	204.070	-58.366	1.17	30.5
7.0	618.8	92.8	526.0	66.3	204.070	-83.851	1.17	30.4
8.0	640.3	114.3	526.0	67.4	204.070	-83.046	1.17	30.4
9.0	778.1	135.2	642.9	89.0	204.071	-75.219	1.17	30.4
10.0	802.0	159.1	642.9	90.1	204.077	-74.378	1.17	30.4
11.0	2285.3	181.1	2104.2	4235.1	204.121	-33.233	1.17	29.7
12.0	2310.5	206.4	2104.2	4116.0	204.115	-32.471	1.17	29.7

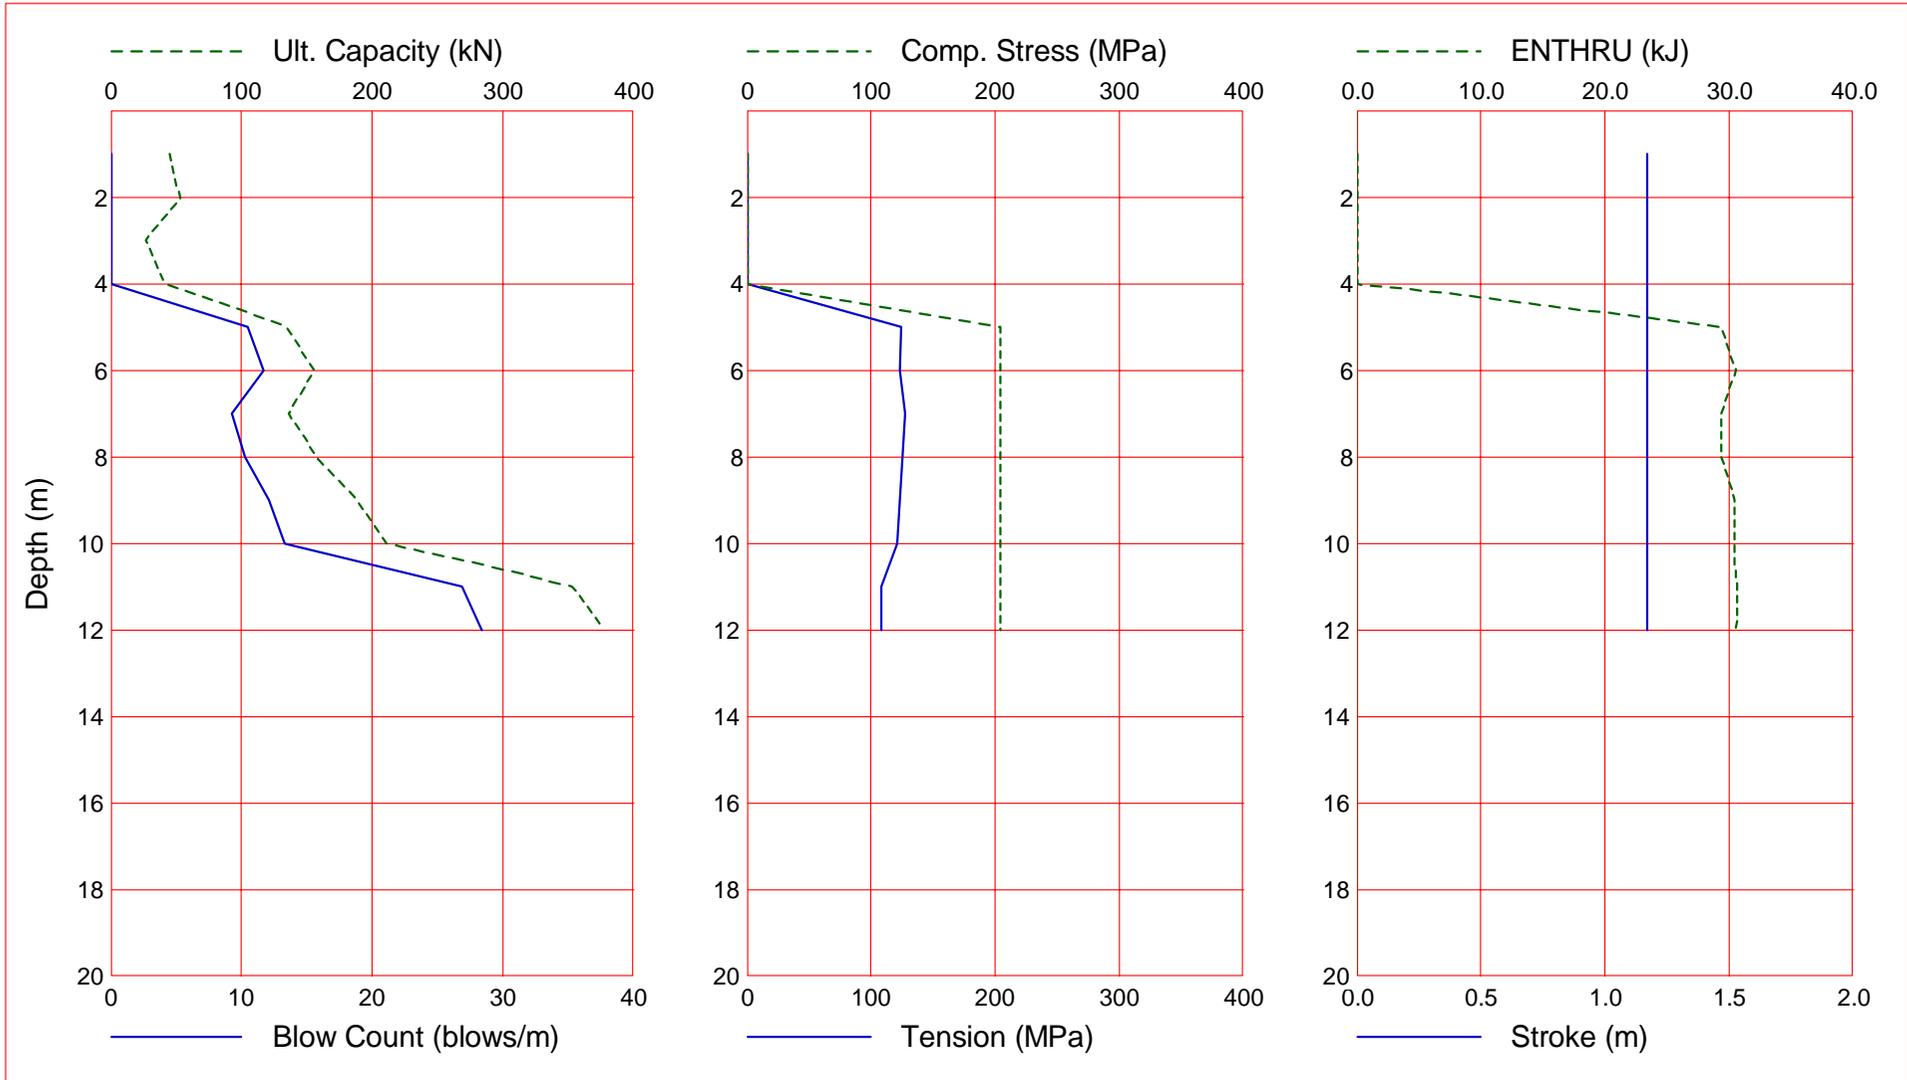
Gain/Loss 1 at Shaft and Toe 0.833 / 1.000

Depth m	Ultimate Capacity kN	Friction kN	End Bearing kN	Blow Count blows/m	Comp. Stress MPa	Tension Stress MPa	Stroke m	ENTHRU kJ
1.0	45.5	2.6	42.9	0.0	0.000	0.000	1.17	0.0
2.0	53.1	10.2	42.9	0.0	0.000	0.000	1.17	0.0
3.0	27.3	22.5	4.8	0.0	0.000	0.000	1.17	0.0
4.0	41.6	36.9	4.8	0.0	0.000	0.000	1.17	0.0
5.0	133.8	52.8	81.0	10.5	204.070	-123.999	1.17	29.4
6.0	155.5	74.5	81.0	11.7	204.070	-123.065	1.17	30.6
7.0	135.7	92.8	42.9	9.3	204.070	-127.010	1.17	29.4
8.0	157.2	114.3	42.9	10.3	204.070	-125.364	1.17	29.4
9.0	187.6	135.2	52.4	12.1	204.071	-122.684	1.17	30.5
10.0	211.5	159.1	52.4	13.3	204.078	-121.163	1.17	30.4
11.0	352.7	181.1	171.6	26.9	204.132	-108.797	1.17	30.7
12.0	378.0	206.4	171.6	28.4	204.117	-108.215	1.17	30.6

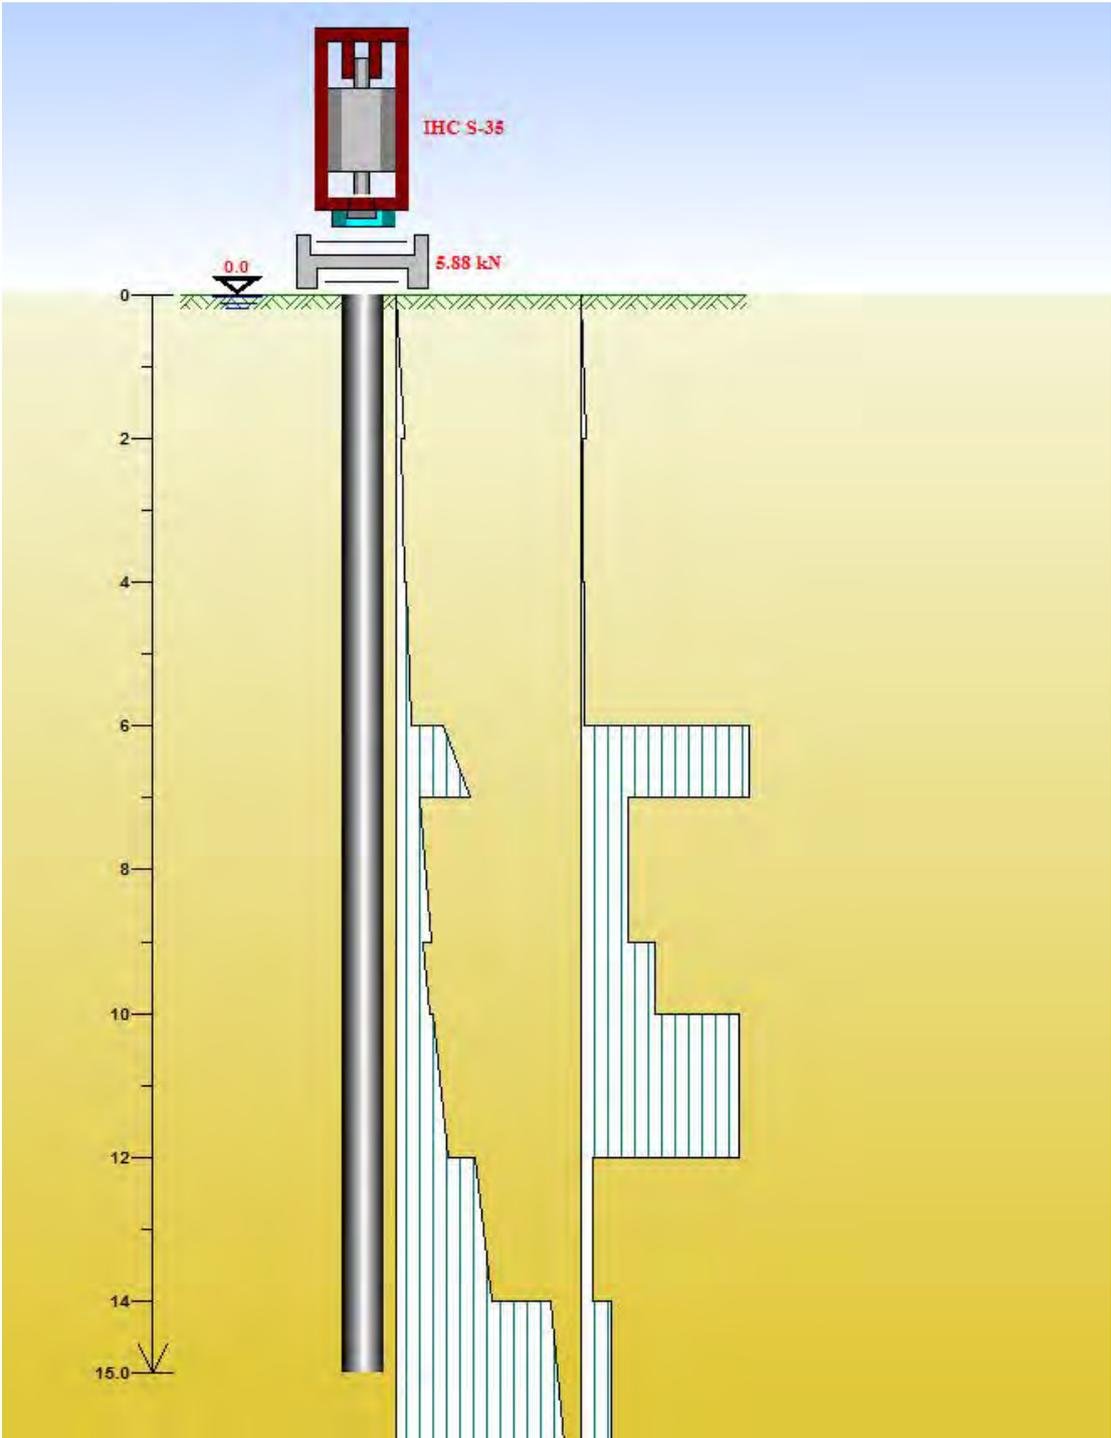
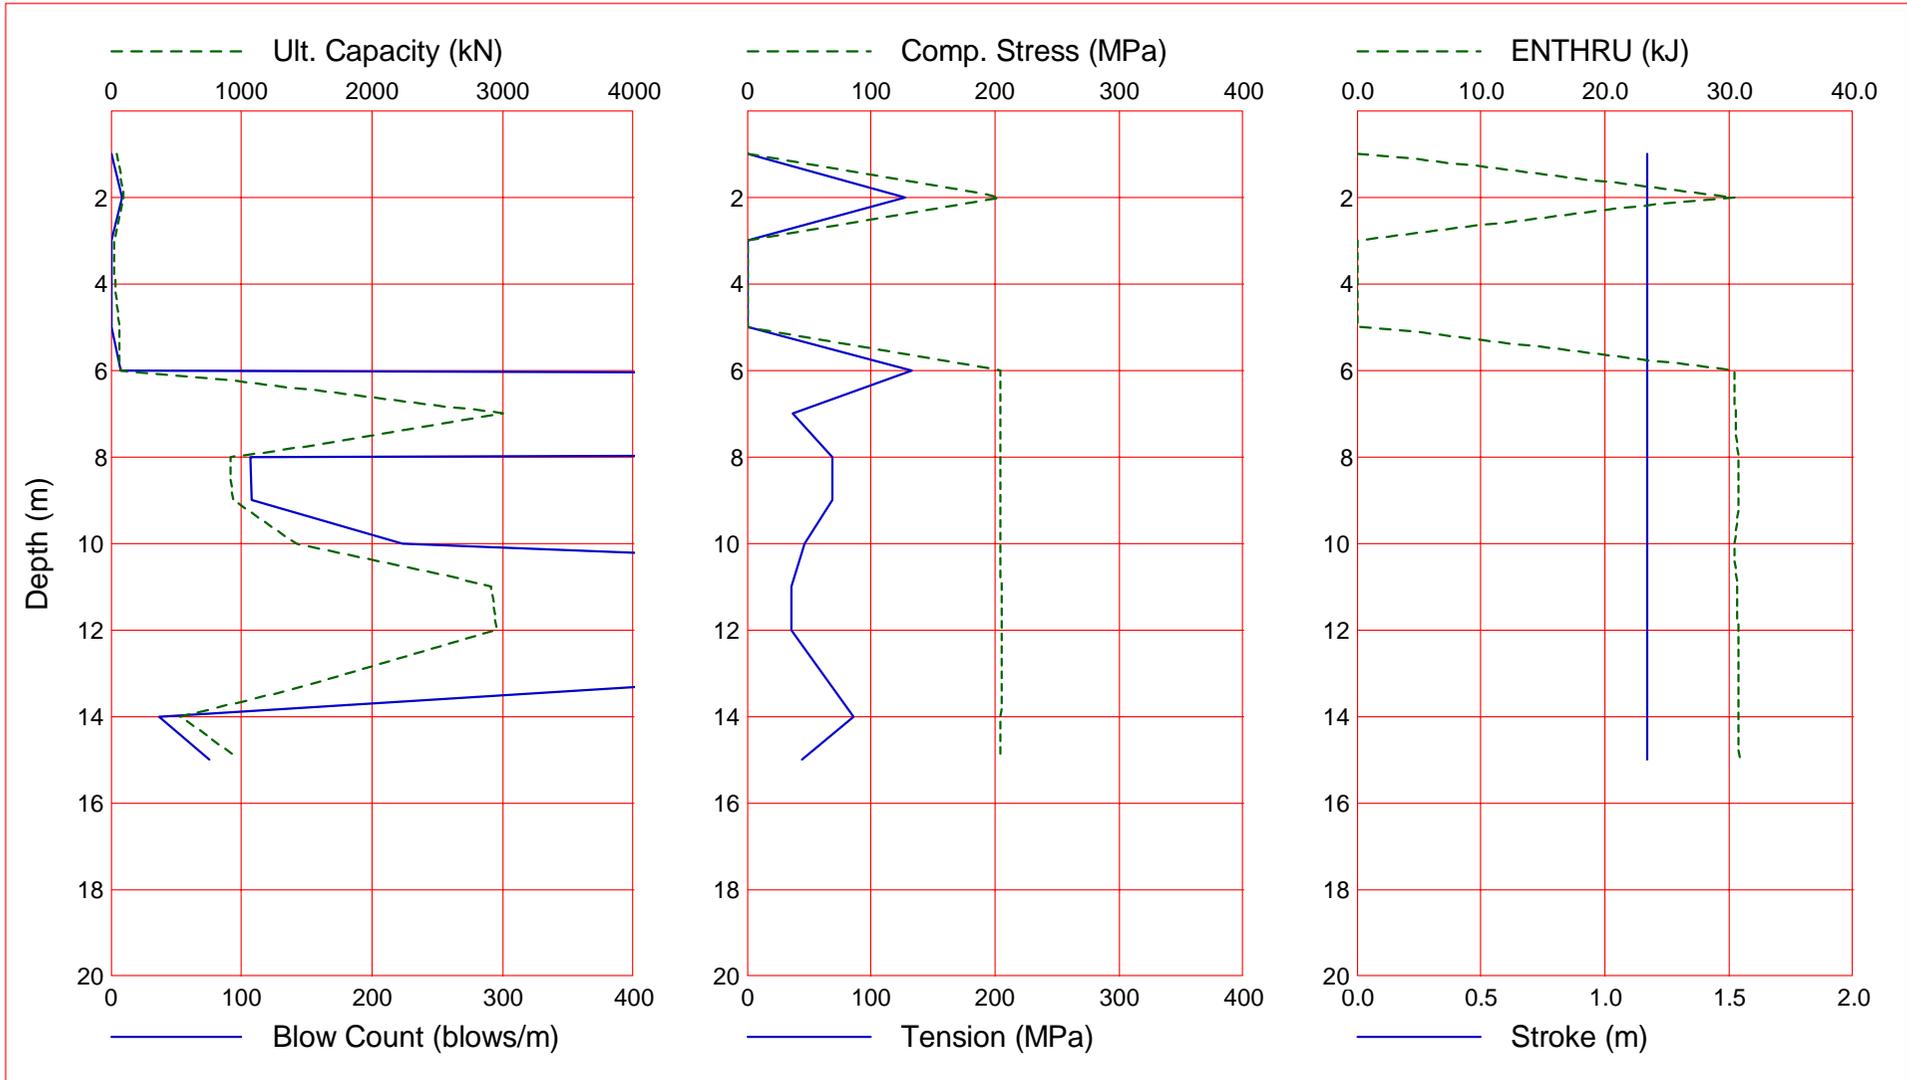
Bridge 1763 – Borehole BH-02 – 610mm CHS casing

Depth m	Ultimate Capacity kN	Friction kN	End Bearing kN	Blow Count blows/m	Comp. Stress MPa	Tension Stress MPa	Stroke m	ENTHRU kJ
1.0	44.6	1.5	43.1	0.0	0.000	0.000	1.17	0.0
2.0	92.2	5.9	86.3	8.7	204.070	-127.036	1.17	30.4
3.0	25.7	9.9	15.8	0.0	0.000	0.000	1.17	0.0
4.0	31.1	15.3	15.8	0.0	0.000	0.000	1.17	0.0
5.0	70.7	23.4	47.3	0.0	0.000	0.000	1.17	0.0
6.0	80.8	33.4	47.3	7.3	204.070	-133.163	1.17	30.4
7.0	2998.7	76.3	2922.5	9999.0	204.674	-36.290	1.17	30.6
8.0	913.1	94.8	818.3	107.2	204.069	-68.950	1.17	30.8
9.0	936.2	118.0	818.3	107.8	204.069	-68.420	1.17	30.8
10.0	1425.3	139.4	1285.9	223.3	204.070	-46.840	1.17	30.5
11.0	2915.4	168.3	2747.1	1059.8	205.055	-35.527	1.17	30.7
12.0	2949.4	202.3	2747.1	1097.2	205.047	-35.812	1.17	30.8
14.0	532.4	327.2	205.2	37.2	204.101	-85.983	1.17	30.8
15.0	976.5	440.0	536.6	75.5	204.090	-44.315	1.17	30.9

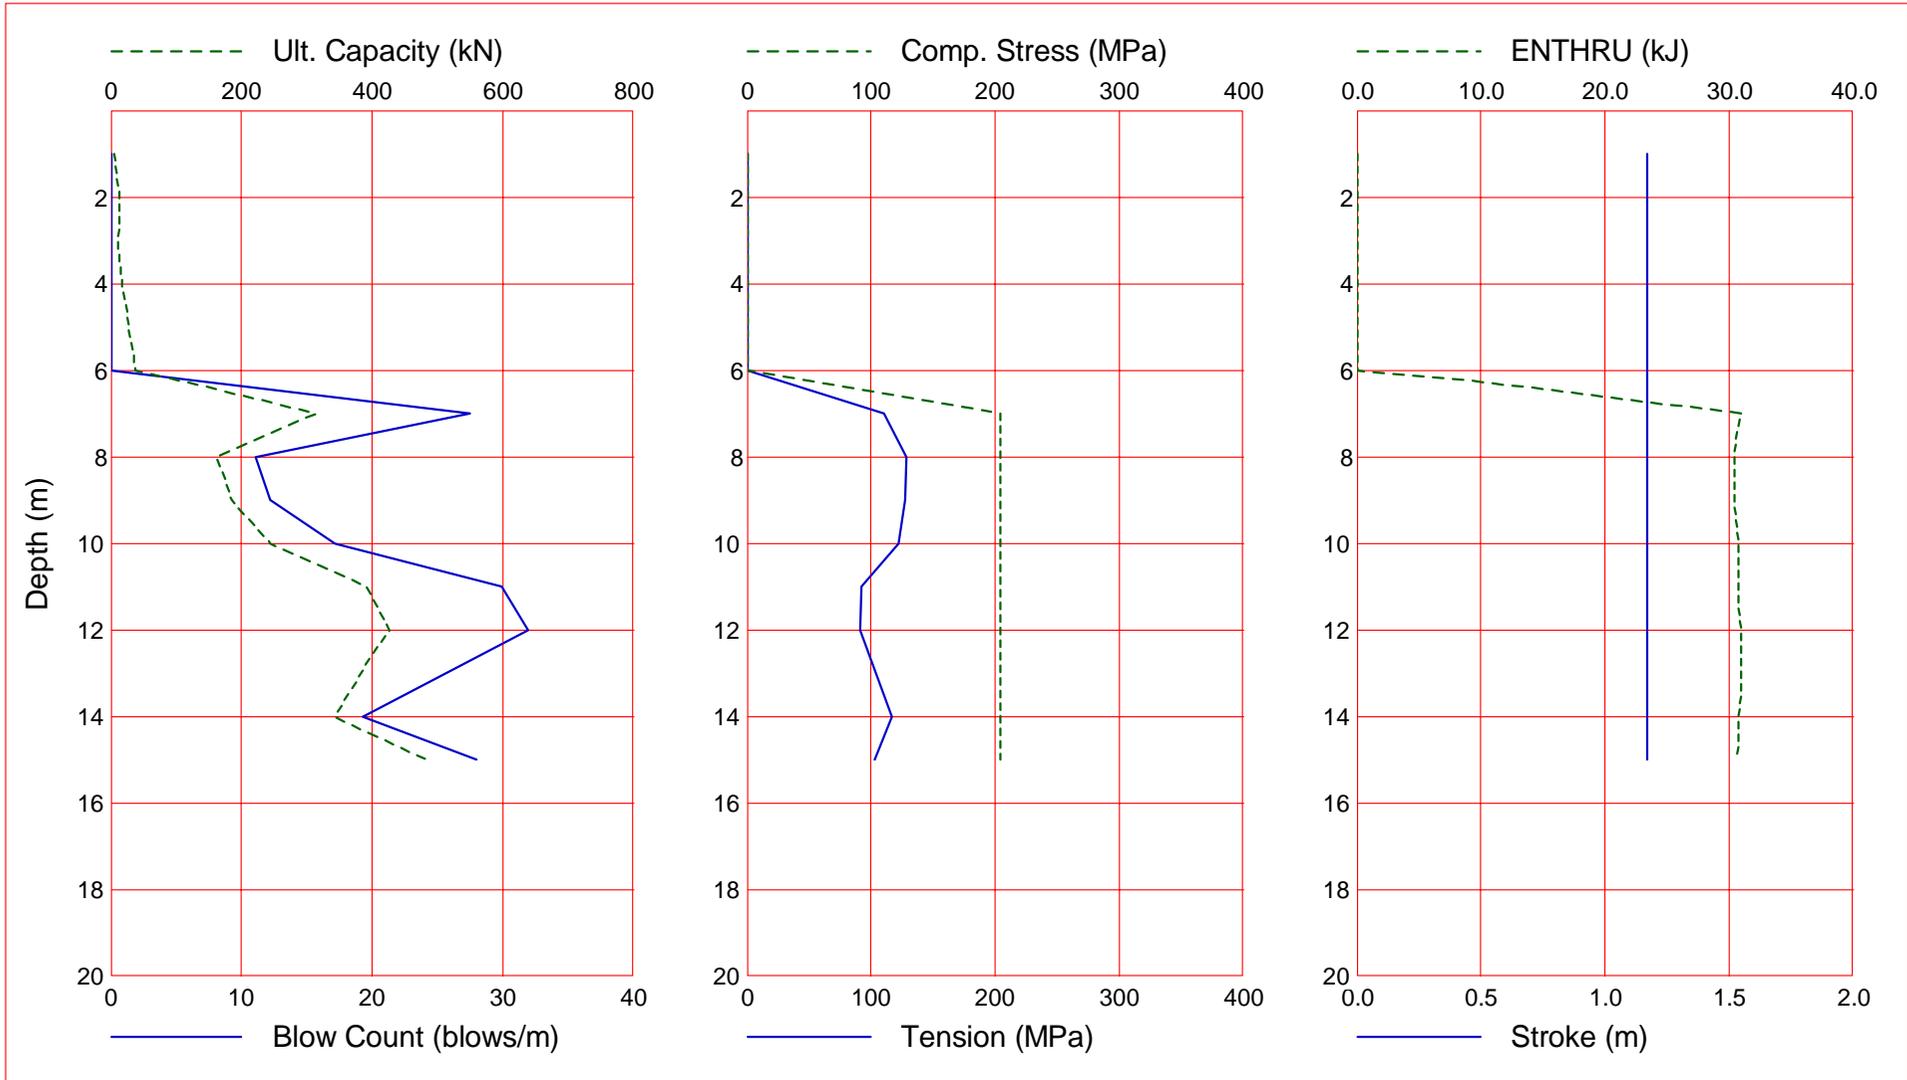
Refusal occurred; no driving time output possible

Depth m	Ultimate Capacity kN	Friction kN	End Bearing kN	Blow Count blows/m	Comp. Stress MPa	Tension Stress MPa	Stroke m	ENTHRU kJ
1.0	5.0	1.5	3.5	0.0	0.000	0.000	1.17	0.0
2.0	12.9	5.9	7.0	0.0	0.000	0.000	1.17	0.0
3.0	11.2	9.9	1.3	0.0	0.000	0.000	1.17	0.0
4.0	16.6	15.3	1.3	0.0	0.000	0.000	1.17	0.0
5.0	27.2	23.4	3.9	0.0	0.000	0.000	1.17	0.0
6.0	37.3	33.4	3.9	0.0	0.000	0.000	1.17	0.0
7.0	314.6	76.3	238.3	27.5	204.069	-109.906	1.17	31.0
8.0	161.5	94.8	66.7	11.1	204.069	-128.915	1.17	30.4
9.0	184.7	118.0	66.7	12.2	204.069	-127.599	1.17	30.4
10.0	244.3	139.4	104.9	17.2	204.070	-121.863	1.17	30.8
11.0	392.3	168.3	224.0	29.9	204.070	-92.680	1.17	30.8
12.0	426.3	202.3	224.0	31.9	204.070	-90.793	1.17	31.0
14.0	344.0	327.2	16.7	19.3	204.103	-116.376	1.17	30.8
15.0	483.7	440.0	43.8	28.0	204.089	-103.014	1.17	30.7

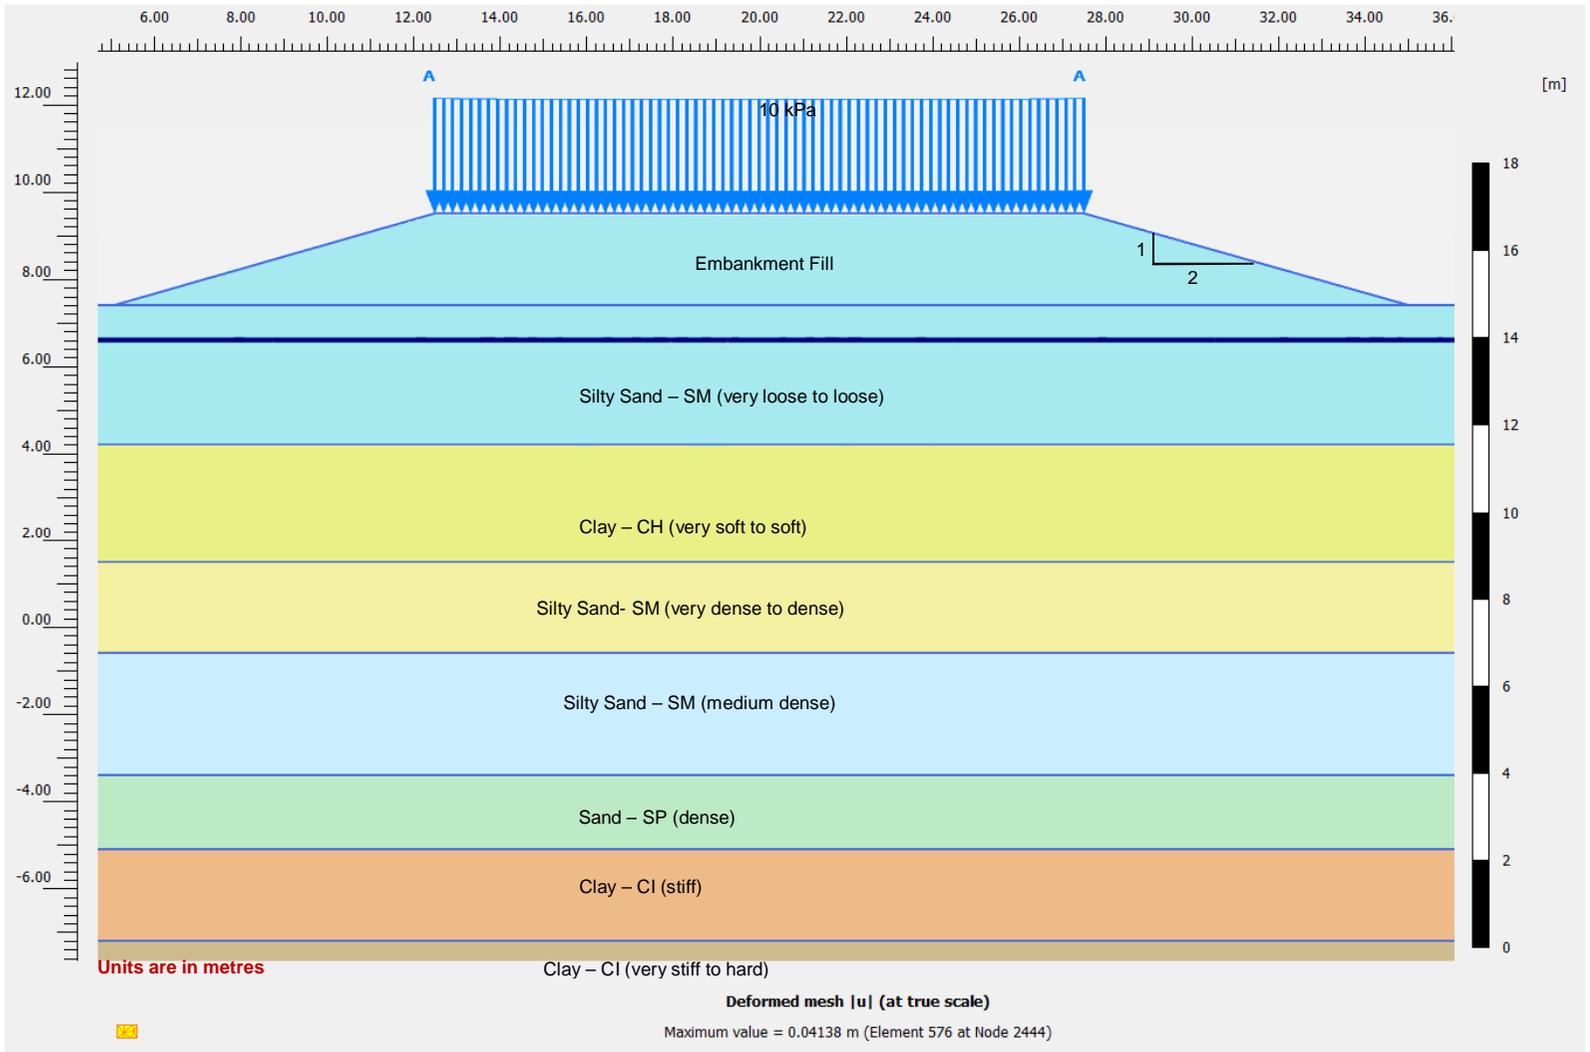
Plate 1 Soil Model for Eastern Approach Embankment of Bridge 1762

The soil profile and soil parameters adopted for PLAXIS analysis are presented in Plate 1 and Table 1, respectively. Mohr-Coulomb and 'Soft Soil Creep' (time dependent behaviour model as described in Plaxis manual) models were used for sandy soils and cohesive soils, respectively.

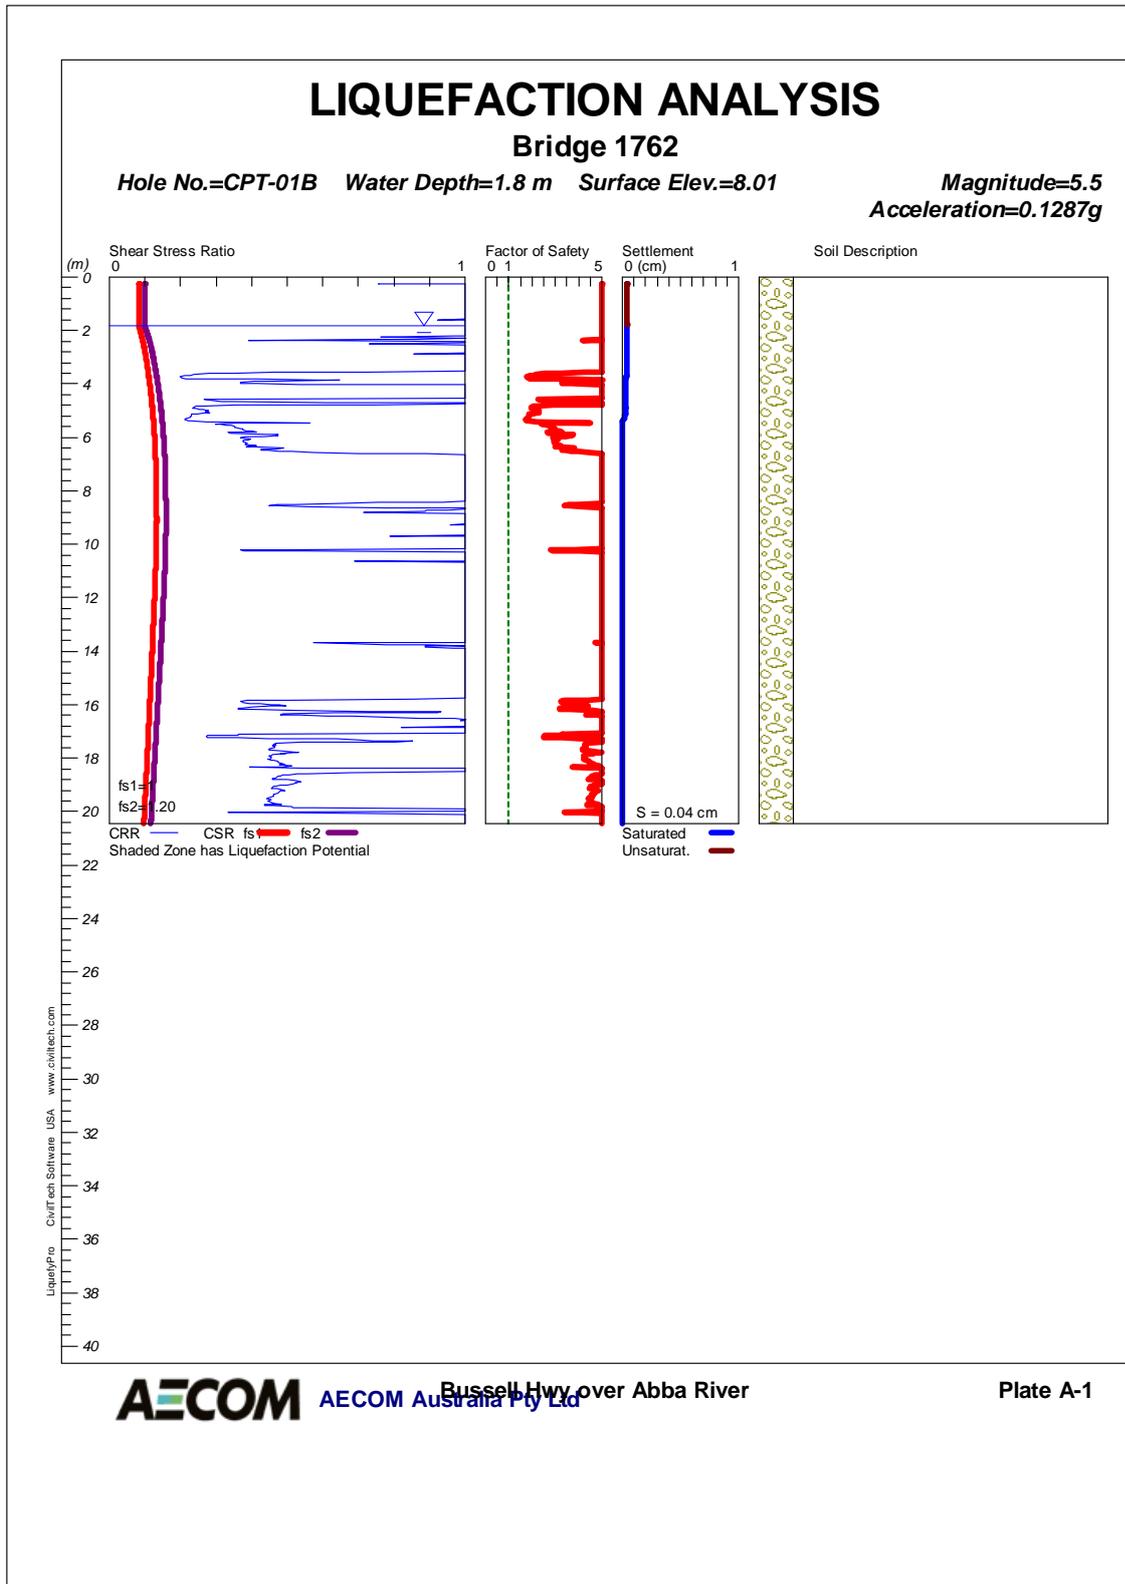
Bridge 1762

LIQUEFACTION ANALYSIS

Magnitude=5.5
Acceleration=0.1287g

Sub-soil Class and Liquefaction: The sub-soil class for the site has been assessed as "Class De – Deep or soft soil site". A preliminary liquefaction analysis was undertaken based on results from CPT testing and the risk of liquefaction for the site was found to be low.

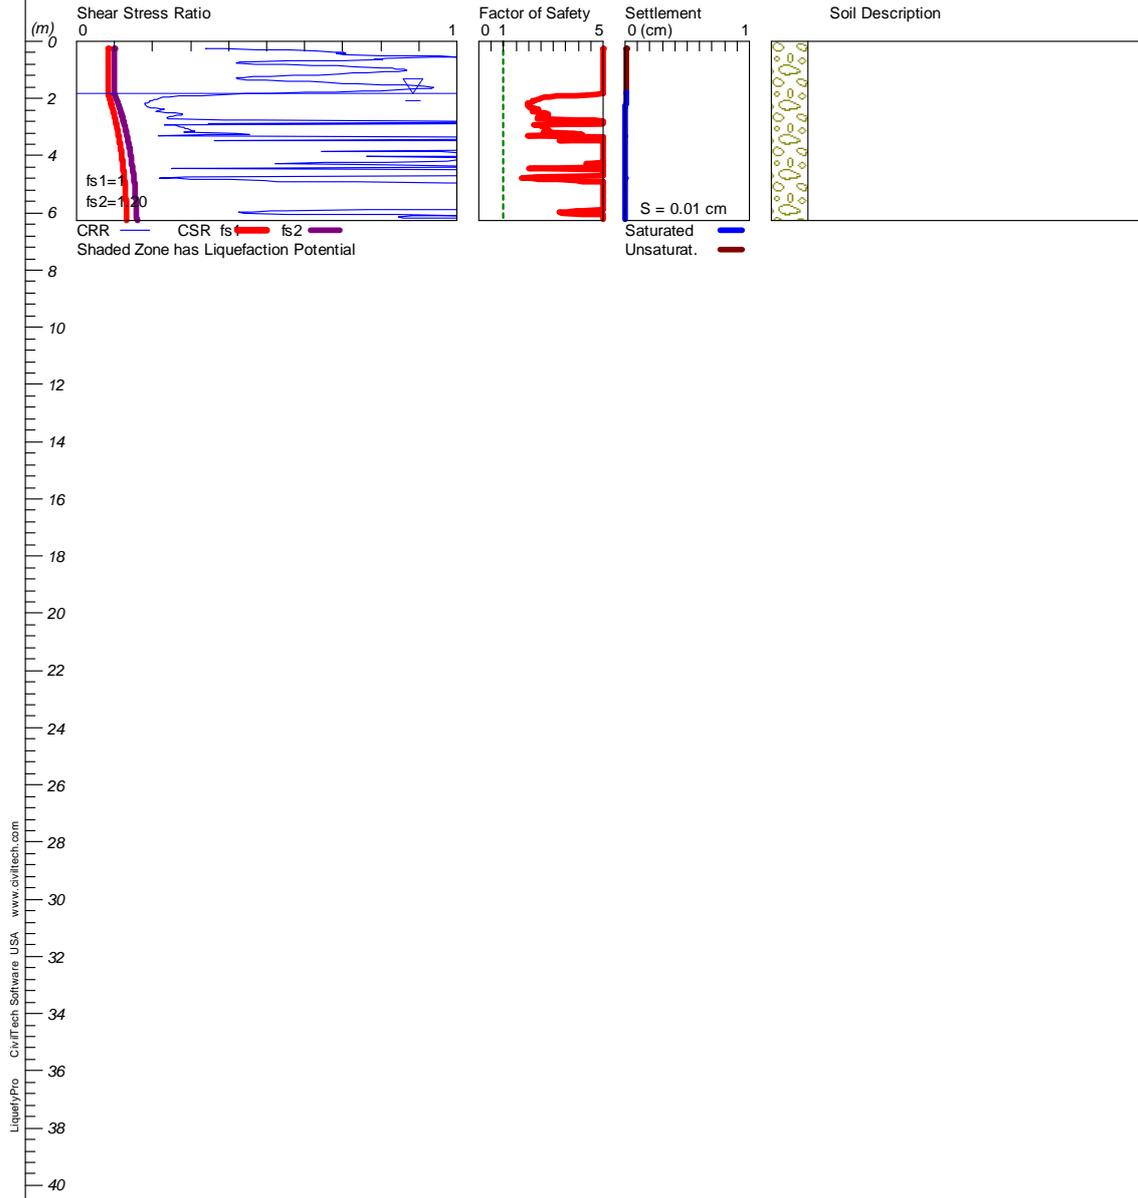
Hole No.=CPT-02 Water Depth=1.8 m Surface Elev.=7.39

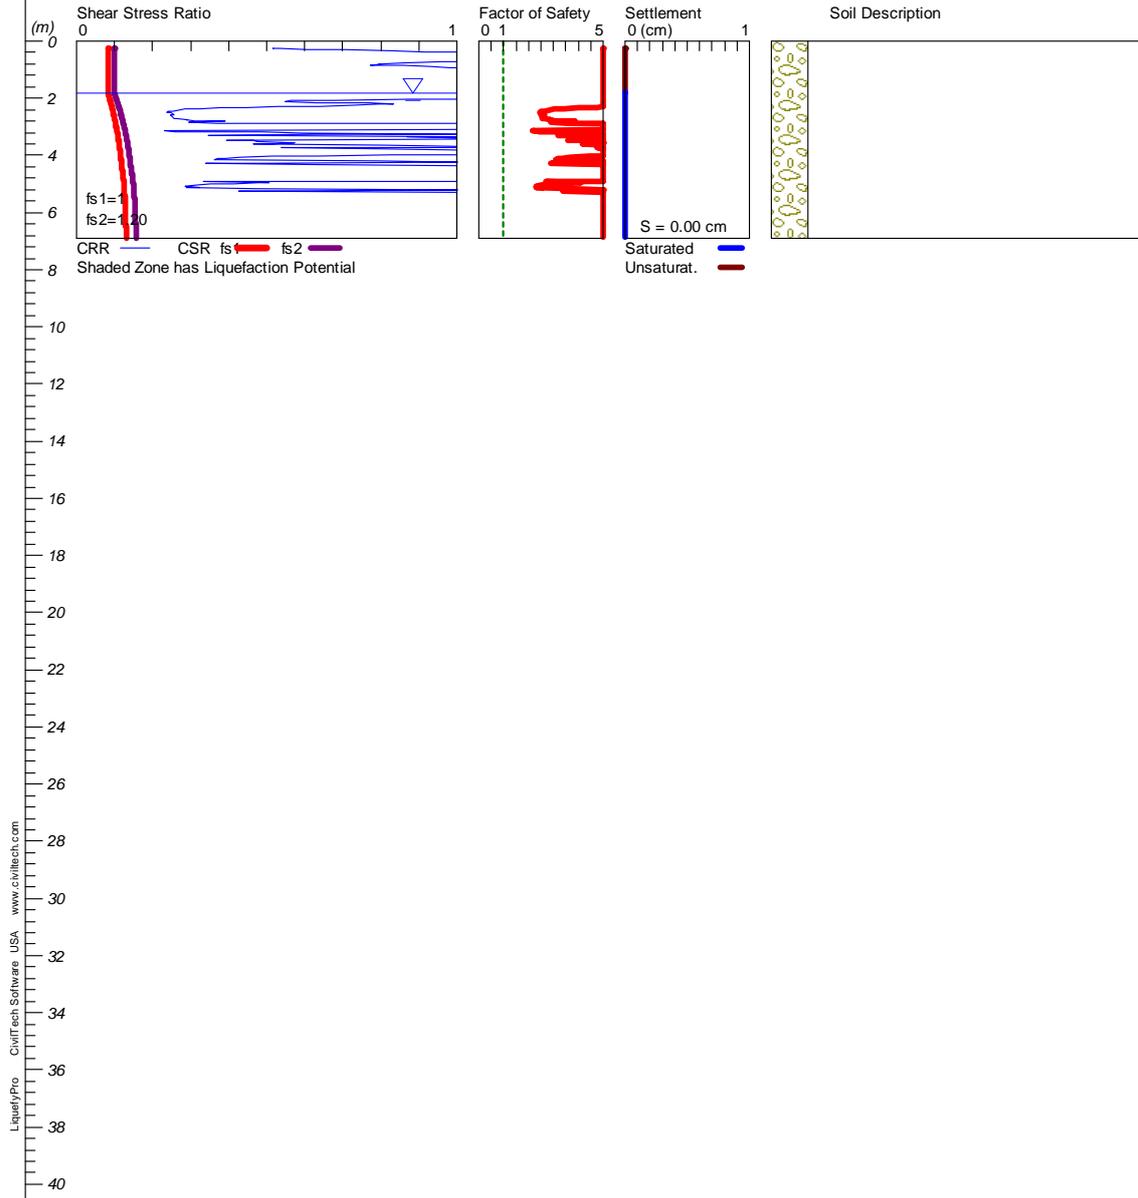
Hole No.=CPT-03 Water Depth=1.8 m Surface Elev.=7.20

Magnitude=5.5
Acceleration=0.1287g

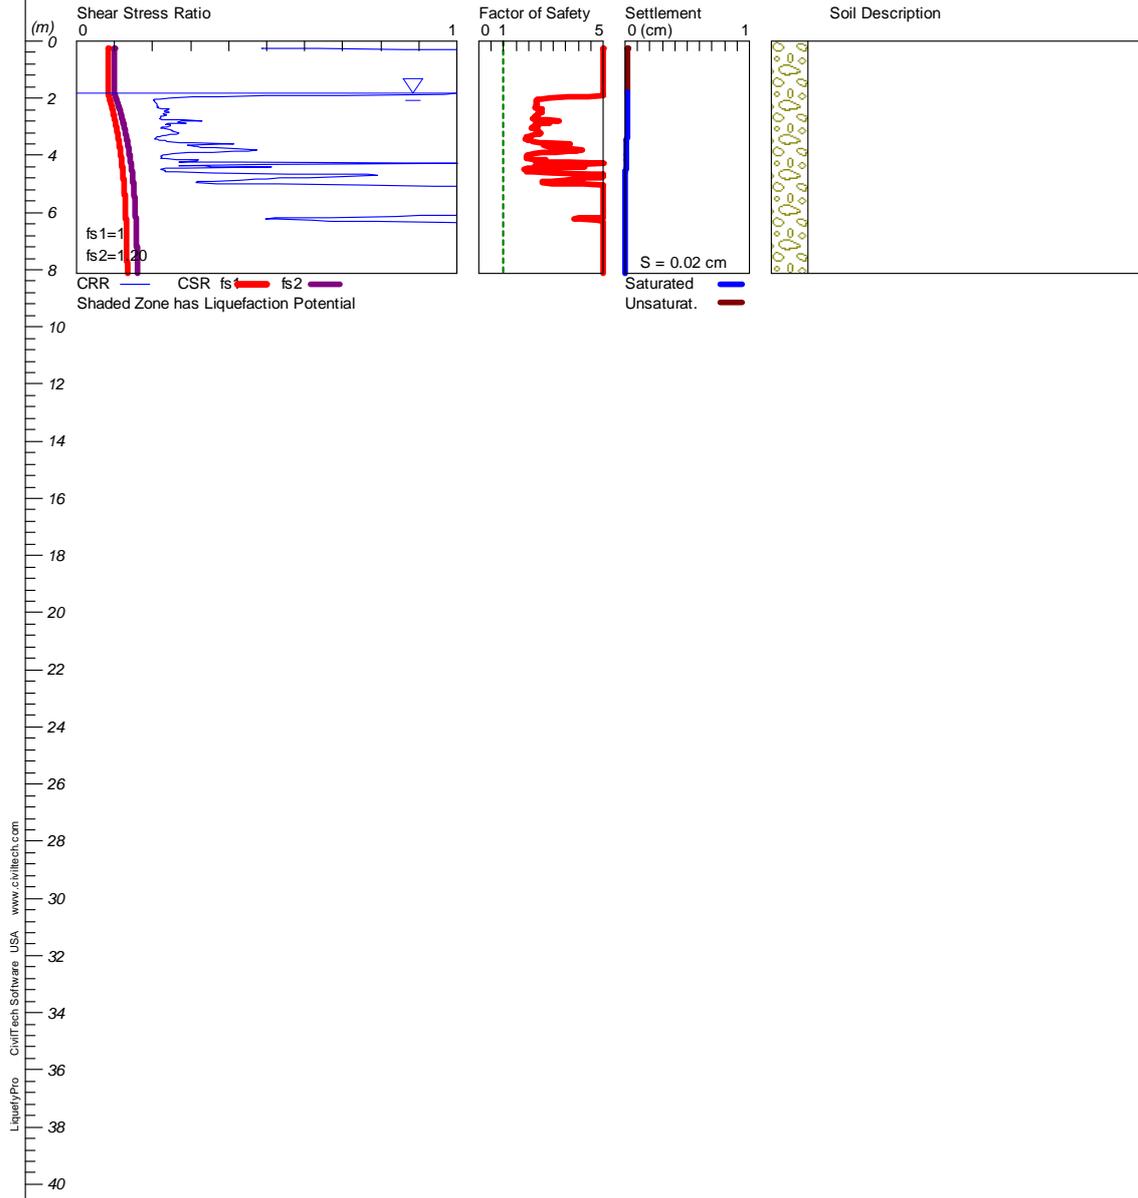
Hole No.=CPT-04 Water Depth=1.8 m Surface Elev.=7.17

Magnitude=5.5
Acceleration=0.1287g
