## Detailed Visual Bridge Inspection Guidelines for Timber Bridges (Level 2 Inspections)

Document No: 6706-02-2231

## **CONDITION ASSESSMENT – LEVEL 2 DETAILED VISUAL INSPECTION GUIDELINES FOR TIMBER BRIDGES**

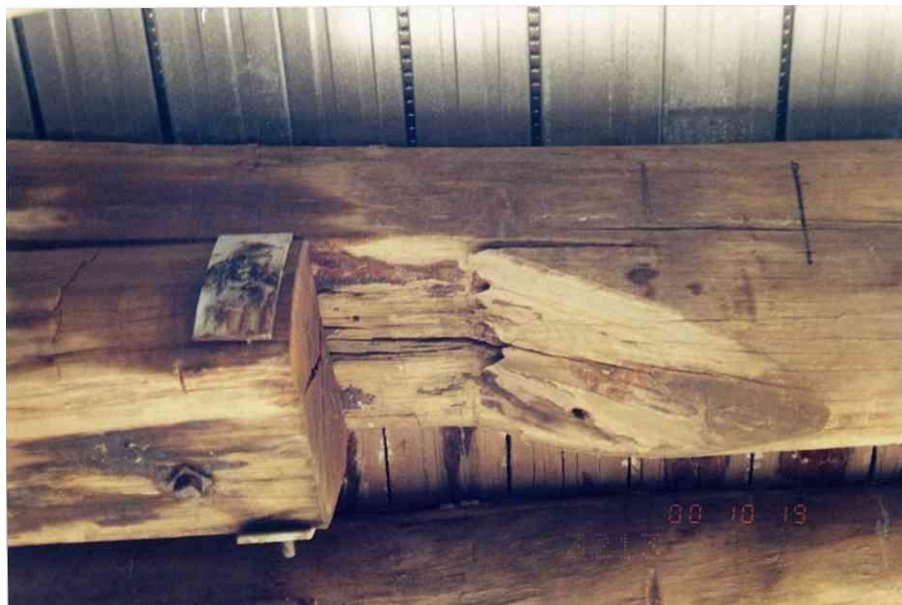
**Figure 8.2 - EXAMPLE OF STRINGER SPLITTING AT HAUNCH**

- Spiral grain (excessive spiral grain may cause long-term splitting)
- Splitting or crushing of corbels (see Figure 8.1)
- Splitting of stringers, need for cross bolts (see Figure 8.2)
- Rot zones
- Rusty steel work
- Deflections (i.e. movement or deformed shape) (excessive especially under traffic)
- Condition and tightness of bolted connections
- Recent preventative maintenance including fungicide treatment or waterproofing
- Evidence of termite damage/activity

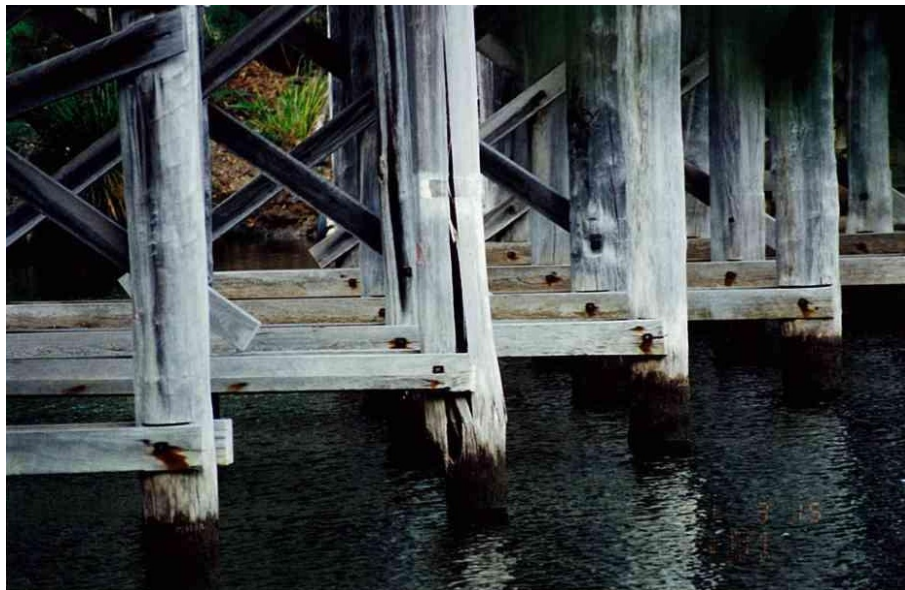
**Figure 8.3 - EXAMPLE OF SPLIT TIMBER PILE**

The condition of any timber pile around waler bolts needs to be critically assessed as rusting of the steel bolt (waler/pile connection) can cause significant deterioration of the timber pile, which in some cases can go unidentified for many years given the presence of the waler. This, if not identified early, can lead to significant section loss of the pile which in the long-term has the potential to cause pile failure (see Figure 8.3). Further guidance on how to identify any deterioration is detailed in Section A.14.6.

- scour of the stream bed
- movement of the ground due to land slips at or around the bridge abutment
- excessive earth pressure caused by movements or settlements of the approach fill
- lateral earth pressure from adjacent construction
- soil liquefaction
- collisions, in the case of bridges over navigable waterways, roads or railways
- sheeting failures
- failure of bracing and/or walers, deterioration of bolt holes
- inefficient props
- loose bolts
- debris
- excessive splitting or failure of a pile (see Figure 8.3)

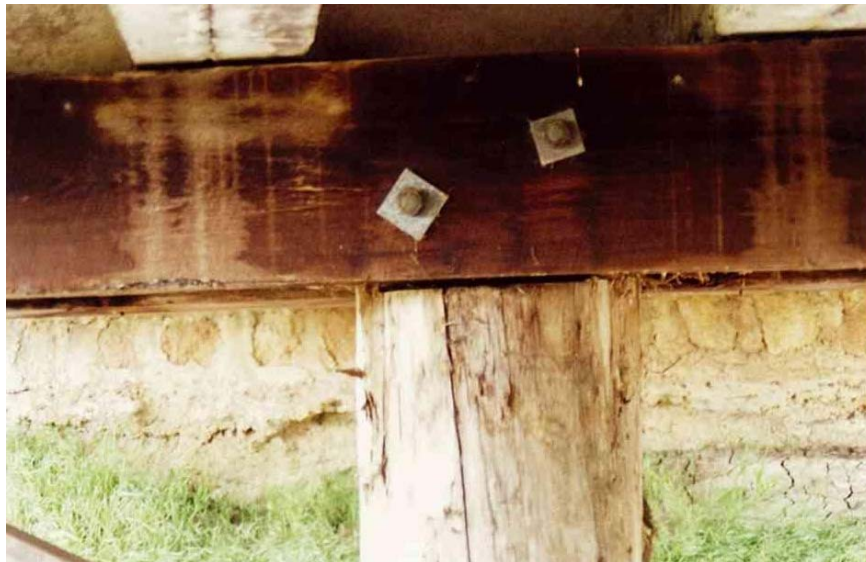
**Figure 8.4 - EXAMPLE OF HALFCAP NOT SEATED ON PILE**

- Poor seating between corbel and halfcap
- Seating of halfcaps on piles (see Figure 8.4)
- Any crushing or splitting of the pile or halfcap at bearing points
- Any bowing, splitting or cracking in the halfcaps, particularly at splice joints (see Figure 8.5)
- General deterioration, weathering of ends, rot zones
- Effectiveness of any strengthening or replacement sections
- Halfcap bolted tightly to pile (tongue or up stand)
- Bolt tightness, condition of bolts and bolt holes
- Folding or crushing of sill beam/halfcaps
- Orientation of the halfcap splice joint. The halfcap splice joint should be orientated to ensure the vertical bolts are in tension and all timber is in compression when the halfcap is loaded. A correctly orientated halfcap splice will reduce the long-term splitting of the timber.

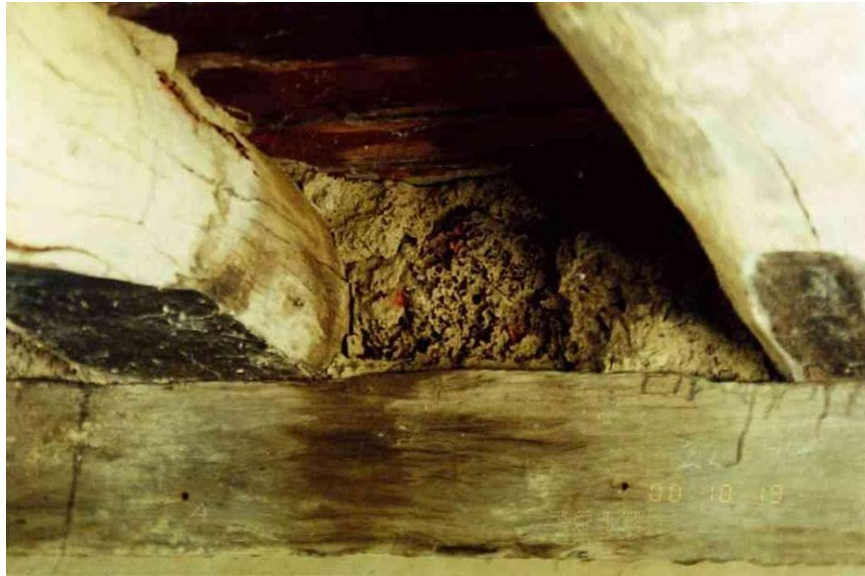
**Figure 10.1 - EXAMPLE OF INSECT INFESTATION IN A TIMBER BRIDGE**

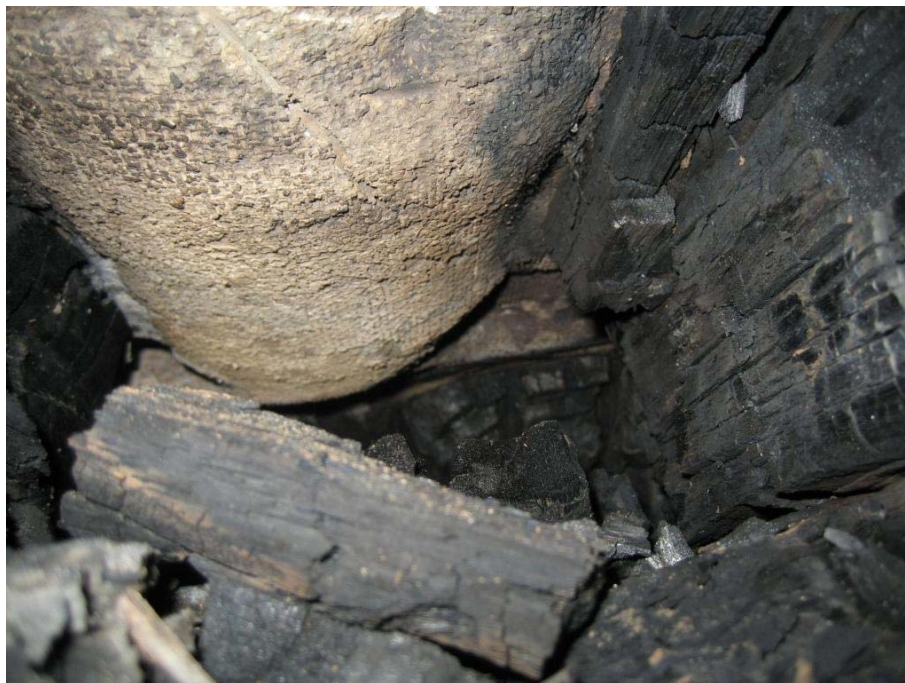
**Figure 10.2 - FIRE DAMAGE IN A TIMBER BRIDGE**

Typical damage caused by fire to timber decking components and a stringer end is shown in Figure 10.2. Unfortunately, if there is a fire at a timber bridge, in an effort to ensure that the fire does not spread and that it is fully contained, timber components may need to be cut or removed. Figure 10.3 shows a solid wandoo stringer that was cut to obtain access to the seat of the fire to ensure it was fully extinguished.

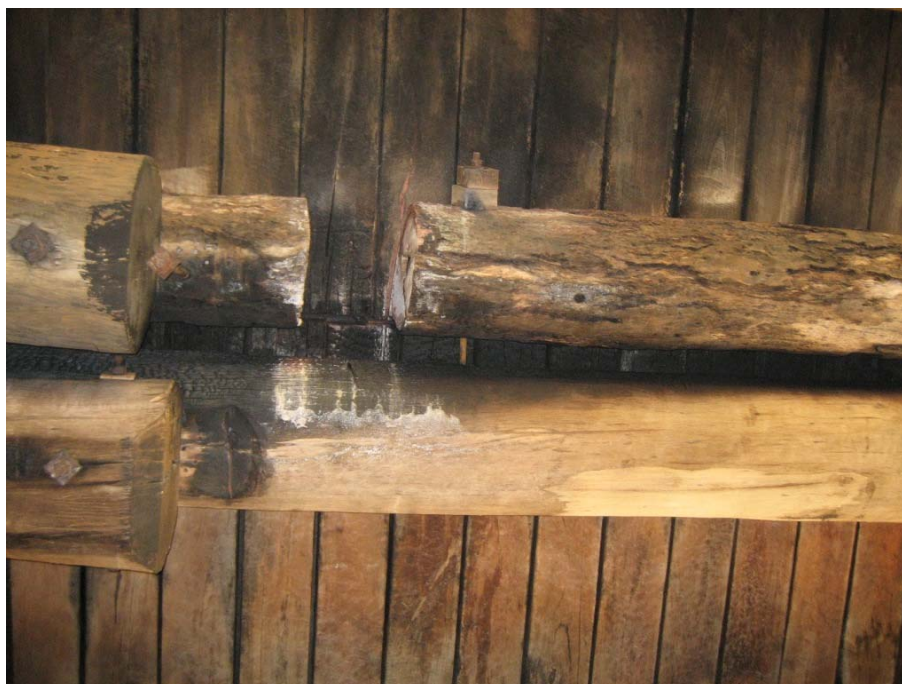
**Figure 10.3 - CUT STRINGER TO OBTAIN ACCESS TO THE SEAT OF THE FIRE**

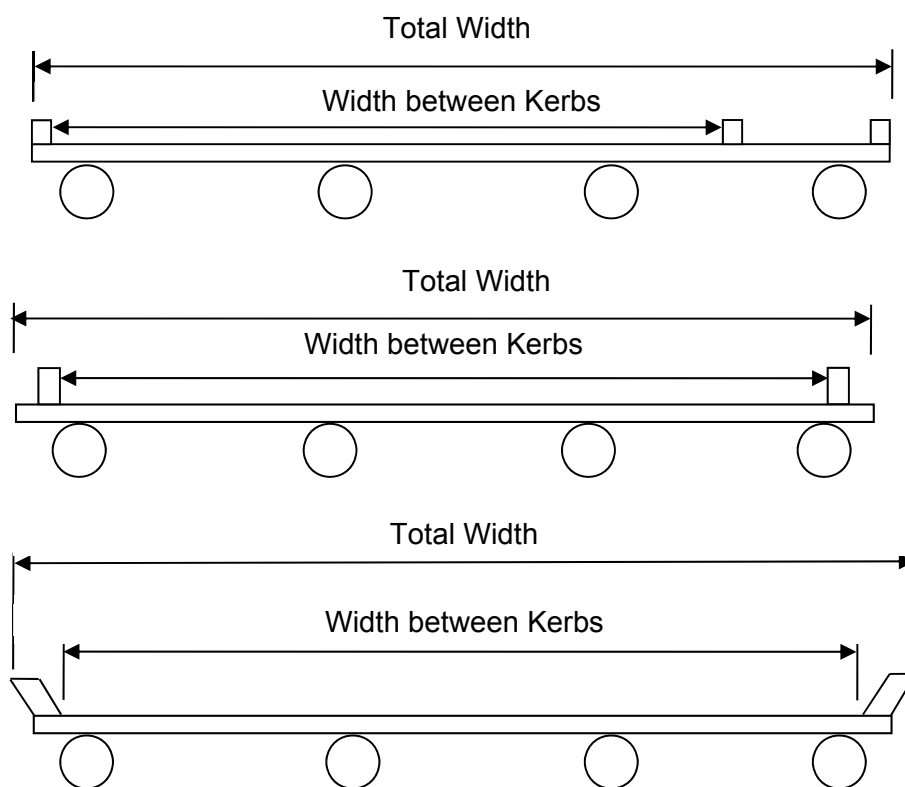
When the road has kerbs and no median or central barrier, the width is measured between the inside face of the LH kerb, across the road to the inside face of the RH kerb, measured perpendicular to the road and measured in metres to two decimal places. If a median or central barrier is present, the width between kerbs becomes the minimum width available for a vehicle, measured perpendicular to the road between the inside face of the kerb to the inside face of the median or barrier.

**Figure A.4 - BRIDGE WIDTH**

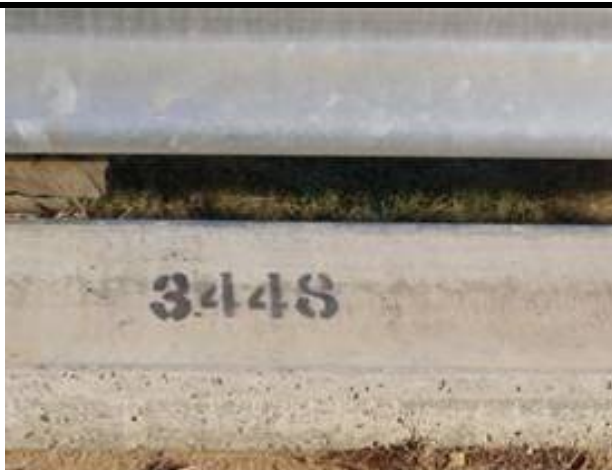
Photo 1 - Typical bridge number

Appendix B, Photos 1 and 2 show typical examples of the bridge number spray painted on the bridge.

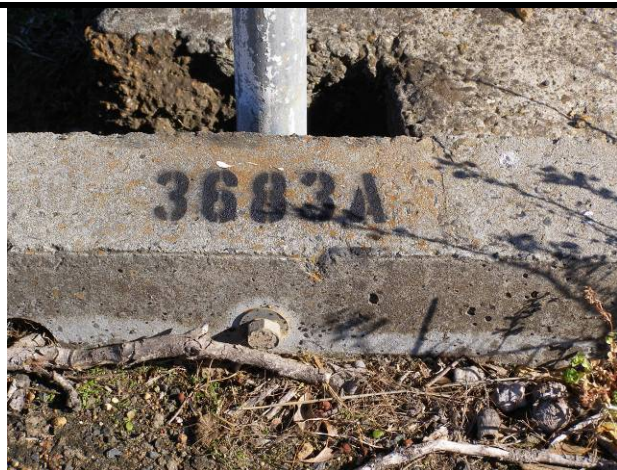
Photo 2 - Bridge number with suffix "A"

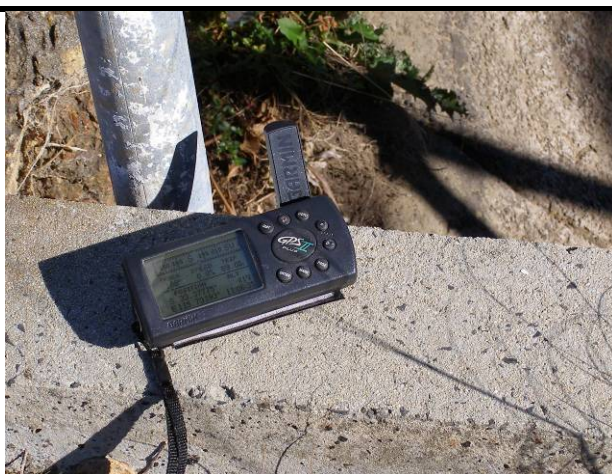
Photo 3 - Locating coordinates with a GPS at Abutment 1, LHS

Appendix B, Photo 3 indicates the usage of a GPS device to measure the coordinates of the bridge.

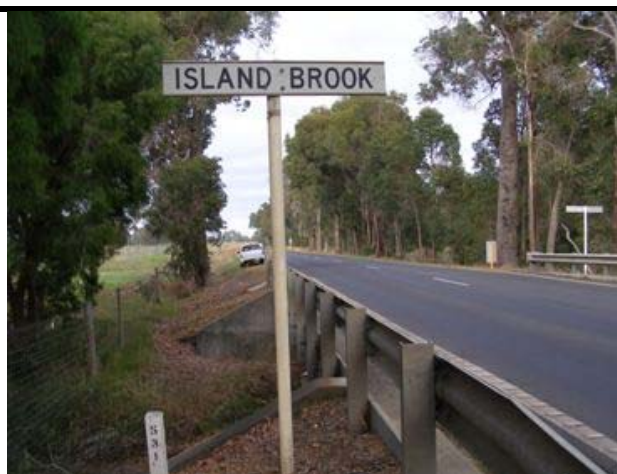
Photo 4 - Crossing name sign

Appendix B, Photo 4 shows a typical crossing sign.

Refer to Appendix B, Photo 4.

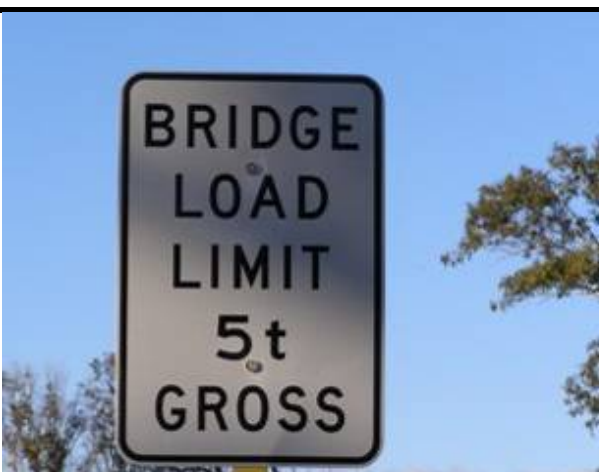
Photo 5 - Bridge load limit sign

Indicate the presence of a load limit sign at each end of the bridge and the value of the posted load limit in tonnes. Refer to Appendix B, Photo 5 for a typical bridge load limit sign.

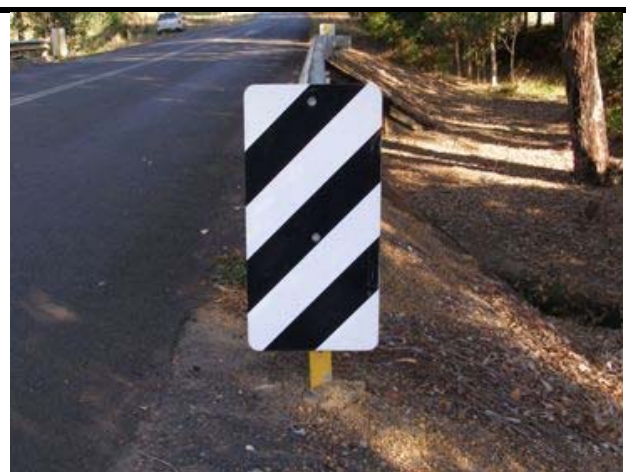
Photo 6 - Width marker in good condition

Refer to Appendix B, Photos 6 and 7 for typical width markers.

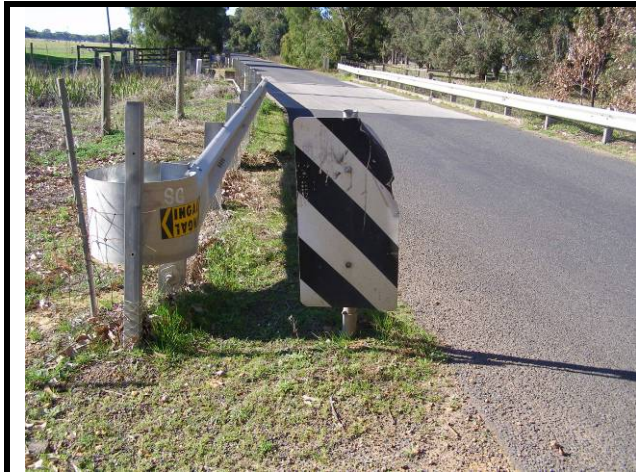
Photo 7 - Width marker in poor condition

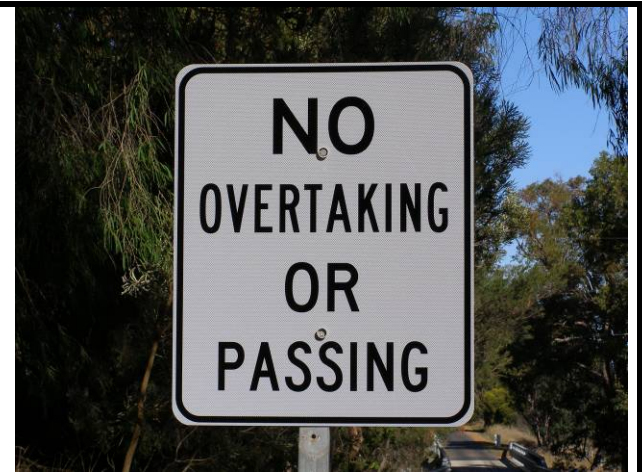
Photo 8 - No Overtaking or Passing sign

Refer to Appendix B, Photos 8 and 9 for some of the other signs that can found on the approach to a bridge.

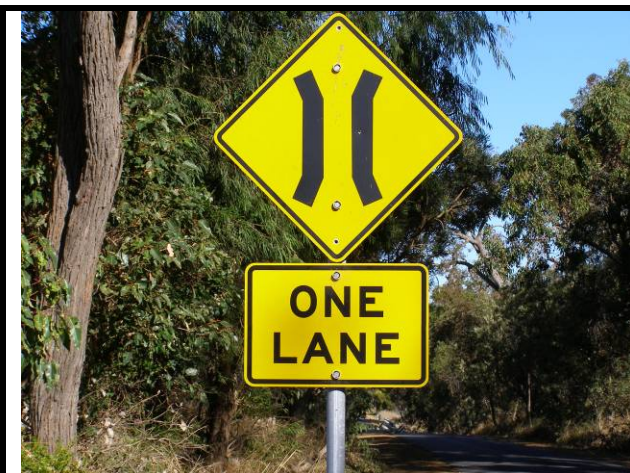
Photo 9 - One Lane bridge sign

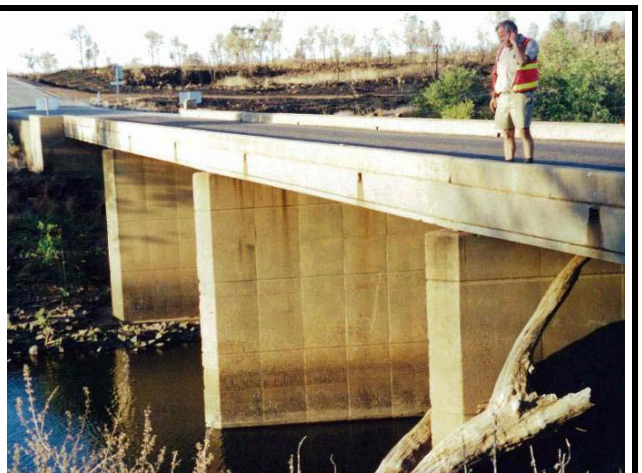
Photo 10 - Bridge with no railing

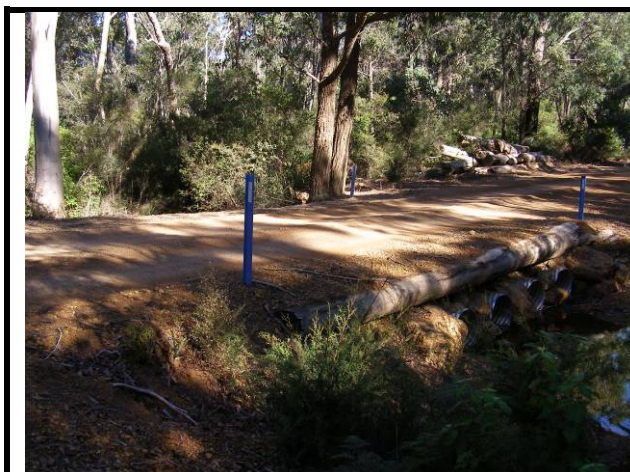
Photo 11 - Bridge with no railing

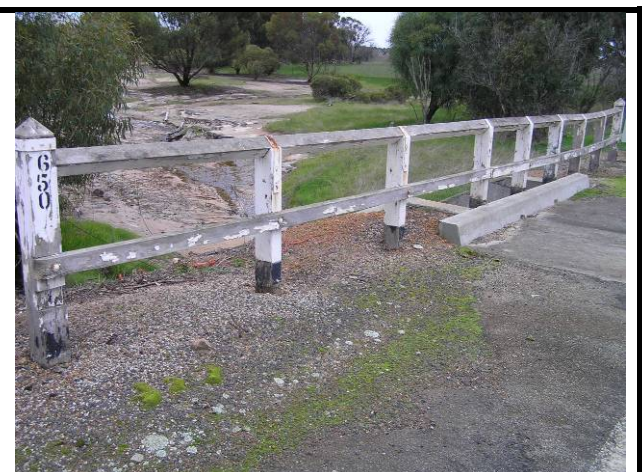
Photo 12 - Timber visibility barrier

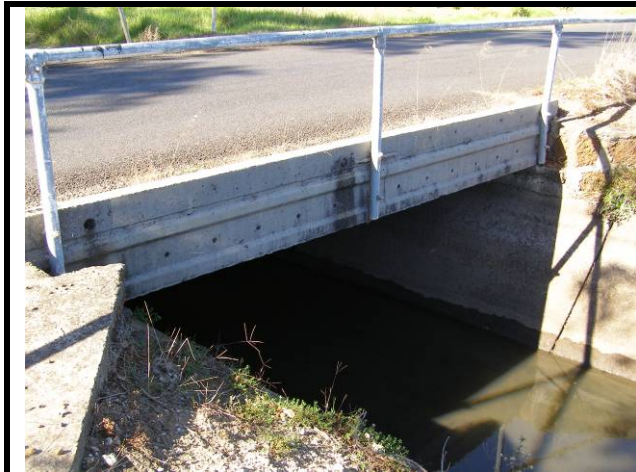
Photo 13 - Steel pipe visibility barrier

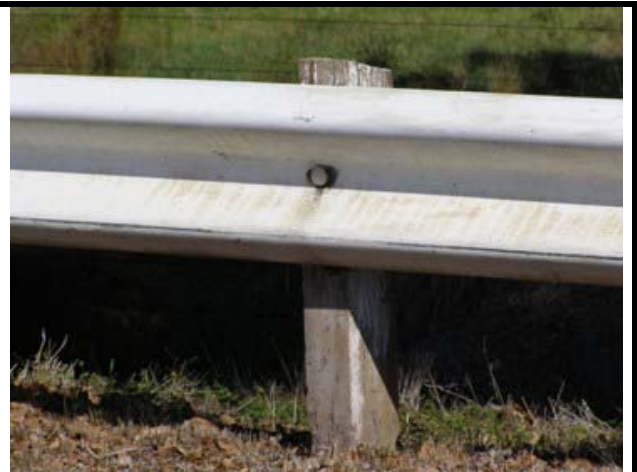
Photo 14 - Timber posts with W Beam barrier

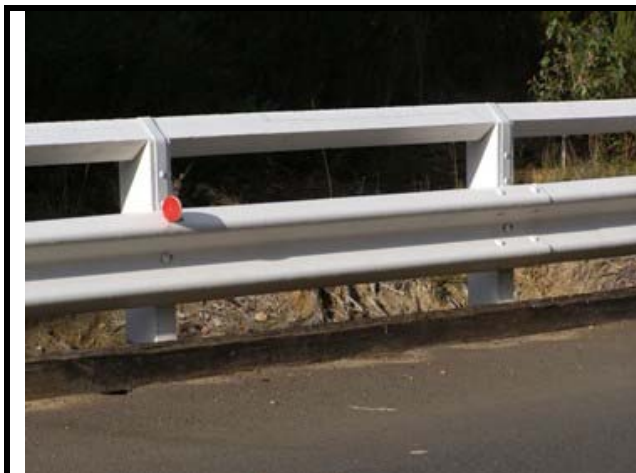
Photo 15 - Timber posts with W Beam barrier and timber top rail

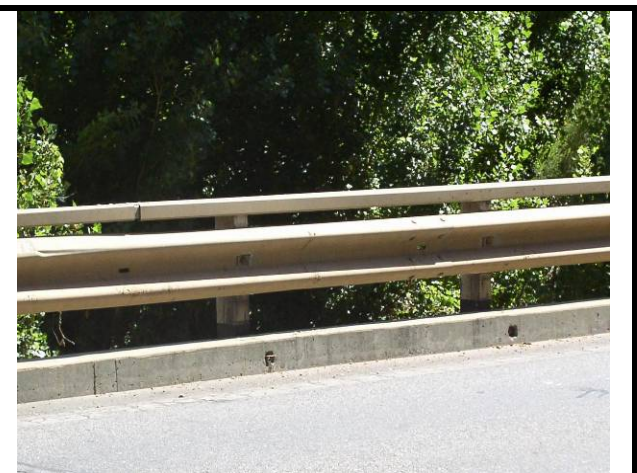
Photo 16 - Timber posts with W Beam barrier and steel top rail

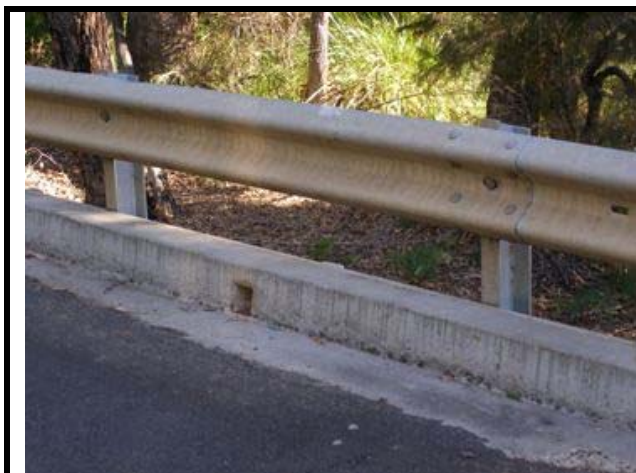
Photo 17 - Steel posts with W Beam barrier

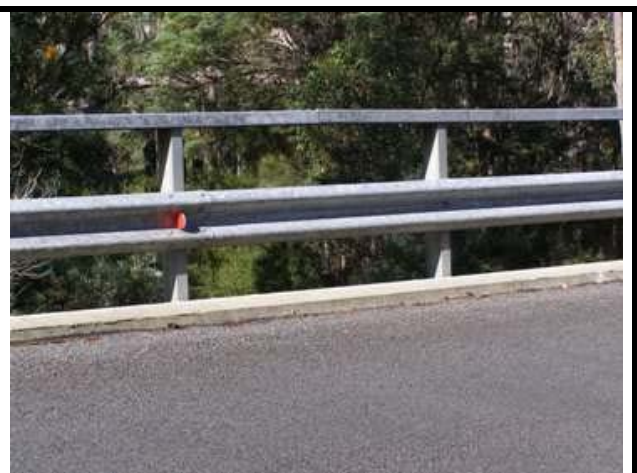
Photo 18 - Steel posts with W beam barrier and steel channel top rail

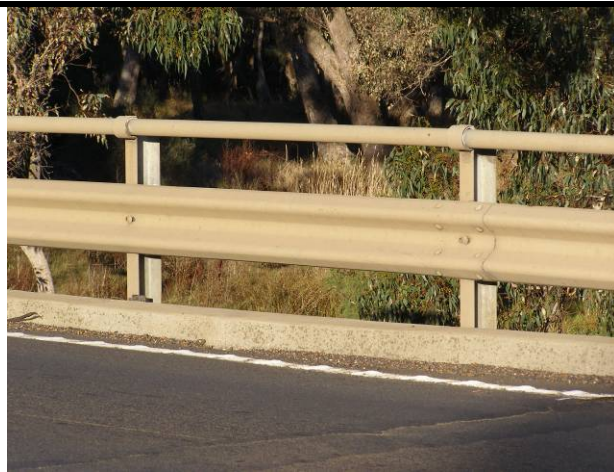
Photo 19 - Steel posts with W Beam barrier and steel pipe top rail

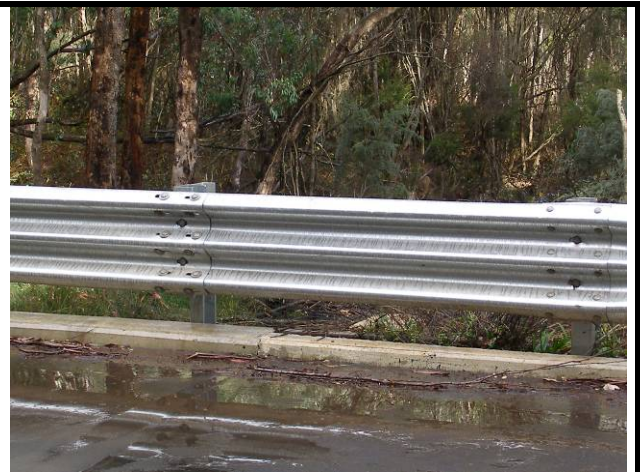
Photo 20 - Steel posts with Thriebeam barrier

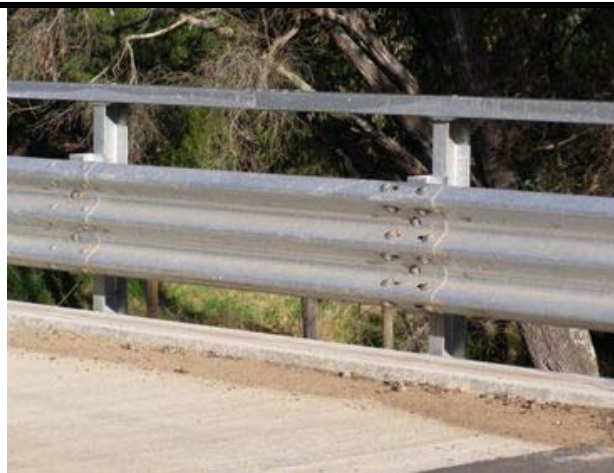
Photo 21 - Steel posts with Thriebeam barrier and steel channel top rail

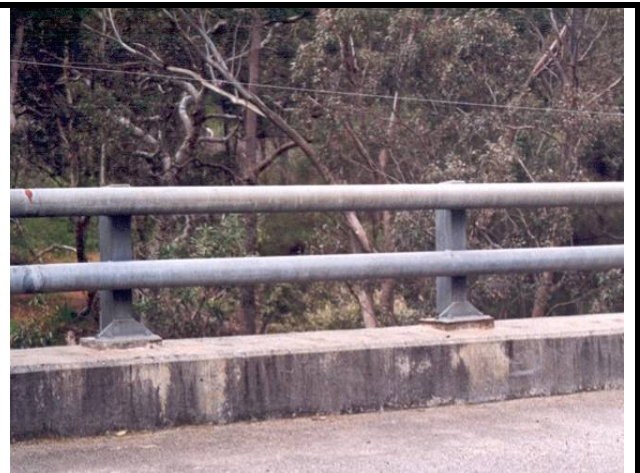
Photo 22 - Steel posts with 2 steel pipe visibility barrier

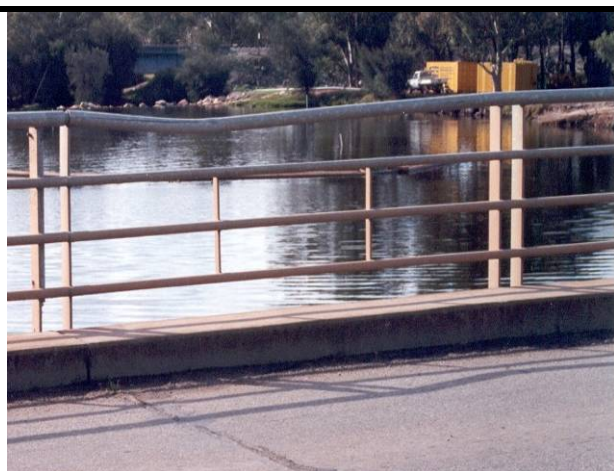
Photo 23 - Steel posts with 4 steel pipe visibility barrier

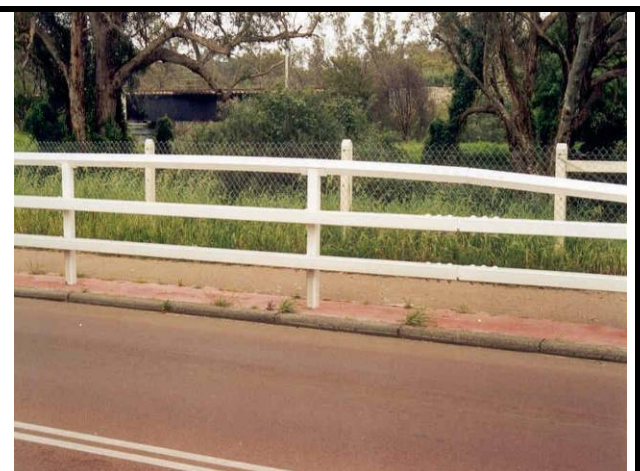
Photo 24 - Steel posts with 2 RHS rails and RHS "Diamond" top rail

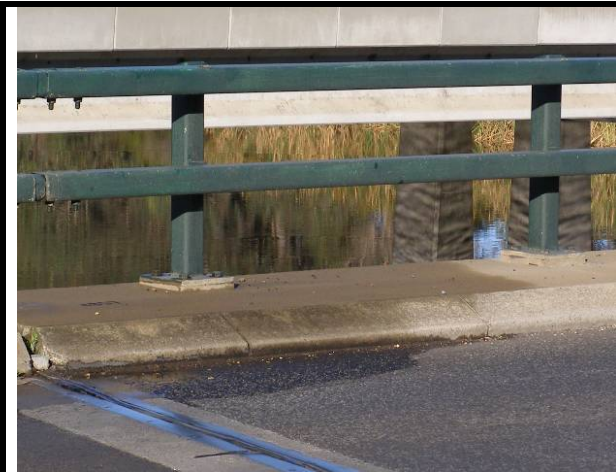
Photo 25 - Steel posts with 2 RHS rails

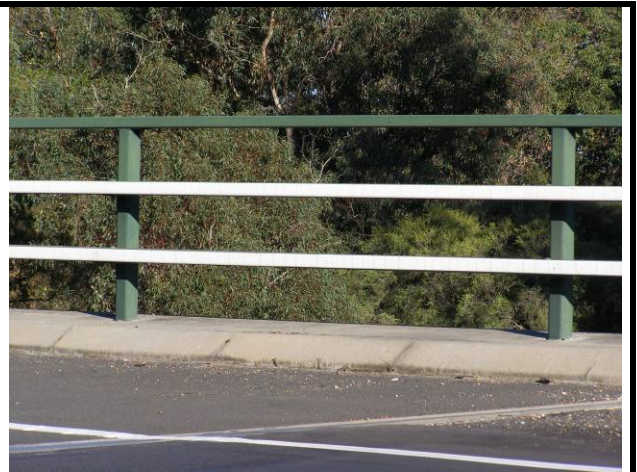
Photo 26 - Steel posts with 2 RHS rails and steel channel top rail

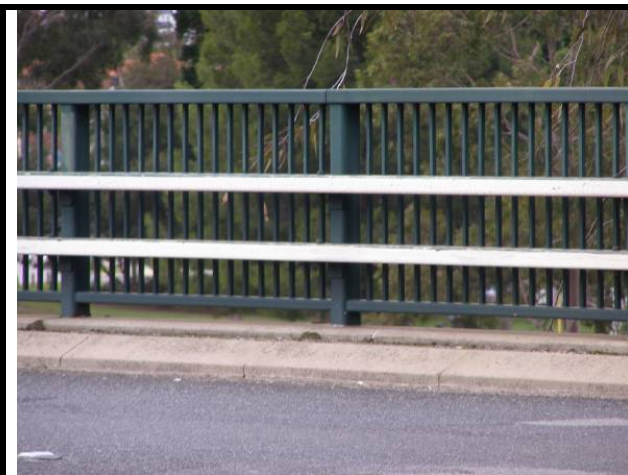
Photo 27 - Steel balustrade with RHS rails

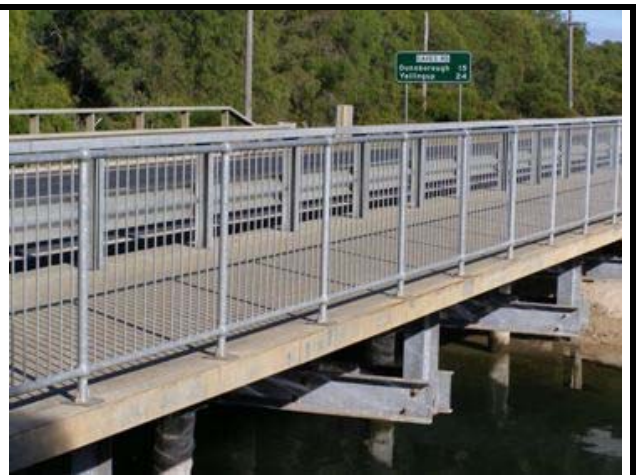
Photo 28 - Steel balustrade

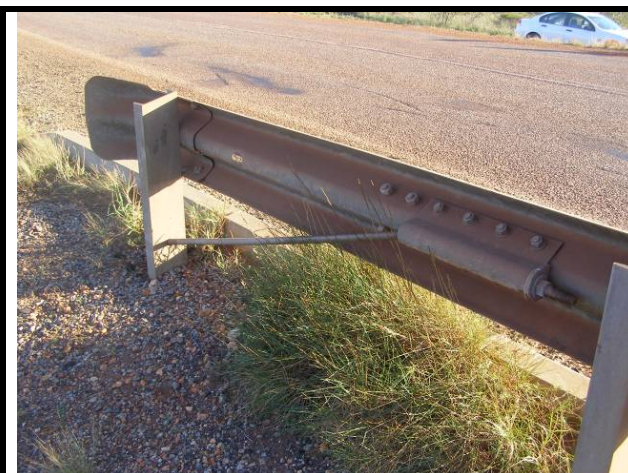
Photo 29 - Fishtail end terminal with tie rod

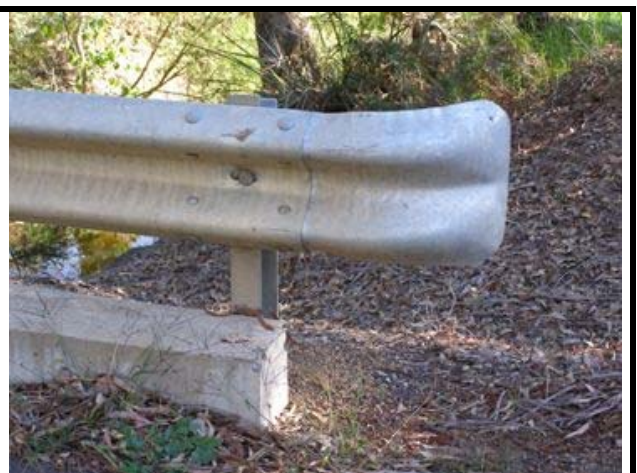
Photo 30 - Fishtail end terminal without tie rod

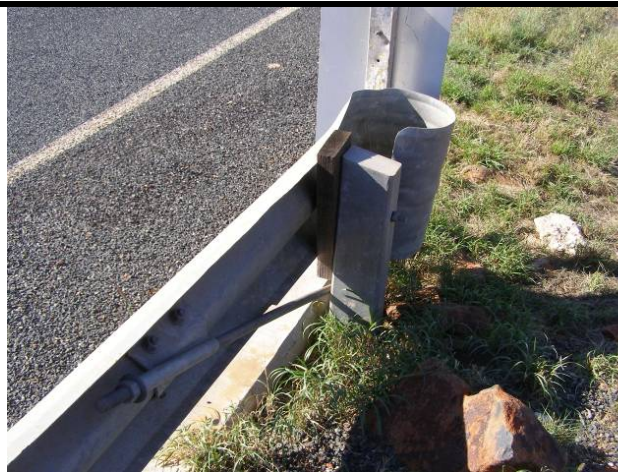
Photo 31 - Non-standard bullnose end terminal

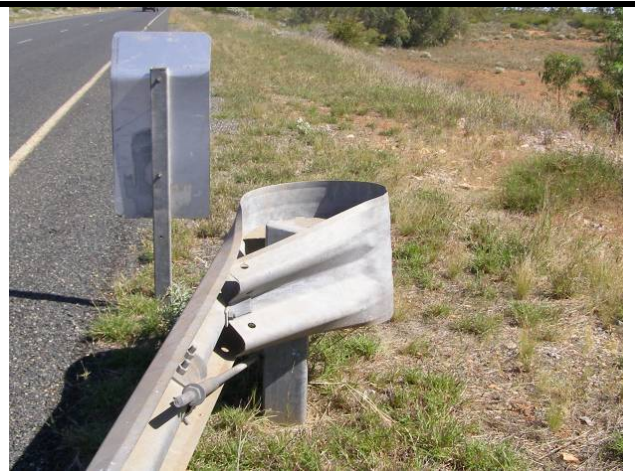
Photo 32 - Bullnose end terminal: w-end bolted (no diaphragm plates)

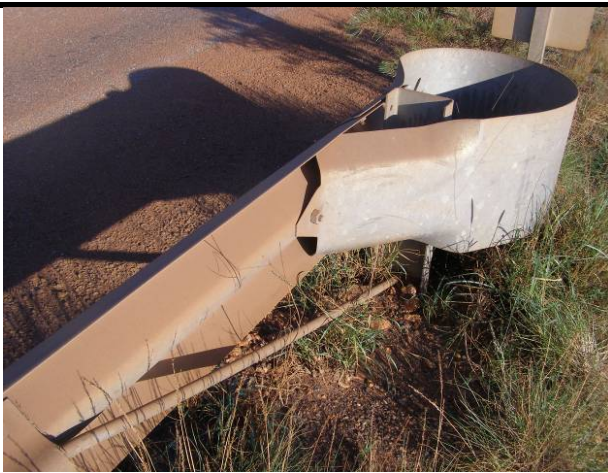
Photo 33 - Bullnose end terminal: flat end bolted (no diaphragm plates)

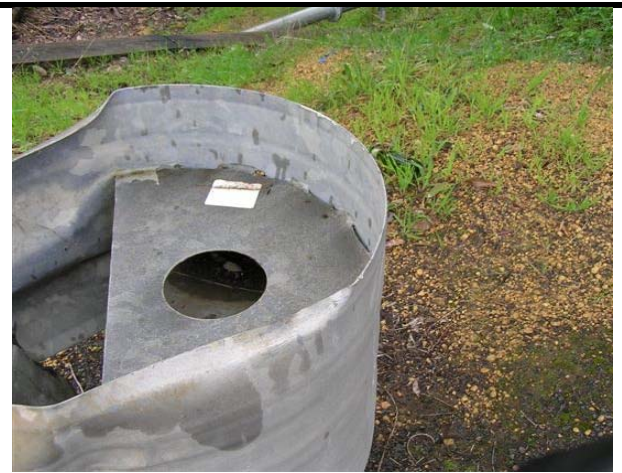
Photo 34 - Bullnose end terminal with 1 and 2 diaphragm plates

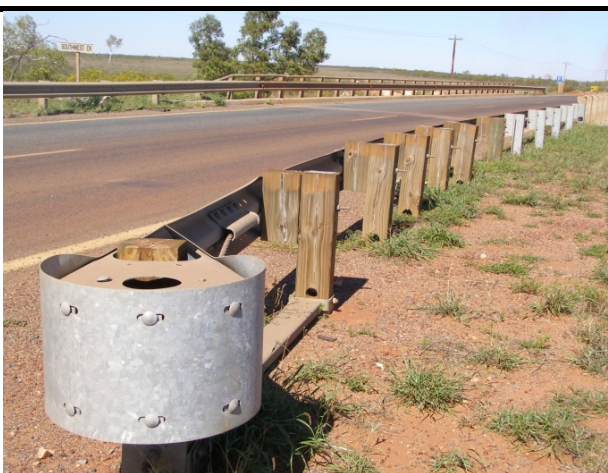
Photo 35 - WAMELT end terminal

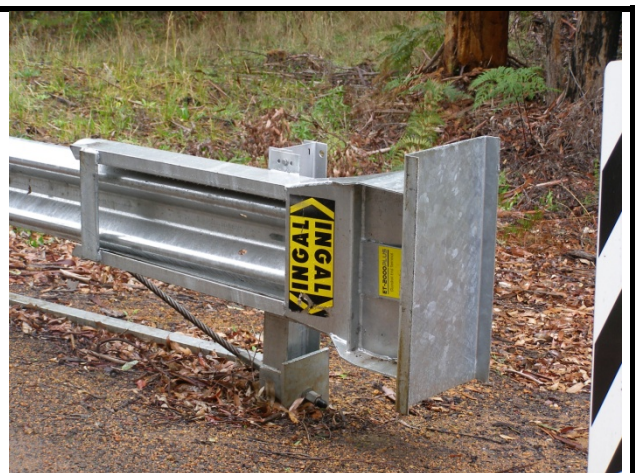
Photo 36 - ET2000 Plus end terminal

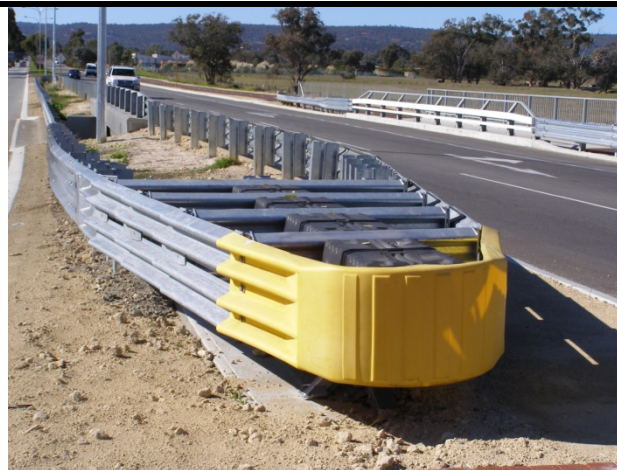
Photo 37 - Crash cushion end terminal

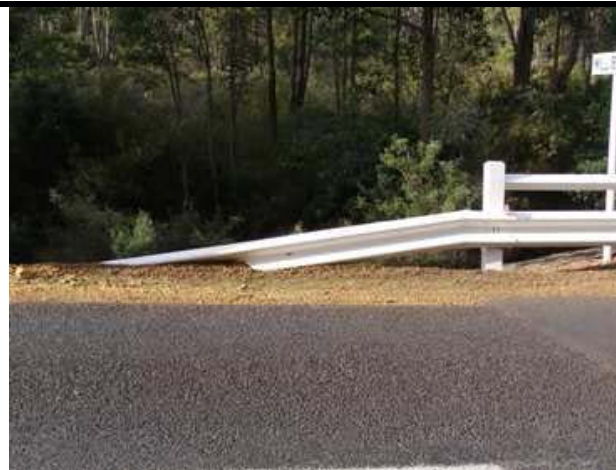
Photo 38 - Turn-down buried end terminal

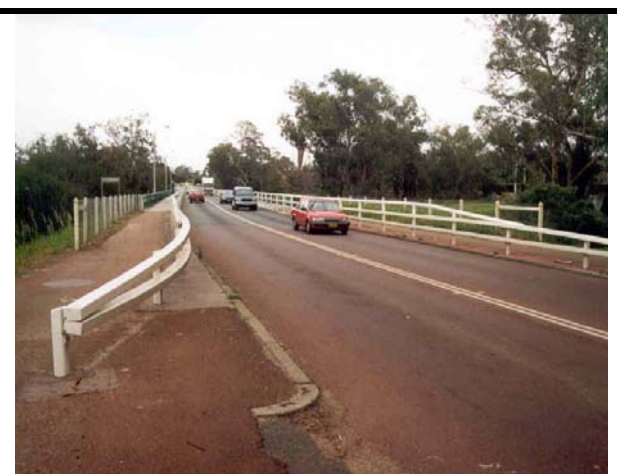
Photo 39 - Abrupt termination, no end terminal

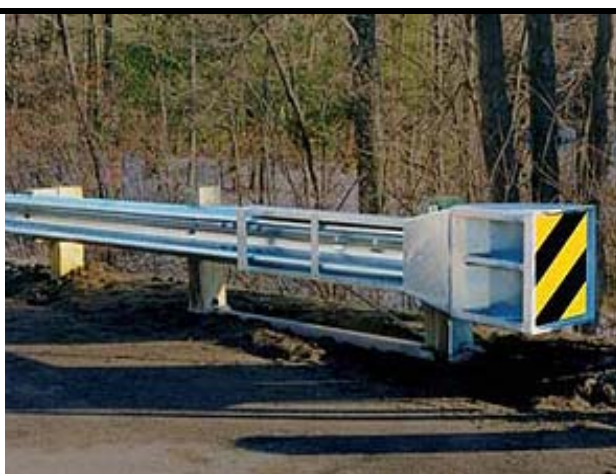
Photo 40 - SKT-350 end terminal

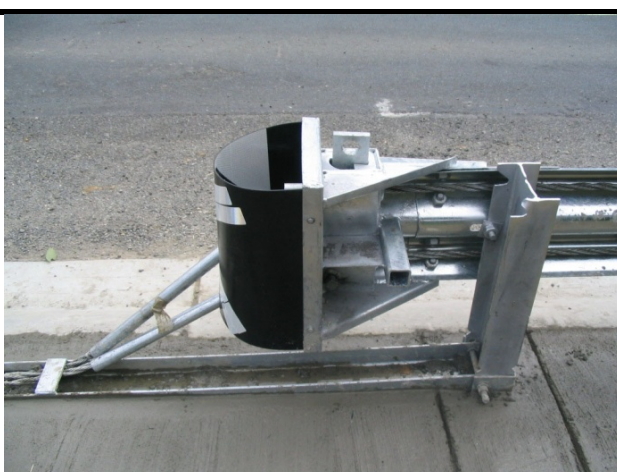
Photo 41 - X Tension (X-350) end terminal

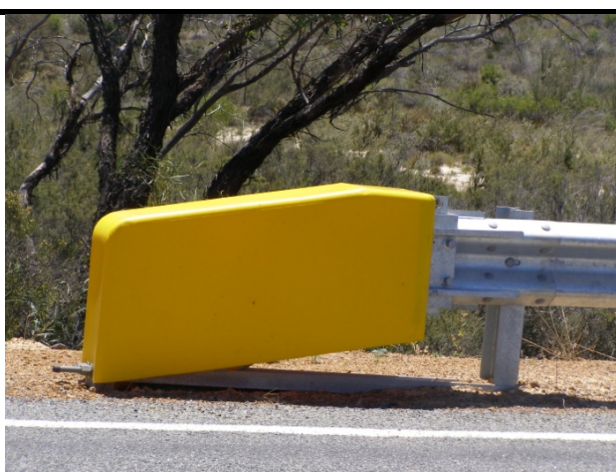
Photo 42 - X Tension (350) end terminal

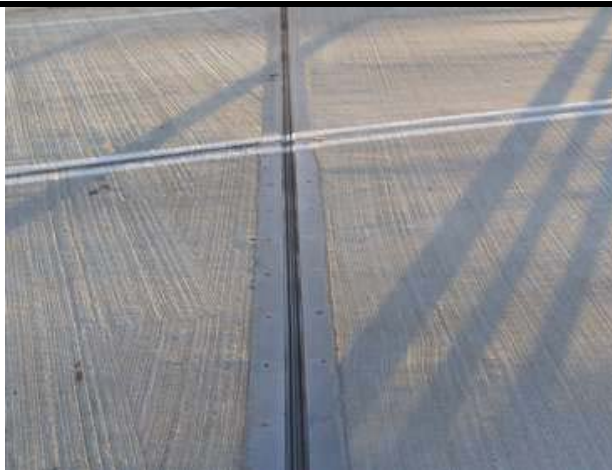
Photo 43 - Approach slab with compression seal expansion joint, e.g. Wabo

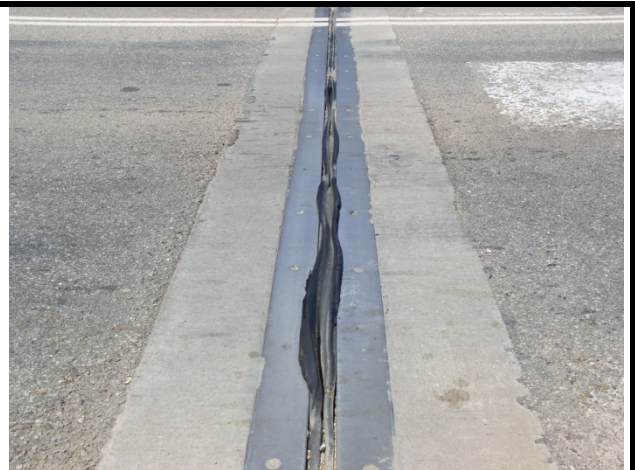
Photo 44 - Perished compression seal

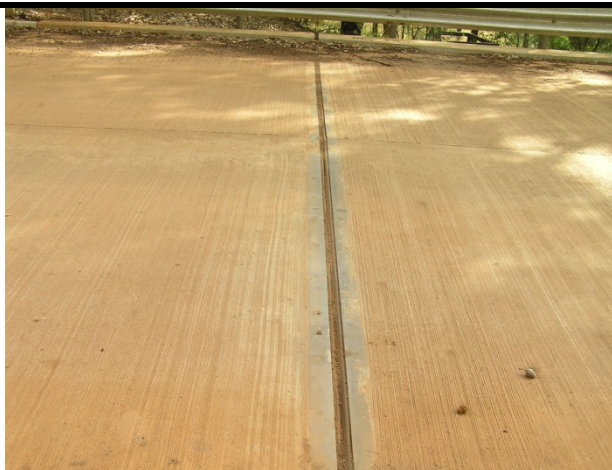
Photo 45 - Compression seal in good condition

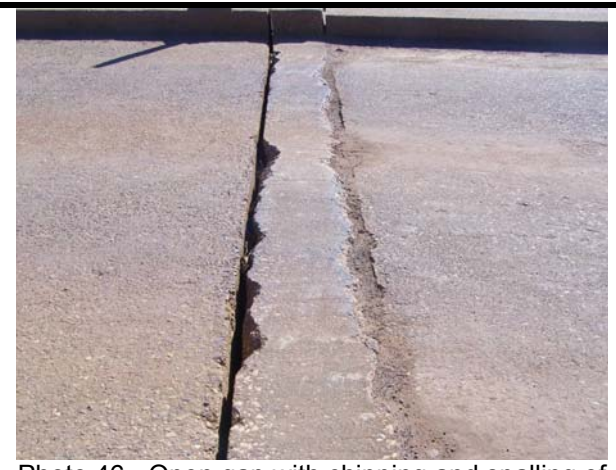
Photo 46 - Open gap with chipping and spalling of the joint

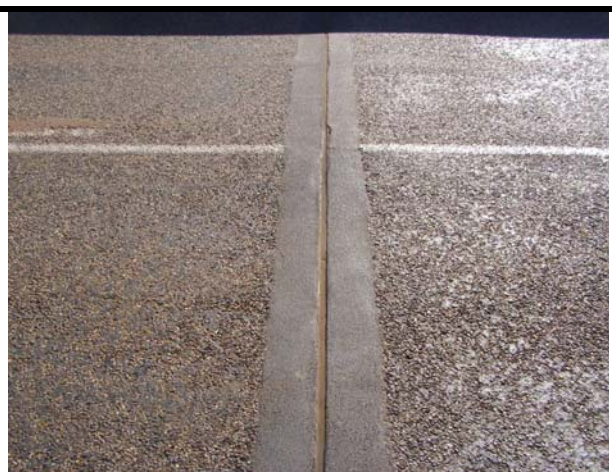
Photo 47 - Pourable joint with nosing

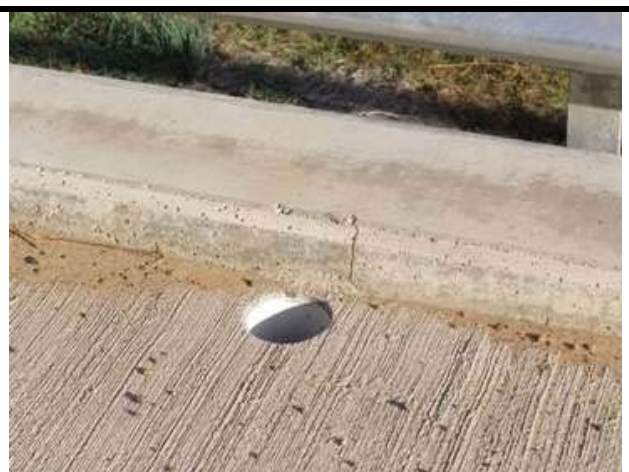
Photo 48 - PVC pipe scupper through deck

Refer to Appendix B, Photos 48 to 51 for typical examples.

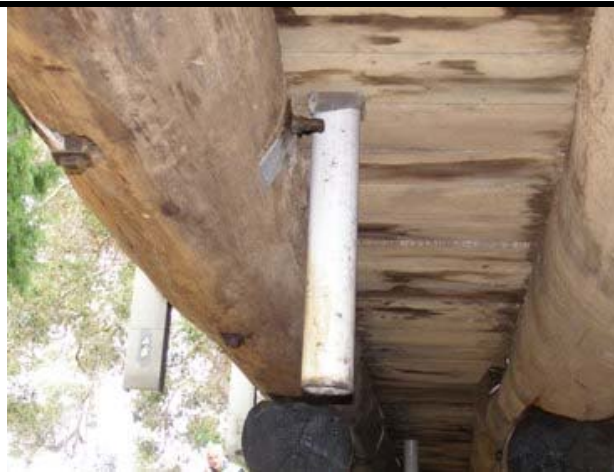
Photo 49 - PVC pipe scupper through deck, extending below stringer

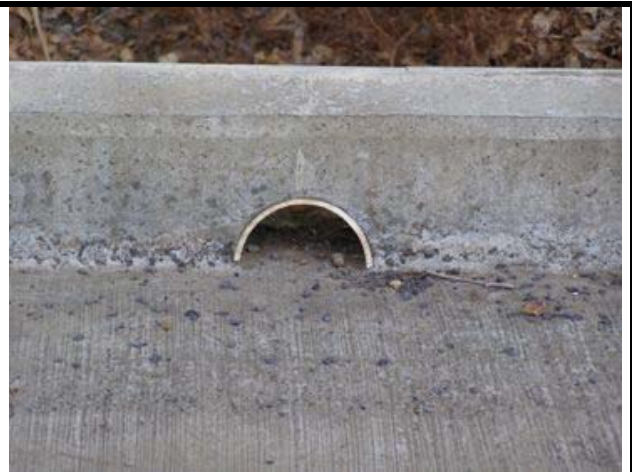
Photo 50 - Half PVC pipe scupper through kerb

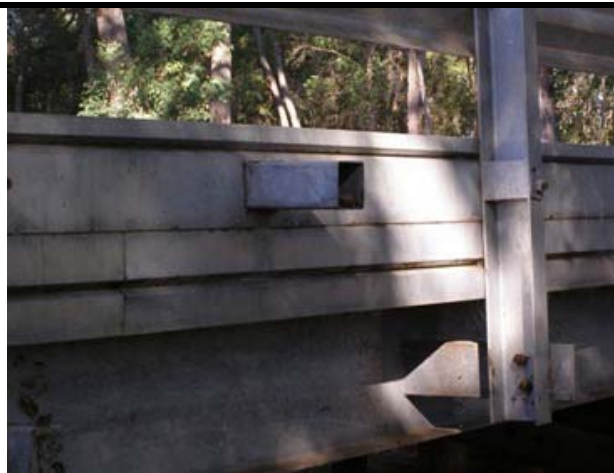
Photo 51 - Box scupper through kerb

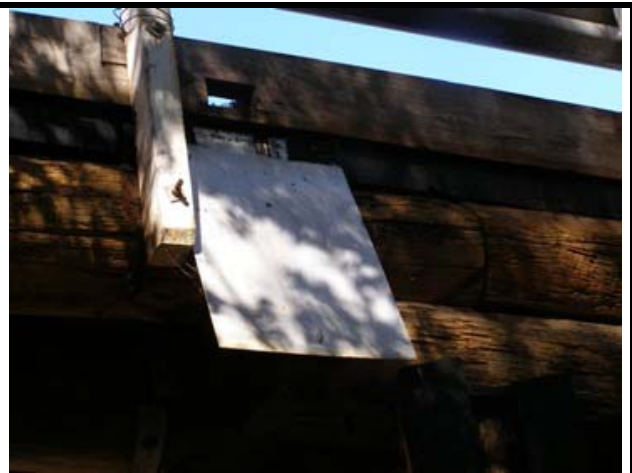
Photo 52 - Typical pressed galvanised iron flashing

Refer to Appendix B, Photos 52 and 53 for typical examples.

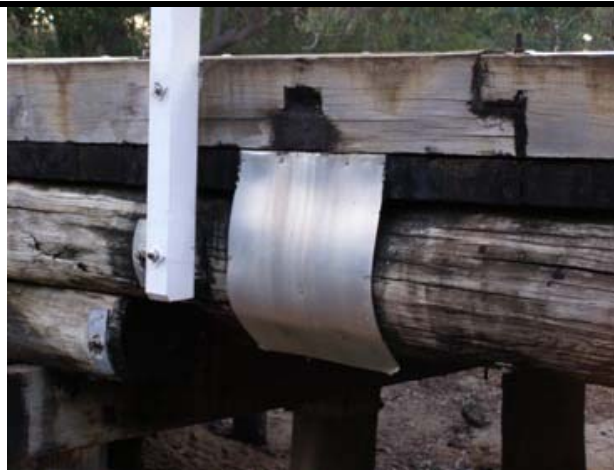
Photo 53 - Typical pressed galvanised iron flashing

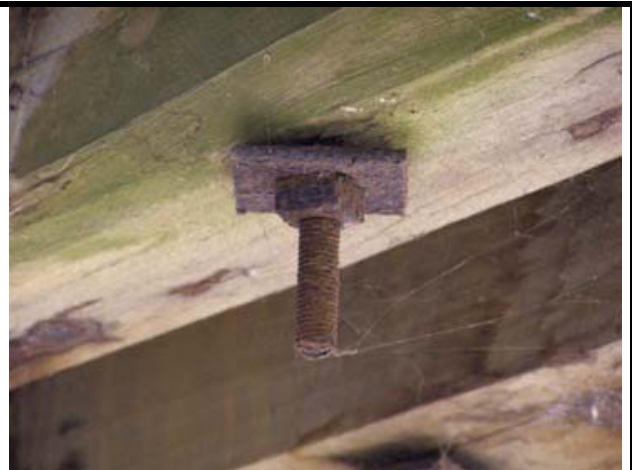
Photo 54 - Bolt tightening required

Refer to Appendix B, Photos 54 and 55 for typical loose bolts.

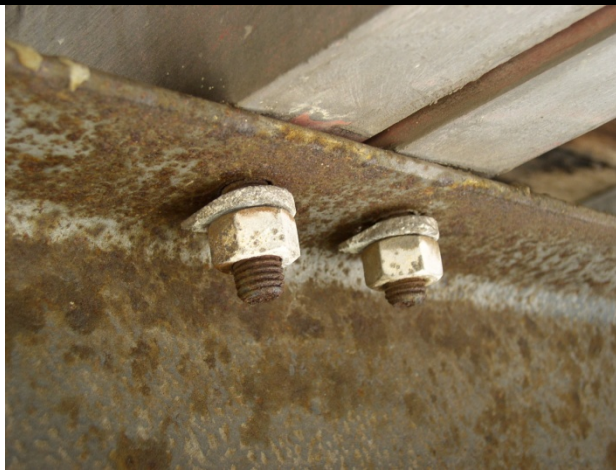
Photo 55 - Bolt tightening required

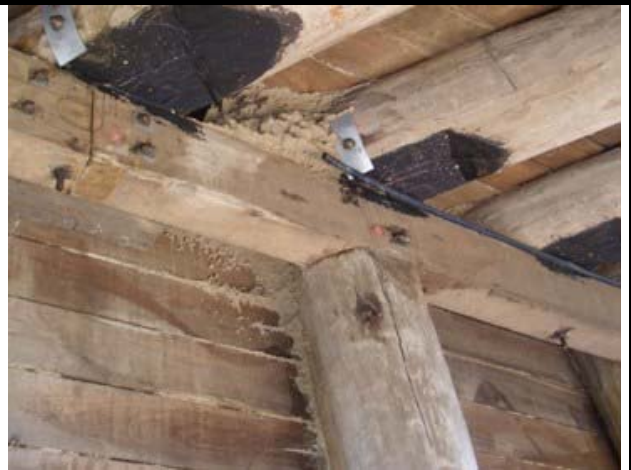
Photo 56 - Termite nest on top of halfcap and behind pile

Refer to Appendix B, Photos 56 to 58.

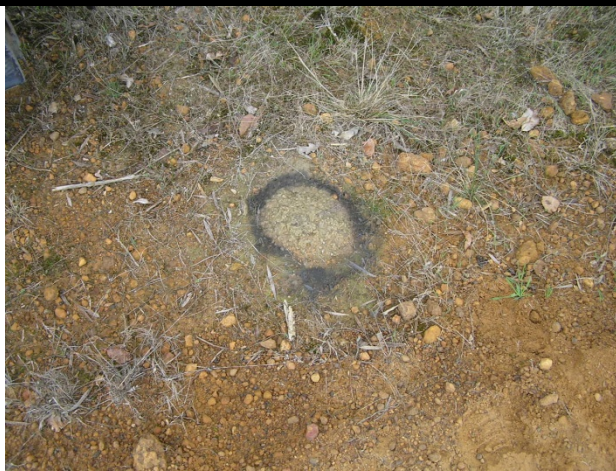
Photo 57 - Termite nest near bridge

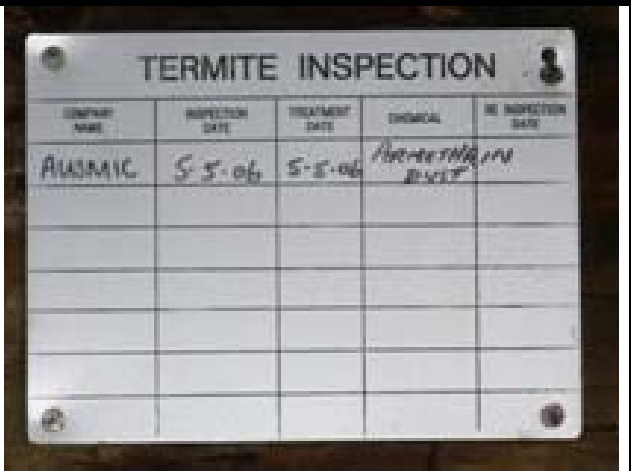
Photo 58 - Termite inspection plaque
