## Detailed Visual Bridge Inspection Guidelines for Timber Bridges (Level 2 Inspections)

Document No: 6706-02-2231

## **CONDITION ASSESSMENT – LEVEL 2 DETAILED VISUAL INSPECTION GUIDELINES FOR TIMBER BRIDGES**

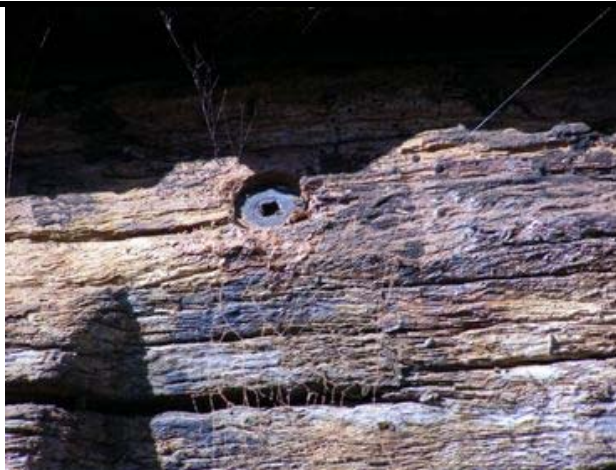
Photo 59 - Boracol plug in stringer

Refer to Appendix B, Photos 59 to 63 for typical preventative maintenance works undertaken.

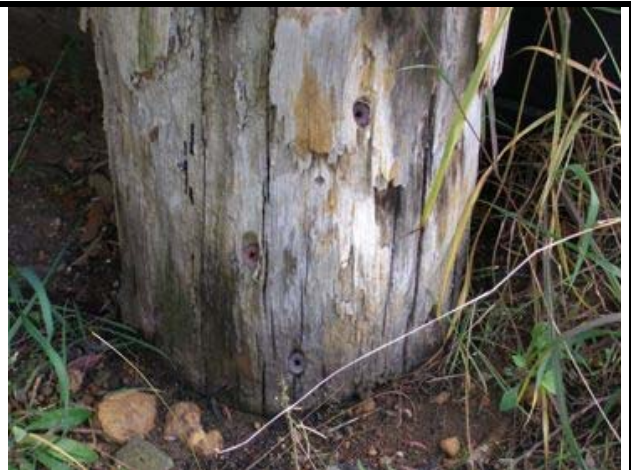
Photo 60 - Boracol plugs in piles

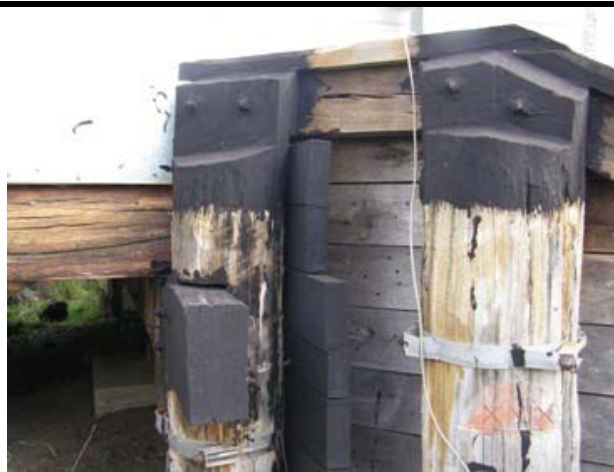
Photo 61 - Preventative end treatment to top of piles

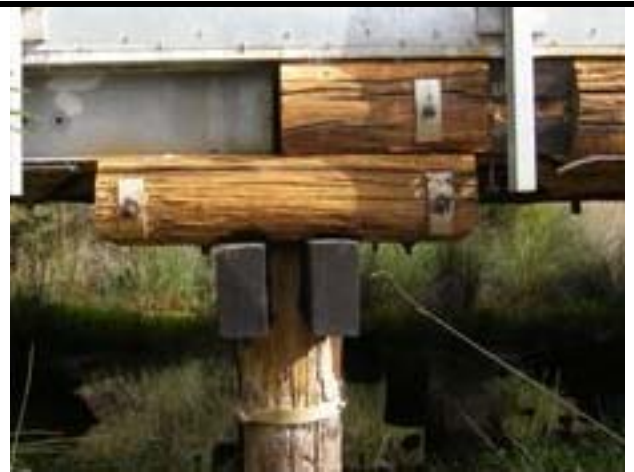
Photo 62 - Preventative treatment to timber components

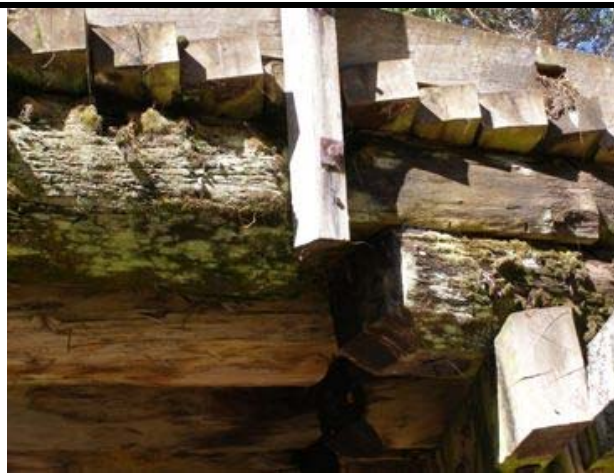
Photo 63 - Preventative treatment required  
Note: moss on side of stringer and corbel

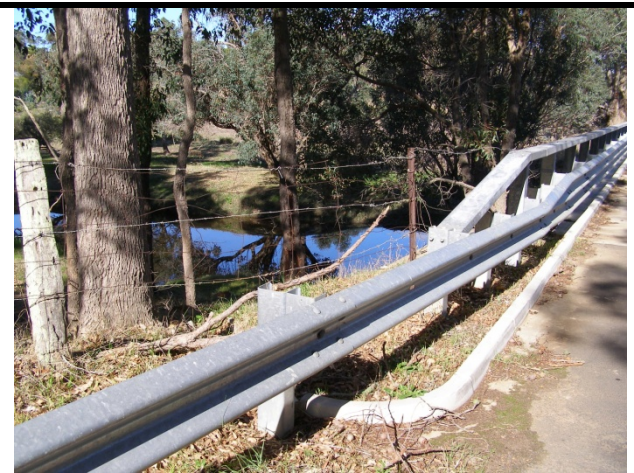
Photo 64 - Fence attached to bridge

Refer to Appendix B, Photos 64 to 67.

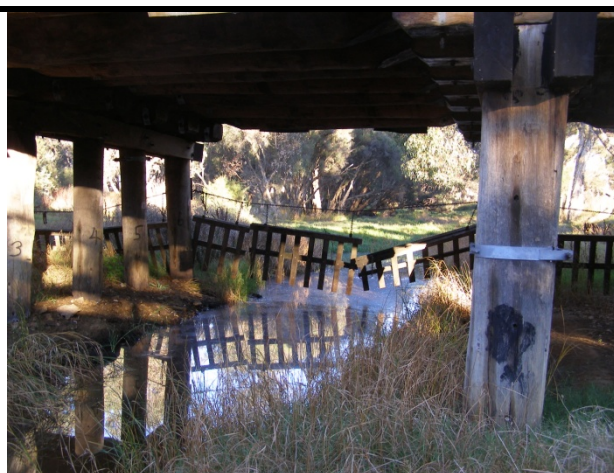
Photo 65 - Fence attached to bridge across waterway

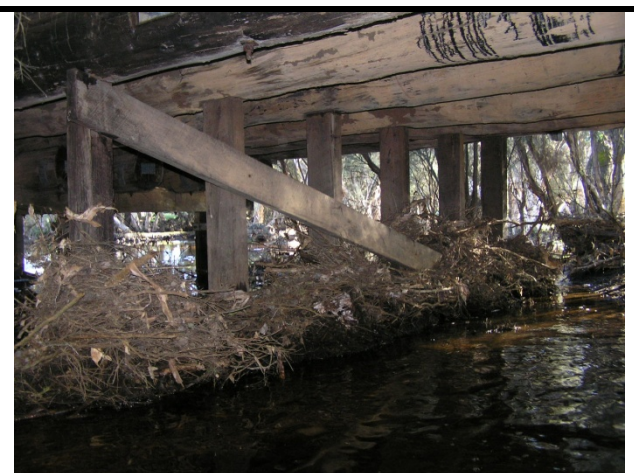
Photo 66 - Build-up of vegetation debris against piles

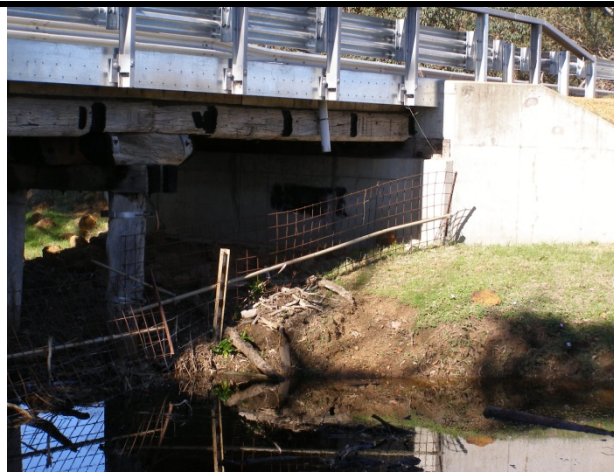
Photo 67 - Fence alongside bridge restricting easy access

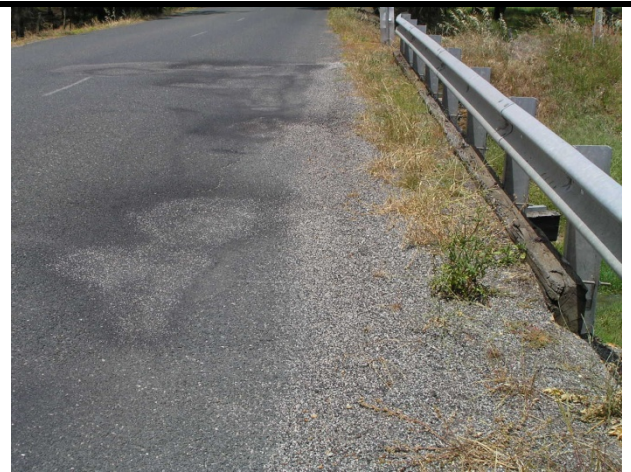
Photo 68 - Typical "fair" road surface

Refer to Appendix B, Photos 68 and 69.

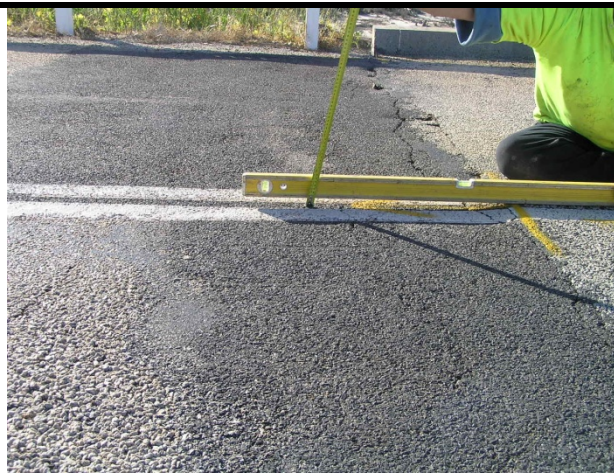
Photo 69 - Approach road settlement

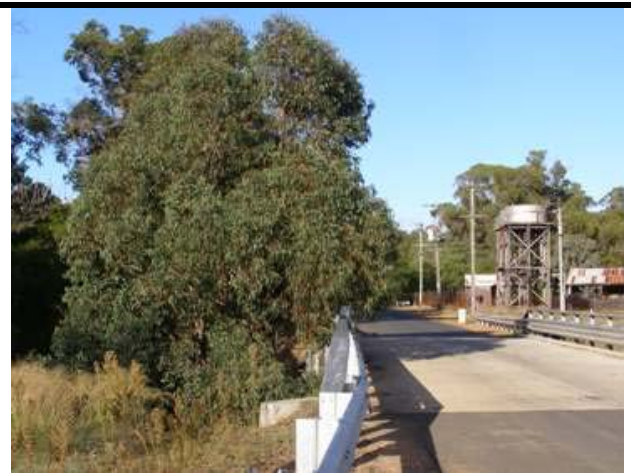
Photo 70 - Tree growing too close to the bridge

Refer to Appendix B, Photos 70 and 71.

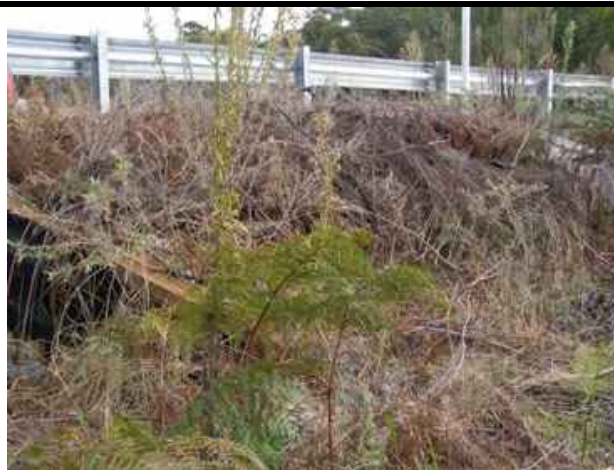
Photo 71 - Dried tree prunings are a fire hazard

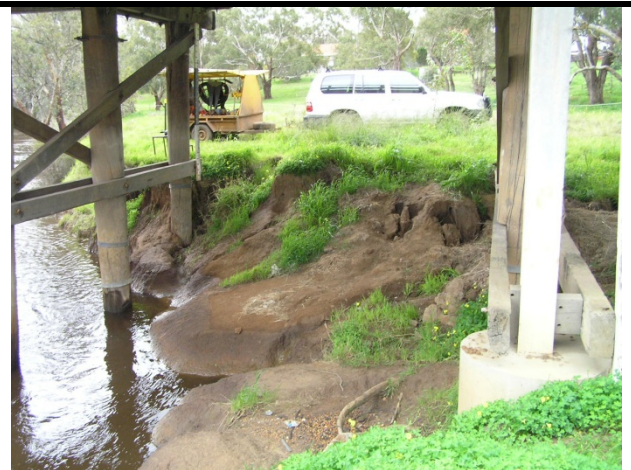
Photo 72 - Bank erosion

Refer to Appendix B, Photos 72 and 73.

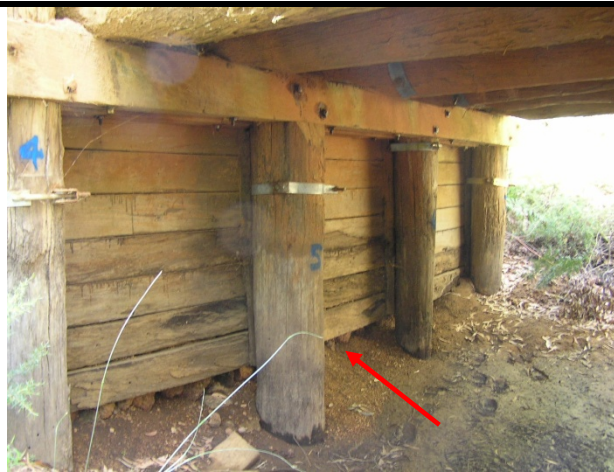
Photo 73 - Scour at Abutment 2

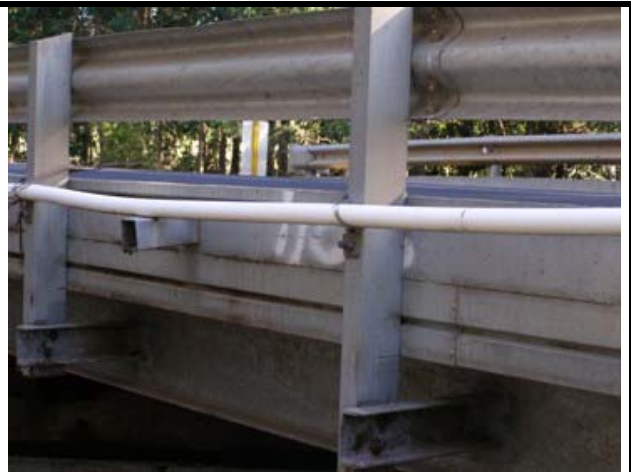
Photo 74 - Telecom pipe attached to the LHS side of the bridge

Refer to Appendix B, Photos 74 and 75.

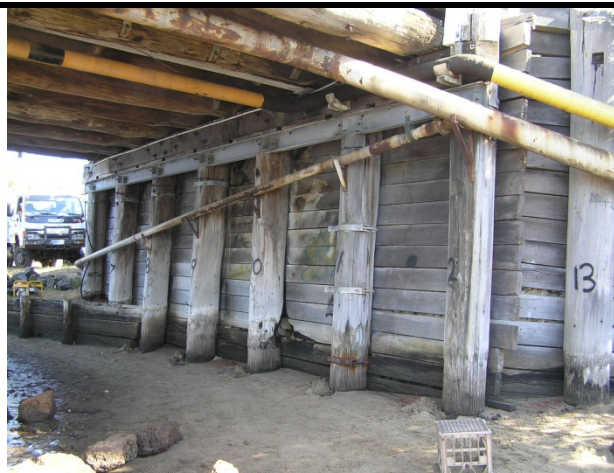
Photo 75 - Various services

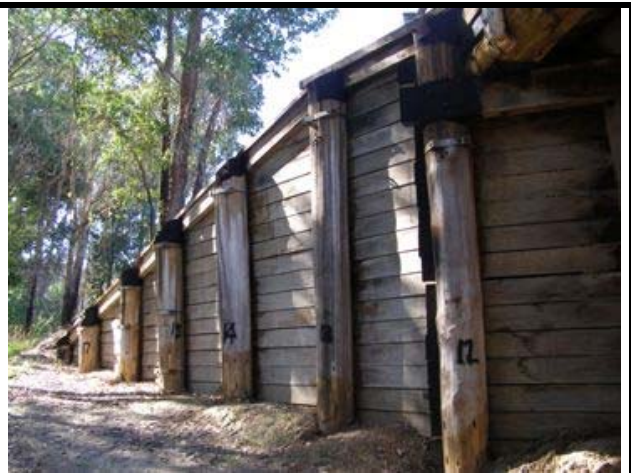
Photo 76 - Typical wing wall piles, Abutment 1, RHS

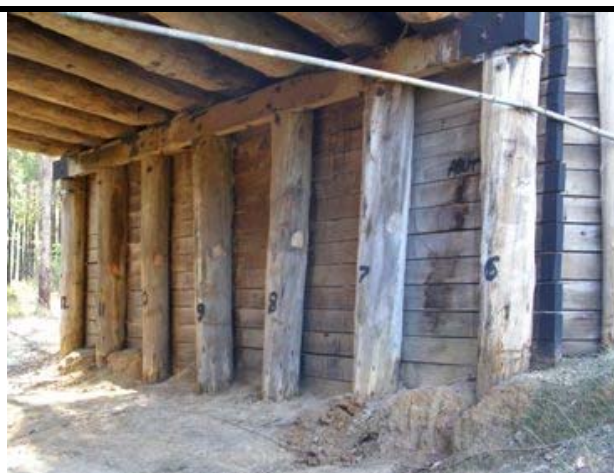
Photo 77 - Typical abutment piles, Abutment 1

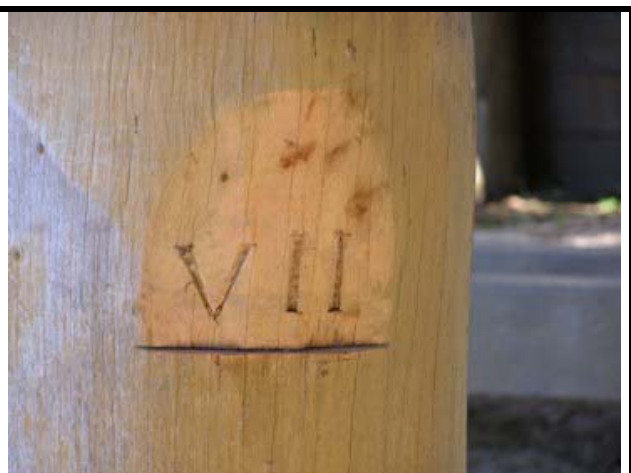
Photo 78 - Driven depth mark (blaze)

Refer to Appendix B, Photos 78 and 79 for examples.

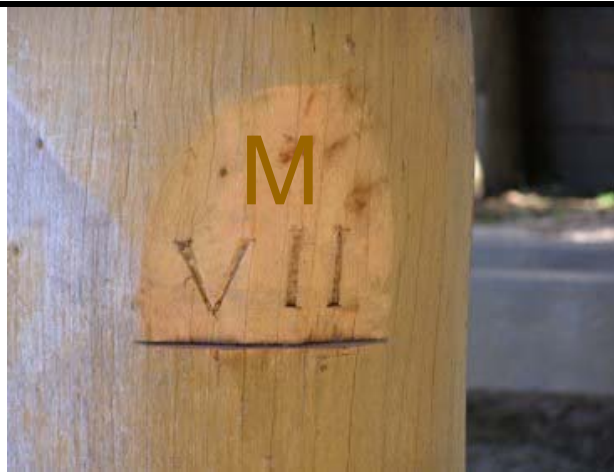
Photo 79 - Blaze marking with "M" above is measured in metres

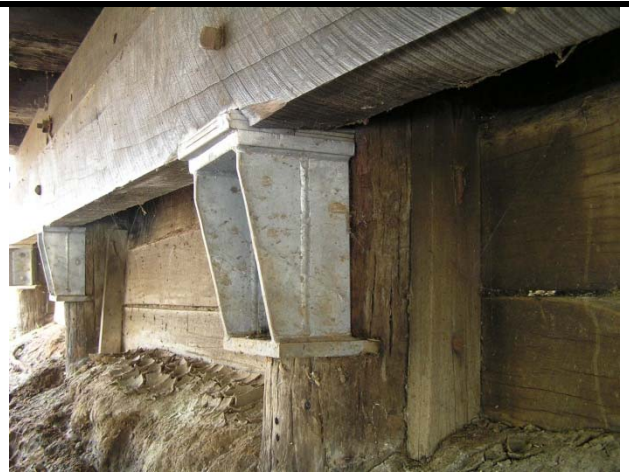
Photo 80 - Steel support bracket for halfcap

Refer to Figure A.28 for explanation of various scenarios of halfcap bearings that can be encountered. In the instances where there are two halfcaps (typically steel below timber) both the steel and timber halfcap bearing is required to be measured if the steel bearing value is less than 50 mm. Refer to Appendix B, Photos 80 and 81 for examples of steel halfcap support brackets.

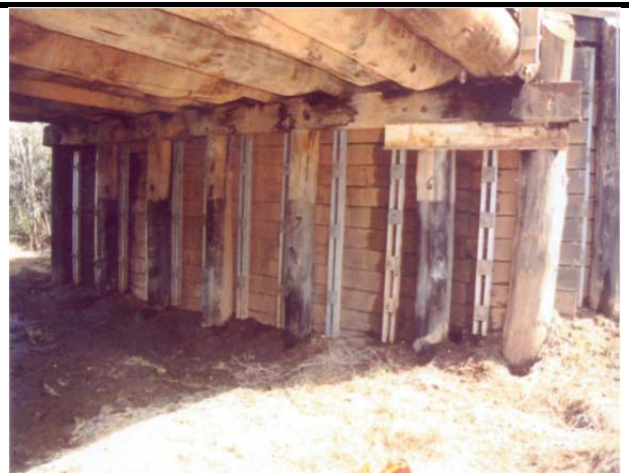
Photo 81 - Steel support bracket for halfcap

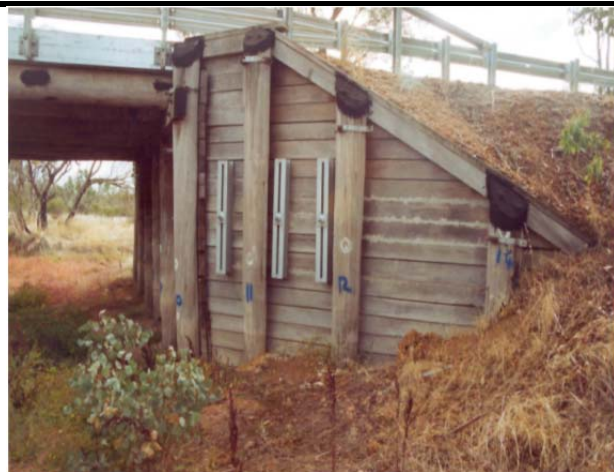
Photo 82 - Tie back bolts in abutment

Refer to Appendix B, Photos 82 and 83 for examples.

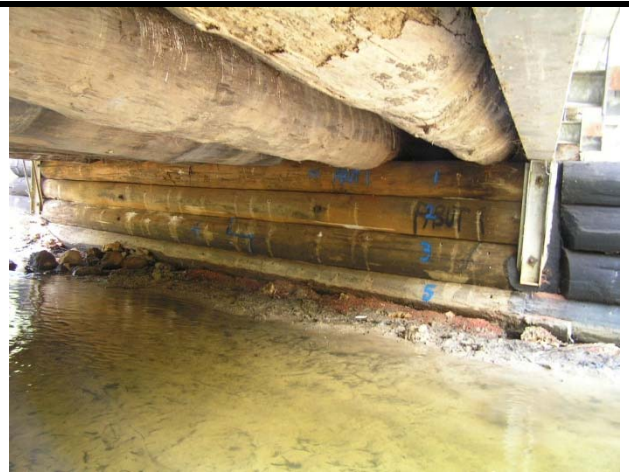
Photo 83 - Tie back bolts in wing wall

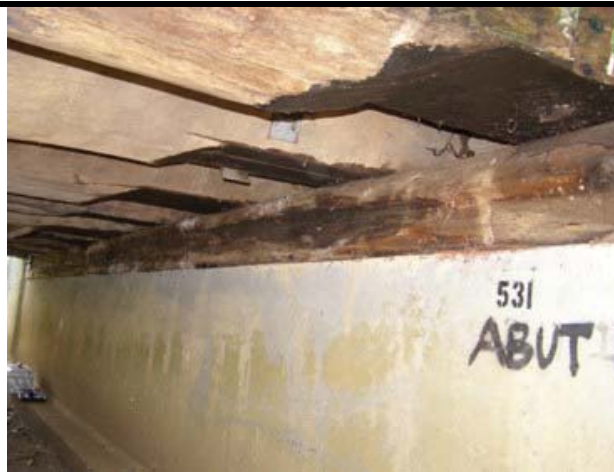
Photo 84 - Typical bedlog abutment

Refer to Appendix B, Photo 84 for a typical bedlog abutment.

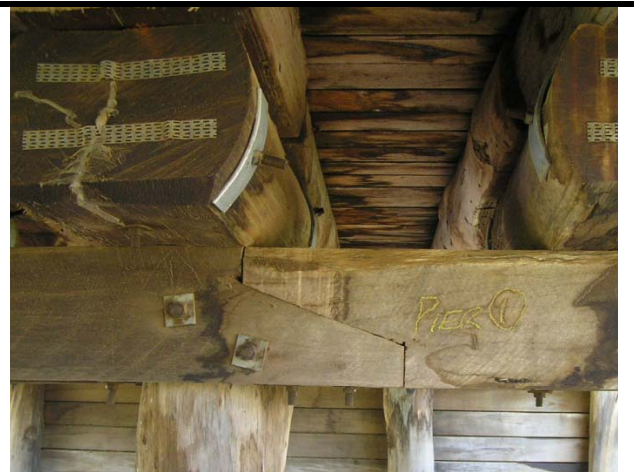
Photo 85 - Typical sill beam abutment

Refer to Appendix B, Photo 85 for a typical example of a sill beam abutment.

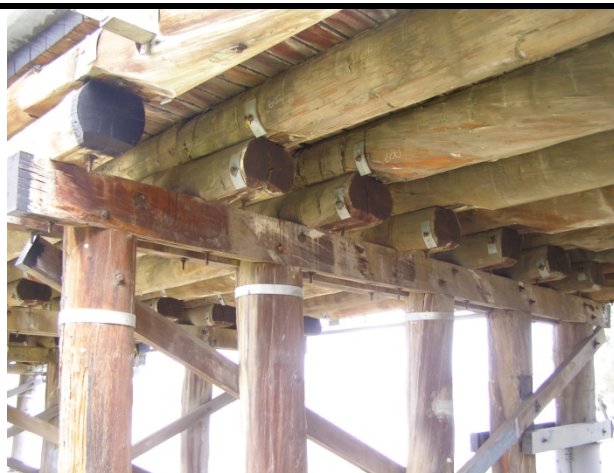
Photo 86 - Typical halfcap joint

Refer to Appendix B, Photos 86 to 88 and Figure A.41 for examples.

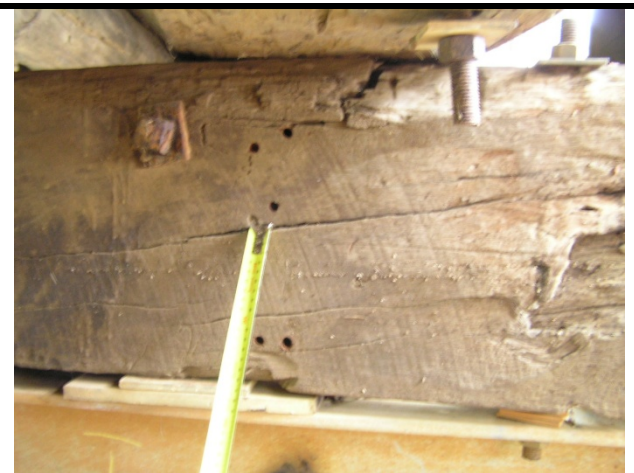
Photo 87 - Overall view of a halfcap

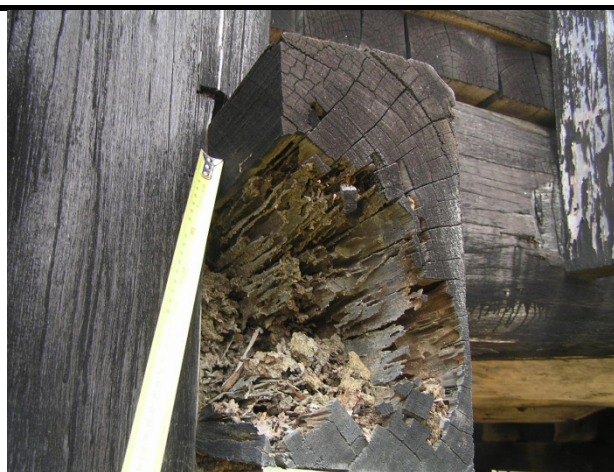
Photo 88 - Horizontal and vertical splits in a halfcap

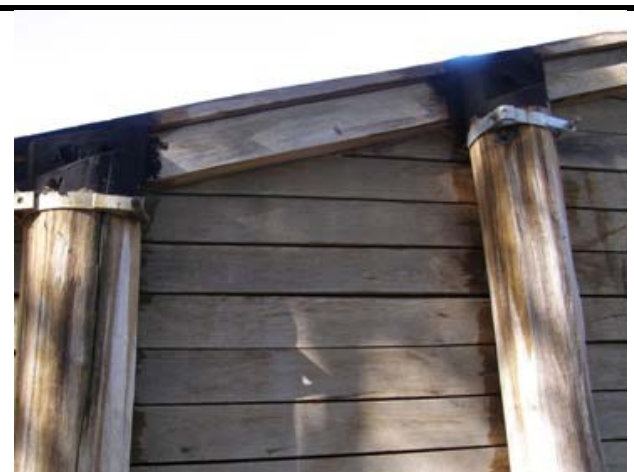
Photo 89 - Rotten halfcap end

These larger sketch boxes indicate the four ends of the halfcaps and are used to show where the splits and rotten areas of the halfcap are located. Refer to Appendix B, Photo 89 and Figure A.42 for examples.

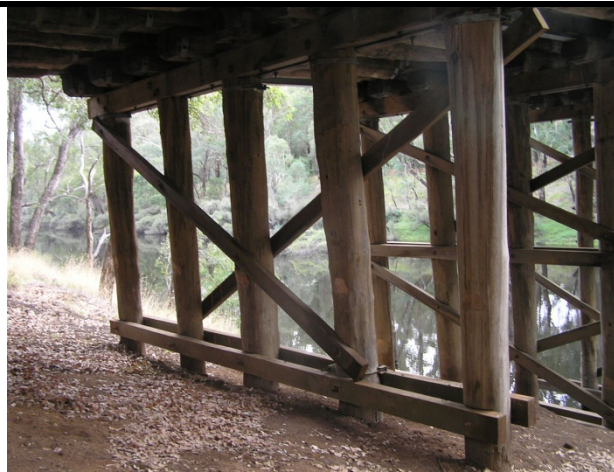
Photo 90 - Typical wing wall timber sheeting

Draw and label the approximate position of the piles. Also draw a representation of the location and extent of any rot zones present in the sheeting. Modify the diagrams provided as necessary to clearly represent the shape and relationship of elements, e.g. truncate concrete at the wing walls or add extra sheeting lines as required. Refer to Appendix B, Photo 90 and Figure A.43.

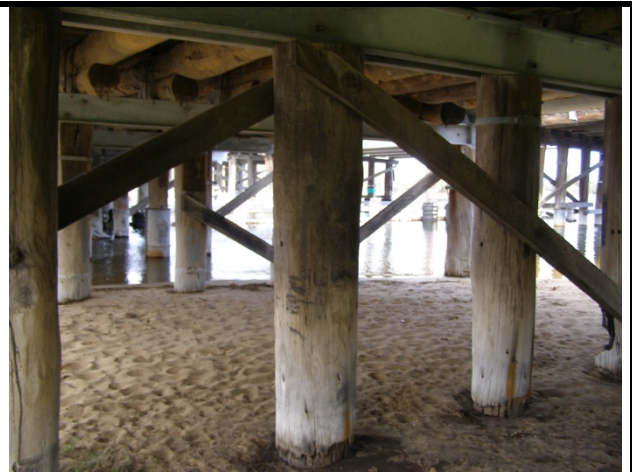
Photo 91 - Typical timber pier

Indicate the pier number being assessed. Piers are numbered in ascending order from Abutment 1 to Abutment 2. Refer to Appendix B, Photo 91 for a typical timber pier.

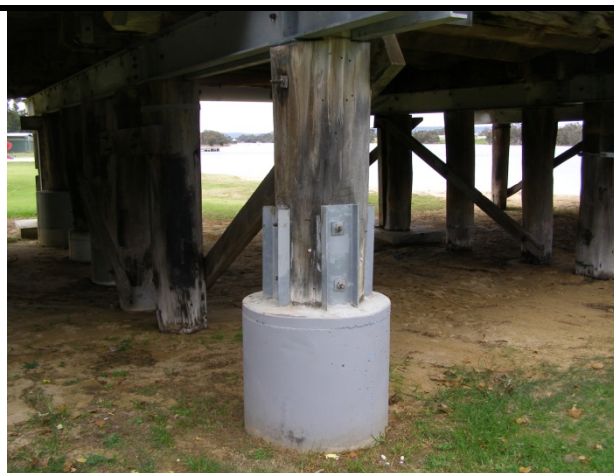
Photo 92 - Typical pier piles

Piles are numbered from left to right. Refer to Form 1 (Section A.1 on page A.3) for correct bridge orientation. Refer to Appendix B, Photo 92 for typical timber pier piles. If the pile has been potted, then write "Pot" underneath the pile number. Refer Appendix B, Photos 93 and 94 for examples.

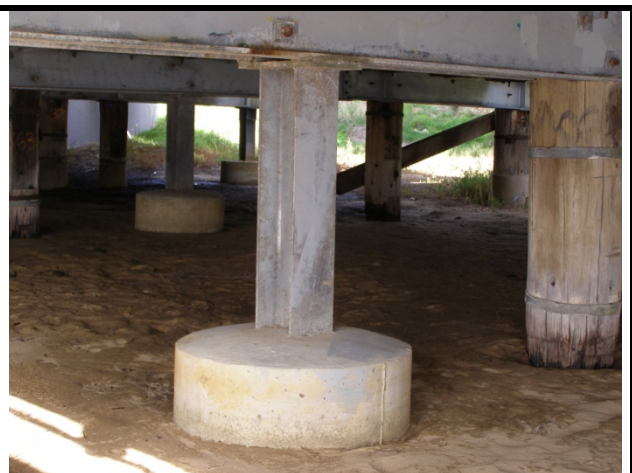
Photo 93 - Pier pile pot type 1

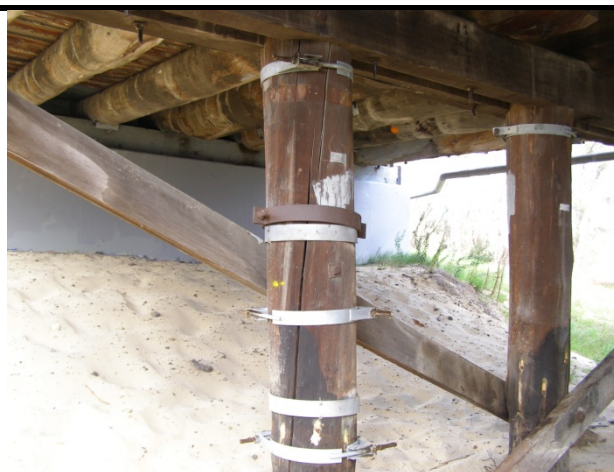
Photo 94 - Pier pile pot type 2

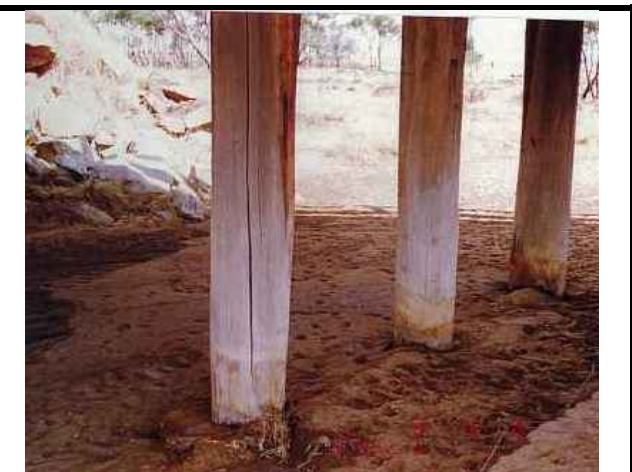
Photo 95 - Pile with multiple bands

Refer to Appendix B, Photo 95 for a multi banded pier pile.

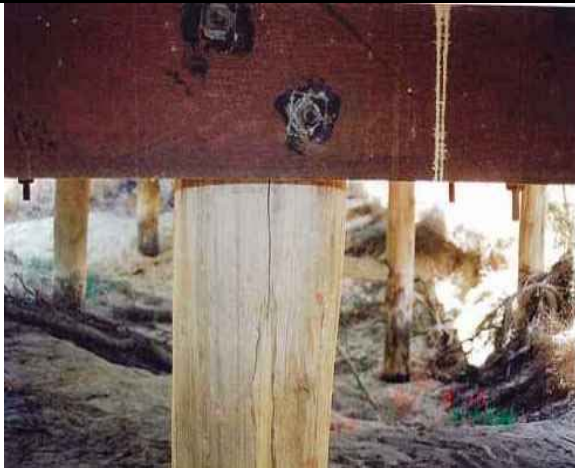
Photo 96 - Shows one long split, multiple banding is required

Refer to Appendix B, Photos 96 to 98 for examples.

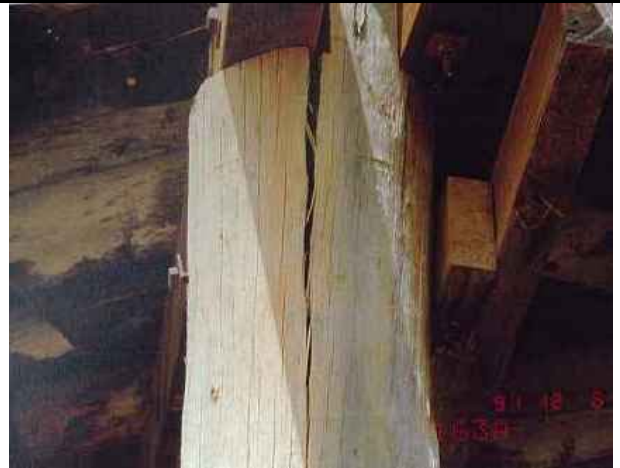
Photo 97 - Shows small split, banding is not warranted

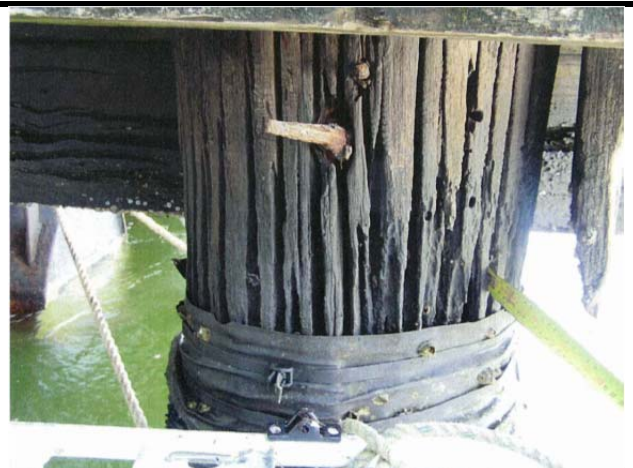
Photo 101 - Photo of end of pile with splits

This sheet is used to record extra information when necessary. For example, to show pile section rot zones, pipes and excessive splitting that cannot be represented clearly on Pier or Abutment Sheets. Refer to Appendix B, Photo 101 for such a pile.

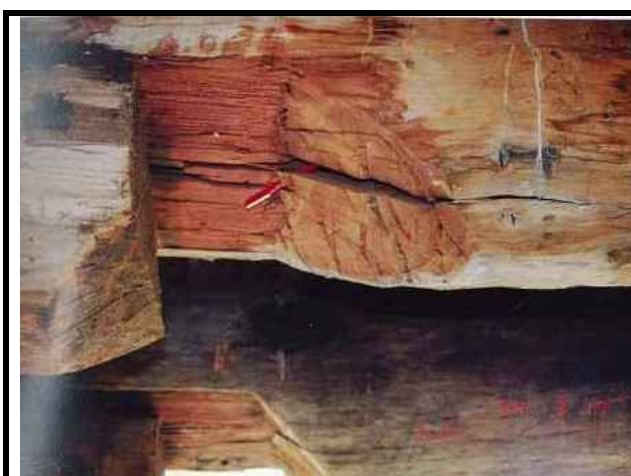
Photo 104 - Stringer cross-bolted for splits

Refer to Appendix B, Photos 104 to 107 for typical stringer bolting (cross bolting) and splits.

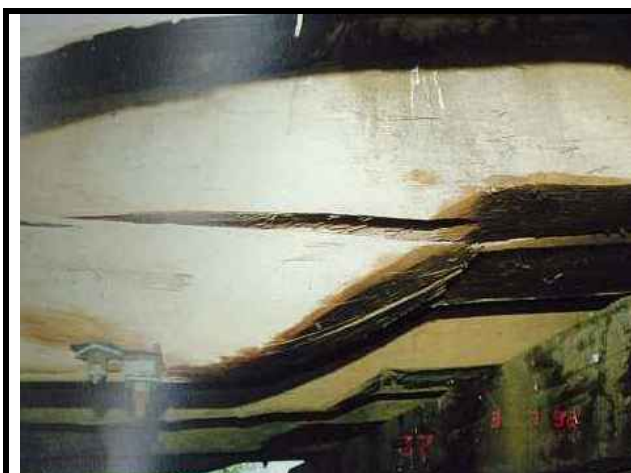
Photo 106 - Shows LV split in Stringer and MV split in Corbel. Gang nailing on Corbel is not effective to stop splitting.

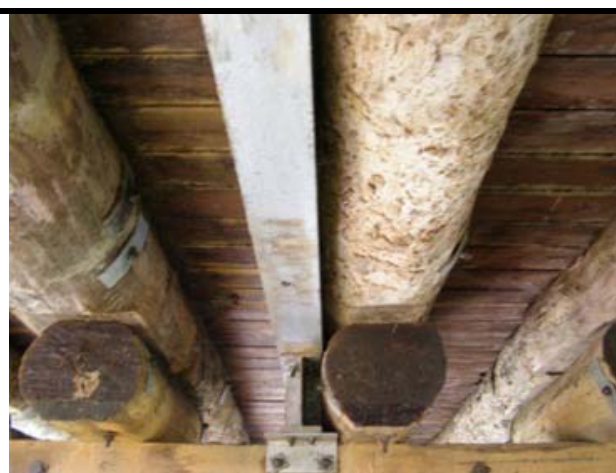
Photo 107 - Shows large horizontal (LH) split. Existing bolt requires tightening.

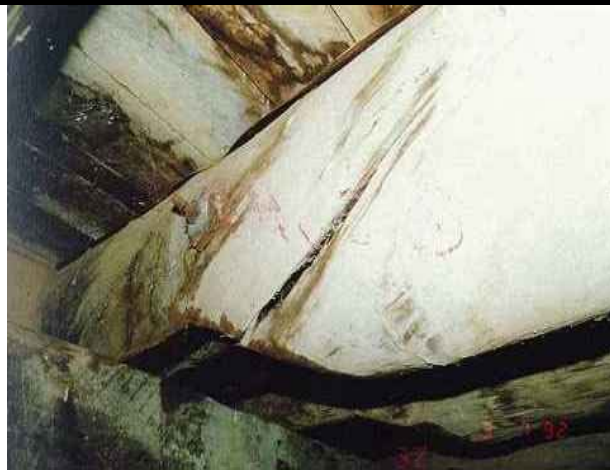
Photo 108 - Timber stringer with steel stringer alongside

If stringers have been placed side-by-side then an inverted long U is placed across the top of the columns to indicate that the stringers are touching or in very close proximity. Refer to Appendix B, Photo 108 and Figure A.51.

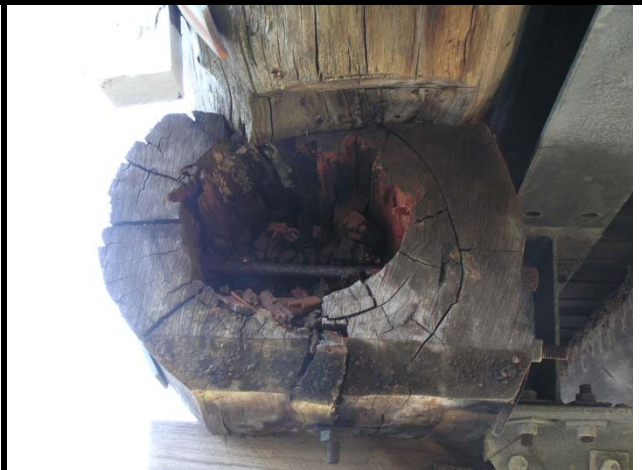
Photo 109 - Shows LV twisting type of split. This split can spiral around the entire stringer.

Spiral grain is more susceptible to opening up with twisting splits that can form around the entire stringer. These stringers are indicated by number along the line. Refer to Appendix B, Photo 109 for an example of a stringer with spiral grain.

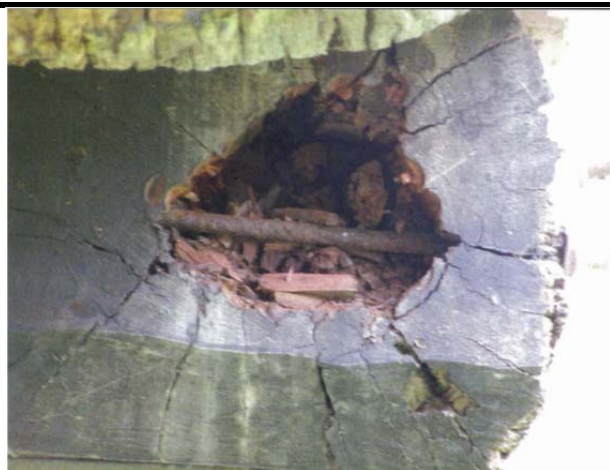
Photo 110 - Splits and rot hole in end of corbel. It is crushing and failing.

This sheet is used to record extra information when a corbel has excessive splitting or rot zones that cannot be represented clearly on the Pier Sheet. Refer to Appendix B, Photos 110 to 112 for such corbels.

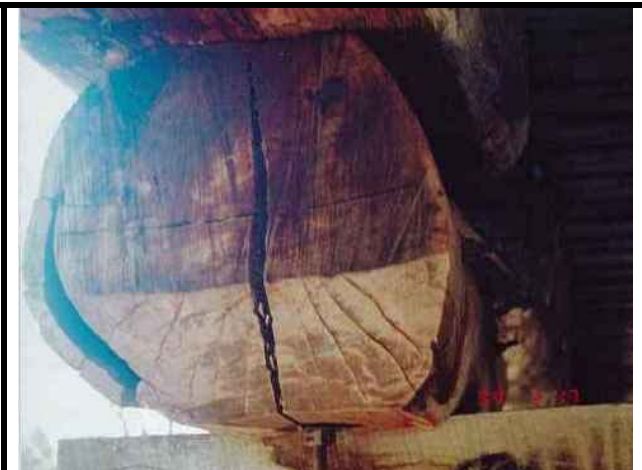
Photo 111 - Example of a damaged corbel

Refer to Figure A.56 which is an example of Appendix B, Photo 111.
