Structures Engineering

Detailed Visual
Inspection Guidelines
for Culverts
(Level 2 Inspections)

DETAILED VISUAL CULVERT INSPECTION GUIDELINES (Level 2 Inspections)

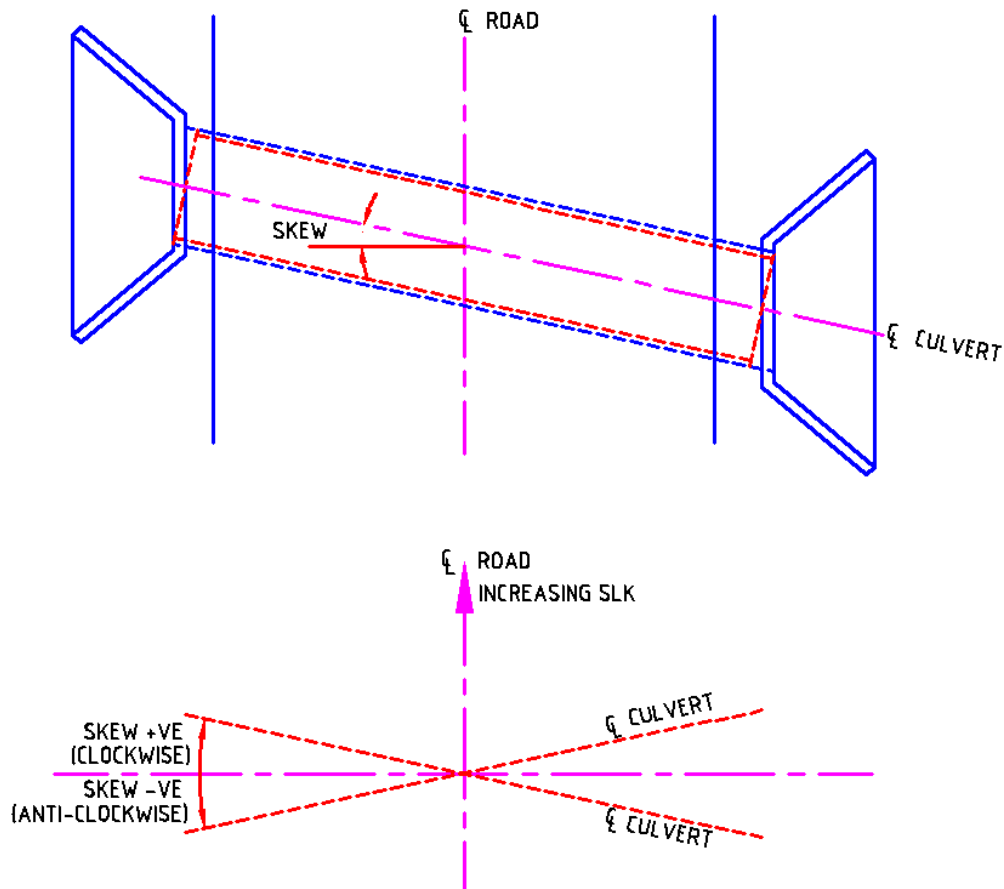
Figure 8 - CULVERT SKEW

The skew is defined as the angle between the longitudinal centreline of the culvert and a line perpendicular to the road centreline. It is measured in degrees to a tolerance of 5°. The skew can be positive or negative (refer Figure 8) and this should be noted on the inspection form.

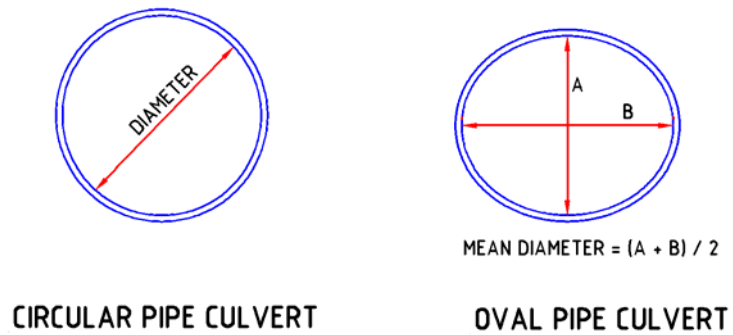
Figure 10 - CIRCULAR CULVERT DIAMETER

For circular culverts, diameter refers to the nominal internal diameter of a pipe, measured in metres to two decimal places. In the case of elliptical culverts, it is the mean diameter. Refer Figure 10. Where there are circular culverts of different diameter, the largest diameter should be recorded and notes describing the other diameter(s) should be recorded in the general comments section.

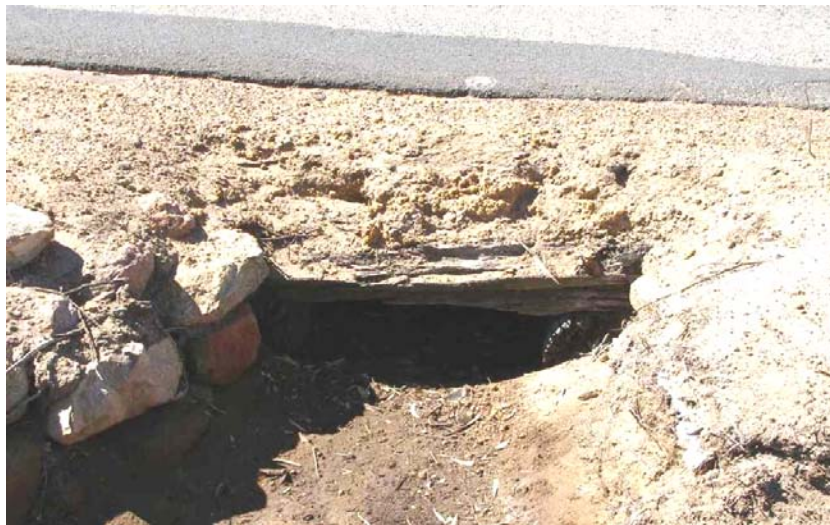
Photo 1 - TIMBER BEDLOG CULVERT

Timber culverts are sometimes referred to as bedlog culverts, and there are a number of these culverts still in service. Being constructed of timber, they are susceptible to significant and relatively rapid deterioration, and require the most frequent inspection cycle of all culvert types.

Timber culverts must be differentiated from timber bridges. Any deck supported on timber stringers (longitudinal beams), regardless of clear opening size, is defined as a bridge and is inspected as such. Timber culverts are therefore only those without timber stringers with clear openings of less than or equal to three metres.

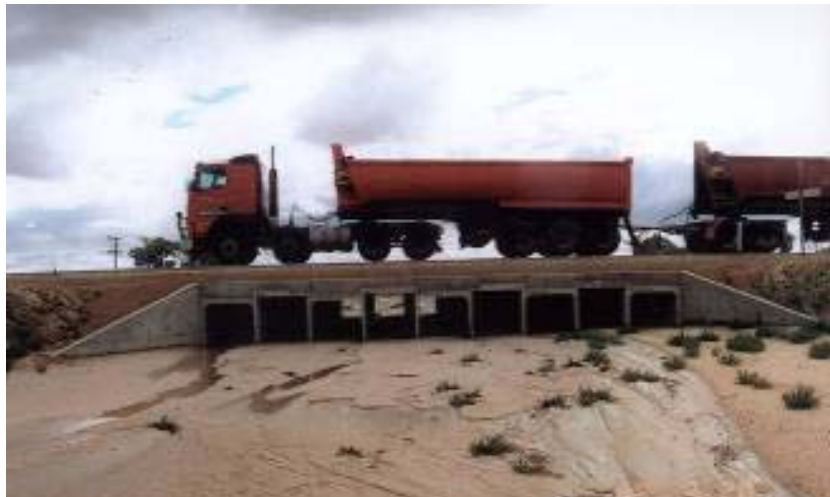
Photo 2 - REINFORCED CONCRETE BOX CULVERT (LINK SLAB TYPE)

The original concrete culverts were cast in situ boxes and many suffer from cracking and spalling due to lack of concrete cover or ingress of moisture. Once repairs are required to these structures (such as concrete patching or crack repairs) they tend to be an ongoing problem as other areas fail due to general dampness through the porous concrete. More recent precast concrete units generally appear more robust and perform well, although there are some reinforcement corrosion problems in salt affected areas of WA.

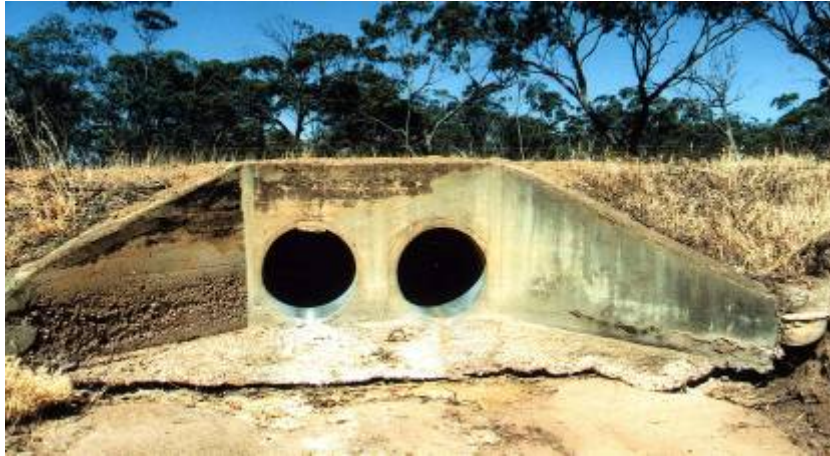
Photo 4 - STEEL PIPE CULVERT

Steel culverts are pipe culverts. Most of the deterioration of the metal occurs at the pipe invert where the water ponds. Inspections are required to check protective coatings and galvanising, and for cracks, loss of section and corrosion, especially around joints and seams, and the condition of the invert. The pipe inverts can also be affected by abrasion if the sediment content of the water flow is high.

Pipes may be of multi-plate bolted constructed or by forming the pipe barrels with the use of helical continuous lock seam running parallel to corrugations.

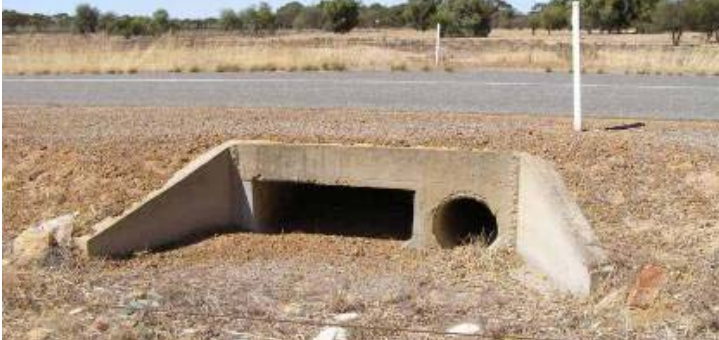
Severity Level	Description	Photographs
1	No waterways issues identified with no scour.

<p data-bbox="970 1205 1235 1234">No scouring present</p>

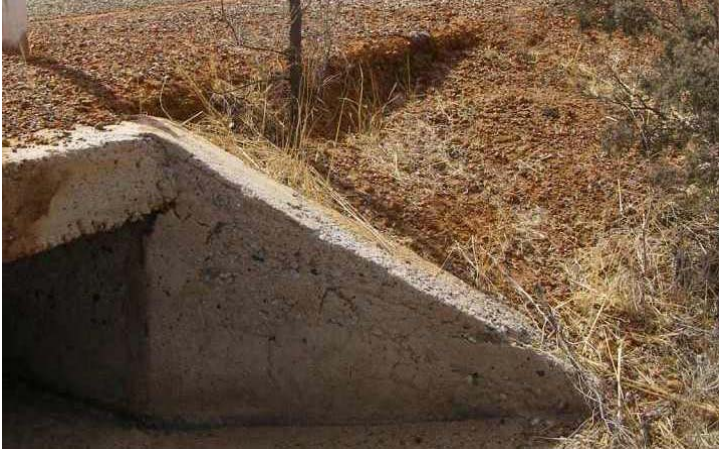
Severity Level	Description	Photographs
2	Minor scouring may be present at either the inlet channel, outlet channel, on the road embankment either side of the wing walls or on the road shoulder behind either headwall.

<p data-bbox="853 694 1348 728">Minor scour on the road embankment</p>

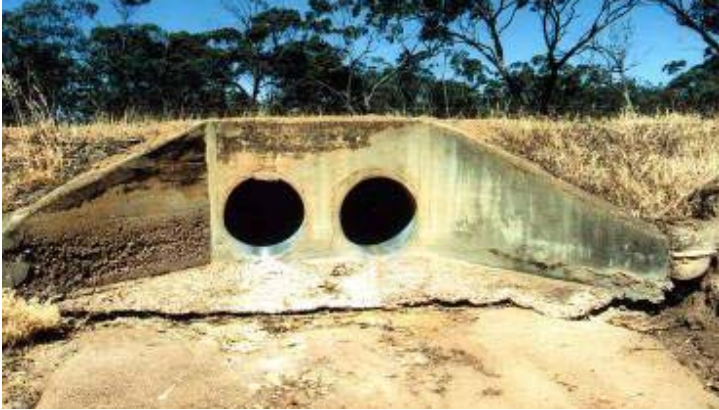
<p data-bbox="874 1200 1327 1234">Minor scour under the outlet apron</p>

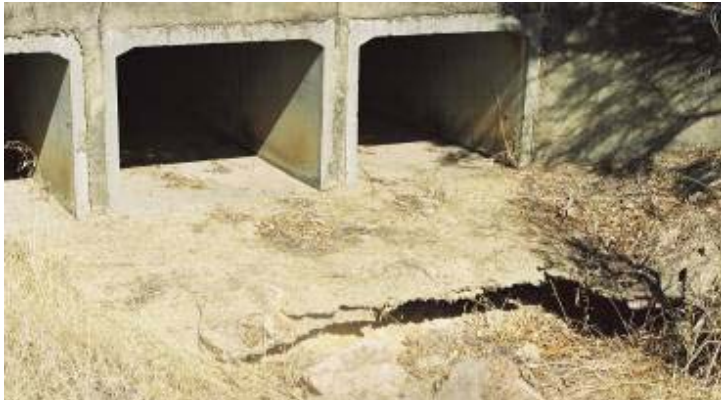
Severity Level	Description	Photographs
3	Noticeable scouring is present at either the inlet channel, outlet channel, on the road embankment either side of the wing walls or on the road shoulder behind either headwall. The level of scouring is not likely to develop into a potential hazard to stability or cause significant structural damage in the short-term.

<p data-bbox="831 645 1369 678">Noticeable scouring under the inlet apron</p>

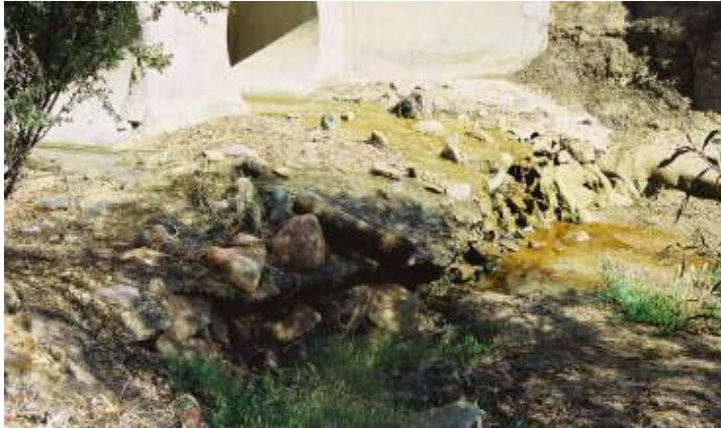
<p data-bbox="858 1169 1342 1202">Scouring of the downstream riverbed</p>
4	Significant scouring is present at either the inlet channel, outlet channel, on the road embankment either side of the wing walls or on the road shoulder behind either headwall. The level of scouring is likely to develop into a potential hazard to stability or cause significant structural damage to the culvert.

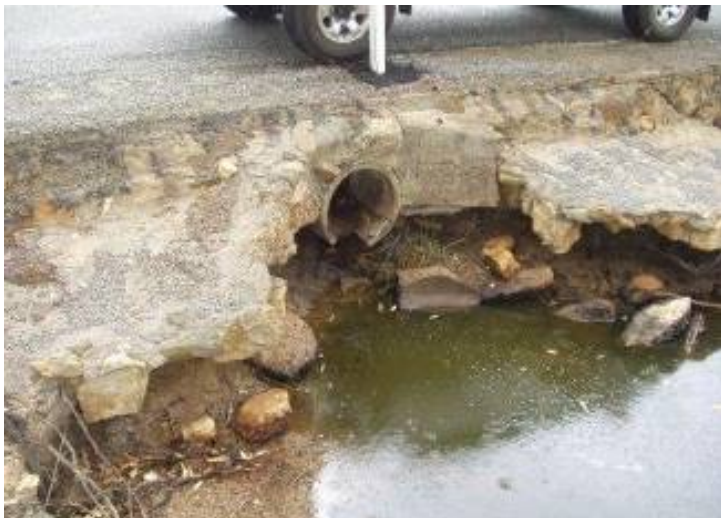
<p data-bbox="847 1731 1353 1765">Severe scouring under the pipe culvert</p>

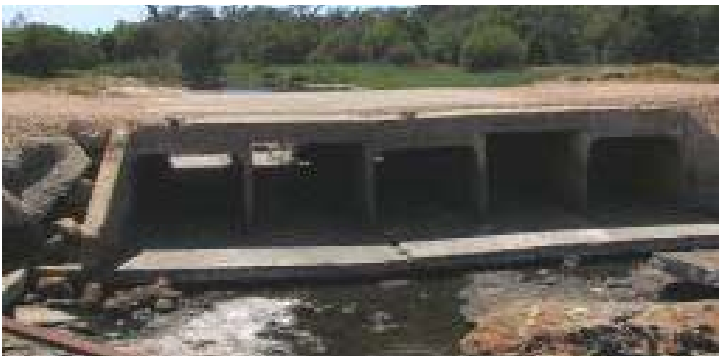
Severity Level	Description	Photographs
5	Advanced scouring is present that is currently causing stability issues or will very quickly cause significant structural damage to the culvert.

<p data-bbox="759 600 1442 663">Water is no longer flowing through the culvert but is flowing underneath with structural failure of the base</p>

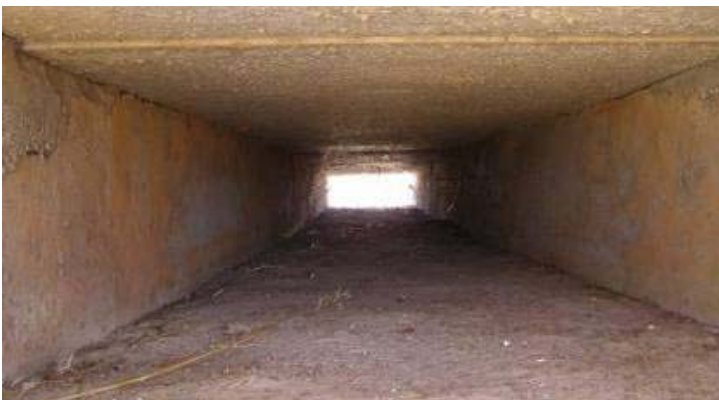
Severity Level	Description	Photographs
1	No waterways issues identified with no impediments to the flow condition of the culvert units.

<p data-bbox="919 1301 1283 1328">No obstruction to water flow</p>
2	Minor silting or obstruction of the waterway up to 10% of entry/exit.

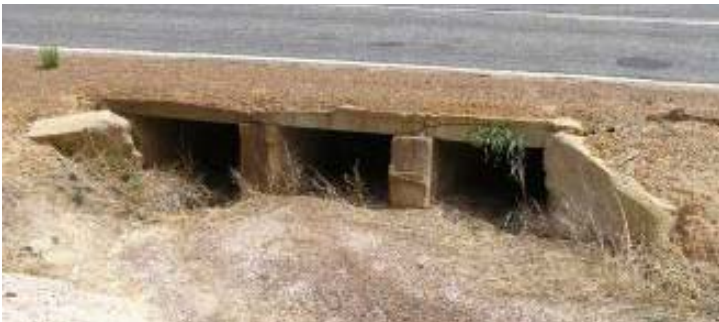
<p data-bbox="858 1671 1340 1697">Minor (< 10%) silting of the waterway</p>

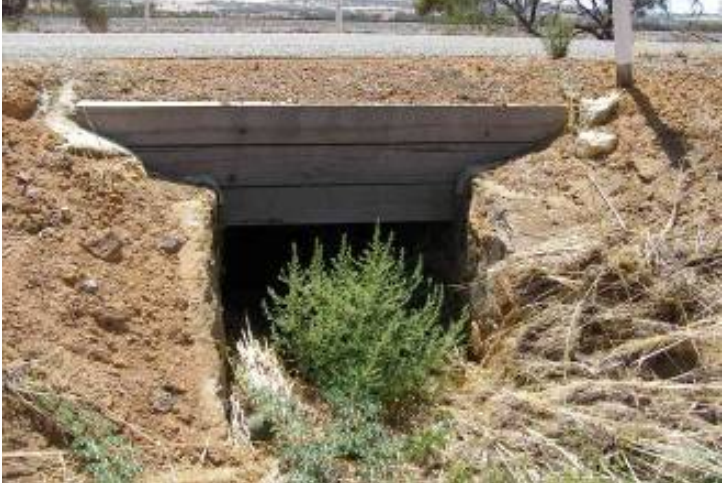
Severity Level	Description	Photographs
3	<p>Silting or obstruction of the waterway of between 10% and 25% of entry/exit. Silting is evident along the length of the culvert.</p>

<p>Vegetation blocking the culvert entrance</p>
4	<p>Silting or obstruction of the waterway of over 25% of entry/exit.</p>

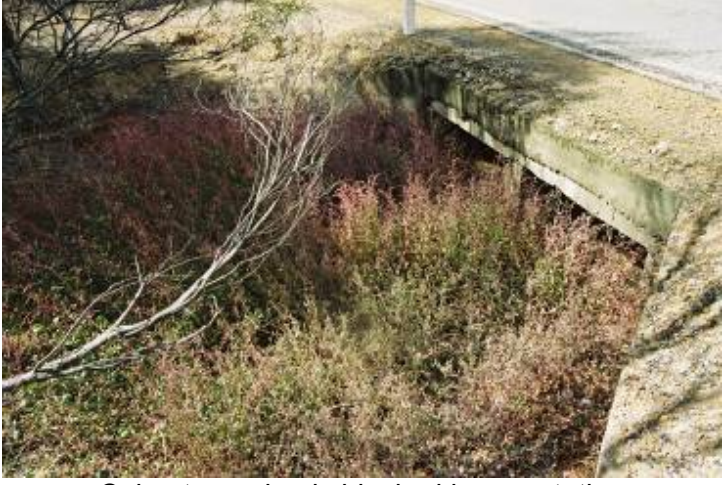
<p>Culvert opening is blocked by vegetation</p>
5	<p>Silting or obstruction of the waterway at entry/exit is so severe that water flow is likely to cause structural damage to the culvert.</p>

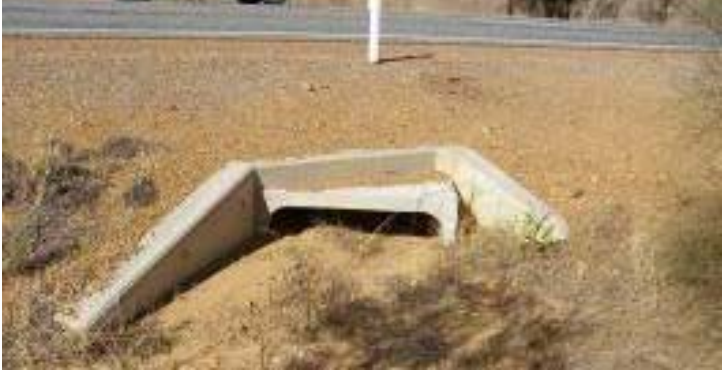
<p>Box culvert is almost completely blocked</p>

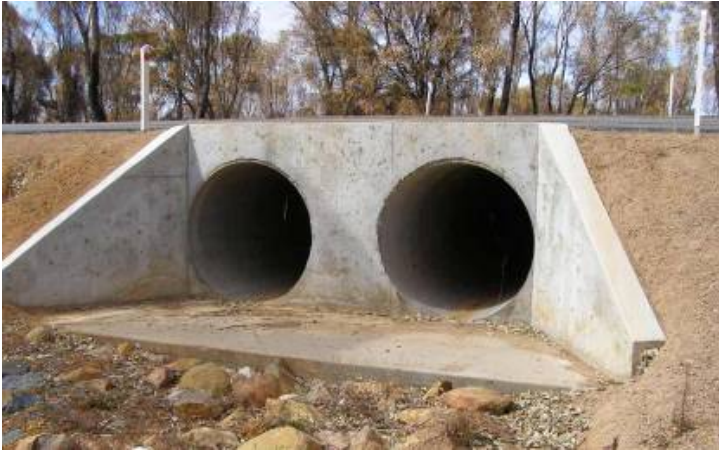
Severity Level	Description	Photographs
1	All structural components are in good condition with little or no deterioration.

<p data-bbox="762 768 1439 797">As-new condition of headwall, wing walls and apron</p>
2	Minor deterioration or damage only in structural components. Defects are more surface in nature and do not affect the structural integrity.

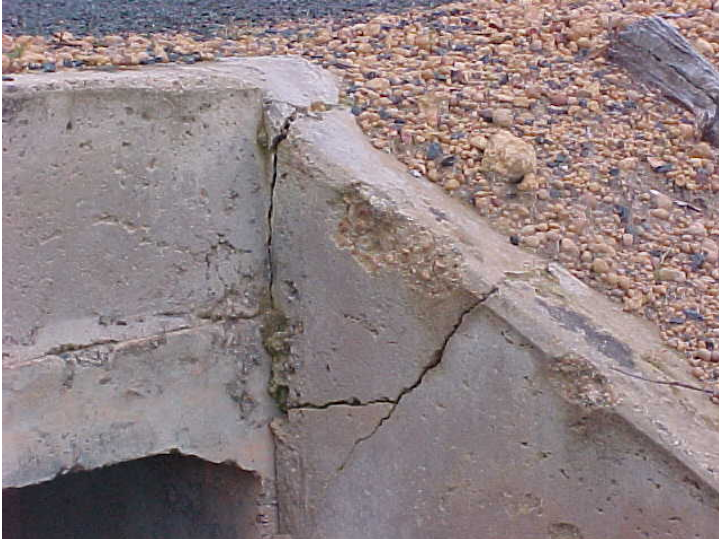
<p data-bbox="751 1355 1450 1420">Cracks and minor damage to concrete wing wall (non primary structural component)</p>

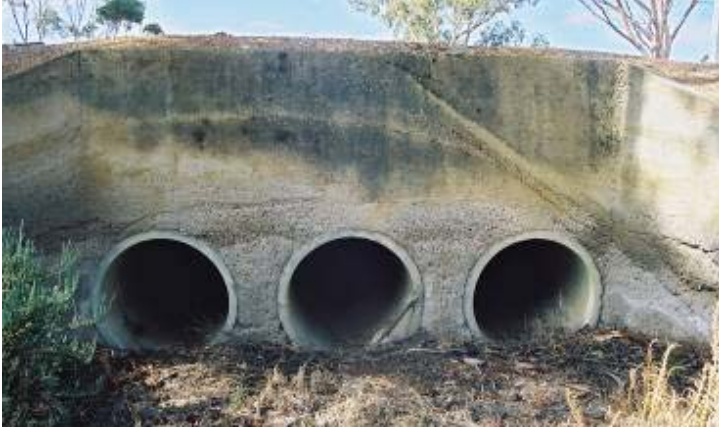
<p data-bbox="774 1915 1428 1944">Construction joint on headwall and minor cracking</p>

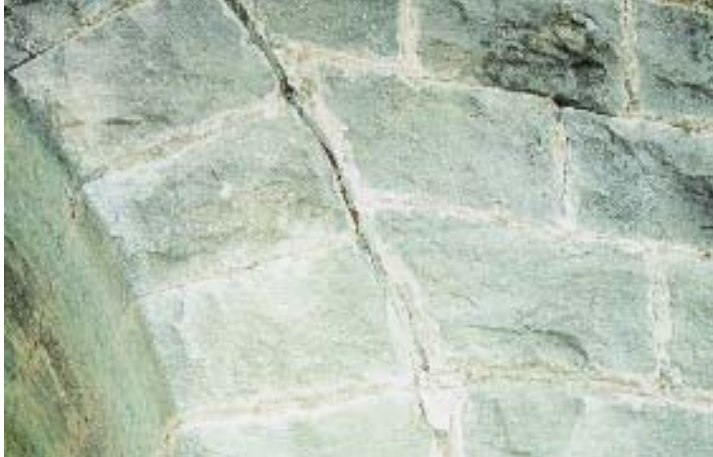
Severity Level	Description	Photographs
3	Medium deterioration or damage in structural components. Defects are not yet affecting the structural integrity.

<p data-bbox="938 703 1267 741">Cracking in masonry wall</p>

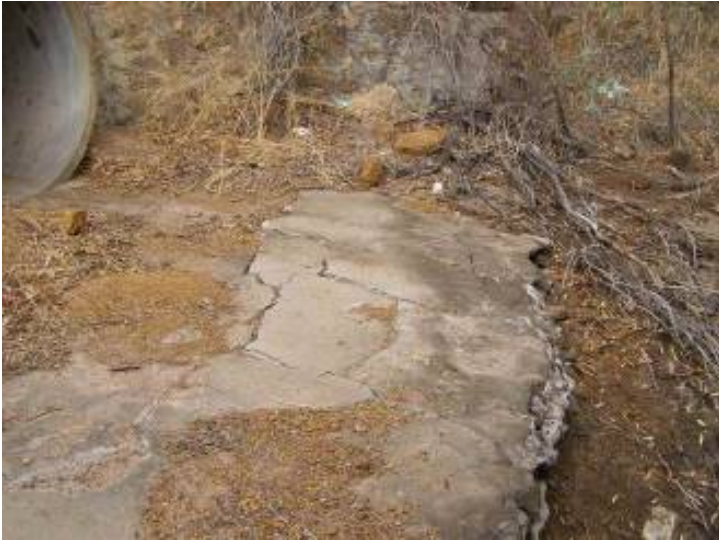
<p data-bbox="967 1339 1238 1377">Badly cracked apron</p>

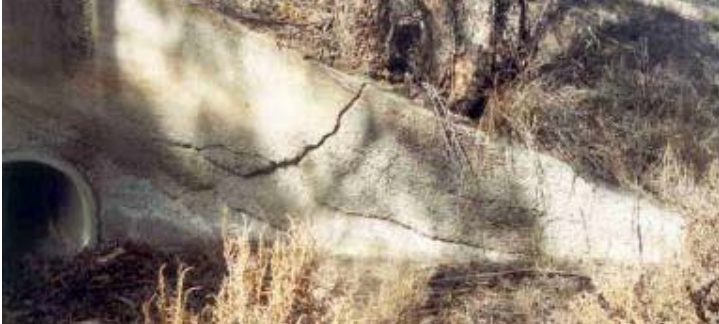
<p data-bbox="746 1760 1455 1830">Wing wall is cracked and is tilting over (caused by tree growth)</p>

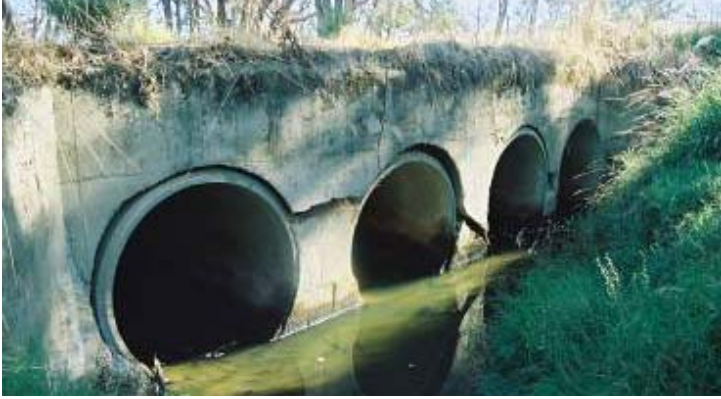
Severity Level	Description	Photographs
4	Significant deterioration or damage in structural components. Defects are starting to affect the structural integrity.

<p data-bbox="756 645 1447 678">Headwall has separated from pipes and is collapsing</p>

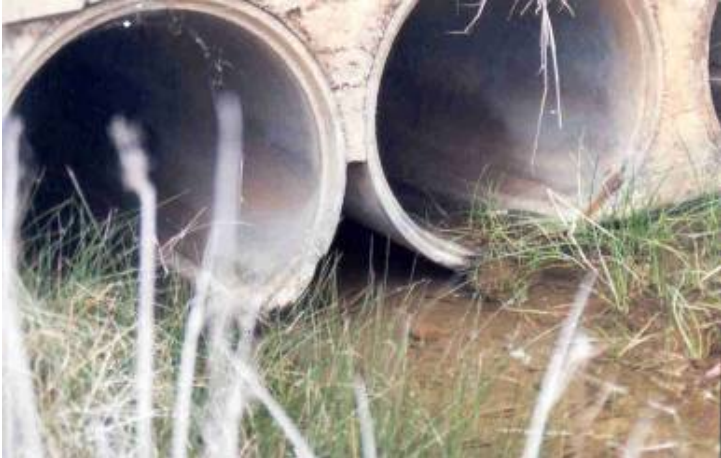
<p data-bbox="778 1196 1425 1263">Headwall has concrete sections missing, pipes in danger of being undermined</p>
5	Structural components are showing signs of distress or have already failed. Defects affect the structural integrity.

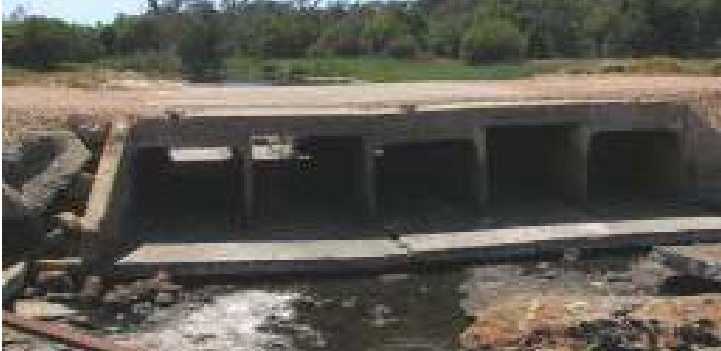
<p data-bbox="1015 1648 1185 1682">Apron failure</p>

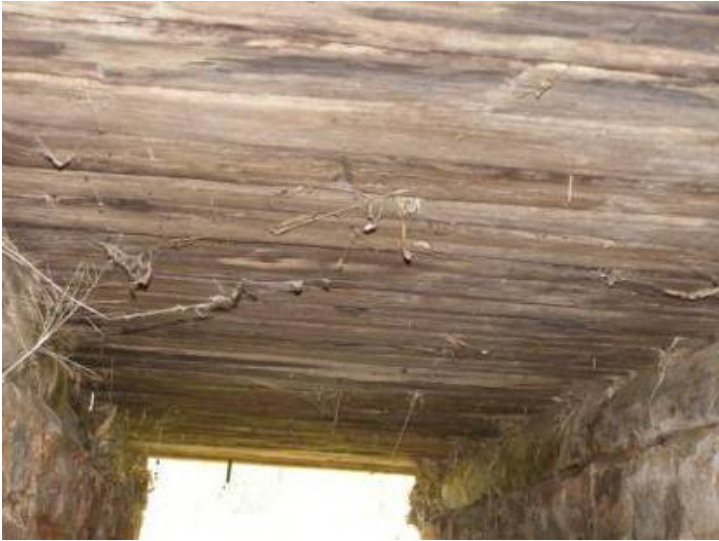
Severity Level	Description	Photographs
1	<p>All structural components are in good condition with little or no deterioration.</p> <p>Barrels – the line and invert of the culvert is straight with no water being retained in the culvert.</p> <p>Concrete – any cracking is only hairline (≤ 0.1 mm) and cracks are widely spaced and very infrequent; no spalling; minor efflorescence on the underside of the link slab or near unit joints.</p> <p>Steel – no evidence of corrosion.</p> <p>Masonry – any cracking is only hairline or fine (≤ 0.3 mm) and contained within the mortar joints.</p> <p>Timber – may have very minor splits only.</p>

<p>No timber deterioration</p>

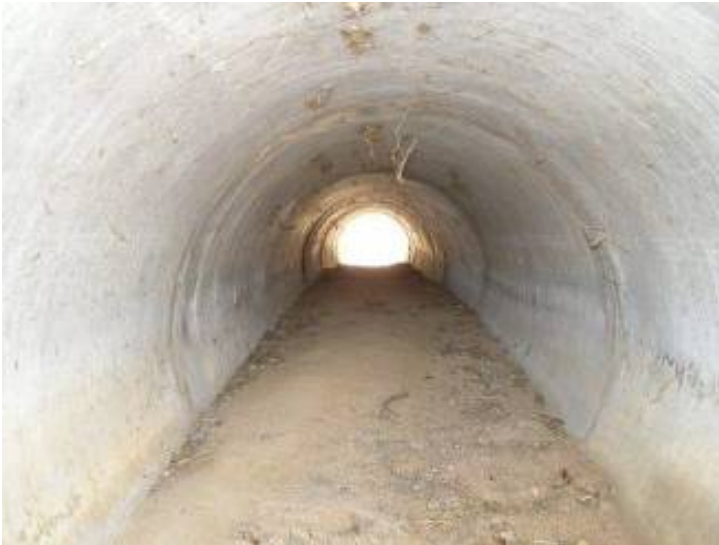
<p>No concrete spalling or cracking (Note: Silting is severity level 3)</p>

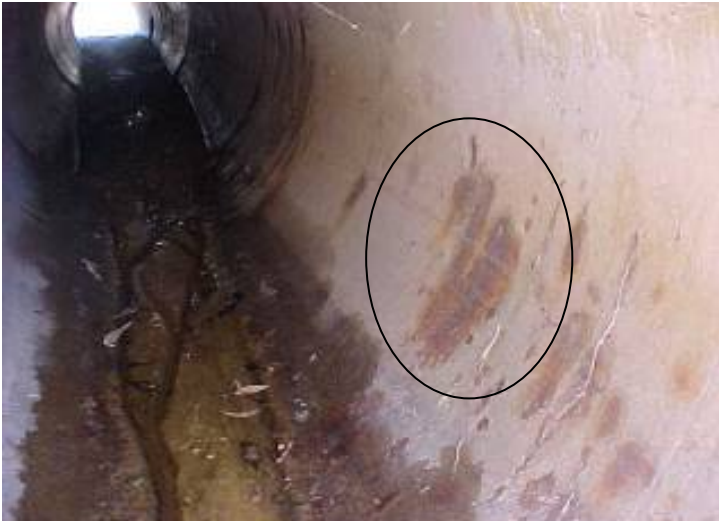
Severity Level	Description	Photographs
2	<p>Minor deterioration or damage only in structural components. Defects are more surface in nature and do not affect the structural integrity or ability to withstand significant water flows. Culvert barrel cell joints seem tight with no evidence of leaching.</p> <p>Barrels – the line and invert of the culvert is straight but there is minor differential settlement (≤ 5 mm) which may have resulted in some water ponding in the culvert.</p> <p>Concrete – any cracking is fine (> 0.1 mm and ≤ 0.3 mm) and cracks are widely spaced and very infrequent; minor localised spalling; localised rust staining; no exposed reinforcing steel; damp patches and efflorescence may be visible.</p> <p>Steel – localised superficial surface corrosion and no pitting.</p> <p>Masonry – medium cracking (> 0.3 mm and ≤ 1.0 mm) of the mortar between blocks or minor loss of the mortar between blocks; mortar is still sound.</p> <p>Timber – minor rot zones; may have splitting or weathering.</p>

<p>Localised rust staining</p>

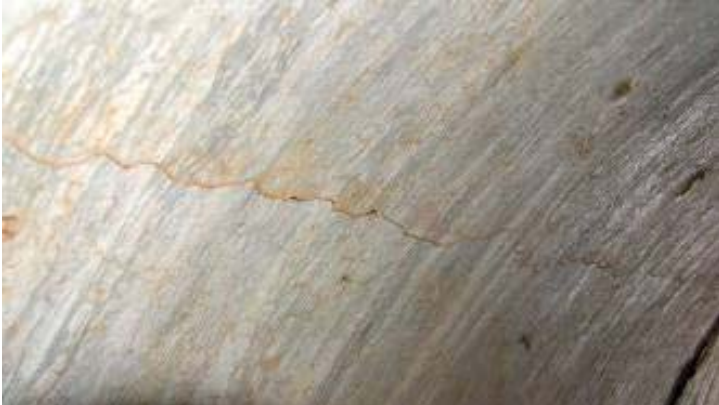
<p>Minor cracking</p>

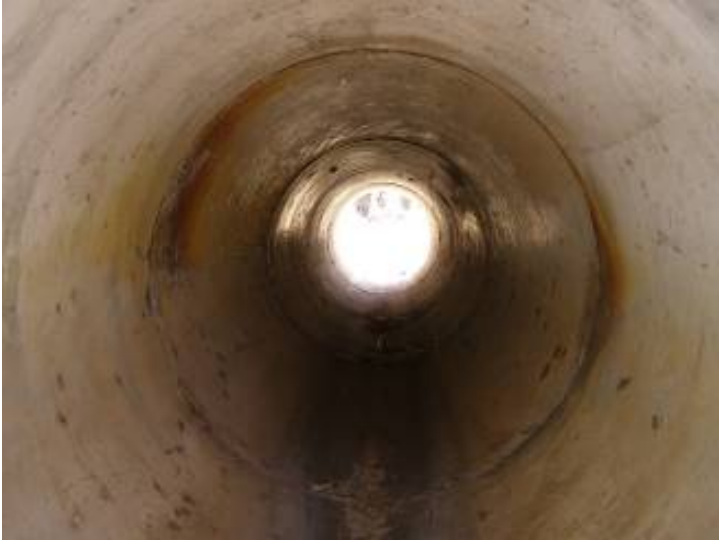
<p>Minor rust staining around the joints</p>

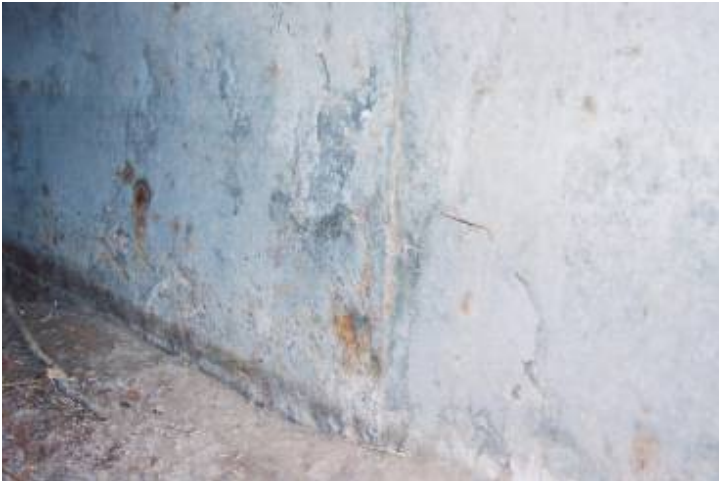
<p data-bbox="780 725 1422 757">Minor rust staining and areas of spalled concrete</p>

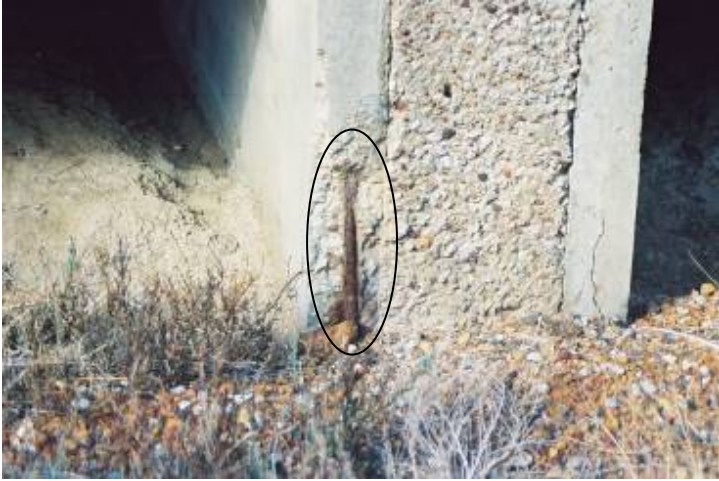
<p data-bbox="766 1303 1439 1335">Exposed reinforcement in outside leg of box culvert</p>
<p data-bbox="277 1352 293 1384">3</p>	<p data-bbox="373 1352 703 1720">Medium deterioration or damage in structural components. Defects are not yet affecting the structural integrity or ability to withstand significant water flows. Some evidence of fill or water leakage passing through the culvert barrel cell joints.</p> <p data-bbox="373 1738 703 2033">Barrels – there may be some deviation of the line of the culvert due to local buckling, separation or differential settlement (> 5 mm and ≤ 30 mm) which may have resulted in water ponding in the culvert.</p> <p data-bbox="373 2051 660 2083">Concrete – infrequent</p>

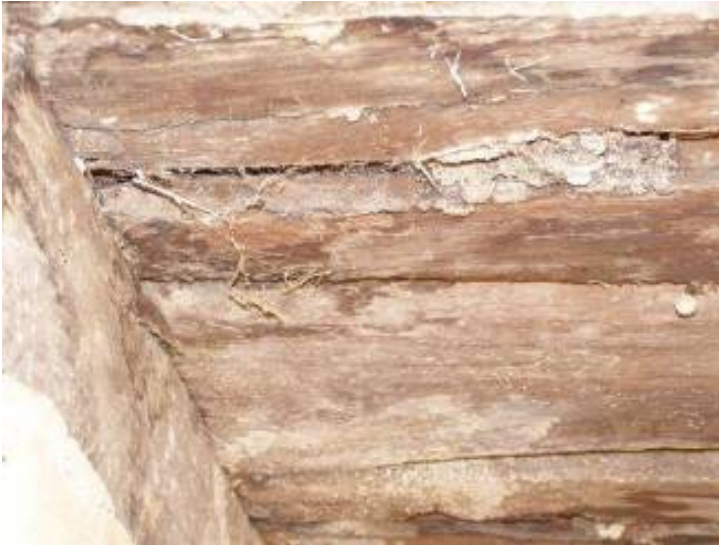
<p data-bbox="823 1944 1378 1975">Some limited rotting of timber components</p>

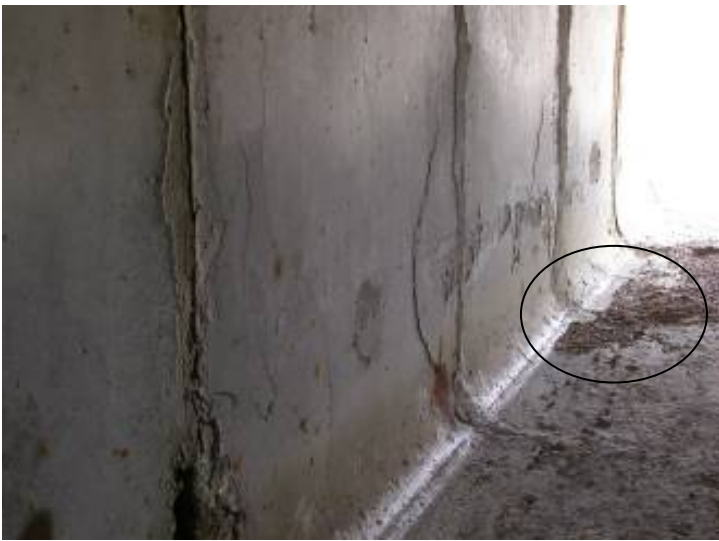
<p>Evidence of leakage through the barrel joints</p>

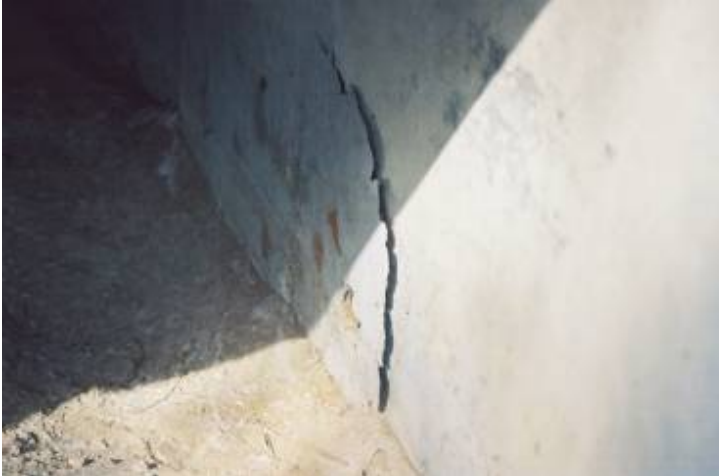
<p>Spall in wall of culvert unit</p>

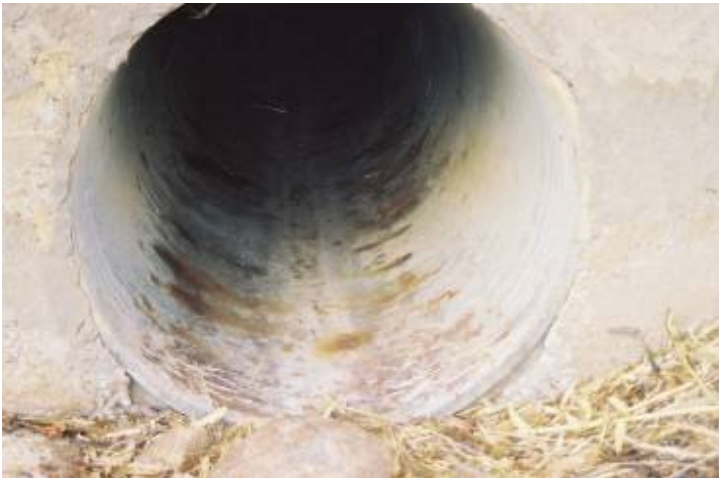
<p>Major rust staining and cracking of the pipe invert</p>

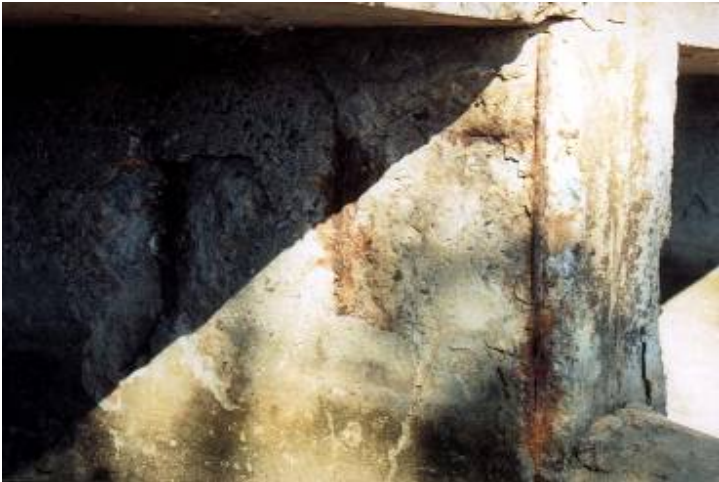
<p>Exposed reinforcement and spalled concrete</p>

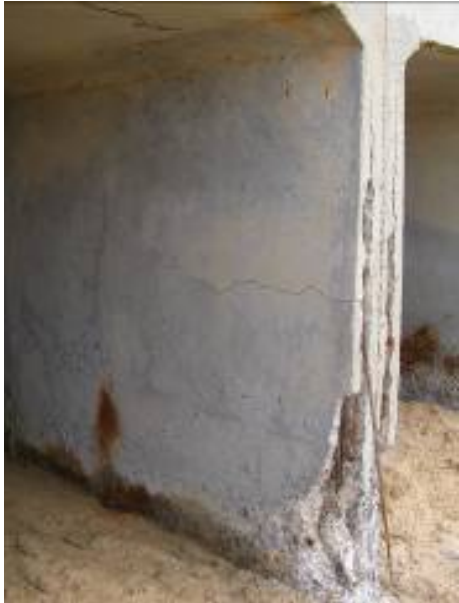
<p>Badly damaged culvert (ends are typical of internal sections)</p>

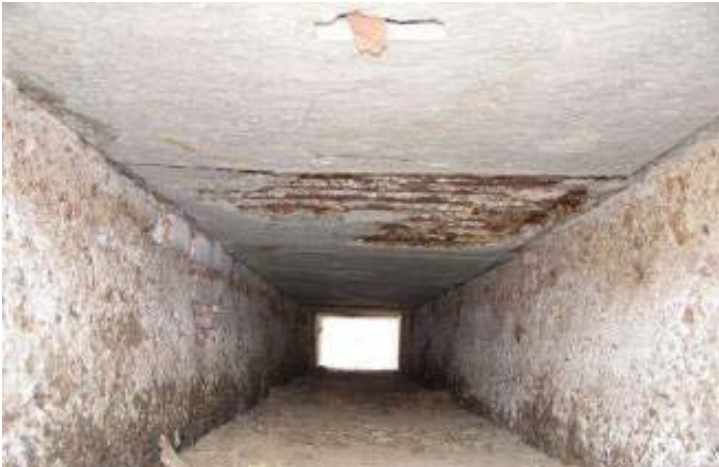
<p>Exposed and corroded reinforcement</p>

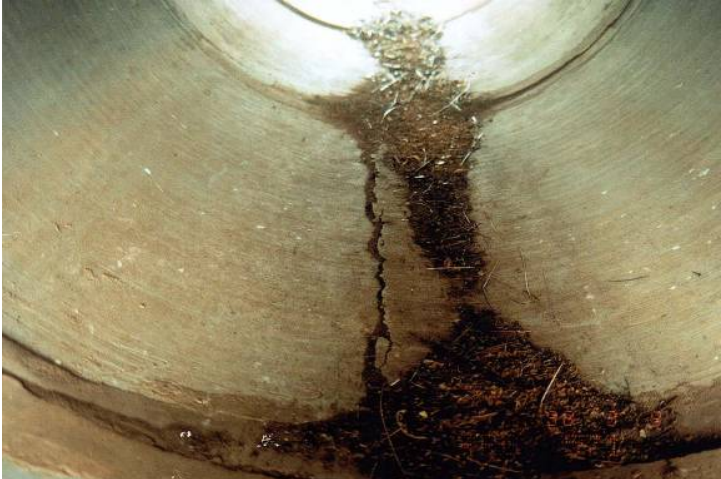
<p>Major heavy longitudinal crack in the pipe invert</p>

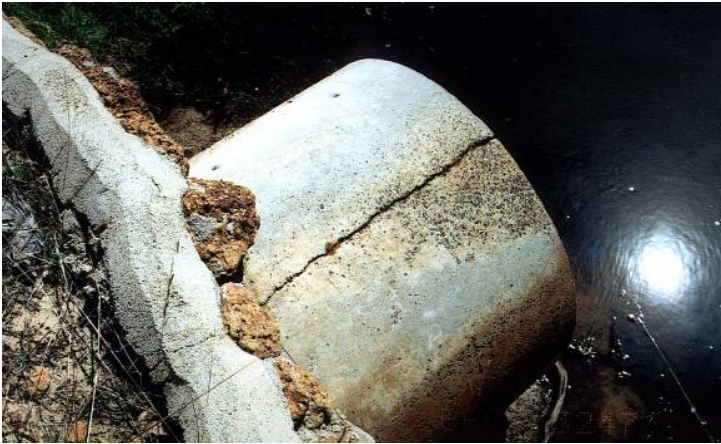
<p>Heavy longitudinal crack in the top of the pipe</p>

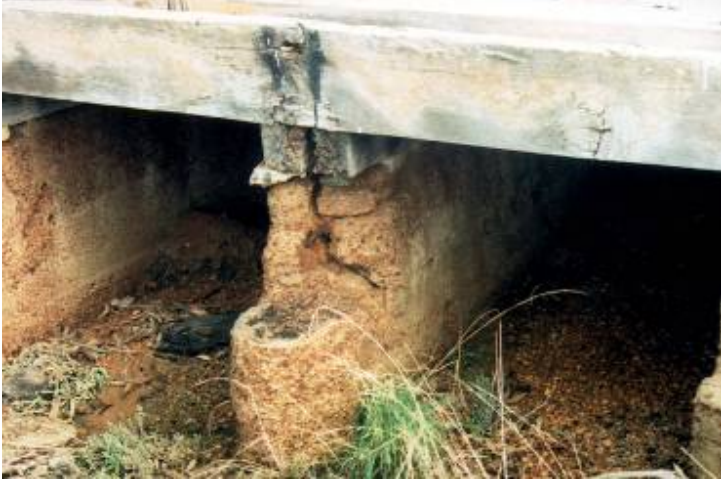
<p data-bbox="788 1308 1414 1344">The end of the wall has major abrasion damage</p>

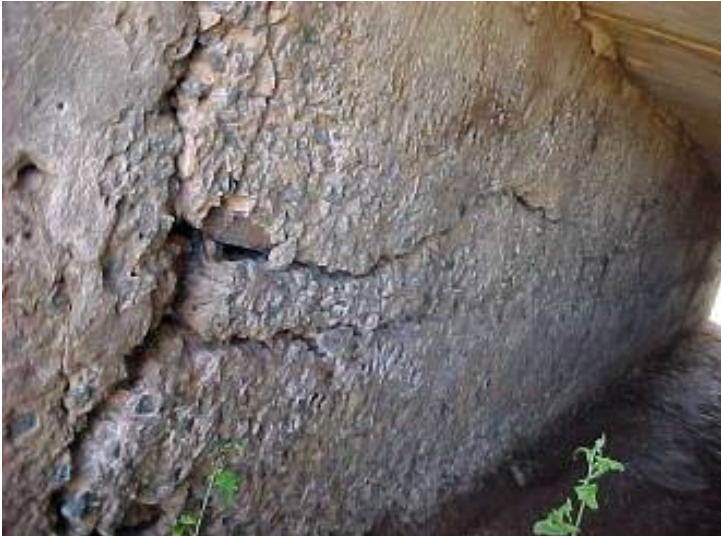
<p data-bbox="778 1939 1423 1975">Culvert pier wall is severely cracked and abraded</p>

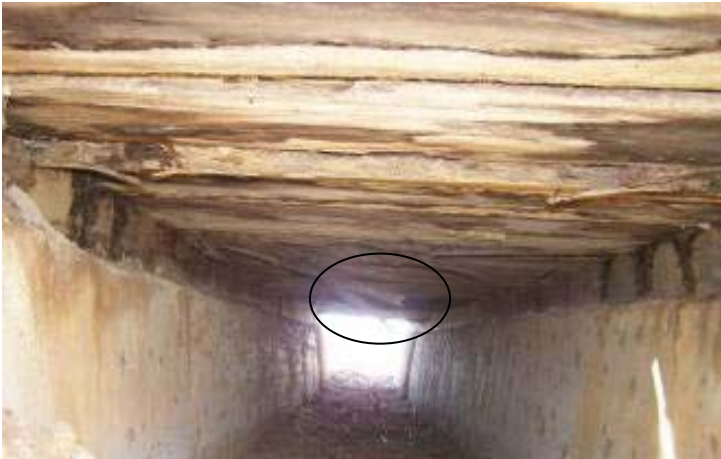
<p data-bbox="892 1314 1310 1348">Localised signs of timber failure</p>

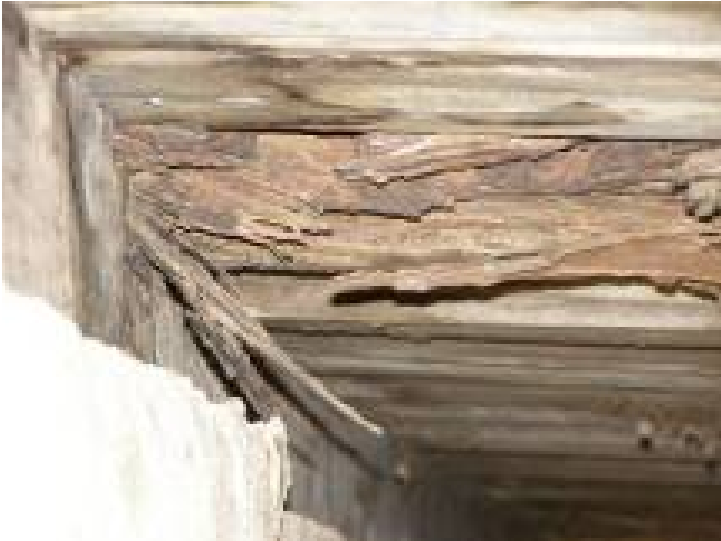
<p data-bbox="805 1953 1398 1986">Failed timber components, typical throughout</p>

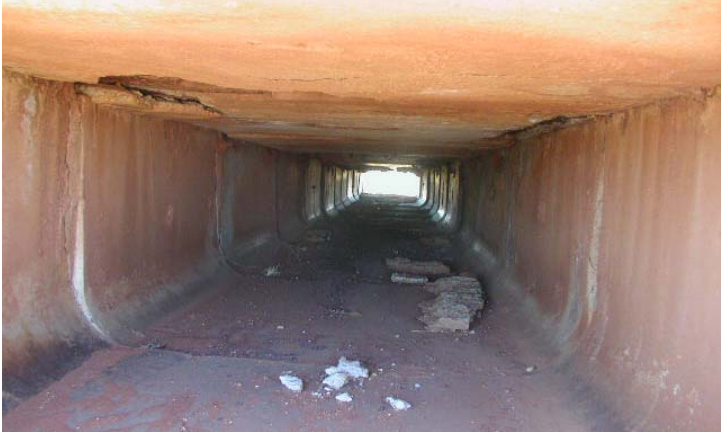
<p data-bbox="794 680 1409 712">Spalled concrete and widespread delamination</p>

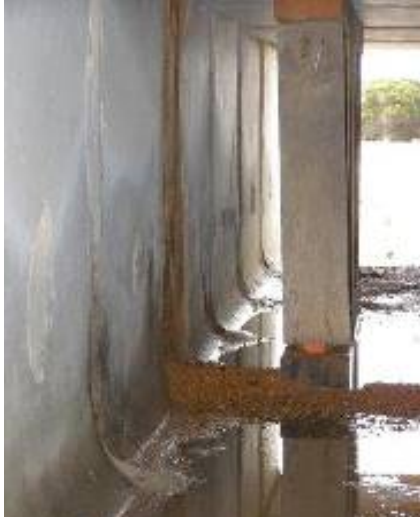
<p data-bbox="745 1301 1458 1332">Joints badly cracked with propping to reinstate stability</p>

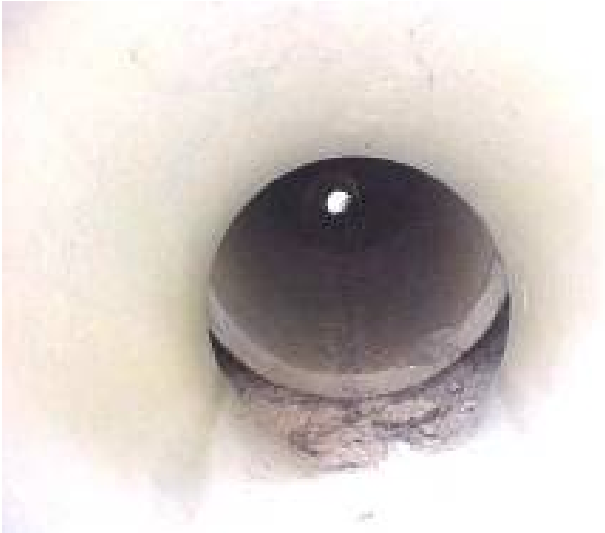
<p data-bbox="745 1930 1458 1995">Misalignment of pipe culverts (repair needed to prevent scour and subsidence)</p>

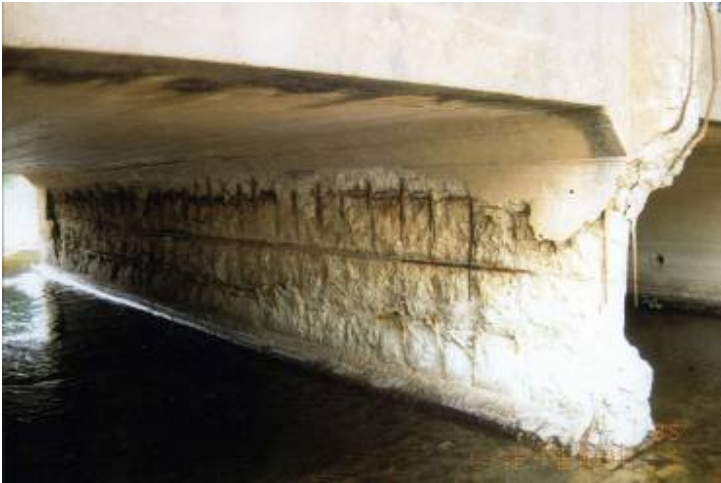
<p data-bbox="740 725 1463 763">Major spalling of wall due to salt attack of reinforcement</p>

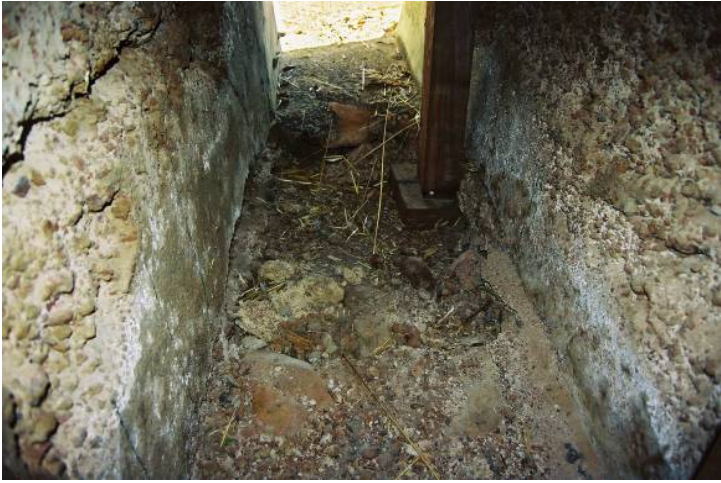
<p data-bbox="740 1303 1463 1370">Walls have major abrasion and have been propped to maintain structural stability</p>

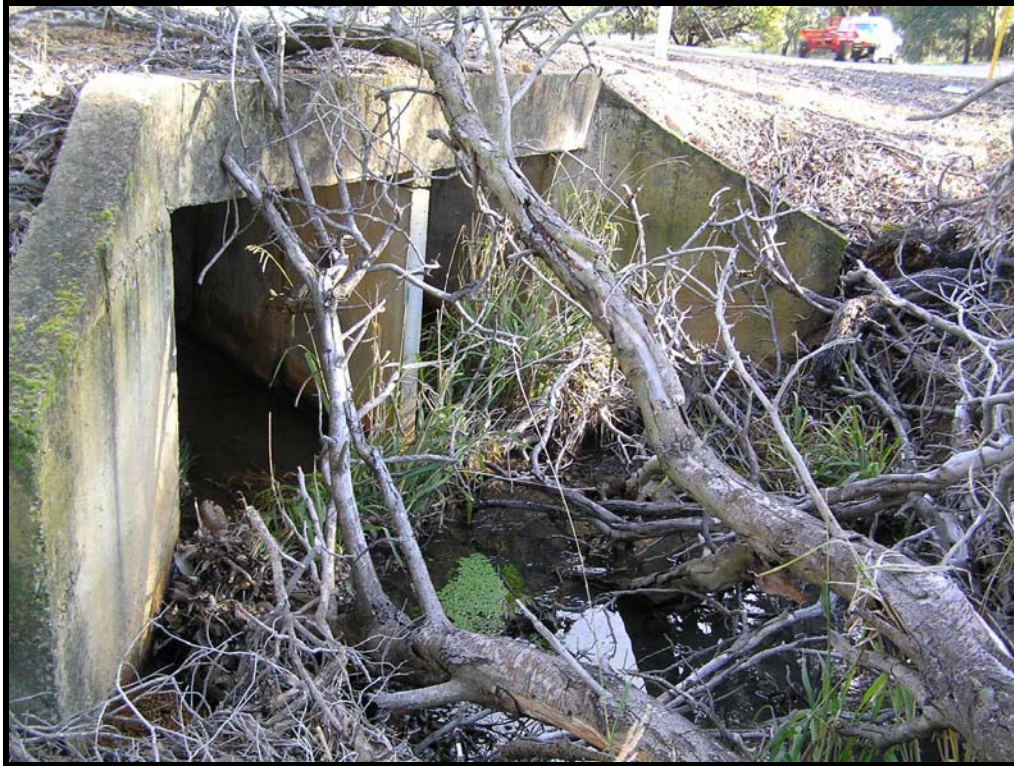
Photo 3 - BUILD-UP OF DEBRIS AT INLET (LHS)

2. Waterways Vegetation, debris, embankment erosion, scour, silt build-up, blockages, damaged guide-banks, revetment mattresses, rock protection		Scour <input type="text" value="1"/> Flow <input type="text" value="3"/>	Heavy build-up of debris at inlet (LHS) requires clearing. Vegetation impeding waterway both sides, restricting flow.	R208 R205

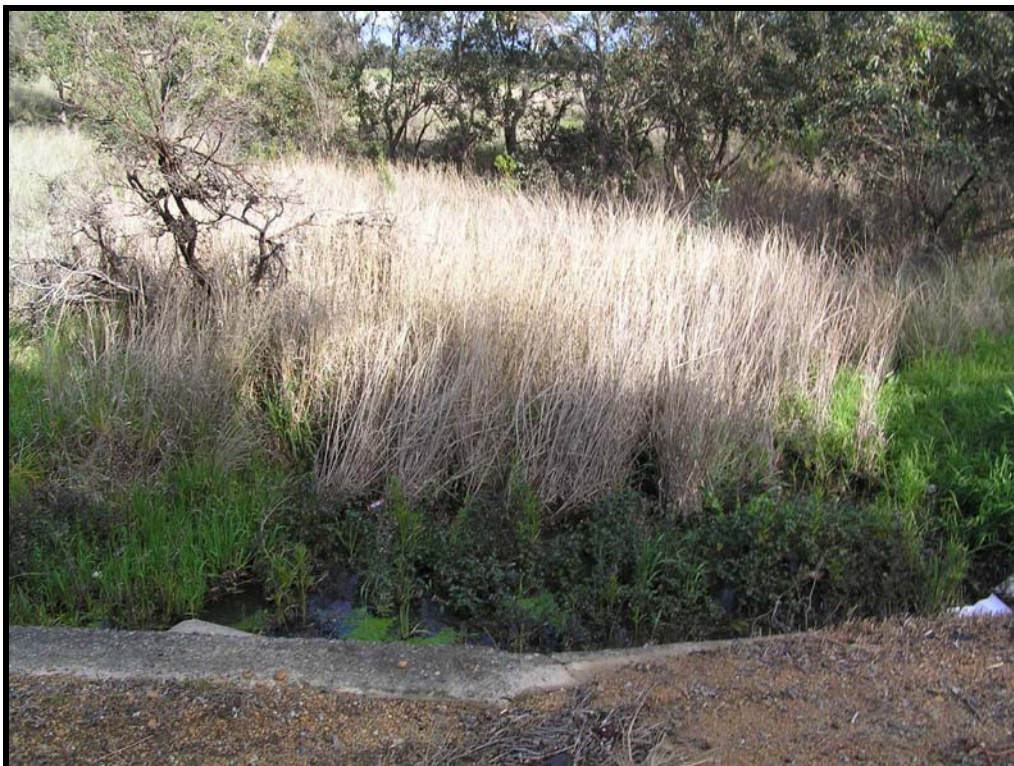
Photo 4 - VEGETATION RESTRICTING FLOW ON RHS

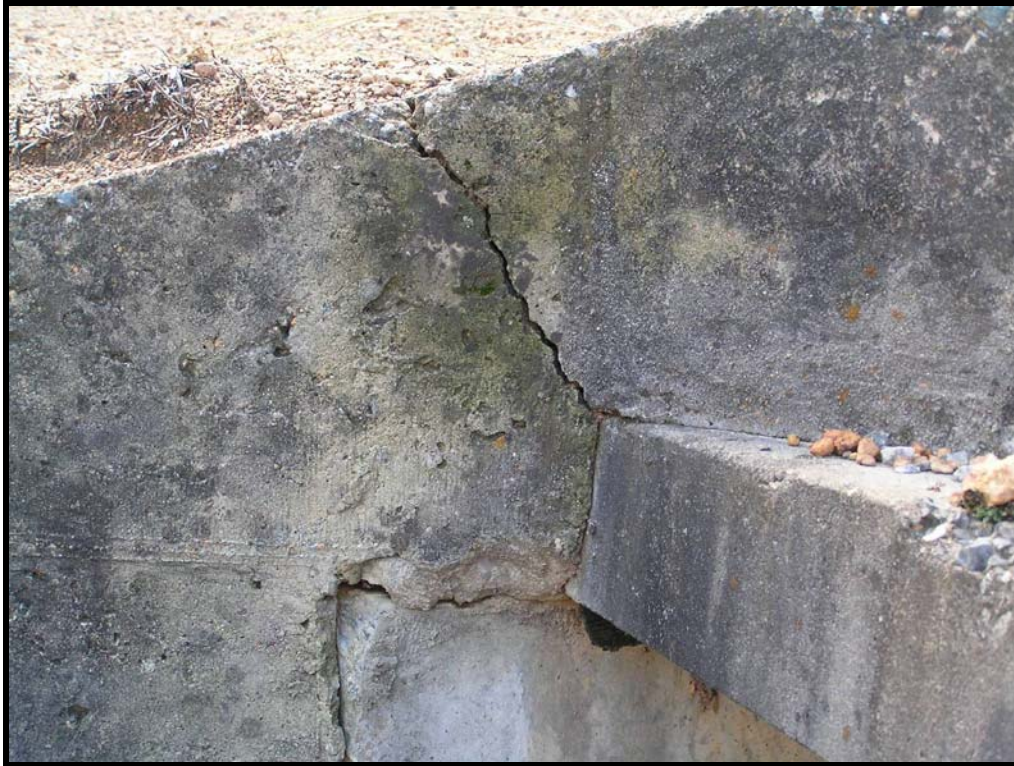
Photo 5 - CRACK BETWEEN RHS WING WALL 1 AND RHS HEADWALL

3. Walls & Aprons Headwalls, wing walls, aprons: material defects, impact damage, coatings, movement/settlement		Head LHS <input type="text" value="2"/> Head RHS <input type="text" value="2"/> Wing LHS 1 <input type="text" value="2"/> Wing LHS 2 <input type="text" value="2"/> Wing RHS 1 <input type="text" value="2"/> Wing RHS 2 <input type="text" value="2"/> Apron LHS <input type="text" value="N/A"/> Apron RHS <input type="text" value="N/A"/>	4 mm crack between RHS wing wall 1 and RHS headwall. Not load bearing. Structural stability not affected. 0.7 mm crack between RHS wing wall 2 and RHS headwall. Not load bearing. Structural stability not affected.
