Structures Engineering

Detailed Visual
Inspection Guidelines
for Culverts
(Level 2 Inspections)

DETAILED VISUAL CULVERT INSPECTION GUIDELINES (Level 2 Inspections)

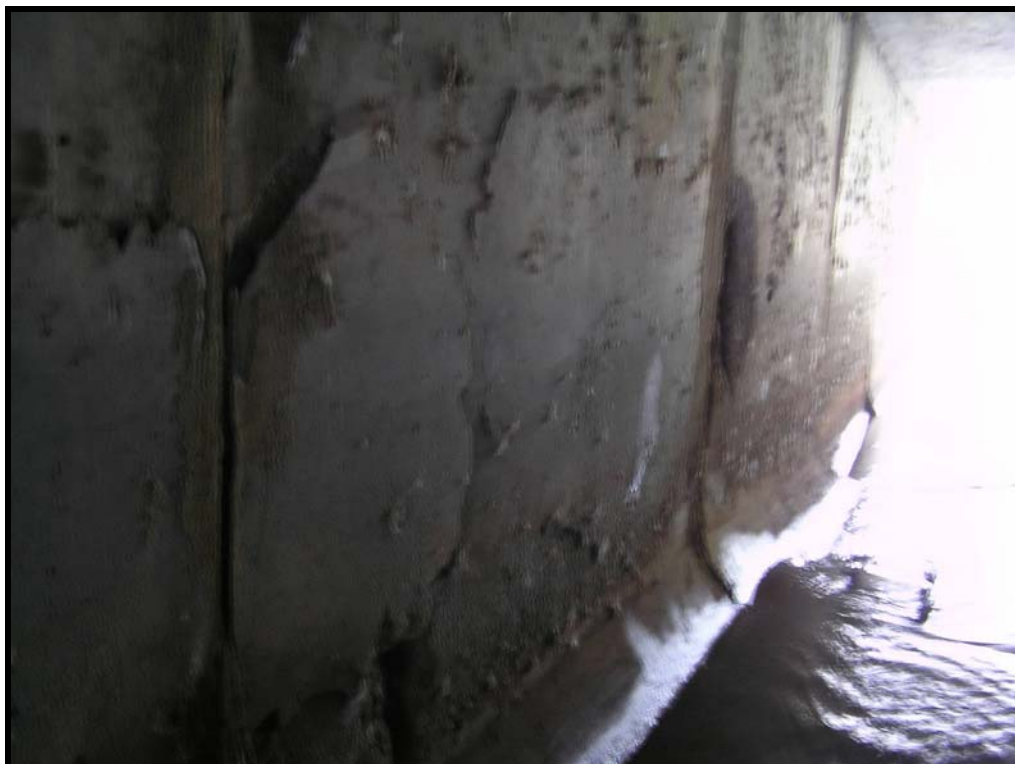
Photo 6 - TYPICAL DELAMINATION AND SPALLING OF CULVERT UNITS

Culvert is in poor condition with attention required within the next couple of years to ensure structural integrity. Delamination and spalling has resulted in advanced corrosion of steel reinforcement over large areas of each culvert unit with advanced section loss. Culvert replacement is recommended.

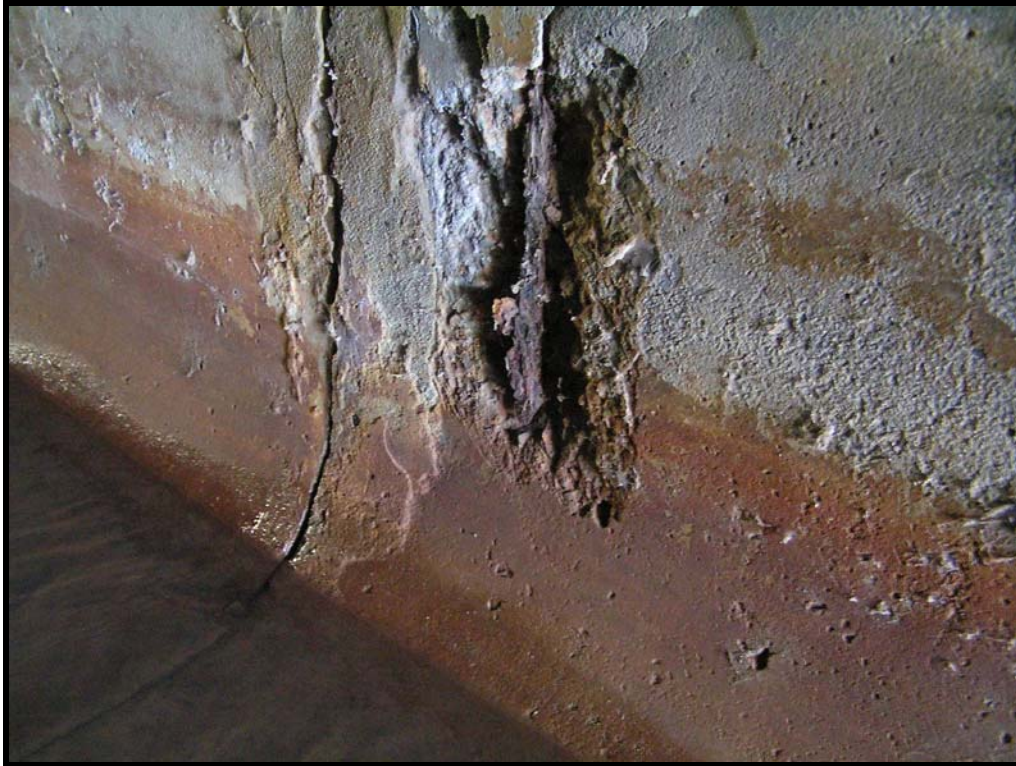
Photo 7 - TYPICAL CORROSION OF REINFORCEMENT IN CULVERT UNITS

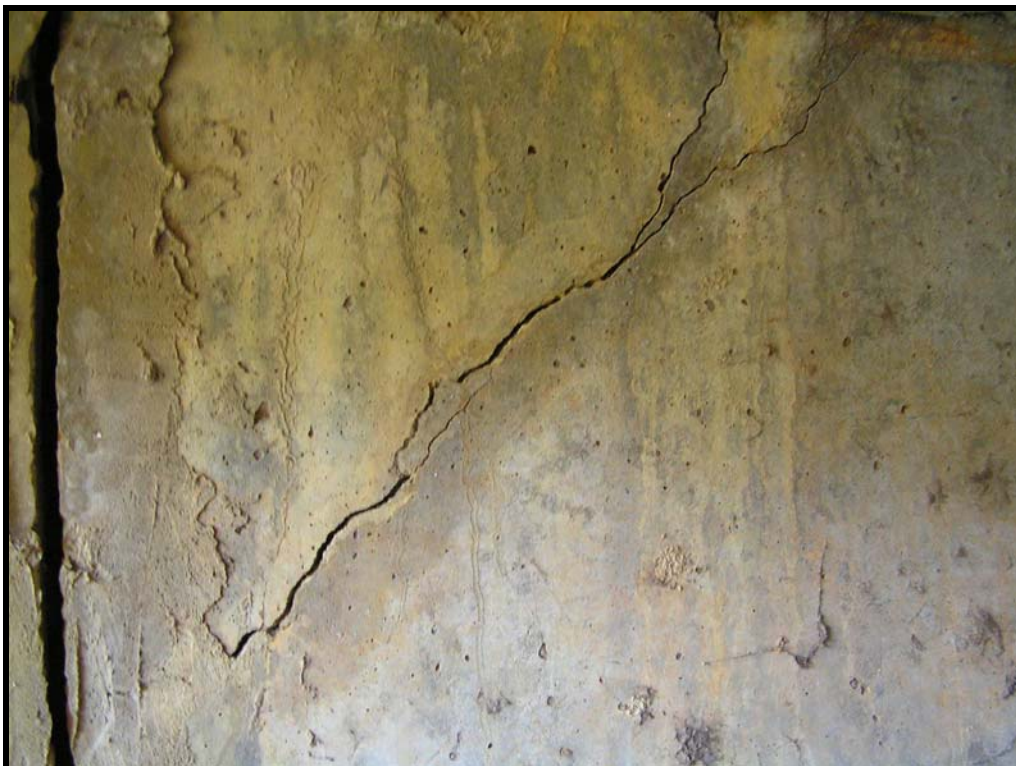
Photo 8 - 4 mm CRACK BARREL 2, UNIT 2, A2 SIDE

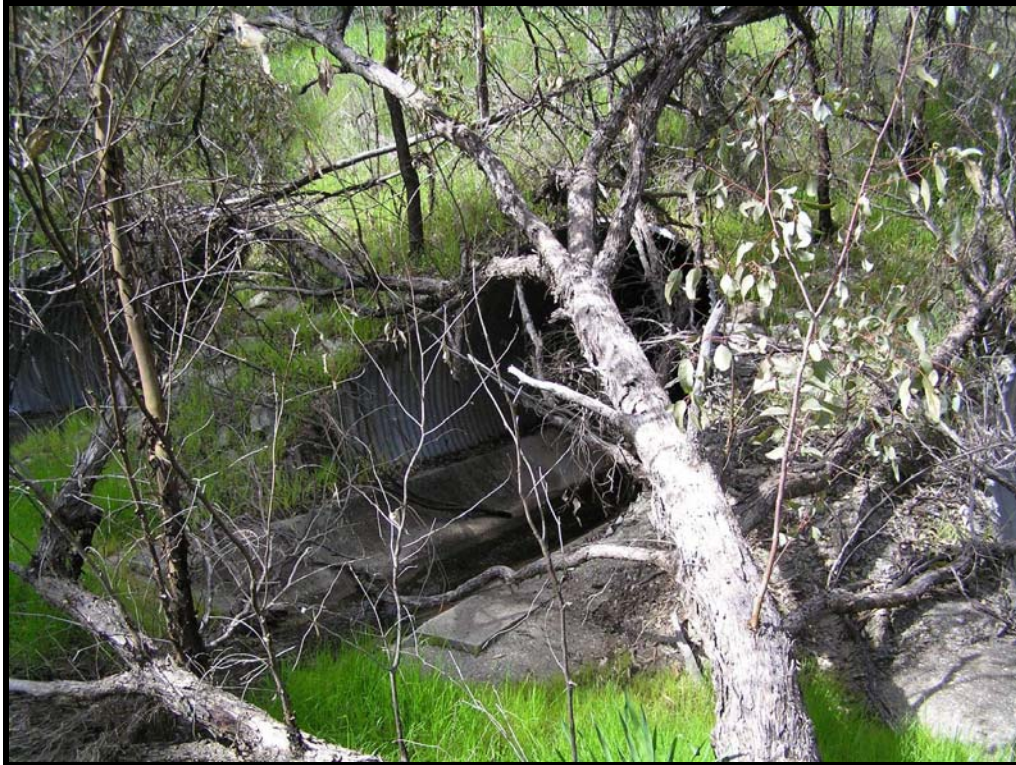
Photo 3 - WATERWAY PARTIALLY BLOCKED BY TREE AT INLET (LHS)

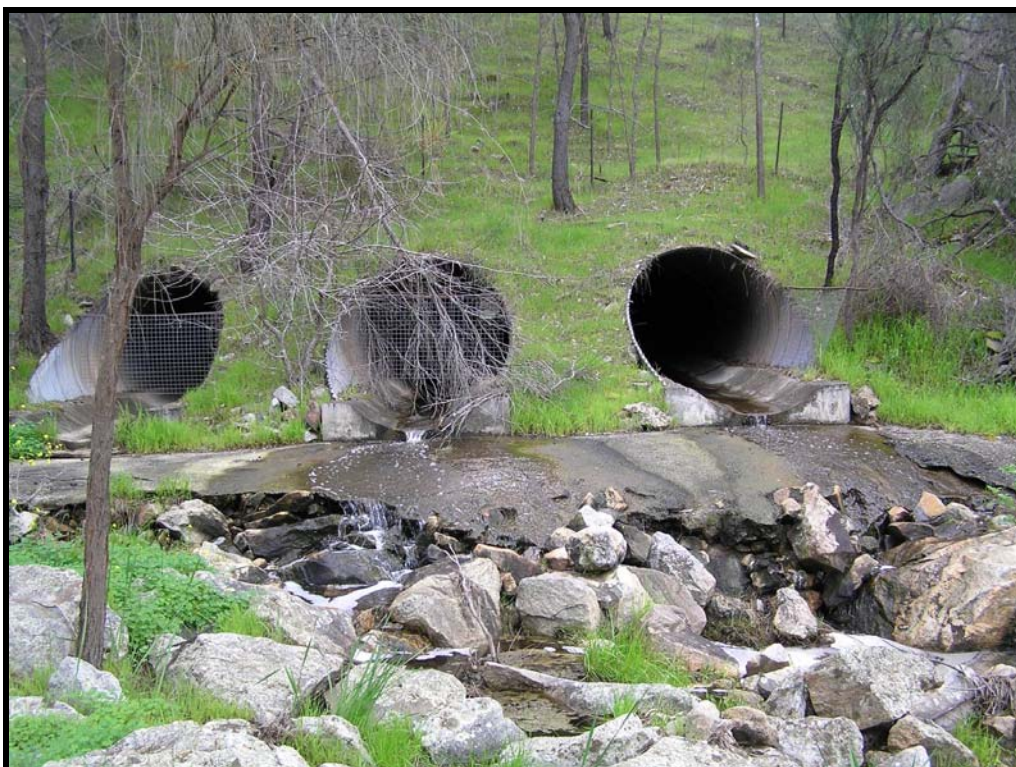
Photo 4 - UNDERMINING OF APRON ON RHS

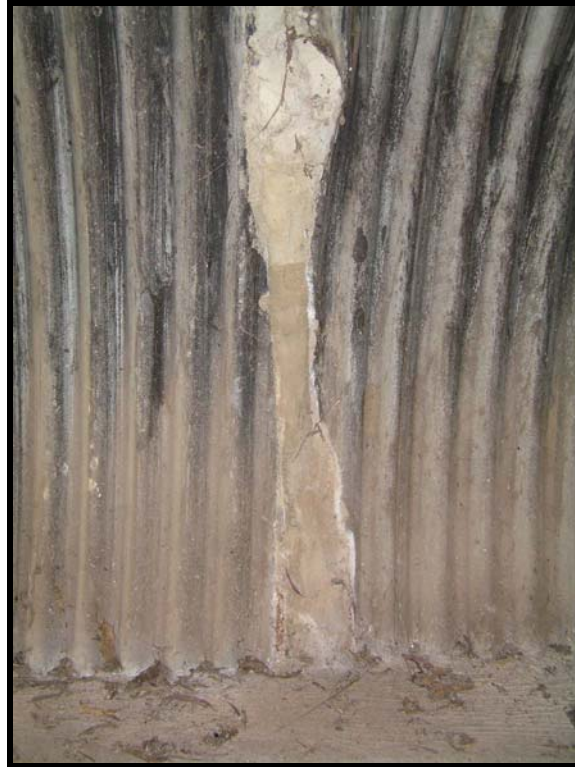
Photo 5 - TYPICAL CONCRETE PATCH AT CULVERT JOINTS

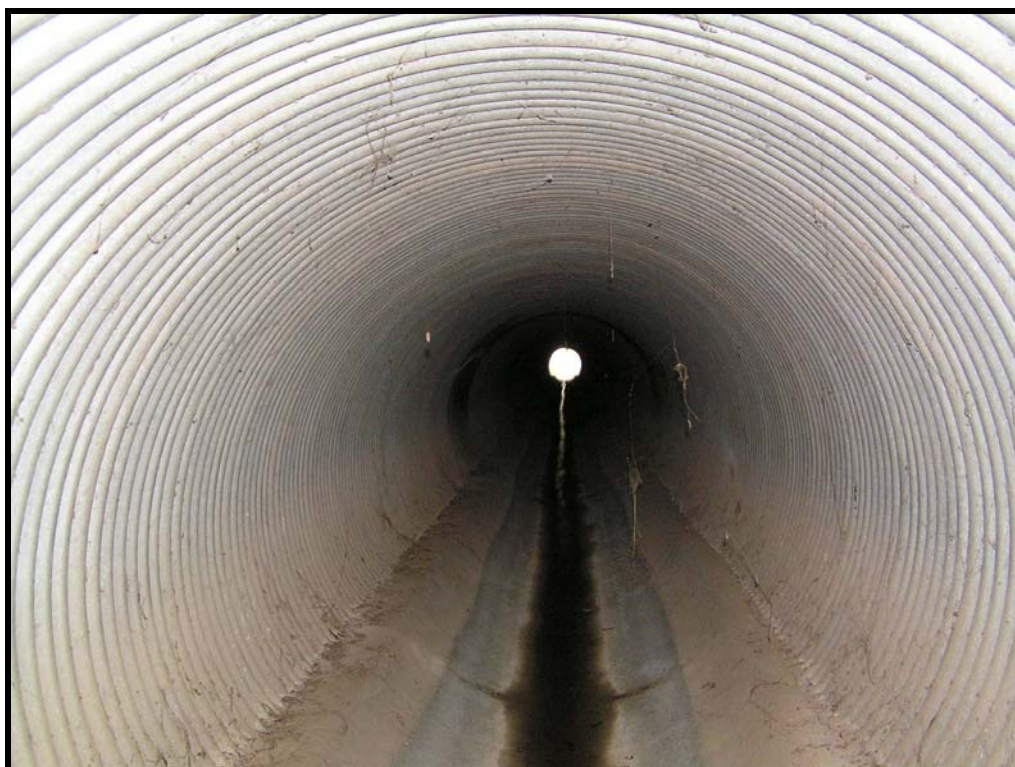
Photo 6 - TYPICAL CULVERT BARREL AND CONCRETE INVERT
