Clearing Desktop Report – Short Form

Proposal Name:	T4 Widening - M041 – York Merredin – SLK 112.32 – 143.41		
Region/Directorate:	Wheatbelt		
Local Government Authority:	Shire of Bruce Rock		
Road/Bridge Name and No:	York Merredin M041		
Proposal Location (SLK):	SLK 112.32 – 143.41		
TRIM Link to Spatial Data:	CPS 818 shapefile - D22#885668		
EOS No:	2701		
Expected Proposal Start Date:	October 2022		
Project No:	30000432 Task Code: 19130		19130
LISC TRIM No:	D22#685135 HRA TRIM No: D22#191933		D22#191933

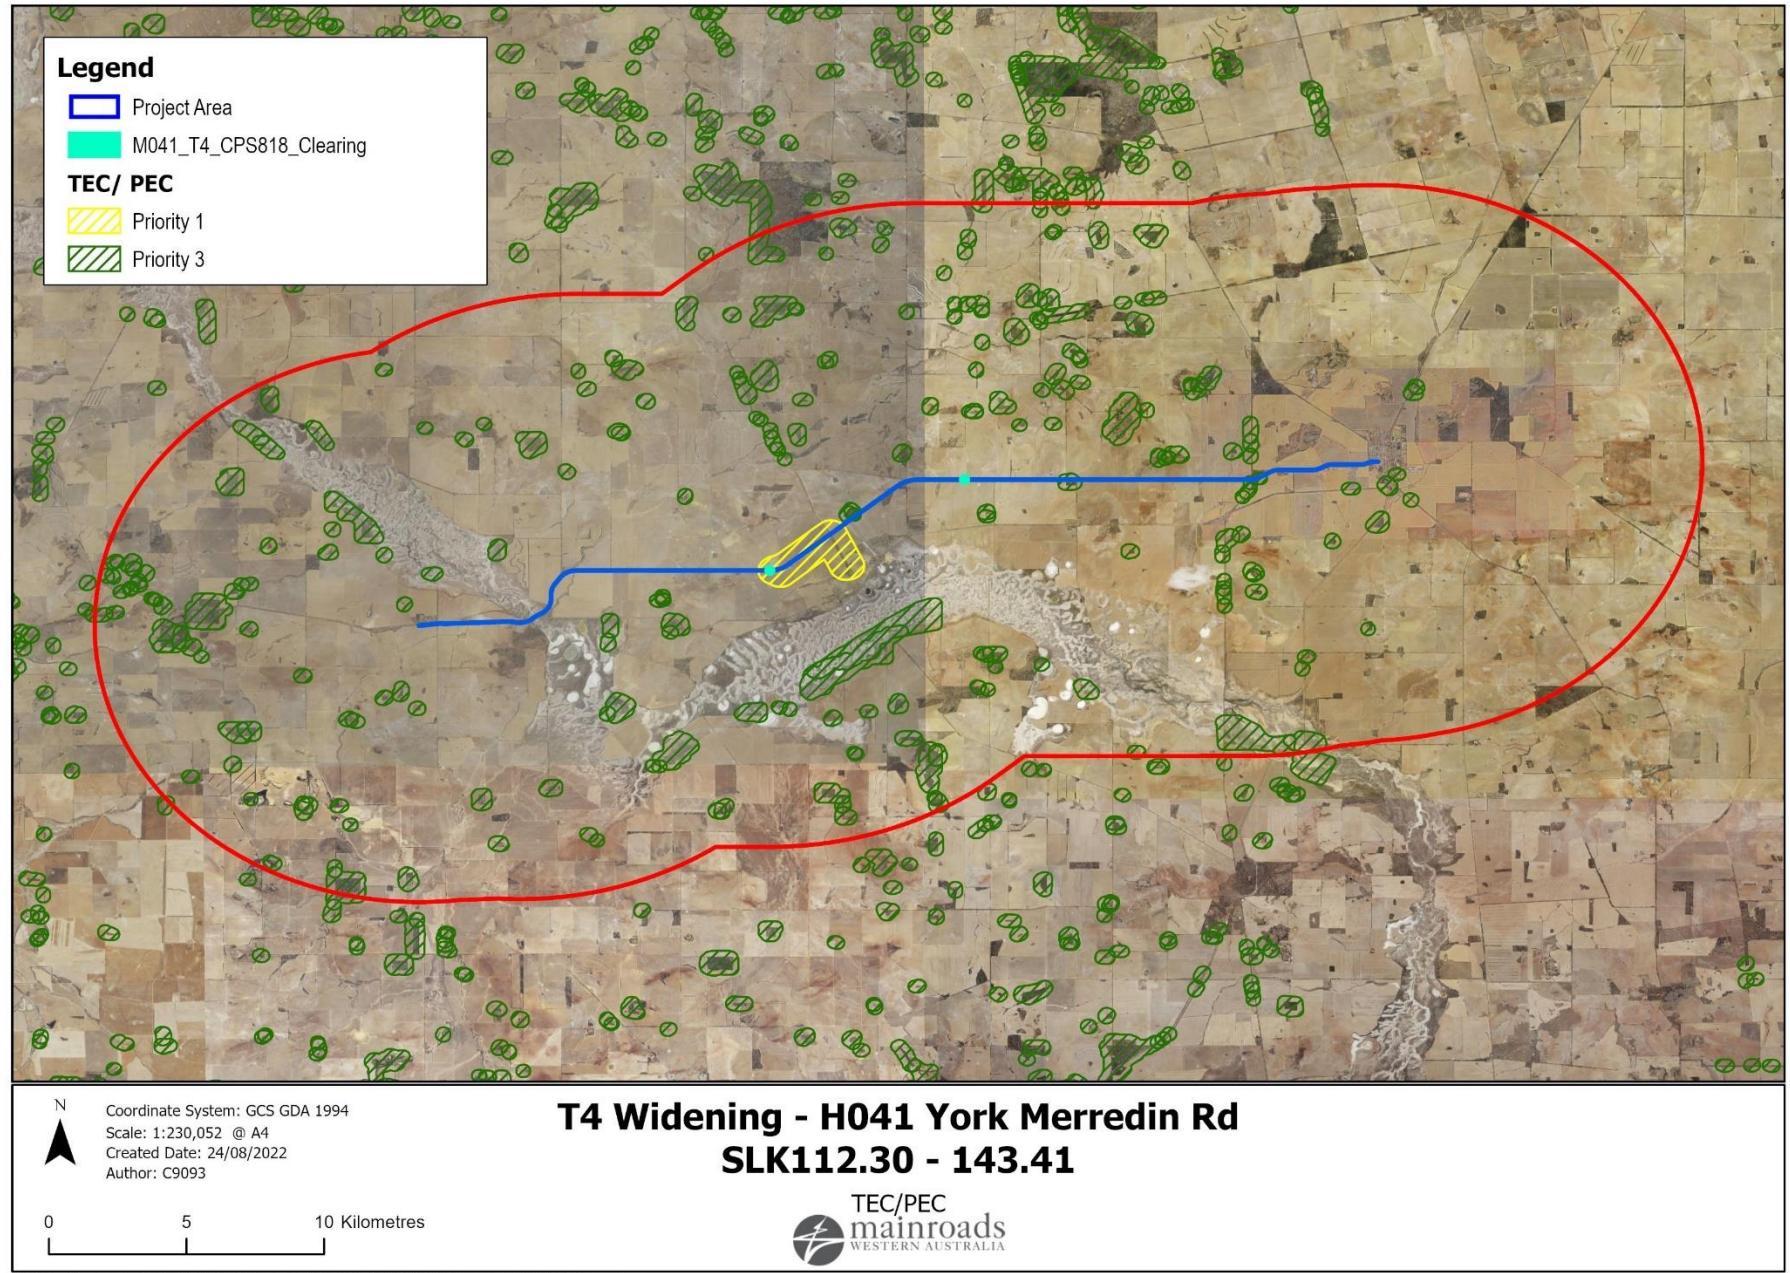
Figure 3: Threatened Ecological Communities and Priority Ecological Communities

Analysis of GIS datasets suggest that the Commonwealth listed TEC <i>Eucalypt woodlands of the Western Australian Wheatbelt</i> occurs within 1,500m of the proposed clearing area (Figure 3).
	No proposed clearing areas intersect these mapped areas of TEC. Furthermore, the vegetation proposed does not represented the TEC in accordance with the criteria listed in <i>"Eucalypt Woodlands of the Western</i>
