# **METROPOLITAN REGIONAL ROAD GROUP (MRRG)**

## **Guidelines for the Submission of Road Rehabilitation Projects**

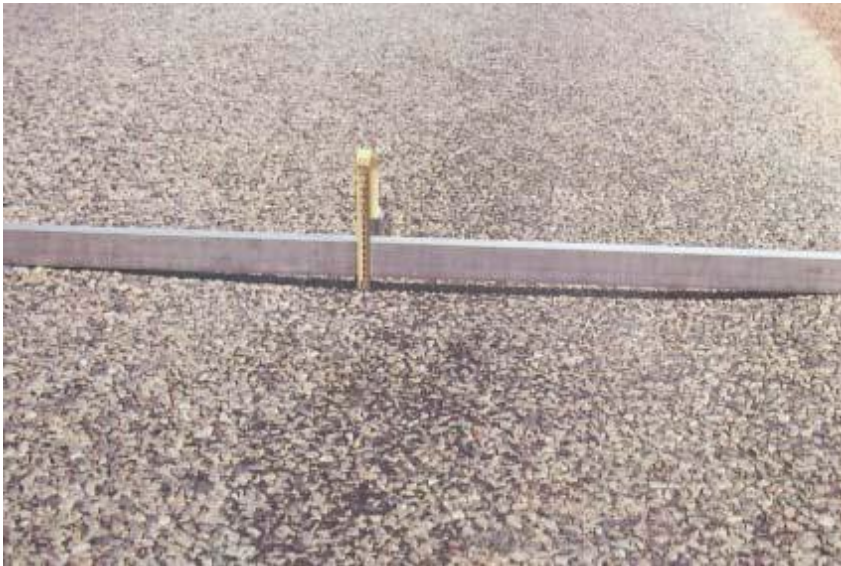
## LOW SEVERITY

LOW - Depression below a 1.2m straight edge from 10-15 mm MEDIUM - Depression below a 1.2m straight edge from 16-25 mm

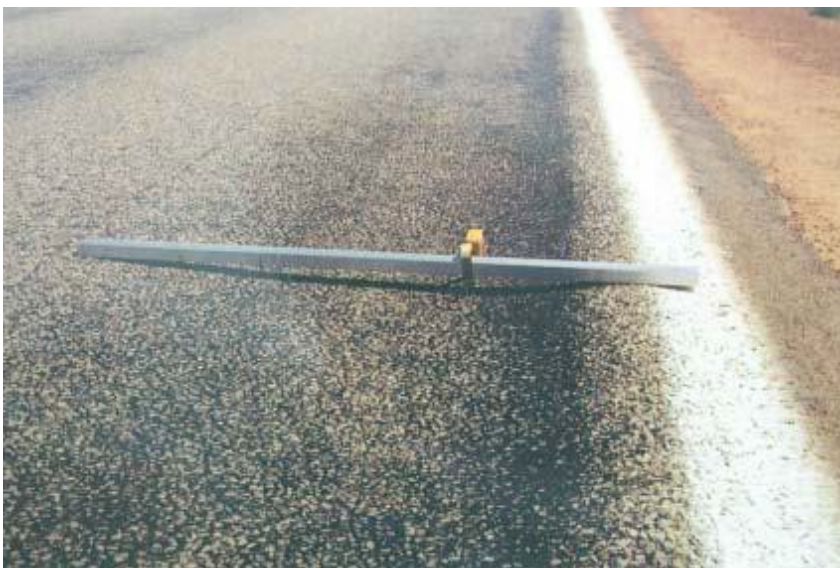
**HIGH SEVERITY**

HIGH - Depression below a 1.2m straight edge exceeds 25 mm or ponding of water hazardous traffic to occur.

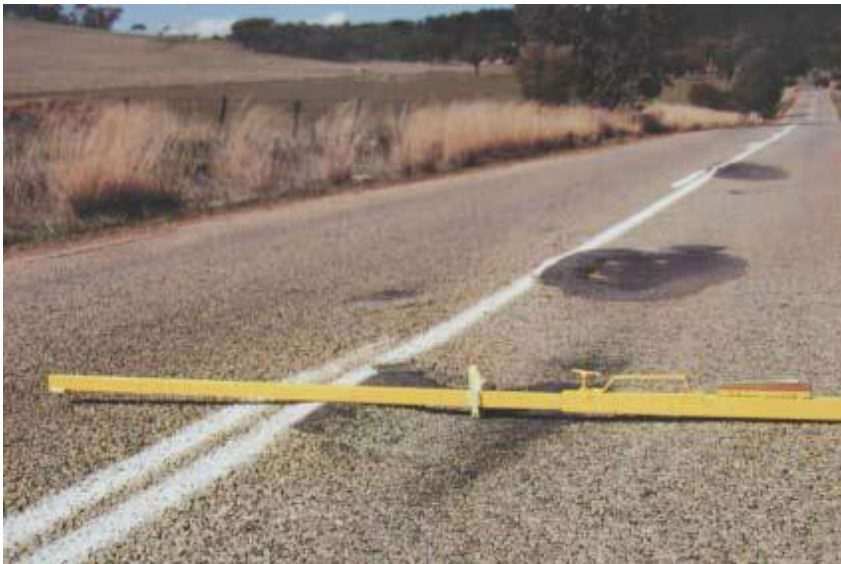
**LOW SEVERITY**

Medium - Depth below a 3m straight edge from 36-50mm when measured to the trough with one end of the straight edge resting on the crest of the bulge.

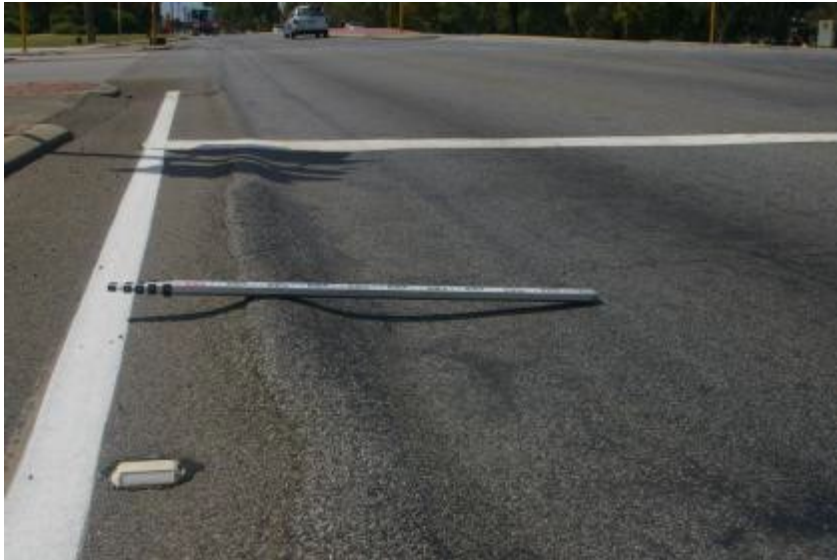
**HIGH SEVERITY**

High - Depth below a 3m straight edge from exceeds 50mm when measured to the trough with one end of the straight edge resting on the crest of the bulge.

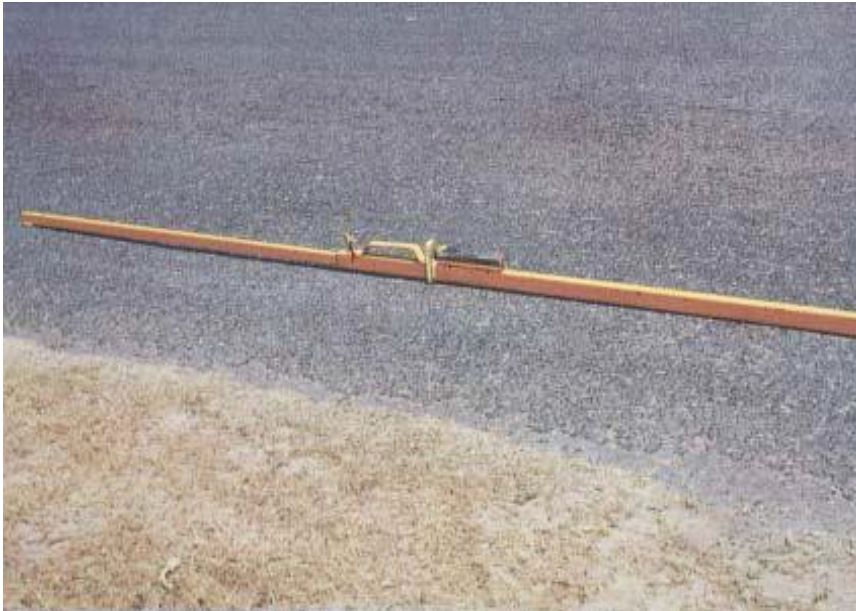
**LOW SEVERITY**

Low - Depression below a 3m straight edge from 15-25 mm Medium - Depression below a 3m straight edge from 26-40 mm

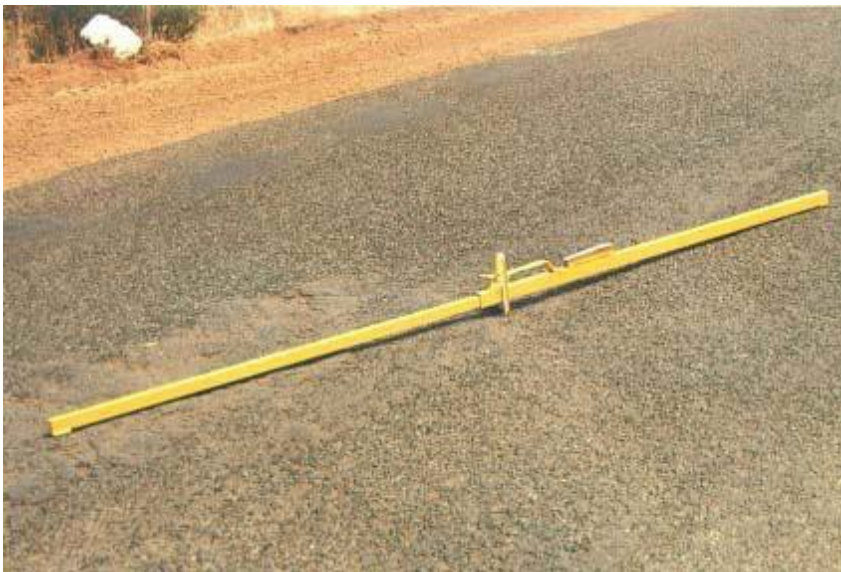
**HIGH SEVERITY**

High - Depression below a 3m straight edge exceeds 40 mm or ponding of water hazardous to traffic occurs.

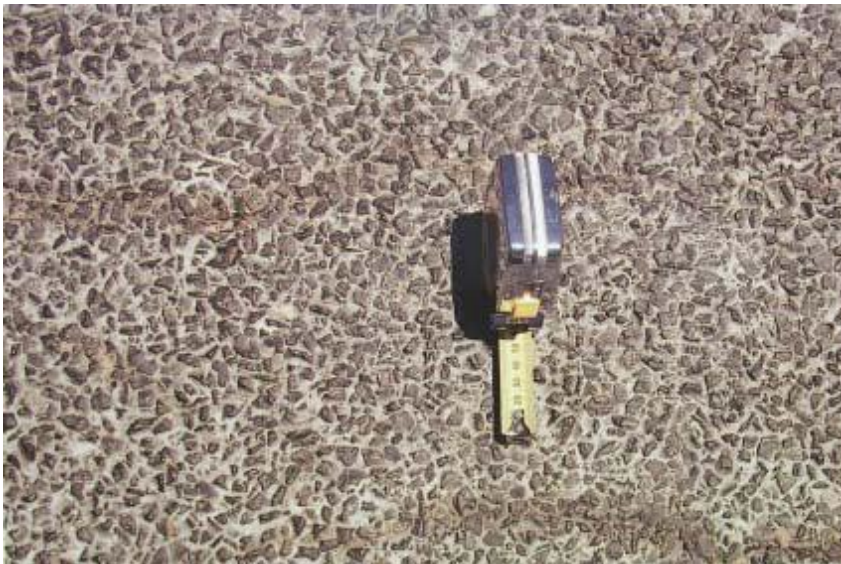
### LOW SEVERITY

LOW – Dominant crack width less than 2 mm wide MEDIUM - Dominant crack width 2-5 mm wide HIGH - Dominant crack width more than 5 mm wide

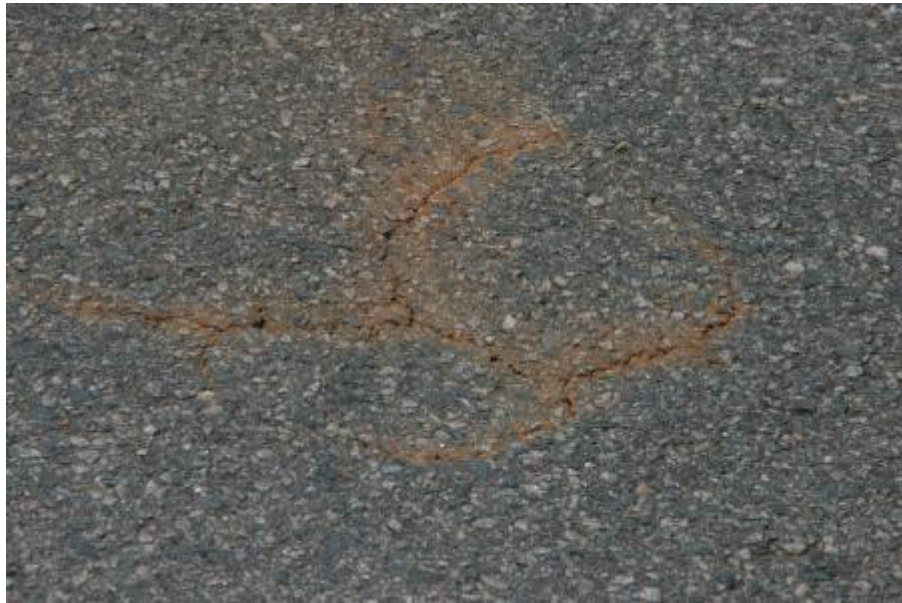
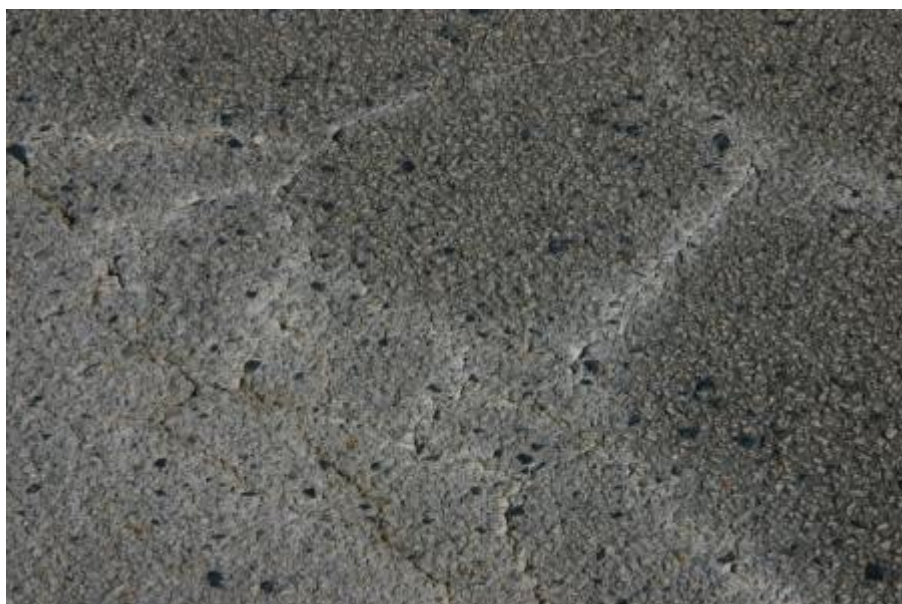
HIGH - All environmental unstable cracks are rated as high.

**HIGH SEVERITY Environmental unstable cracks**

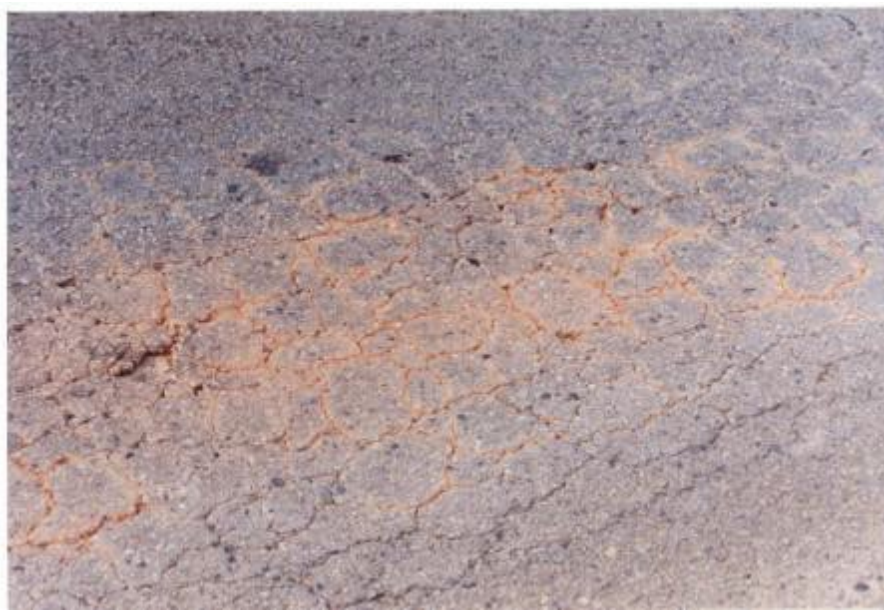
HIGH - All fatigue cracks are rated as high.

**HIGH SEVERITY structural cracking with pumping**

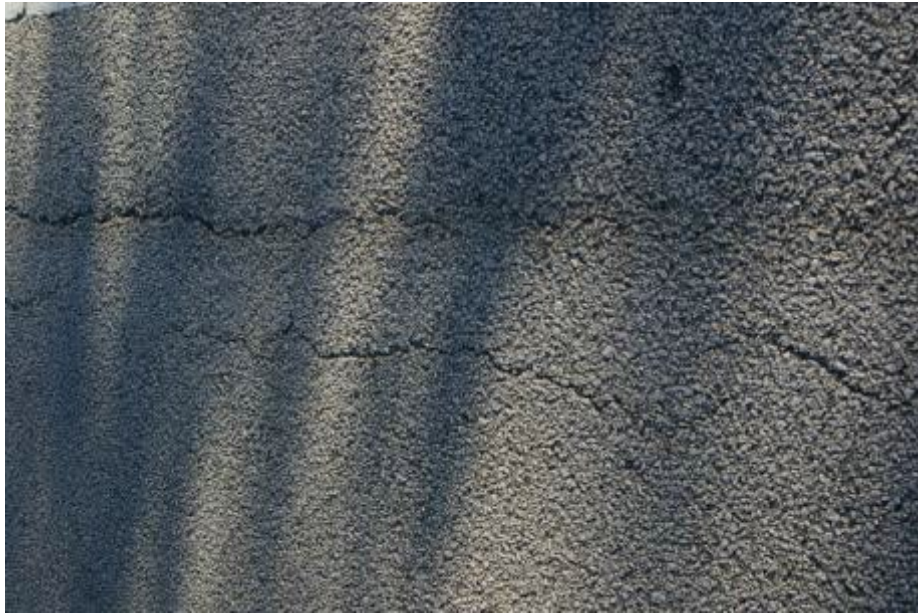
**HIGH SEVERITY structural cracking early stages of development**

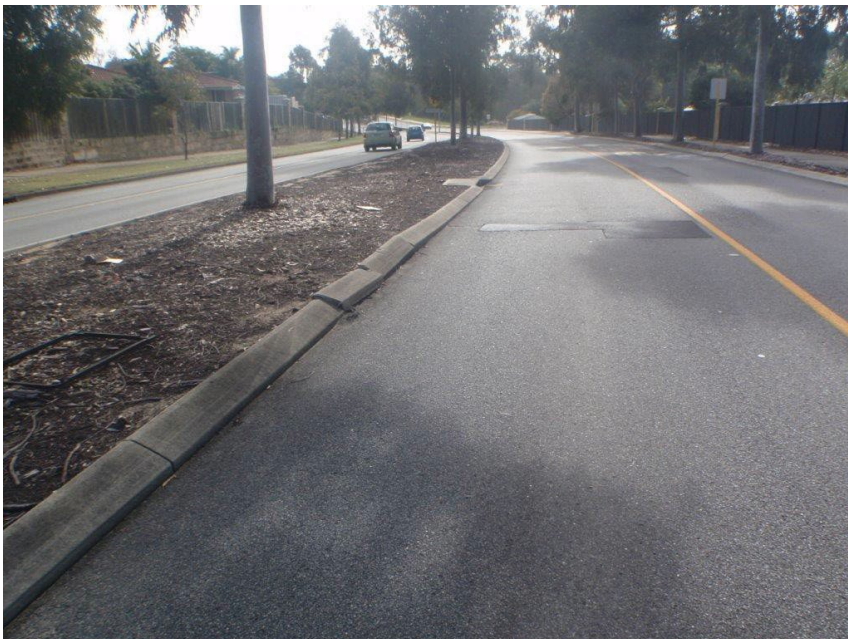
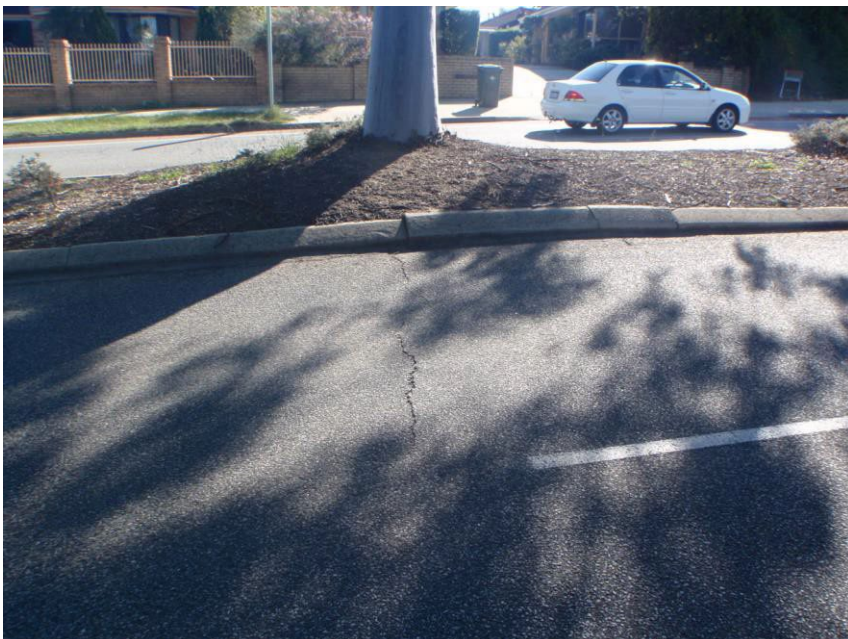
LOW – Vertical/horizontal variation from a 3 m straight edge is 20 – 50 mm. MEDIUM - Vertical/horizontal variation from a 3 m straight edge is 51 – 80 mm. HIGH - Vertical/horizontal variation from a 3 m straight edge is more than 80 mm.

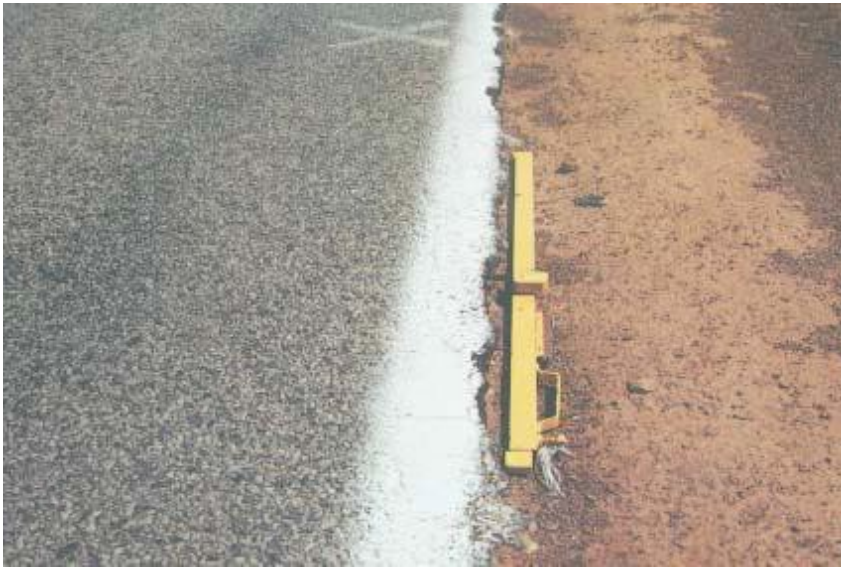
**LOW SEVERITY**

LOW - Edge break between 20 and 50 mm from the original seal width MEDIUM - Edge break between 51 and 100 mm from the original seal width HIGH - Edge break over 100 mm from the original seal width.

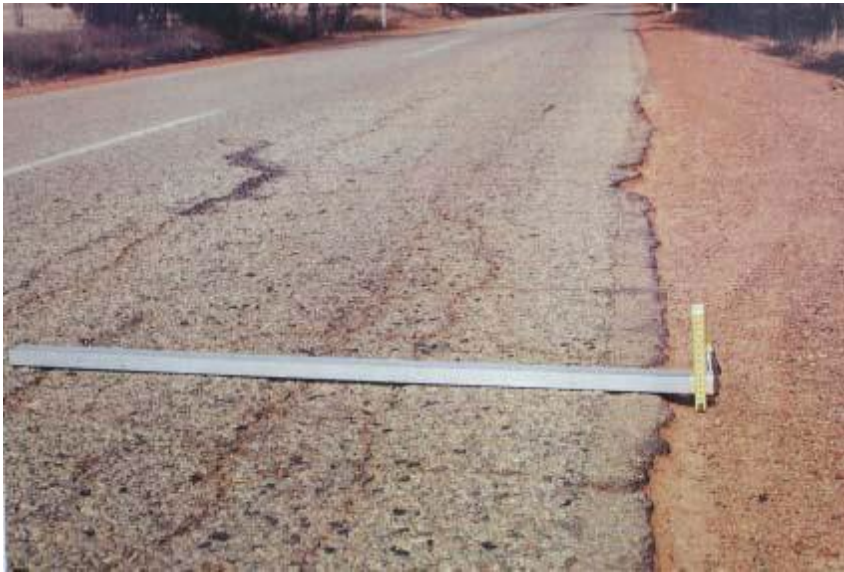
**LOW SEVERITY**

LOW - Vertical drop between 15 and 25 mm MEDIUM - Vertical drop between 26 and 50 mm HIGH - Vertical drop greater than 50 mm

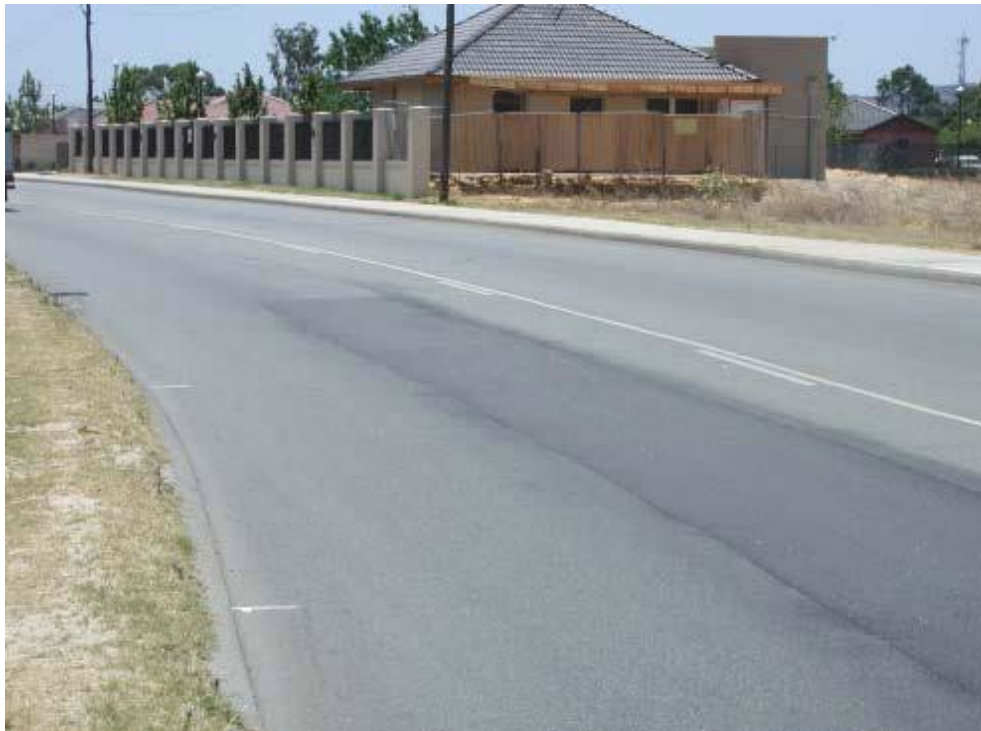
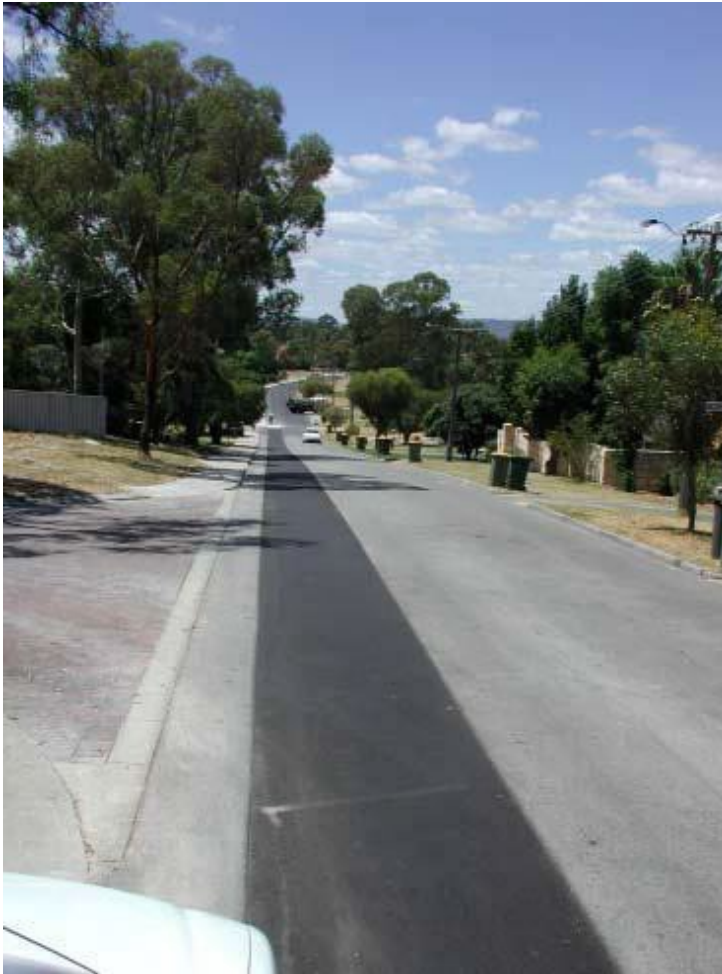
HIGH – Patching is always rated as HIGH severity.

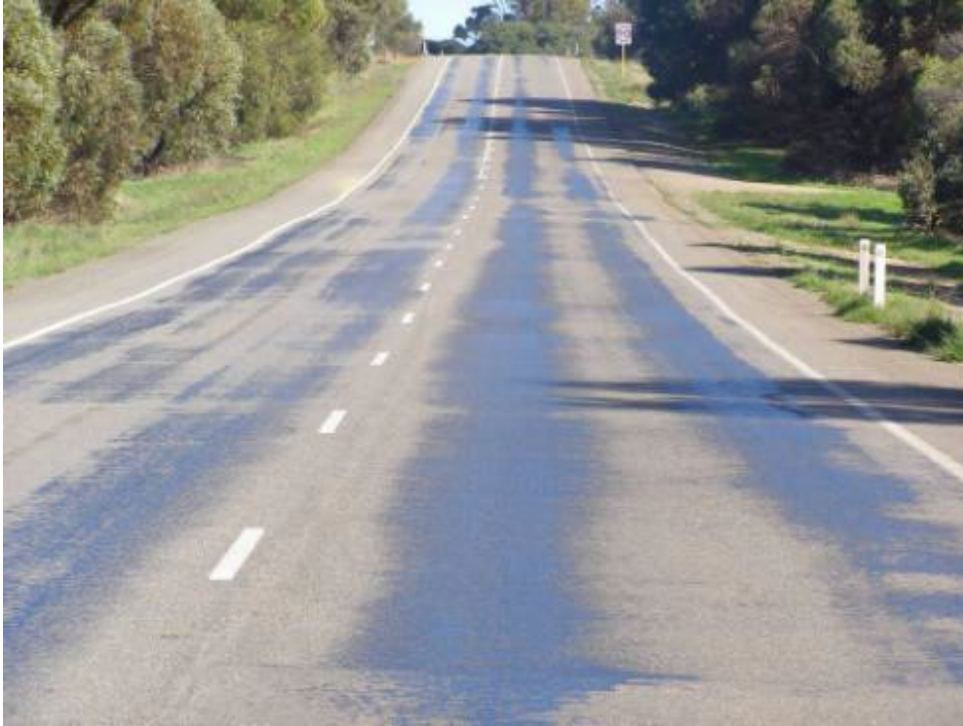
## Flushing

Flushing typically occurs on Chip Seal roads and is a defect caused by either bitumen rising to the surface of the road, or stone aggregate being pushed down into the surface.

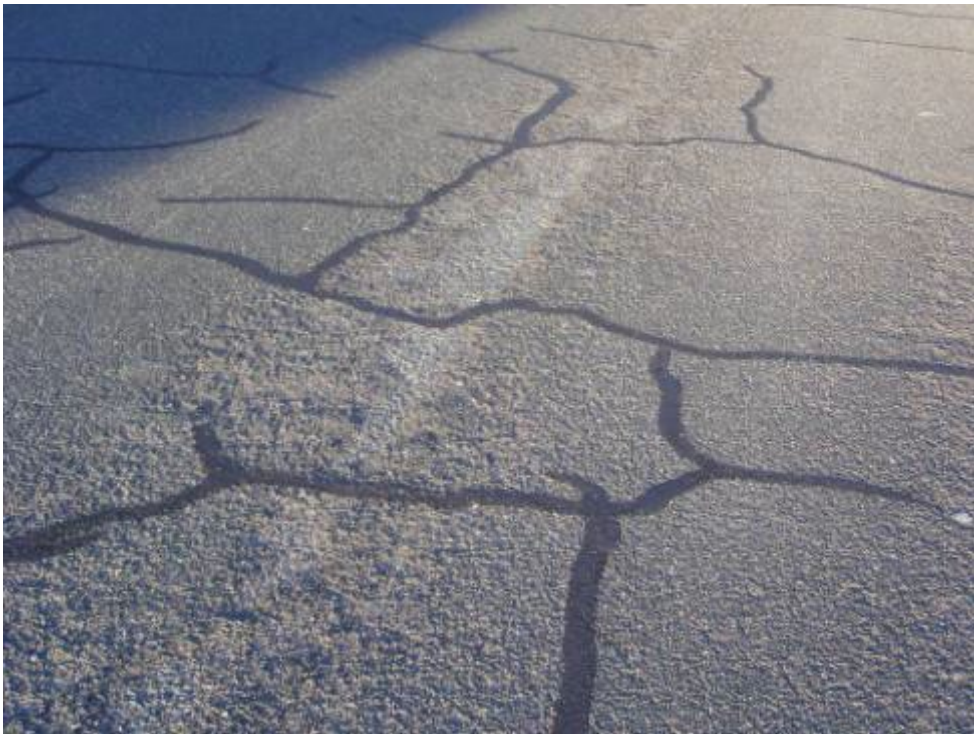
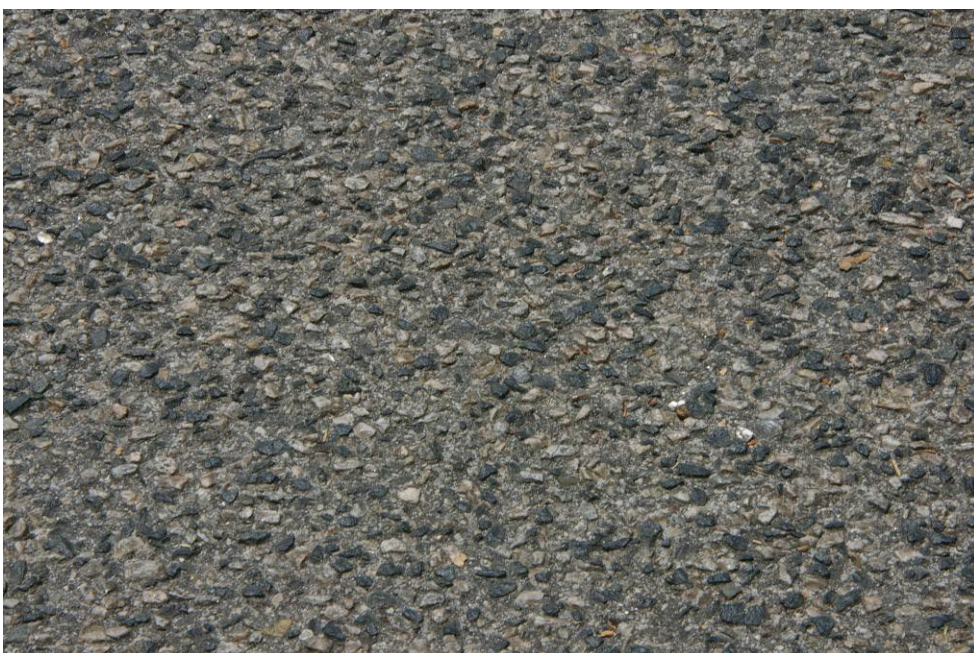
## Ravelling

Ravelling commences as the loss of fines from the surface. The bitumen binder oxidises and hardens over time due to exposure to oxygen and ultra violet light and the asphalt becomes more prone to ravelling and surface cracking. Ravelling is often highly evident in the non-trafficked areas, but does not appear as severe in the wheel paths, as the aggregate itself is subject to attrition in these areas, thus the surface texture is lower in the wheel paths than non-wheel paths. Ravelling shall be scored only where the resultant surface texture is high leaving coarse aggregate well exposed.
