# EPBC 2017/7880 Annual Compliance Report 2021/2022

Marble Bar Road Coongan Gorge Realignment  
and MO30 Material Pit Expansion: Pilbara  
Region, WA.

# Northern Quoll

## Camera Trap Monitoring Program

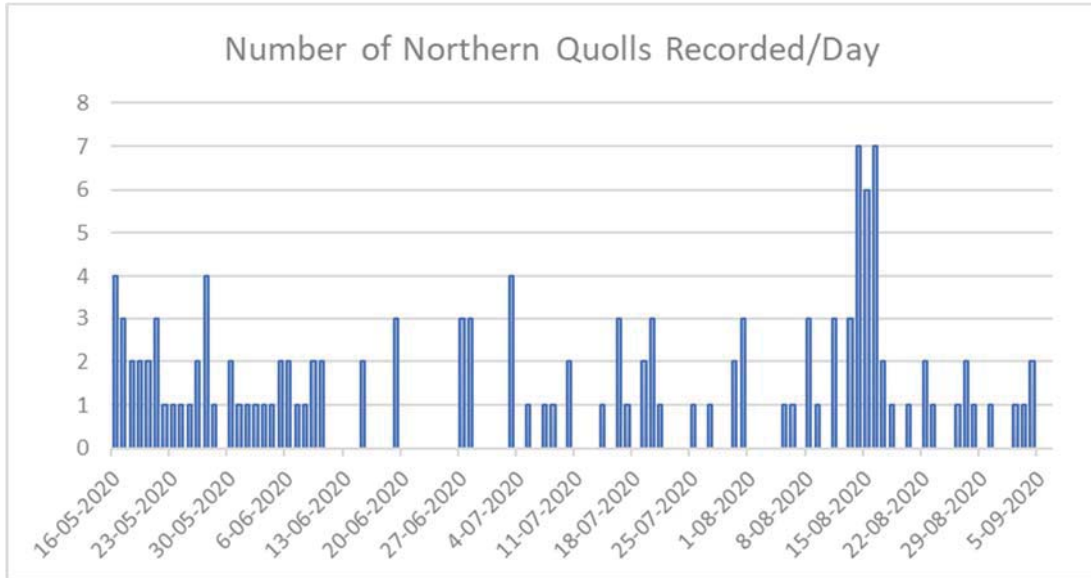
**Plate 1: Number of Northern Quolls Recorded/Day (2020)**

During the 2020 monitoring period northern quolls were recorded on 91 of the 116 days of monitoring. The specific days and number of northern quolls recorded are shown in Plate 1.

During 2020, northern quolls were consistently recorded from the commencement of monitoring (16 May 2020) until the 11 June 2020 from which point records became relatively intermittent. From about the 8 August 2020 records increased in frequency with a peak around the 16 August 2020.

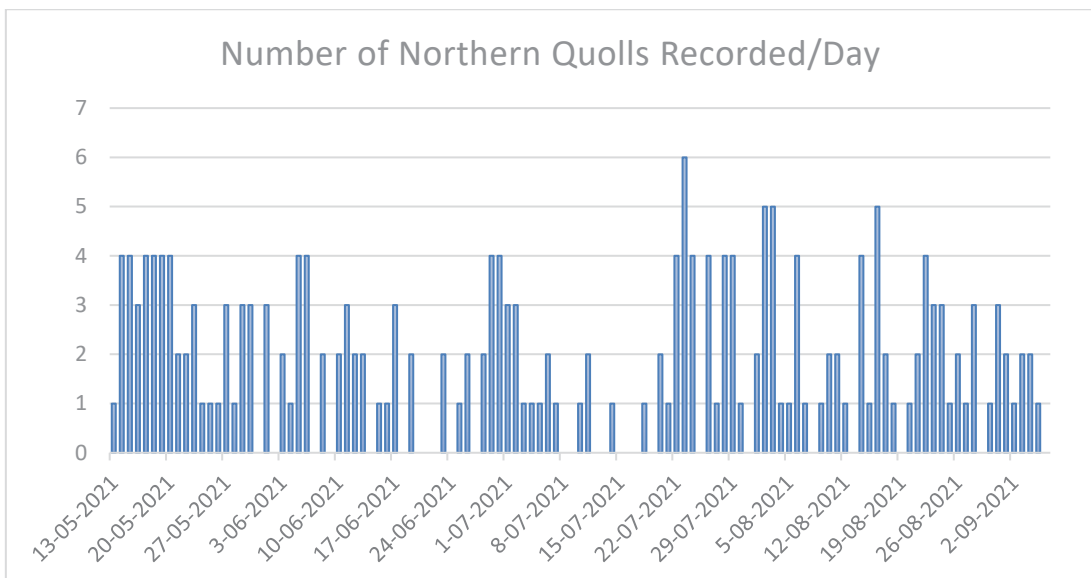
**Plate 2: Number of Northern Quolls Recorded/Day (2021)**

During the 2021 monitoring period northern quolls were recorded on 100 of the 116 days of monitoring. The specific days and number of northern quolls recorded are shown in Plate 2.

During the 2021 monitoring period northern quolls were consistently recorded from the commencement of monitoring from the 13 May 2021 until the 30 May 2021 from which point records became generally more intermittent. From about the 20 July 2021 records increased in frequency with detections peaking at six in one day on the 23 July 2021.

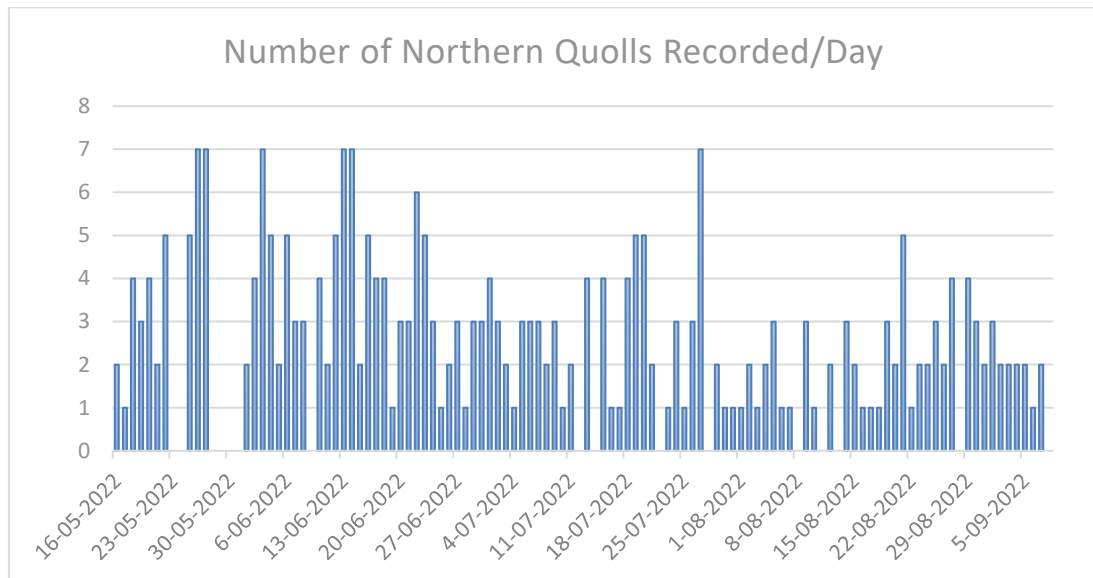
**Plate 3: Number of Northern Quolls Recorded/Day (2022)**

During the 2022 monitoring period more northern quoll detections were made than either of the two previous phases carried out in 2020 and 2021. With the exception of a few gaps in detections in late May and then in mid-July and early August northern quolls were consistently recorded over the entire monitoring period. There is a drop off in detections around early July and again early August which may correspond to the breeding cycle of the species.

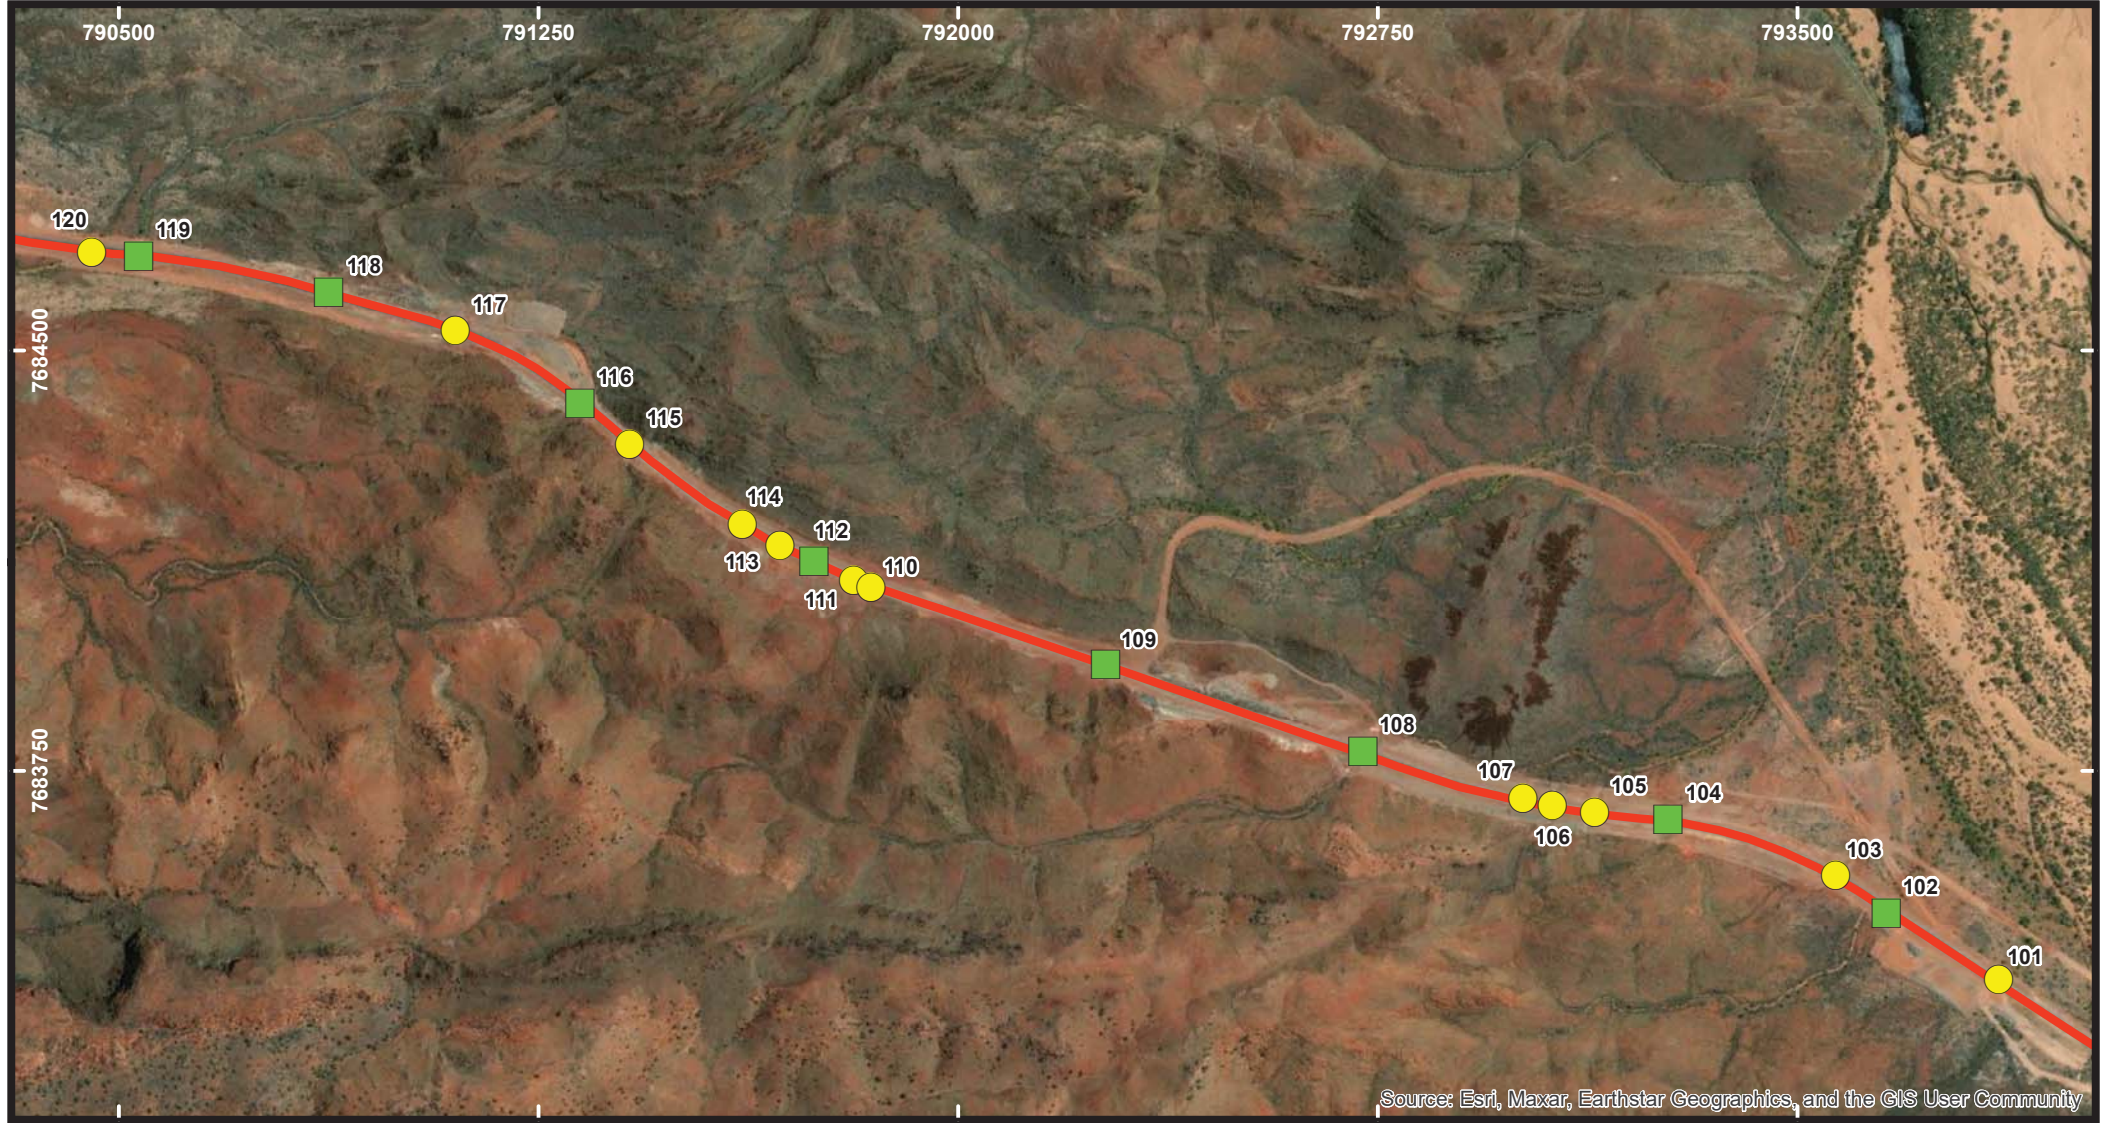
**Culvert  
Locations**

Culverts were installed at 20 locations along the new road realignment. Twelve sites utilised pipe culverts and eight, box culverts (Figure 1). The number (and size) of actual culverts at each site ranges from one to five as determined by anticipated hydraulic requirements.

Culverts were installed at 20 locations along the new road realignment. Twelve sites utilised pipe culverts and eight, box culverts (Figure 1). The number (and size) of actual culverts at each site ranges from one to five as determined by anticipated hydraulic requirements.

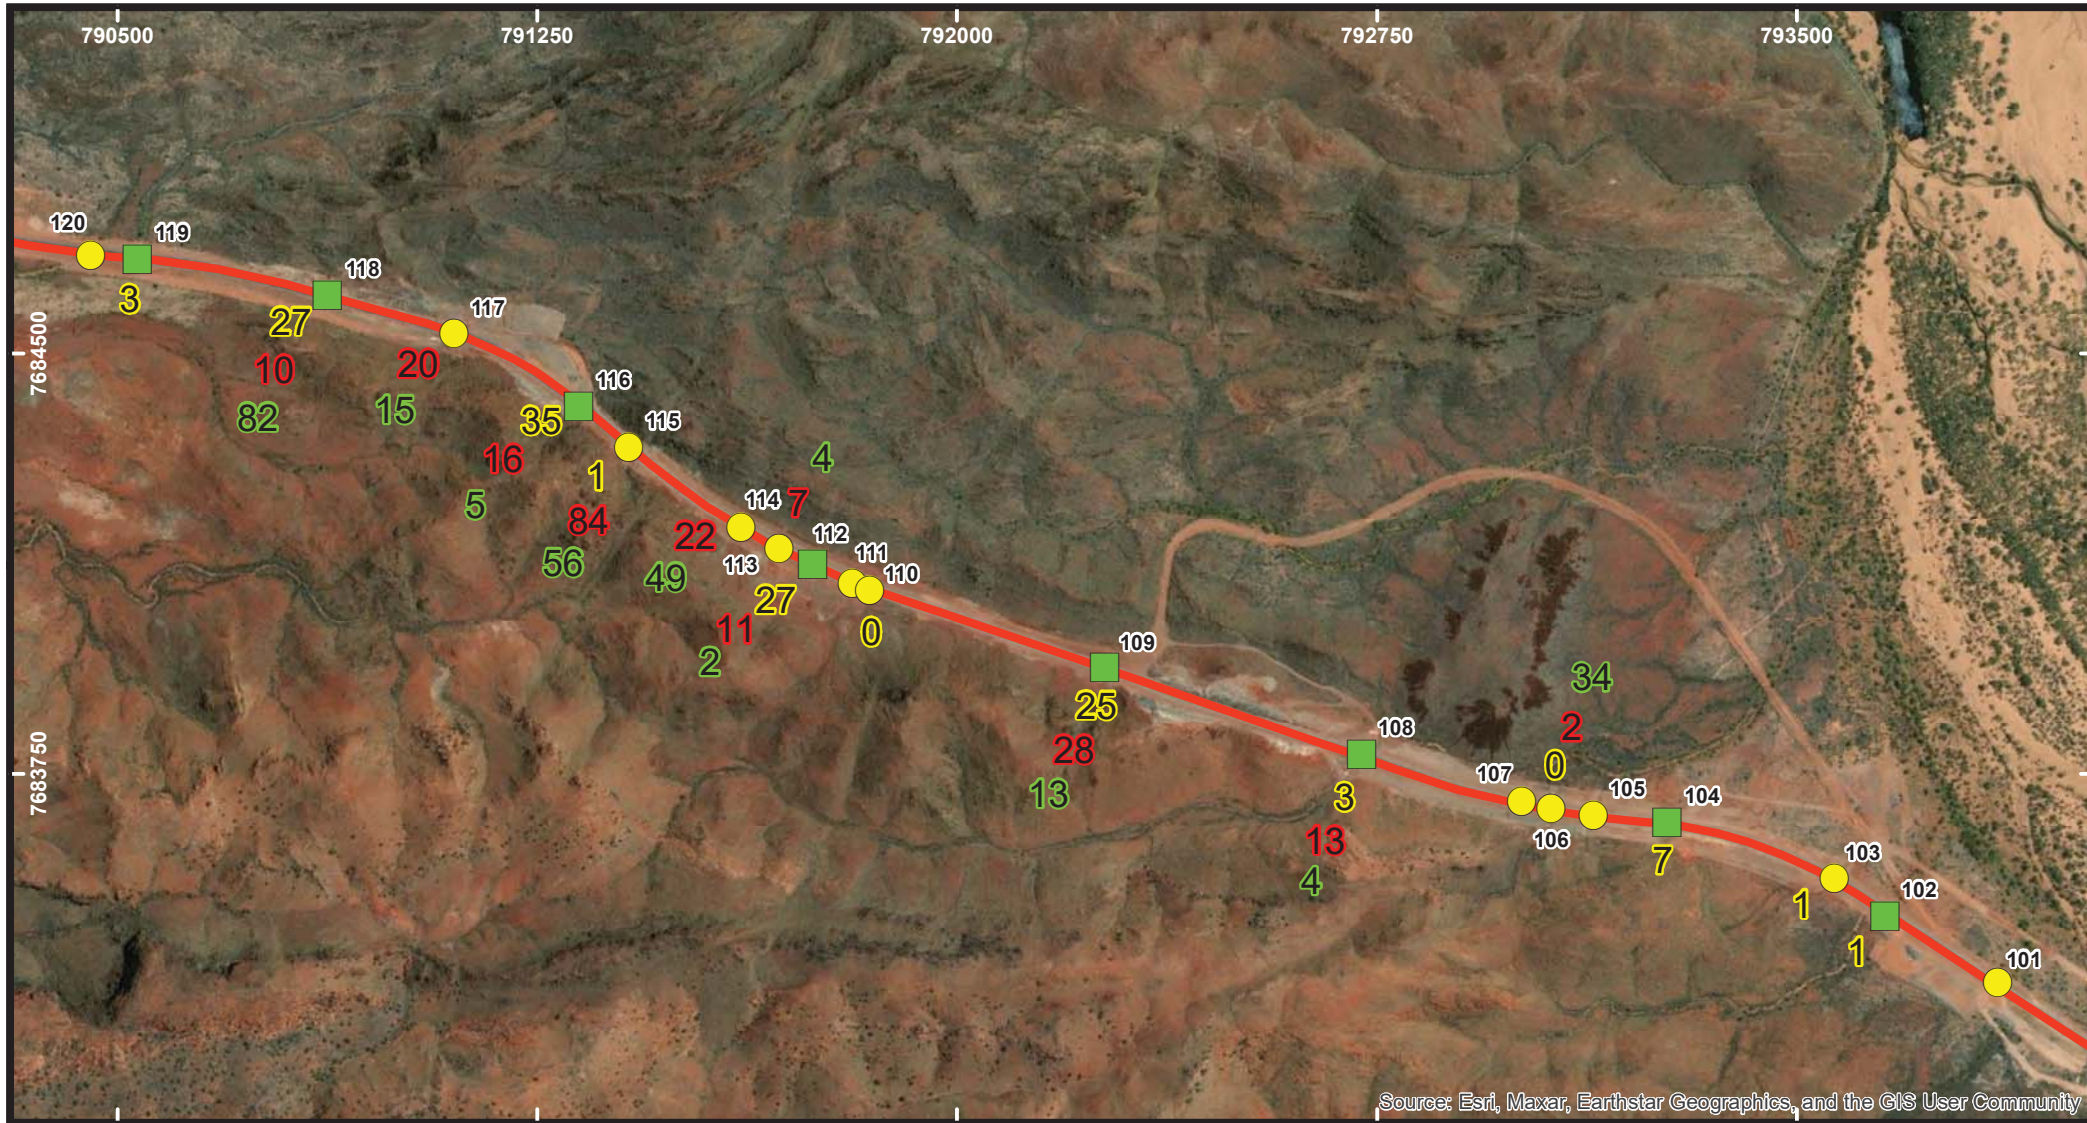
Figure 2 provides a summary of the total number of northern quolls recorded at each culvert during each monitoring period. Table 4 details total detections and actual culvert use during each monitoring period.
