NorthLink WA Perth-Darwin National Highway (Swan Valley Section)

Project No: EP19-111(28)

Doc name:	Compliance Assessment Report NorthLink WA Perth-Darwin National Highway (Swan Valley Section)					
Doc no.:	EP19-111(28)128/	EP19-111(28)128A LR				
Version	Date	Author Reviewer				
1	December 2023	Liesl Rohl	LR	Toni Burbidge	ТВ	
1	Draft for Main Roads review					
А	December 2023	Liesl Rohl	LR	Toni Burbidge	ТВ	
	Updated following Main Roads review

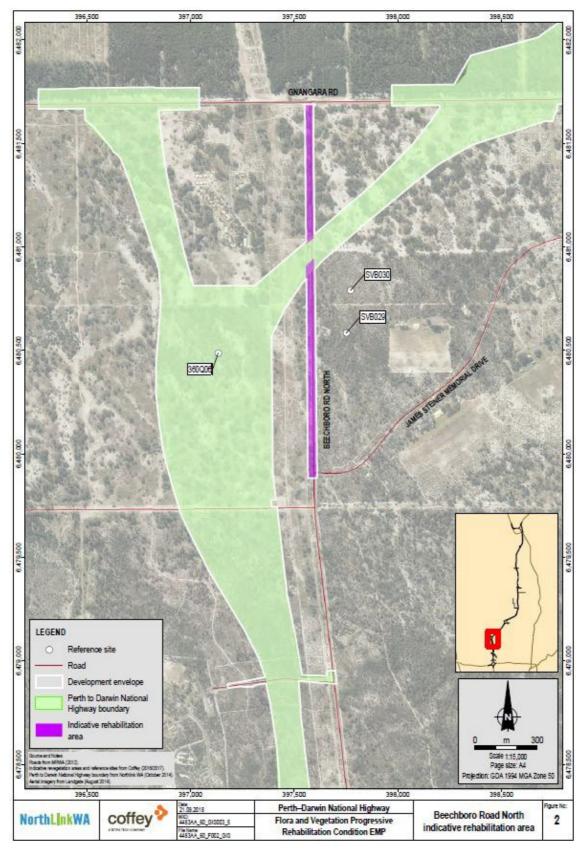
Plate 2: Beechboro Road North indicative rehabilitation area.

Objective two relates to this potential non-compliance. The *Condition Environmental Management Plan – Flora and Vegetation – Progressive Rehabilitation* sets out the requirements for rehabilitation of Beechboro Road North, including the two management targets required to achieve the environmental objective.

Management target 2 requires the rehabilitation site to meet the completion criteria after 3 years (i.e. by August 2022). Ecoscape undertook post-revegetation monitoring in summer 2022 (3rd year of monitoring), which determined that 2 of 7 completion criteria had been met. Given 5 completion criteria (criteria 1-5), had not been met after three years, management target 2 has not been achieved. As such, condition environmental objective 11-1(2) has not been met.

The failure to achieve the management target is due to difficult site conditions, which includes poor seed germination within in-situ soils, extreme heat in summer of 2021/2022 and heavy predation by local fauna. The ongoing lack of success at this site is largely due to predation by kangaroos and to a lesser extent by rabbits.

The CEMP Flora and Vegetation – Progressive Rehabilitation (2018) details the completion criteria to meet the management targets of density and cover of rehabilitation. Amendments to the target completion percentages may be required to account for the site and contributing factors to low seedling survival. This may include broadening the range of species approved to plant and reducing the diversity whilst increasing the rehabilitation success using species able to survive in the soil type, climatic conditions and that are less prone to predation.
