Review of Regional Claypan Occurrences (Ecoedge 2019a)

Client:	GHD MRWA BORR team
Attention:	Fionnuala Hannon < Fionnuala.Hannon@ghd.com >
From:	Debbie Brace < debbie@ecoedge.com.au > debbie@ecoedge.com.au 0484 771 825
Date:	19 August 2019
Subject:	Review of Potential Claypan Occurrences in the BORR Southern Section

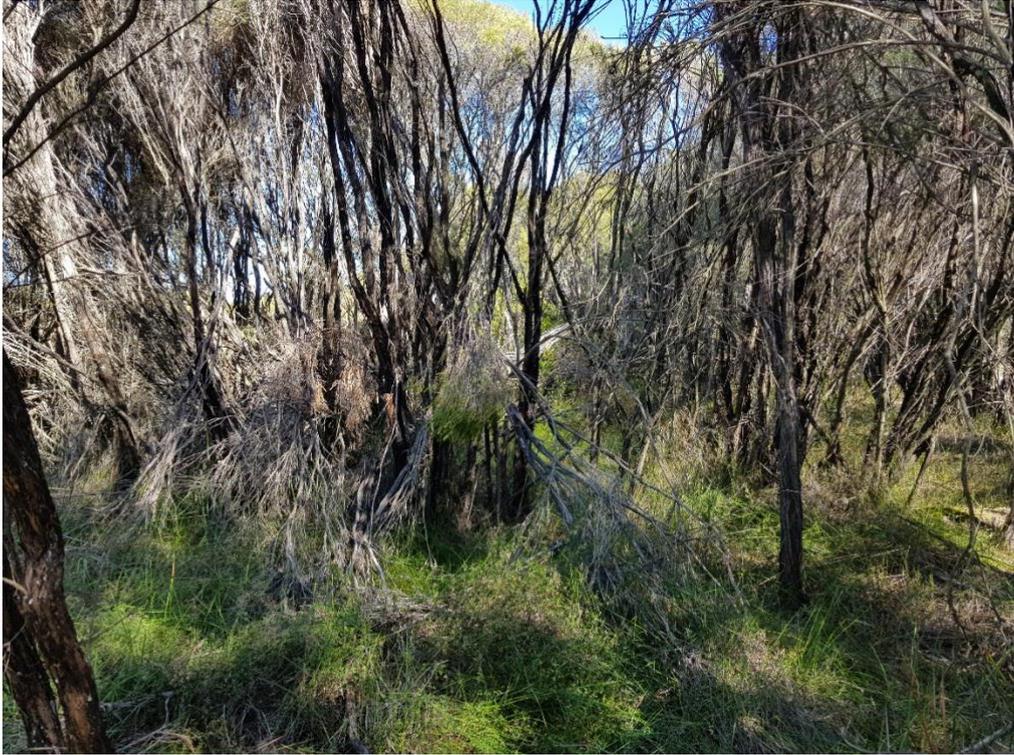
The wetland was found not to be a claypan community, the soil being a sandy-loam at the surface. The vegetation was dominated by *Melaleuca raphiophylla* and *M. viminea*, with an open sedgeland of *Lepidosperma longitudinale* over a grassland of *Sporobolus virginicus*. On Lot 160 *Opercularia hispidula* is one of the understorey species (**Figure 2**). With normal winter rains the wetland is inundated to a depth of 0.5-0.7 m.

Figure 2. Photograph of the wetland where it extends into Lot 160.

The wetland visited on Lots 5 and 160 south of Centenary Road was found not to be a clay-based wetland, and therefore is not a potential occurrence of the 'Clay pans of the Swan Coastal Plain' TEC.
