Structures Engineering

Routine Visual Bridge Inspection Guidelines (Level 1 Inspections) for Bridges

Document No: 6706-02-2234

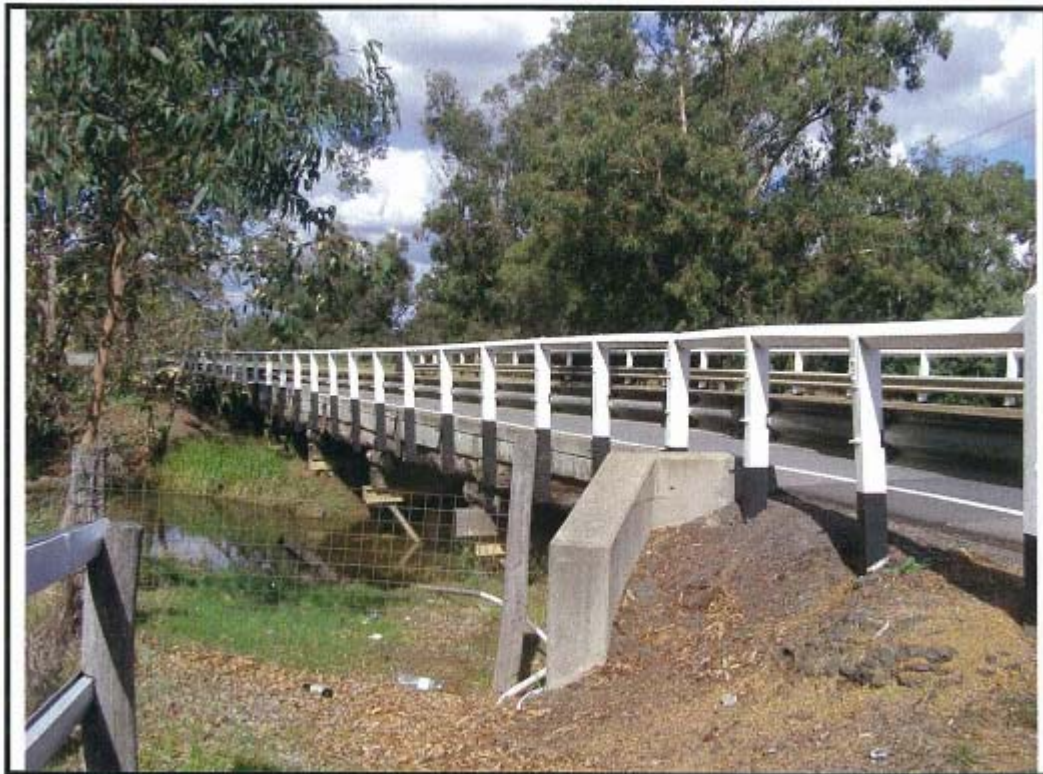
Photo No. 2: LHS View – Note Farmer's Fence

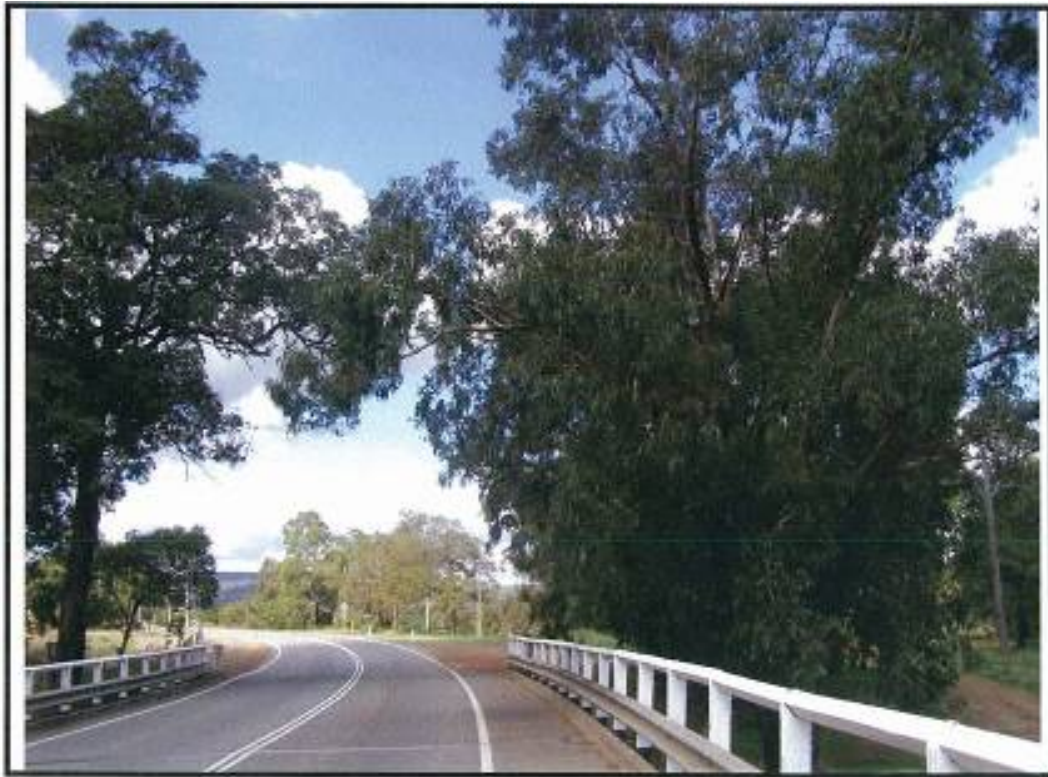
Photo No. 3: Tree Overhanging the Road, RHS

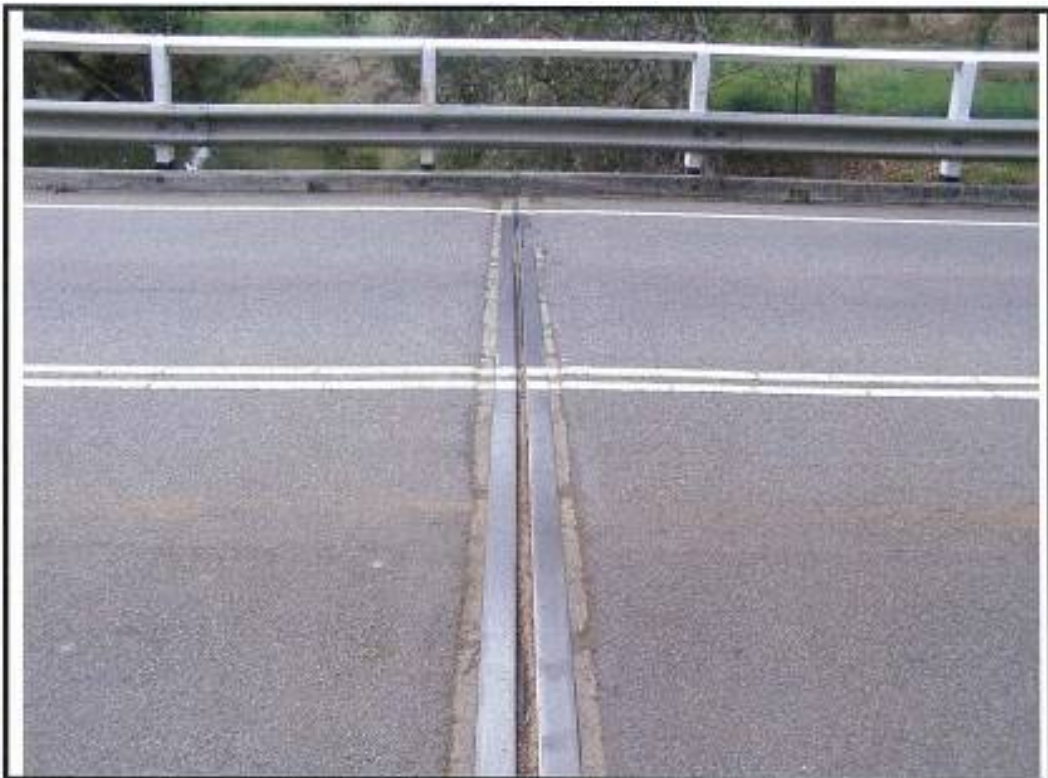
Photo No. 4: Centre Expansion Joint, Full of Debris

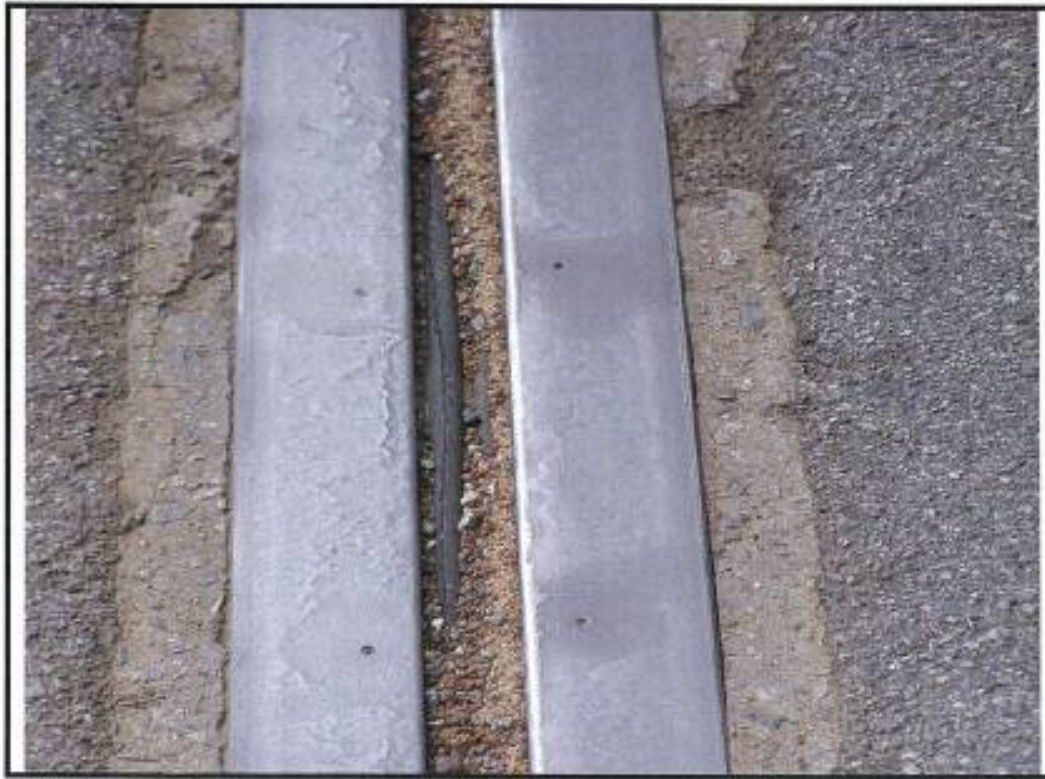
Photo No. 5: Top Surface of Wabo Rubber is Perished

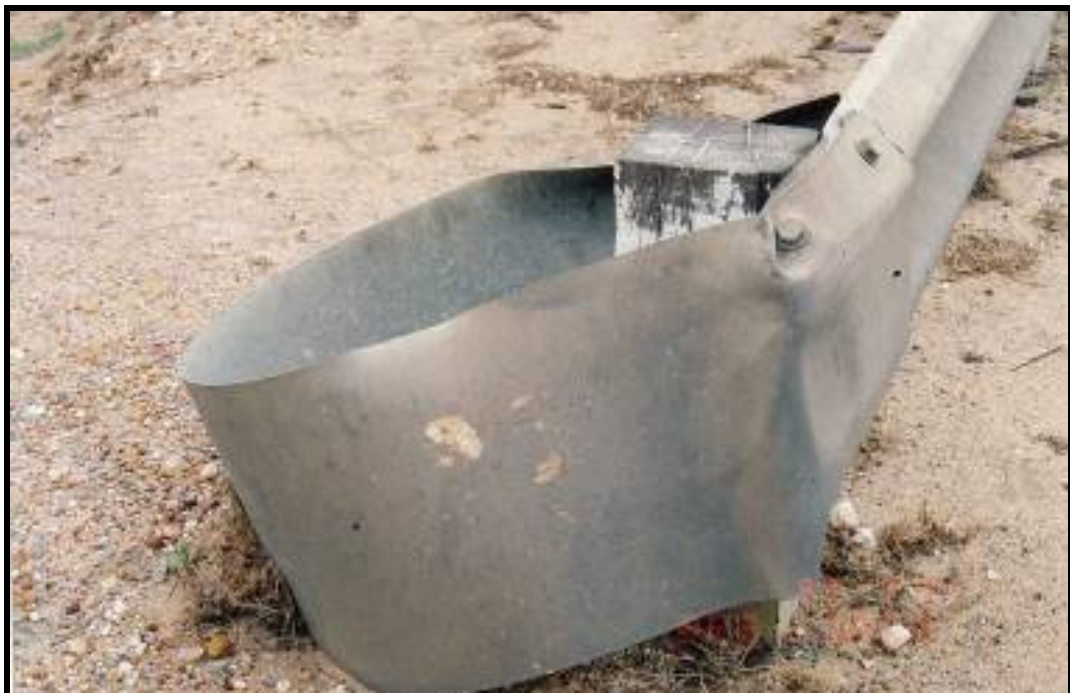
Photo 14 - IMPACT DAMAGE TO BULL NOSE

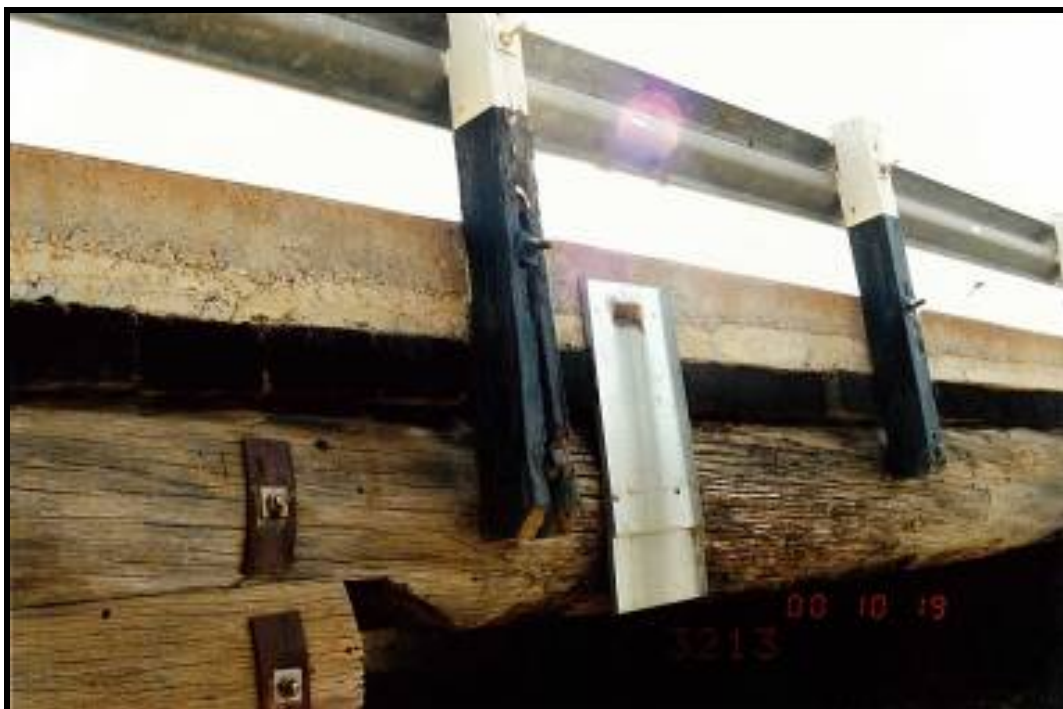
Photo 19 - LARGE VERTICAL SPLIT IN TIMBER POST

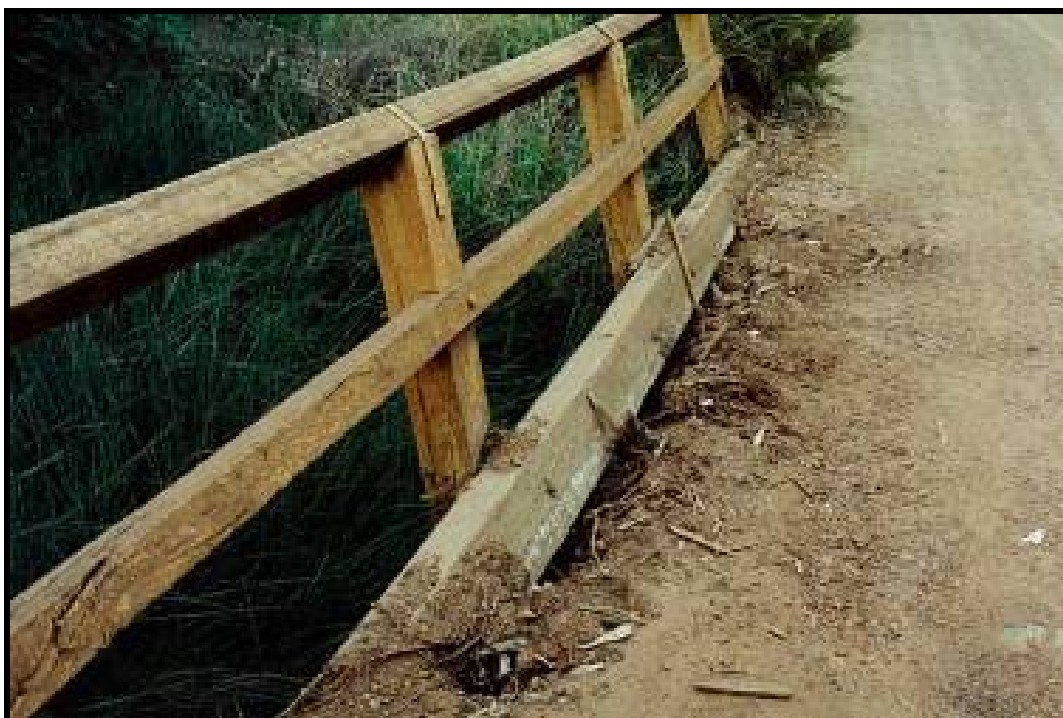
Photo 20 - RAILING LEANING OVER AND KERB DETACHING FROM DECK

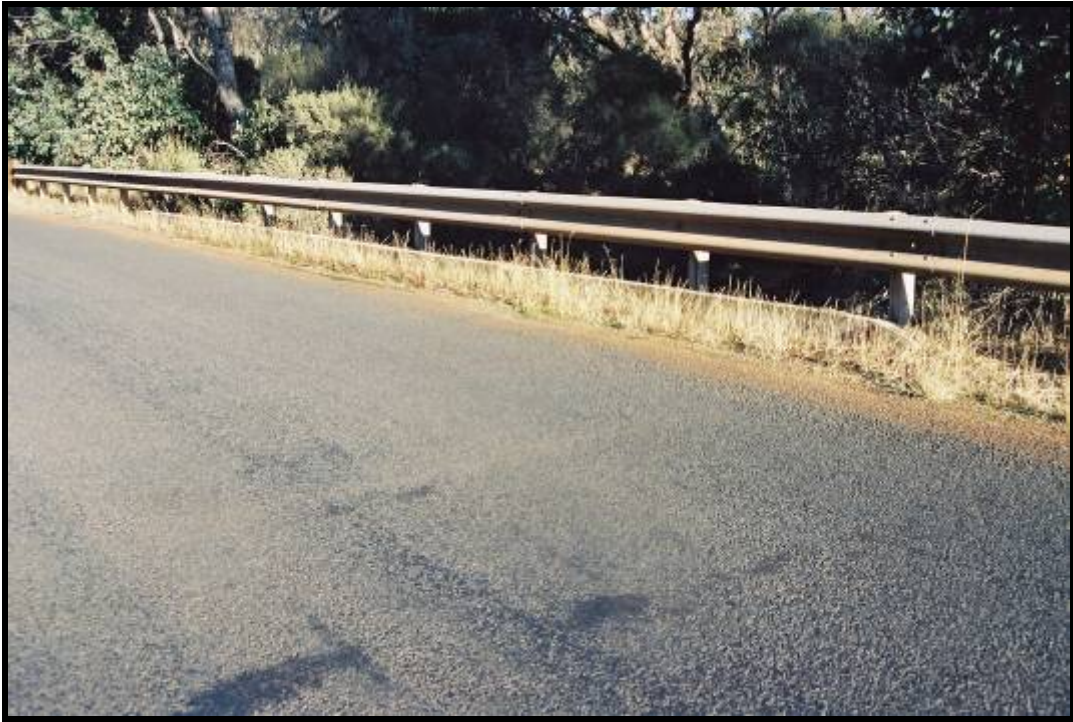
Photo 21 - VEGETATION REQUIRES CLEARING TO ENABLE SCUPPERS TO FUNCTION

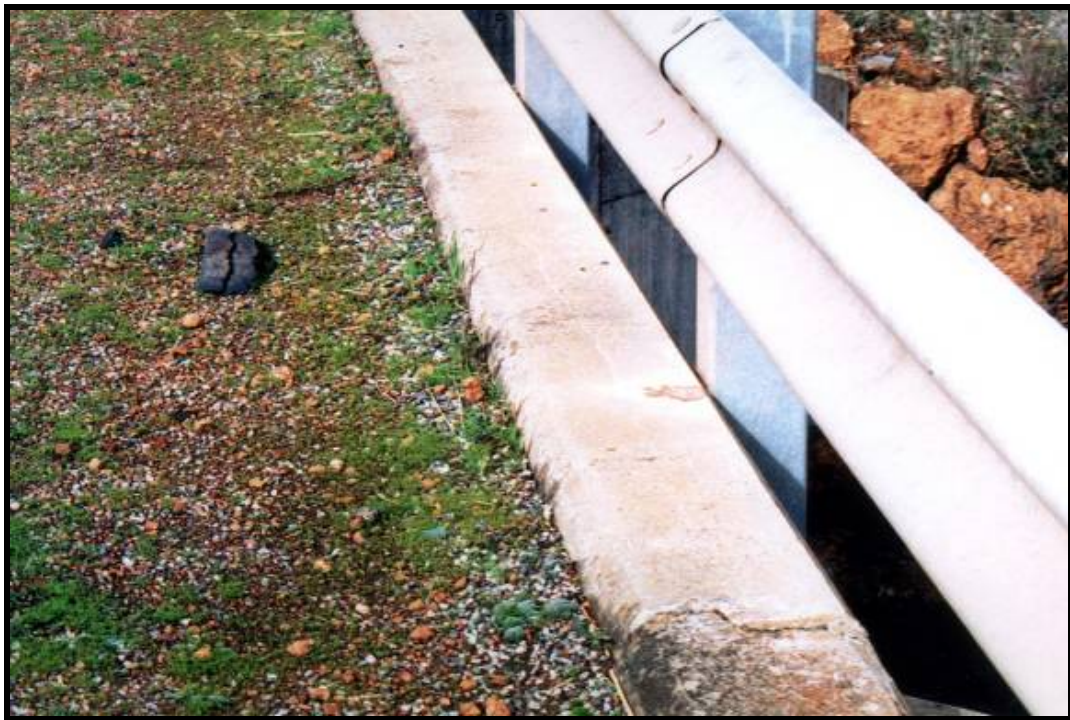
Photo 22 - SCUPPERS ARE BLOCKED BY EXCESSIVE ROAD DEBRIS

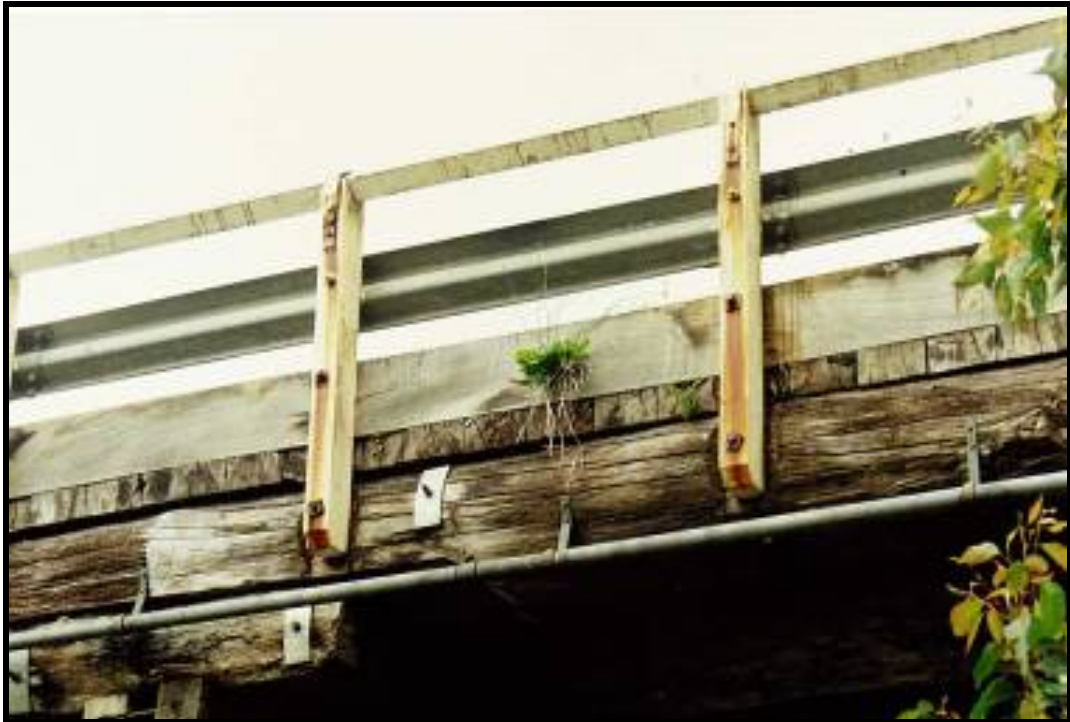
Photo 23 - VEGETATION GROWING THROUGH THE SCUPPER

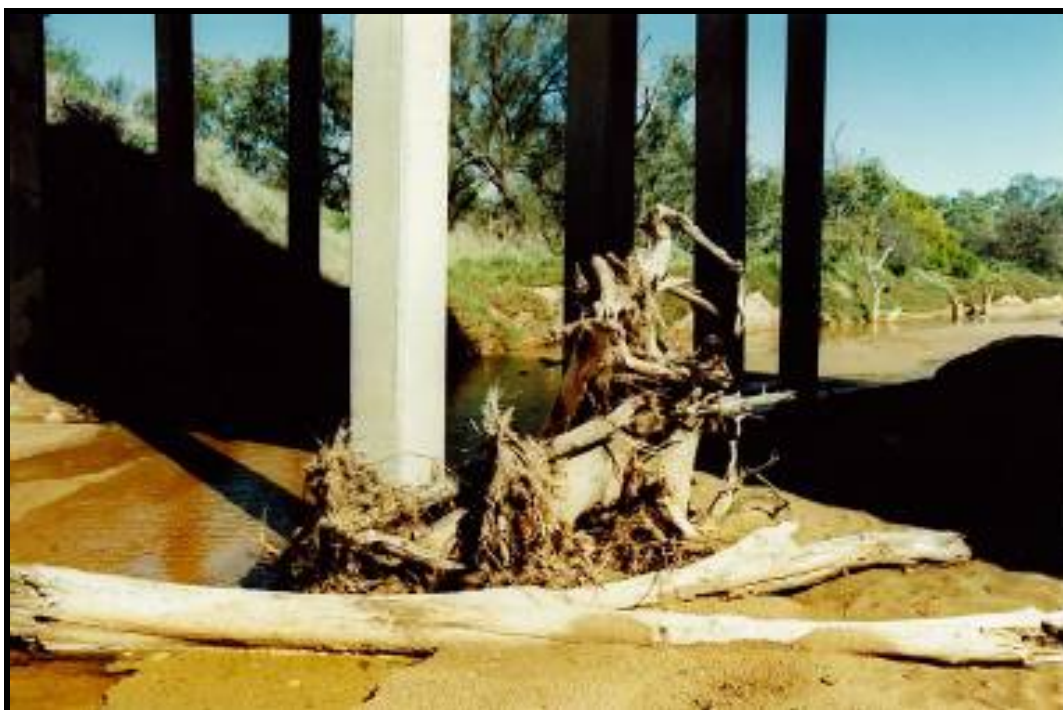
Photo 30 - DEBRIS BUILD-UP AROUND PIER 3

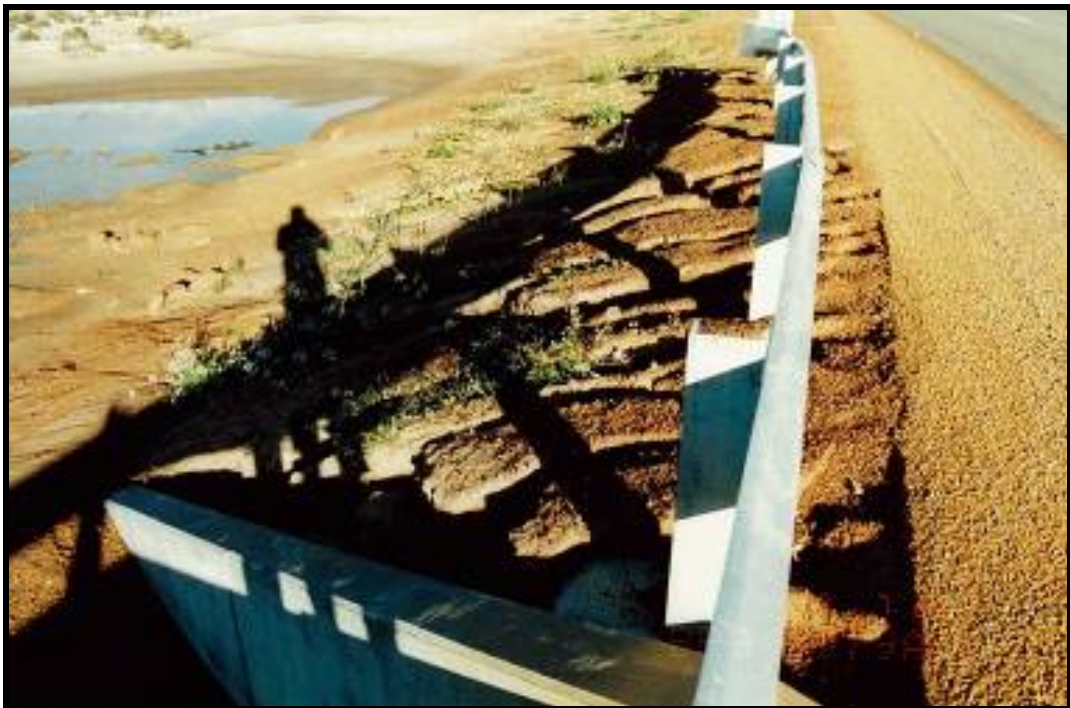
Photo 32 - EMBANKMENT EROSION

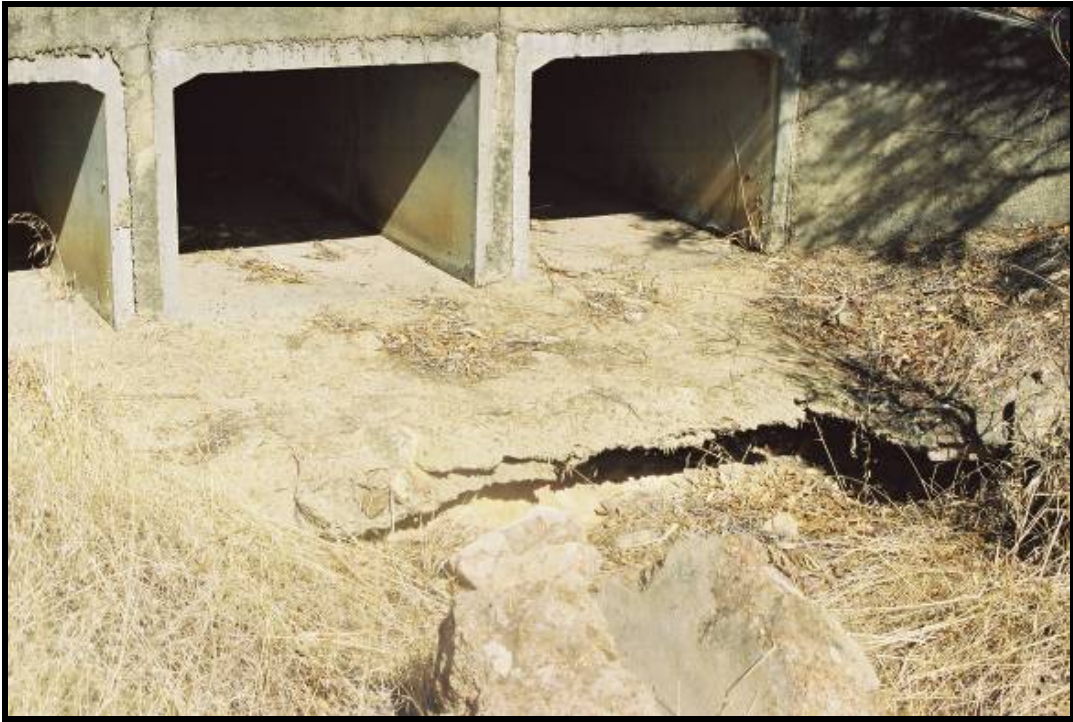
Photo 33 - SEVERE SCOURING UNDER THE INLET APRON

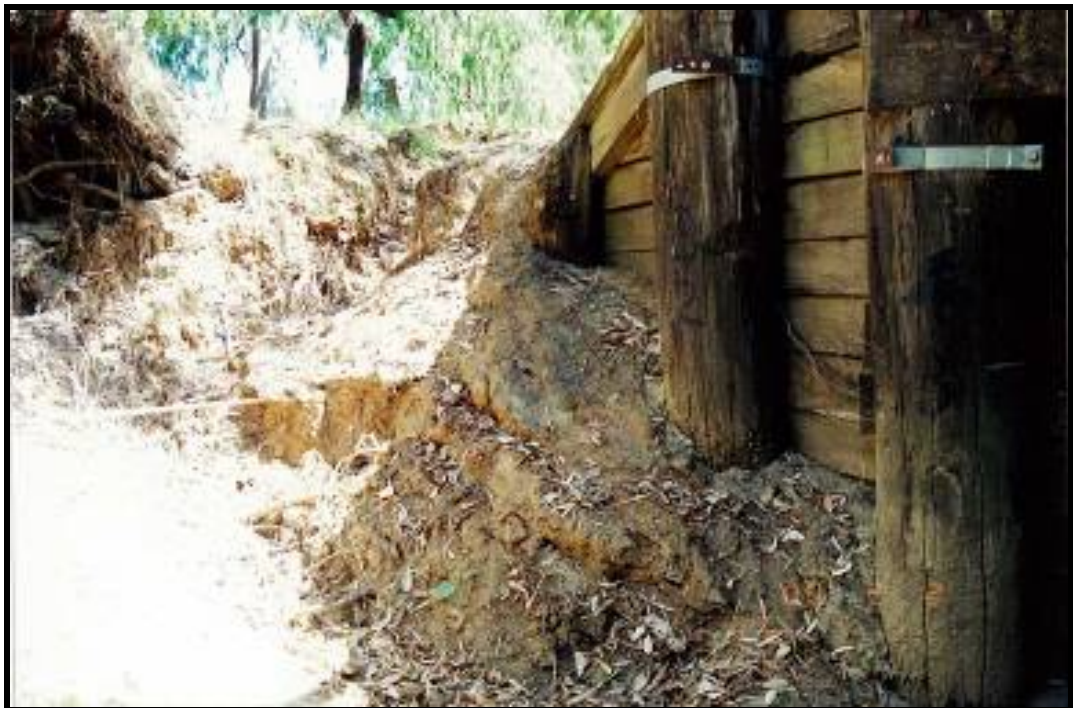
Photo 34 - SCOUR NEAR ABUTMENT WING WALL

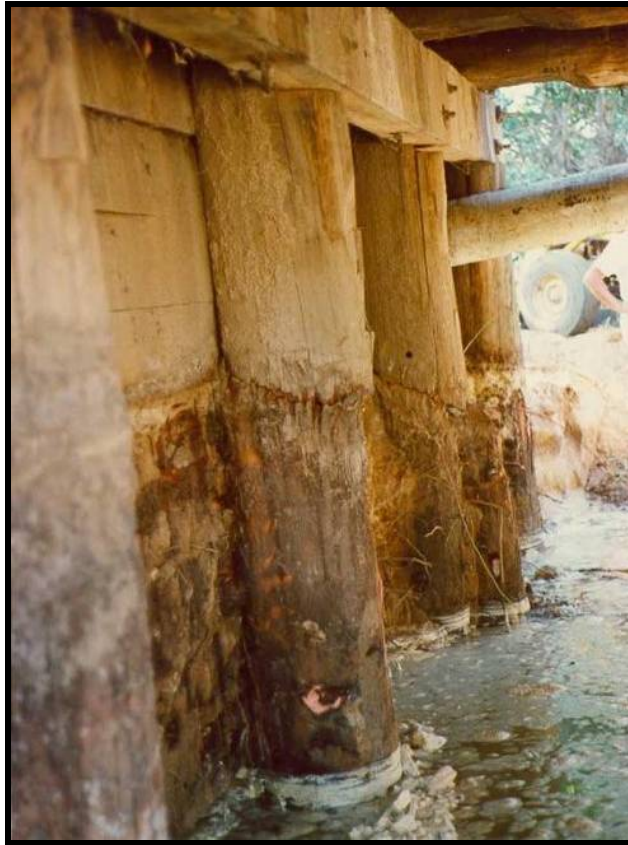
Photo 35 - SCOUR OF ABUTMENT PILES

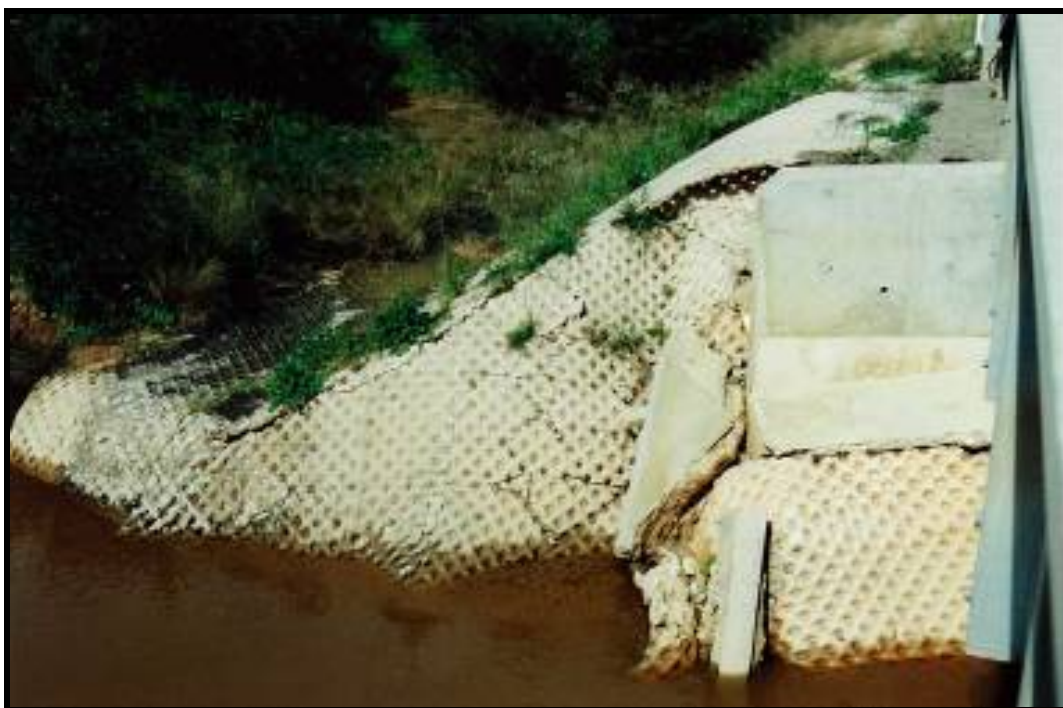
Photo 37 - REVETMENT MATTRESS DAMAGE AT ABUT 1 RHS

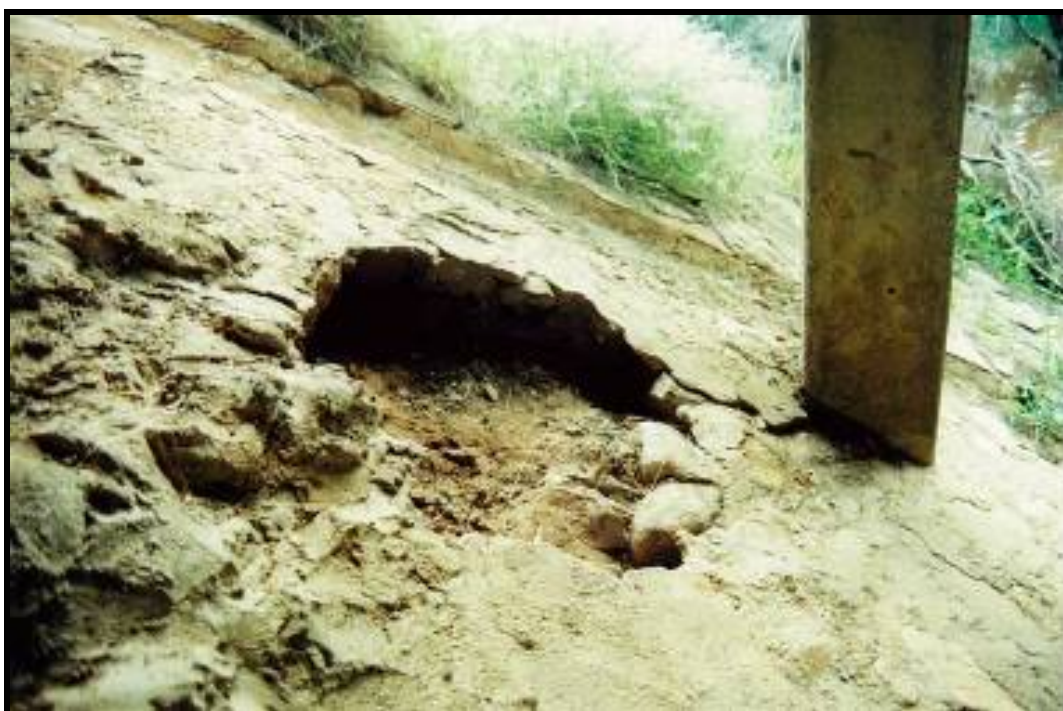
Photo 38 - SMALL SECTION OF STONE PITCHING MISSING AT ABUT 1

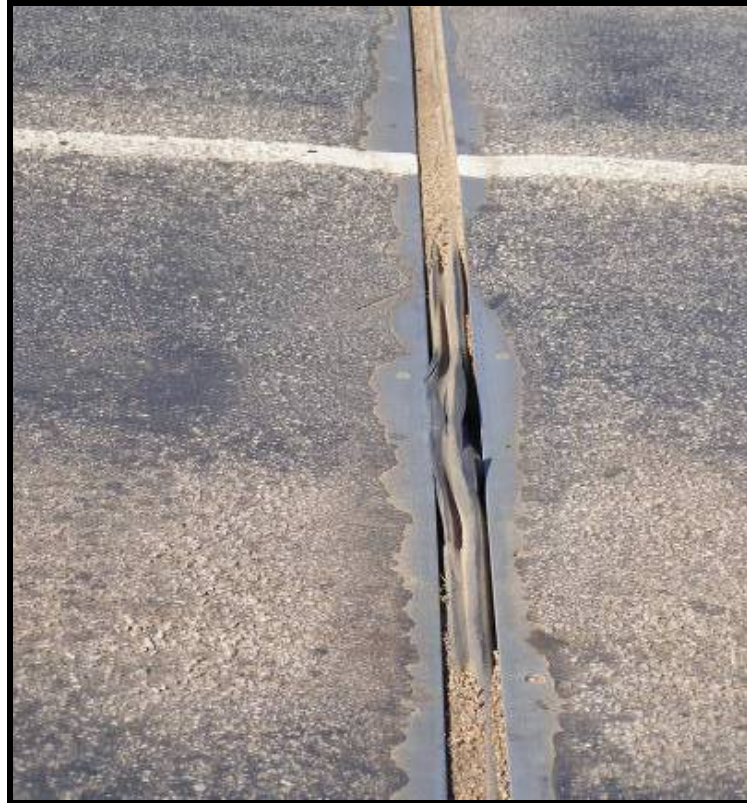
Photo 45 - DAMAGED SEAL IN DECK JOINT

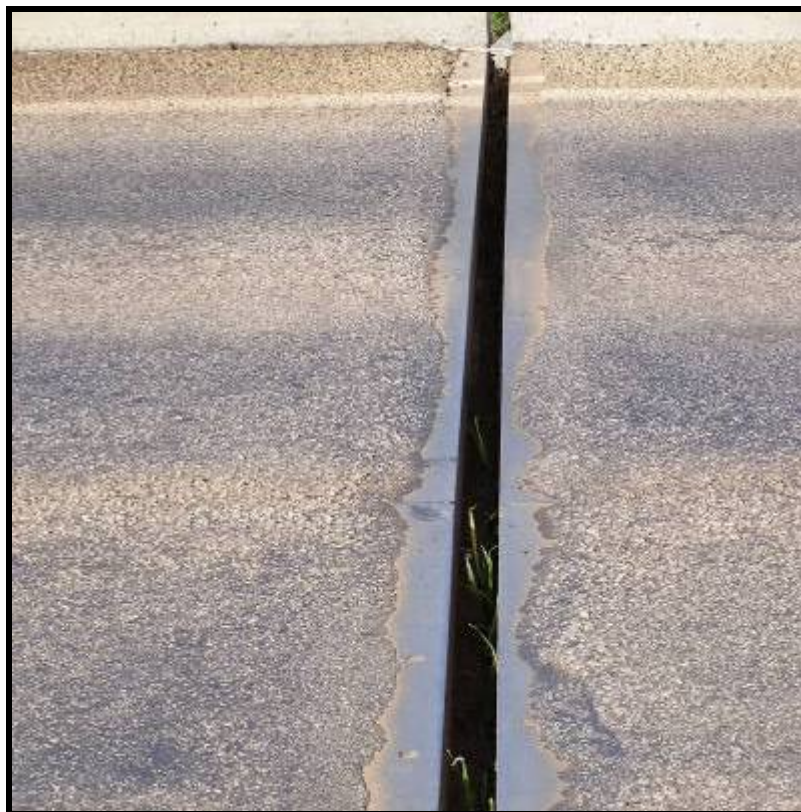
Photo 46 - MISSING SEAL IN DECK JOINT

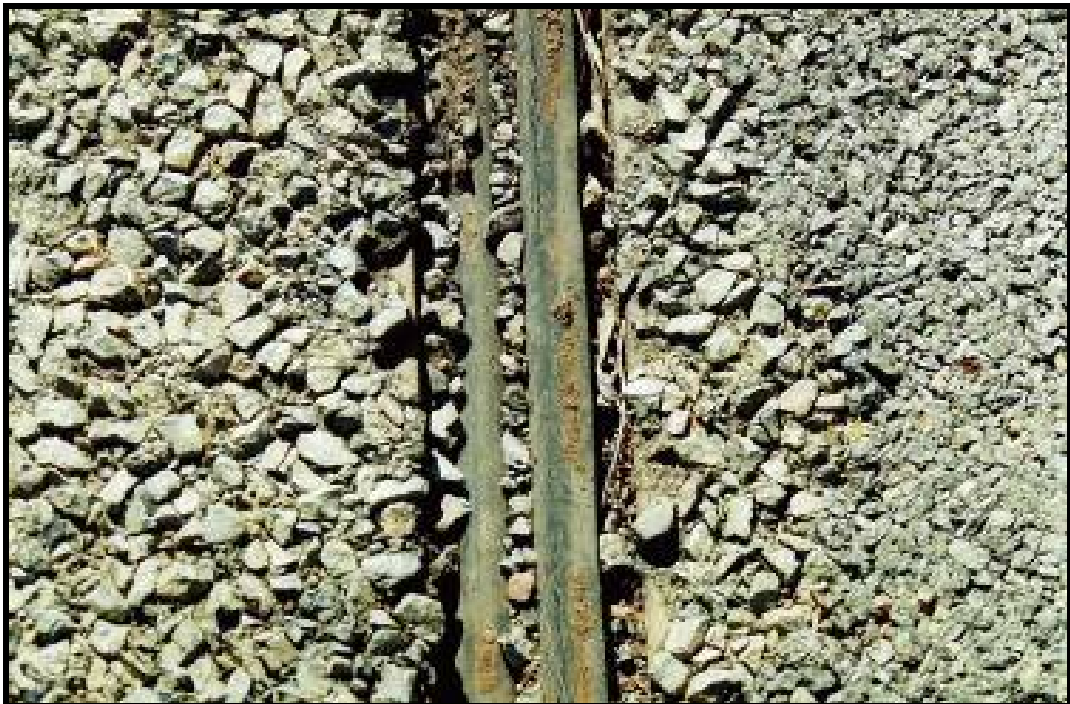
Photo 48 - CLOSE UP OF WABO JOINT

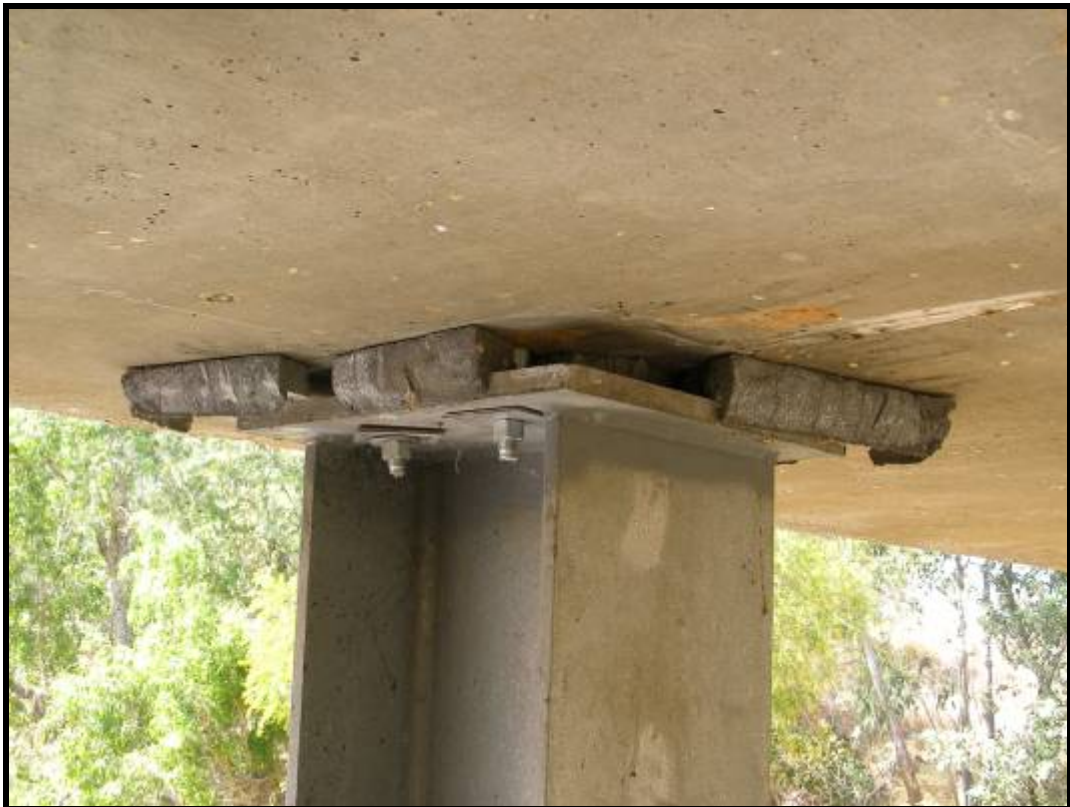
**Photo 54 - PIER 3 COLUMN 1, DRY PACK BREAKING UP
SUPERSTRUCTURE (TIMBER BRIDGES)**

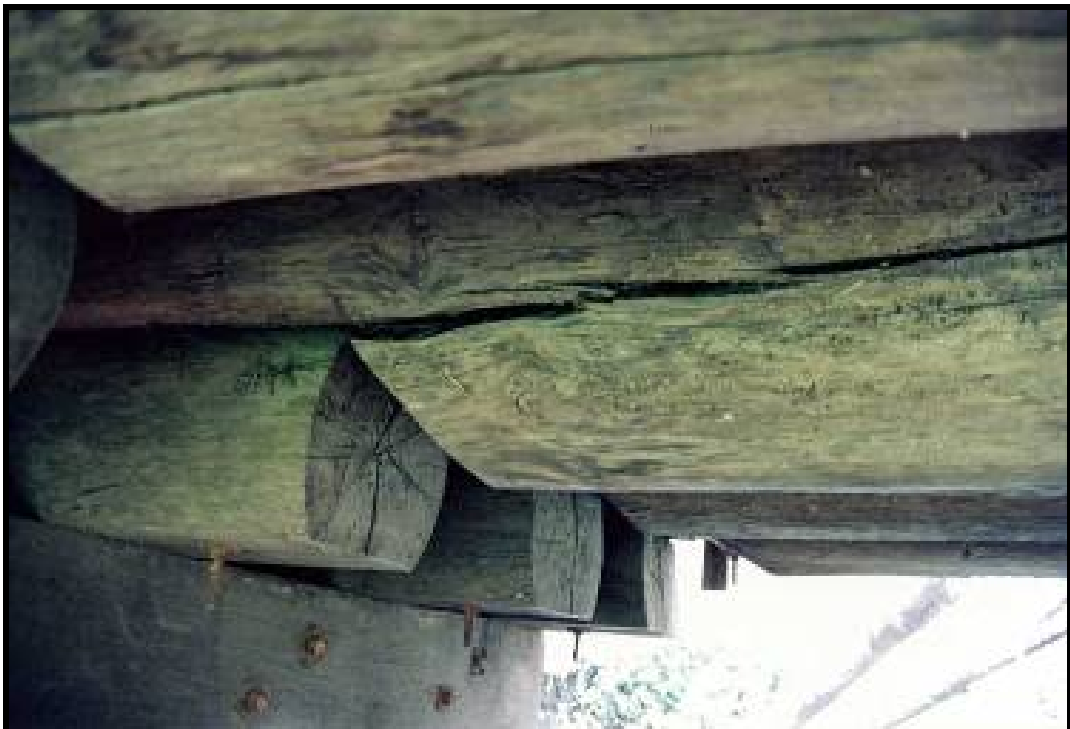
Photo 58 - LARGE HORIZONTAL SPLIT IN STRINGER

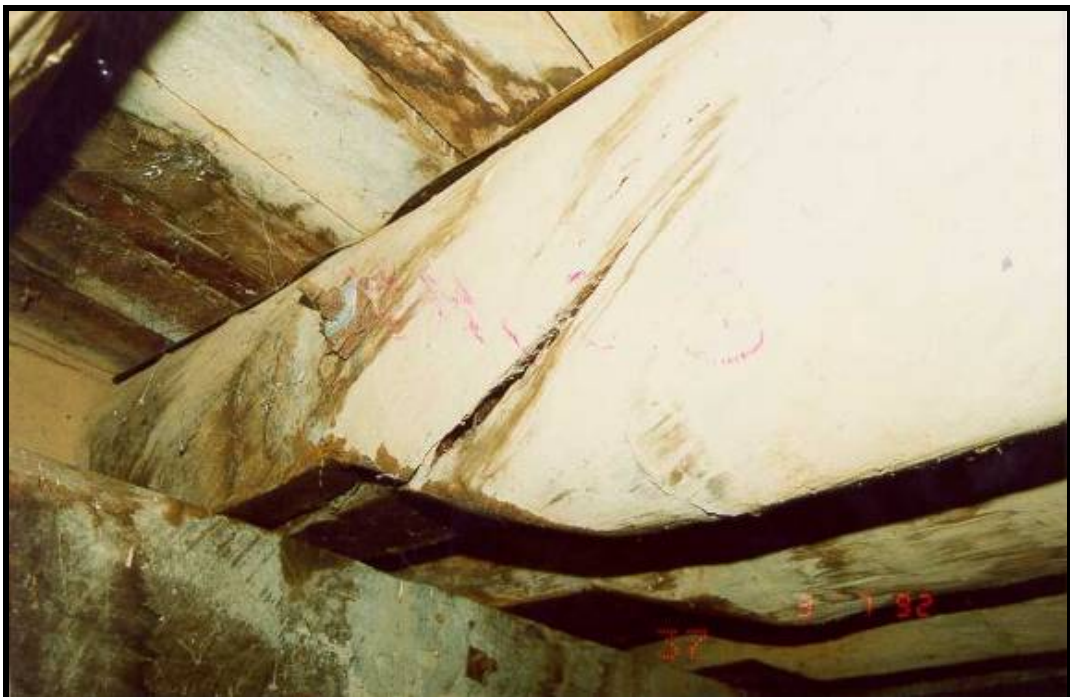
Photo 60 - TWISTING SPLIT IN STRINGER

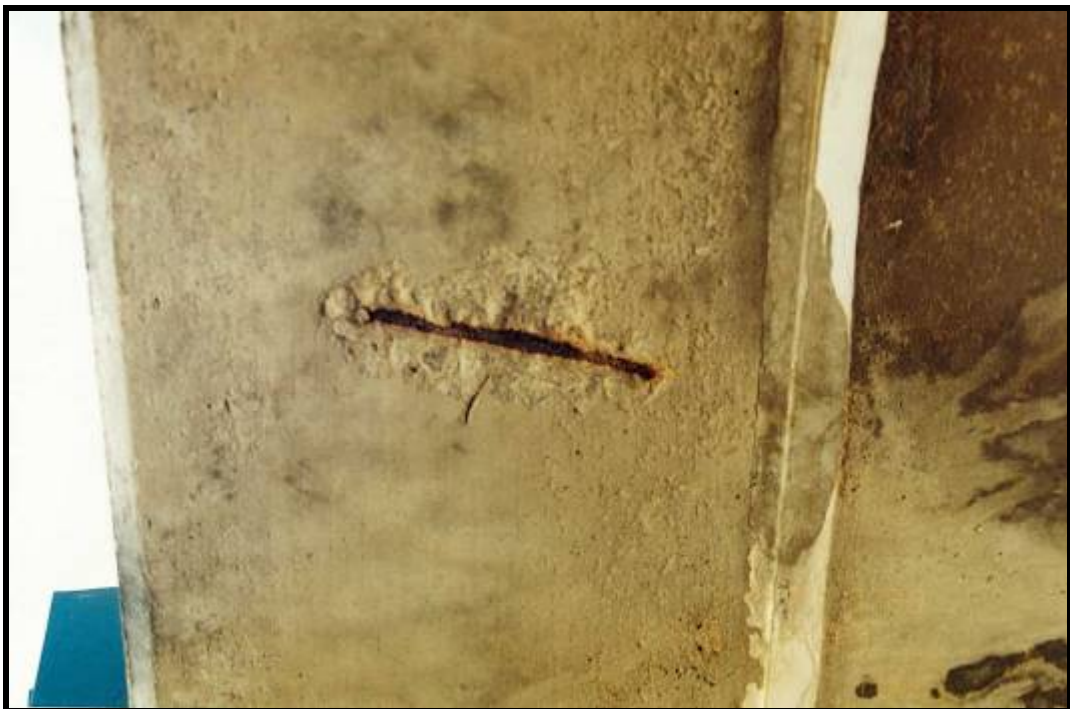
Photo 66 - EXPOSED REINFORCEMENT IN SOFFIT NEAR PIER, LHS (No change since previous inspection)

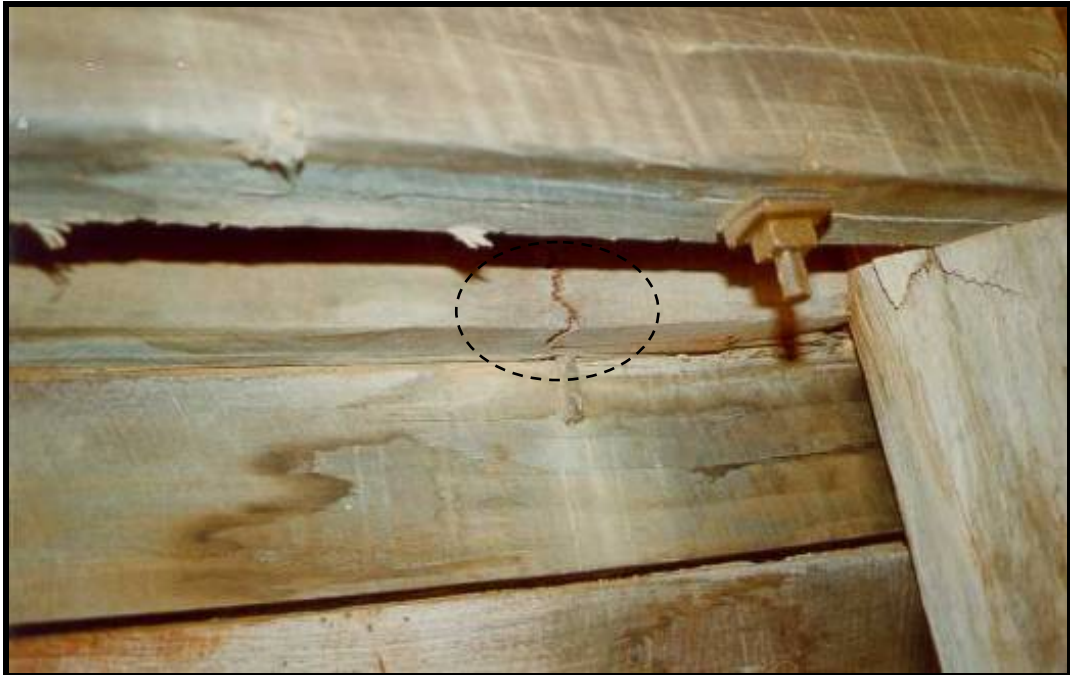
Photo 67 - FAILED REAR HALFCAP

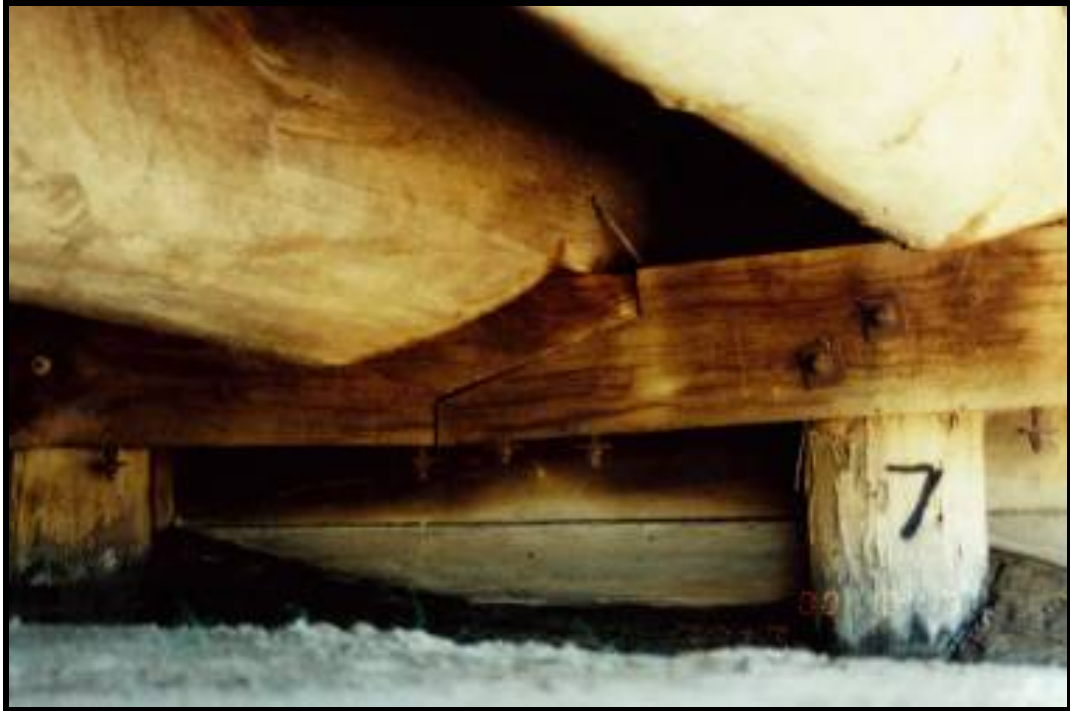
Photo 69 - HALFCAP BOWING AT JOINT LOCATION

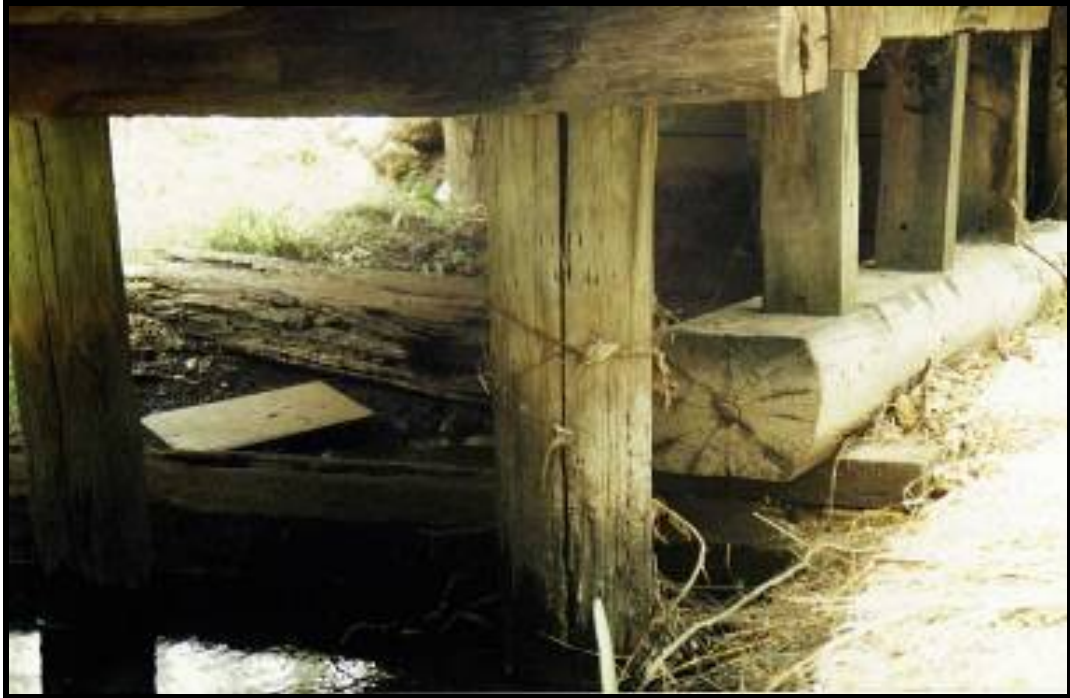
Photo 71 - LARGE VERTICAL SPLIT IN PILE

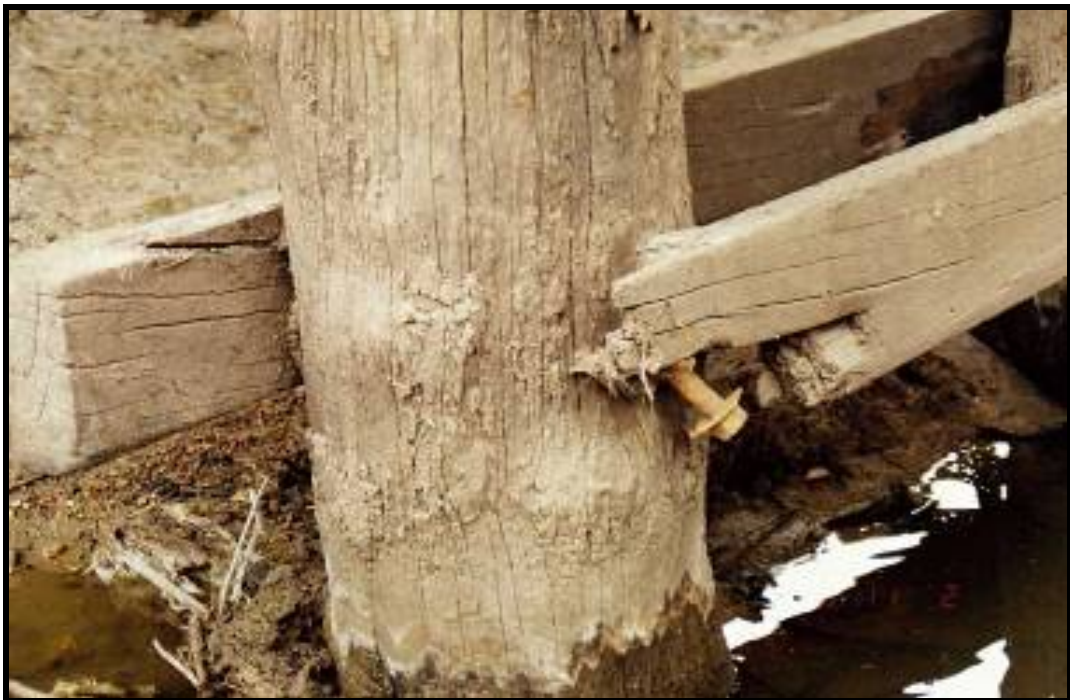
Photo 72 - DAMAGED WALER

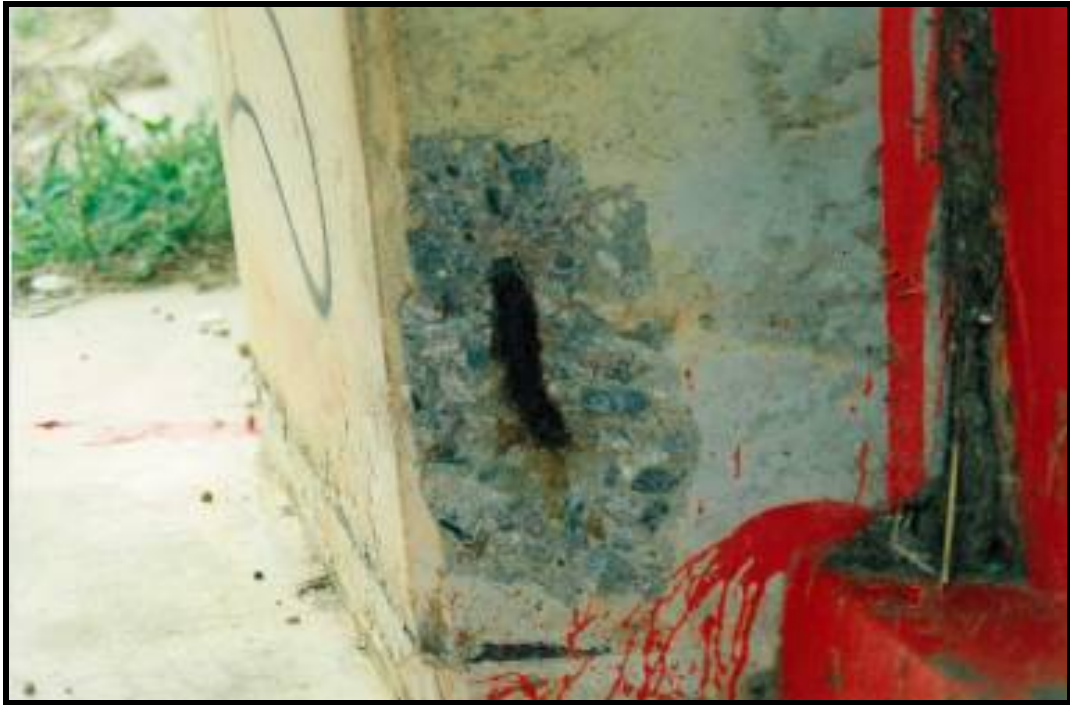
Photo 77 - SPALLED CONCRETE & EXPOSED REINFORCEMENT, PIER 2, COLUMN 1

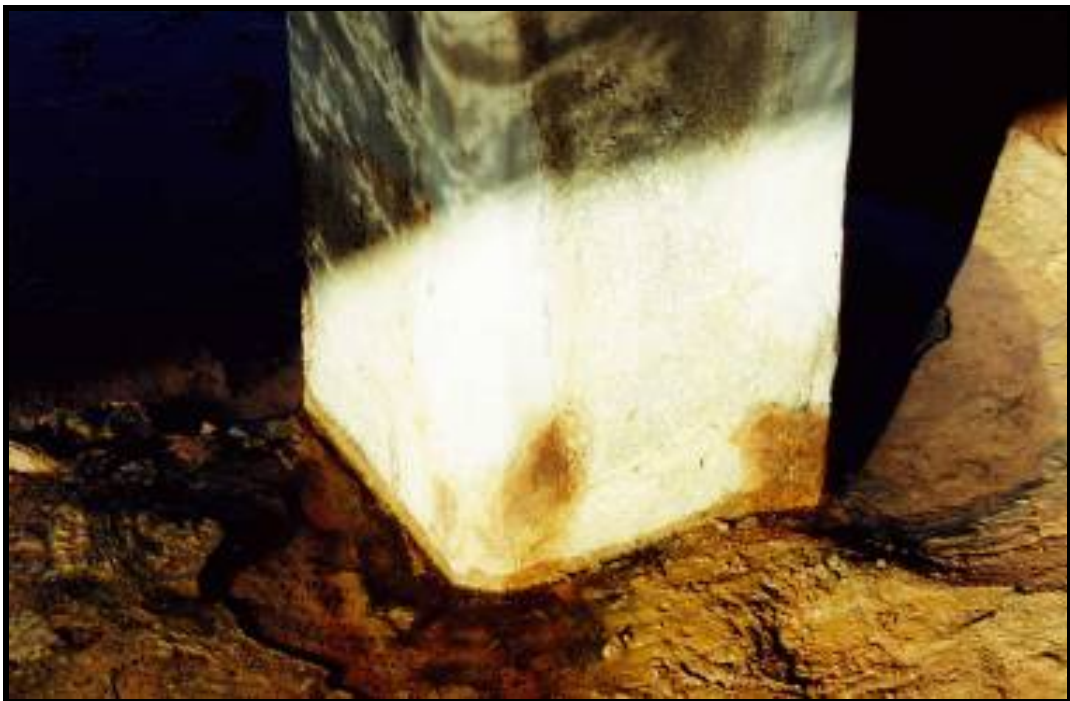
Photo 78 - MEDIUM CRACKS AND RUST STAINING TO BOTTOM OF PILE
