Structures Engineering

Routine Visual Bridge Inspection Guidelines (Level 1 Inspections) for Bridges

Document No: 6706-02-2234

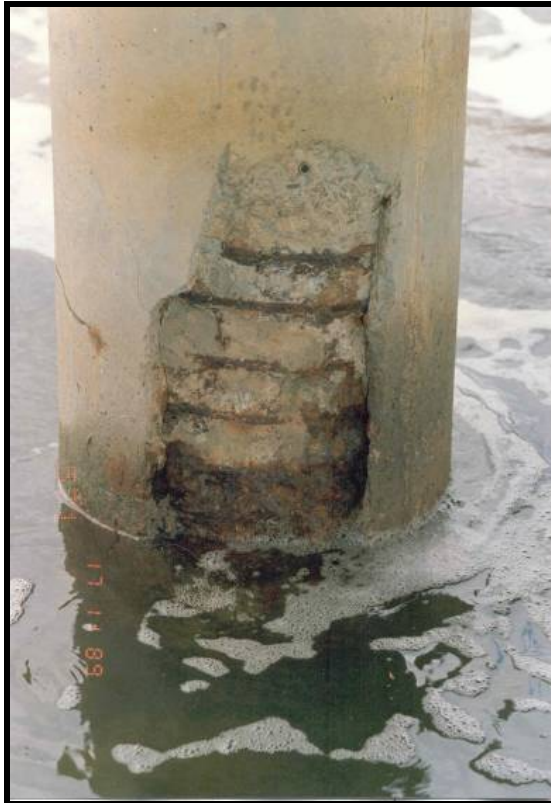
Photo 79 - CORROSION OF REINFORCEMENT ACCOMPANIED BY SPALLING

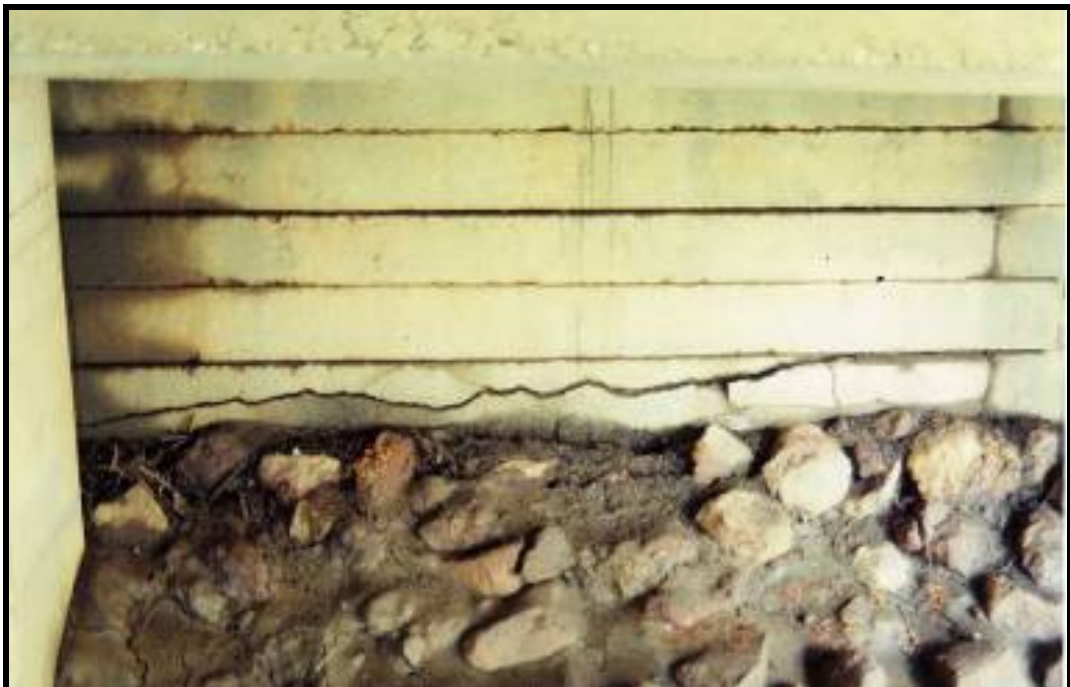
Photo 82 - HEAVILY CRACKED ABUTMENT CRIB WALL PANEL

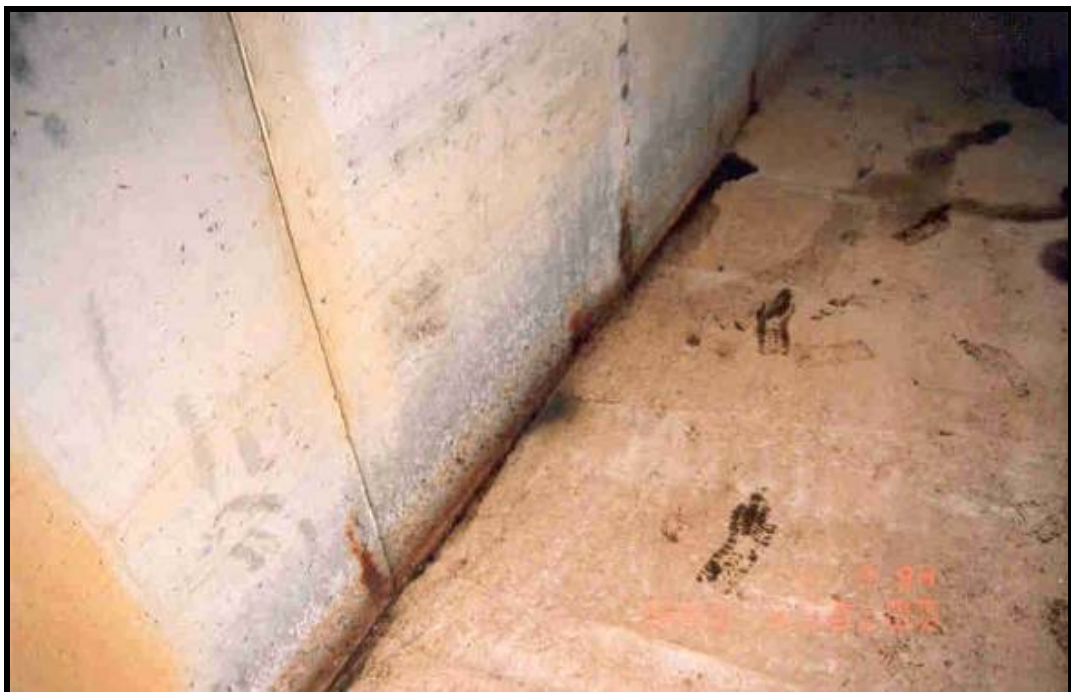
Photo 88 - PRECAST BOX UNIT RUST STAINING, BOTTOM CORNERS OF THE LEGS
