Structures Engineering

Sign Gantry Guidelines (Level 1 and Level 2 Inspections)

SIGN GANTRY INSPECTION GUIDELINES

Document No. 6706-02-2239

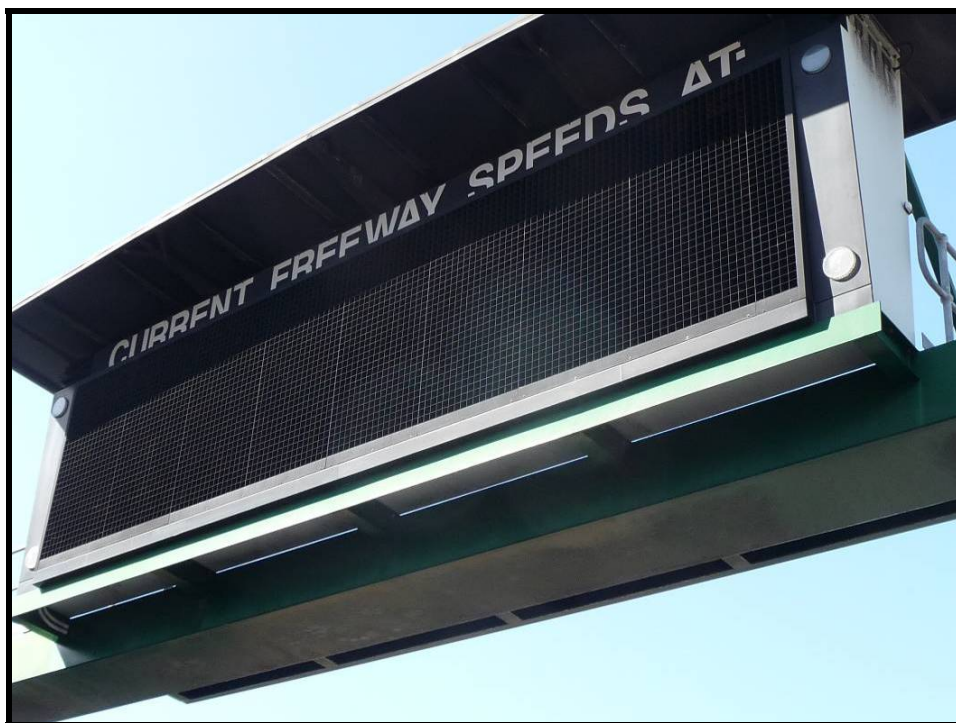
Photo 23 - VARIABLE MESSAGE SIGN – NO DEFECTS OBSERVED

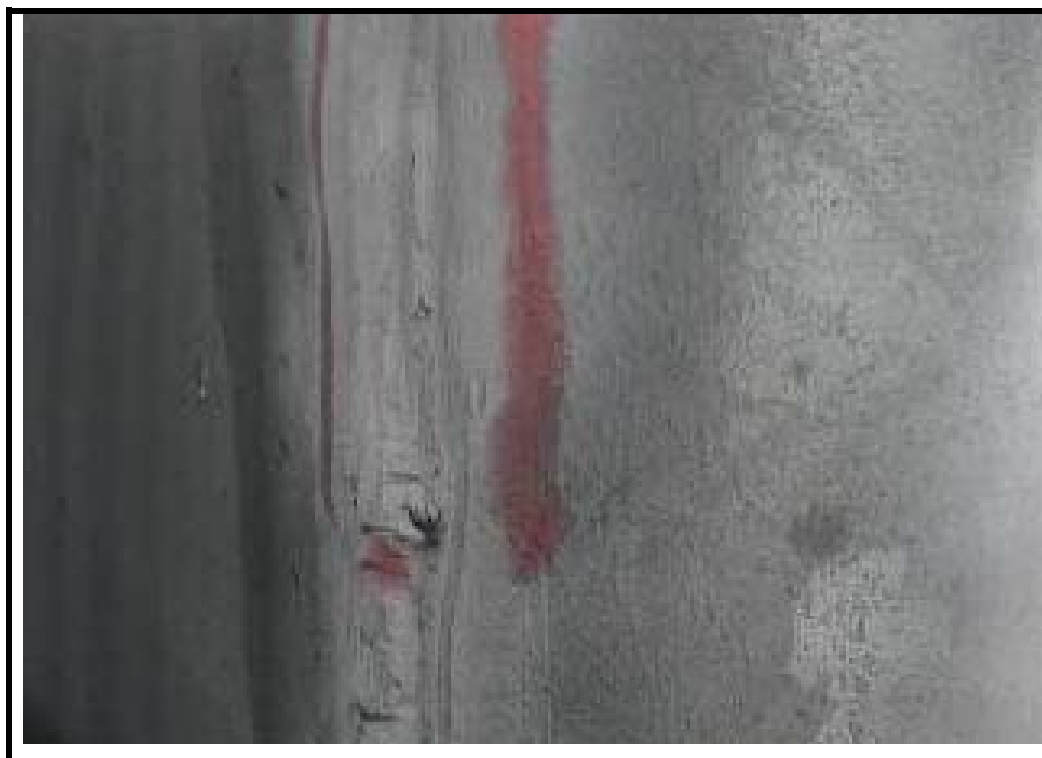
Photo No. 12: Sign connection 1 – close up of slag inclusions

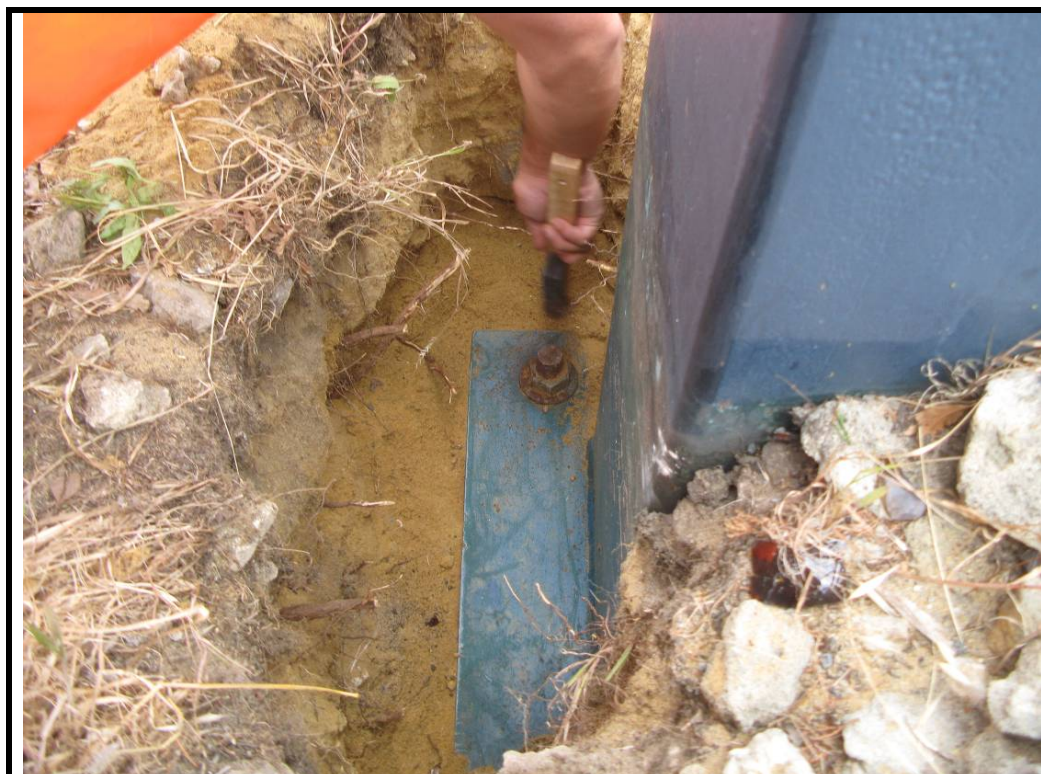
Photo No. 18: LHS column base plate exposed

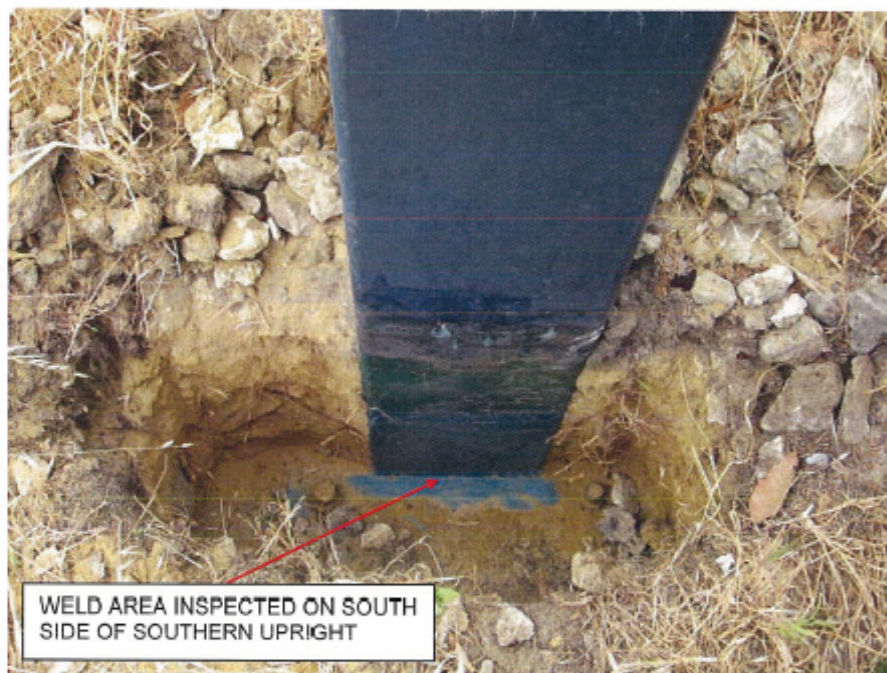
Figure 3

The only nominated weld area suitable for eddy current was located on the South side base plate to gantry upright box section as shown in Figure 3.
